Lake Fork River Improvement Project: Phase II

**Final Report
March 31, 2019**

The Lake Fork Valley Conservancy completed river improvements along approximately 3000 linear feet of the Lake Fork of the Gunnison, at the north end of the Town of Lake City. This is Phase II of a three phase project to improve the river through Town.

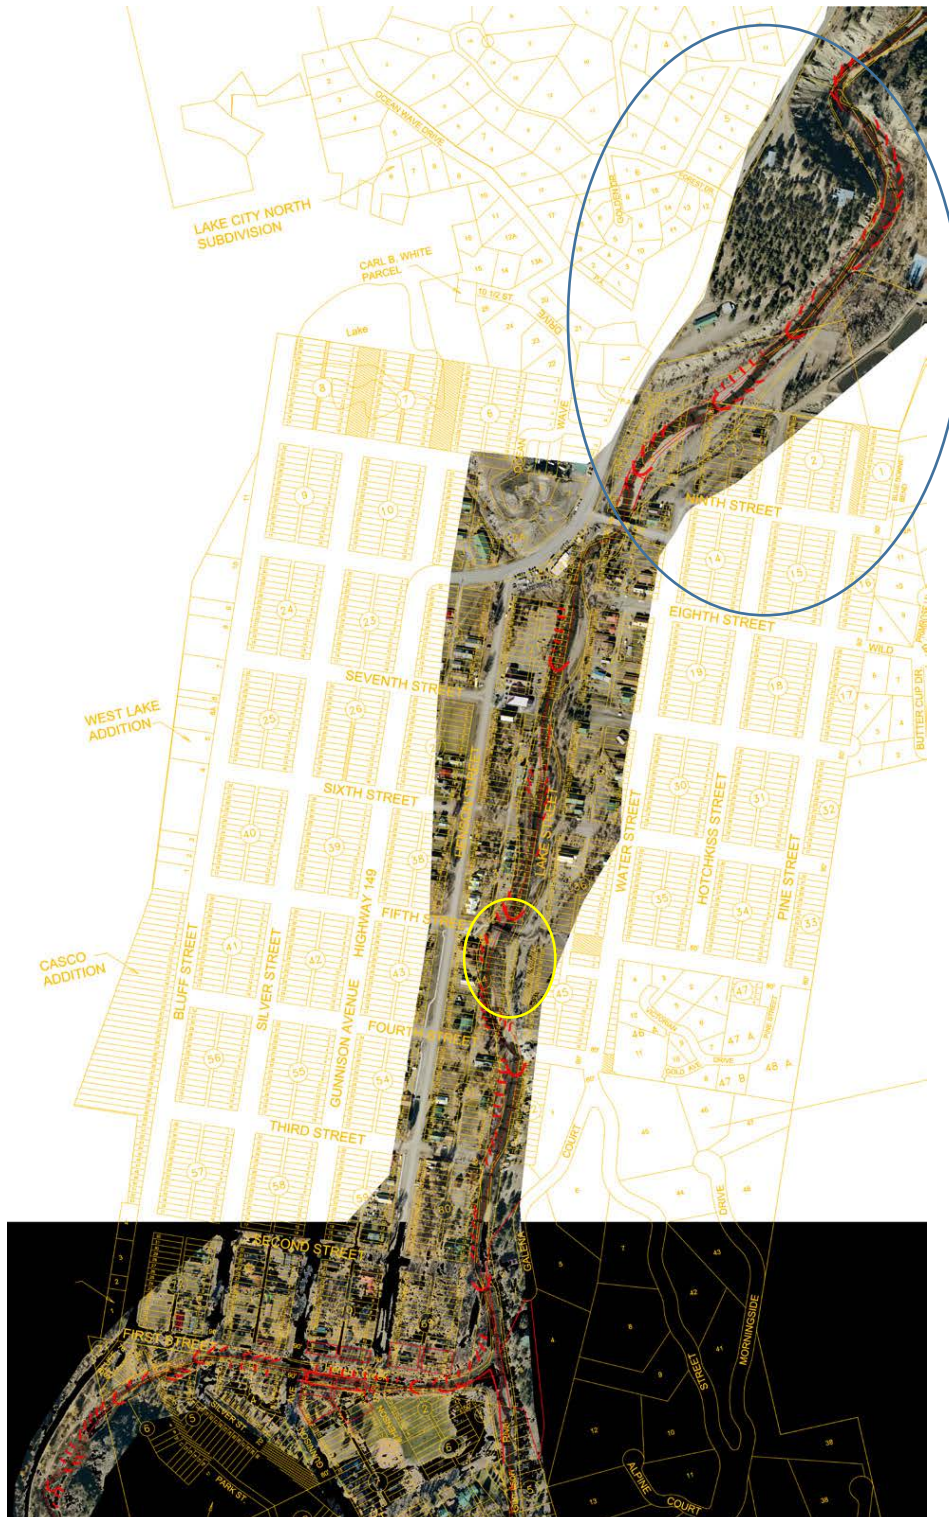
Figure 1. Comprehensive River Enhancement Project Area. Phase II is below the 8 ½ Street Bridge and also upstream near the 5th Street Pedestrian Bridge, within the ovals below. Phase III will be the remaining areas between 2nd Street and 8 ½ Street Bridge. See Appendix A for Design Drawings.

The area below the 8½ Street Bridge (in the oval in Figure 1) has never been developed, although being primarily private parcels owned by the Main Family, Brad Griffith, and Silver

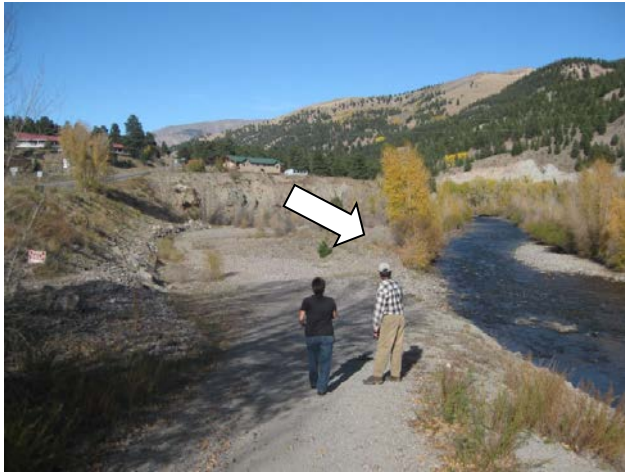
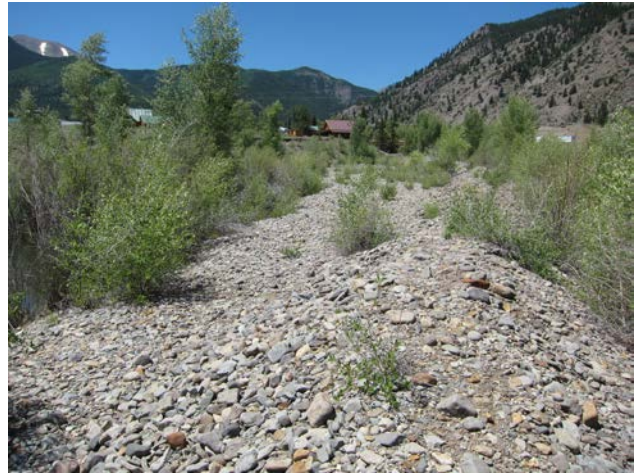
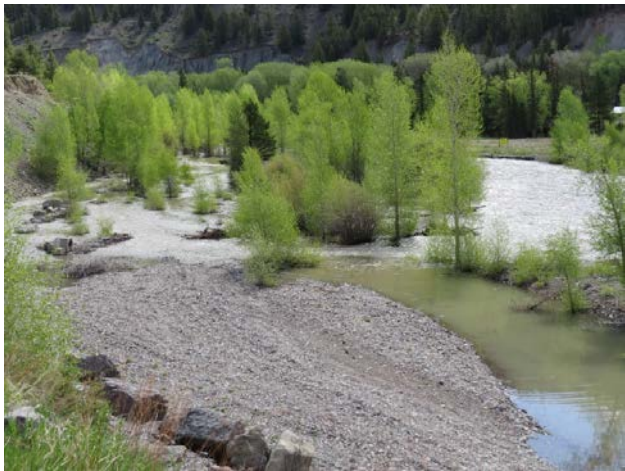
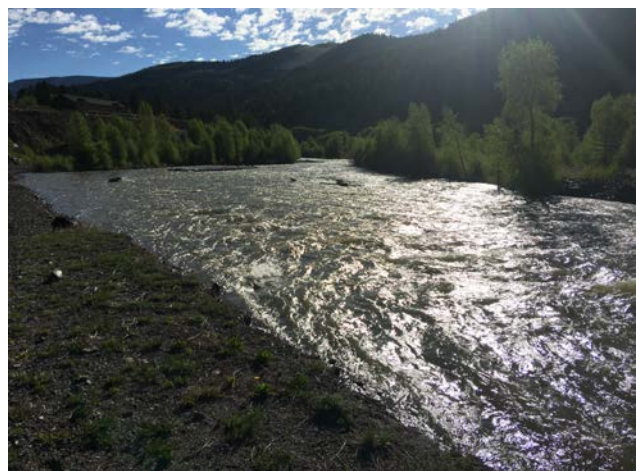
Figure 3. Pre-construction photos of area pre-flood (2009) and post-flood (2014 and 2016). In 2015-16, many of the trees on the left bank were lost. The first photo shows the gravel berm on the west side. This one was mostly washed out with the high flows in 2014-16 (third and fourth photos). The second photo shows the old gravel berm on the east side of the river, which was removed.

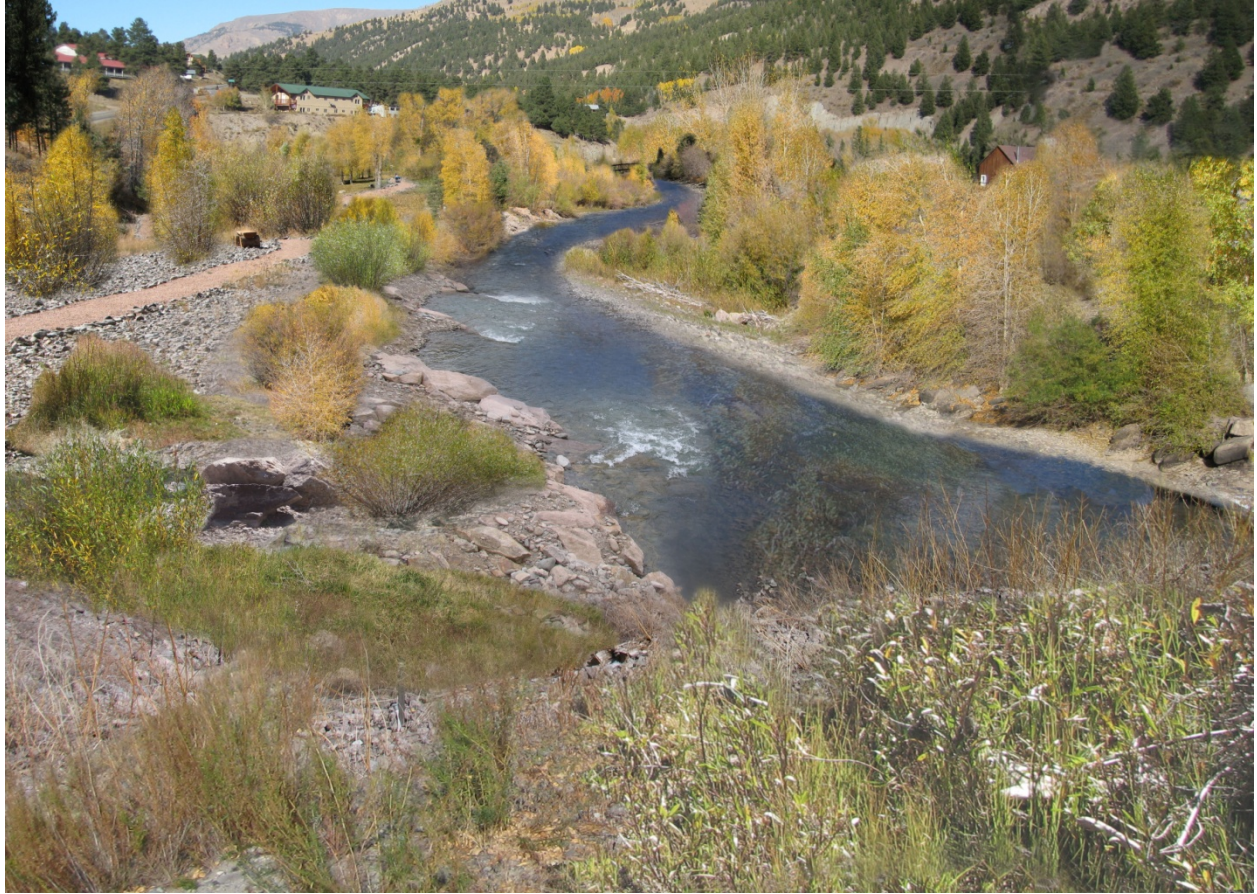
Figure 4. A graphical rendition of proposed improvements on the Lake Fork below the 8 ½ Street Bridge in Lake City with trail and revegetation within the proposed open space river park.

Figure 4 shows what we hope the area will look like once we manage to get significant vegetation to establish.

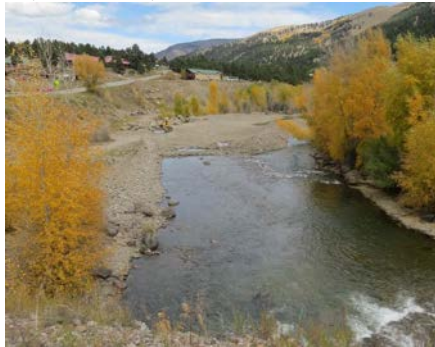
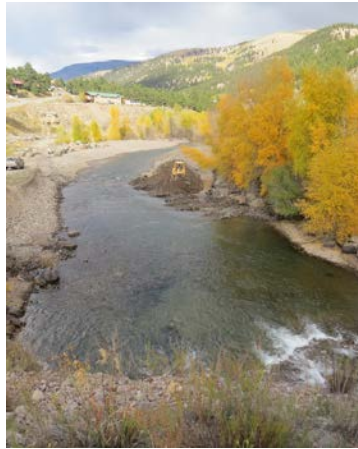
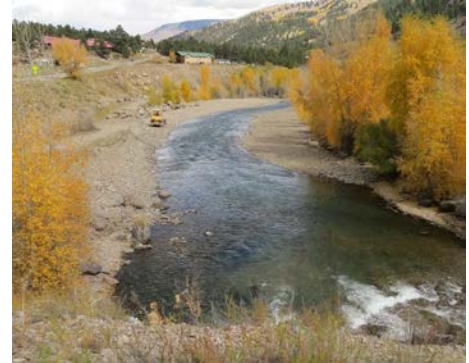
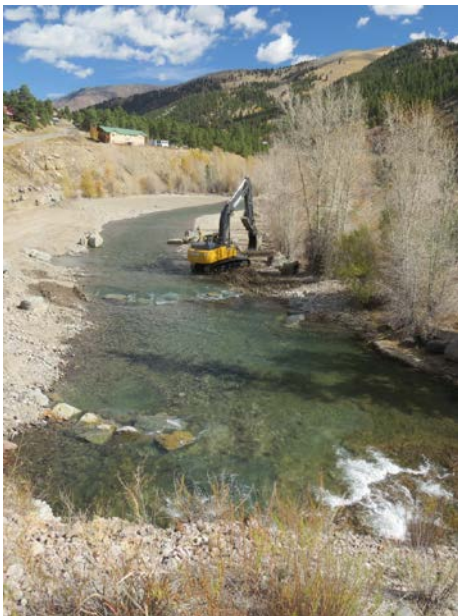
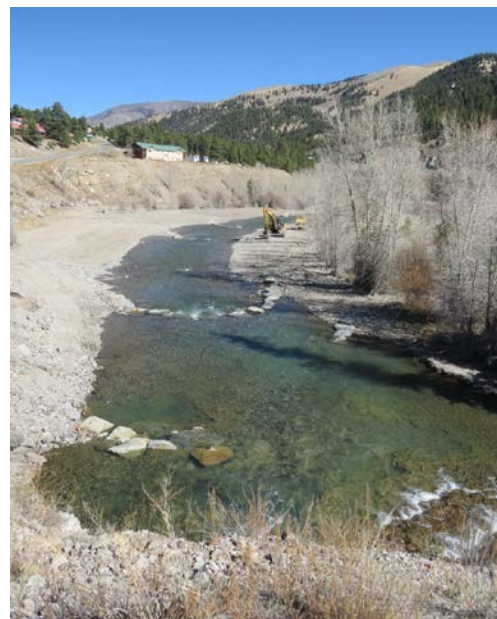
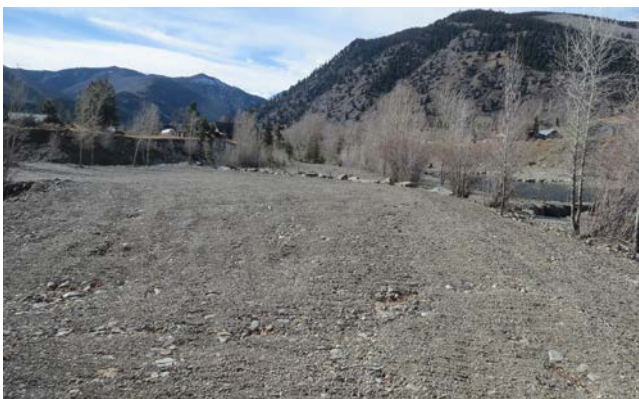
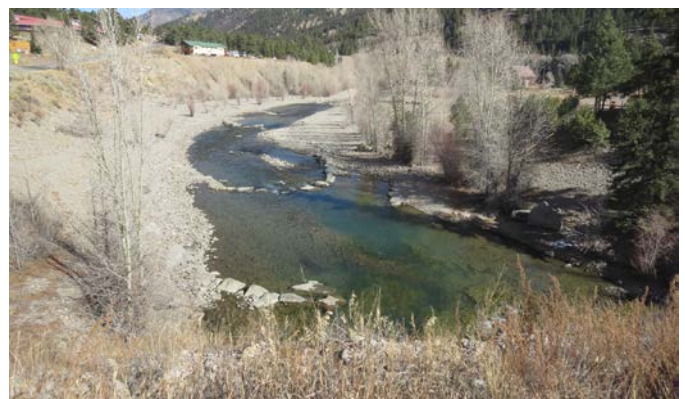
Figure 5. Reshaping of the flood plain and structure installation below the 8 ½ Street Bridge (fall 2016). The second to last photo is looking back toward the bridge and shows where a large area of berm was removed. Last photo is the area after one year of high flow (fall 2017).

of 8½ Bridge were removed (see photo montage in Figure 5). Any shrubs and trees disturbed during reshaping were transplanted to newly created floodplains (see Task 3). We had to reduce the number of smaller structures such as clusters and vanes due to the large size of the boulders that were delivered. Once the large cross vanes and j hooks were constructed, we did not have enough rock to complete all proposed structures. But this ensures that these larger structures will withstand higher flood levels. Vanes we were able to construct were strategically placed in critical bends of the river to ensure stability.

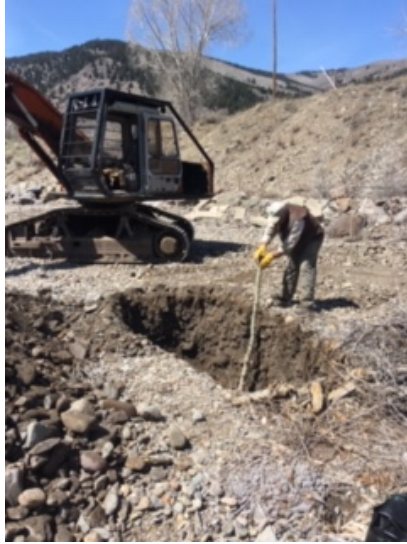
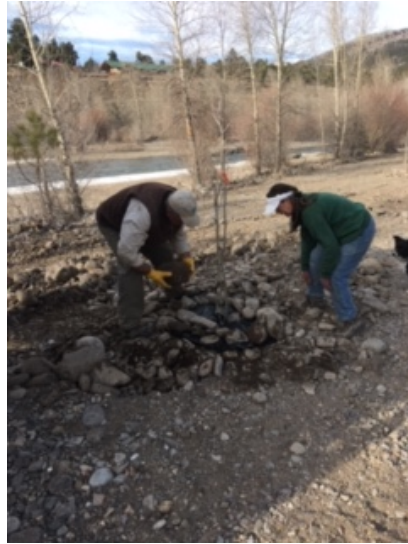
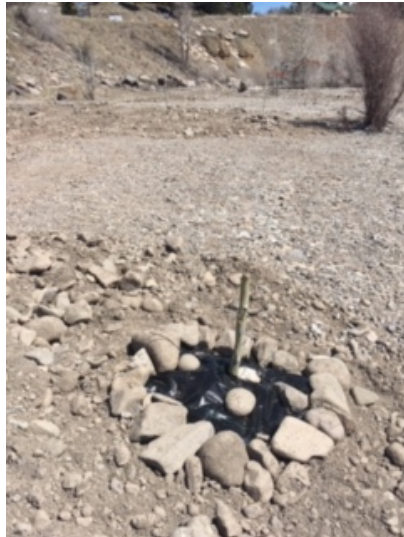
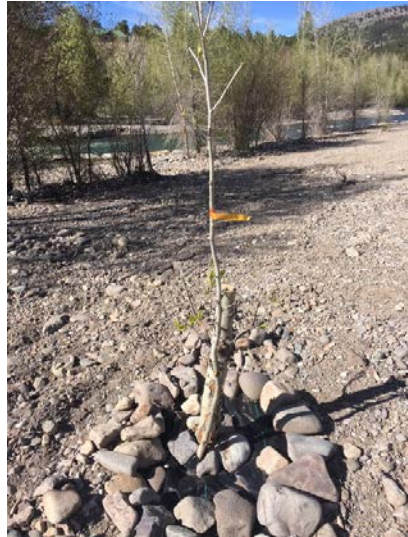
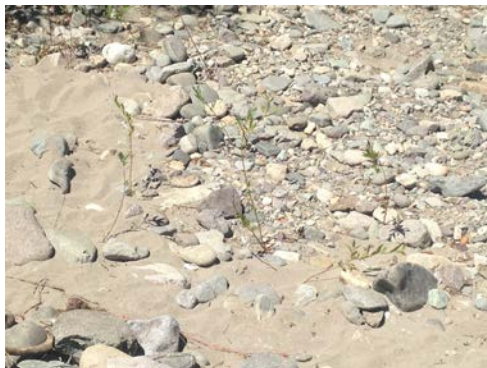
Figure 6. Photos of pole planting work in April 2017. The 4th photo shows a transplant sprouting leaves in late May, 2017. The last photo shows natural recruitment that is occurring along the river bank after high flows.

LFVC applied for a small grant from US Fish and Wildlife Service Partners and received \$3,000 to plant willow and poplar pole cuttings. We hired a local contractor to dig 150 holes to a depth of base flow ground water table in early April 2017. FFC Fencing out of Monte Vista, CO, then cut 50 cottonwood and 100 willow poles and planted in these holes. Each cutting was fertilized with root stimulator, backfilled with surrounding substrate, and covered with weed barrier fabric (Figure 6). In addition, we have purchased native grass and forb seed to broadcast in the area this coming summer. We had initially planned to seed last year but the drought of 2018 was severe and we decided to wait for more favorable conditions. As with the transplants discussed above, the pole cuttings showed good growth during the 2017 season, but failed to thrive in 2018. We hope that this year's conditions help revive the growth of the cuttings.

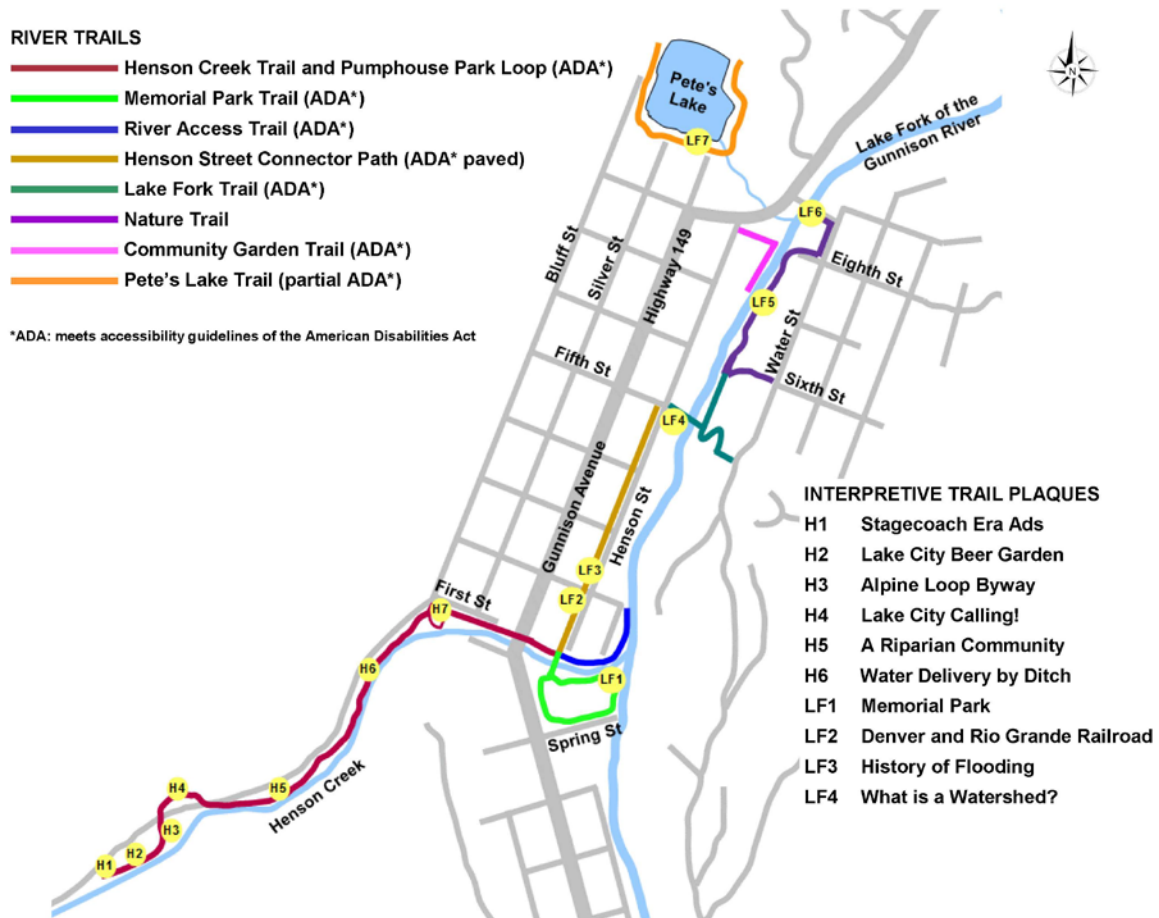
Figure 7. Trails Map showing locations of first ten plaques. Plaques LF5 and LF6 are not completed and will be part of next phase design. Finished plaques are found in Appendix E.

LFVC coordinated the design and implementation of the first phase of an interpretive trail system along existing and new trails along Henson Creek and the Lake Fork (see map Figure 7). This system is helping to increase knowledge of river systems and appreciation for the asset this river provides the community. LFVC has used these plaques for environmental education programs with local youth and adults.

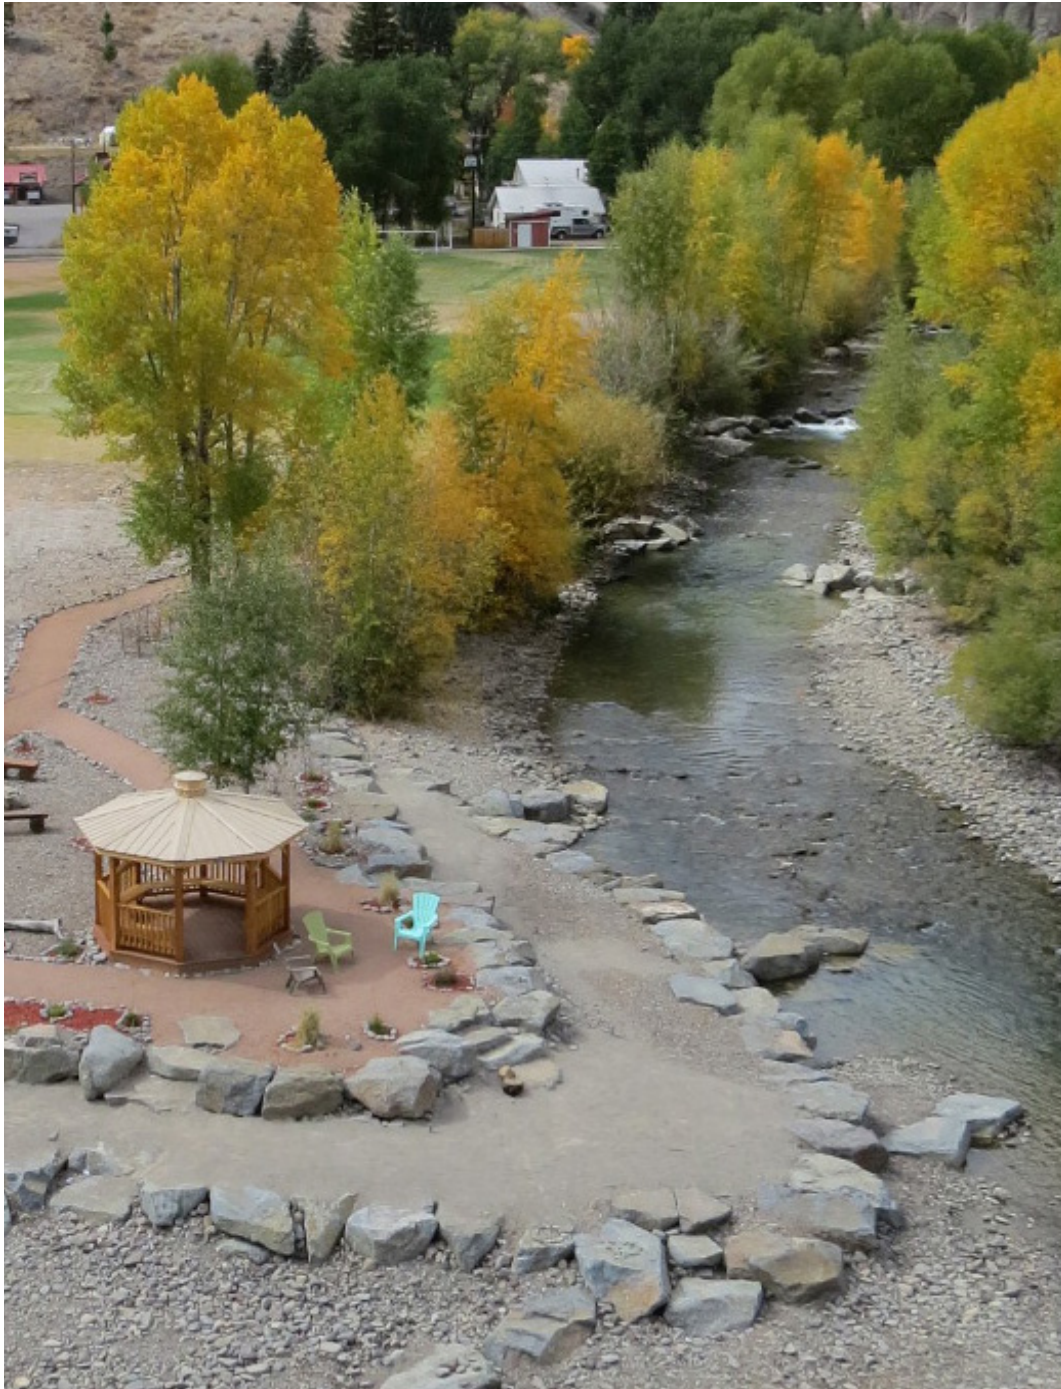
Figure 8. Developed park space on the confluence terrace at Memorial Park. LFVC constructed the terrace in 2014 as part of Phase I and the extended trail in 2015. The town installed the gazebo and other recreational infrastructure in 2015.

The town also installed a gazebo and landscaping. See Figure 8 for a view of this very aesthetic and much visited recreational space.

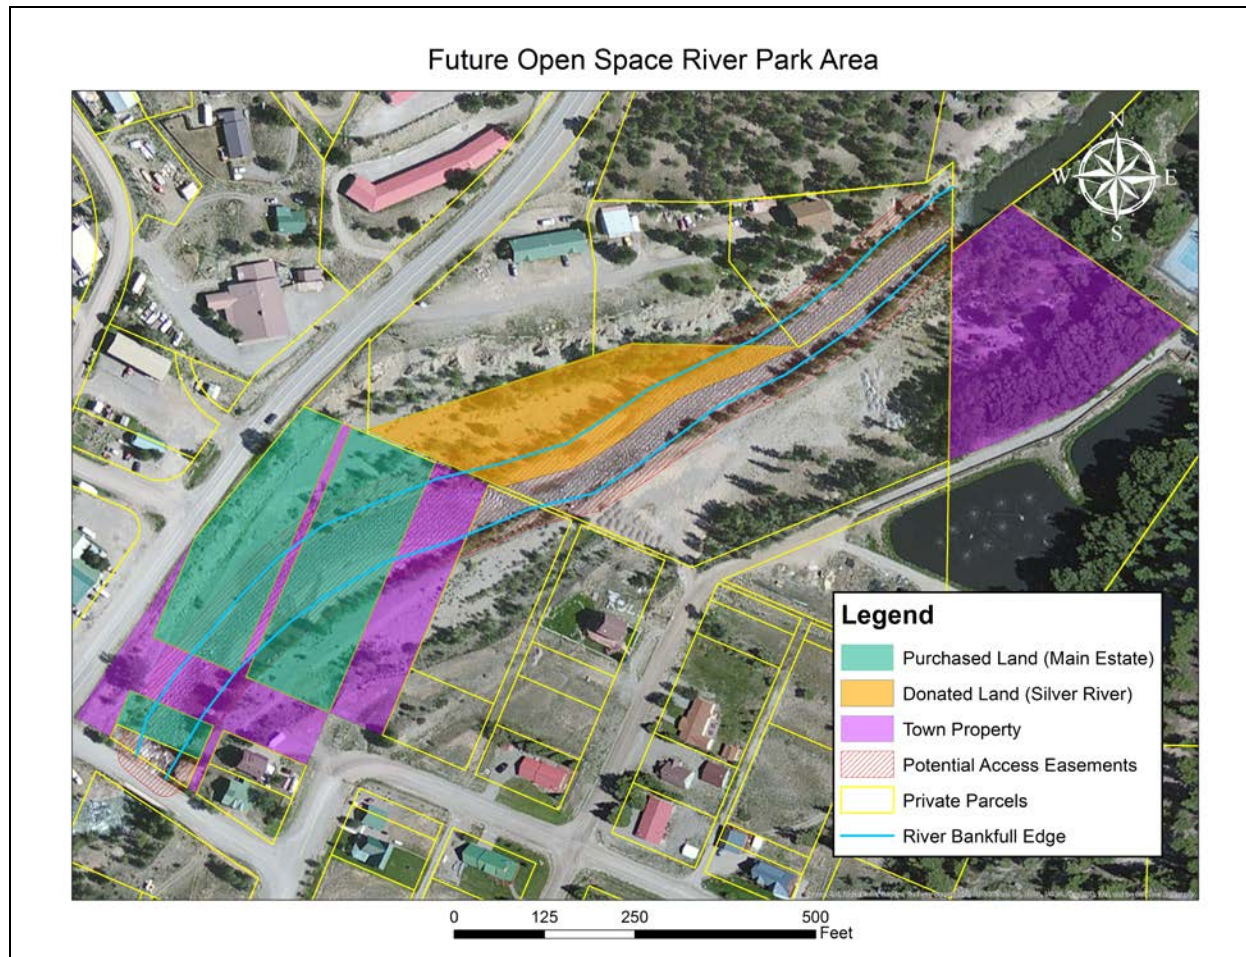
Figure 9. Proposed open space park area showing purchased and acquired parcels, as well as Town public lands. The red hatched area is the initially proposed area for fishing access easements. We will not know what this will look like in terms of ownership and easement until after completion of the River Recreation Corridor Plan.
