Phase 2 Instream Work Extents

6500 L.F.
Channel
Work

LAKE FORK GUNNISON
CHANNEL IMPROVEMENT PROJECT
PREPARED FOR:
WEBCO INC.
LAKE FORK VALLEY CONSERVANCY

PREPARED BY:
HYDROGEO DESIGNS LLC.
320 CHARLES ST.
P.O. BOX 775
BUENA VISTA, CO 81211

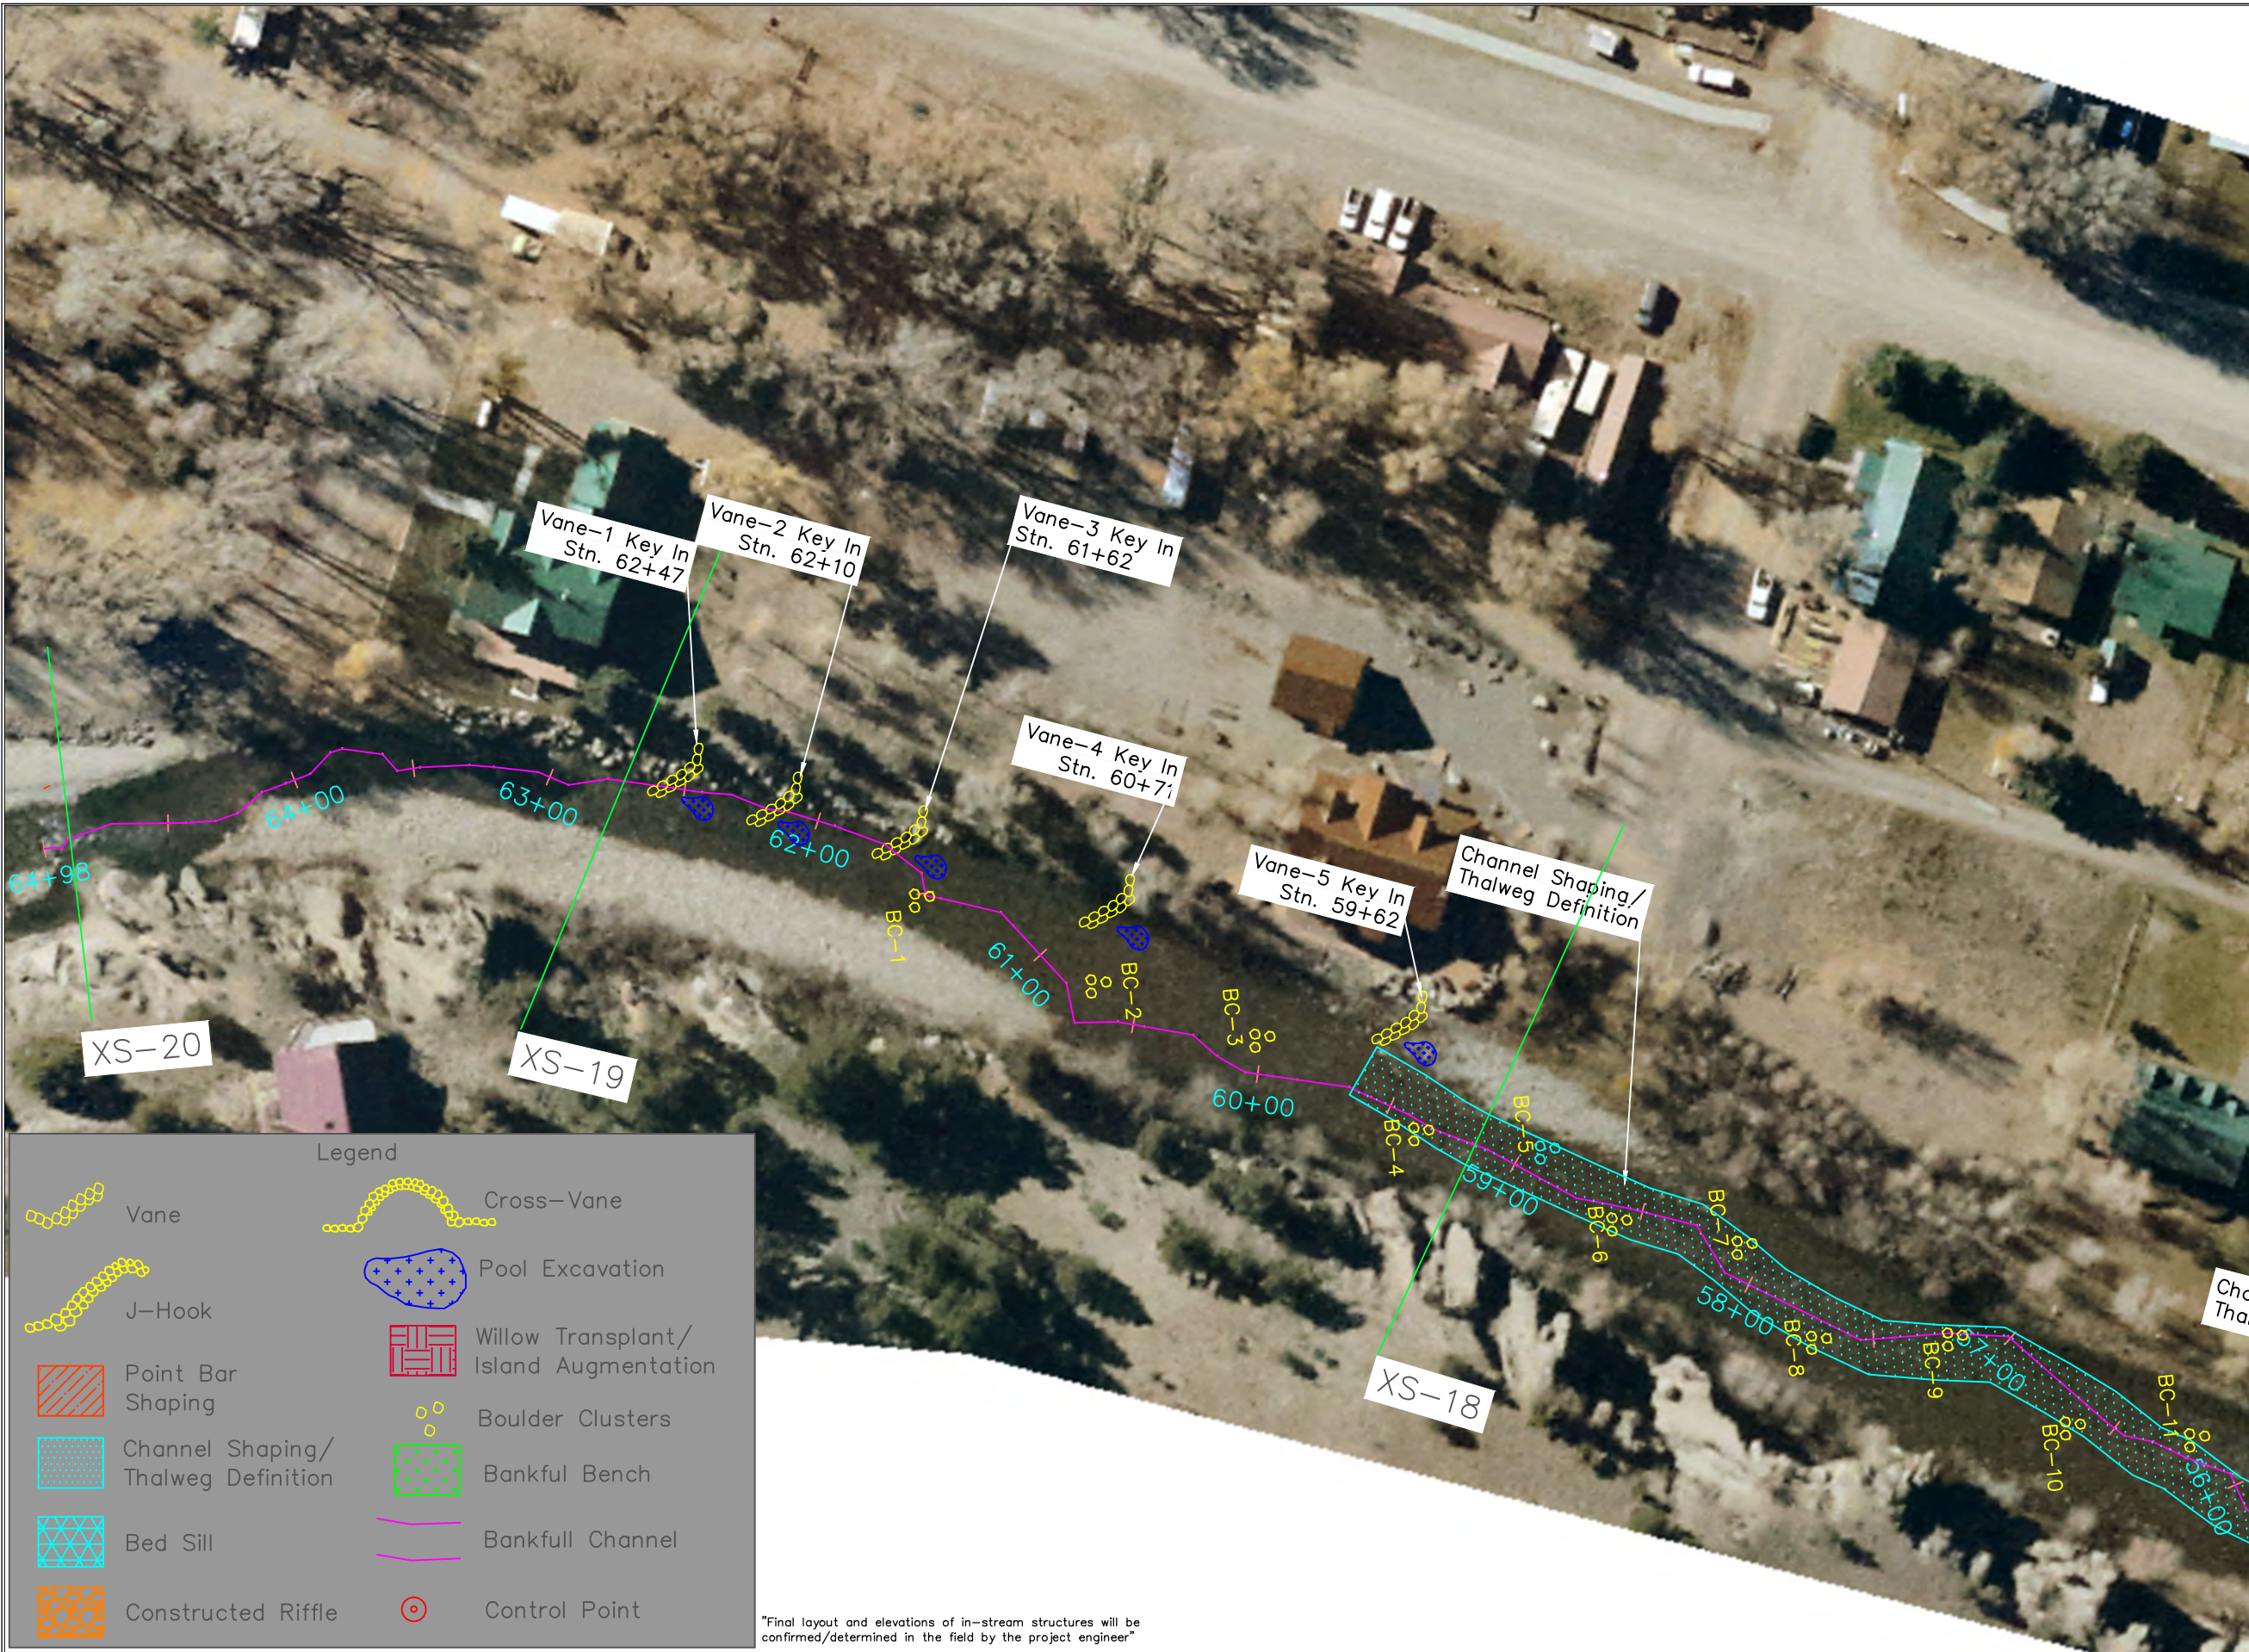
SHEET NUMBER
2 OF 25

PROJECT ID
Lake Fork of the
Gunnison River
AirPhoto
Stn. 65+00–56+00

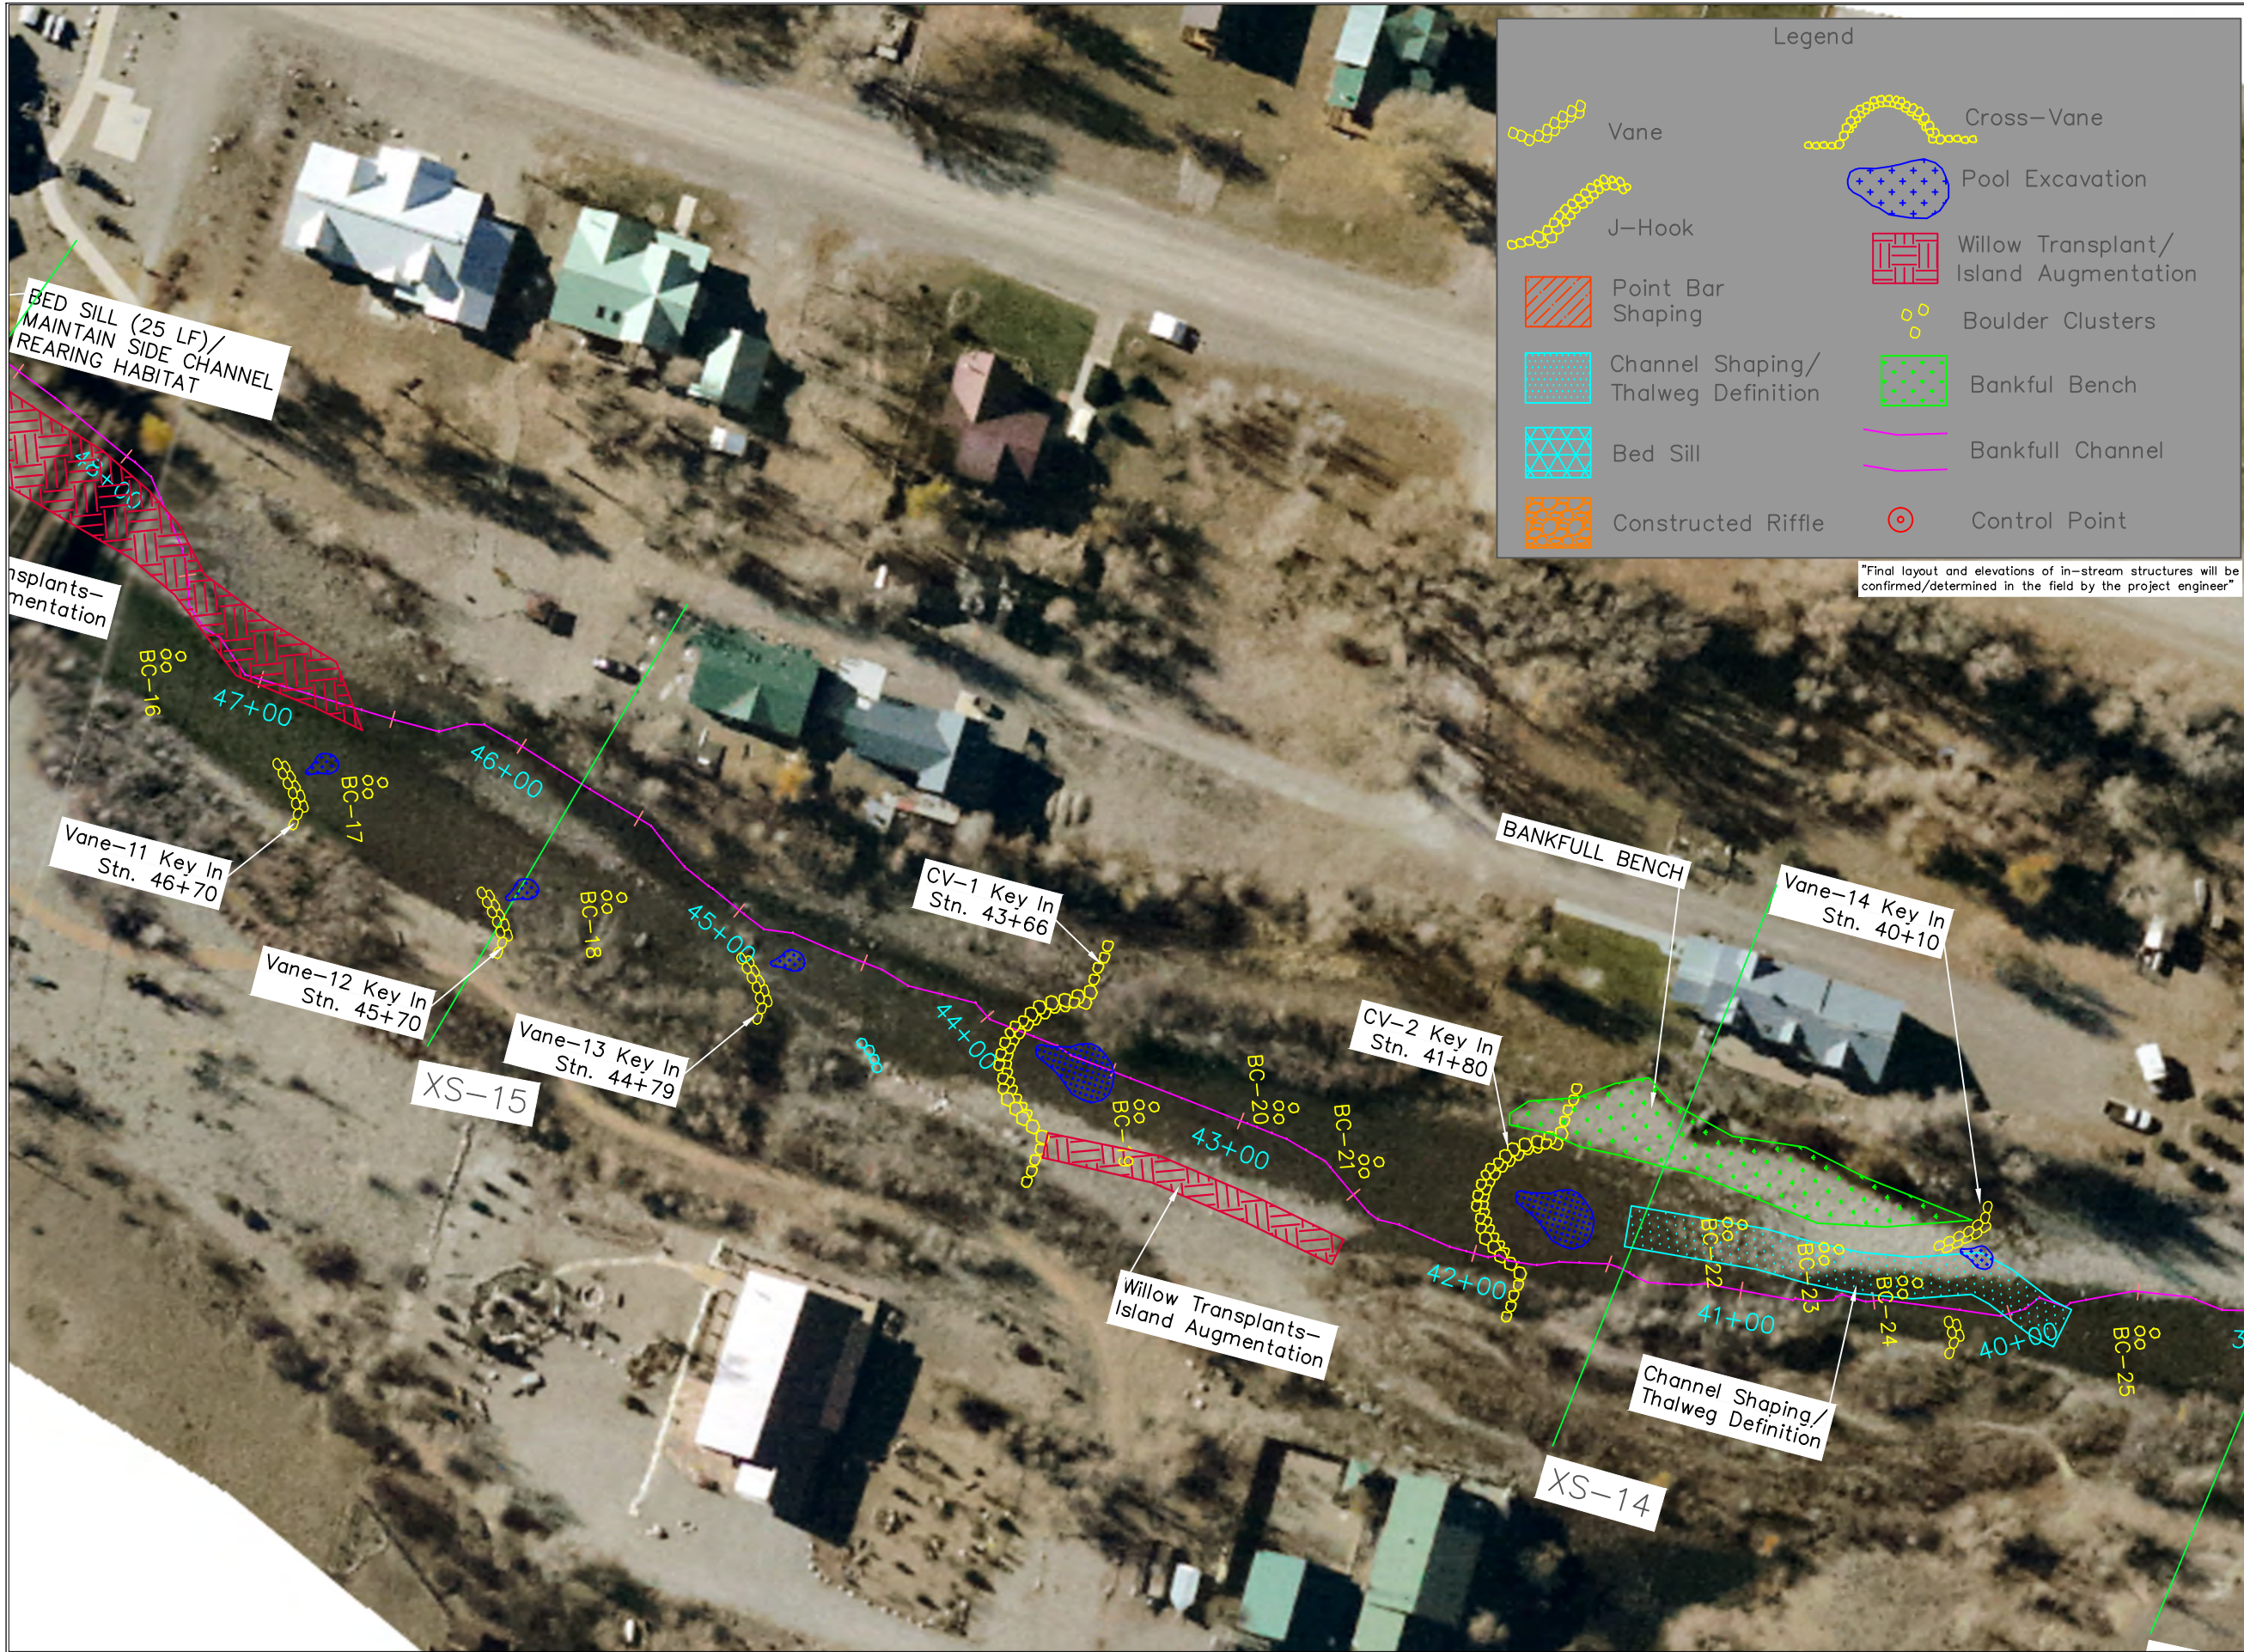
Vane		Cross-Vane
	J-Hook		Pool Excavation
	Point Bar Shaping		Willow Transplant/ Island Augmentation
	Channel Shaping/ Thalweg Definition		Boulder Clusters
	Bed Sill		Bankfull Bench
	Constructed Riffle		Bankfull Channel
			Control Point

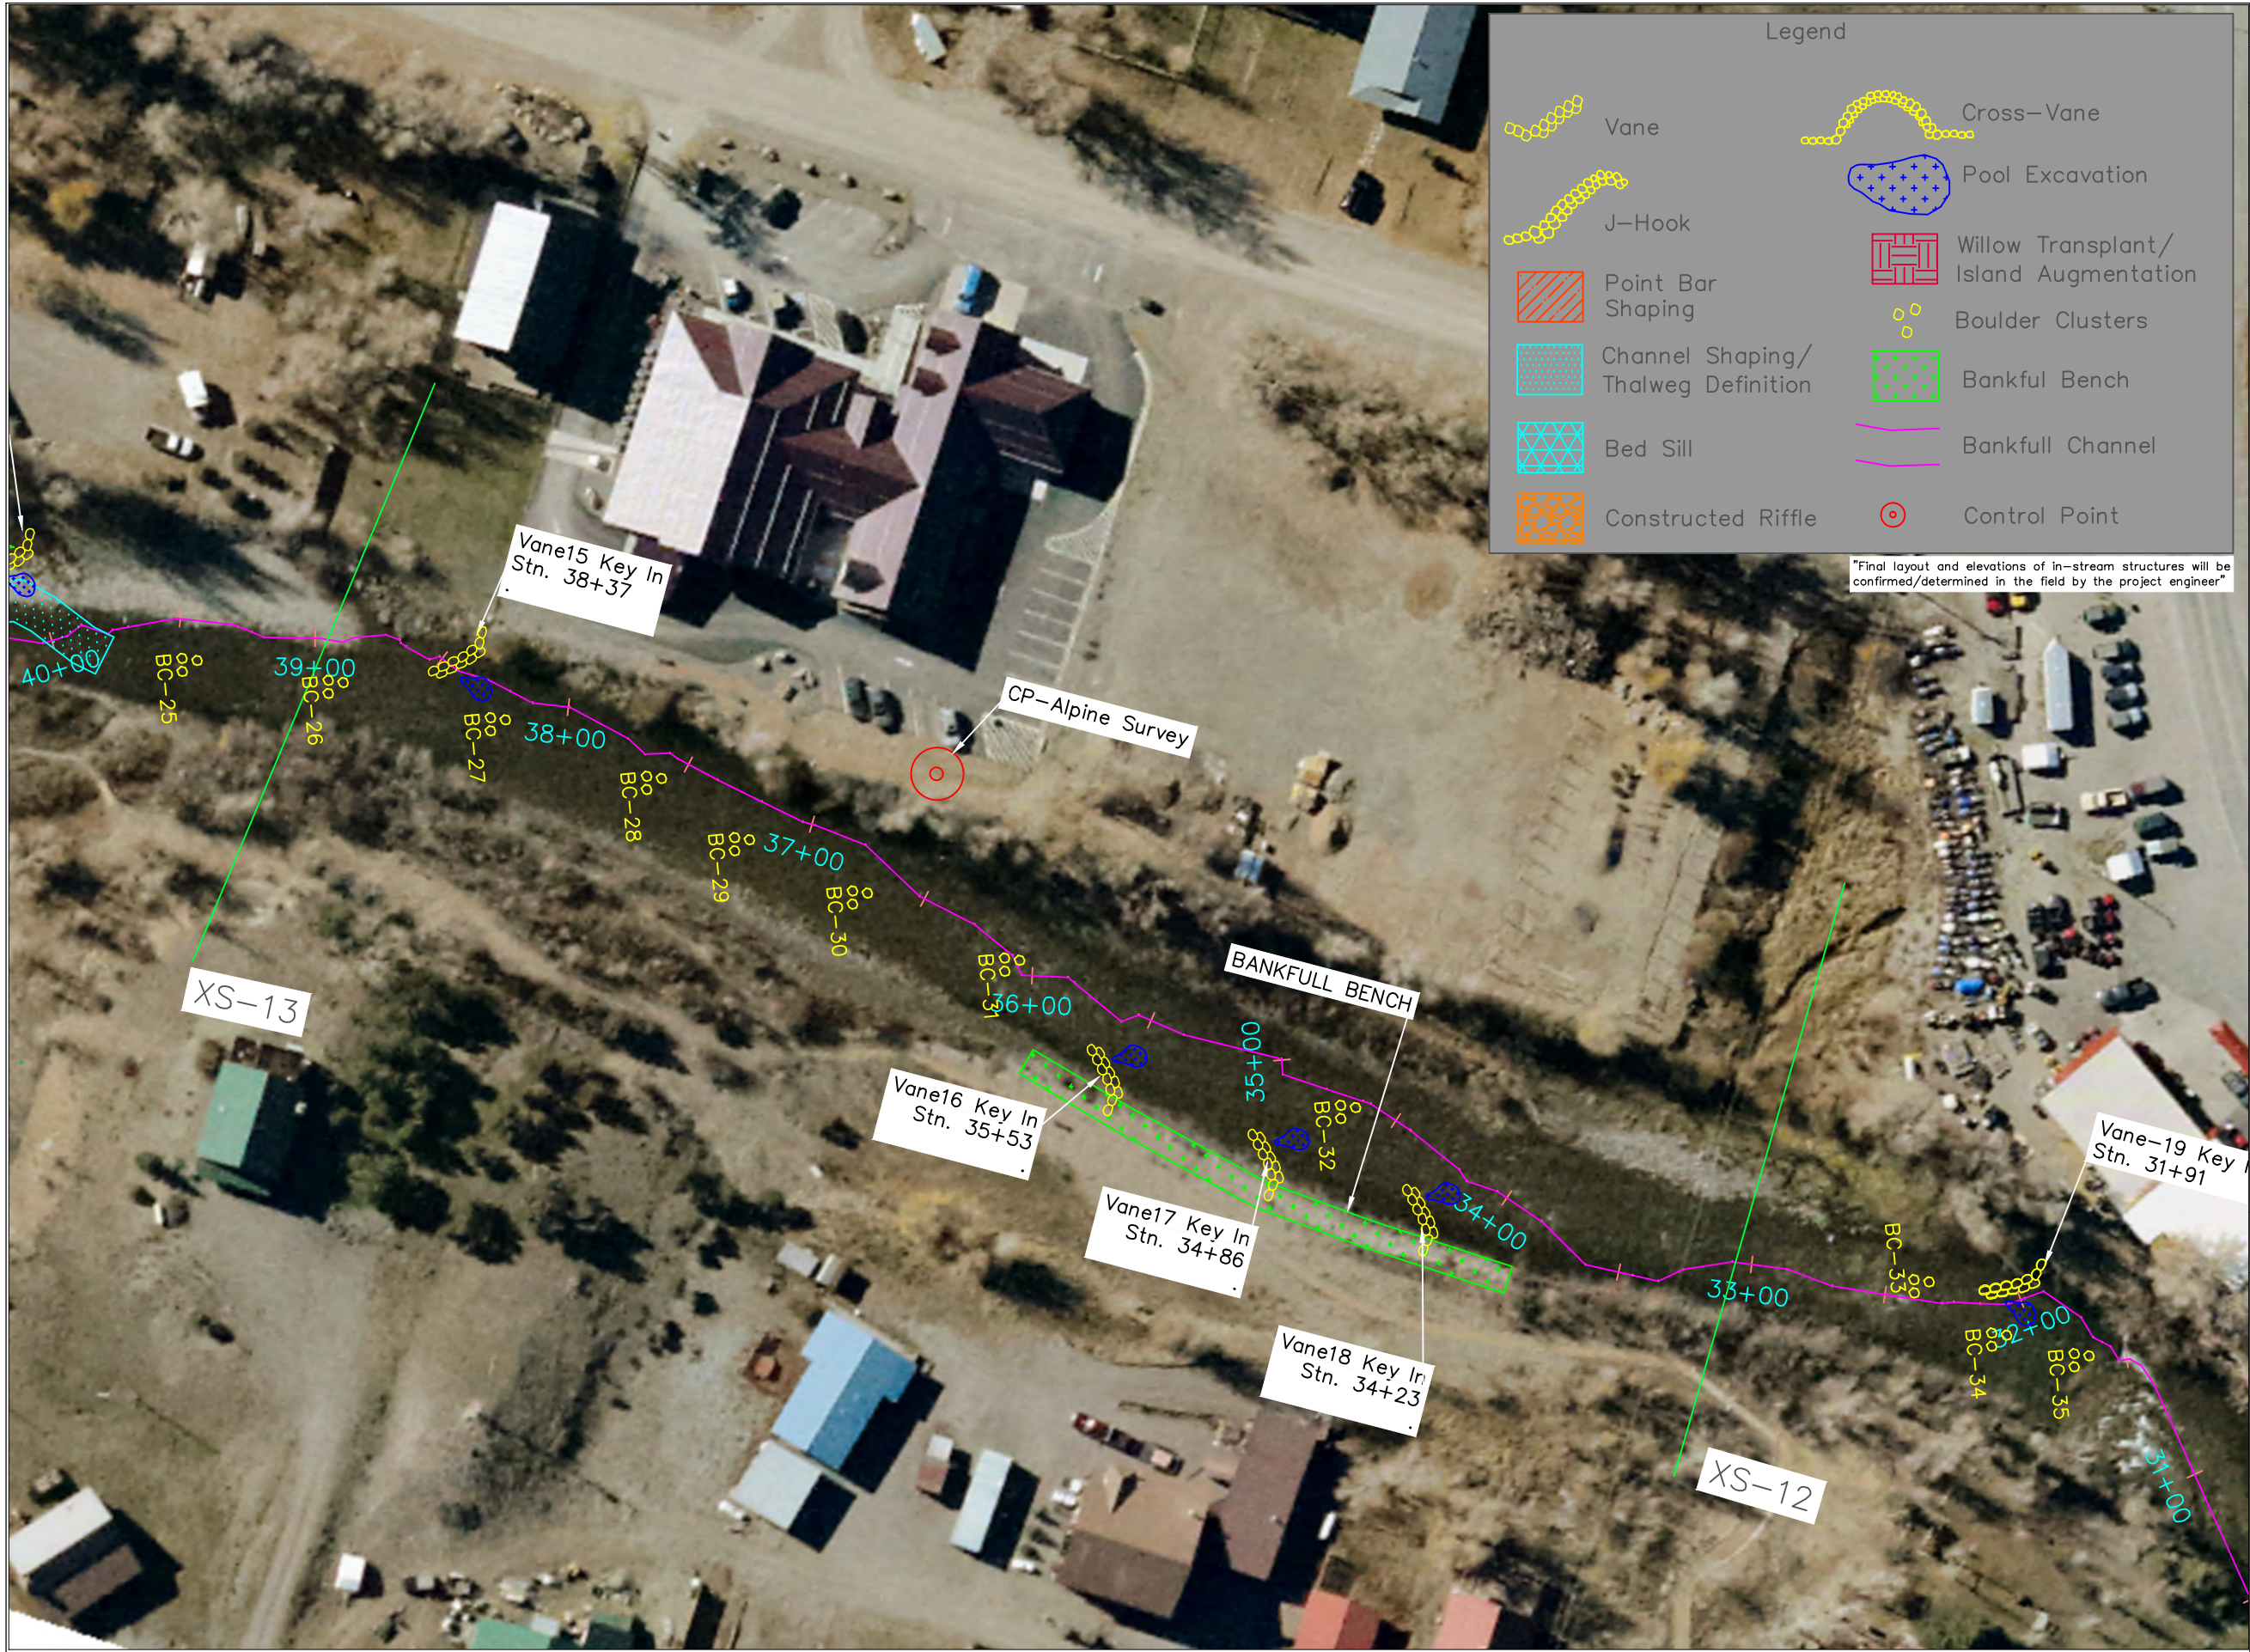
SHEET NUMBER
4 OF 25

Vane		Cross-Vane
	J-Hook		Pool Excavation
	Point Bar Shaping		Willow Transplant/ Island Augmentation
	Channel Shaping/ Thalweg Definition		Boulder Clusters
	Bed Sill		Bankfull Bench
	Constructed Riffle		Bankfull Channel
			Control Point

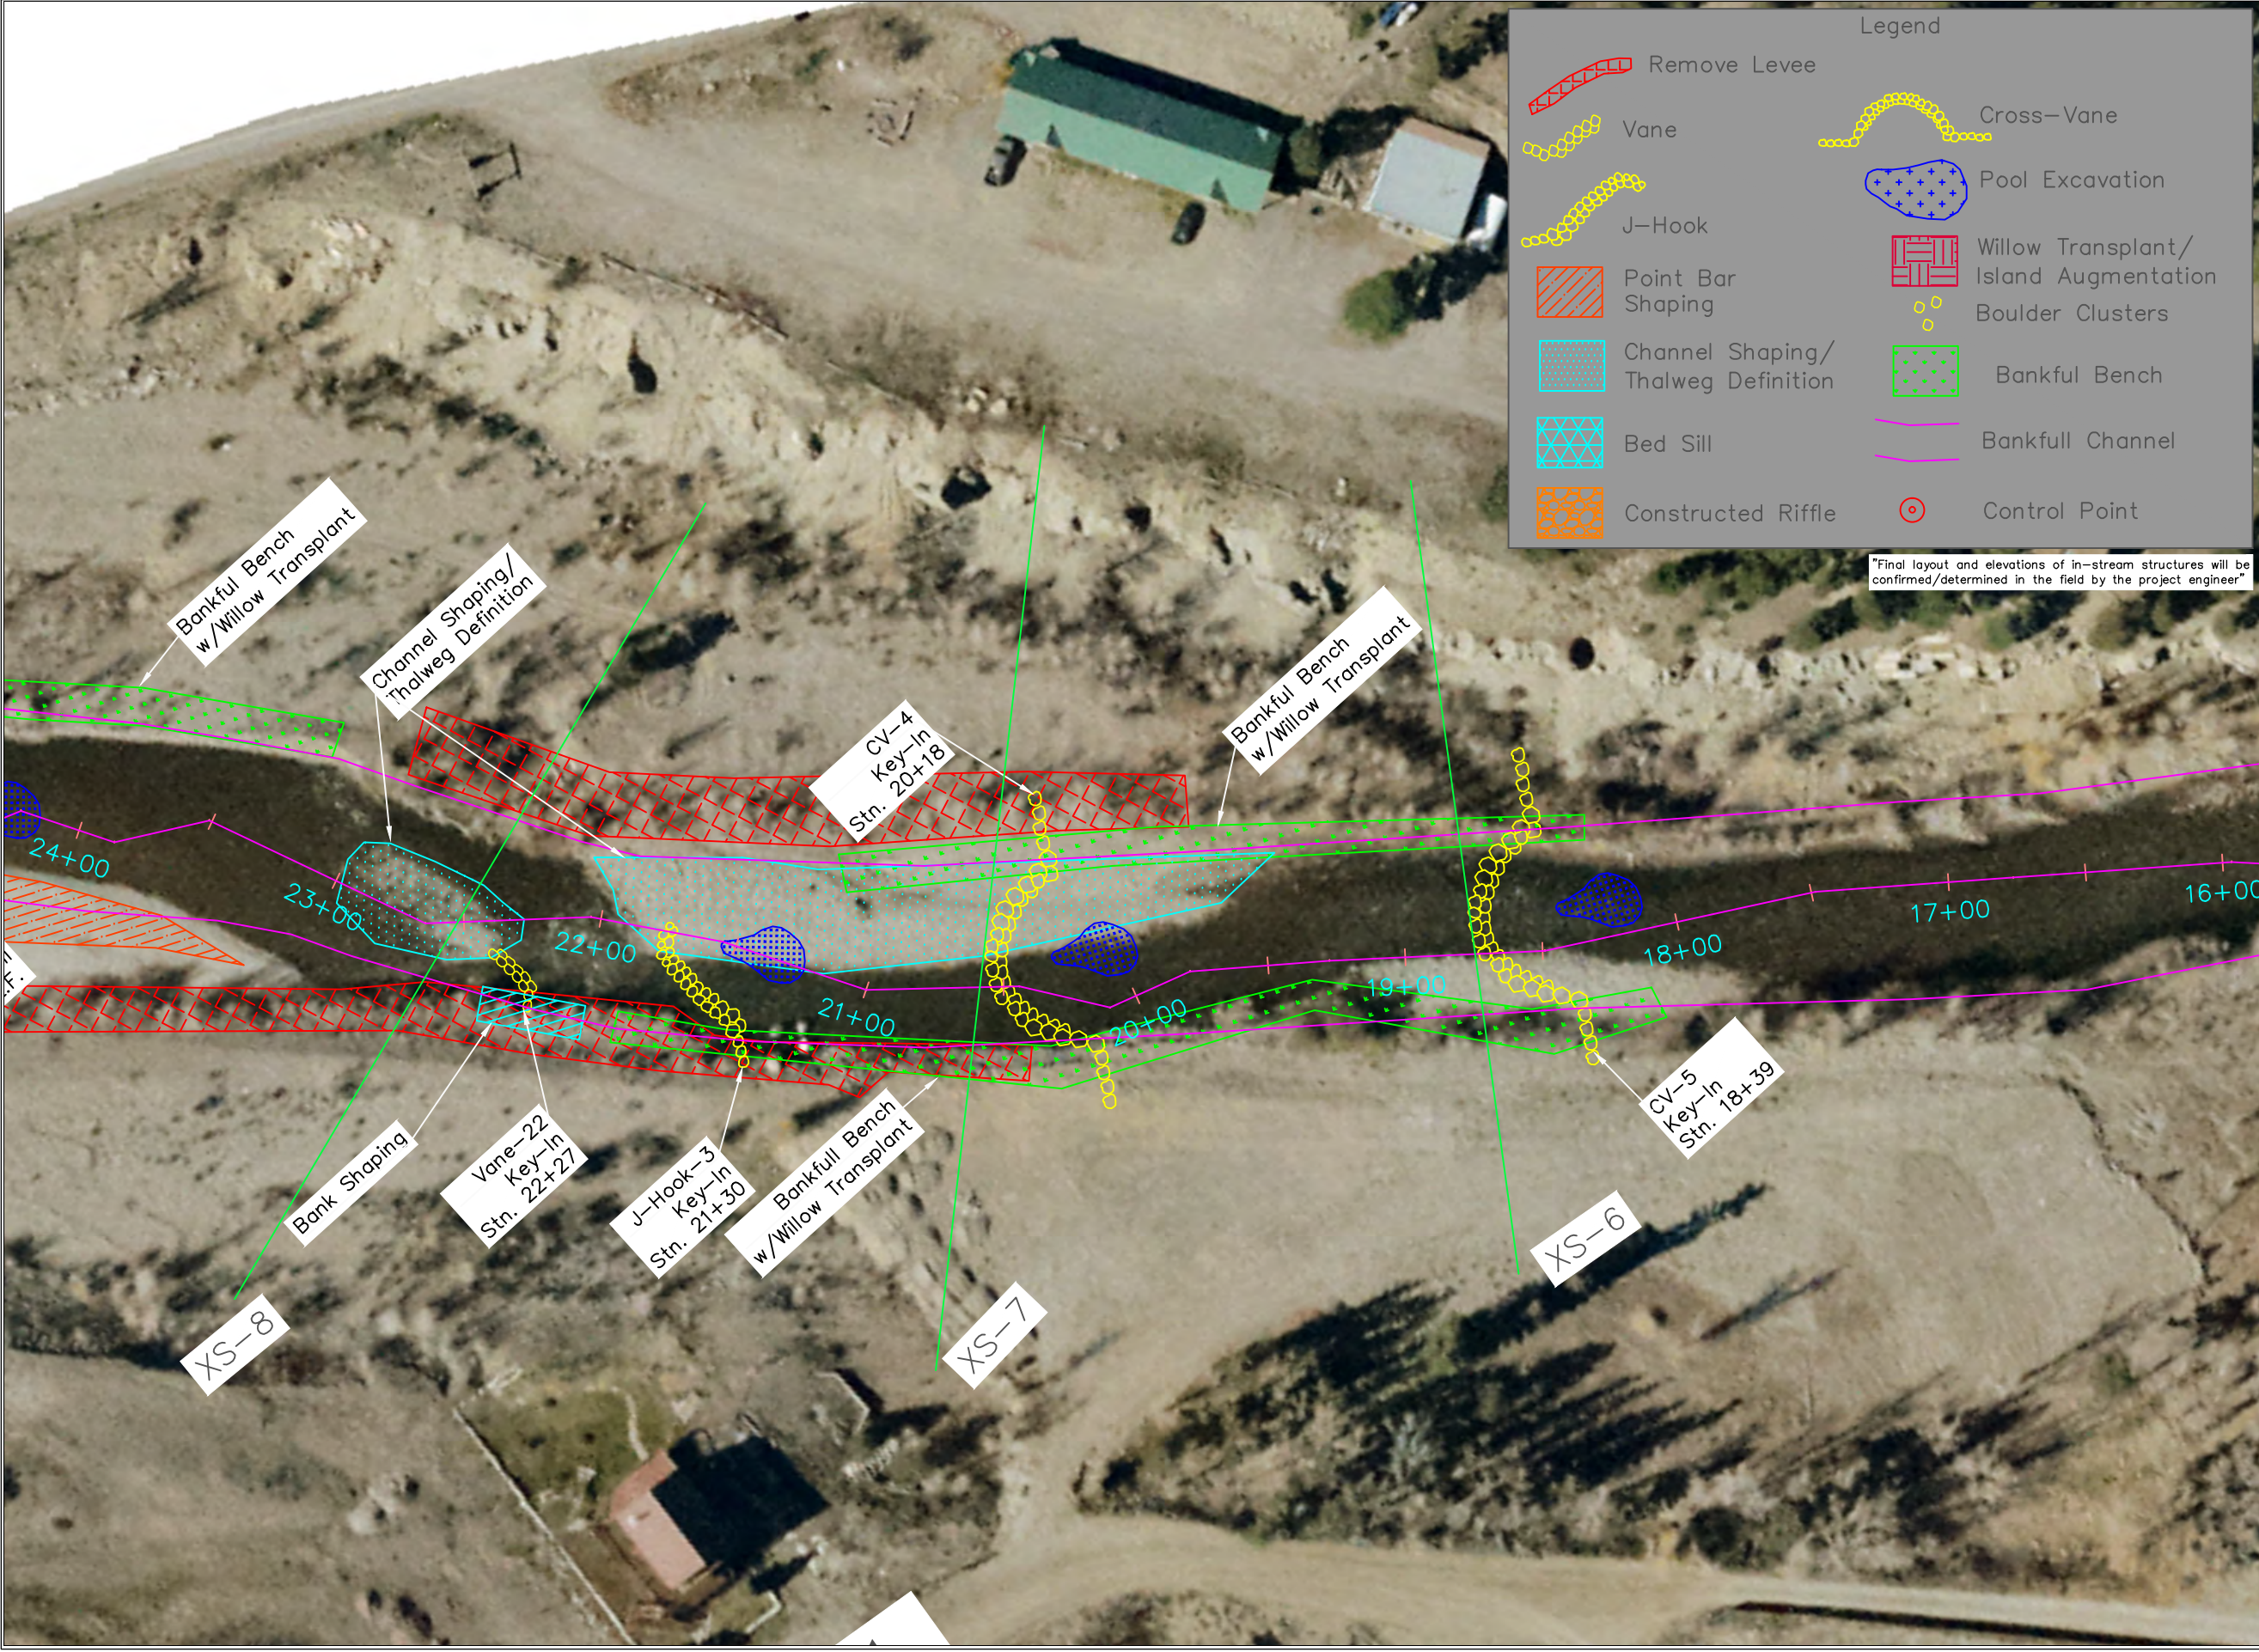
SHEET NUMBER
6 OF 25

Remove Levee		Cross-Vane
	Vane		Pool Excavation
	J-Hook		Willow Transplant/ Island Augmentation
	Point Bar Shaping		Boulder Clusters
	Channel Shaping/ Thalweg Definition		Bankful Bench
	Bed Sill		Bankfull Channel
	Constructed Riffle		Control Point

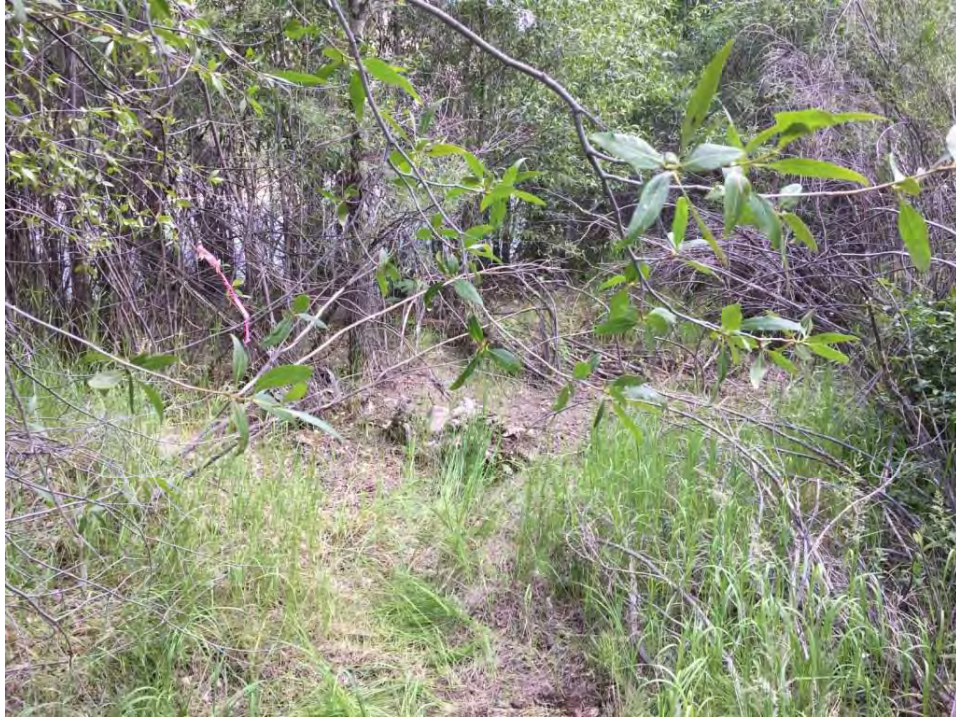
Photograph 1. Photograph taken July 15, 2016 looking north at Sample Pt A-4 wetland (Lake Fork of the Gunnison Restoration).

This sample point is located along the banks of the River (Figure 2, Photograph 1). The dominant vegetation includes an overstory comprised of wetland species including narrowleaf cottonwood (*Populus angustifolia*, FACW), and alder (*Alnus tenuifolia*, FACW). The understory in Wetland A is dominated by coyote willow (*Salix exigua*, FACW) and gray willow (*Salix bebbiana*, OBL) with an herb stratum dominated by blue joint reedgrass (*Calamagrostis canadensis*, FACW). The wetland supports a sandy loam from 0 to 6 inches with a color of 10 YR4/2 with redoximorphic features including concentrations showing a color of 10YR4/6 and coated sand grains present in the soil test pit sample. Cobble exists below 6 inches below the ground surface (see data form A-4 wet in Appendix B). Wetland hydrology consisted of saturation of the soils at the surface on the day of investigation. All three wetland criteria are met at this site.

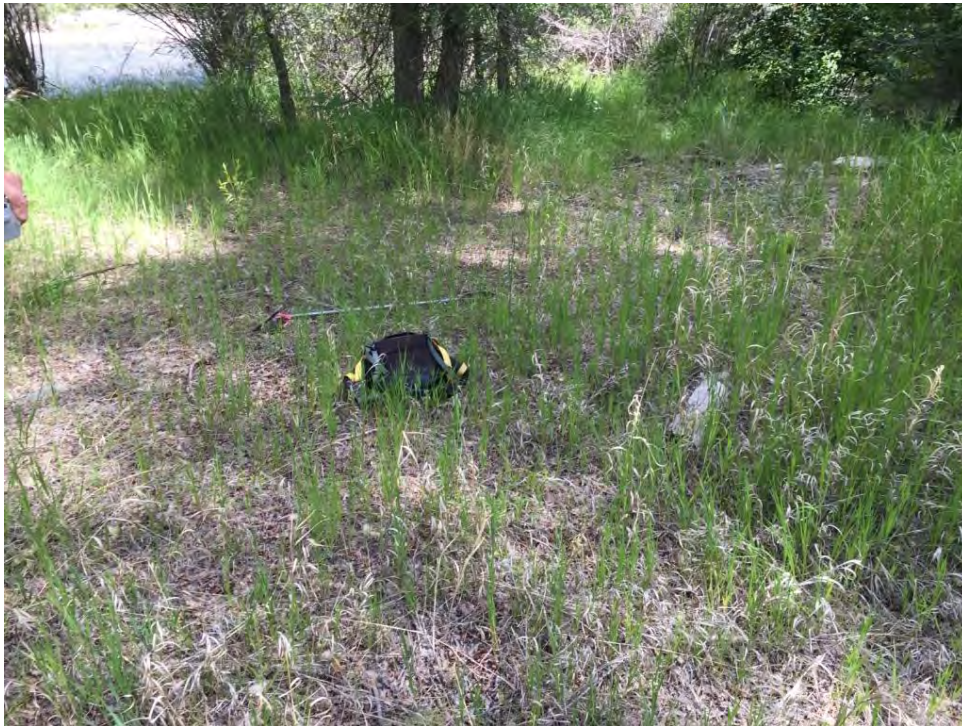
Photograph 2. Photograph taken July 15, 2016 looking west at Sample Pt A-4 upland (Lake Fork of the Gunnison Restoration).

The adjacent upland to Wetland A at this location is comprised of well drained riparian that is dominated by wetland vegetation such as narrowleaf cottonwood (FACW), timothy (*Phluem pretense*, FAC), blue joint reedgrass (FACW), mint (*Mentha arvense*, FACW) and field horsetail (*Equisetum arvense*, FAC) (Photograph 2). The upland area does not include any soils and is comprised entirely of cobble. No wetland hydrology was present on the day of investigation. A lack of wetland hydrology and hydric soils distinguishes the uplands from the wetland area.

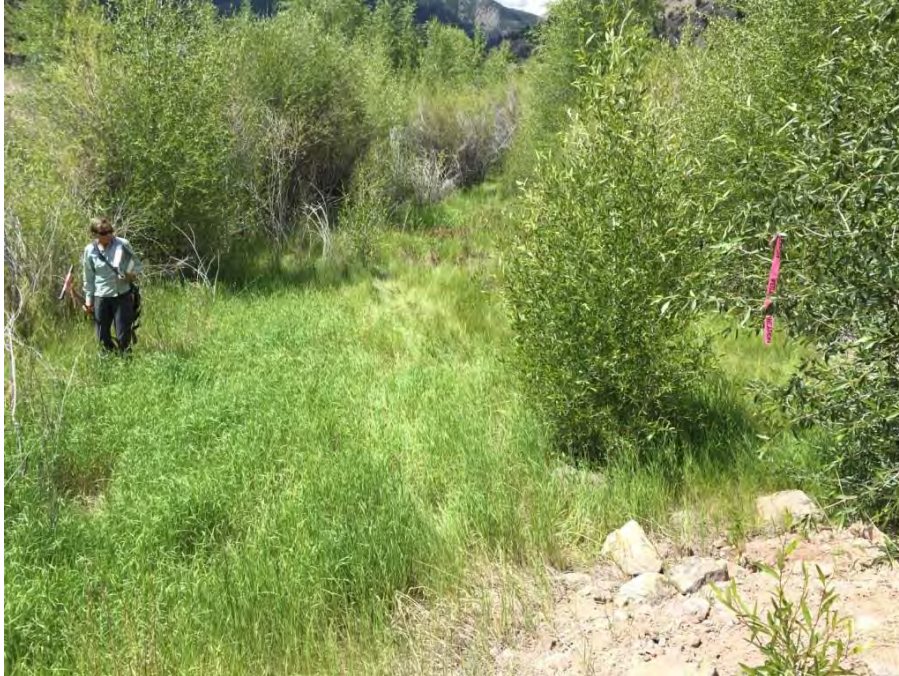
Photograph 3. Photograph taken July 15, 2016 looking south at Sample Pt B-1 wetland (Lake Fork of the Gunnison Restoration).

Sample point B-1 wet is dominated by wetland vegetation consisting of narrowleaf cottonwood (FACW), coyote willow (FACW), and blue joint reedgrass (FACW) (Photograph 3). The sandy silty loam soils at the test pit exhibit a color of 10YR3/1 with concentrations showing a color of 10YR4/6 and coated sand grains (10YR2/1) from 0 to 4 inches with cobble 4 inches below the ground surface. Saturated soil conditions and water at the ground surface are positive indicators of wetland hydrology. All three wetland criteria are met at the site.

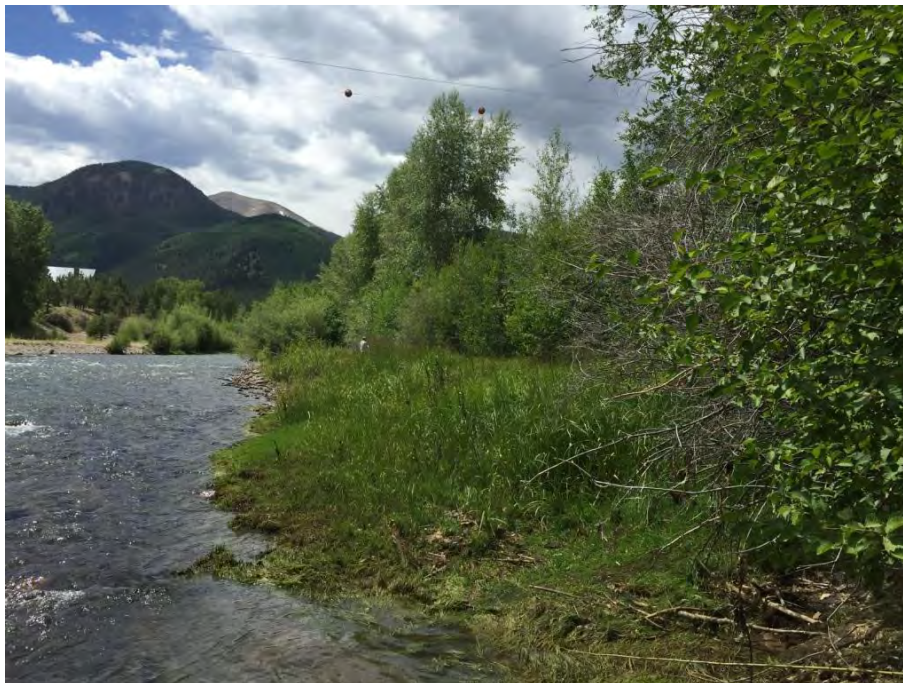
Photograph 4. Photograph taken July 15, 2016 looking south at from wetland data point C-1 towards Sample Point C-4 wetland (Lake Fork of the Gunnison Restoration).

A dominance of wetland vegetation at the sample point for C-4 wet includes alder (FACW) coyote willow (FACW) and narrowleaf cottonwood (FACW) with an understory of wetland graminoids such as beaked sedge (*Carex utriculata*, OBL), arctic rush (FACW) and manna grass (*Glyceria manna*, OBL (Photograph 4). The sandy loam at the test pit exhibits a color of 10YR3/1 from 0 to 18 inches with 10YR4/6 concentrations along the pore linings and coated sand grains with a color of 10YR2/1 in the matrix. Hydrology in the area consisted of ground surface saturation and a water table at 6 inches below the ground surface on the day of investigation. This area meets all three wetland criteria.

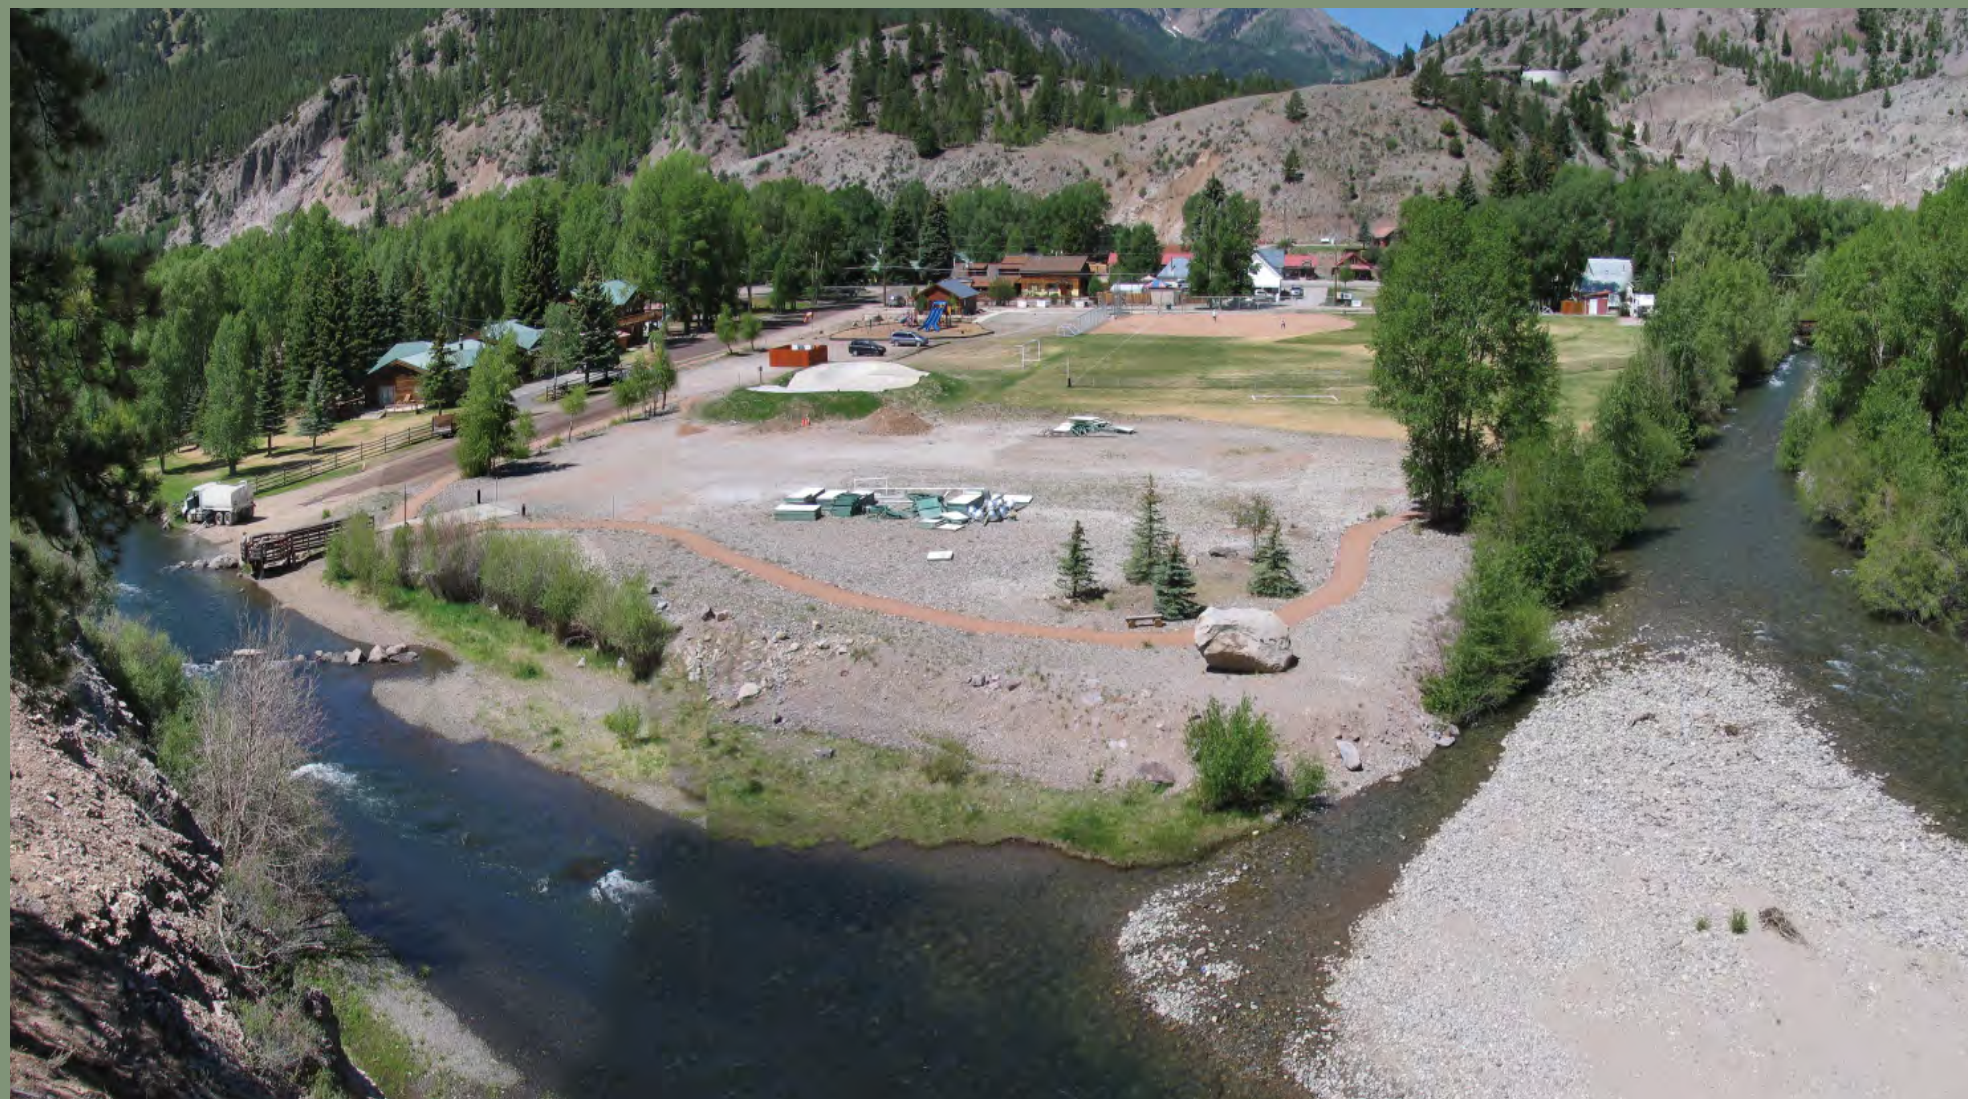
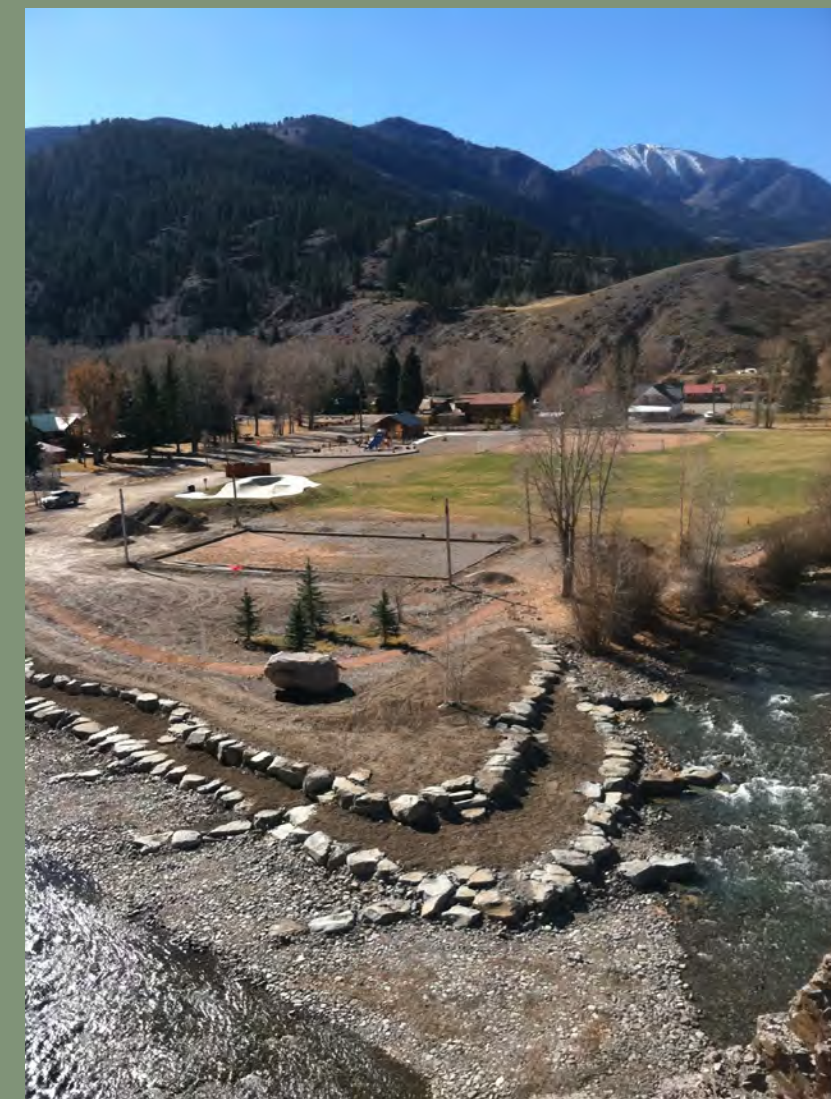
Before and After Terrace Construction

Prior to construction, a gravel bar formed mid-stream, and the banks were eroded and hard to access. This caused gravel and cobble to back up Henson Creek and degrade fisheries habitat. During construction, boulders and fill tied the gravel bar into the bank, and rock terraces were built to stabilize the banks. The terrace expanded usable park space by about 10,000 square feet. Photos courtesy of the Lake Fork Valley Conservancy

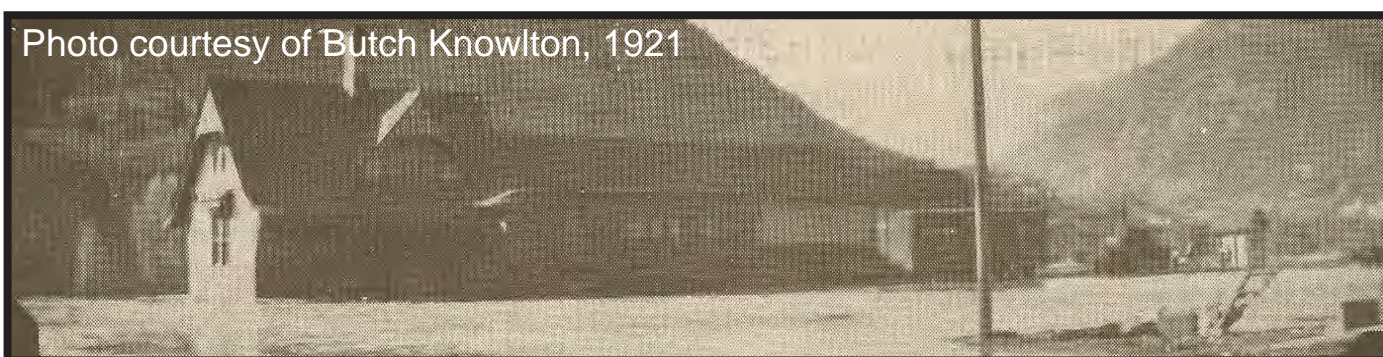
JUNE OF 1921 was a wet one. Heavy rain and melting snow transformed Henson Creek and the Lake Fork River into wild torrents. The floodwaters jumped fortified river banks, demolished homes, bridges and water storage tanks, and inundated the Denver & Rio Grande Railroad Depot, destroying the track. This, combined with the decline in mining, led to the demise of the Lake City portion of the railway in the early 1930s.

Photo courtesy of Butch Knowlton, 1921
