Phase 2 Instream Work Extents

6500 L.F.
Channel
Work

LAKE FORK GUNNISON
CHANNEL IMPROVEMENT PROJECT
PREPARED FOR:
WEBCO INC.
LAKE FORK VALLEY CONSERVANCY

PREPARED BY:
HYDROGEO DESIGNS LLC.
320 CHARLES ST.
P.O. BOX 775
BUENA VISTA, CO 81211

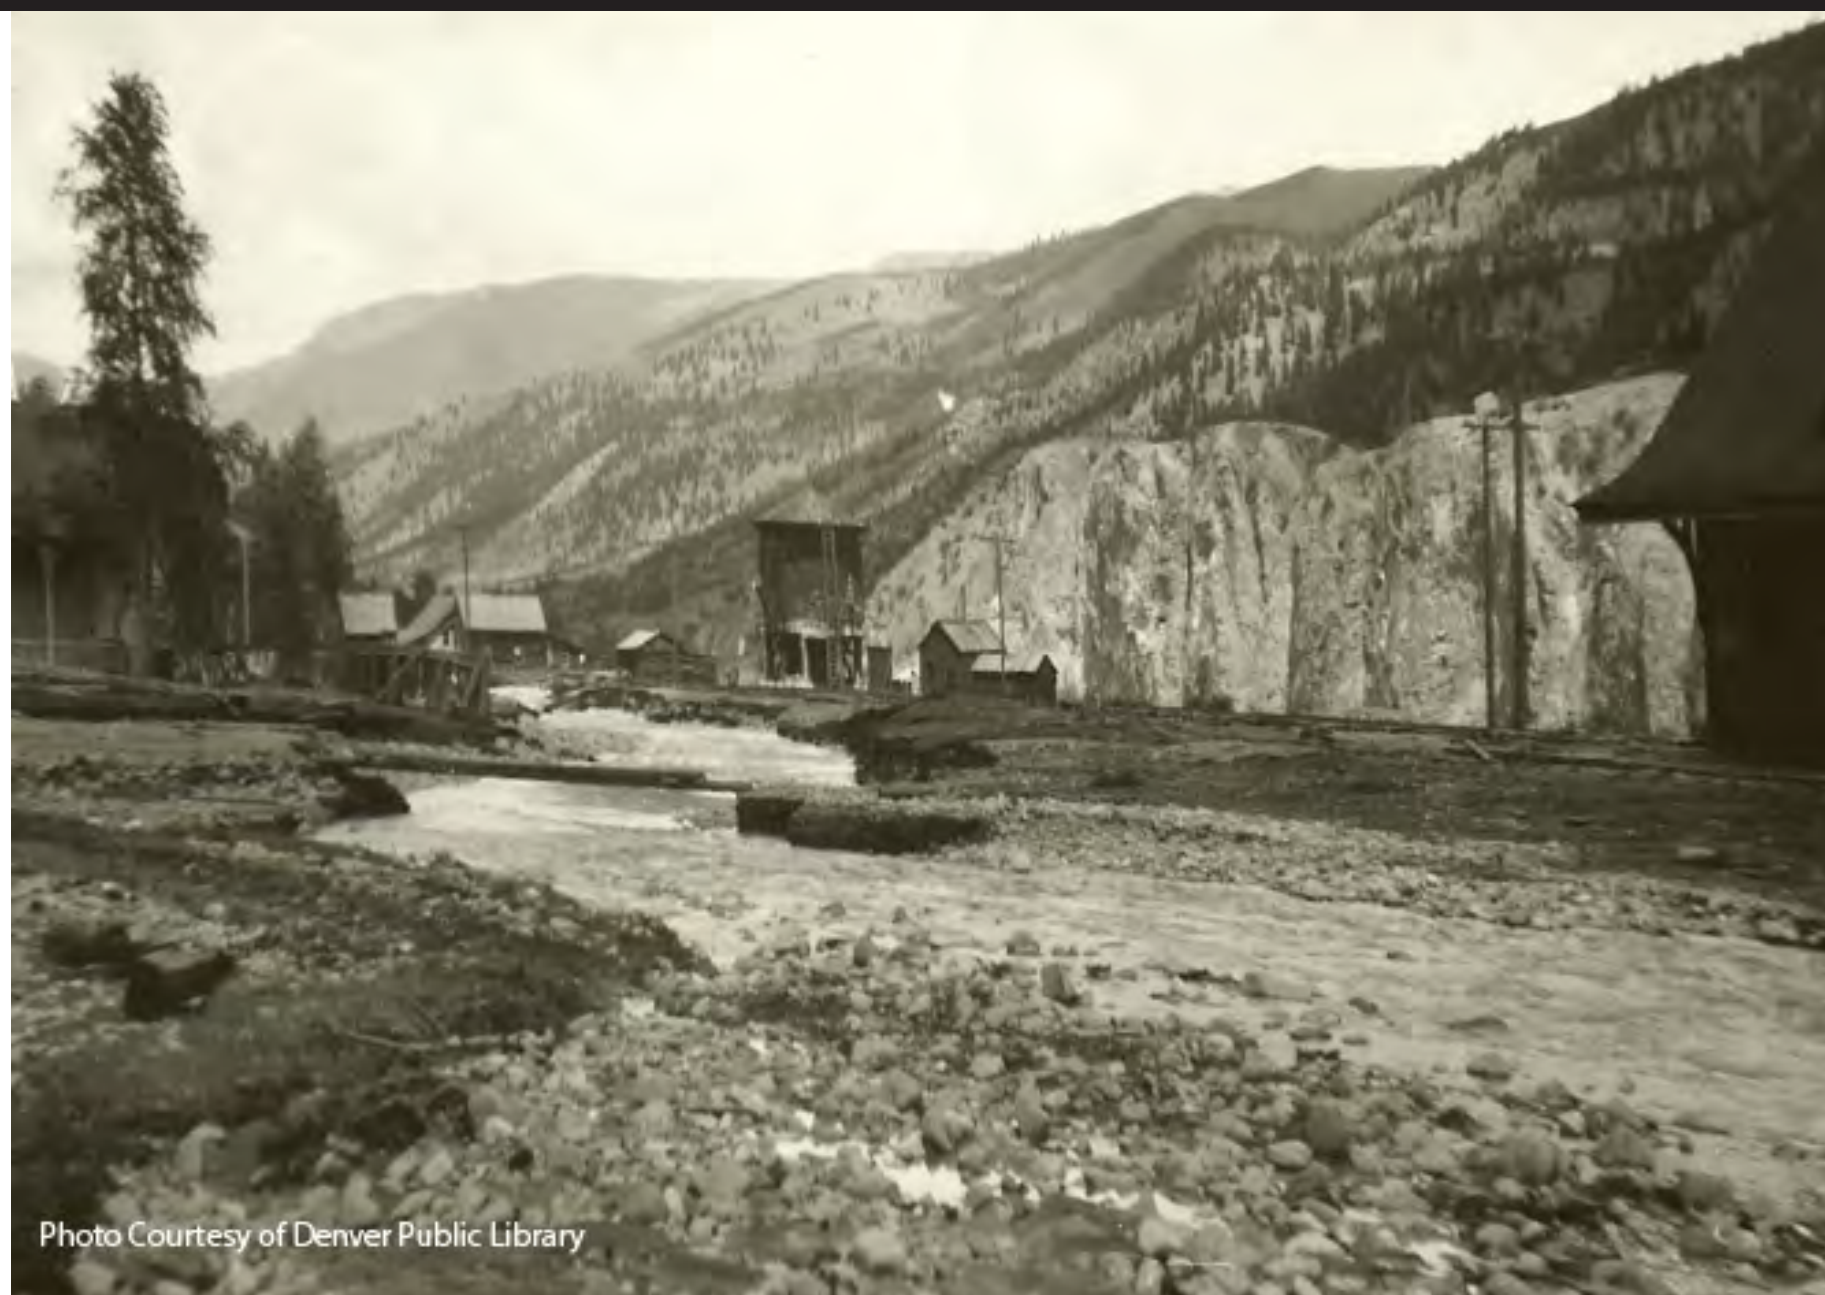
The Lake Fork flooded what is today known as Henson Street. Back then, train tracks ran down the street to the train depot, which is visible at the far right. This view is looking north. Below is what the area looks like today.

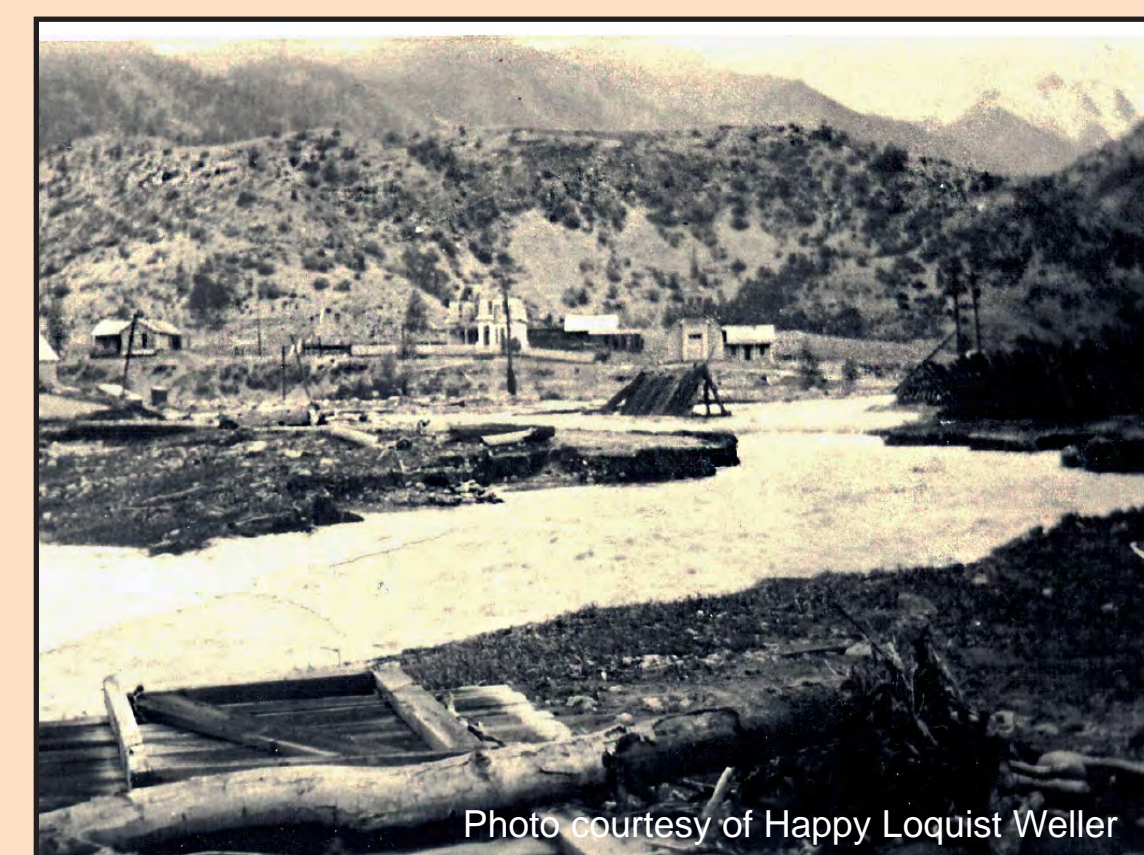
A view from the approximate location of the current foot bridge over Henson Creek looking upstream at the remains of the Gunnison Avenue Bridge after the flood.
