Water Plan Grant Application

Governor Basin Restoration Project Uncompahgre Watershed Partnership

NATURAL RESOURCE DAMAGES FUND PROJECT PROPOSAL: GOVERNOR BASIN RESTORATION PROJECT IN OURAY COUNTY, COLORADO

PREPARED BY THE UNCOMPAHGRE WATERSHED PARTNERSHIP

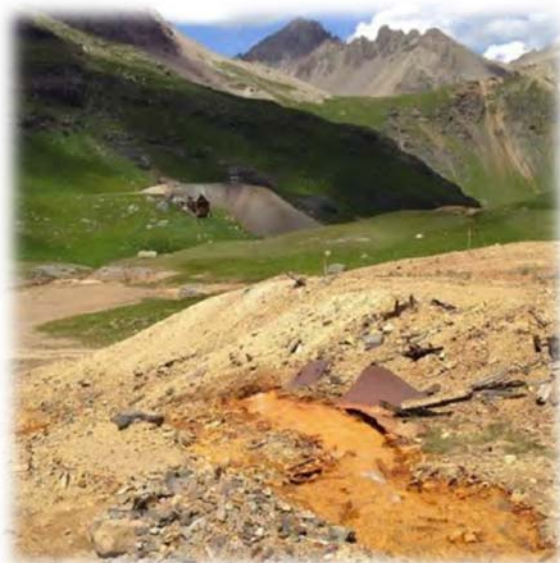
Governor Basin is impacted by waste rock and tailings, from the Terrible and Virginus mines, that leach metals that impair water quality, downgradient aquatic and terrestrial habitat, and watershed health. During the restoration project, waste rock and tailings will be capped and covered. Drainage channels will be constructed to capture and divert flow away from mine waste and tailings. Soil amendments and a custom high alpine seed mix will be used to revegetate the restoration area.

Photo 1. View from the Terrible #3 Adit drainage channel. The foreground of the photo characterizes resource damage common throughout the project area. Left of center, drainage from the Terrible Mine flows into Governor Creek. The background of the photo includes alpine tundra characteristic of the San Juan Mountains. Photo credit: Jeff Litteral, DRMS

View from the Terrible #3 Adit drainage channel. The foreground of the photo characterizes resource damage common throughout the project area. Left of center, drainage from the Terrible Mine flows into Governor Creek. The background of the photo includes alpine tundra characteristic of the San Juan Mountains. Photo credit: Jeff Litteral, DRMS.

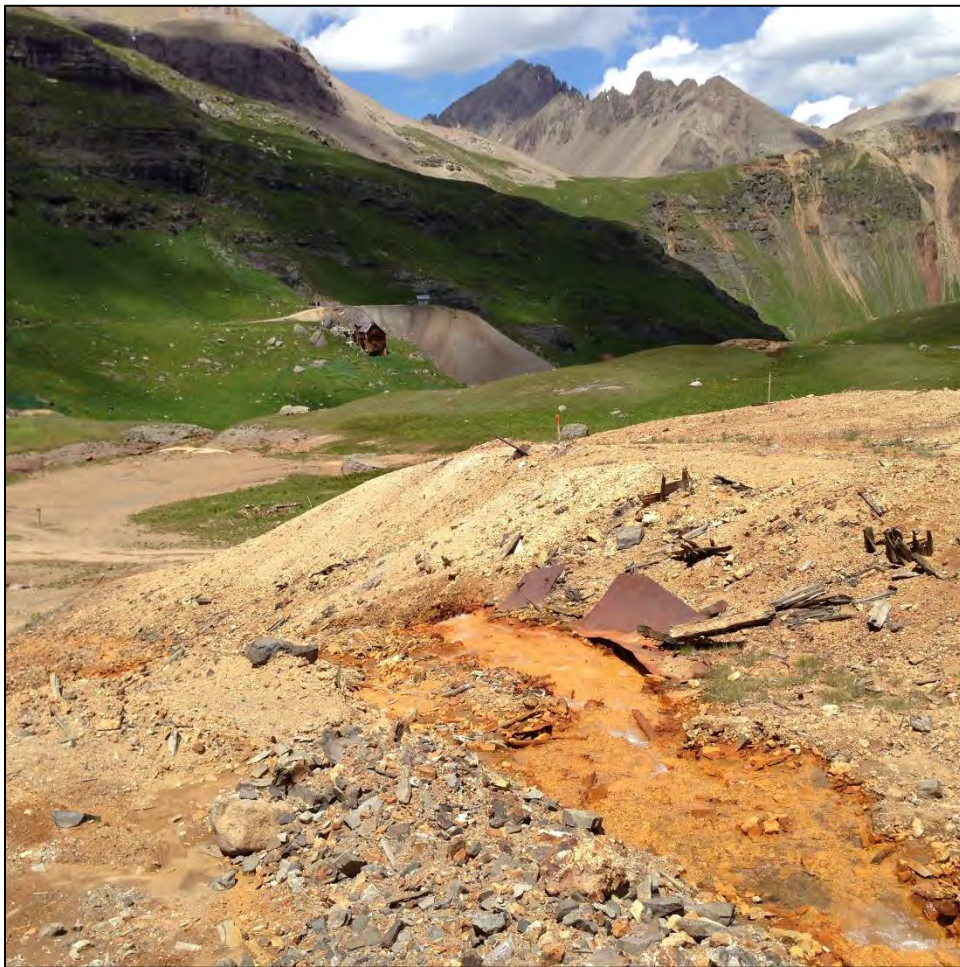
Conceptual project design for the Governor Basin restoration project. Neutralizing waste rock from the Virginius Mine Dump will be used as the cover material (blue polygon) to isolate mine waste from the Terrible mine and mill sites (white, yellow, red, and orange polygons). Multiple best management practices will be used in the primary restoration area to improve water quality and support restoration of alpine, riparian, and aquatic habitat.

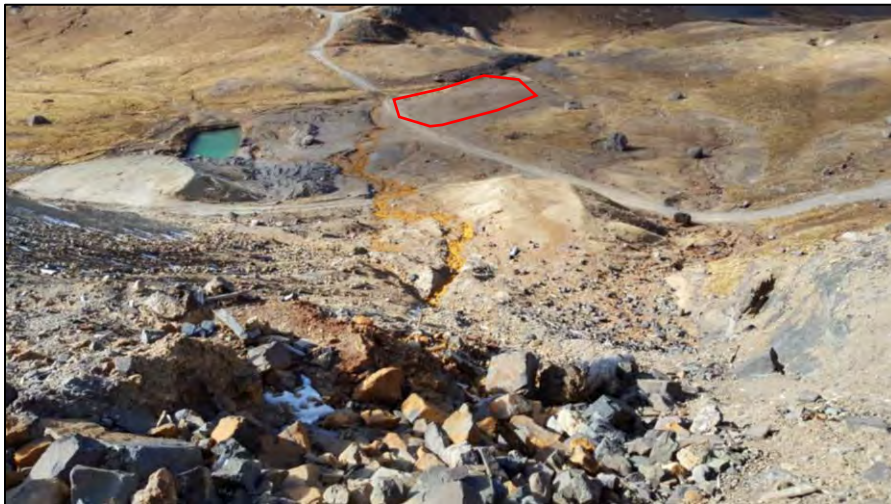
View of tailings near Governor Basin Road. The tailings limit plant growth in the area. The red polygon shows the approximate area of the USFS claim.

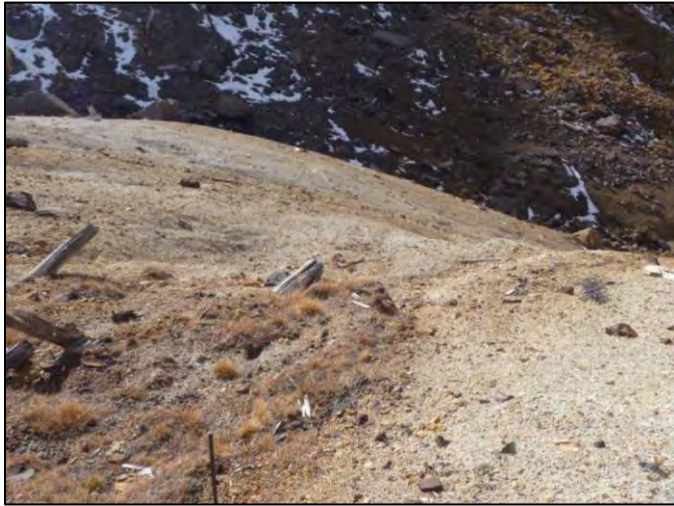
Photo 3. View from above Terrible #1 waste rock. Terrible #1 waste rock pile is approximately 1.0 acre.

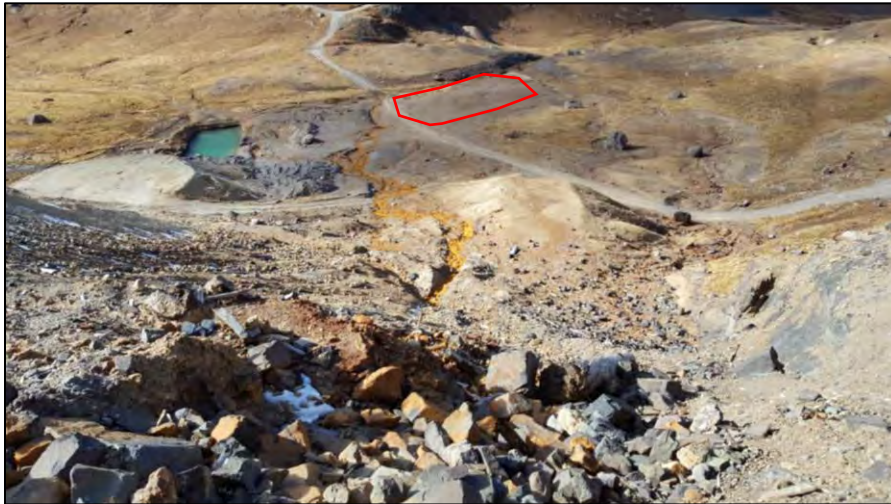
Photo 2. View of tailings near Governor Basin Road. The tailings limit plant growth in the area. The red polygon shows the approximate area of the USFS claim.

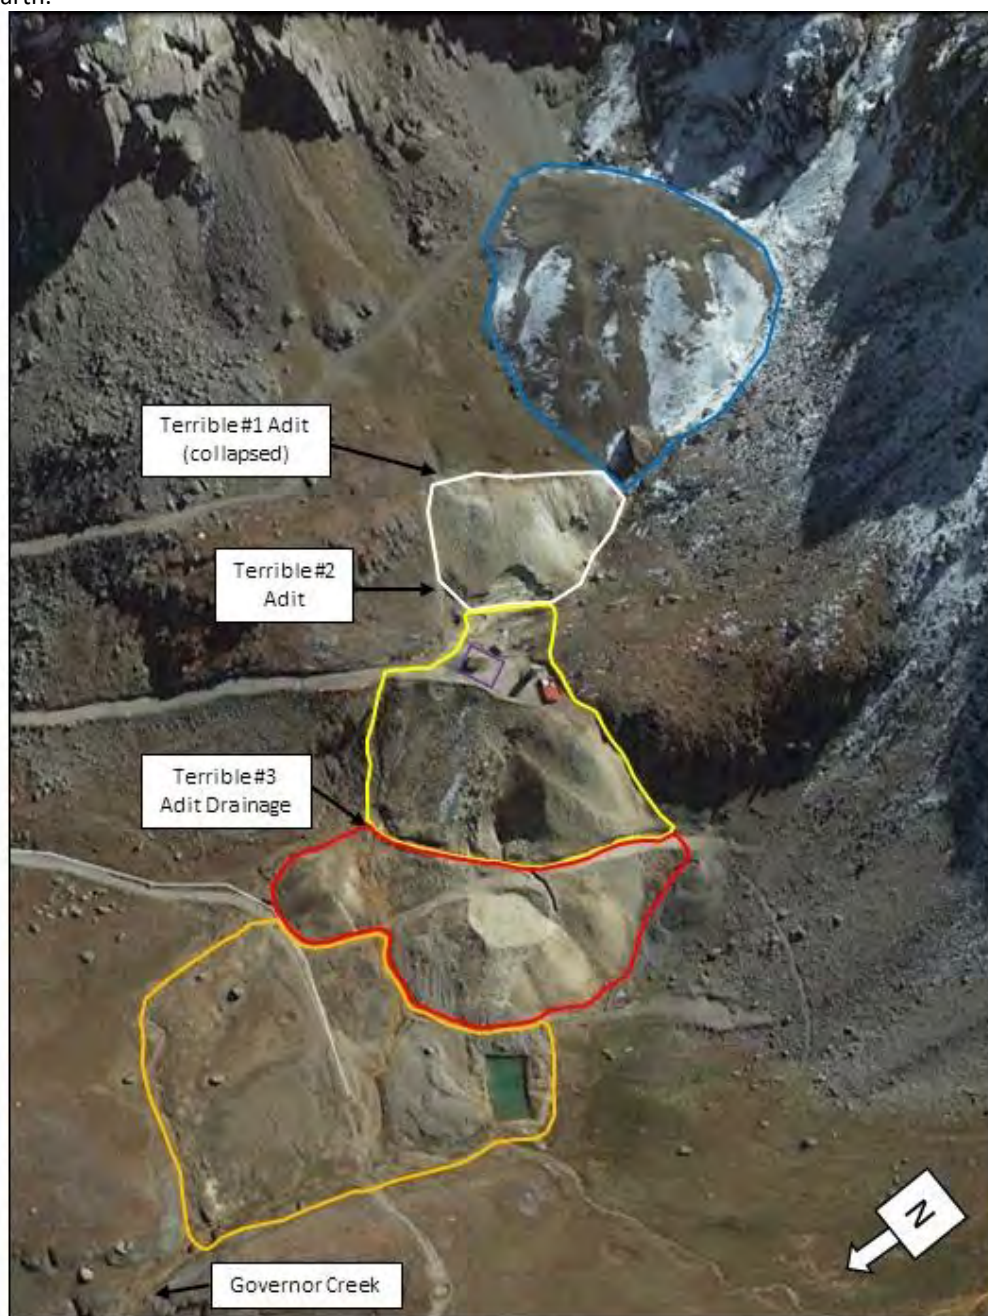
Figure 4. Detailed map of the Virginius and Terrible Mine sites. The Virginius waste rock is outlined in blue. The Terrible #1 mine dump is outlined in white, #2 mine dump in yellow, and #3 mine dump in red. Mixed tailings from the Virginius and Terrible veins are outlined in orange. The polygon boundaries are approximate. Imagery courtesy of Google Earth.

In July 2014, Fortune Minerals, the mining company that owned the Revenue-Virginius mine, collected surface water samples at five locations in upper Governor Basin. Samples were collected from four separate tributaries including a channel from San Sophia Basin to the west, the Humboldt Mine drainage, and two drainage channels that originate from and pass over the Terrible mine waste. One sample was collected below the point where these drainage channels converge in the upper basin (Figure 4).

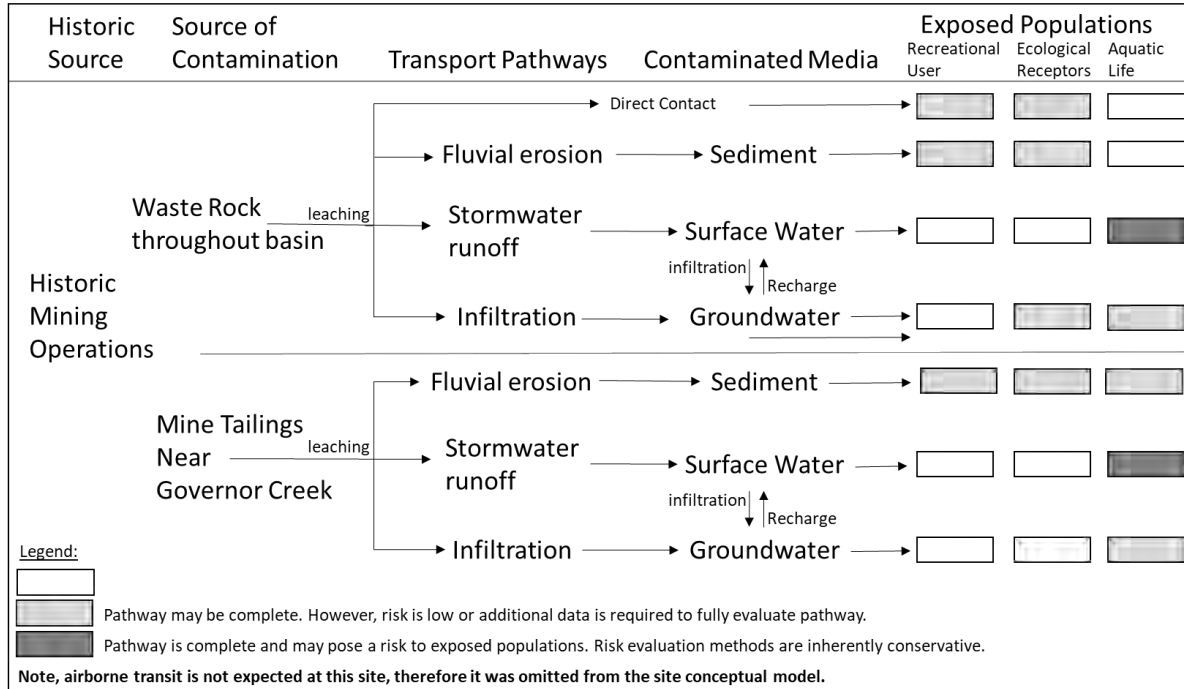
Figure 5. Conceptual site model of Governor Basin.
