Re: Colorado Watershed Restoration Grant Annual Report -- Coal Basin and Crystal River Confluence Area Restoration Project

South Fork of Dutch Creek Pilot Project Report

Prepared by: Sharon Clarke, Roaring Fork Conservancy;
Justin Anderson, Mark Lacy, Brian McMullen, and John Proctor,
White River National Forest
March 26, 2014

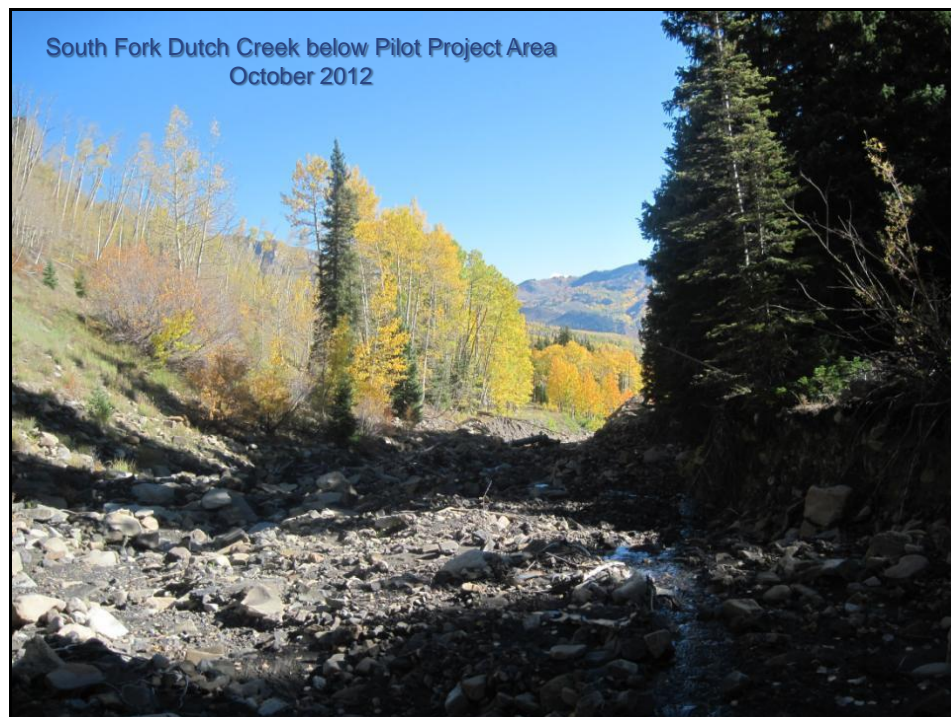
Figure 2. South Fork of Dutch Creek below the pilot project area.

The South Fork of Dutch Creek in Coal Basin (shown in [Figure 2](#)) is a good example of an impacted stream - the channel has a high width to depth ratio, lacks riparian vegetation, and excessive fines clog the channel. The 10-acre South Fork of Dutch Creek Pilot project was designed as a reclamation project for this severely-impacted area. The pilot project was also designed to study the costs and benefits of several different restoration techniques in order to determine the most favorable methods to be utilized in the planned landscape-scale restoration of Coal Basin.

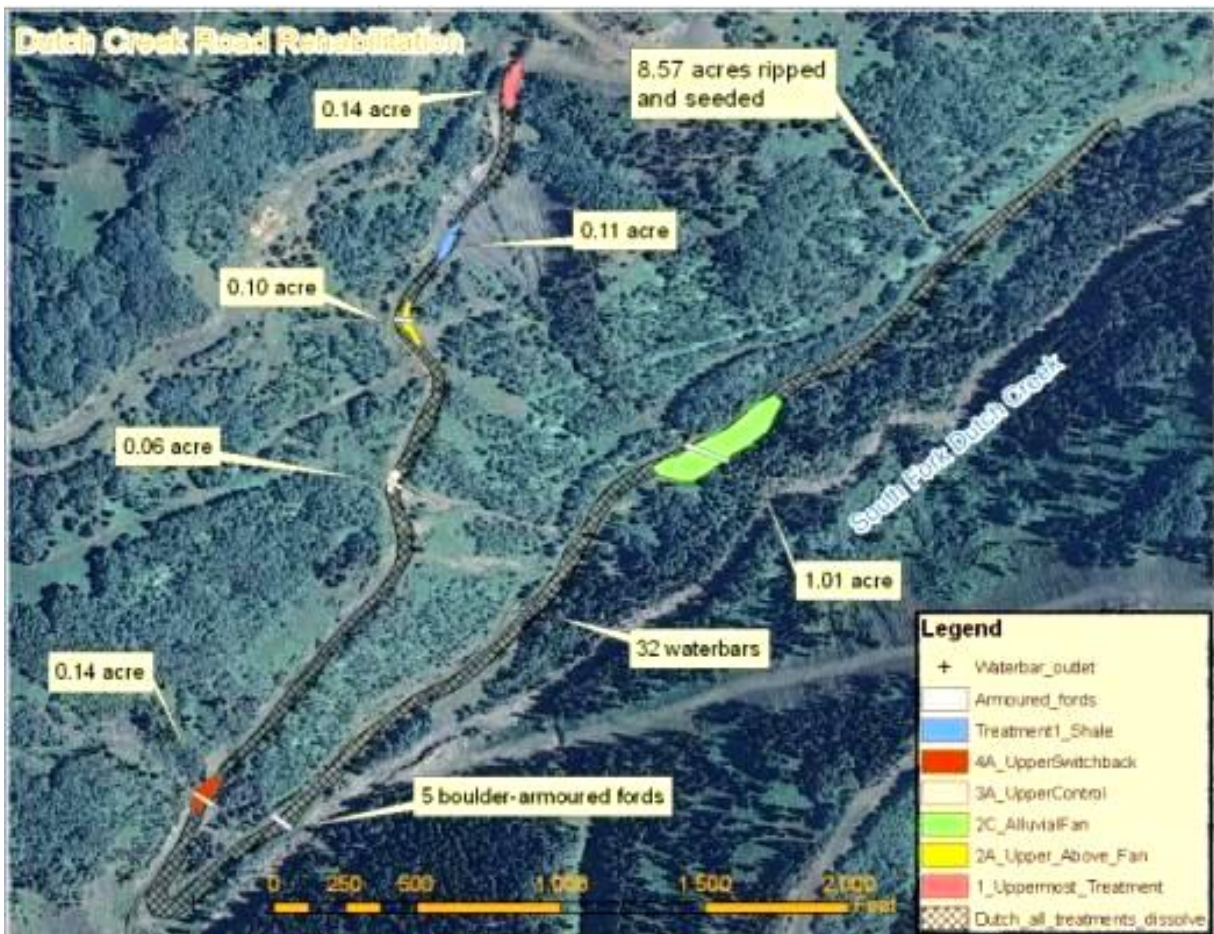
Figure 4. Pilot project area with treatment areas outlined.

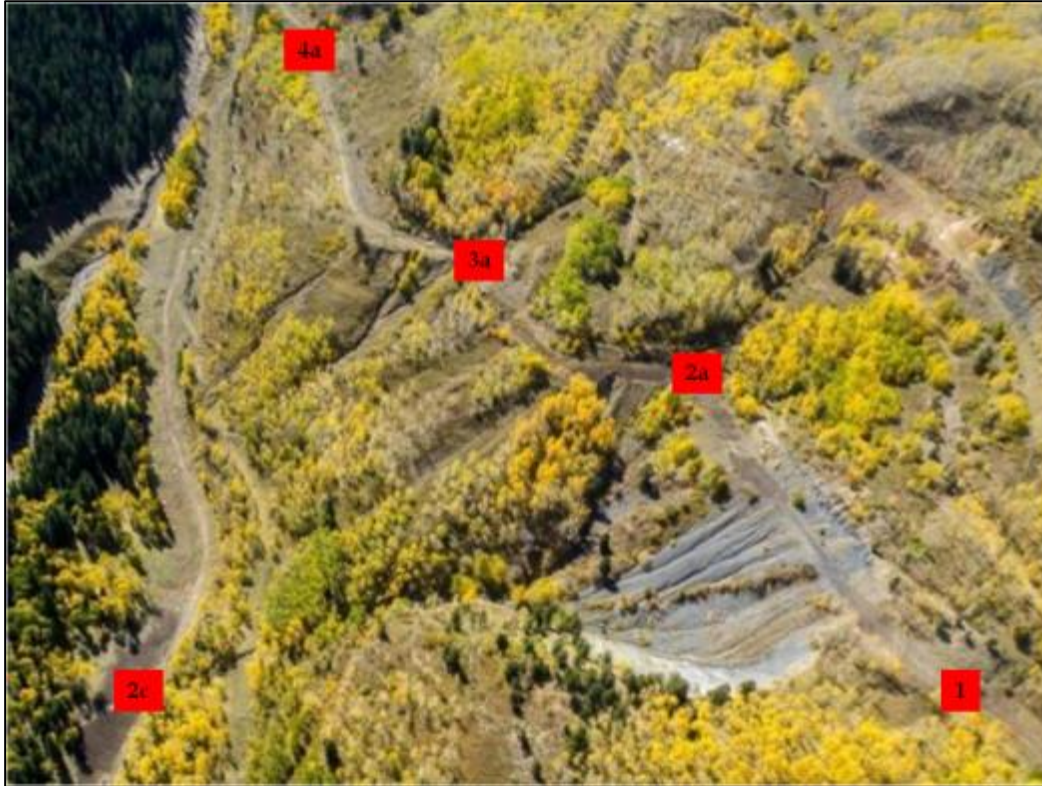
Figure 5. Pilot project area with work ongoing, September, 2012 (source: EcoFlight). Note the darkened surface at area 2c (“alluvial fan”) area, where the largest volume of compost/biochar was applied.

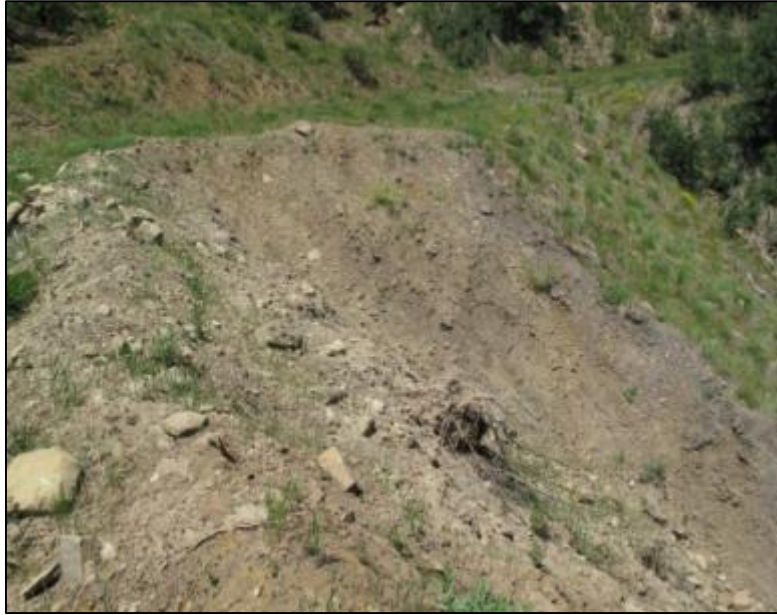
Figure 6. Area 2a before restoration.

Site 2a in [Figure 6](#) shows an intermittent stream channel failure associated with a road crossing. Some of the water from the channel was routed down the road, causing gullying and rilling and a head-cut where water exited the road prism. The area was rehabilitated by reconnecting and hardening the stream crossing, cross ripping the road prism adjacent to the stream channel, placing wood perpendicular to the slope at the head cut, amending the soils with biochar and compost, and seeding the entire area with locally-sourced (“ecotypic”) native grasses (see [Figure 7](#)).

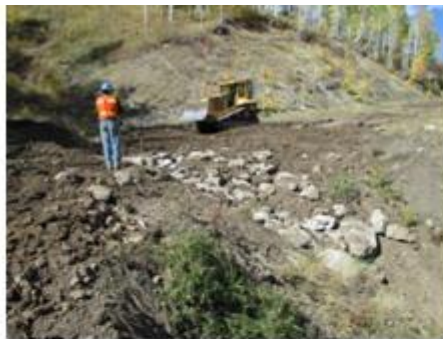
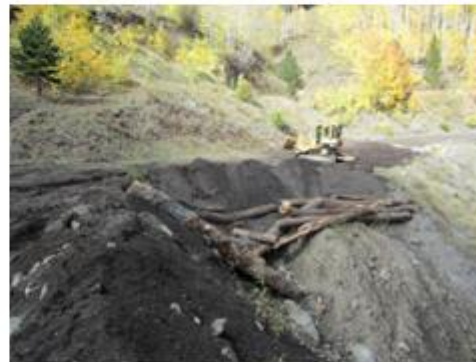
2a
Disconnecting Connected
Disturbed Area (CDA)

Figure 7. Area 2a during restoration.

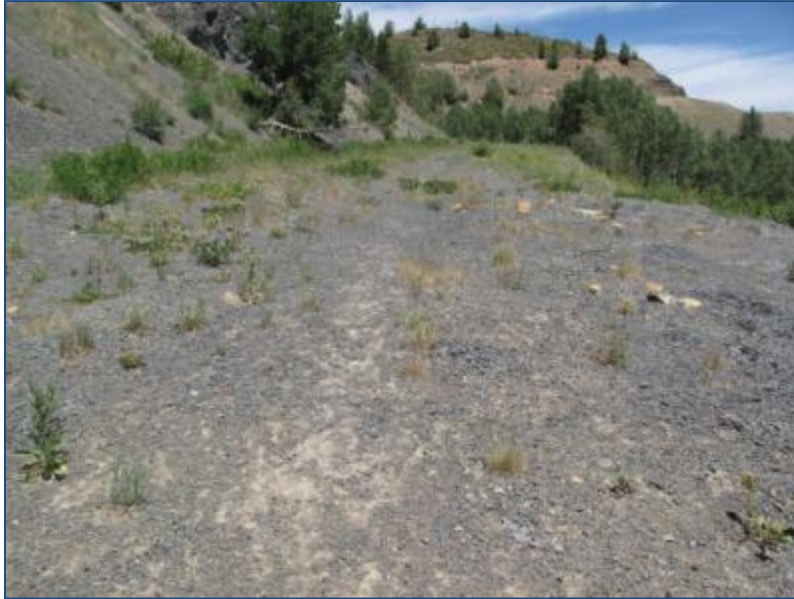
Figure 8. Road prism before treatment; road had minimal infiltration and excessive overland flow.

Figures 8 and 9 show the road prism before and after reclamation. In Coal Basin there are approximately 17 miles of legacy mining roads that were built using the cut-and-fill method; these were in-sloped to convey water, which was subsequently routed through culverts under the road. The culverts contributed to channel degradation by increasing flows in channels not naturally designed to carry these flows. Part of the reclamation work done by CDRMS was to out-slope the road prism and remove the culverts. Additional work still needed to be done on the road prism to improve water routing, increase water

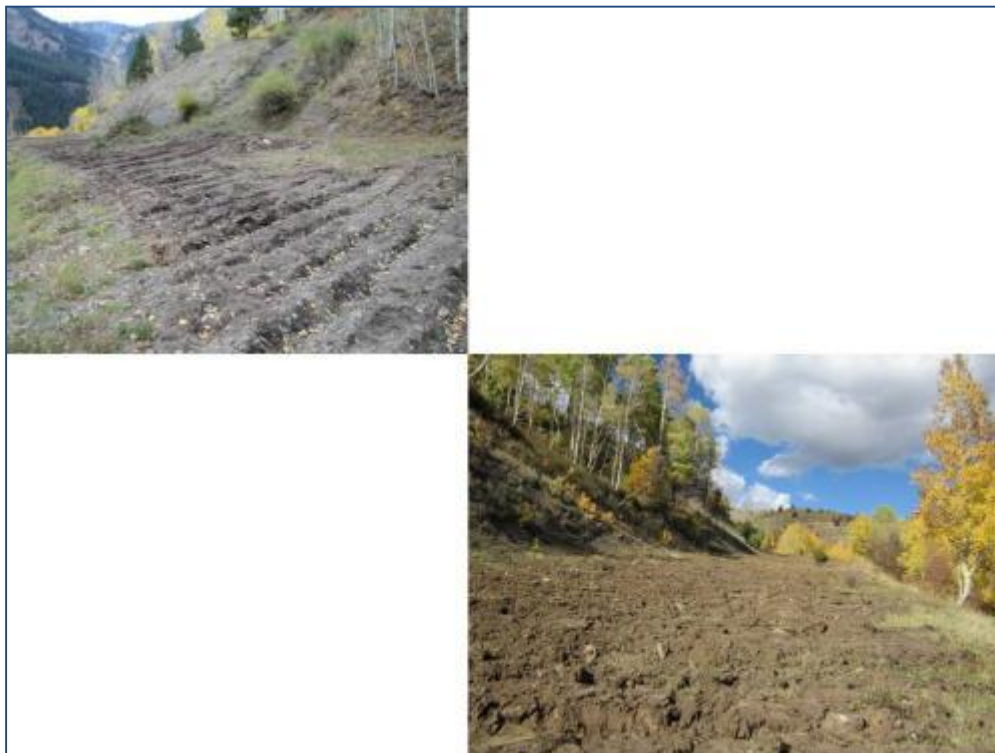
Figure 9. Cross-rippled road with compost/biochar soil amendment (above) and without soil amendment (below).

infiltration and vegetative cover, and reduce soil losses by sheet flow and rill/gully erosion. To accomplish this, the road prism in the pilot project area was cross-rippled to a depth of 18", water bars were constructed in-between the reconnected intermittent and ephemeral channels, and the entire road prism was broadcast-seeded in the fall of 2012. Selected areas were amended with compost and/or a compost-biochar mixture.

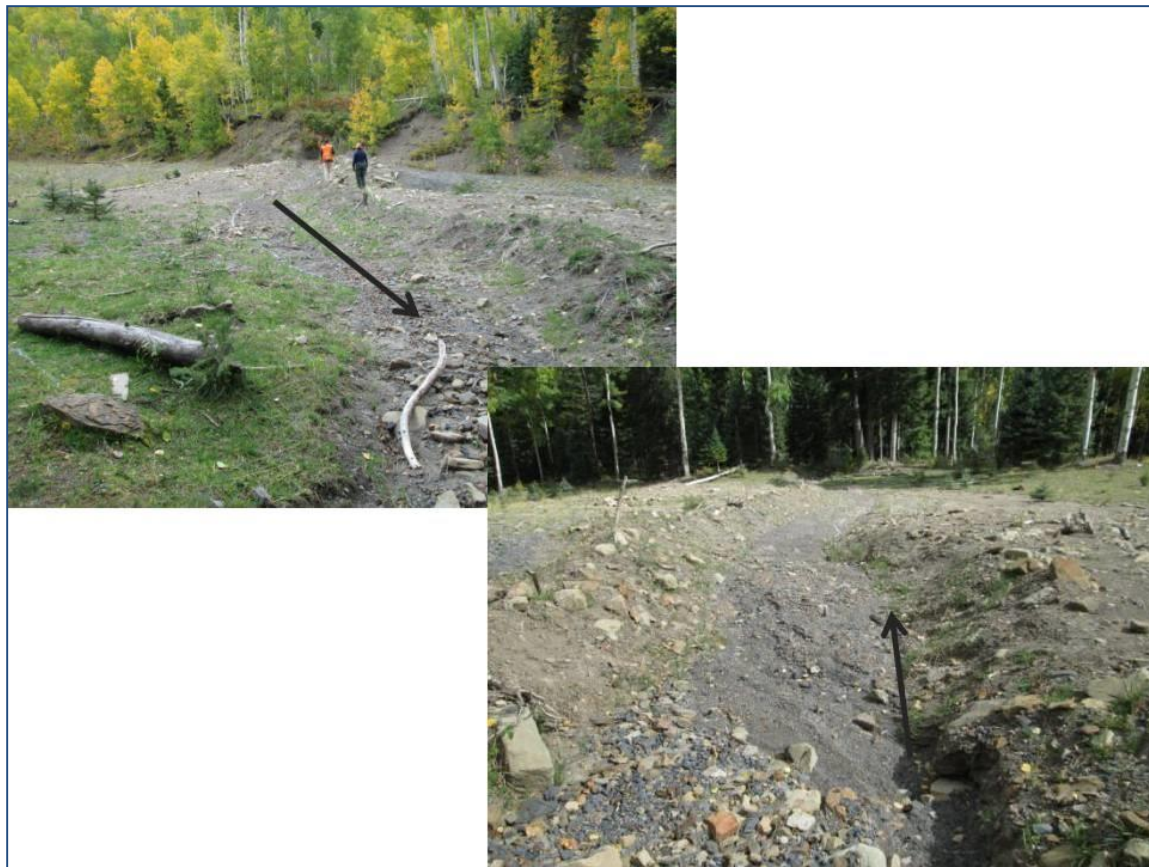
Figure 10. Area 2c alluvial fan before restoration (arrows show direction of flow).

Figures 10-13 show the extensive work done on the intermittent stream channel (area 2c), road prism, and floodplain. The primary objective of this effort was to reduce overland flow and sediment delivery to the streams and to provide opportunities for water infiltration and sediment storage in the upland areas, all while increasing vegetative cover. [Figure 10](#) shows the intermittent channel as it drops to the valley floor near the confluence with the South Fork of Dutch Creek. Low gradient areas and associated wide floodplains, such as this area, are where sediment is naturally stored. To attempt to mimic this natural function, restoration began upslope at site 2a and continued to the confluence area at site 2c. A natural alluvial fan located near the confluence of Braderich and Coal Creeks was used for reference during construction of the alluvial fan shown in [Figures 12](#) and [13](#). Several things were done as part of this site reclamation: the stream road crossing was stabilized (as discussed above); the road prism was cross-ripped and soil amendments were added; a 1-acre alluvial fan was constructed; grade controls were installed at the downstream end of the fan/intermittent stream channel using logs; and the area was revegetated with a grass seed mix, spruce seedlings, and willow cuttings.

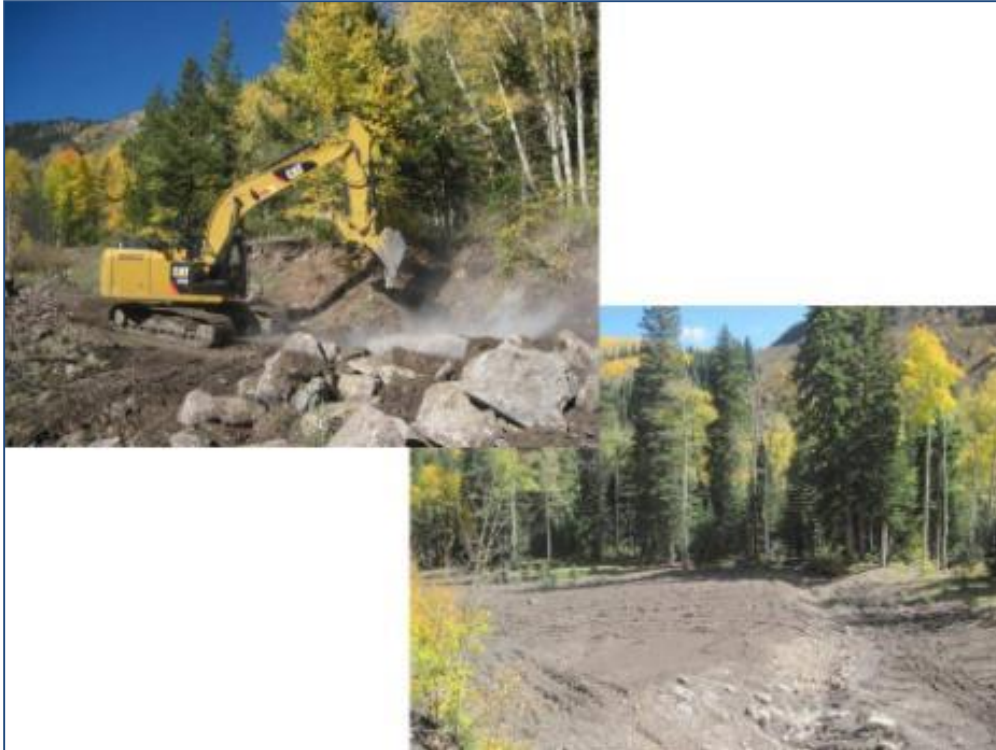
Figure 11. Area 2c alluvial fan during restoration.

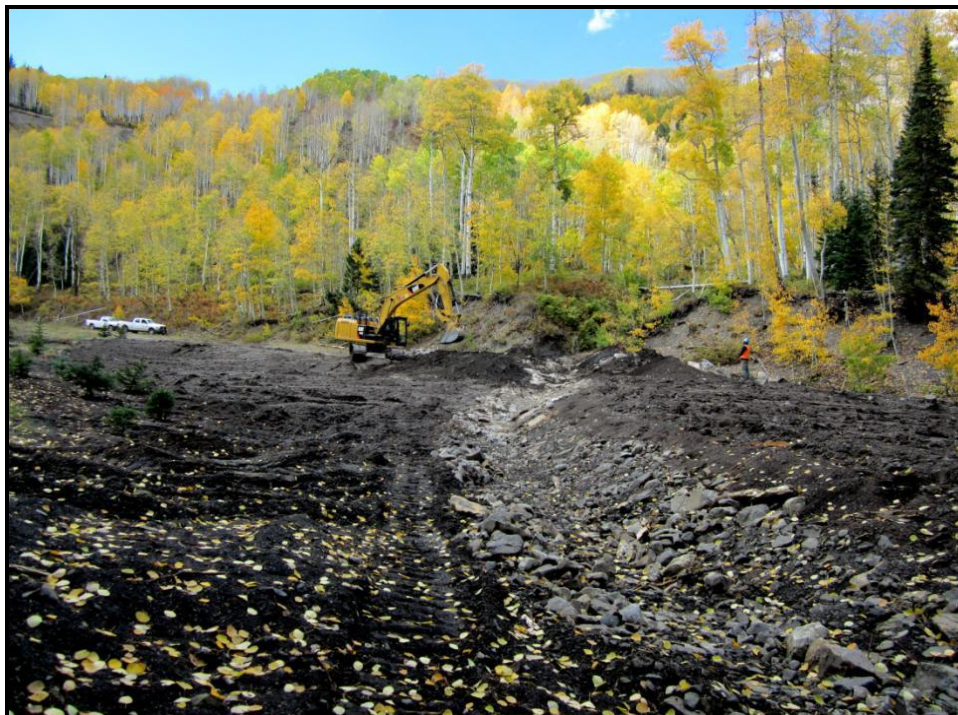
Figure 12. Area 2c alluvial fan during restoration.

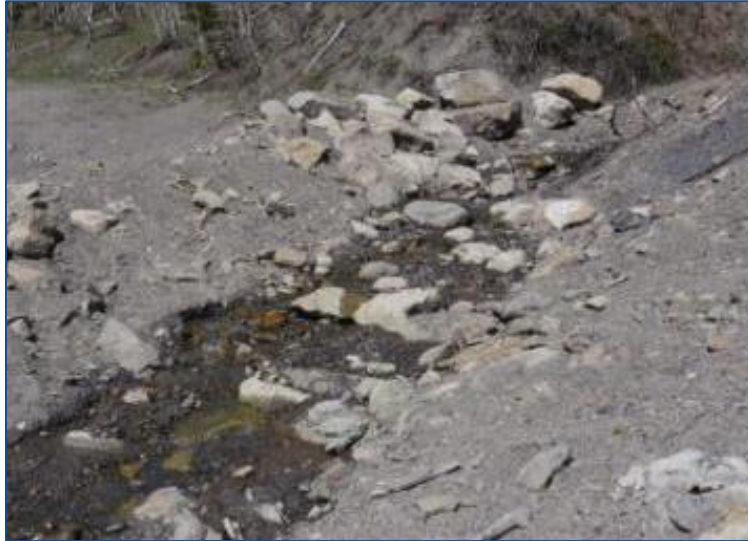
Figure 13. Area 2c alluvial fan transporting water and dissipating sediment following restoration. May 13, 2013.

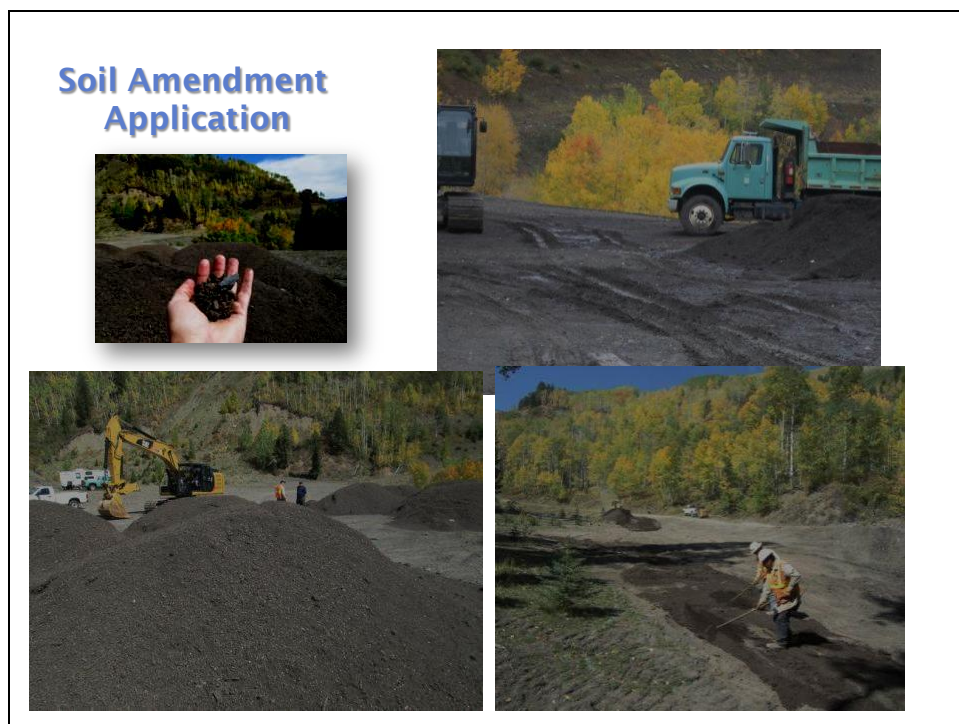
Figure 14. Application of biochar/compost and compost only soil amendments in treatment areas. Top left photo is a close up of biochar. Piles in photos are compost/biochar blend.

Figure 14 shows the application of soil amendments. The purpose of soil amendments is to reduce soil compaction/bulk density, increase soil moisture content, and provide nutrients for plants. Three treatment types were used: a control (no amendments); compost only; and compost with biochar. Compost was obtained from the South Canyon Landfill/Heartland Environmental Services and biochar from Biochar Reclamation, LLC. Table 2 lists the location of the different treatment options.

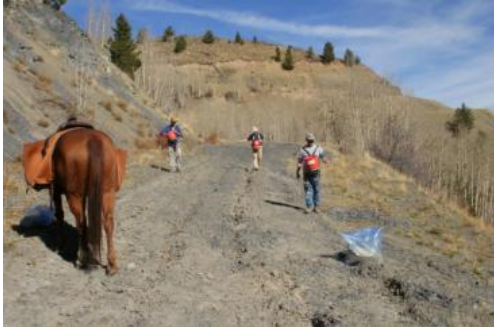
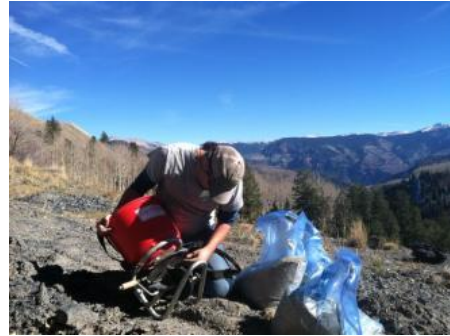
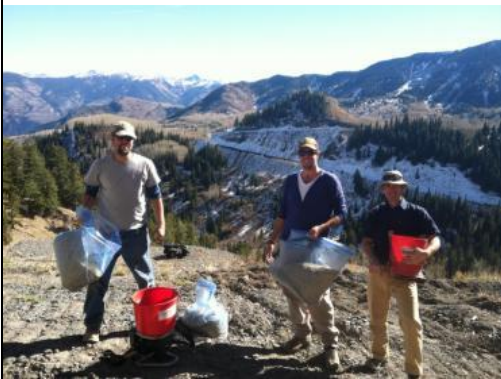
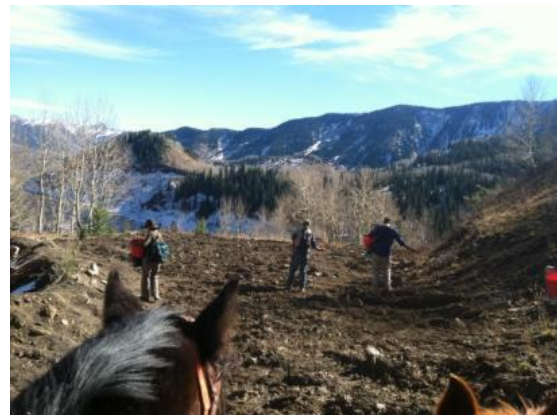
Seeding with Native Vegetation October 31, 2012

Figure 15. Seeding with native (ecotypic) WRNF grass seed mix.

To improve vegetative cover, thereby increasing water infiltration and decreasing erosion, the treatment areas were seeded and trees were planted. In the fall of 2012, approximately 1.5 miles of road constituting a CDA to the Dutch Creek drainage were ripped and crossed ripped, and then broadcast-seeded at 35 pure live seed (PLS)/acre with a genetically local (ecotypic) grass seed mix (see [Figure 15](#)). The seed mix was comprised of 60% WRNF mountain brome and 40% WRNF slender wheatgrass. Prior to this effort, the road had been revegetated with cultivar grasses, including both native and exotic perennial grass species. Additionally, a 1-acre alluvial fan reconstruction area was broadcast-seeded at 35 PLS/acre with a genetically local (ecotypic) grass seed (see [Figure 16](#)). The grass seed mix was comprised of 40% WRNF mountain brome, 35% WRNF slender wheatgrass and 25% WRNF blue wildrye. Prior to seeding, the native soil on this 1-acre site had been amended with 10% biochar/compost.

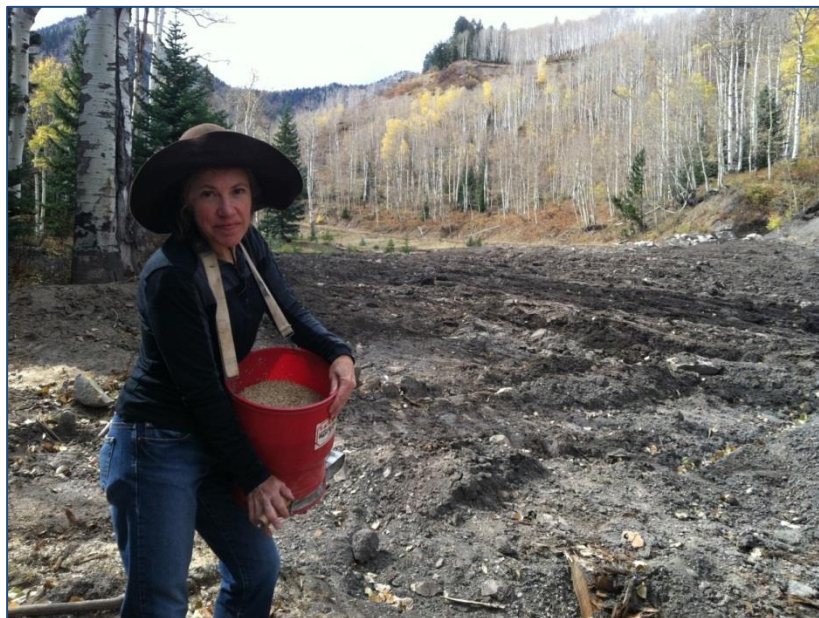
Figure 16. Reconstructed alluvial fan seeded with WRNF mountain brome, slender wheatgrass and blue wildrye.

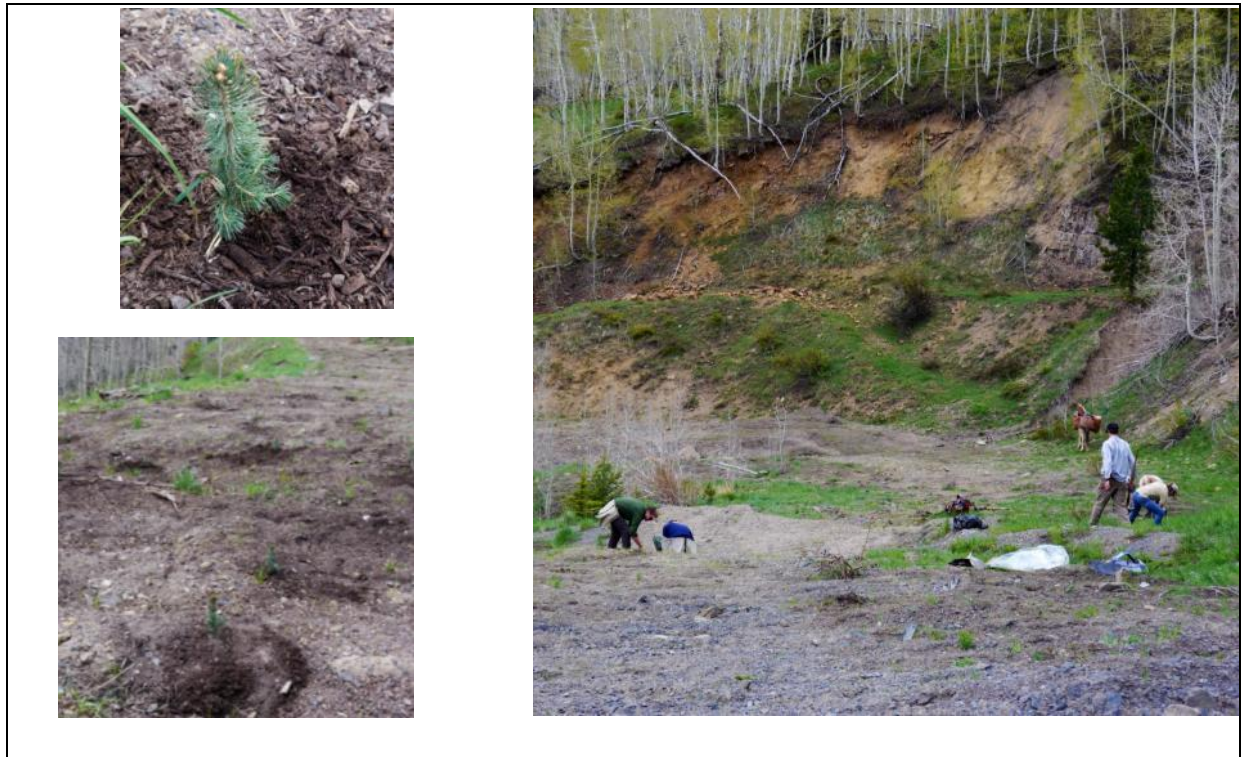
Figure 17. Engelmann spruce tree planting, June 2013.
Note the improvement of conditions at the micro-site level.

On June 3rd and 4th, 2013, 750 Engelmann spruce trees (provided by the USFS) were planted by USFS staff with the help of Colorado Parks and Wildlife and the brute strength of “Aspen”, a USFS mule(see [Figure 17](#)). Each tree was planted in a hole where the soil was amended to improve conditions at the micro-site level. Planting took place over approximately 4 acres within a 9,000’- long decommissioned road prism. Wet draws from the top to the alluvial fan and then down to the gate at the Lamphouse (an abandoned mining facility) were planted, in addition to all amended soil locations and other water bars that had visible water. The idea was to plant timber stringers up draws and mimic naturally-occurring features on such aspects. (Cottonwood sprouting out of cottonwood logs half buried on the upslope end of the fan was noted.)

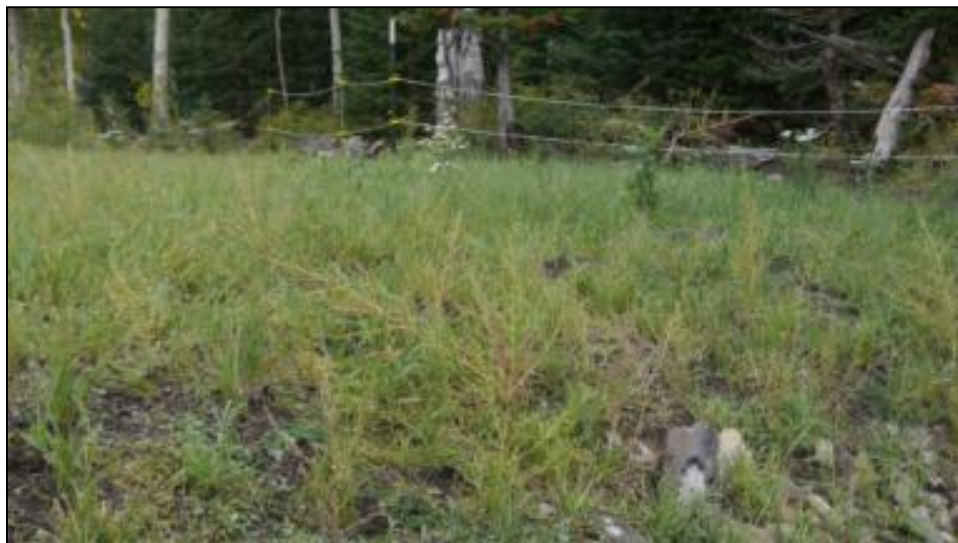
Figure 18. Electric fence in alluvial fan area.

To protect the vegetation in the project area from cattle grazing, an electrical fence was installed by USFS personnel before cattle were turned out in the USFS grazing allotments (see [Figure 18](#)). Mules and horses were used to haul fencing material to the project site. This fence was taken down after the cattle were removed and stored for the winter. It will be put back up in the spring of 2014.

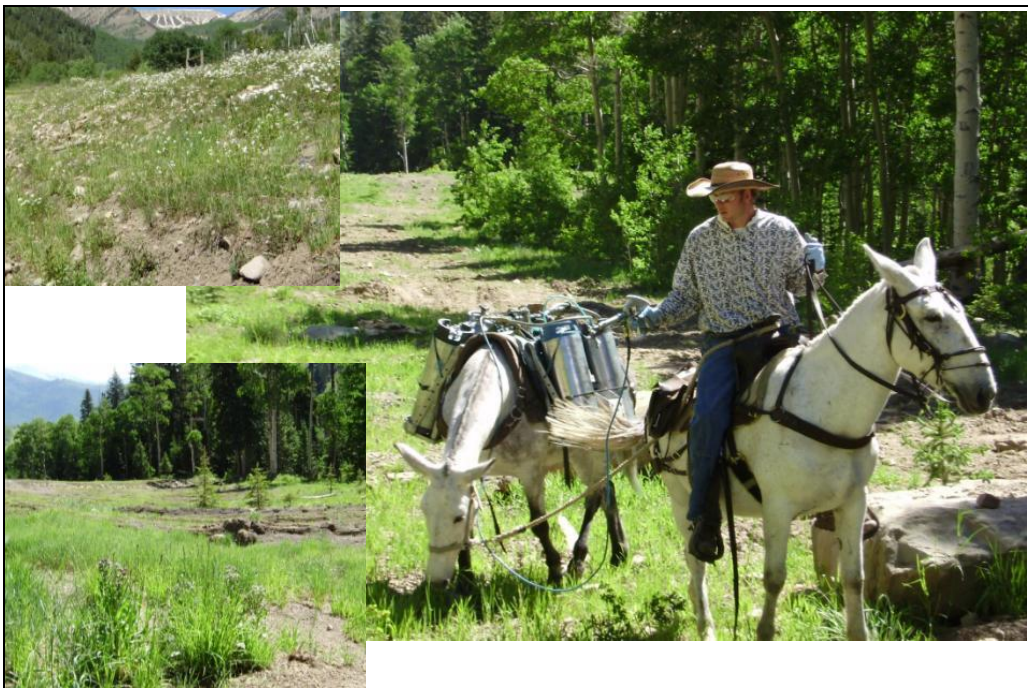
Figure 19. Spot spraying for weeds (June 2013) in the treatment areas.

Due to the amount of ground disturbed from coal mining and associated activities (such as roads, wash plants, and refuse piles), there are large areas of Coal Basin significantly impacted by noxious weeds (notably, plumeless thistle, hounds tongue, oxeye daisy, and Canada thistle³). The ground disturbance associated with the pilot project only compounded the problem. While addressing this added infestation was outside the purview of the USFS annual weed spraying program, USFS personnel played an essential role in the design and implementation of a successful program to treat the pilot project area. USFS expertise was used to identify potential applicators, most effective timing, application rates, chemicals, and methods. Sixteen acres of ground within and adjacent to the pilot project area were treated for noxious weeds during the week of June 18-21, 2013 (see [Figure 19](#)). Subsequent hand treatments (pulling) followed throughout the growing season when resource specialists were at the site for monitoring events.

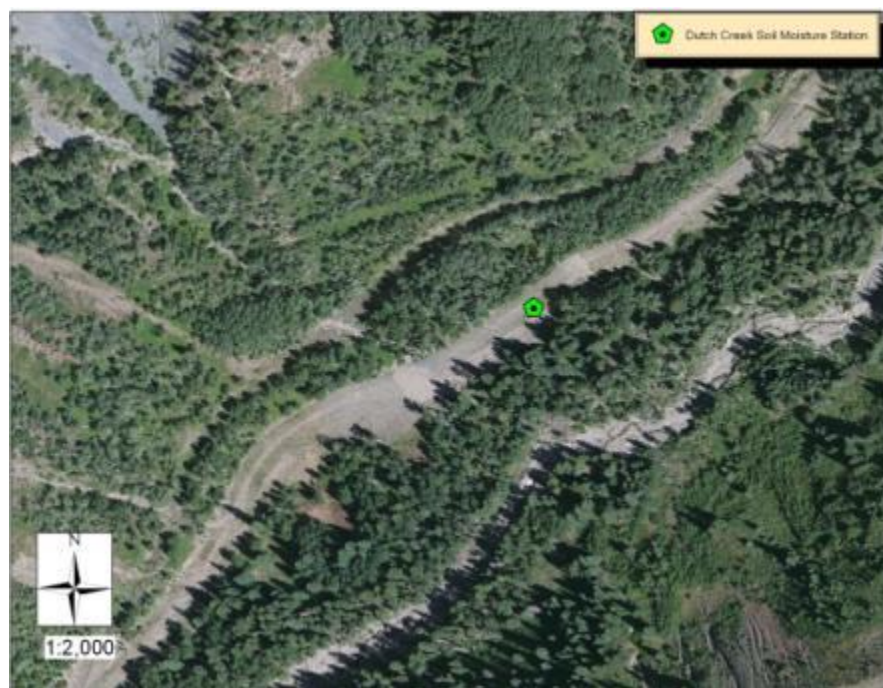
Figure 21. Location of the soil moisture monitoring station in the pilot project area.

Continuous soil monitoring probes were installed at the project site to collect data to facilitate the comparison of the effectiveness of a biochar/compost mix, compost, and no soil amendments for improving soil moisture (see [Figures 20 and 21](#)). The system consists of a tipping bucket for precipitation data, a photovoltaic panel and battery for solar power, and soil moisture and temperature probes installed within the rooting zone for local vegetation (see [Figure 22](#)). Probes were located at 2", 8", and 20" depths, following protocols established by Natural Resources Conservation Service (Soil Climate Analysis Network) stations and in a manner compatible with local soil moisture data being collected

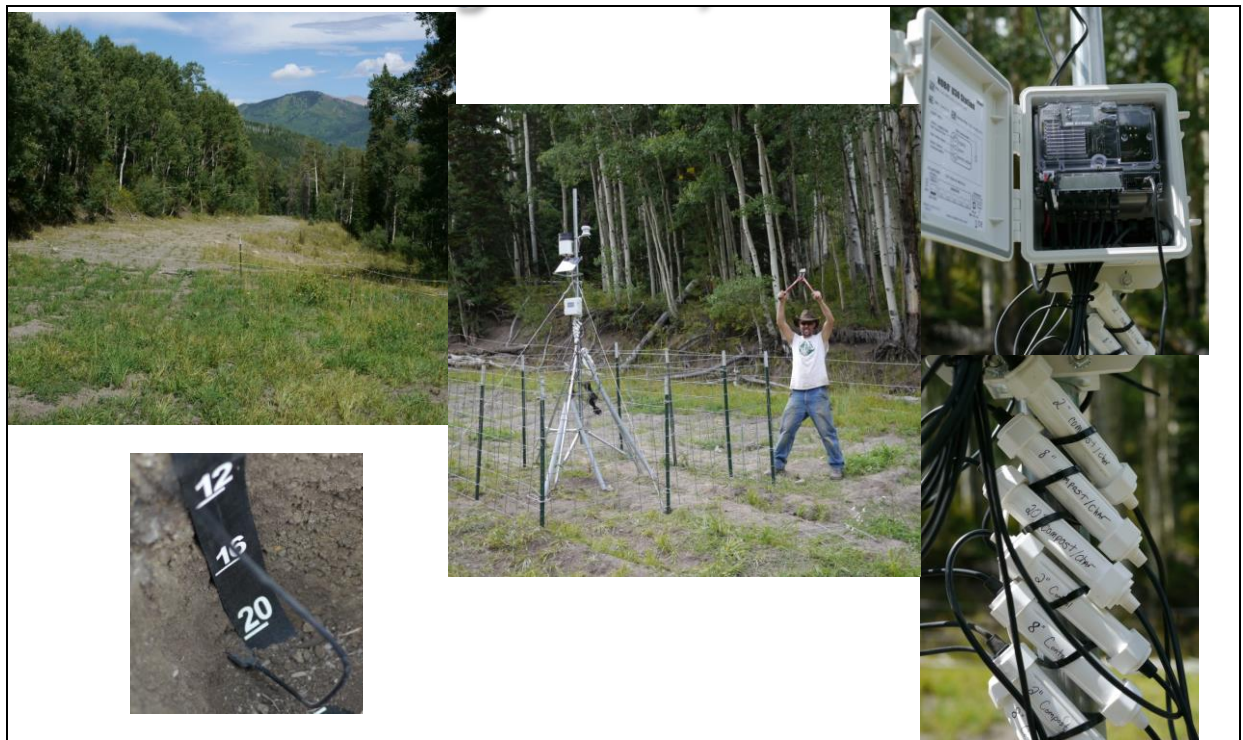
Figure 22. Soil moisture monitoring station. August 2013.

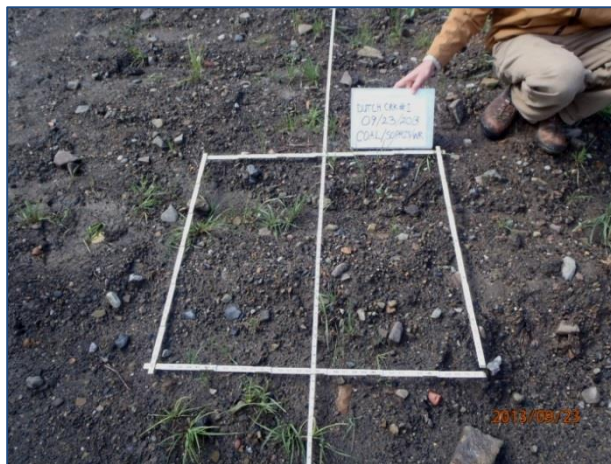
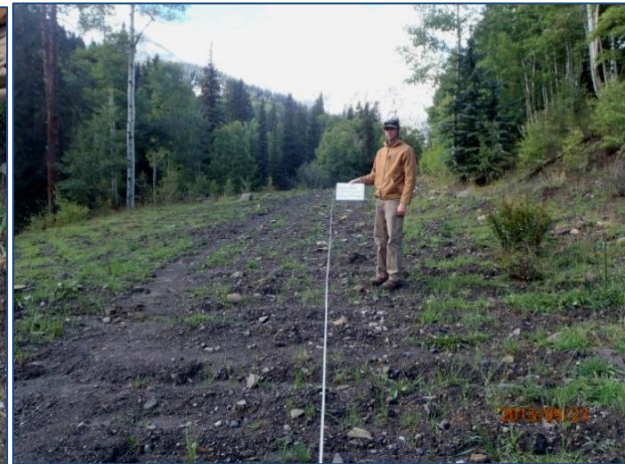
Figure 27. Dutch Creek transect # 1.

Figure 28. Dutch Creek transect # 1.

On September 23rd, 2013, data was collected from one cover frequency transect (Dutch Creek #1) to determine source performance of the ecotypic seed sources utilized as well as the first year success of that revegetation effort (see [Figures 27](#) and [28](#)). Plans to measure two additional transects along this 1.5 mile stretch of road were interrupted by the government furlough. No additional transects associated with the Dutch Creek road decommissioning were measured in 2013.

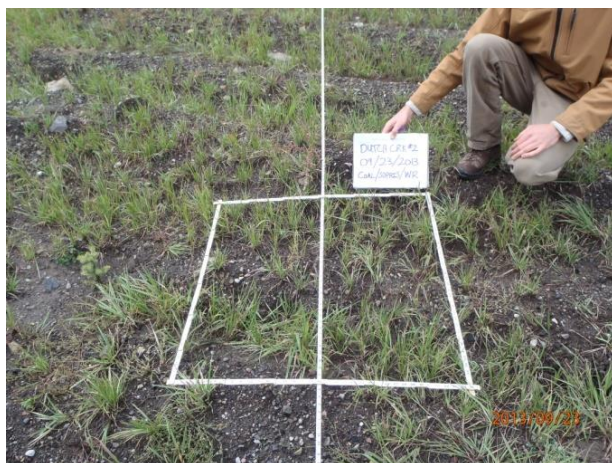
Figure 30. Slender wheatgrass in transect #2.

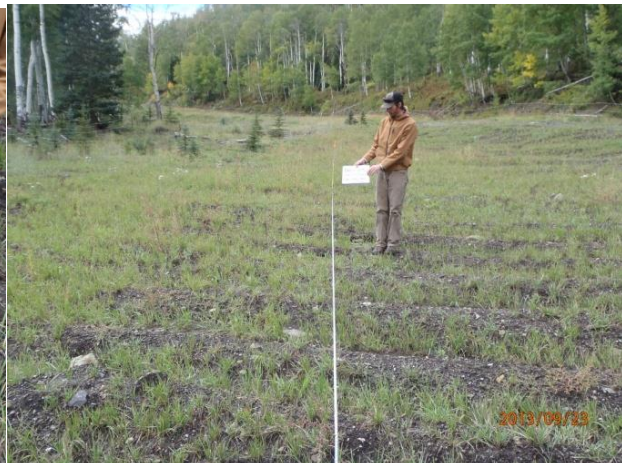
Figure 31. Transect #2.

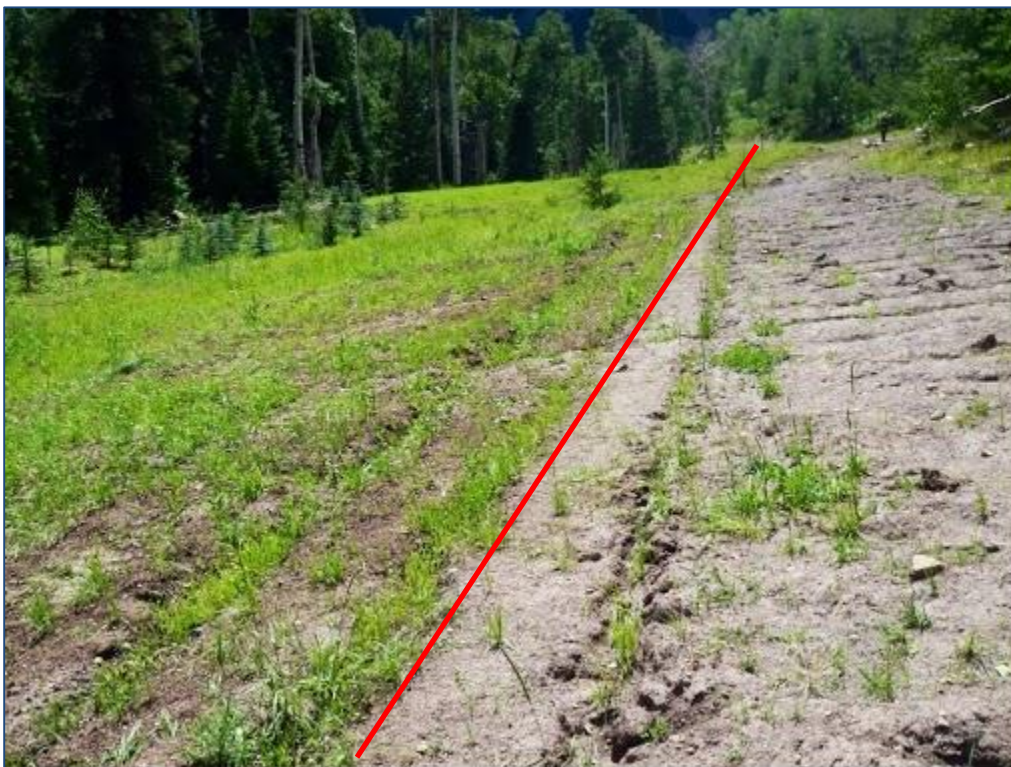
Figure 33. Contrast between alluvial fan area amended with compost-biochar (left of red line) and without (control-right of red line). September 24, 2013.

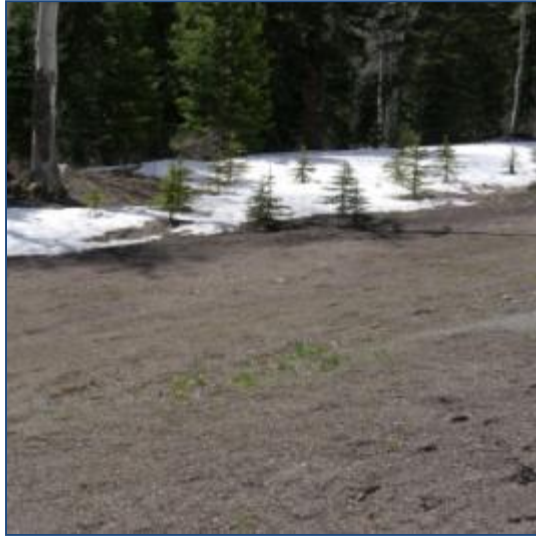
Figure 34. Alluvial fan. May 13, 2013.

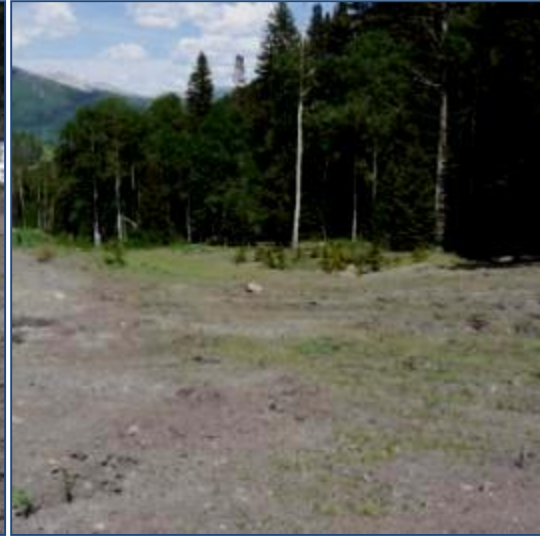
Figure 35. Alluvial fan. June 10, 2013.

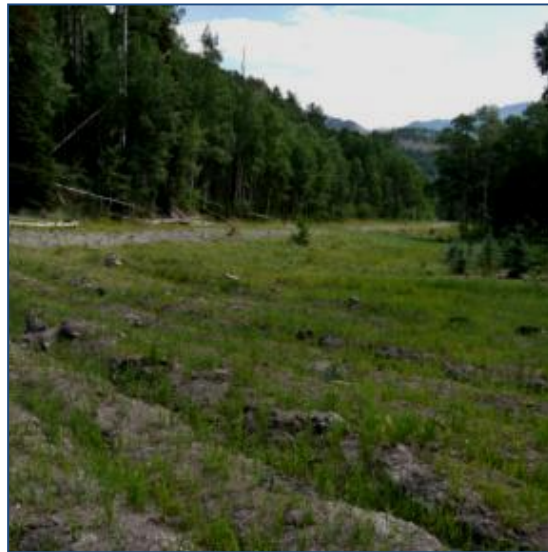
Figure 36. Alluvial fan. July 10, 2013.
