**Post-Fire Restoration in the Poudre River Watershed**  
Final Report

Skin Gulch

Seaman Reservoir

Coalition for the Poudre River Watershed  
Grant Amount: \$100,000  
Prepared by: Jennifer Kovecses

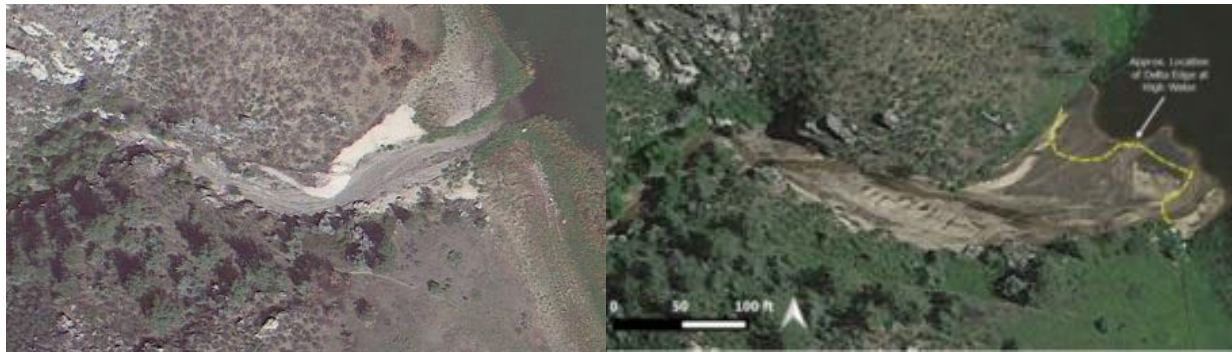
*Figure 3. Left - Photo of the delta in 2012 post-fire in low water and Right - Photo of delta in 2014 during low water. Photos show increased sediment deposition to the delta over a 2 year period. Yellow line indicates the visible extent of the delta at high water.*

reservoir and has started to create an unstable sediment fan/delta at the mouth of UT21 (Figures 3). Seaman Reservoir is owned and operated by the City of Greeley. In 2013 and 2014, restoration efforts focused on mulching and seeding of the burned areas in the headwaters of UT21. There has been continued concern about the risk the sediment in the delta poses to reservoirs water quality and storage capacity. Additionally, the delta’s proximity to the inflow into the

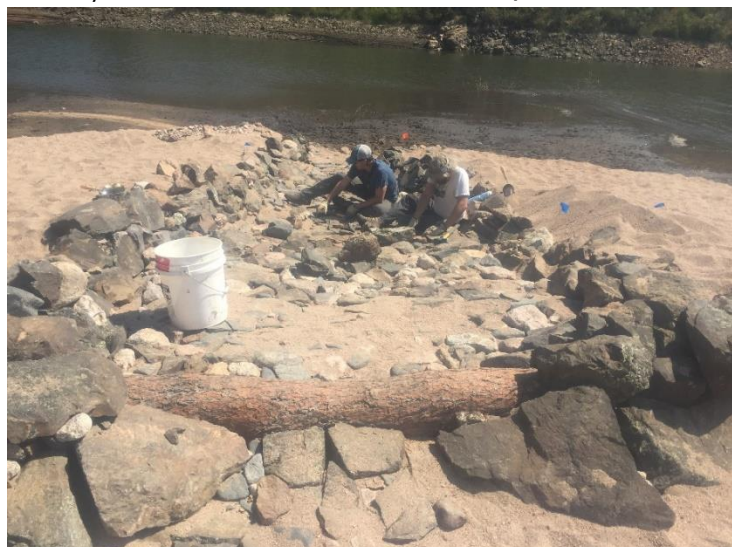
*Figure 4. Installation of rock structures & log weirs in delta channel to stabilize the channel at Seaman Reservoir*

sediment in the delta. One goal of the restoration design was to hold this creek channel in place. The second was to stabilize the highly-mobile sand/cobble delta and prevent it from releasing sediment into the reservoir. We installed various treatments to hold the channel in place and prevent it from migrating and causing more delta instability (Figure 4). Burned trees were felled to create log structures in the banks of the channel and in the floodplain. The channel was lined with stones/rocks collected from upstream. When water levels in the reservoir dropped, crews installed media-lunas at the toe of the delta face

and installed erosion control matting on the delta face, covered it with mud, and seeded it with native vegetation.

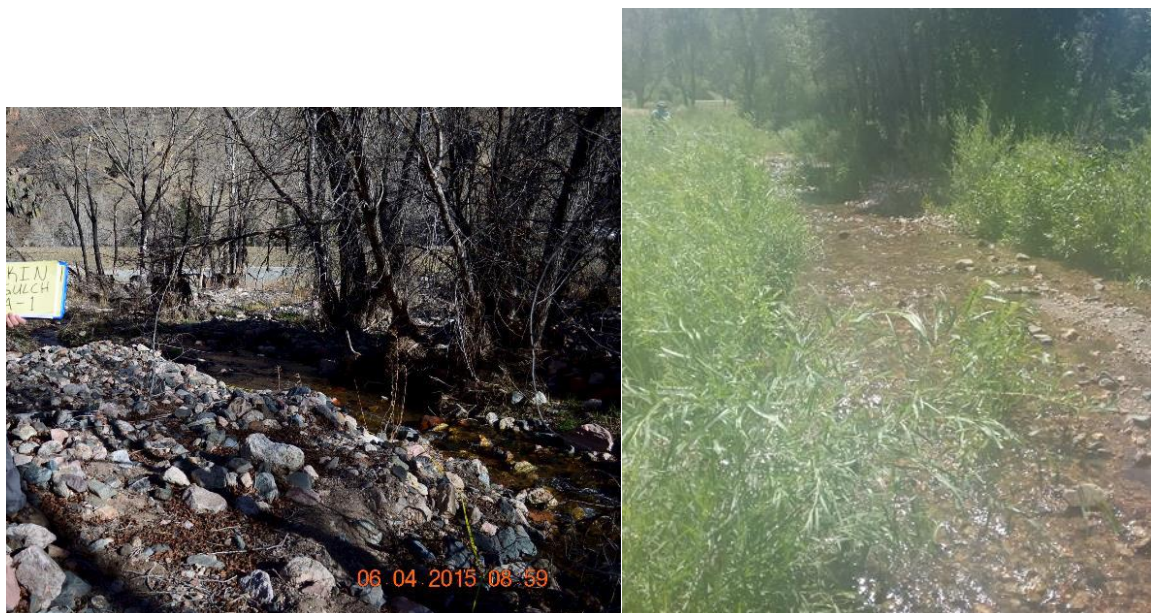
*Figure 5. Reach A, just upstream of CO-14 culvert. Left) pre-restoration, June 2015; Right) post-restoration August 2016.*

The Skin Gulch project resulted in 5,700 feet of creek being restored, over 3 acres of floodplain habitat improved, and 50 volunteers were engaged in the project. Vegetation successfully established in the riparian and floodplain areas (Figure 5-7) and the re-aligned channel has remained stable to date.

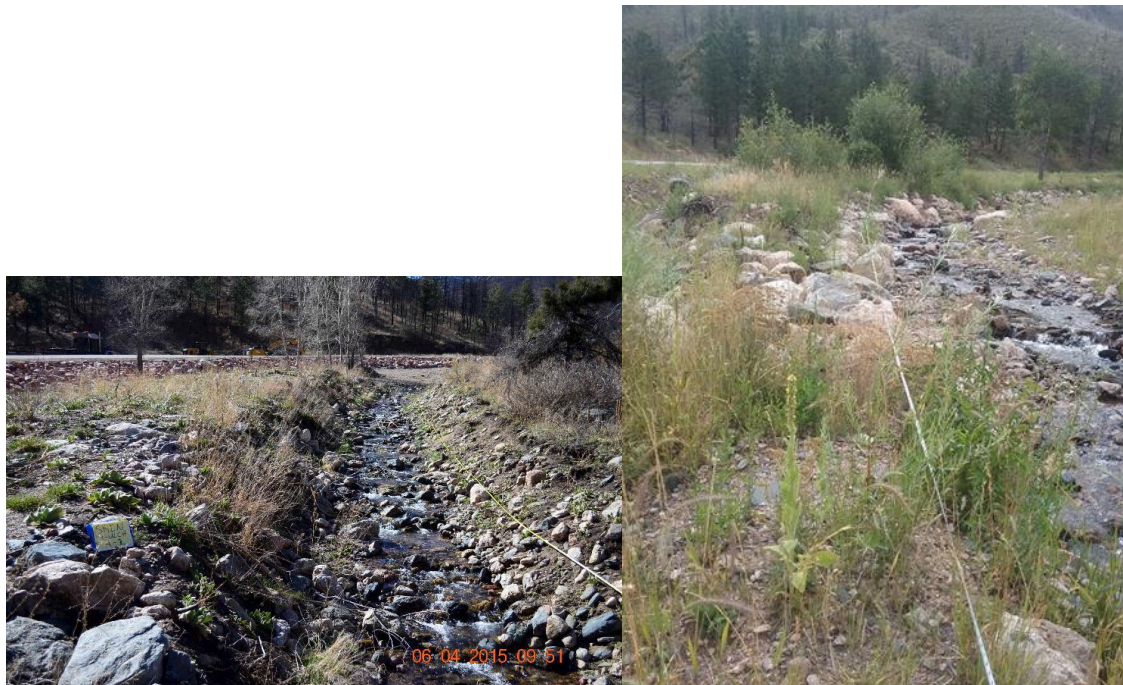
*Figure 6. Reach A, middle section. Left: pre-restoration; 2) post-restoration August 2016*

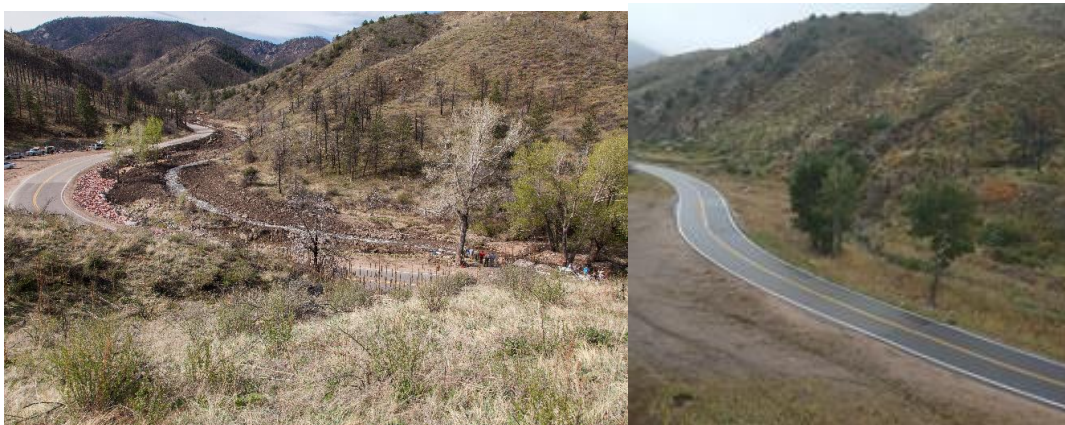
*Figure 7. Skin Gulch Reach A, viewed from downstream end. Photo on the left - channel construction complete, prior to first volunteer planting day, spring 2015. On the right: after all construction and planting complete, fall 2016.*

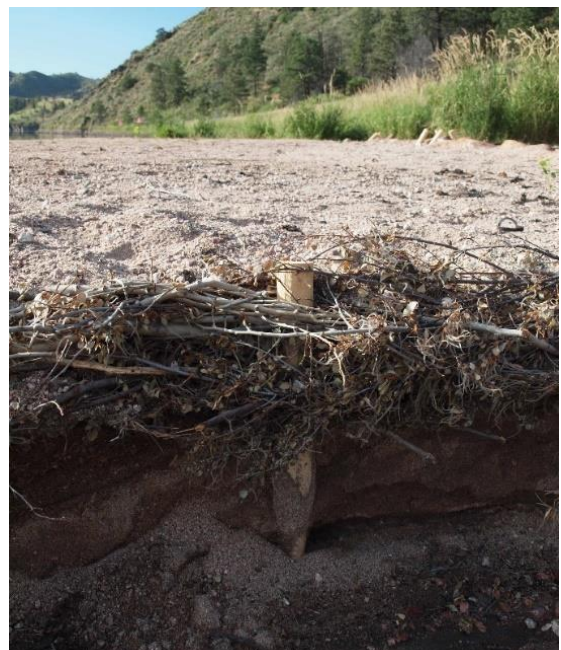
Figure 8. Post-storm damage on recently installed bank treatments at Seaman Reservoir.

logs etc.) because the delta is mainly composed of sand. Following the two weeks of Rocky Mountain Youth Corps work, there was a summer storm that passed through, eroding sediment away from recently installed structures (Figure 8). After this storm, our priorities changed and we focused on armoring the channel to protect the bank structures and to prevent any further erosion of the channel. This challenge was compounded by the fact that levels in reservoir started to drop rapidly. This caused two issues: one, it exacerbated the erosion in the channel by initiating some headcutting and two, as we had not anticipated having the delta face exposed until 2017, we did not have a finalized design for in place when the reservoir levels dropped. This meant re-working our project schedule of tasks. It did however offer an opportunity to address one of the most important aspects of the project sooner rather than later.

While this project was difficult, it was an opportunity to learn how to manage and implement a logistically and physically challenging project. Through trial and error, we also learned the best techniques/ methods to use for installing structures into sand on the delta.
