I am writing to submit the final deliverables and to close-out our grant for the Water Supply Reserve Fund, Dolores River Restoration Partnership Maintenance & Monitoring Project. This report includes a breakdown of the work occurred through the assistance of this funding and the final monitoring report.

Tres Rios BLM Field Office 2019 Rapid Monitoring

2019 Tres Rios Field Office Rapid Monitoring Summary Report

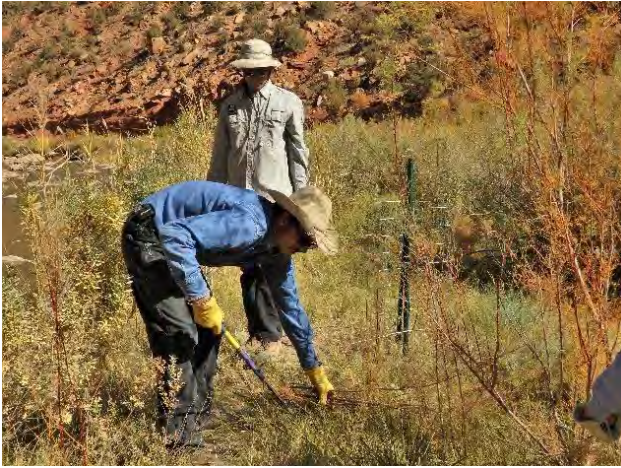
Figure 1. Volunteers caging cottonwoods and cutting tamarisk

1) 30 native trees were planted along the Dolores River at a campsite accessible for boaters and via the Y/11 Road, which will help the ecological condition of the site as well as improve the aesthetics for recreators. 15 box elders and 15 cottonwoods were planted and watered. WRV volunteers also helped to cage the trees in order to protect them from beaver and other wildlife.

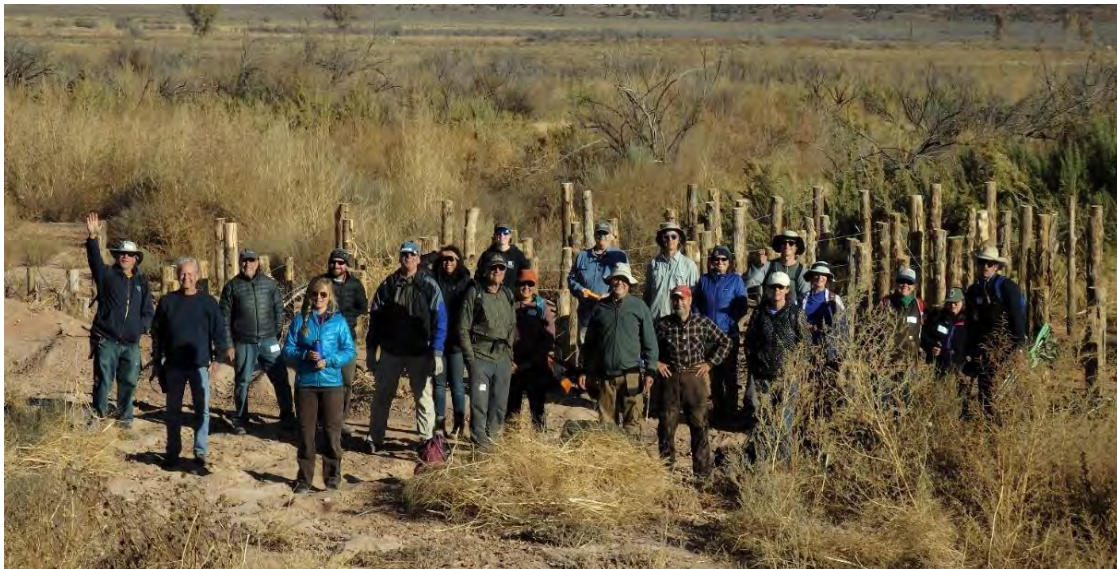
Dolores River responsible for watering the largest mature cottonwood gallery along the Dolores River in the Paradox Valley. In 2013, a massive flood event blew out the channel below a culvert, directing the water north and away from the cottonwoods. Since, cottonwoods in question have become less vibrant and unhealthy, which has driven the BLM to re-direct seasonal flows from East Paradox Creek back to the original path. The BLM and Southwest Conservation Corps (SCC) used chainsaws to cut tamarisk branches, which volunteers weaved into wooden posts previously installed 20 feet into the ground and broadcasted native grass seed. The overall intent of this project is to build up sediment transported down the creek to block the channel created in 2013 and direct water back to its native course. Since the posts were inserted in July, 2019, a rain event had occurred, sending water through the area, providing evidence the structure was working.

Figure 2. WRV Volunteers ready to complete the baffle on E. Paradox Creek

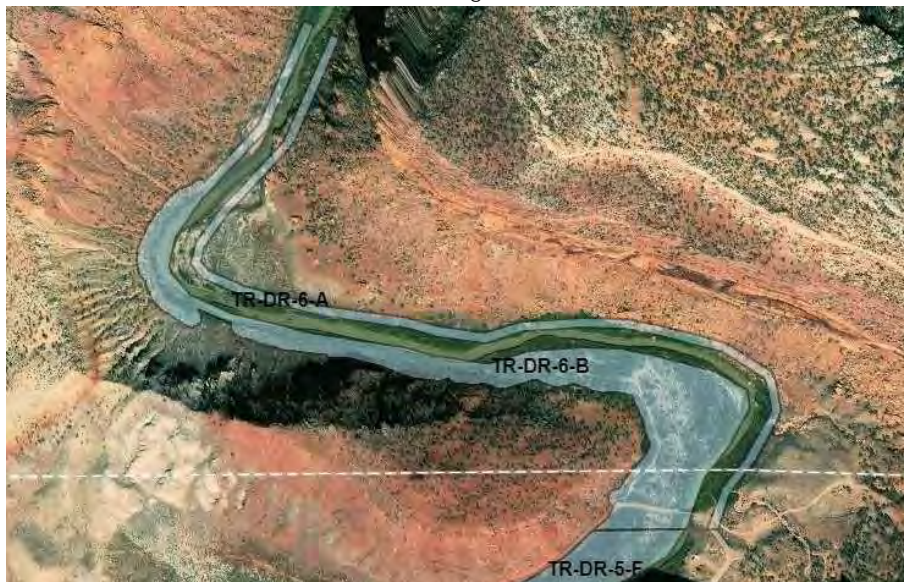
TR-DR-6-A

- Site Size = 6.10 acres
- Activities to date = none

- Russian knapweed scattered throughout the site at a density of ~ 11-20%
- Tamarisk non-woody resprouts throughout the site with a density of ~ 0-5%
- Cheatgrass present but minimal throughout the site

- Active revegetation – none
- Passive revegetation - Site meets DRRP Passive Recruitment Threshold – meets willow threshold of 100 stems or more, that are at least 0.5 meters in height.

- Tamarisk Relative Cover = 6-10%. DRRP Goal is < 5%
- Native/Desirable Relative Cover = 71-80%. DRRP Goal is >75%, or ideally >80%
- Absolute Vegetation Cover = 71-80%. DRRP Goal is > 30%
- Tamarisk beetle present throughout the site; tamarisk severely defoliated

- Old signs of cattle use in this area, stubble height ≥ 6 inches
- Natural revegetation of coyote willow, New Mexico privet, and sage within this site
- Dominant native species on the site were coyote willow and New Mexico privet
- Evidence of wildlife utilization (animal sightings, scat, other) = elk scat, mule deer scat, bear scat, mountain lion scat
- Poison ivy present on site
- This site is difficult to monitor when river is high

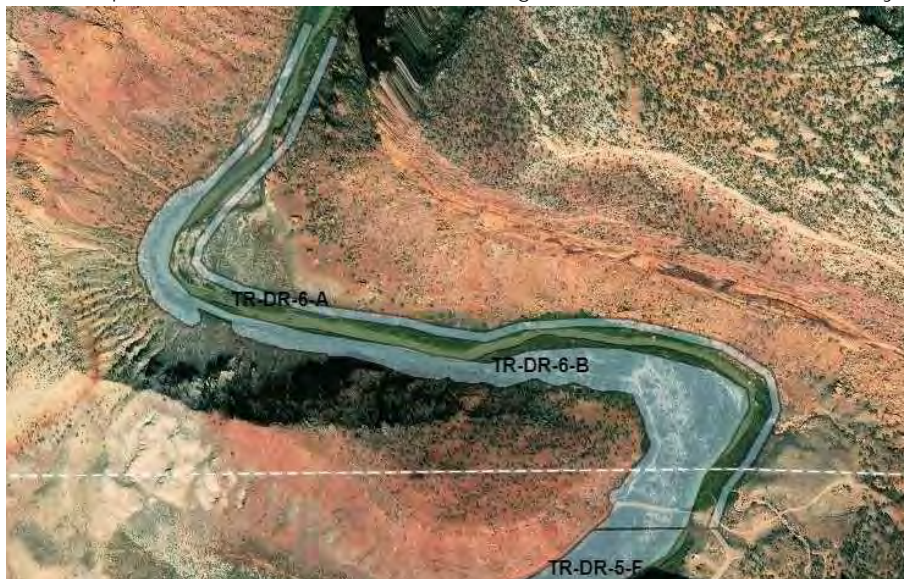
TR-DR-6-B

- Site Size = 19.64 acres
- Activities to date = secondary weeds herbicide treatments

- Russian knapweed scattered throughout the site at a density of ~ 6-10%
- Hoary cress present along the upland portion of the site at a density of 0-5%
- Tamarisk non-woody resprouts throughout the site with a density of ~ 0-5%
- Kochia moderate, cheatgrass and Russian thistle present but minimal throughout the site

- Active revegetation – none
- Passive revegetation - Site meets DRRP Passive Recruitment Threshold – meets willow threshold of 100 stems or more, that are at least 0.5 meters in height. Less than 20 cottonwoods greater than 1 meter in height and between 1 and 10 years of age present on the site.

- Minimal white crust present on soil
- Old signs of cattle use in this area, stubble height ≥ 6 inches
- Natural revegetation of four-wing saltbrush and rabbitbrush within this site
- Dominant native species on the site were four-wing saltbrush and western tansy mustard

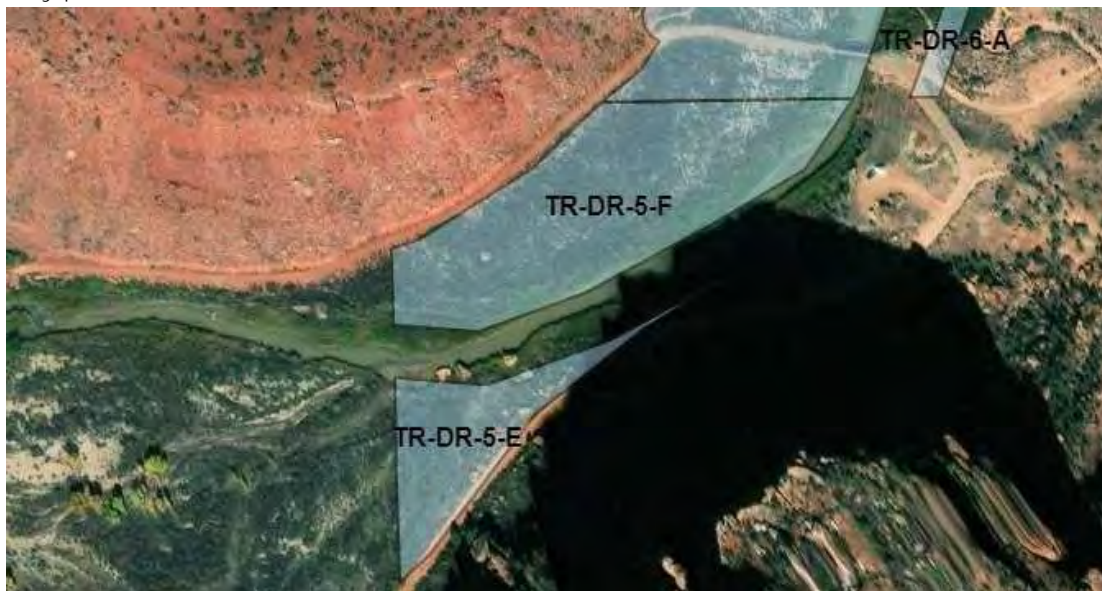
TR-DR-5-F

- Old signs of cattle use in this area, stubble height ~ 4 inches
- Natural revegetation of rabbitbrush, sage, and western peppergrass within this site
- Dominant native species on the site were sage and New Mexico privet
- Evidence of wildlife utilization (animal sightings, scat, other) = deer scat
- Poison ivy present on site

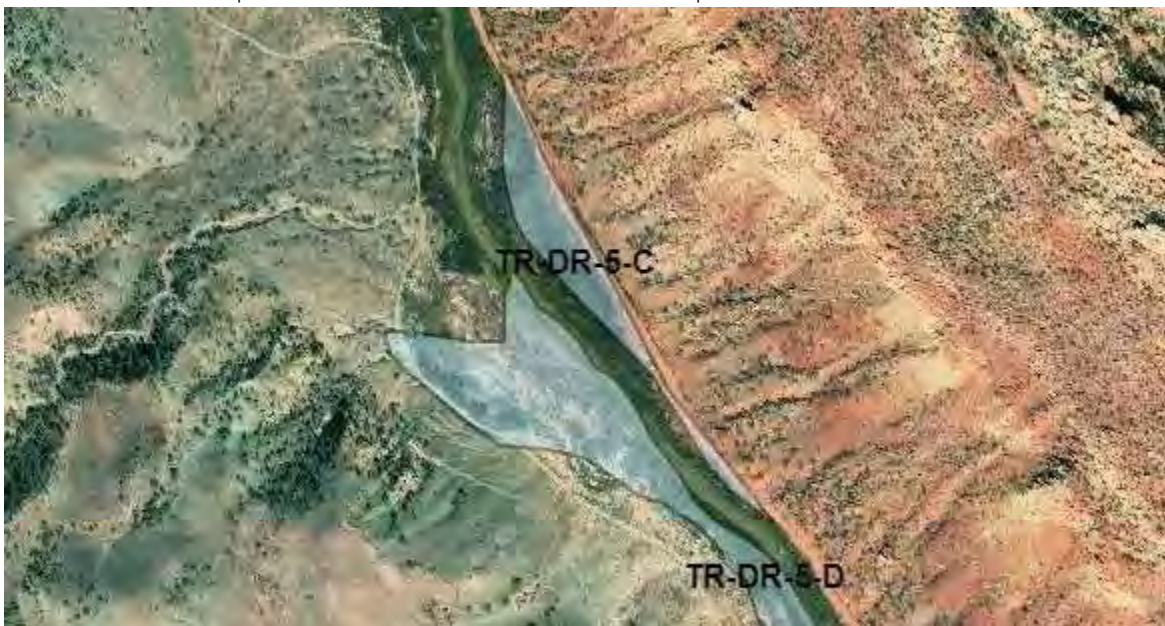
TR-DR-5-D

- Old signs of cattle use in this area, stubble height ≥ 6 inches
- Natural revegetation of cottonwood, rabbitbrush, three-leaf sumac, New Mexico privet, and saltbrush within this site
- Dominant native species on the site were coyote willow and alkali sacaton
- Evidence of wildlife utilization (animal sightings, scat, other) = deer scat
- Road leading into this site and poison ivy present on site

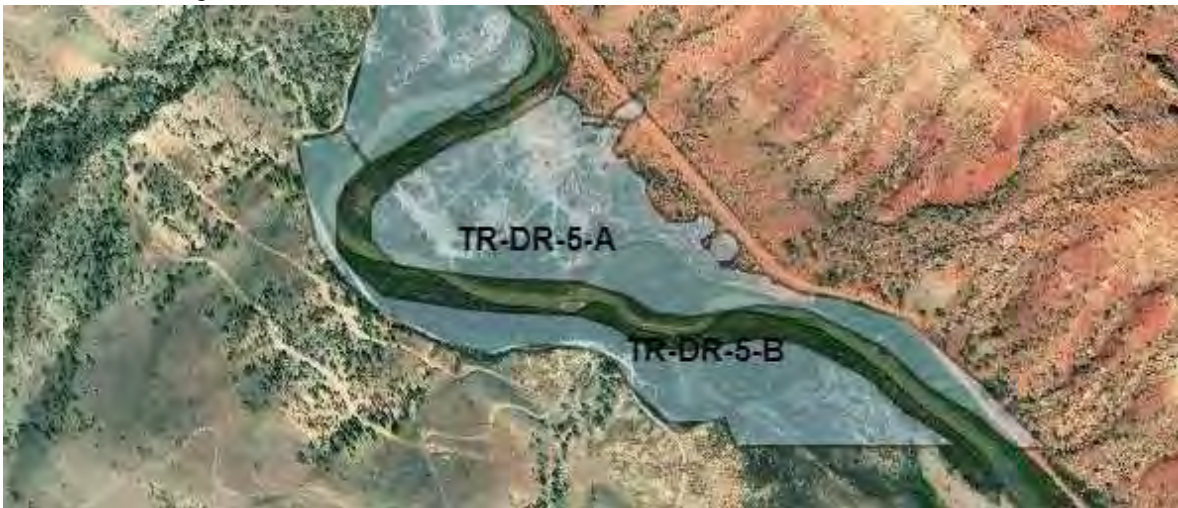
TR-DR-5-A

- Old signs of cattle use in this area, stubble height ≥ 6 inches
- Natural revegetation of coyote willow, sage, cottonwood, and rabbitbrush within this site
- Dominant native species on the site were Coyote willow and inland saltgrass
- Easy access from campsite, heavy boater activity, and poison ivy present on this site
- Small cottonwoods hidden by drop off by bank

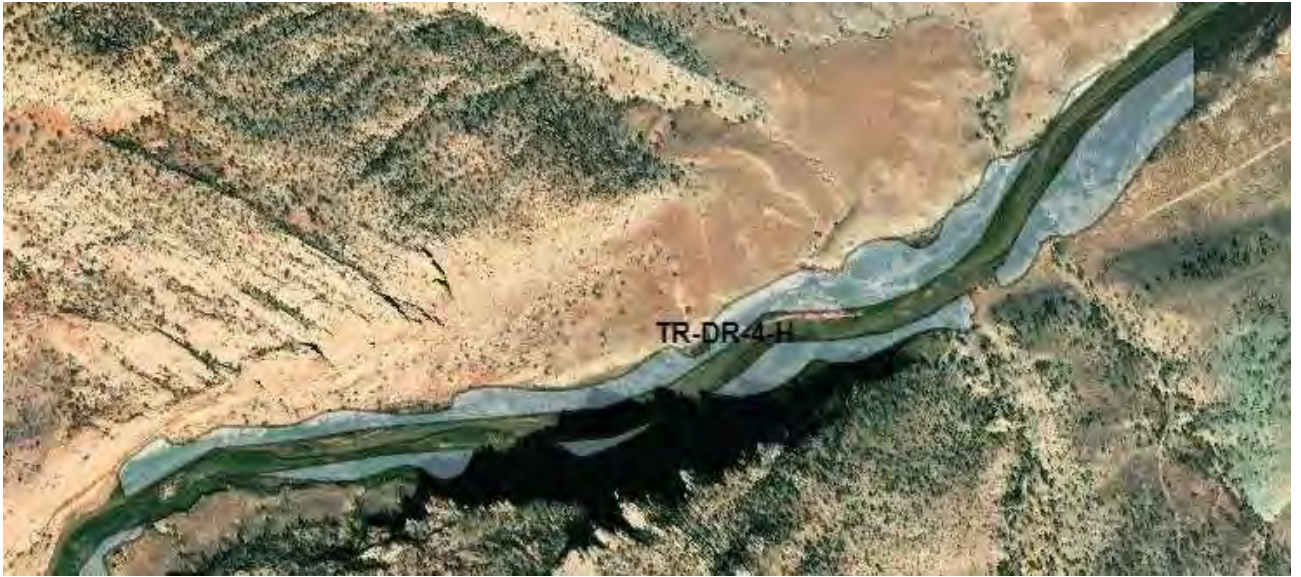
TR-DR-4-G

- Old signs of cattle use in this area, stubble height ≥ 6 inches
- Natural revegetation of coyote willow, greasewood, sage within this site
- Dominant native species on the site were coyote willow and inland saltgrass
- Evidence of wildlife utilization (animal sightings, scat, other) = coyote and elk scat
- Minimal white crust present on soil
- Difficult trek when river is high with mostly walking along the steep cliff in the upland portion of this site

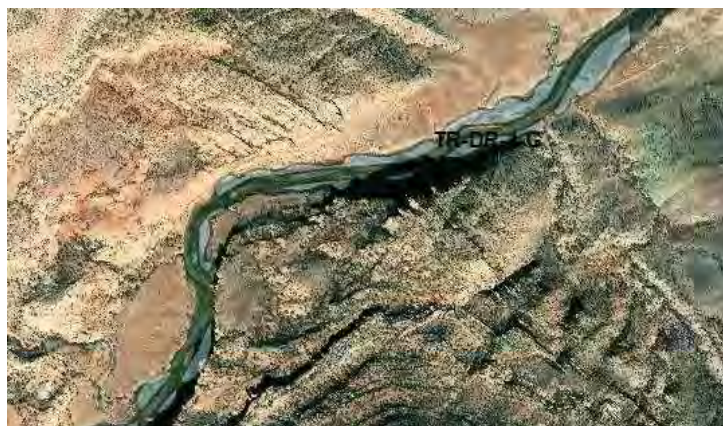
TR-DR-4-F

- Old signs of cattle use in this area, stubble height ≥ 6 inches
- Natural revegetation of coyote willow, phragmites, greasewood, New Mexico privet, and sage within this site
- Dominant native species on the site were coyote willow and greasewood
- Evidence of wildlife utilization (animal sightings, scat, other) = bear and deer scat and tracks
- Minimal white crust present on soil
- Far upstream edge of polygon is hard to reach in higher water

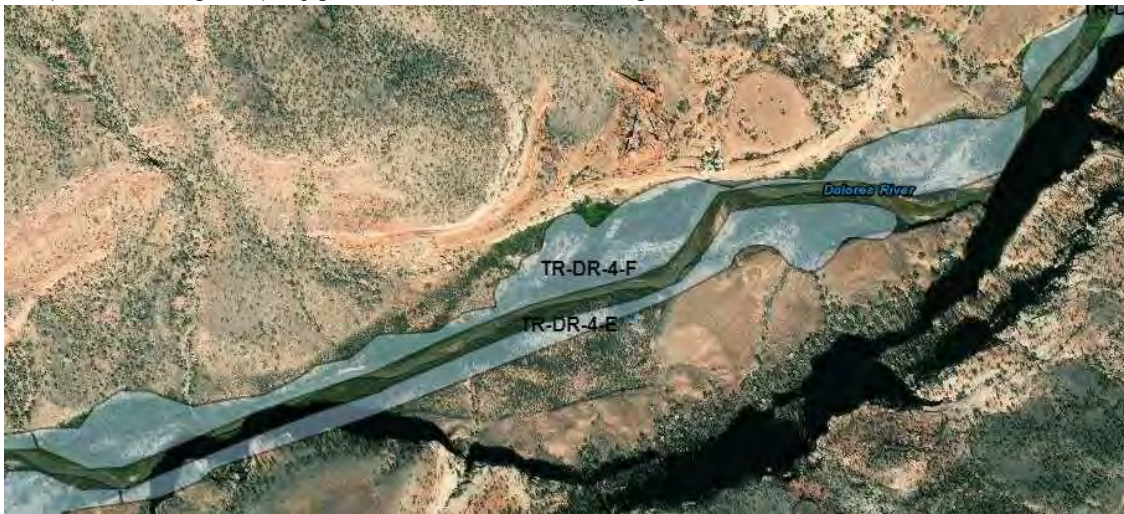
TR-DR-4-E

- Old signs of cattle use in this area, stubble height ≥ 6 inches
- Natural revegetation of coyote willow, sumac, greasewood, and New Mexico privet within this site
- Dominant native species on the site were coyote willow and New Mexico privet
- Evidence of wildlife utilization (animal sightings, scat, other) = elk and deer scat and tracks

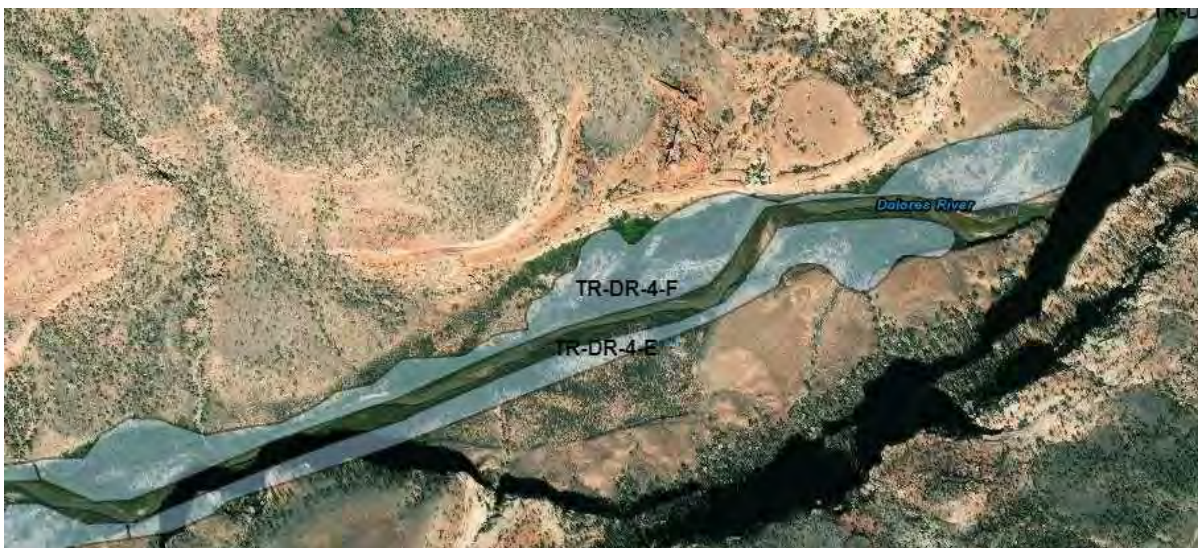
TR-DR-4-D

- Old signs of cattle use in this area, stubble height ≥ 6 inches
- Natural revegetation of coyote willow, cottonwood, New Mexico privet, greasewood, and sueda within this site
- Dominant native species on the site were coyote willow and alkali sacaton
- Evidence of wildlife utilization (animal sightings, scat, other) = deer scat and tracks

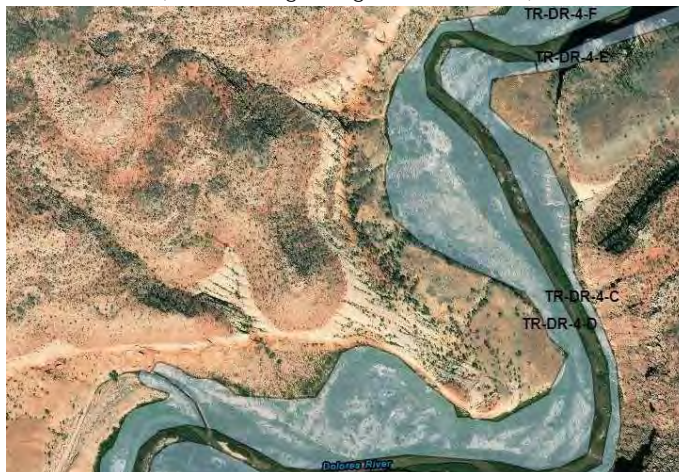
TR-DR-4-C

- Old signs of cattle use in this area, stubble height ≥ 6 inches
- Natural revegetation of rubber rabbitbrush, New Mexico privet, three-leaf sumac, and sage within this site
- Dominant native species on the site were coyote willow and sand dropseed
- Evidence of wildlife utilization (animal sightings, scat, other) = elk and deer scat and tracks
- Difficult to traverse with high river, and unmarked trail goes through the majority of the site
- Poison ivy present on this site

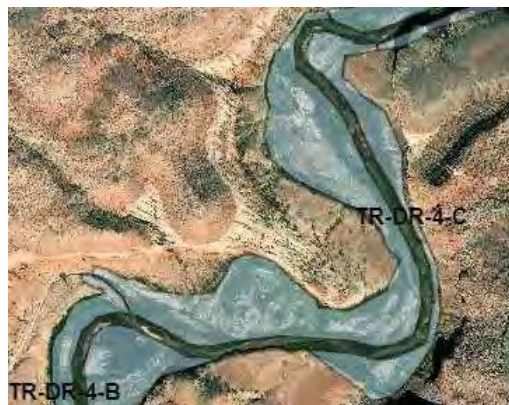
TR-DR-4-A

- Old signs of cattle use in this area, stubble height ≥ 6 inches
- Natural revegetation of greasewood and rabbitbrush within this site
- Dominant native species on the site were New Mexico privet and coyote willow
- Evidence of wildlife utilization (animal sightings, scat, other) = bear, coyote, and mule deer scat and tracks
- Minimal white crust present on soil

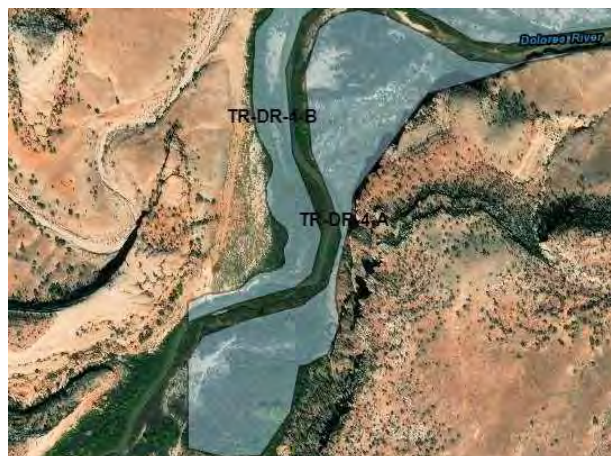
TR-DR-4-B

- Old signs of cattle use in this area, stubble height ≥ 6 inches
- Natural revegetation of coyote willow, New Mexico privet, rabbitbrush, greasewood, and three-leaf sumac within this site
- Dominant native species on the site were coyote willow and New Mexico privet
- Evidence of wildlife utilization (animal sightings, scat, other) = bear scat and tracks

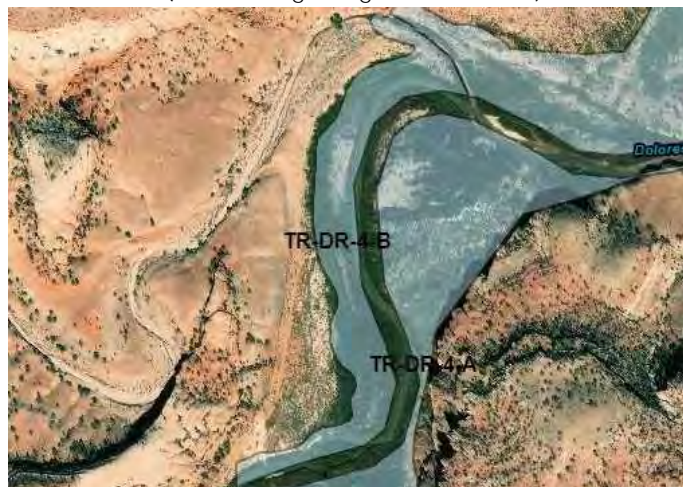
TR-DR-3-PVT1-A

- Old signs of cattle use in this area, stubble height ≥ 6 inches
- Natural revegetation of coyote willow, New Mexico privet, and rabbitbrush within this site
- Dominant native species on the site were coyote willow and rabbitbrush
- Evidence of wildlife utilization (animal sightings, scat, other) = mule deer and elk

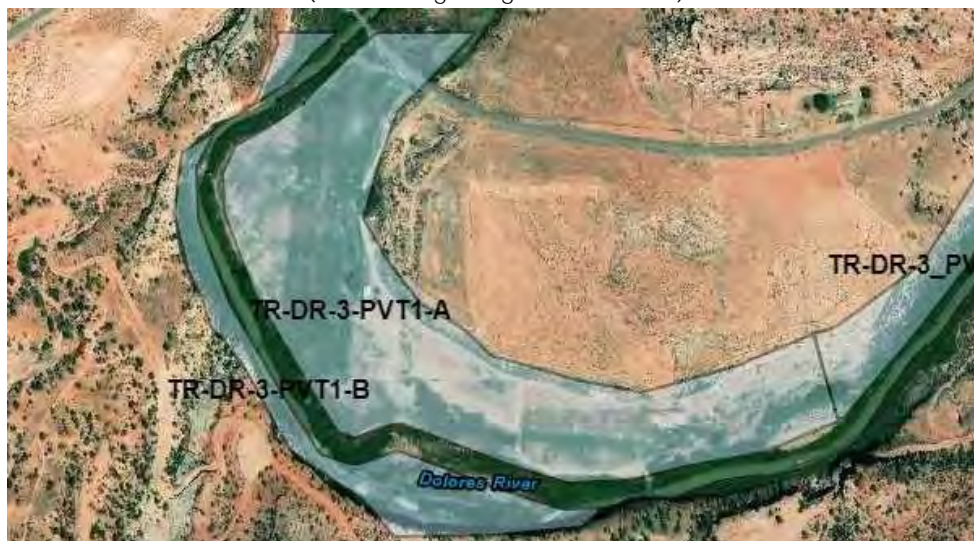
TR-DR-3-PVT1-B

- Old signs of cattle use in this area, stubble height ≥ 6 inches
- Natural revegetation of coyote willow and rabbitbrush within this site
- Dominant native species on the site were coyote willow and rubber rabbitbrush

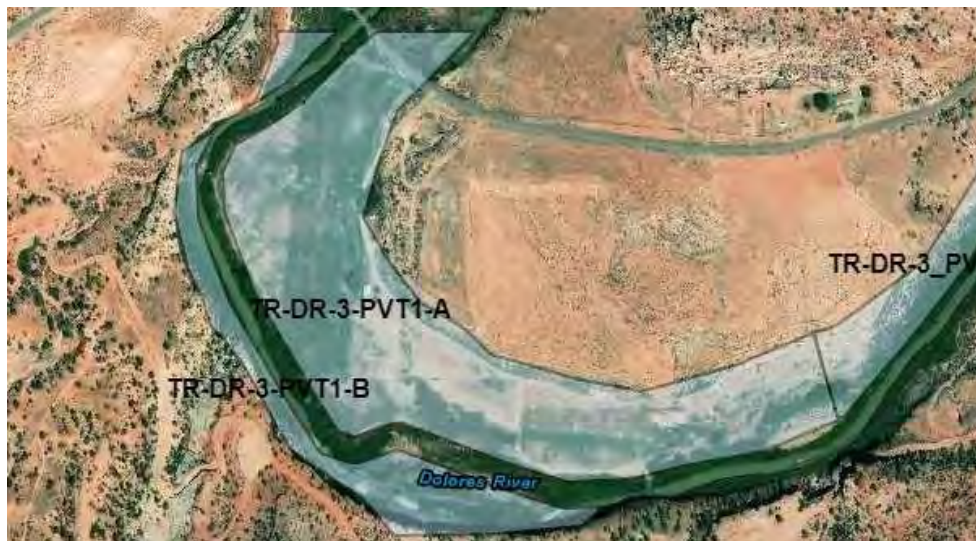
TR-DR-3-PVT1-RR

- Old signs of cattle use in this area, stubble height ≥ 6 inches
- Natural revegetation of coyote willow, rabbitbrush, New Mexico privet, sage, four-wing saltbrush, and greasewood within this site
- Dominant native species on the site were coyote willow and New Mexico privet
- Evidence of wildlife utilization (animal sightings, scat, other) = mule deer

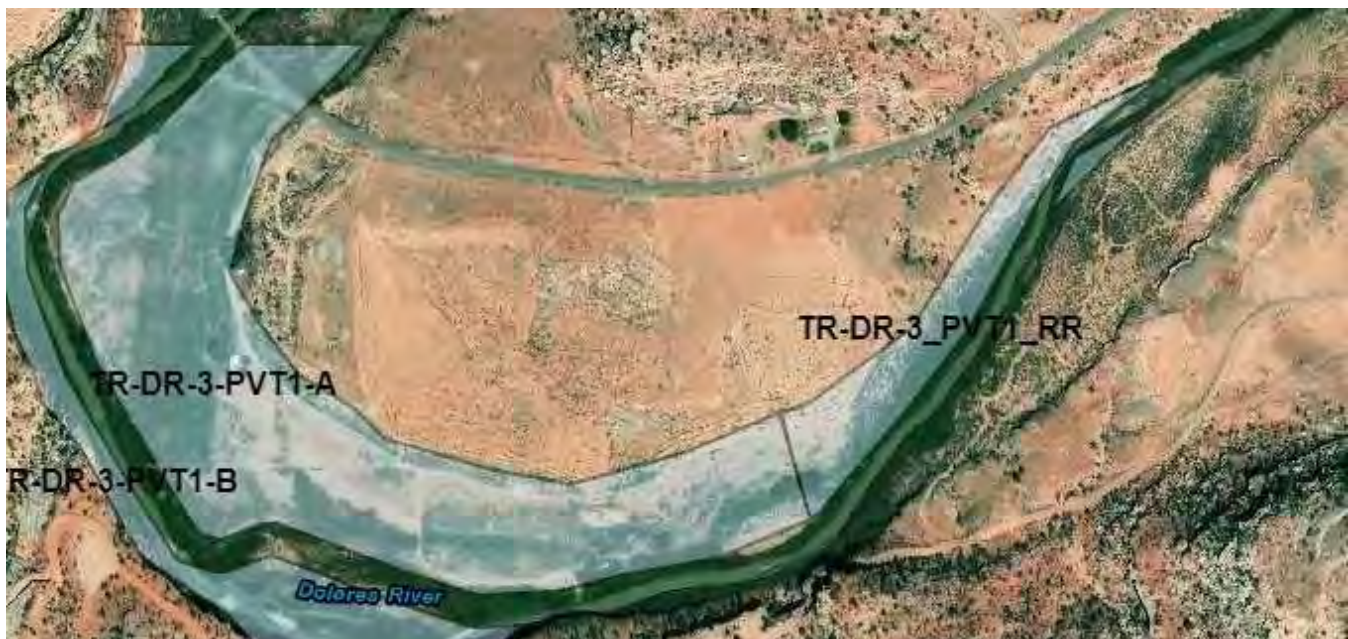
TR-DR-3-PVT1-RL

- Old signs of cattle use in this area, stubble height ≥ 6 inches
- Natural revegetation of coyote willow, rabbitbrush, New Mexico privet, sage, and greasewood within this site
- Dominant native species on the site were coyote willow and New Mexico privet
- Evidence of wildlife utilization (animal sightings, scat, other) = mule deer

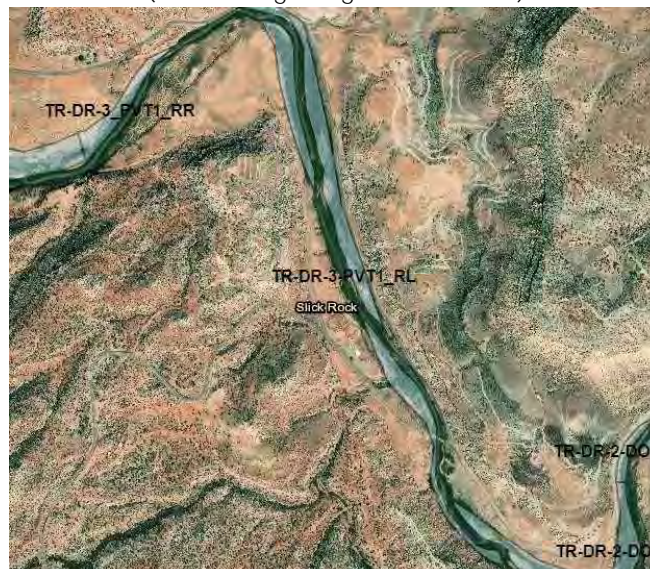
TR-DR-2-DOE-RR3

- Old signs of cattle use in this area, stubble height ≥ 6 inches
- Natural revegetation of coyote willow, rabbitbrush, New Mexico privet, and four-wing saltbrush within this site
- Dominant native species on the site were coyote willow and New Mexico privet
- Evidence of wildlife utilization (animal sightings, scat, other) = mule deer

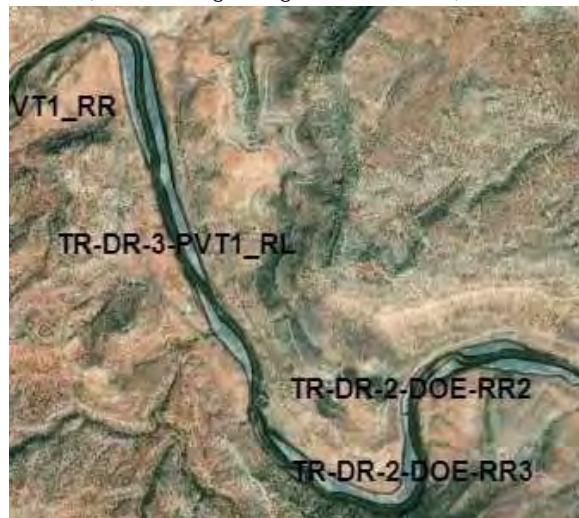
TR-DR-2-DOE-RR2

- No signs of cattle use in this area, stubble height \geq 6 inches
- Natural revegetation of coyote willow, New Mexico privet, and three-leaf sumac within this site
- Dominant native species on the site were coyote willow and New Mexico privet

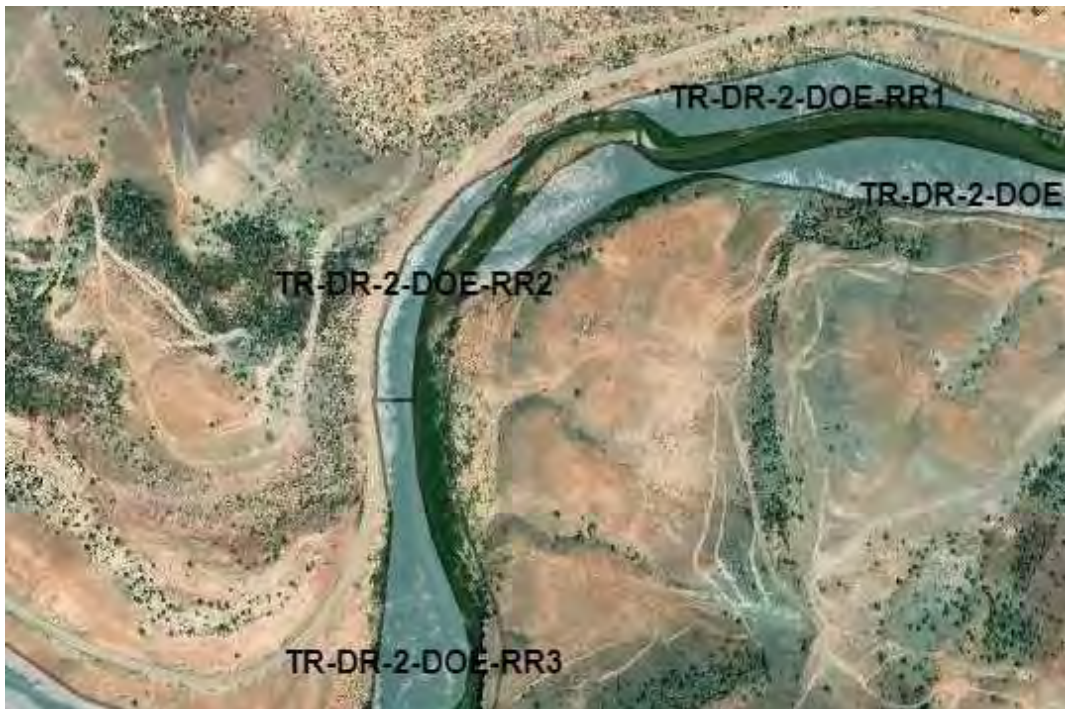
TR-DR-2-DOE-RL1

- Old signs of cattle use in this area, stubble height ≥ 6 inches
- Natural revegetation of coyote willow, rabbitbrush, New Mexico privet, greasewood, and three-leaf sumac within this site
- Dominant native species on the site were coyote willow and New Mexico privet
- Evidence of wildlife utilization (animal sightings, scat, other) = mule deer and black bear

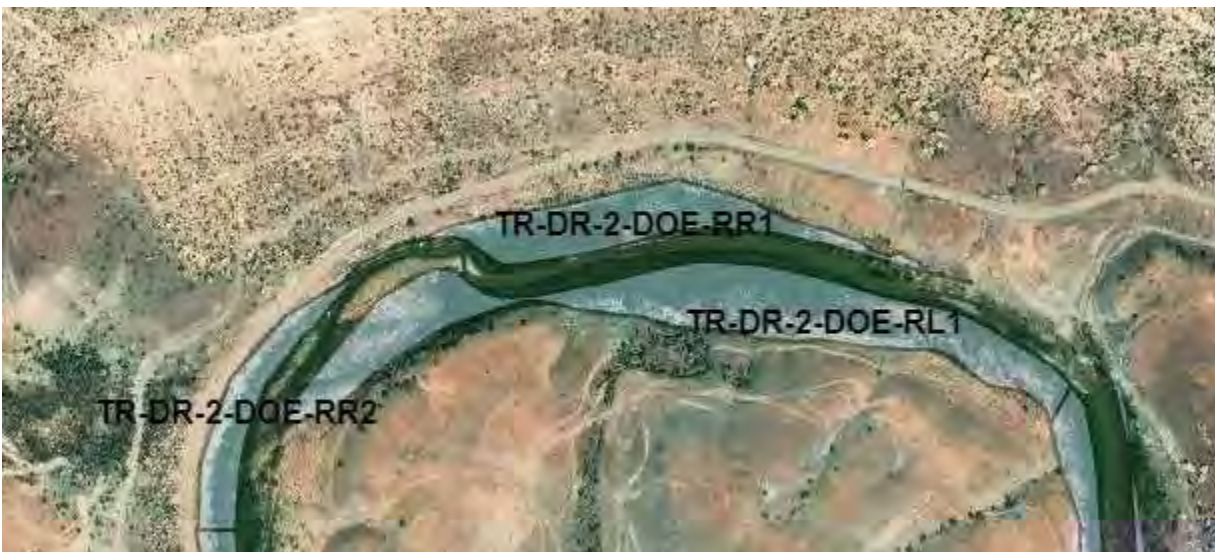
TR-DR-2-DOE-RR1

- Old signs of cattle use in this area, stubble height ≥ 6 inches
- Natural revegetation of greasewood, three-leaf sumac, sand dropseed, New Mexico privet, and box elder maple within this site
- Dominant native species on the site were coyote willow and New Mexico privet
- Evidence of wildlife utilization (animal sightings, scat, other) = mule deer

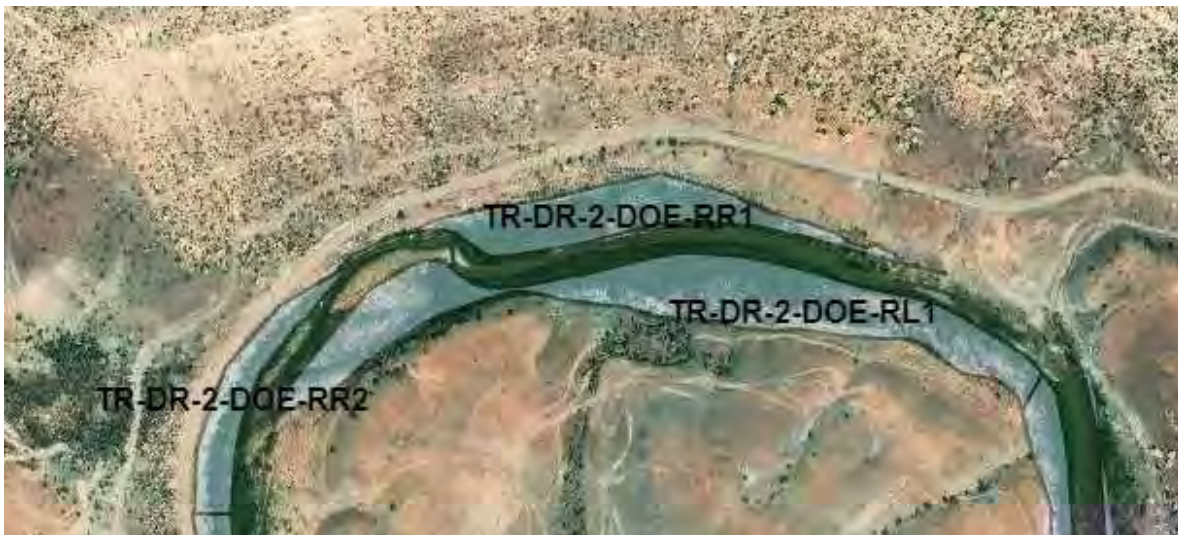
TR-DR-2-RR-1

- Old signs of cattle use in this area, stubble height ≥ 6 inches
- Natural revegetation of greasewood, suaeda, coyote willow, and cottonwood within this site
- Dominant native species on the site were coyote willow and New Mexico privet
- Evidence of wildlife utilization (animal sightings, scat, other) = mule deer, coyote, and elk

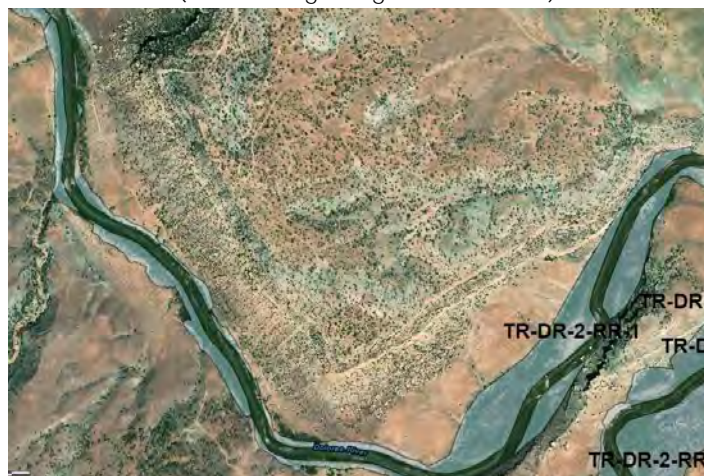
TR-DR-2-RL-1

- Old signs of cattle use in this area, stubble height ≥ 6 inches
- Natural revegetation of greasewood, suaeda, coyote willow, New Mexico privet, phragmites, and rabbitbrush within this site
- Dominant native species on the site were coyote willow and New Mexico privet
- Evidence of wildlife utilization (animal sightings, scat, other) = mule deer and black bear

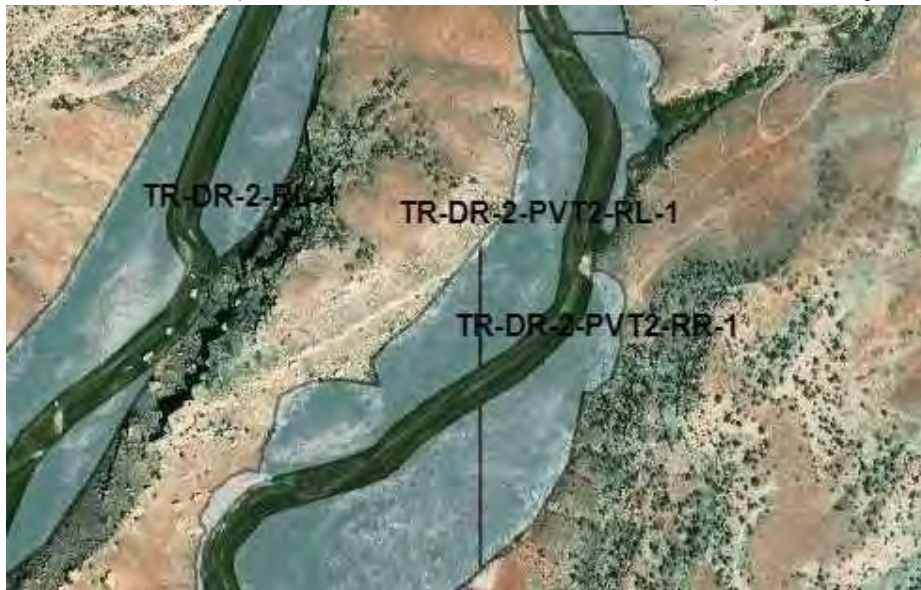
TR-DR-2-PVT2-RL1

- Old signs of cattle use in this area, stubble height ≥ 6 inches
- Natural revegetation of rabbitbrush, New Mexico privet, greasewood, and coyote willow within this site
- Dominant native species on the site were coyote willow and New Mexico privet
- Evidence of wildlife utilization (animal sightings, scat, other) = black bear
- Minimal white crust present on soil

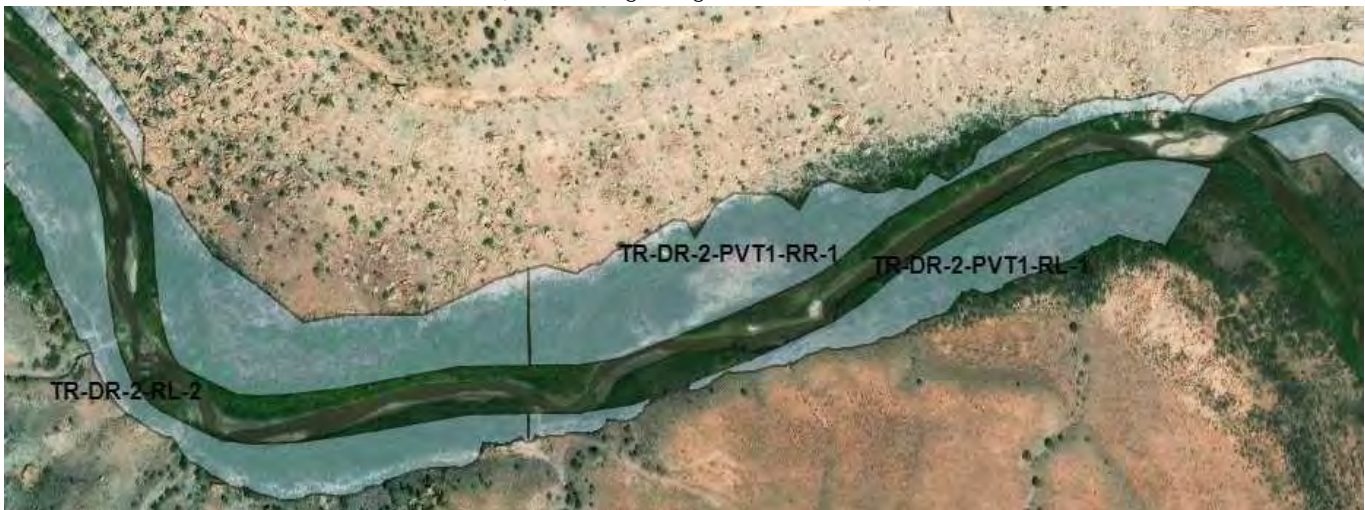
TR-DR-2-PVT1-RR-1

- Site Size = 4.12 acres
- Activities to date = hack-and-squirt Russian Olive treatment

- Russian knapweed scattered throughout the site at a density of ~0-5%
- Canada thistle present in isolated patches of ~0.18 acres and ~0.25 acres both with a density of ~0-5%
- One large Russian olive tree at the upstream end of the site
- Tamarisk non-woody re-sprouts throughout the site with a density of < 1%
- Cheatgrass present but minimal throughout the site

- Active revegetation – none
- Passive revegetation - Site meets DRRP Passive Recruitment Threshold – meets willow threshold of 100 stems or more, that are at least 0.5 meters in height.

- Tamarisk Relative Cover = 6-10%. DRRP Goal is < 5%
- Native/Desirable Relative Cover = 61-70%. DRRP Goal is >75%, or ideally >80%
- Absolute Vegetation Cover = 81-90%. DRRP Goal is > 30%
- Tamarisk beetle larva present on tamarisk throughout the site; tamarisk slightly defoliated

- Old signs of cattle use in this area, stubble height ≥ 6 inches
- Natural revegetation of New Mexico privet, rabbitbrush, greasewood, and coyote willow within this site
- Dominant native species on the site were coyote willow and sage
- Evidence of wildlife utilization (animal sightings, scat, other) = mule deer

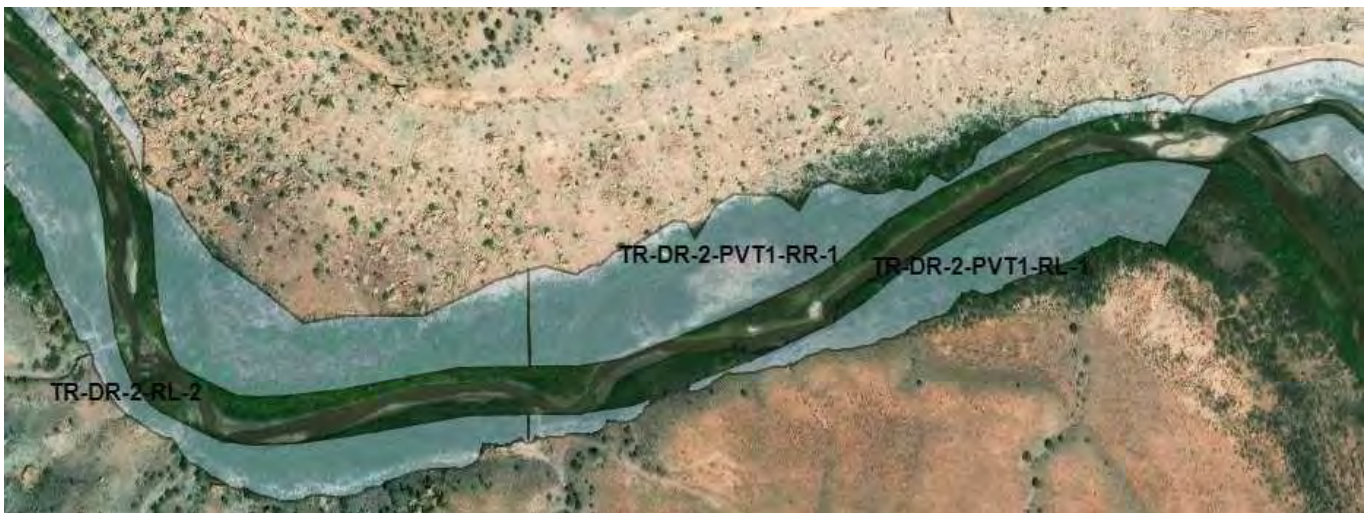
TR-DR-2-PVT1-RL-1

- Site Size = 3.07 acres
- Activities to date = none

- Russian knapweed scattered throughout the site at a density of ~5-10%
- Tamarisk non-woody re-sprouts throughout the site with a density of < 1%

- Active revegetation – none
- Passive revegetation - Site meets DRRP Passive Recruitment Threshold – meets willow threshold of 100 stems or more, that are at least 0.5 meters in height.

- Tamarisk Relative Cover = 0-5%. DRRP Goal is < 5%
- Native/Desirable Relative Cover = 81-90%. DRRP Goal is >75%, or ideally >80%
- Absolute Vegetation Cover = 81-90%. DRRP Goal is > 30%
- Tamarisk beetle larva present on tamarisk throughout the site; tamarisk slightly defoliated

- Old signs of cattle use in this area, stubble height ≥ 6 inches
- Natural revegetation of sage, rabbitbrush, greasewood, and coyote willow within this site
- Dominant native species on the site were coyote willow and New Mexico privet
- Evidence of wildlife utilization (animal sightings, scat, other) = mule deer and black bear

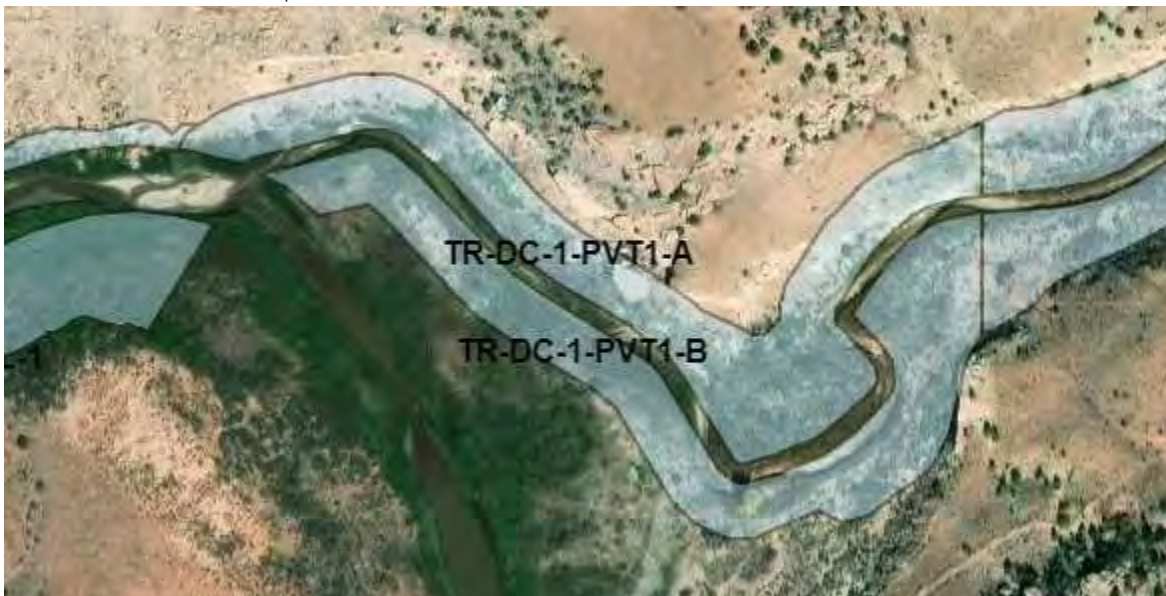
TR-DC-1-PVT1-A

- Site Size = 3.68 acres
- Activities to date = primary tamarisk removal, hack-and-squirt Russian olive treatment, secondary weeds herbicide treatments, and tamarisk resprout treatments

- Russian knapweed present in a patch of ~1.35 acres at a density of ~5-10%
- Tamarisk non-woody re-sprouts throughout the site with a density of < 1%
- Cheatgrass and Kochia moderate, Russian thistle present but minimal throughout the site

- Active revegetation – none
- Passive revegetation - Site meets DRRP Passive Recruitment Threshold – meets willow threshold of 100 stems or more, that are at least 0.5 meters in height.

- Tamarisk Relative Cover = 0-5%. DRRP Goal is < 5%
- Native/Desirable Relative Cover = 81-90%. DRRP Goal is >75%, or ideally >80%
- Absolute Vegetation Cover = 71-80%. DRRP Goal is > 30%
- Tamarisk beetle larva present on tamarisk throughout the site; **Coniatus** weevil and weevil baskets present on tamarisk; tamarisk slightly defoliated

- Fresh signs of cattle use in this area, stubble height \geq 6 inches
- Natural revegetation of rabbitbrush and four-wing saltbrush within this site
- Dominant native species on the site were spear-leaf rabbitbrush and four-wing saltbrush
- Evidence of wildlife utilization (animal sightings, scat, other) = mule deer
- Extensive white crust present on soil

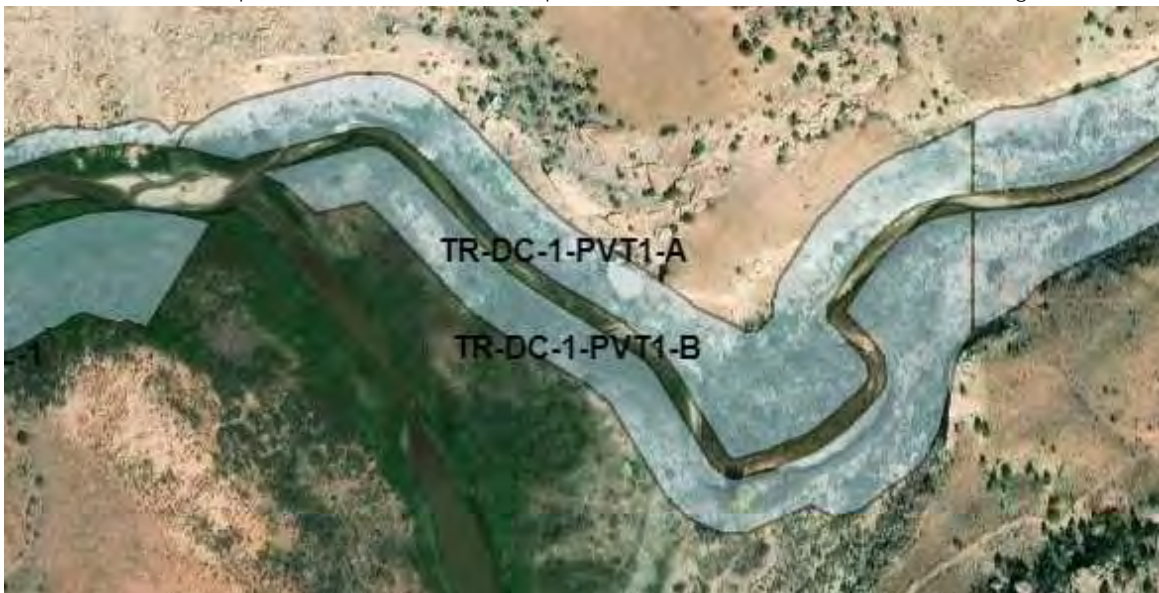
TR-DC-1-PVT1-B

- Site Size = 3.54 acres
- Activities to date = primary tamarisk removal, hack-and-squirt Russian olive treatment, secondary weeds herbicide treatments, and tamarisk resprout treatments

- Russian knapweed scattered throughout the site at a density of ~31-40%
- A few Russian olive trees scattered along the bank in the middle of the site
- Tamarisk non-woody re-sprouts throughout the site with a density of ~ 5%
- Cheatgrass moderate, Kochia and Russian thistle present but minimal throughout the site

- Active revegetation – none
- Passive revegetation - Site meets DRRP Passive Recruitment Threshold – meets willow threshold of 100 stems or more, that are at least 0.5 meters in height.

- Tamarisk Relative Cover = 0-5%. DRRP Goal is < 5%
- Native/Desirable Relative Cover = 41-50%. DRRP Goal is >75%, or ideally >80%
- Absolute Vegetation Cover = 71-80%. DRRP Goal is > 30%
- Tamarisk beetle and beetle larva present on tamarisk throughout the site; tamarisk slightly defoliated

- Old signs of cattle use in this area, stubble height ≥ 6 inches
- Natural revegetation of rabbitbrush, coyote willow, cottonwoods, and phragmites within this site
- Dominant native species on the site were spear-leaf rabbitbrush and inland saltgrass

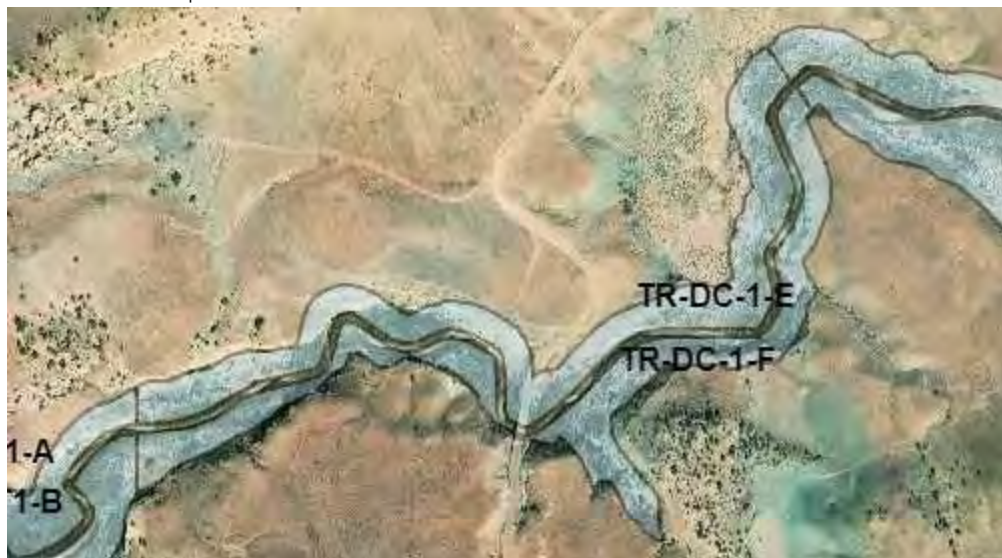
TR-DC-1-E

- Site Size = 7.70 acres
- Activities to date = primary tamarisk removal, secondary weeds herbicide treatments, and tamarisk resprout treatments

- Russian knapweed present on ~3.05 acres at a density of ~5-10%
- One Russian olive tree under the bridge
- Tamarisk non-woody re-sprouts throughout the site with a density of ~5%
- Cheatgrass and Kochia present but minimal throughout the site

- Active revegetation – none
- Passive revegetation - Site meets DRRP Passive Recruitment Threshold – meets willow threshold of 100 stems or more, that are at least 0.5 meters in height.

- Tamarisk Relative Cover = 0-5%. DRRP Goal is < 5%
- Native/Desirable Relative Cover = 81-90%. DRRP Goal is >75%, or ideally >80%
- Absolute Vegetation Cover = 61-70%. DRRP Goal is > 30%
- Tamarisk beetle and beetle larva present on tamarisk throughout the site; **Coniatus** weevil baskets present on tamarisk; tamarisk moderately defoliated

- Old signs of cattle use in this area, stubble height ≥ 6 inches
- Natural revegetation of cottonwoods and greasewood within this site
- Dominant native species on the site were spear-leaf rabbitbrush and inland saltgrass
- Evidence of wildlife utilization (animal sightings, scat, other) = mule deer
- Minimal white crust present on soil

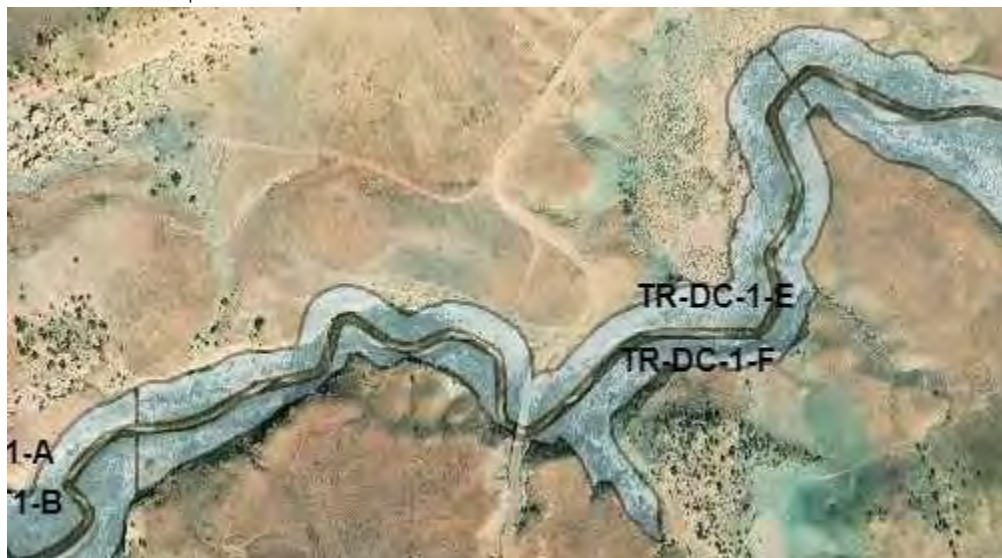
TR-DC-1-F

- Site Size = 6.90 acres
- Activities to date = primary tamarisk removal, secondary weeds herbicide treatments, and tamarisk resprout treatments

- Russian knapweed present in a patch of ~1.40 acres with a density of ~0-5%
- Canada thistle present in an isolated patch of ~0.04 acres with a density of ~0-5%
- Tamarisk non-woody re-sprouts throughout the site with a density of < 1%
- Cheatgrass moderate, Russian thistle present but minimal throughout the site

- Active revegetation – none
- Passive revegetation - Site meets DRRP Passive Recruitment Threshold – meets willow threshold of 100 stems or more, that are at least 0.5 meters in height. Site also meets cottonwood threshold of 20 cottonwoods greater than 1 meter in height and between 1 and 10 years of age.

- Tamarisk Relative Cover = 0-5%. DRRP Goal is < 5%
- Native/Desirable Relative Cover = 81-90%. DRRP Goal is >75%, or ideally >80%
- Absolute Vegetation Cover = 71-80%. DRRP Goal is > 30%
- Tamarisk beetle larva present on tamarisk throughout the site; young tamarisk slightly defoliated

- Old signs of cattle use in this area, stubble height ≥ 6 inches
- Natural revegetation of suaeda, rabbitbrush, and coyote willow within this site
- Dominant native species on the site were spear-leaf rabbitbrush and coyote willow
- Evidence of wildlife utilization (animal sightings, scat, other) = mule deer
- Minimal white crust present on soil
