I am writing to submit the final deliverables and to close-out our grant for the Water Supply Reserve Fund, Dolores River Restoration Partnership Maintenance & Monitoring Project. This report includes a breakdown of the work occurred through the assistance of this funding and the final monitoring report.

Tres Rios BLM Field Office 2019 Rapid Monitoring

2019 Tres Rios Field Office Rapid Monitoring Summary Report

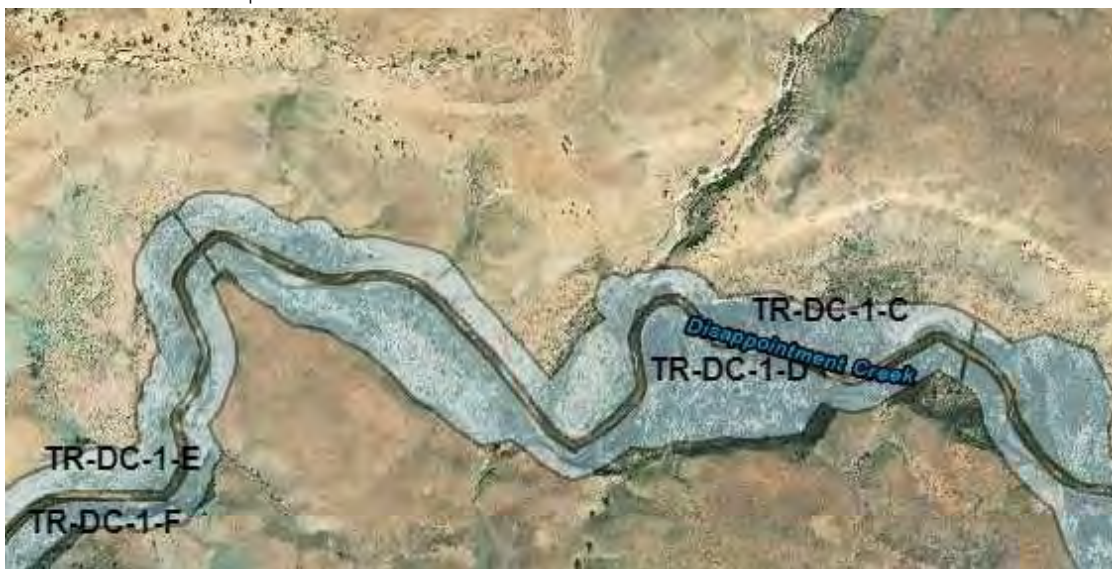
TR-DC-1-C

- Site Size = 8.84 acres
- Activities to date = primary tamarisk removal, secondary weeds herbicide treatments, and tamarisk resprout treatments

- Tamarisk non-woody re-sprouts throughout the site with a density of ~ 5%

- Active revegetation – none
- Passive revegetation - Site meets DRRP Passive Recruitment Threshold – meets willow threshold of 100 stems or more, that are at least 0.5 meters in height.

- Tamarisk Relative Cover = 6-10%. DRRP Goal is < 5%
- Native/Desirable Relative Cover = 91-95%. DRRP Goal is >75%, or ideally >80%
- Absolute Vegetation Cover = 71-80%. DRRP Goal is > 30%
- Tamarisk beetle and beetle larva present on tamarisk throughout the site; **Coniatus** weevil and weevil baskets present on tamarisk; tamarisk moderately to severely defoliated

- Old signs of cattle use in this area, stubble height ≥ 6 inches
- Natural revegetation of suaeda, rubber rabbitbrush, and greasewood within this site
- Dominant native species on the site were rabbitbrush and greasewood
- Minimal white crust present on soil

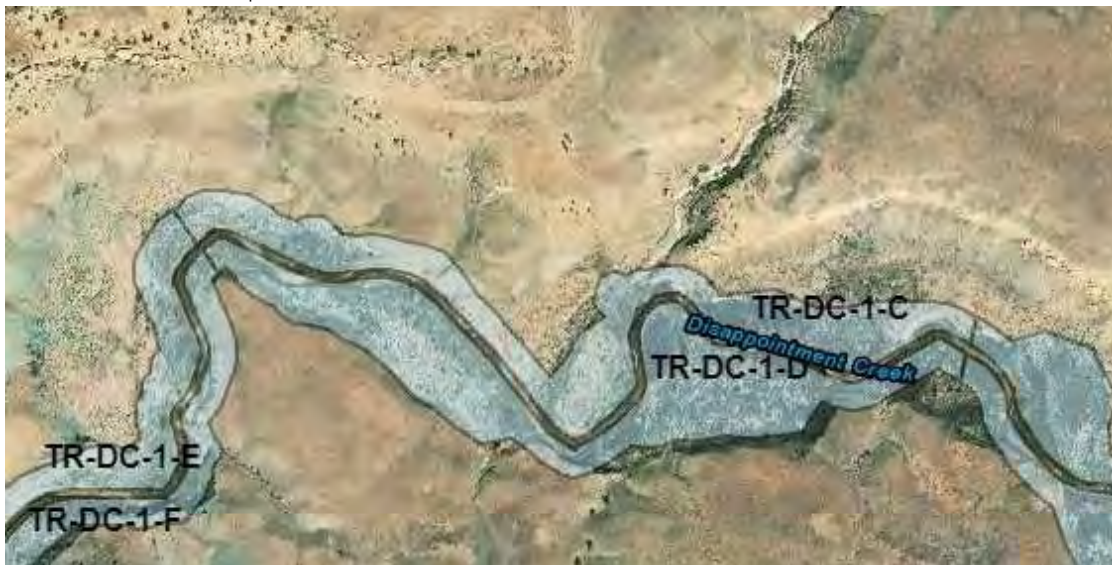
TR-DC-1-D

- Site Size = 10.72 acres
- Activities to date = primary tamarisk removal, secondary weeds herbicide treatments, and tamarisk resprout treatments

- Old signs of cattle use in this area, stubble height ≥ 6 inches
- Natural revegetation of suaeda, rabbitbrush, coyote willow, and cottonwoods within this site
- Dominant native species on the site were rabbitbrush and sage
- Evidence of wildlife utilization (animal sightings, scat, other) = mule deer
- Minimal white crust present on soil

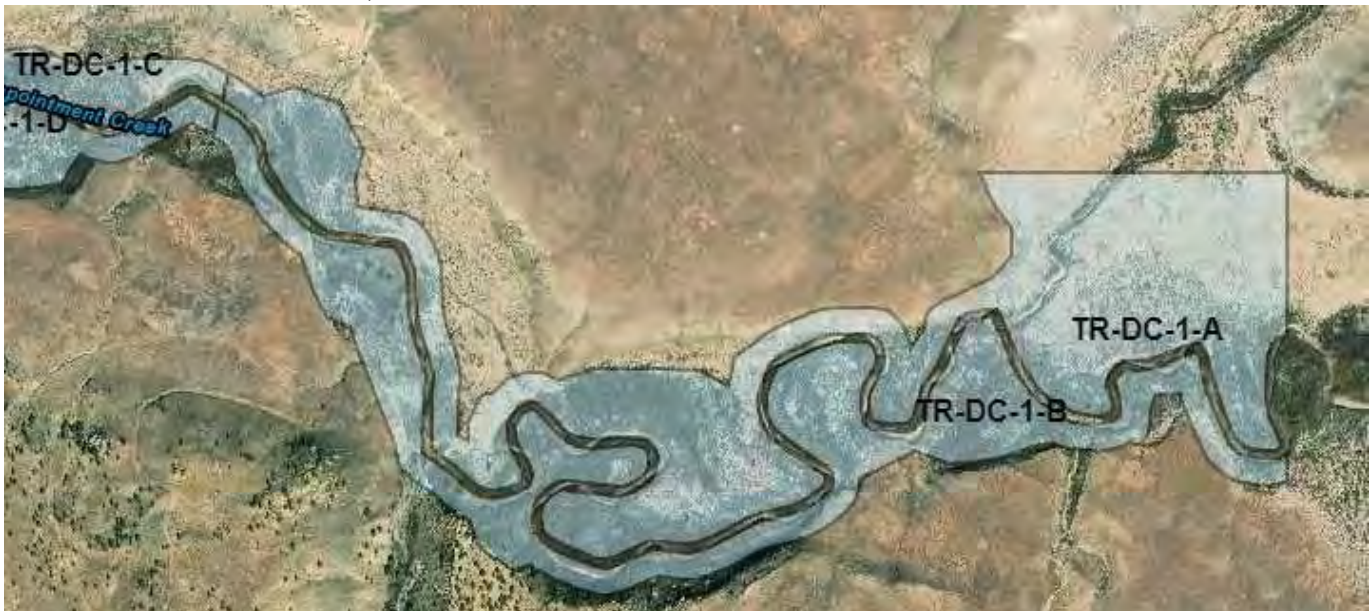
TR-DC-1-A

- Old signs of cattle use in this area, stubble height \geq 6 inches
- Natural revegetation of greasewood, rubber rabbitbrush, sage, coyote willow, and cottonwoods within this site
- Dominant native species on the site were greasewood and phragmites
- Evidence of wildlife utilization (animal sightings, scat, other) = mule deer and elk
- Minimal white crust present on soil

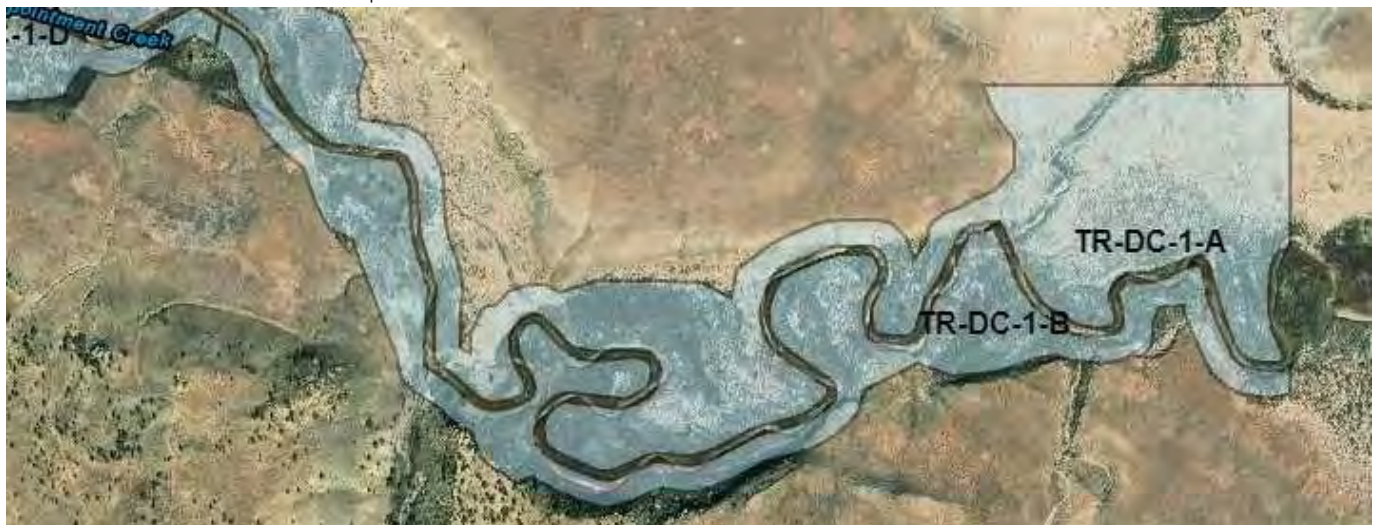
TR-DC-1-B

- Old signs of cattle use in this area, stubble height ≥ 6 inches
- Natural revegetation of suaeda, rabbitbrush, greasewood, phragmites, coyote willow, and cottonwoods within this site
- Dominant native species on the site were rabbitbrush and greasewood
- Evidence of wildlife utilization (animal sightings, scat, other) = cottontail rabbit
- Minimal white crust present on soil

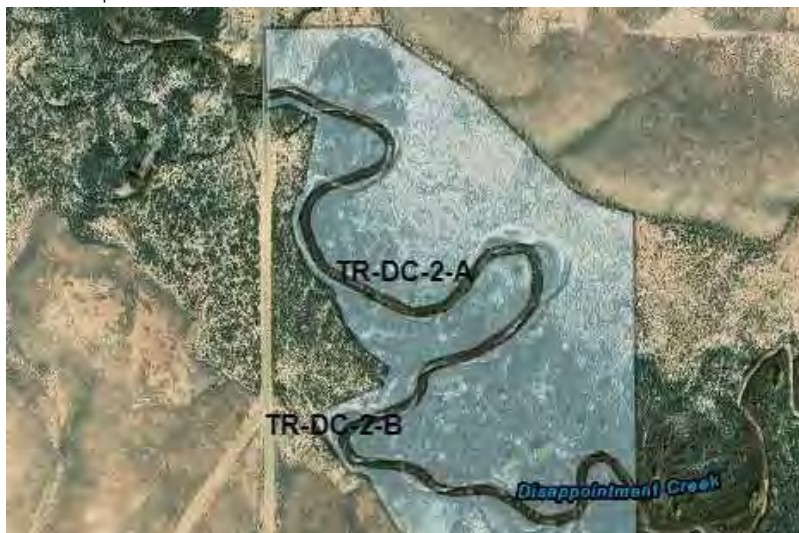
TR-DC-2-A

- Old signs of cattle use in this area, stubble height ≥ 6 inches
- Natural revegetation of suaeda and greasewood within this site
- Dominant native species on the site were coyote willow and greasewood
- Evidence of wildlife utilization (animal sightings, scat, other) = cottontail rabbit, black-tailed jack rabbit, mule deer
- Extensive white crust present on soil

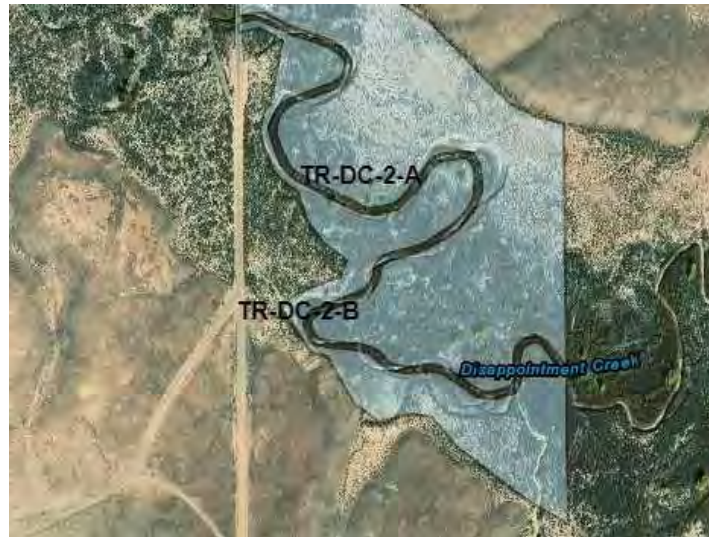
TR-DC-2-B

- Old signs of cattle use in this area, stubble height ≥ 6 inches
- Natural revegetation of cottonwoods, sage, rabbitbrush, and greasewood within this site
- Dominant native species on the site were rabbitbrush and greasewood
- Evidence of wildlife utilization (animal sightings, scat, other) = mule deer
- Minimal white crust present on soil

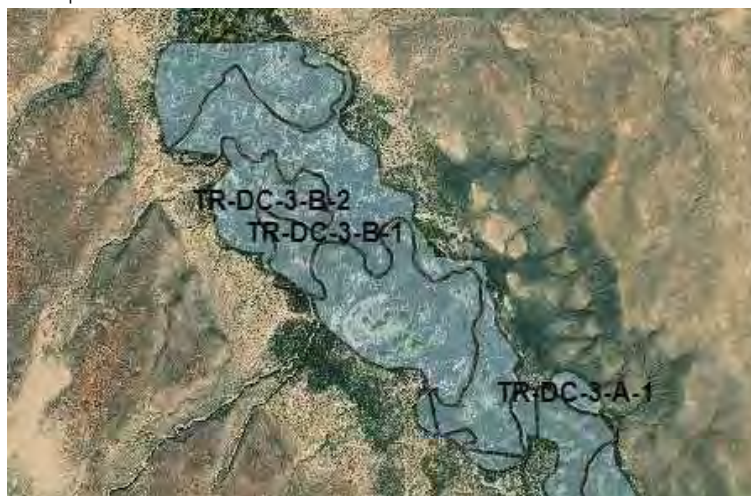
TR-DC-3-B-1

- Old signs of cattle use in this area, stubble height ≥ 6 inches
- Natural revegetation of cottonwood, rabbitbrush, greasewood, sage, coyote willow, and sueada within this site
- Dominant native species on the site were rabbitbrush and coyote willow
- Evidence of wildlife utilization (animal sightings, scat, other) = black bear, elk, coyote, mule deer
- Minimal white crust present on soil

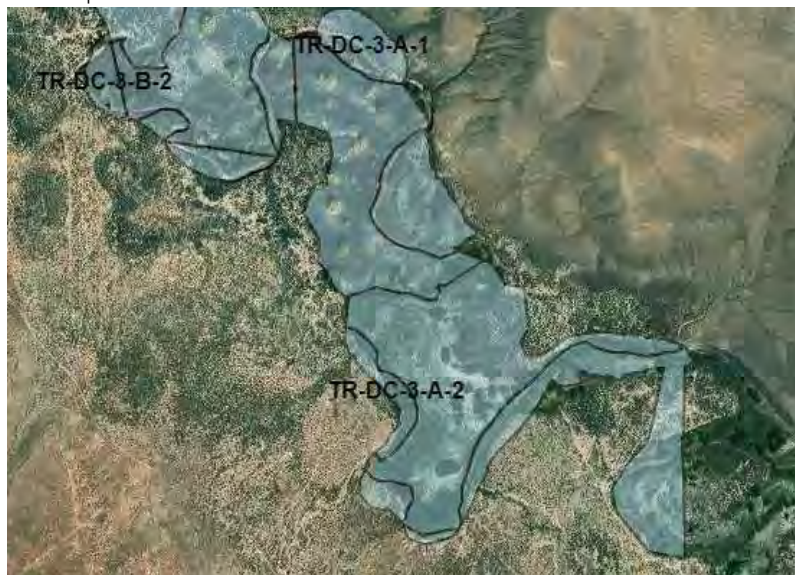
TR-DC-3-A-1

- Old signs of cattle use in this area, stubble height ≥ 6 inches
- Natural revegetation of rabbitbrush, greasewood, phragmites, coyote willow, and cottonwoods within this site
- Dominant native species on the site were rubber rabbitbrush and coyote willow
- Evidence of wildlife utilization (animal sightings, scat, other) = black bear, mule deer, elk
- Minimal white crust present on soil

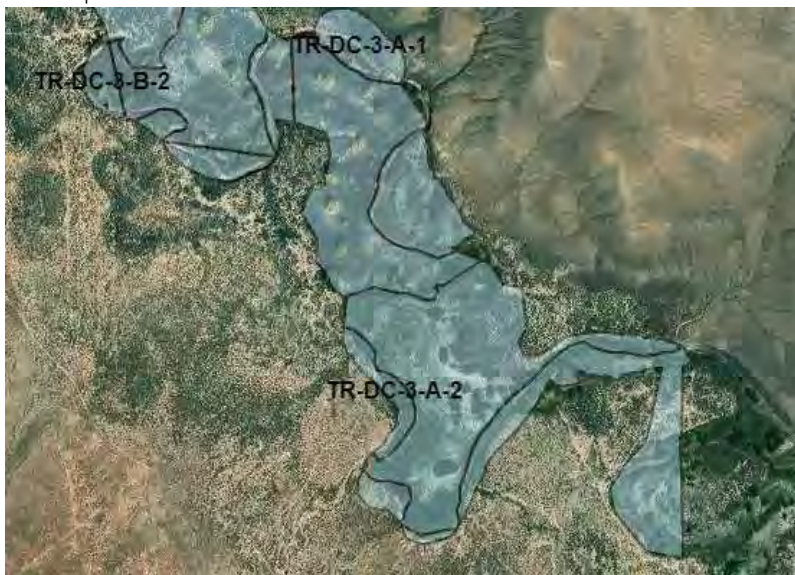
TR-DC-3-A-2

- Old signs of cattle use in this area, stubble height ≥ 6 inches
- Natural revegetation of sage, rabbitbrush, greasewood, suaeda, coyote willow, and cottonwoods within this site
- Dominant native species on the site were rabbitbrush and coyote willow
- Evidence of wildlife utilization (animal sightings, scat, other) = black bear, coyote, mule deer
- Minimal white crust present on soil

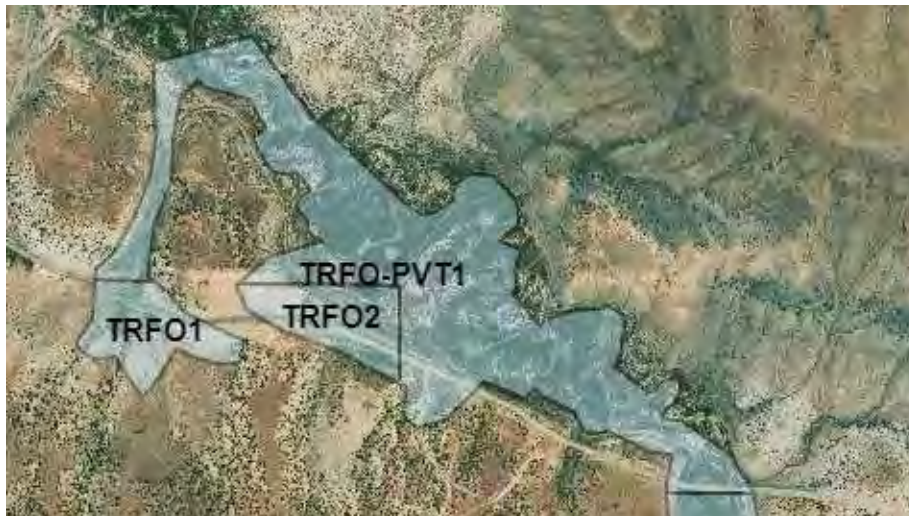
TRFO-PVT1

- Old signs of cattle use in this area, stubble height ≥ 6 inches
- Natural revegetation of suaeda, rabbitbrush, greasewood, coyote willow, and cottonwoods within this site
- Dominant native species on the site were rabbitbrush and coyote willow
- Evidence of wildlife utilization (animal sightings, scat, other) = wild horse, mule deer
- Watch out for electric fence

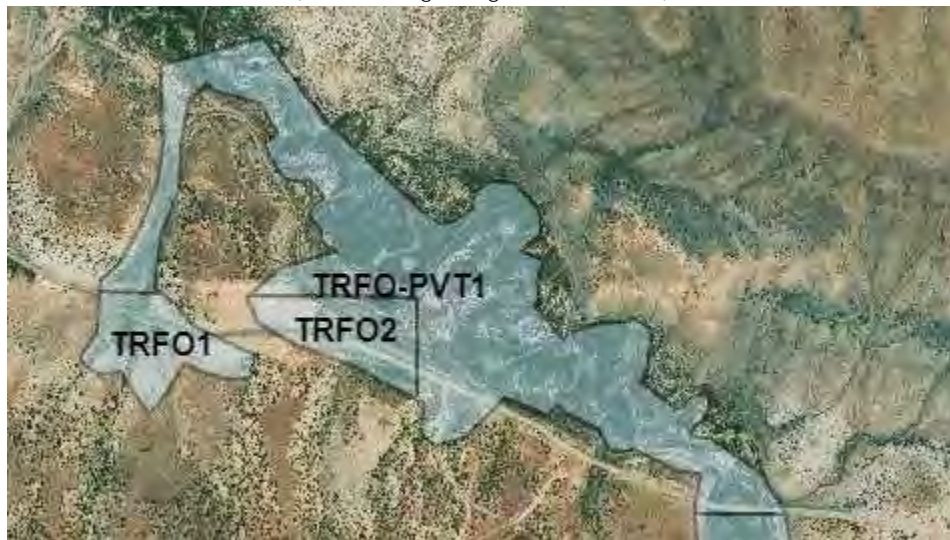
TRFO-1

- Old signs of cattle use in this area, stubble height ≥ 6 inches
- Natural revegetation of suaeda, rabbitbrush, and greasewood within this site
- Dominant native species on the site were Western tansy mustard and greasewood
- Evidence of wildlife utilization (animal sightings, scat, other) = mule deer

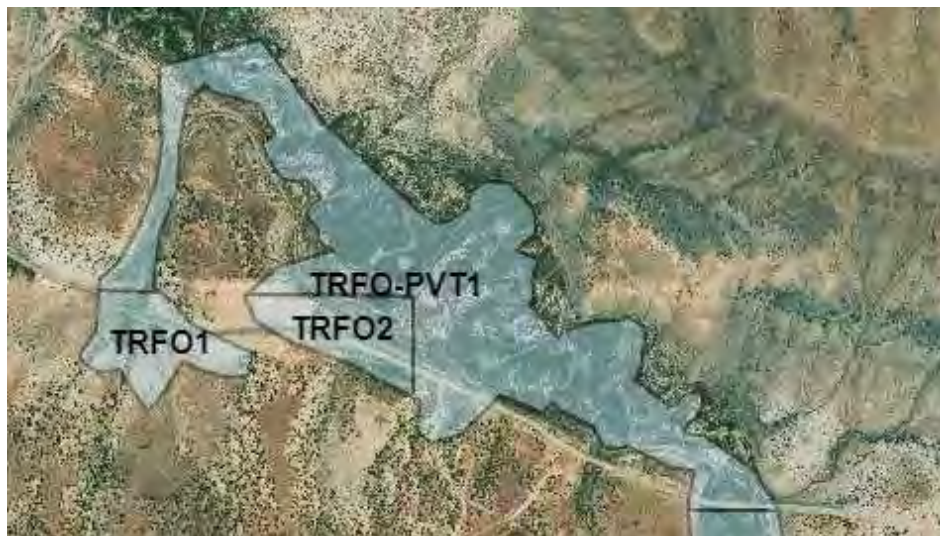
TRFO-2

- Old signs of cattle use in this area, stubble height ≥ 6 inches
- Natural revegetation of suaeda, rabbitbrush, greasewood, and four-wing saltbrush within this site
- Dominant native species on the site were suaeda and greasewood

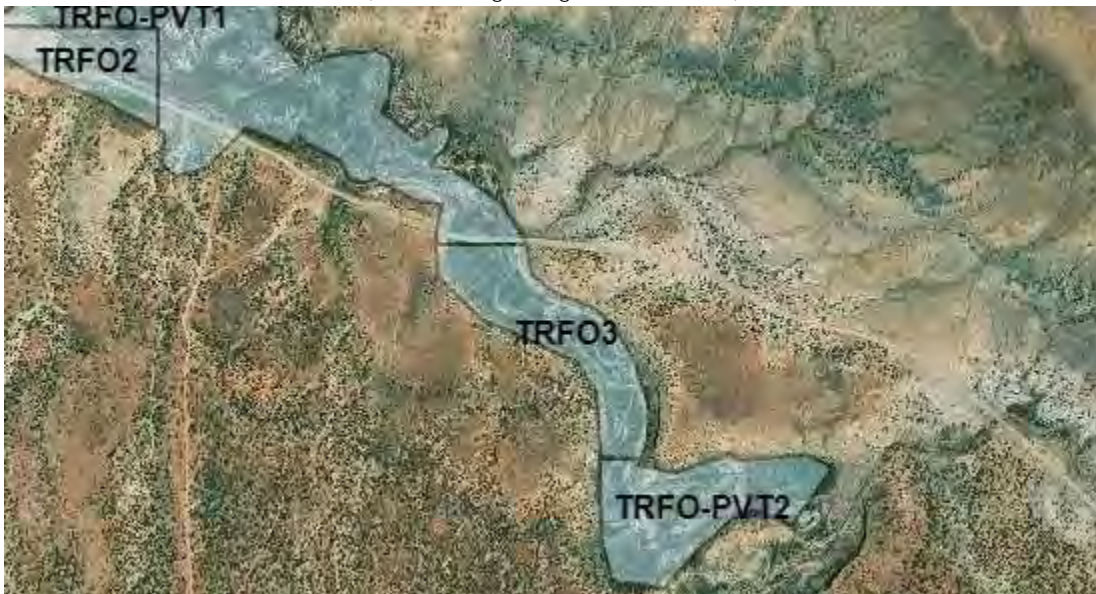
TRFO3

- Old signs of cattle use in this area, stubble height ≥ 6 inches
- Natural revegetation of rabbitbrush, greasewood, coyote willow, and cottonwoods within this site
- Dominant native species on the site were rabbitbrush and greasewood
- Evidence of wildlife utilization (animal sightings, scat, other) = beaver, mule deer

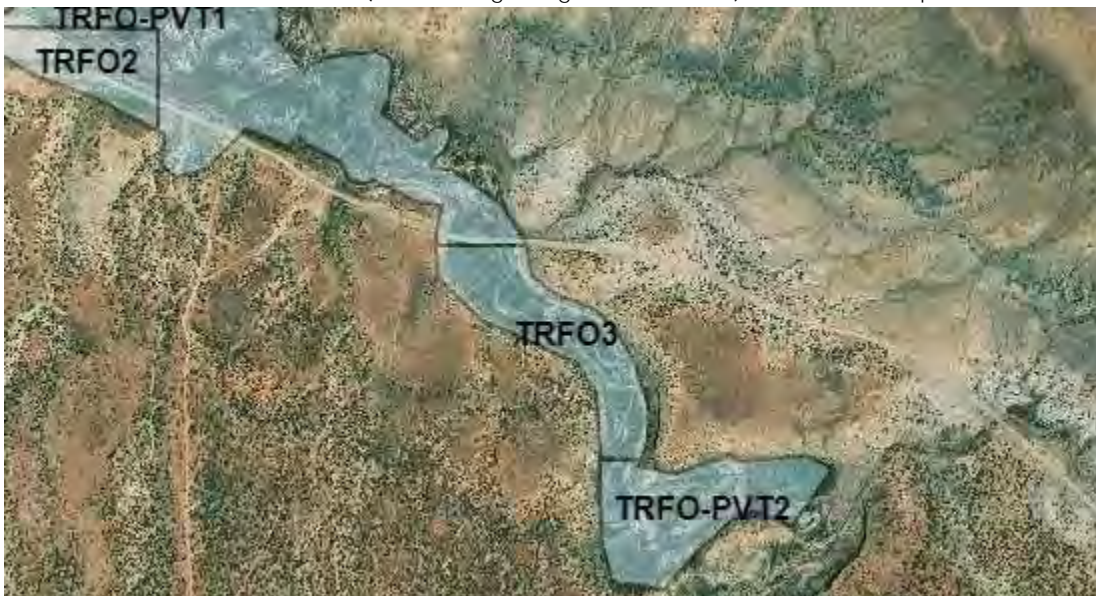
TRFO-PVT2

- Old signs of cattle use in this area, stubble height ≥ 6 inches
- Natural revegetation of suaeda, rabbitbrush, greasewood, coyote willow, and cottonwoods within this site
- Dominant native species on the site were rabbitbrush and coyote willow
- Evidence of wildlife utilization (animal sightings, scat, other) = mule deer, possible beaver
