Reference: Town of Georgetown – Georgetown Lake Lagoon Dredging Project Completion Report

TOWN OF GEORGETOWN  
LAKE LAGOON DREDGING PROJECT

**Georgetown Lake Lagoon  
Construction Record Drawings**

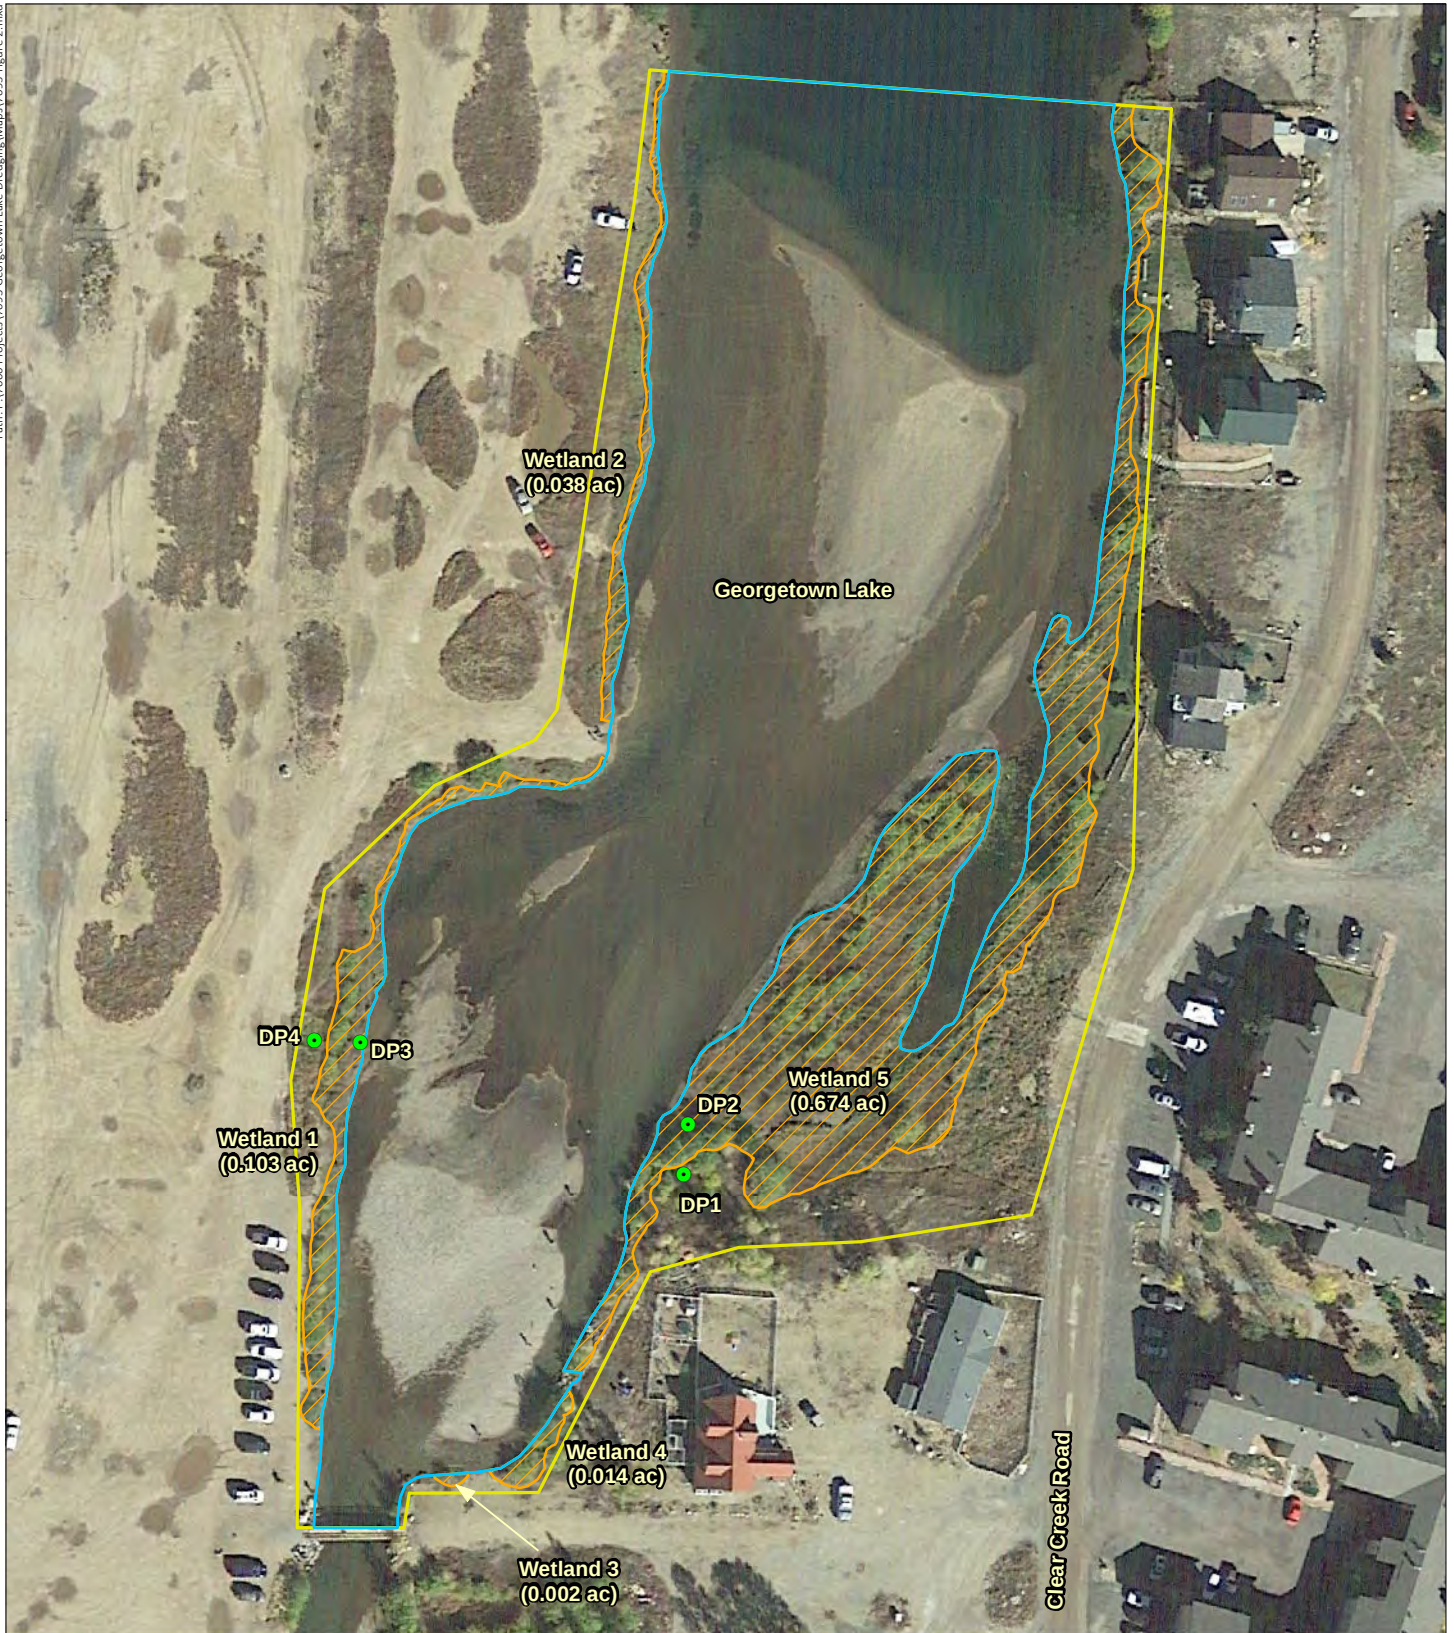
## Figure 2 Existing Conditions

- Data Point
- Project Area Boundary
- Wetland (0.831 ac)
- Open Water (3.509 ac)

Before establishing a plan for sediment removal, pre-existing conditions were investigated. Initial land improvement surveying was accomplished around the Lagoon coastline to accurately map topographic and property boundary conditions. This was augmented with an initial bathymetric survey of the Lagoon floor. Additional site investigation work included a full wetlands delineation around the Lagoon limits as Shown in Figure 2. Based on USACE permitting requirements, any wetlands destruction would require direct remediation and planting of wetlands onsite, acre for acre. Finally, geotechnical borings were performed of the in-situ sediment to understand the naturally occurring sediment deposits, and their ability to be reclaimed as structural fill. Eight borings of the Lagoon were drilled through the ice during the 2017/2018 winter season to provide guidance on the most practical sediment removal alternatives.

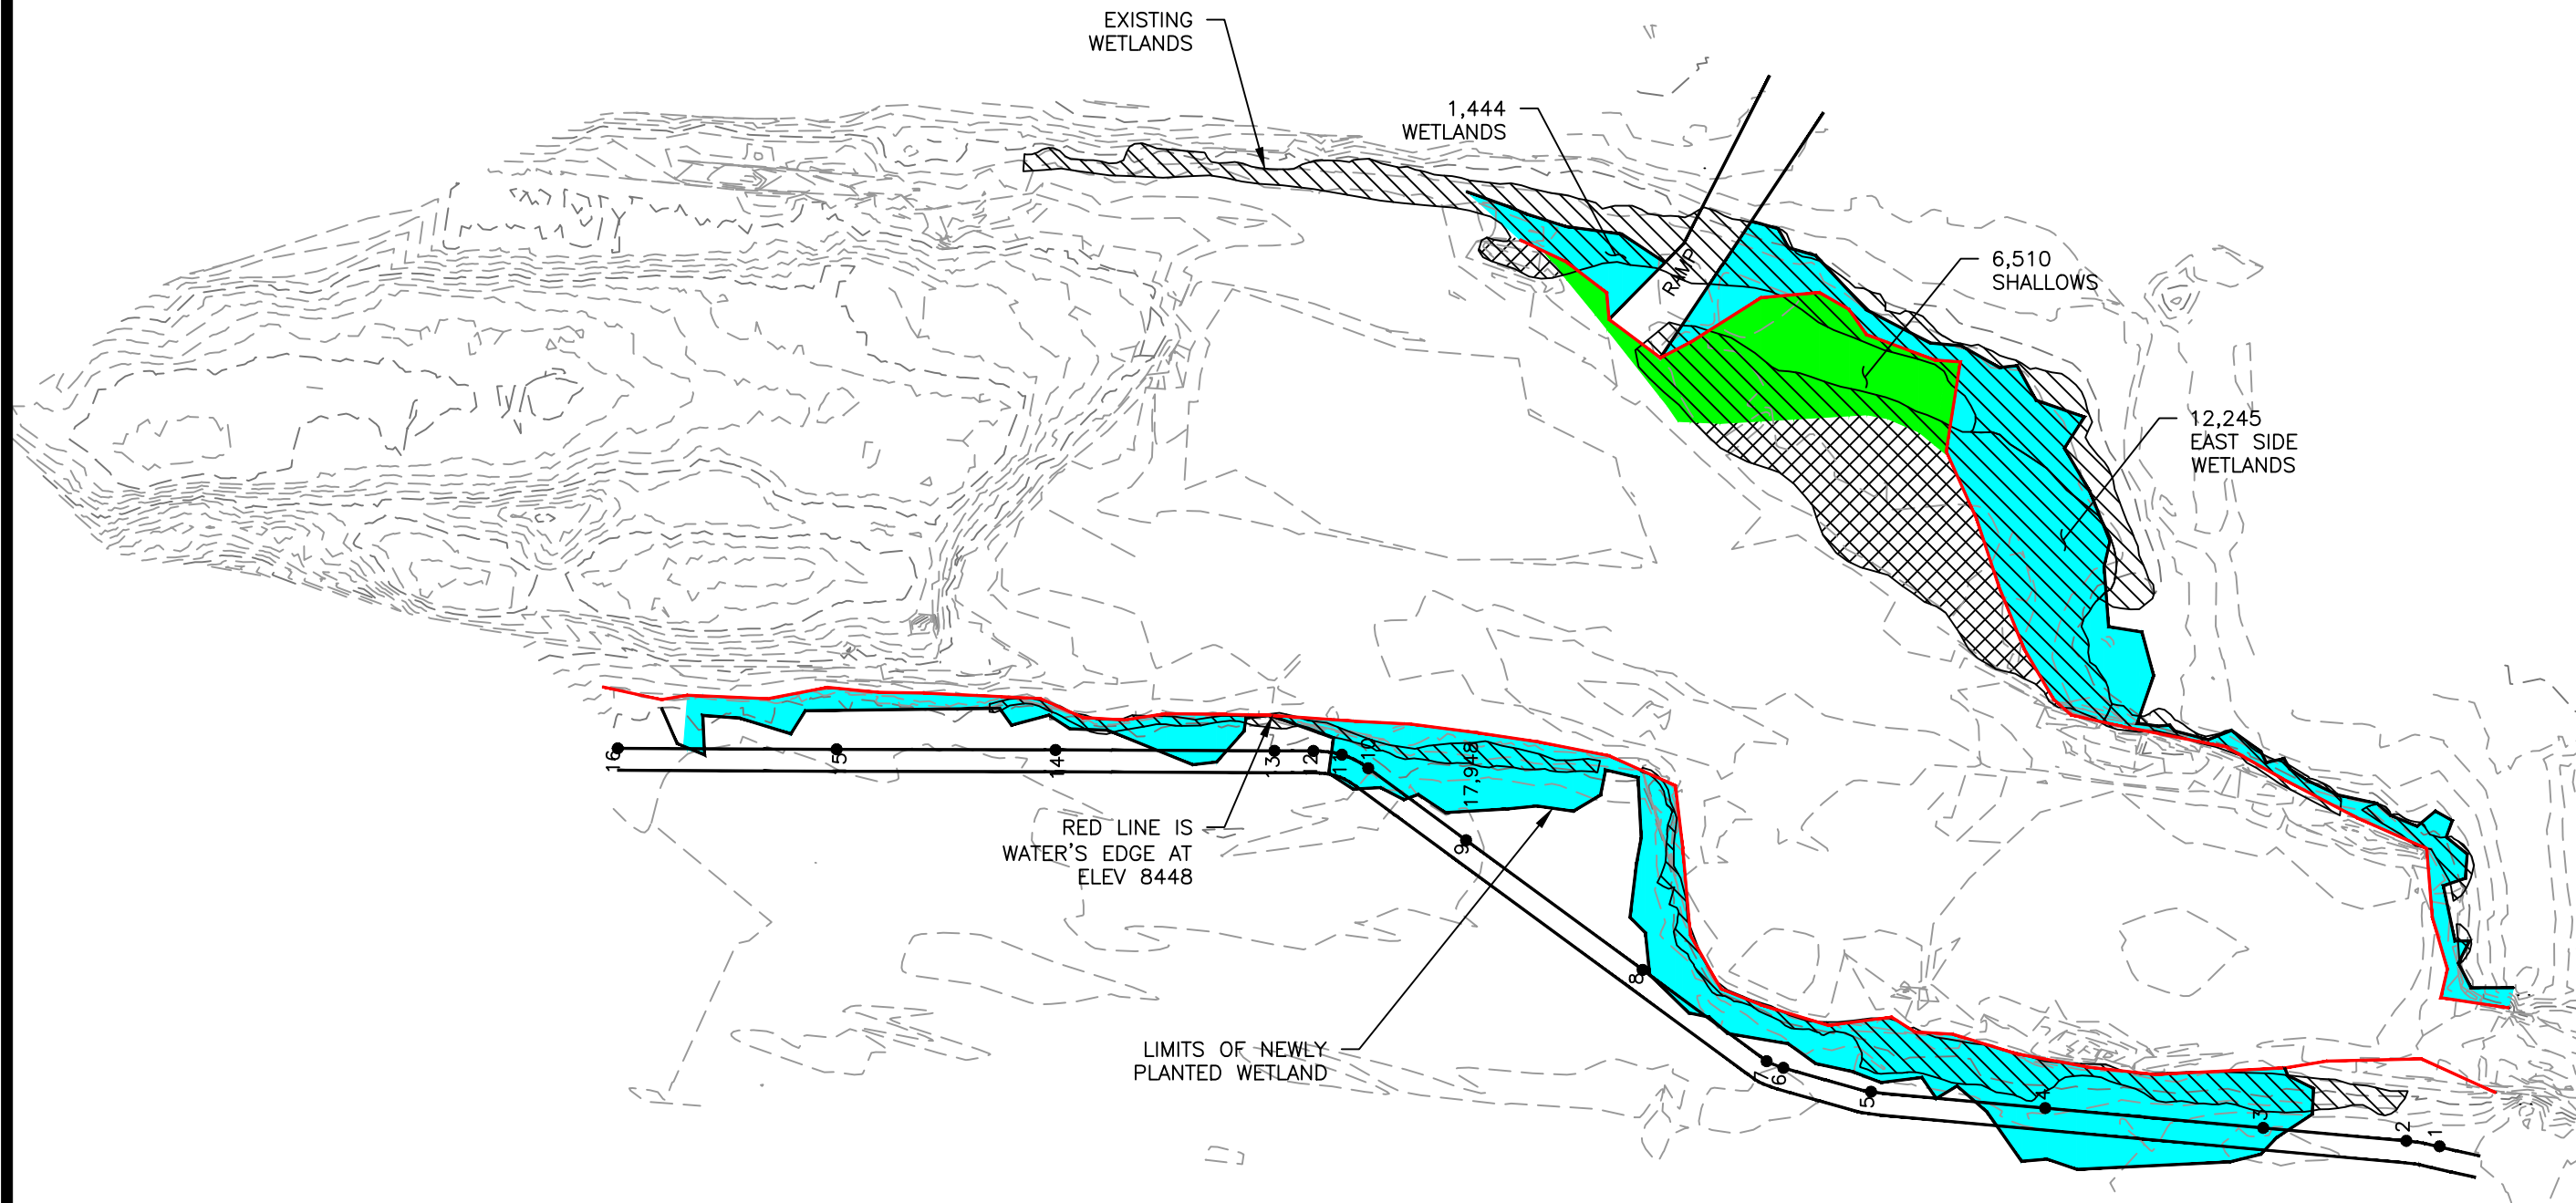
HISTORICALLY OCCURRING WETLANDS (34,844 TOTAL SQ. FT) .80 AC.
-

HISTORICALLY REMOVED WETLANDS (7,516 TOTAL SQ. FT.) .17 AC.
-

NEWLY PLANTED WETLANDS, SUBMERGED (6,510 SQ. FT.) .15 AC
-

NEWLY PLANTED WETLANDS (31,637 SQ. FT.) .73 AC

During construction, wetlands disturbance and mitigation was an important part of the USACE permitting process. As shown on Sheet 3 of the Record Drawings, less than 0.30 total acres of wetlands was disturbed or destroyed during the construction process. However, through the planting of additional wetlands associated with the project, the total established wetlands area around the Lagoon has increased by more than 0.73 acres.
