FINAL REPORT

The Colorado Water Conservation Board

Water Plan Grant: POGG1 PDAA 2019-2496

North Park Irrigated Meadows Project

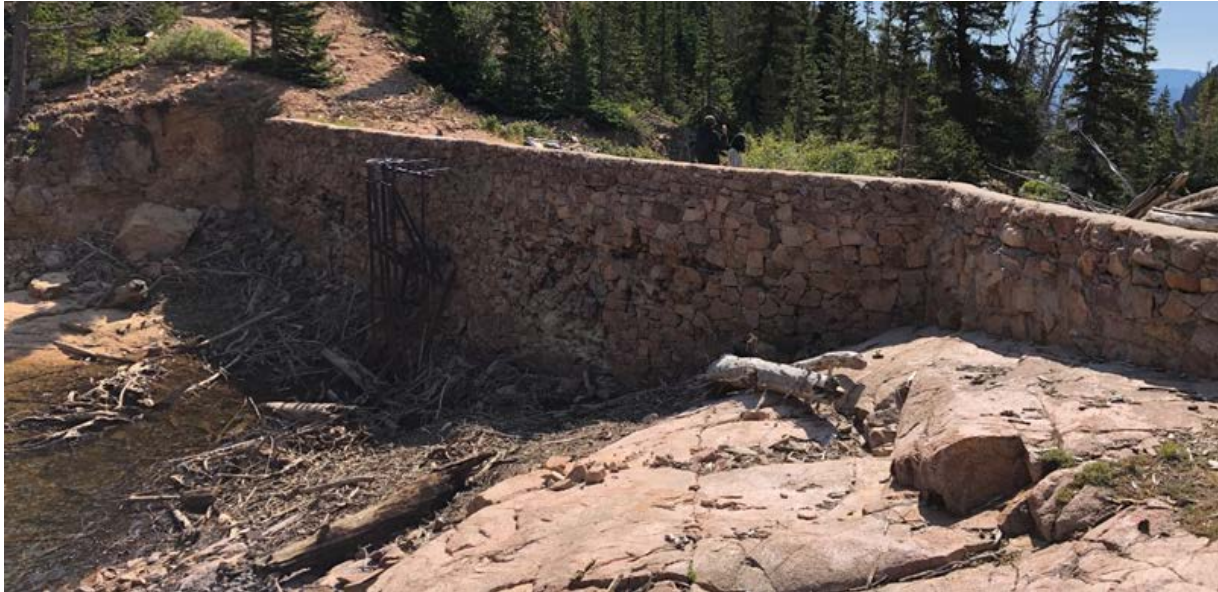
Figure 1. Dam face of Aqua Fria Reservoir and dilapidated headgates prior to completion of project. All debris has since been removed. The dam was hand-laid in ~1940 and the water irrigates over 500 acres of wet meadow habitat in hay production.

Initial work was focused on clearing the debris against the dam face, which was completed in fall of 2019. Telesto Solutions, Inc. has led all inspections, engineering, and design, with Rogue Construction and the landowner completing the construction. All major infrastructure was mobilized successfully to the site prior to snow conditions and winter temperatures forcing construction crews to vacate. In August of 2020, the new PVC pipe was inserted and secured in the dam, a new debris curtain was installed, and remaining repairs to the dam face were completed.

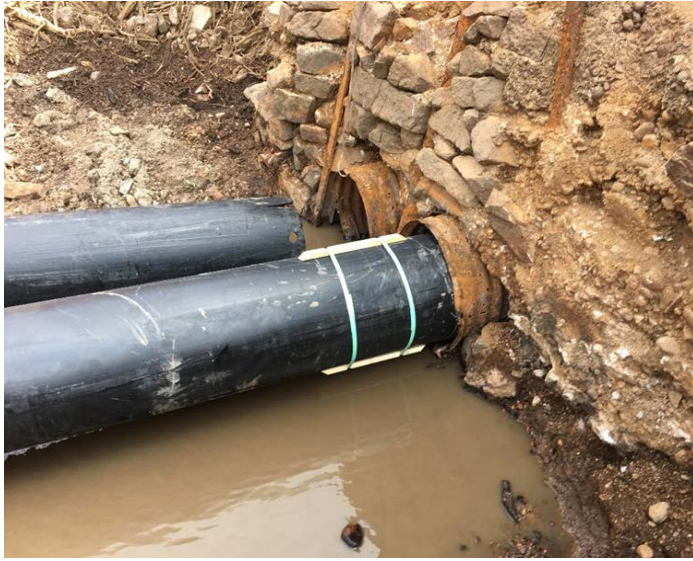
Figure 3. Installation of PVC inserts into dilapidated Corrugated Metal Pipe (CMP).

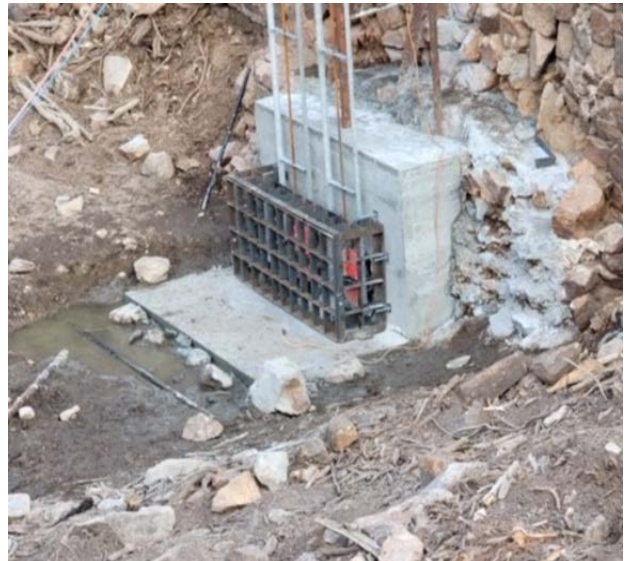
Figure 4. Newly installed headgates and debris curtain at the outlet of Aqua Fria Reservoir.

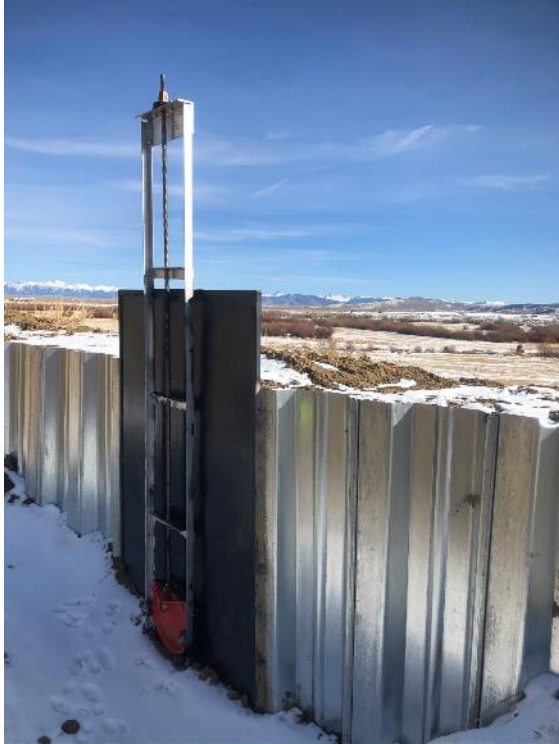
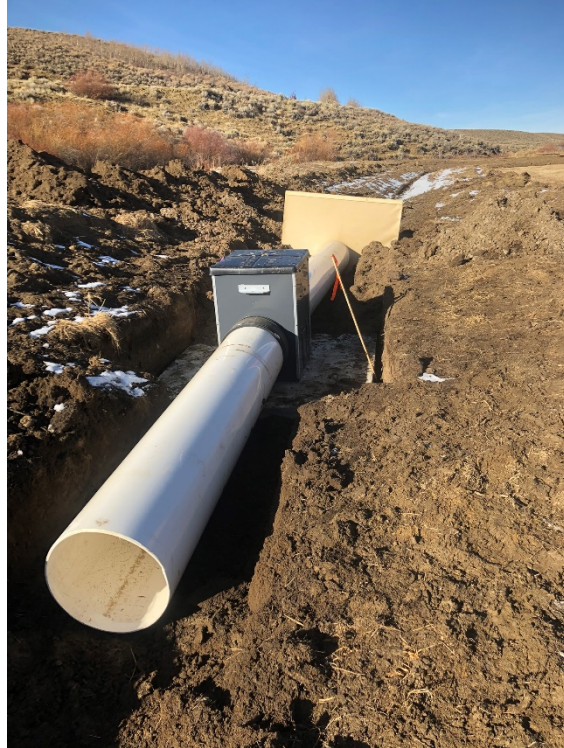
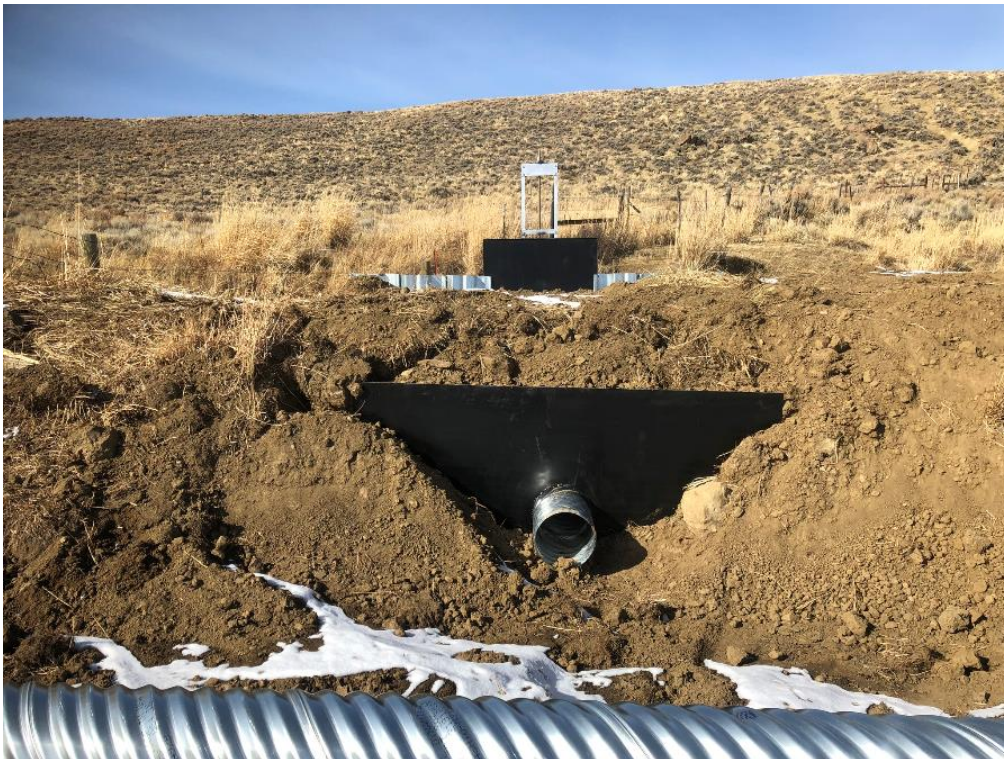
Figure 7. New custom headgate with supporting infrastructure installed at Russell Ranch.

DU engineering team completed a topographic survey of the property and utilized the data to complete a design and construction plan set for construction. DU solicited competitive bids from multiple contractors and entered awarded the contract to Sessions & Sons Construction. An enhanced, properly sloped irrigation ditch was installed. A new custom headgate on the 969 Ditch and crossing pipe with support infrastructure was also installed. An Agri-Drain inline stop log water control structure was also installed in a low-lying area of the field to promote beneficial ponding for irrigation and wildlife. Finally, new turnouts were fabricated and installed.

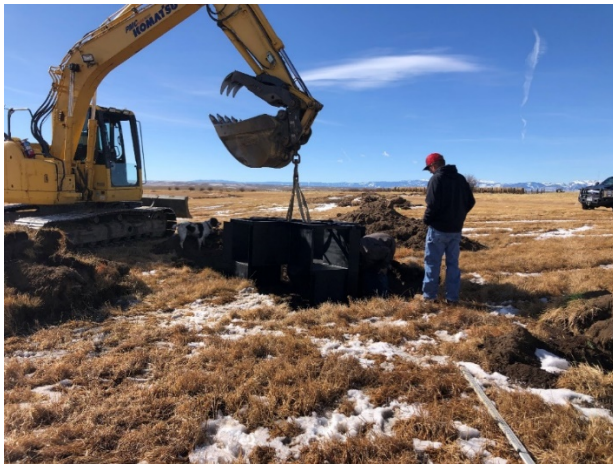
Figure 8. Custom T-box being installed at Sherman Creek Ranch. The structure will allow irrigation

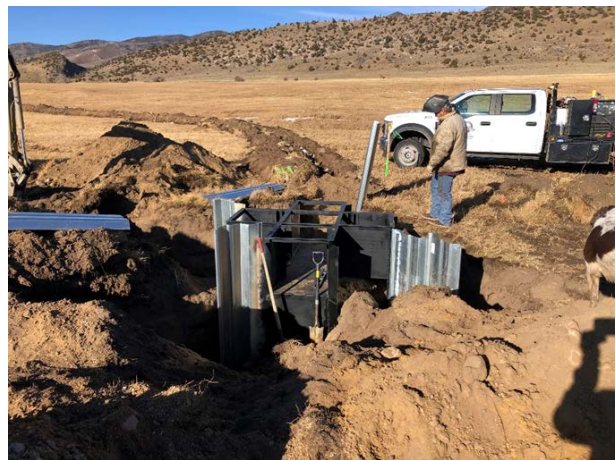
Figure 9. Custom T-box being installed with new ditching at Sherman Creek Ranch.

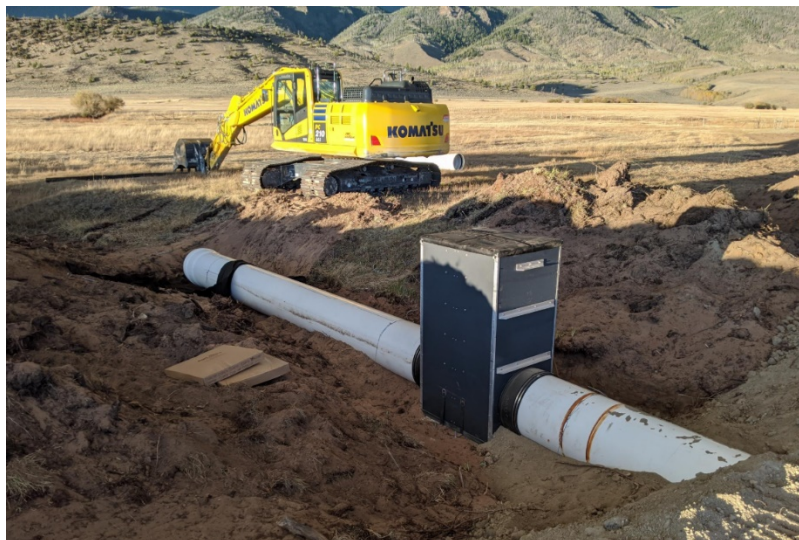
Figure 10. Installation of one of the Agri Drain inline stop log water control structures installed at Sherman Creek Ranch.
