# **FINAL REPORT**

## **Taylor Park, Gunnison County**

### **Watershed Erosion Control & Stream Restoration Project**

**Prepared for:**  
**Colorado Water Plan Grant Program**

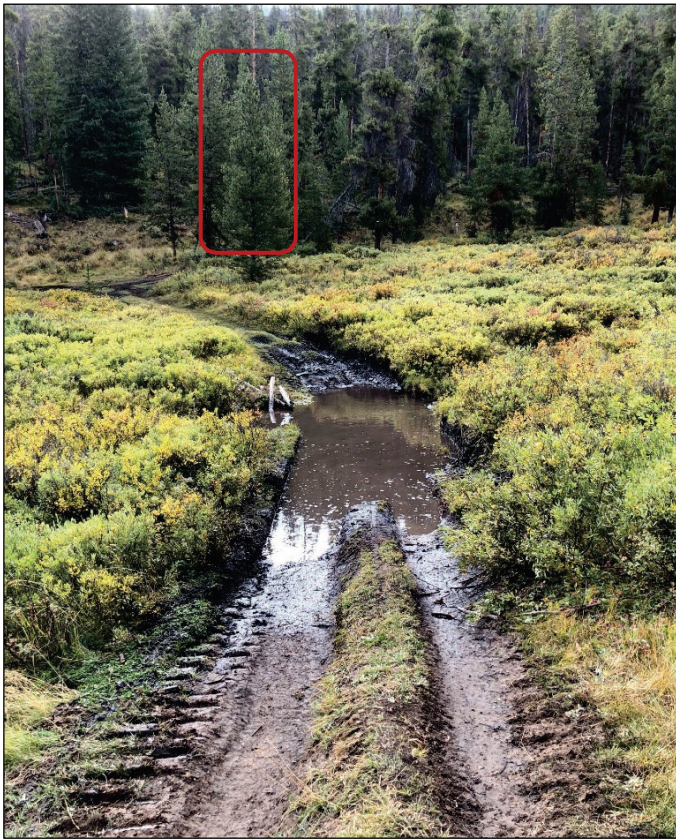
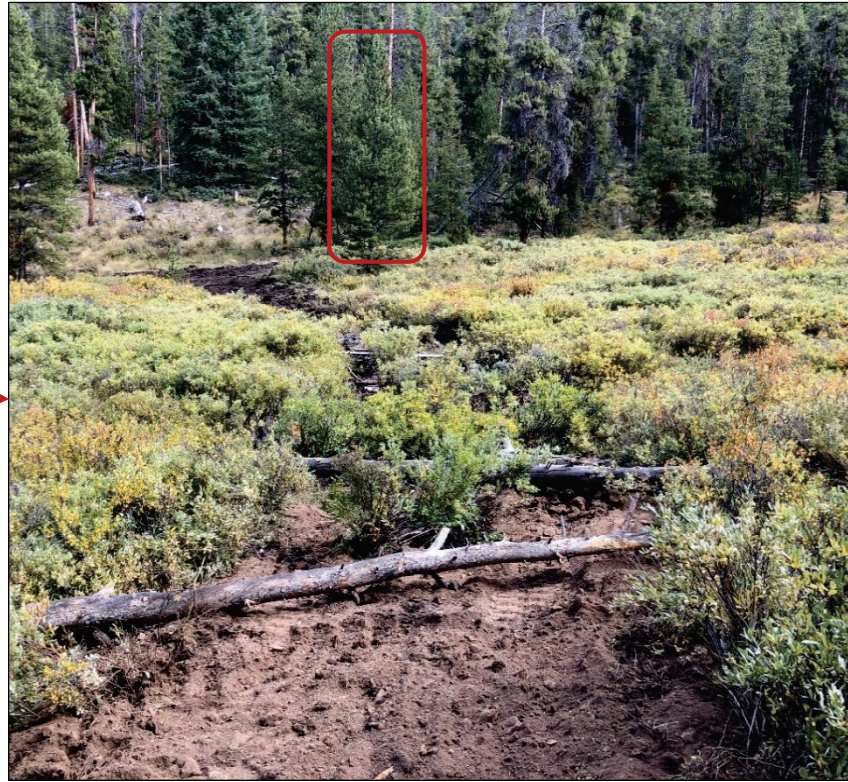
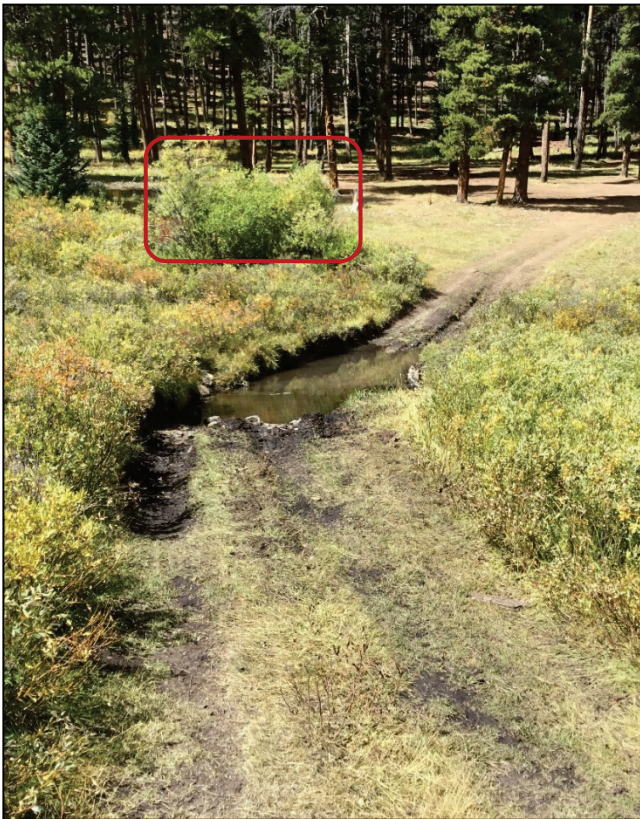
Above and below photos are before and after photos of an illegal stream crossing in Taylor Park, behind Holts cabin area (red rounded rectangles are for comparison reference points). An excavator was used to pull in slash, place root wads and transplant willows.

To accomplish the work, we contracted with a heavy equipment operator to close the road bed. Forest Service staff then reseeded ripped areas with native seed mixes and revegetated and restored other areas of former road bed. In partnership with Gunnison County, who procured and delivered boulders to the project site, Forest Service staff placed boulders to repair stream crossings and also transplanted hundreds of willows.

- Utilizing a Cat D6N dozer to construct tank traps and water bars where necessary to discourage motorized traffic and minimize future erosion in road closure areas.
- Ripping existing compacted road surface to promote natural vegetation.
- Improving water crossings by utilizing an excavator to redirect upper flows and repair single track tire ruts.
- Channelizing flow to original width by using rocks, logs and other native materials.
- Helping restore native vegetation by utilizing harvested native materials.
- Helping restore disrupted areas and improving stream crossings by placing boulders (provided by Gunnison County), transplanting willows, and other activities.

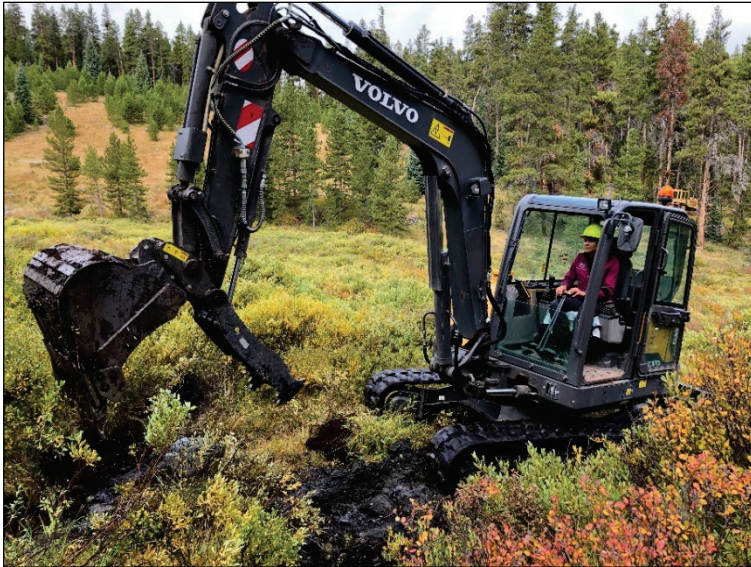
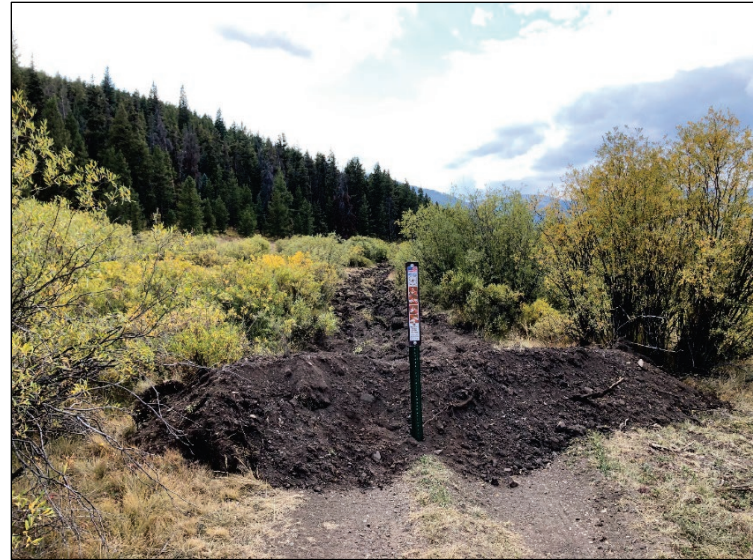
The photo above left is of heavy equipment work on the restoration of the stream crossing. Photo on right is an example of the beginning of a illegal routes close in the area behind Holts cabins.

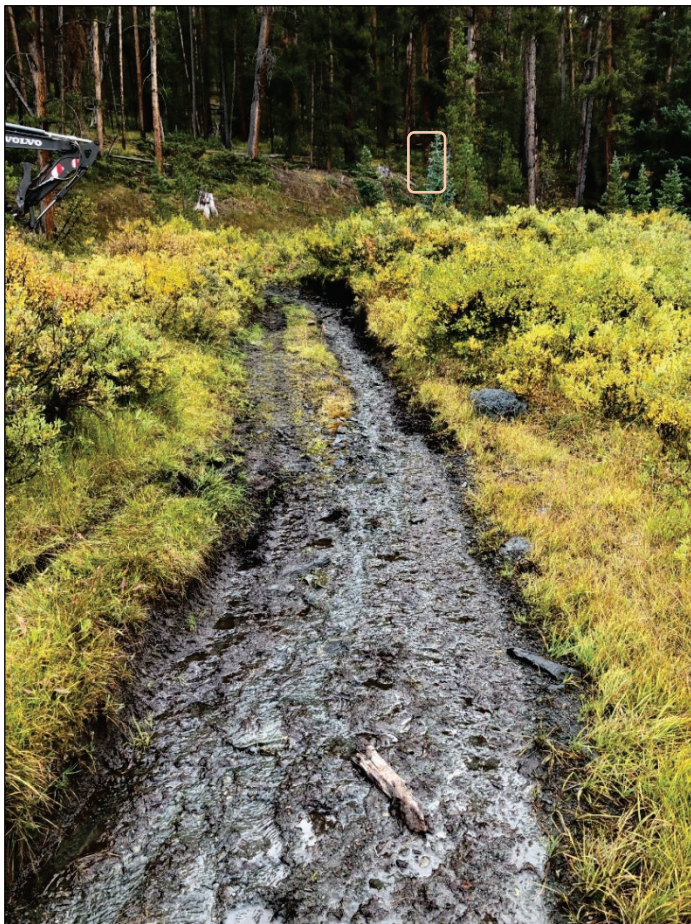
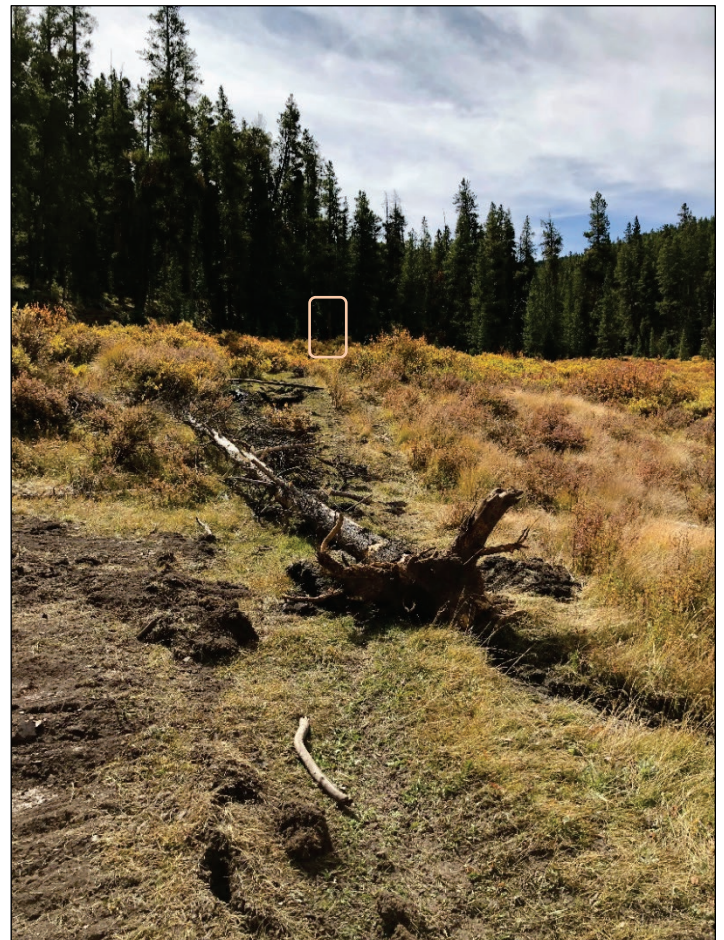
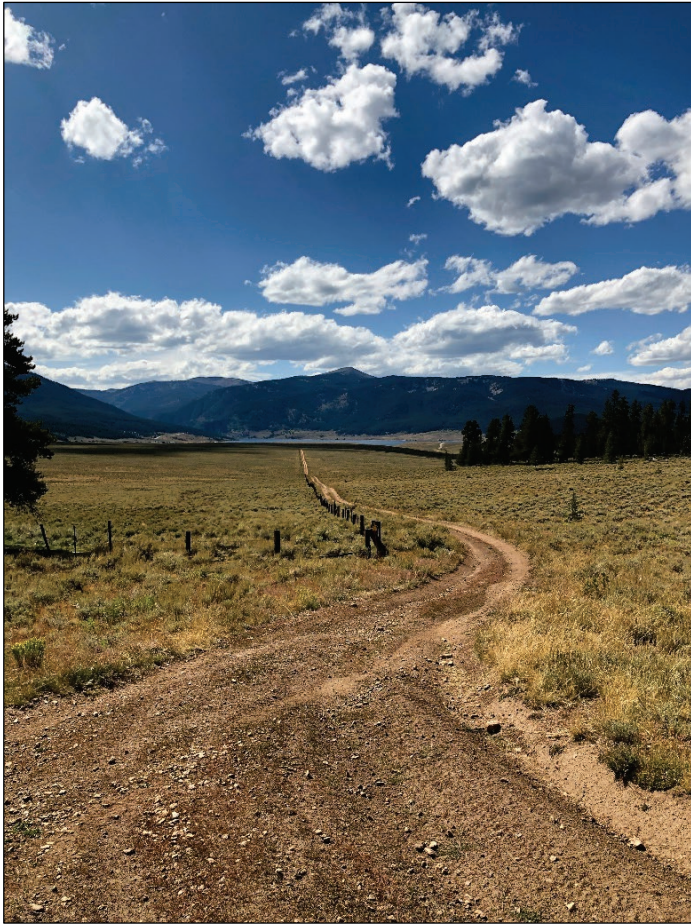
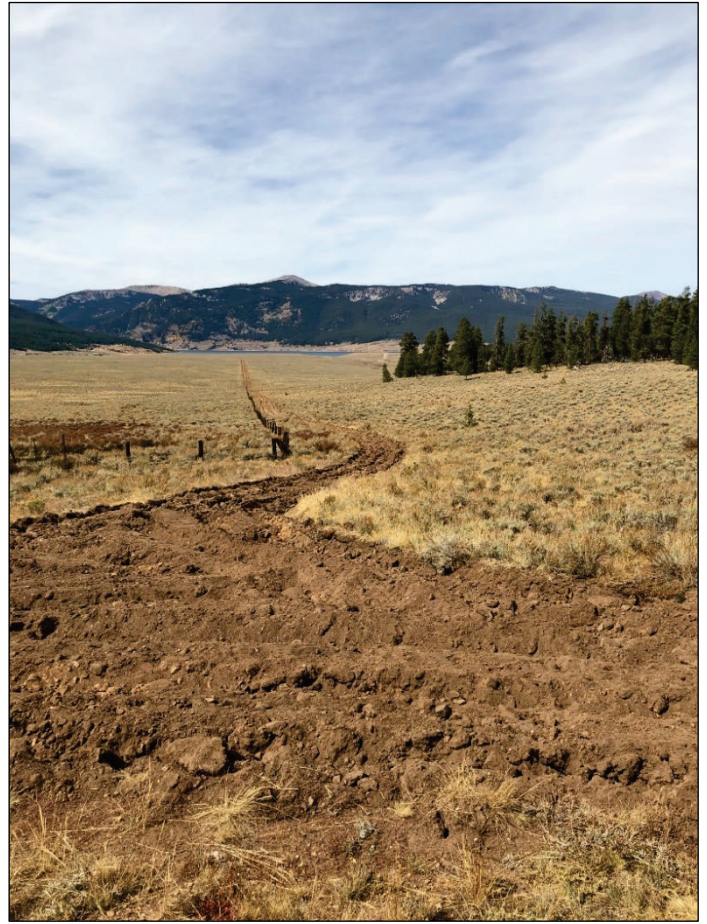
Photos above are before and after of a long illegal route we ripped with a dozer. We also seeded before and after the dozer with a native 4 seed mix. Photos below are also in Taylor Park, near the photo location above. This was a steep hill and we ripped, seeded, and pulled in slash to slow erosion. We also pulled up the sediment plum at the base which was washing into a fen downstream.

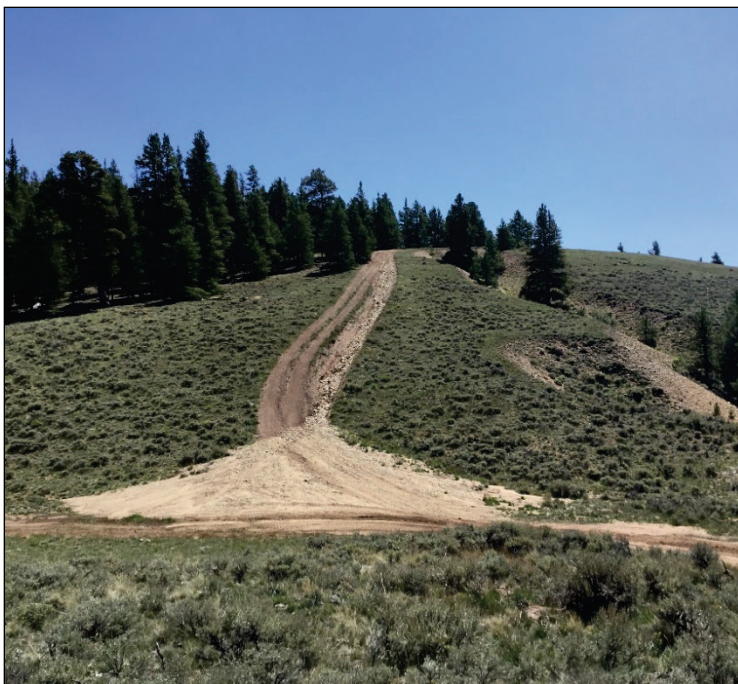
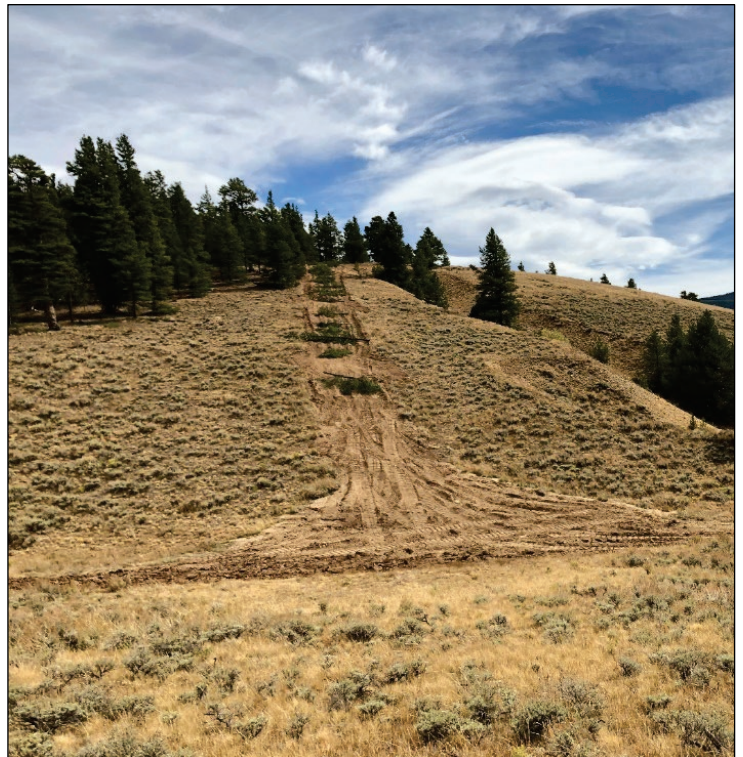
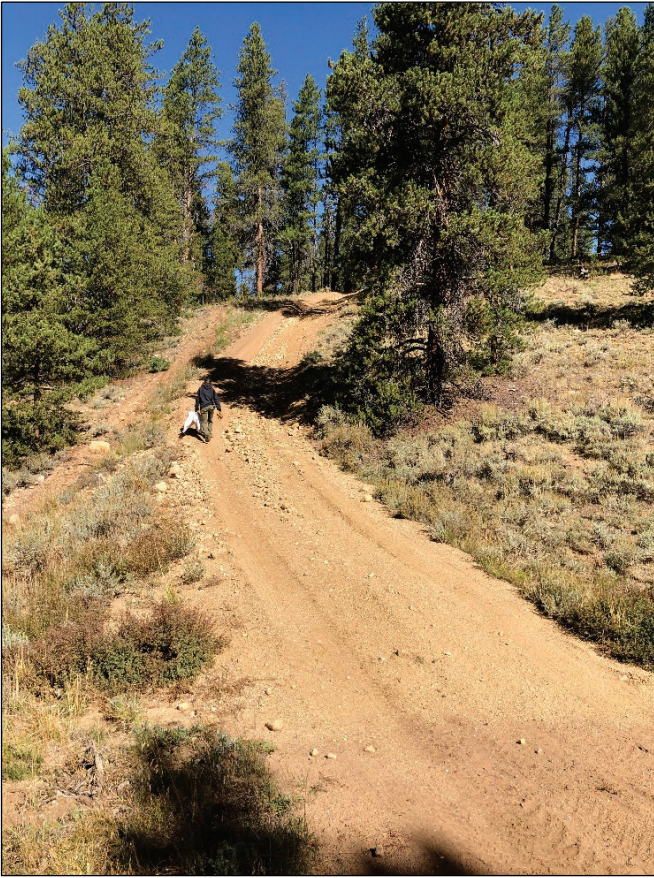
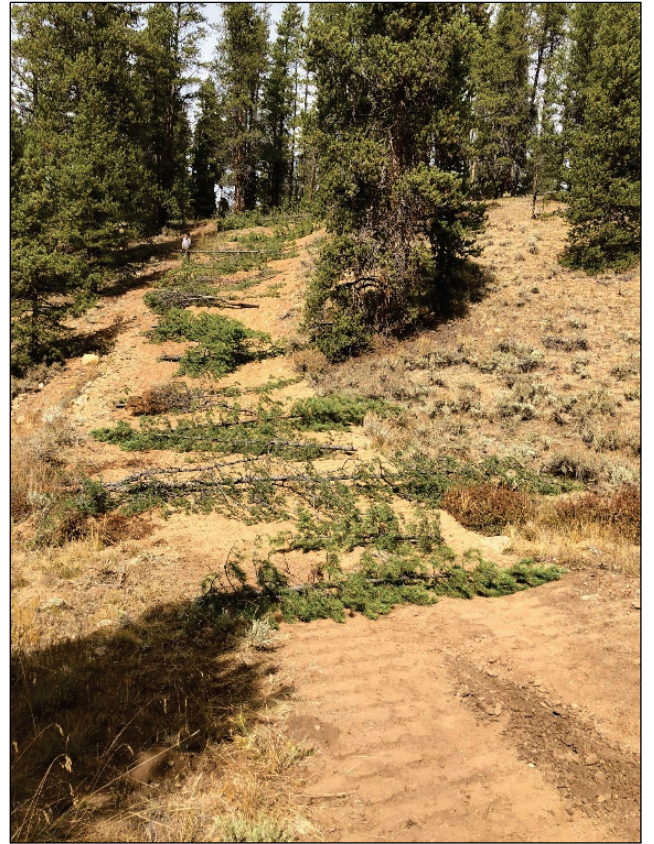
The before and after photos above and below are the same hill, above is the view looking downhill. Below photos are looking up hill. This hill was ripped, seeded and slashed.
