Riparian Reconnect 2019-2020 Project Implementation Grant

Final Report

Tarryall Notch Ranch-Riparian Reconnect Stewardship and Restoration Project 2019-2020 project summary and initial response

Twelvemile Ranch-Riparian Reconnect Stewardship and Restoration Project 2019-2020 project summary and initial response

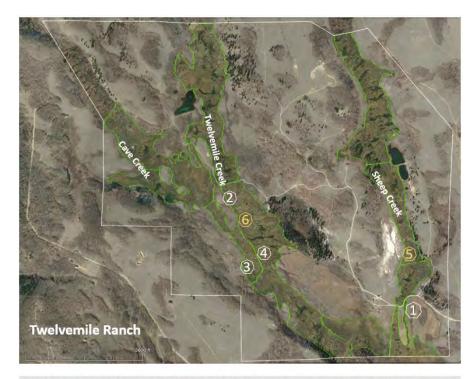
Figure 1 Twelvemile Ranch project priorities for 2019-2021.

Twelvemile ranch project priorities (as outlined in original scope of work)

- 1. Sheep Creek road crossing (began 2019)
- 2. Twelvemile Creek road crossing (began 2019)
- 3. Cave Creek beaver restoration (2019-2020)
- 4. Twelvemile Healey wetland restoration and diversion project (began 2020)
- 5. Sheep Creek spot treatments (potential future project)
- 6. Twelvemile Creek spot treatments (potential future project)

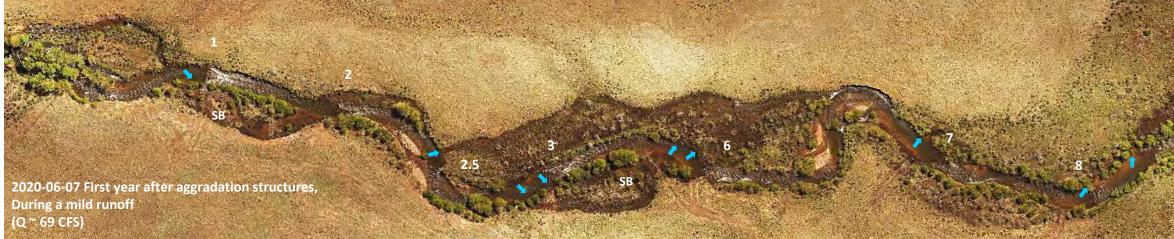
Tarryall Notch Ranch – 2019-2020, upper reach initial response to 2019 treatments

Aggradation structure (identified by number) or speed bump (SB)
 Bank notch

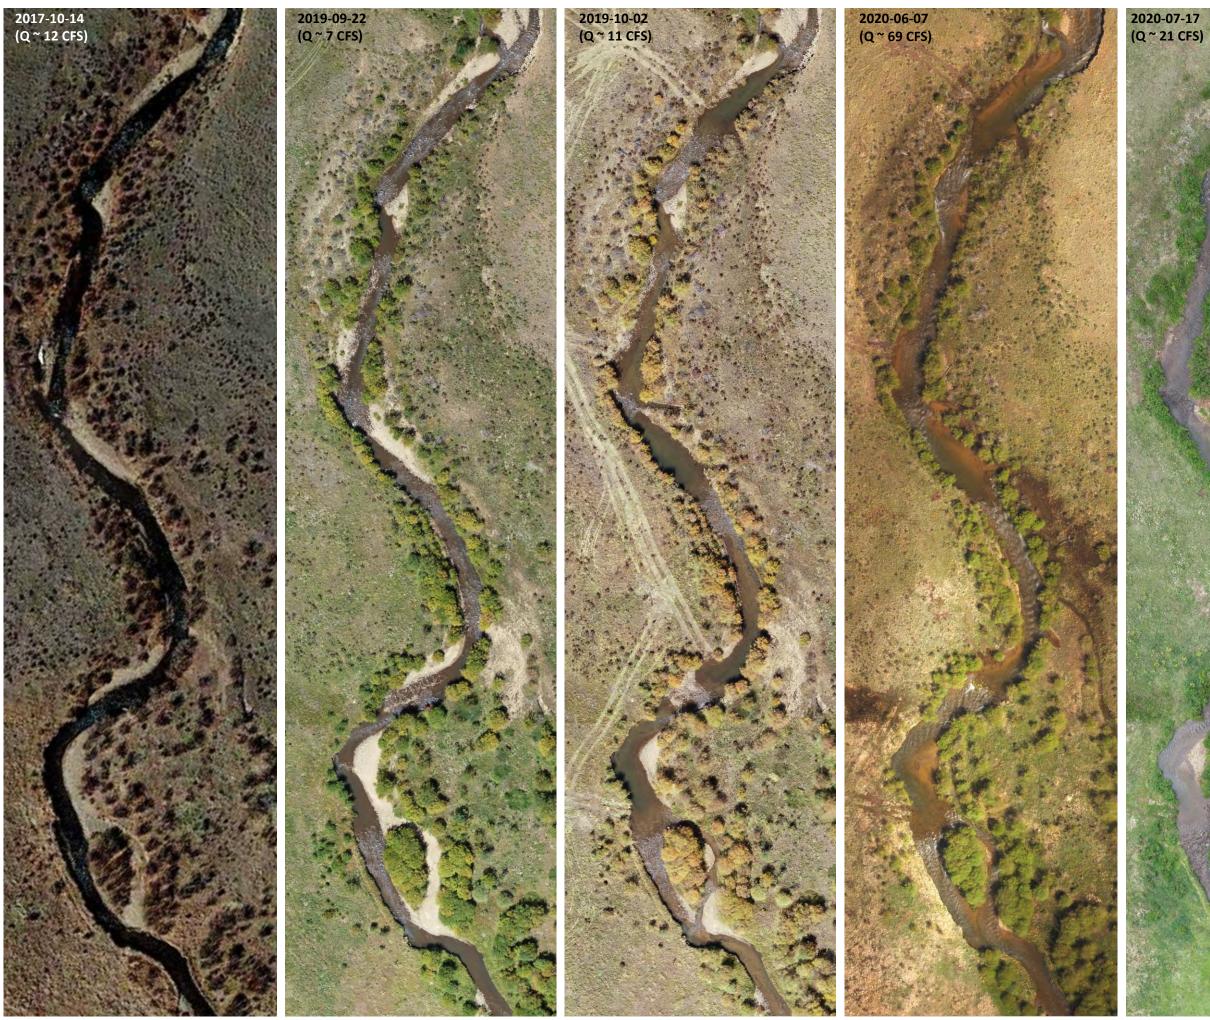
Tarryall Notch Ranch – 2017-2020, Upper reach, segment 3

2019-09-22 Before aggradation structures, 11 years after planting and grazing management (Q ~ 7 CFS)

2020-06-07 First year after aggradation structures, 11 years after planting and grazing management (Q ~ 69 CFS)

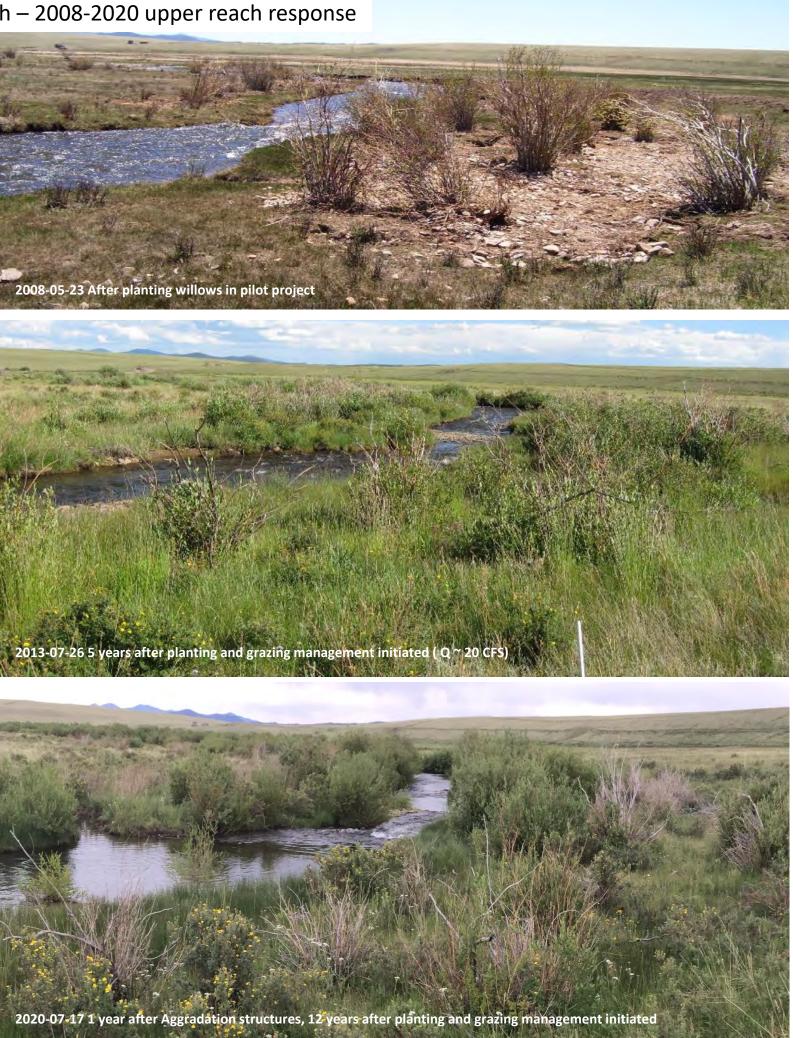
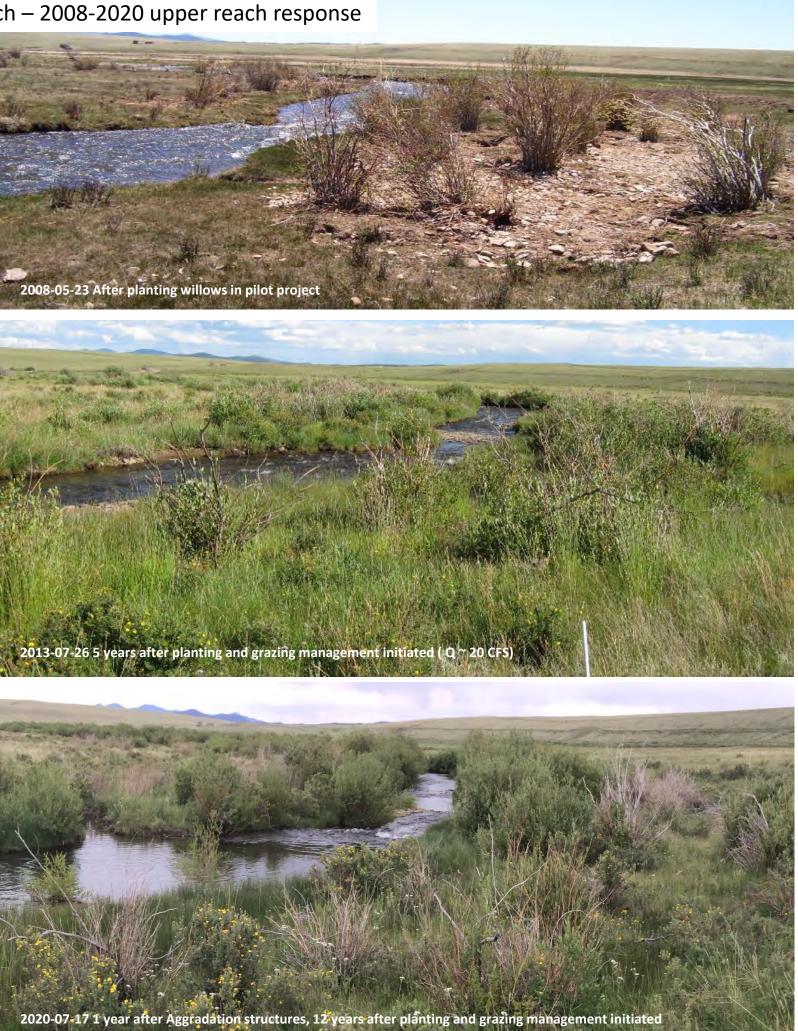
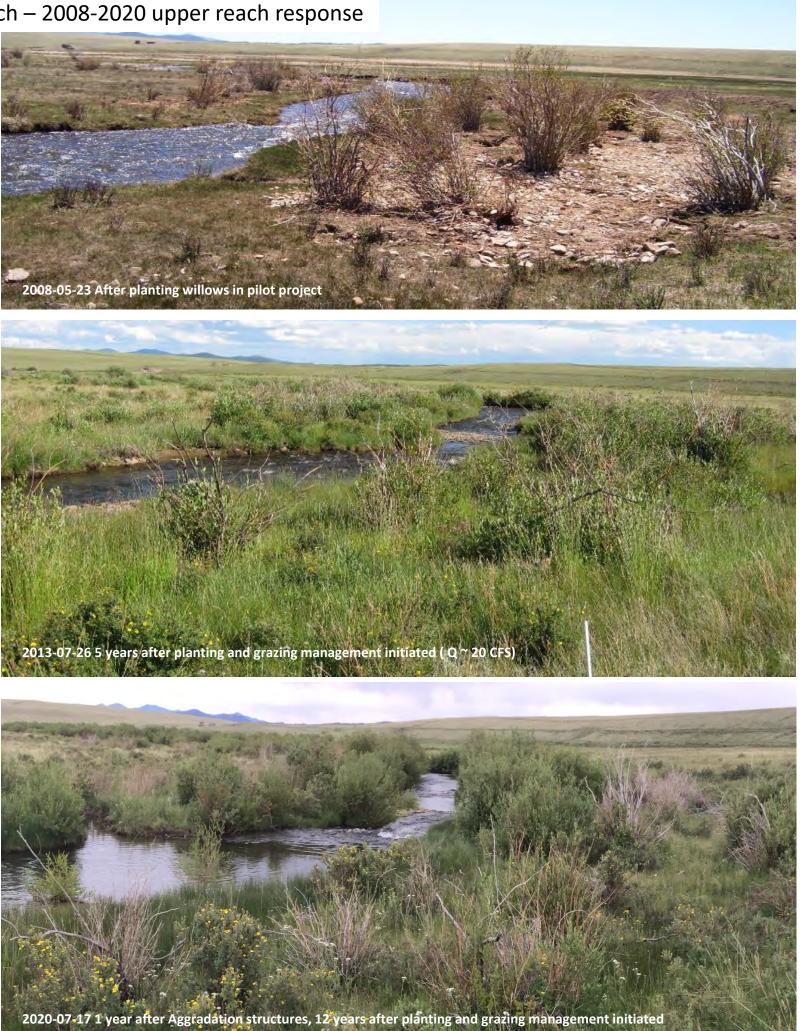
Tarryall Notch Ranch – 2008-2020 upper reach response

2013-09-27 5 years after planting and grazing management initiated (Q \sim 20 CFS)

2019-09-22 Before aggradation structures, 11 years after planting and grazing management (Q \sim 7 CFS)

2020-06-07 First year after aggradation structures during a mild runoff (Q \sim 69 CFS)

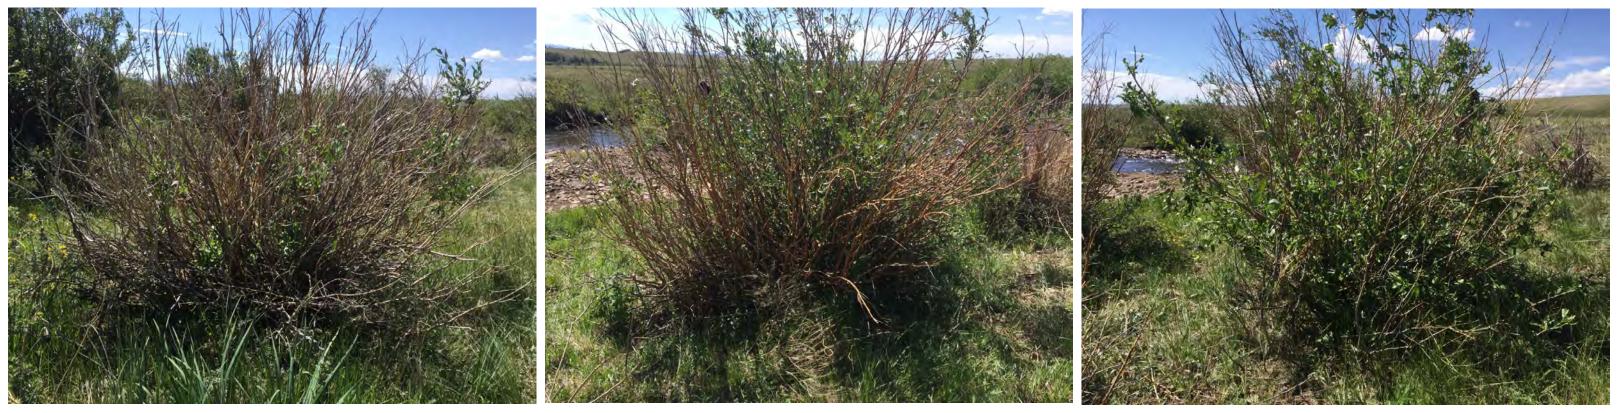
Tarryall Notch Ranch – Drought-stressed willow response to improved riparian hydrology

New growth on drought-stressed willows during the 2020 season indicates a positive response to improved riparian hydrology (all photos from 2020-07-17, after a mild runoff).

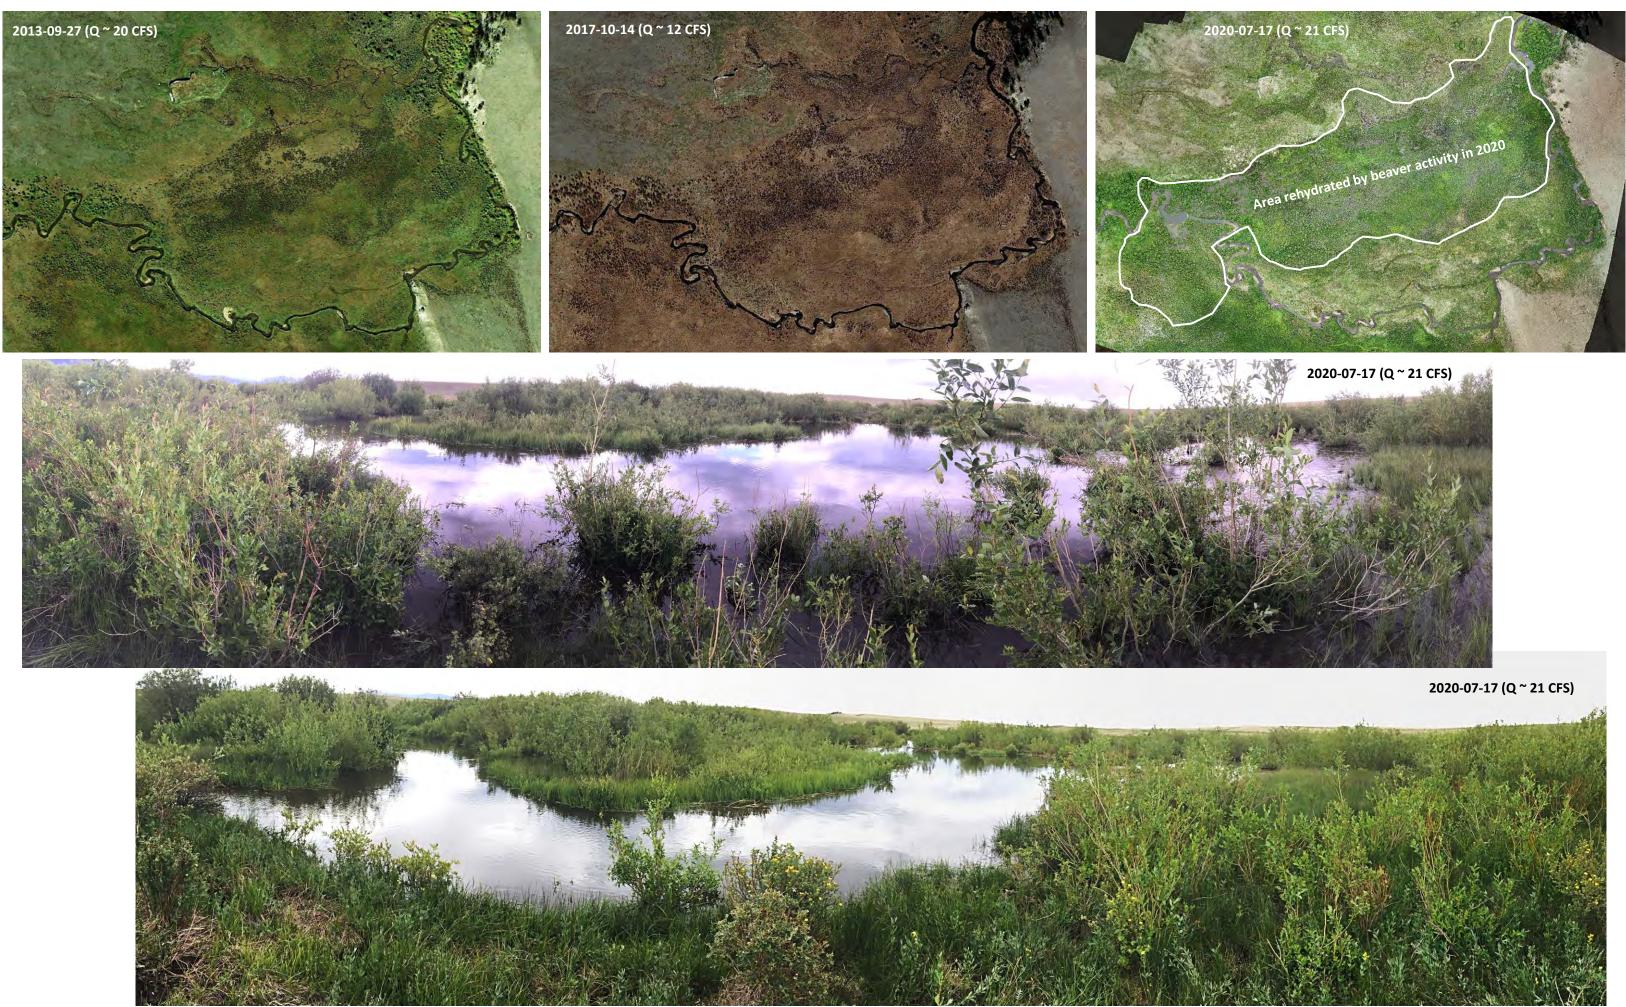
Tarryall Notch Ranch, upper reach – area with surface water 2017-2020

Approximate surface water area = 2500 m² Approximate portion of riparian area with surface water = 13%

2017-10-14 upper reach Before aggradation structures During base flow (Q ~ 12 CFS)

Blue shading shows area of surface water on 2017-10-14

Light blue shading shows area of surface water on 2020-06-07

Approximate surface water area = 6050 m² (140% increase) Approximate portion of riparian area with surface water = 30%

2020-07-17 upper reach First season after aggradation structures During base flow (Q ~ 21 CFS)

Light blue shading shows area of surface water on 2020-07-17 Blue shading is area of surface water on 2017-10-14 (from above)

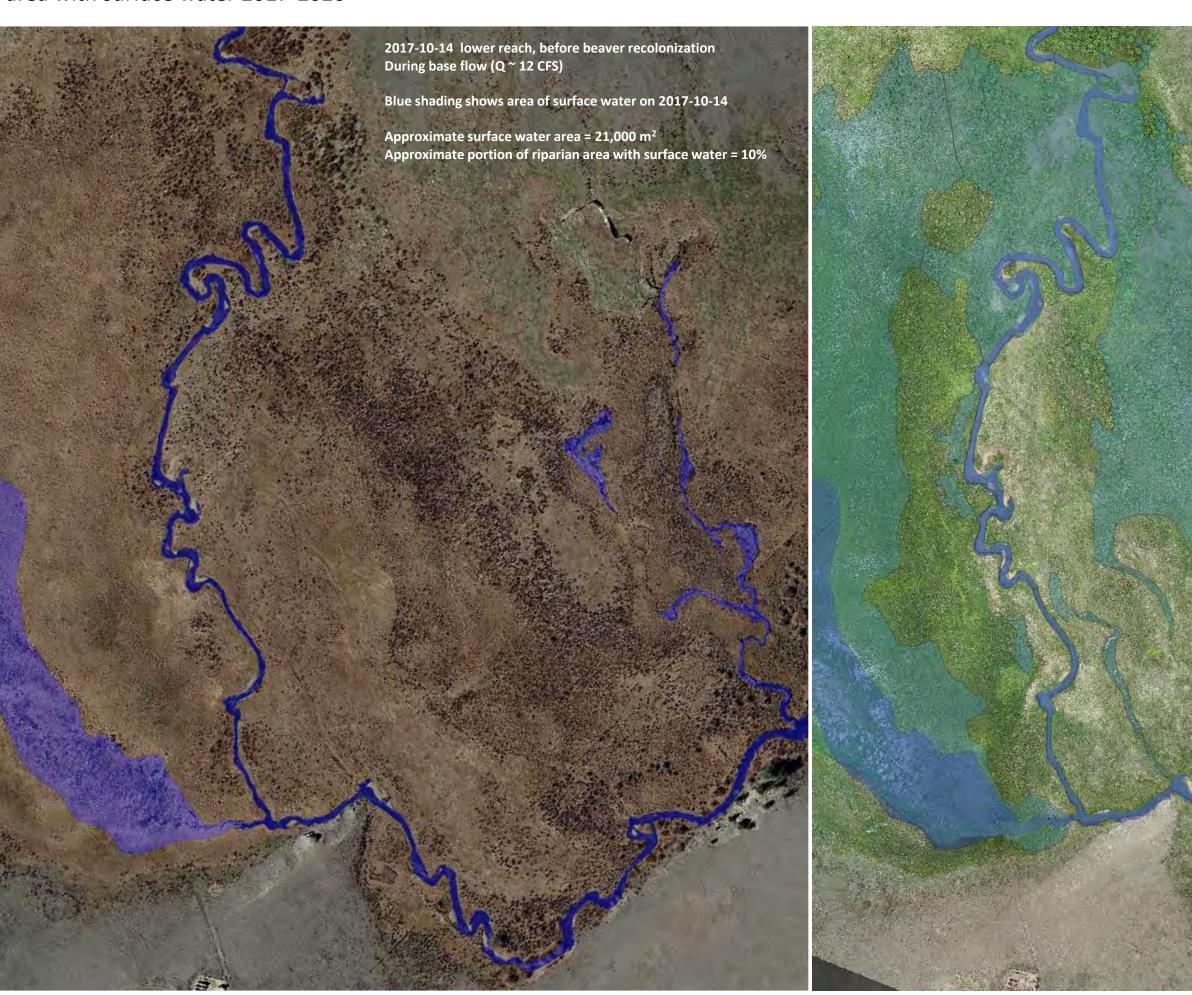
Tarryall Notch Ranch, lower reach – area with surface water 2017-2020

2020-07-17 lower reach, after one beaver colony During base flow (Q \sim 21 CFS)

Light blue shading shows area of surface water on 2020-07-17 Blue shading is area of surface water on 2017-10-14 (from left)

Approximate surface water area = 104,00 m² (400% increase) Approximate portion of riparian area with surface water = 50%

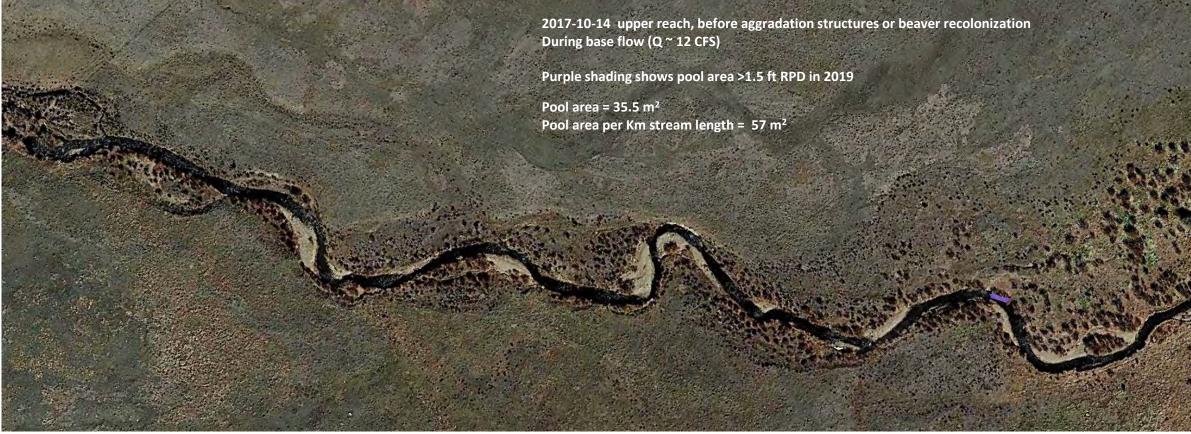
Tarryall Notch Ranch, upper reach – Pool area with RPD > 1.5 ft 2019-2020

2020-07-17 upper reach, first year after aggradation structures and one beaver colony During base flow (Q \sim 21 CFS)

Purple shading shows pool area >1.5 ft RPD in 2020

Pool area = 900.4 m² (2400% increase) Pool area per Km stream length = 1452 m²

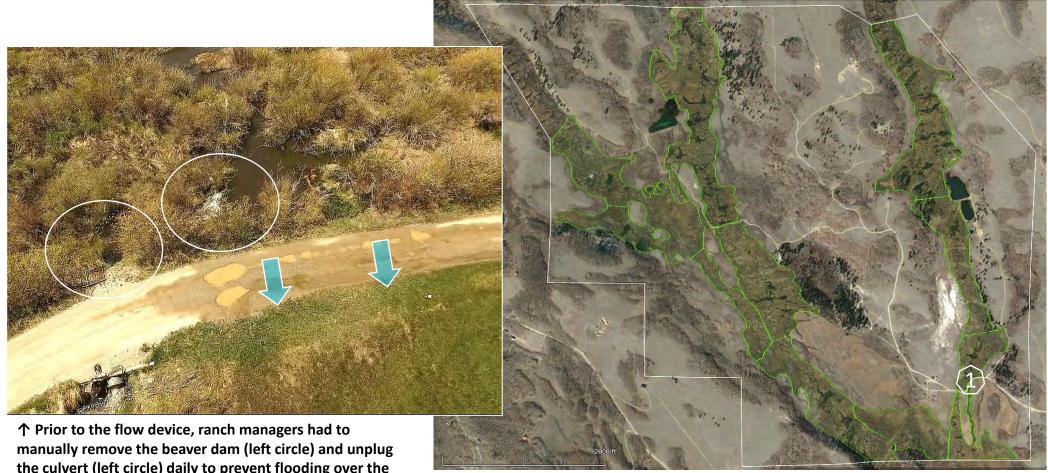
the culvert (left circle) daily to prevent flooding over the road (blue arrows).

↓ Overview of the Sheep Creek culvert area. The flow device is location is drawn in.

↑ Two views of the fence-and-pipe flow device installed at the road to prevent beaver activity from flooding the road. A fence prevents beavers from plugging the culvert. Beavers can dam the creek upstream, but flow through a pipe prevents water level from rising above a certain height. A dome-shaped cage around the inlet to the pipe keeps beavers from plugging it. \downarrow

The ranch access road crosses Sheep Creek, a broad Stage-0 beaver complex. A fence-and-pipe flow device was installed in 2019 to protect the road from flooding, coexistence with beaver populations, and reduce maintenance burden. The goal is to maintain beaver complex habitat while protecting the road.

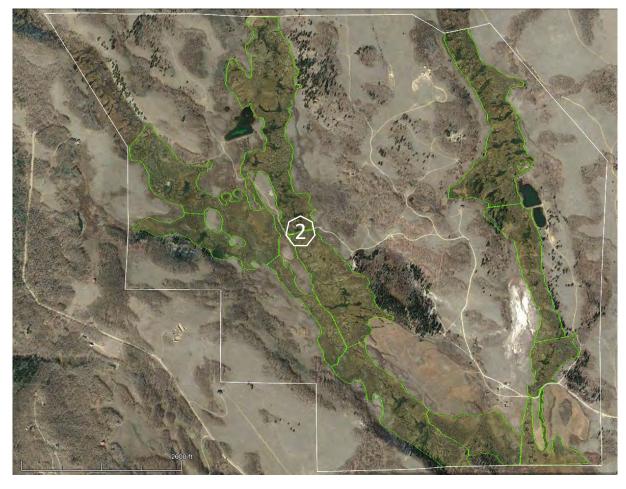
↑ A pond leveler prevents road flooding by limiting the height of the beaver dam. When the dam approaches a level that threatens the road, more water flows through the pipes, eliminating the stimulus that triggers beavers to build the dam higher. (The rocks in the photo above were added in 2020.) \downarrow

The ranch road crosses Twelvemile Creek, a broad Stage-0 beaver complex. A series of Keystone fences and pond leveler flow devices were installed in 2019 to protect the road from flooding, coexistence with beaver populations, and reduce maintenance burden. The goal is to maintain beaver complex habitat while protecting the road.

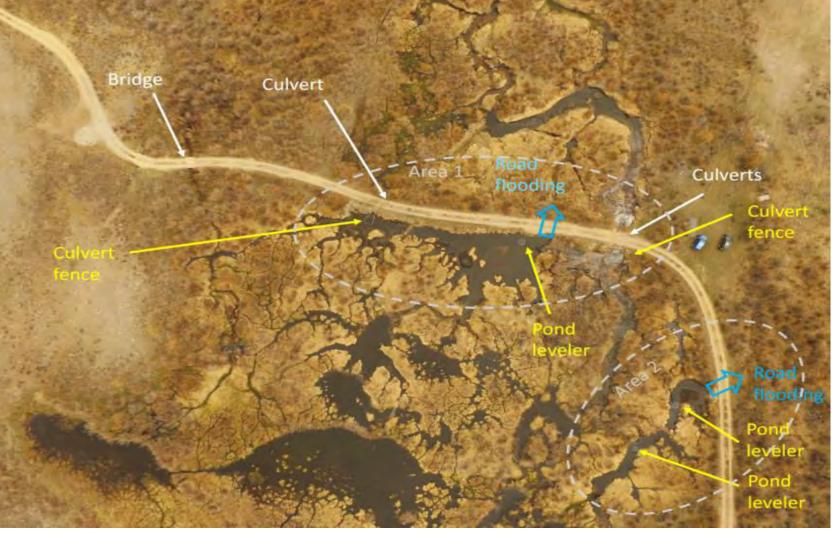
Twelvemile Creek road crossing

↓ Overview of the Twelvemile Creek culvert area. The flow device locations are indicated.

In area 1, Keystone fences prevent beavers from plugging the two culverts.

Keystone fence on west culvert (1 year after installation)

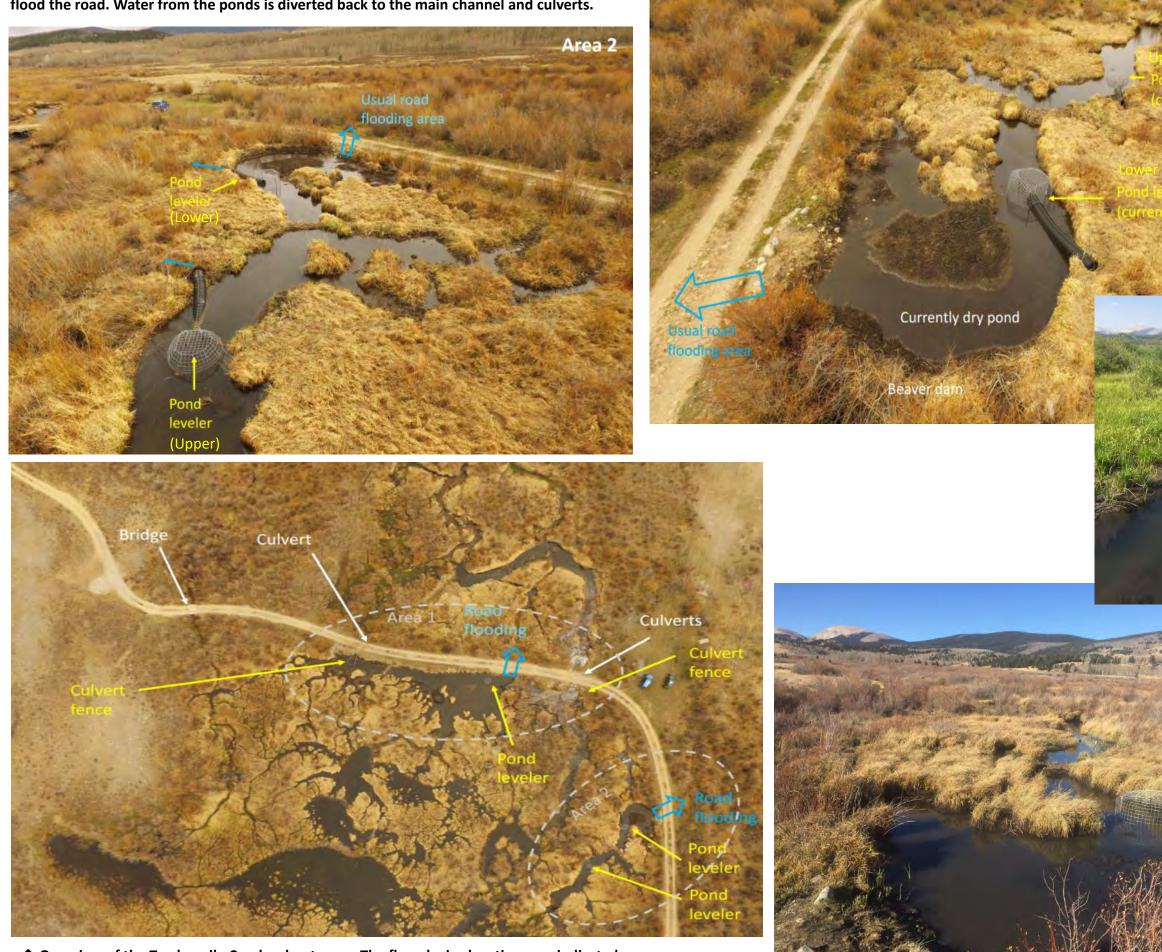
Twelvemile Creek road crossing

In area 2, a series of two pond levelers prevents beavers from building dams high enough to flood the road. Water from the ponds is diverted back to the main channel and culverts.

↑ Overview of the Twelvemile Creek culvert area. The flow device locations are indicated.

Upper of two pond levelers. During low flow periods, this flow device carries all flow. \downarrow

← Lower of two pond levelers. For most of the season when streamflow is low, the upstream leveler (background) carries full flow. The secondary downstream leveler (foreground) kicks in when streamflow is high.

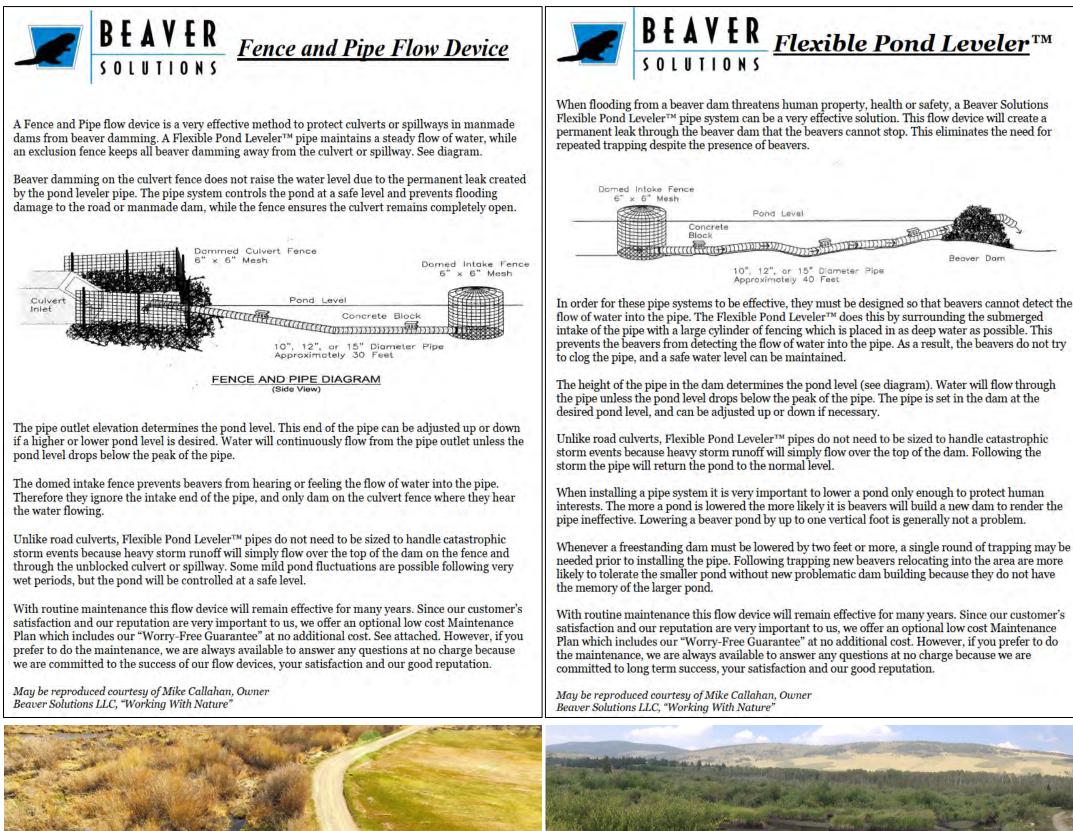
Flow devices used to promote coexistence with beaver and beaver habitat on Twelvemile Ranch

Road culverts are the most common beaver damming problem we encounter. Beavers often dam in culverts because with a little bit of work the entire roadbed becomes a large dam. To a beaver, a road bed with a culvert probably looks like a dam with a hole that must be repaired.

The Keystone Fence™ eliminates beaver damming of culverts. Beaver Solutions™ has installed several hundreds of these devices with a 95% success rate despite the continued presence of beavers. This device eliminates the cost of continued culvert clearing, repairs and trapping.

There are 3 reasons why the Keystone Fence[™] is so effective at protecting culverts from beaver damming. First, damming 30 to 50 feet of fence is a lot more work for the beavers than simply plugging a narrow culvert. This discourages damming. See diagram. Second, if beavers begin to dam near the culvert the fence forces their damming away from the culvert which also discourages them. Third, if the beavers are determined to dam the fence, as they dam on the fence the opening that the water flows into becomes wider and wider. Therefore less water is moving through the fence where the beavers are damming. The decreasing water flow through the fence at the point of damming further decreases the damming stimulus for beavers.

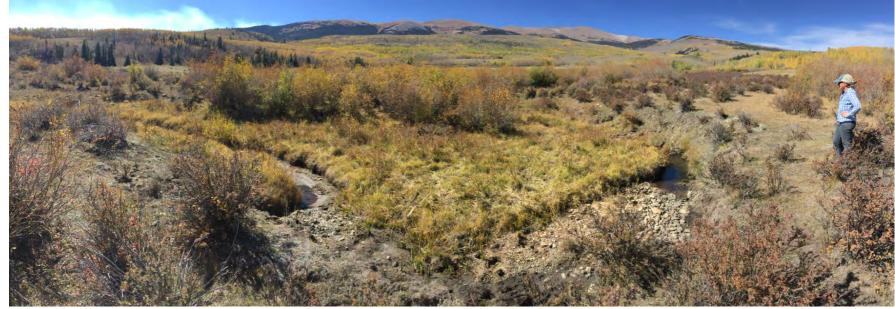
↑ In 2018, before treatment, most of Cave creek was an incised single-thread channel running through abandoned dry beaver complex habitat.

Stage-O beaver complex habitat is widespread on the three streams of Twelvemile Ranch, making it one of the key private conservation properties in the South Platte headwaters. Nevertheless, some reaches have degraded due to the loss of beavers for long periods of time. Cave Creek was identified as the highest priority for restoration and treated over two phases. 35 beaver dam analogs (BDAs) were built on Reach 3 in 2019 and 16 more BDAs were built on Reach 2 in 2020. The purpose of BDAs is to mimic the function of real beaver dams by raising water stage and water table elevation to restore wetland. The treatments also aim to promote recolonization of the reaches by beavers by improving habitat suitability with more deep water, cover, and stimulated willow growth.

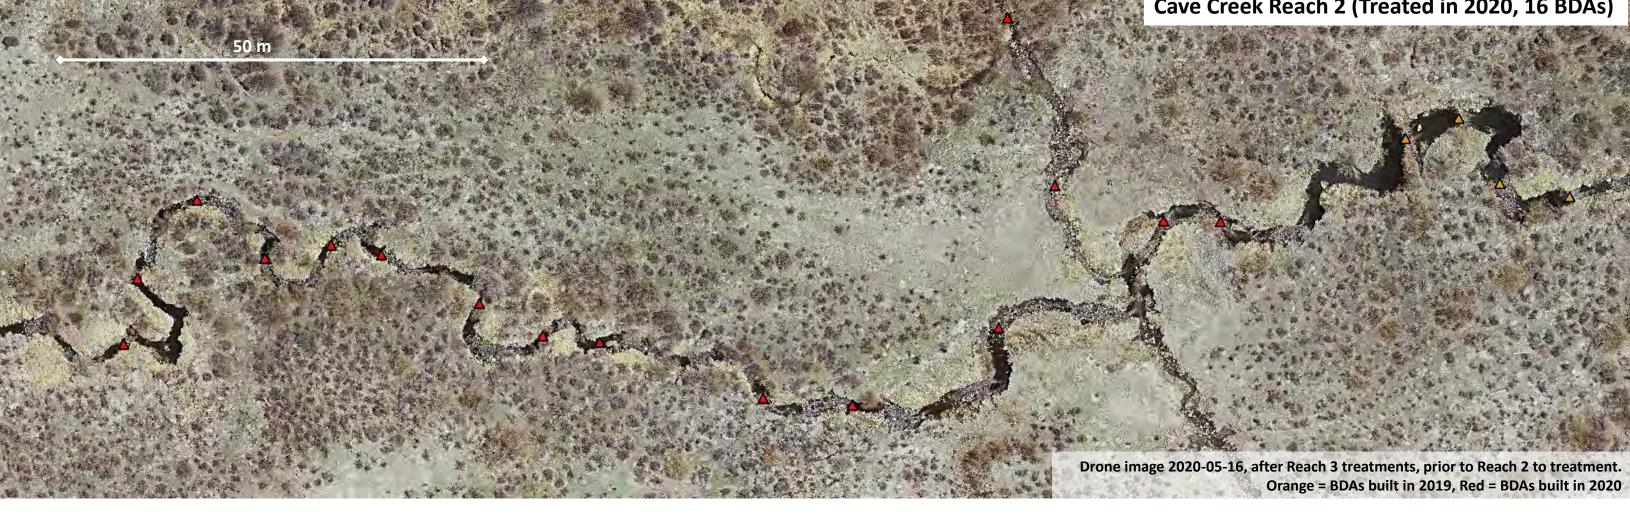
Cave Creek Reach 2 (Treated in 2020, 16 BDAs)

Arrows indicate BDAs that were in place at the time of this photo.

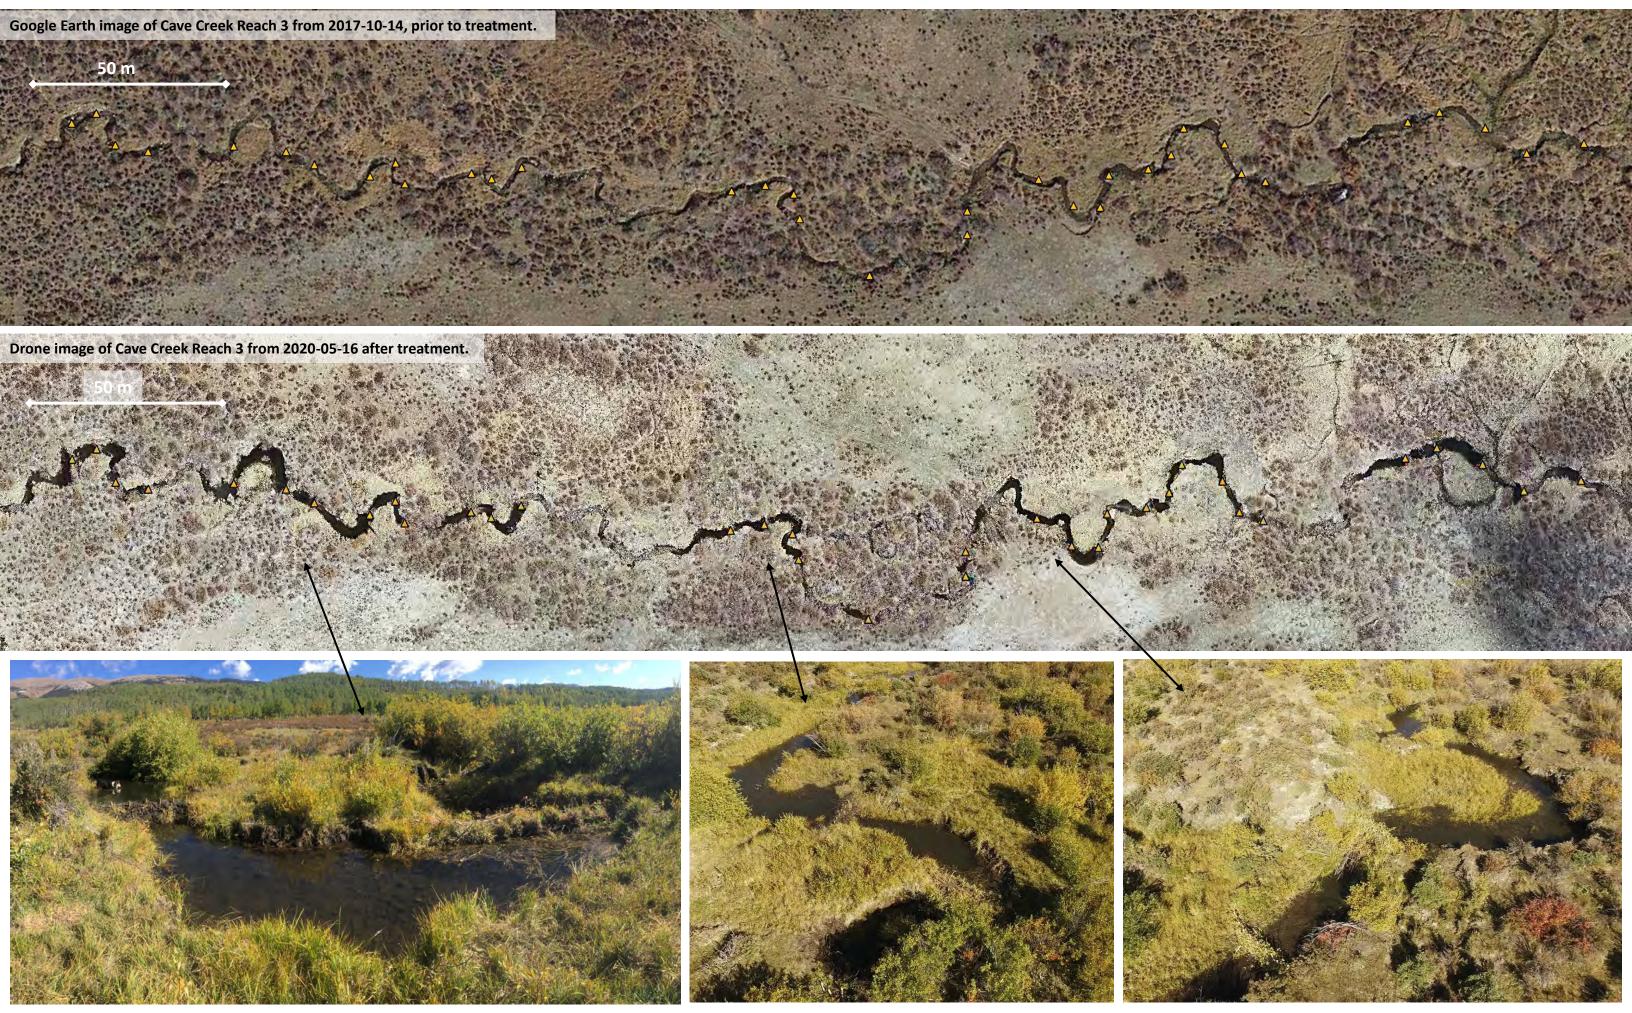
Cave Creek Reach 3 (Treated in 2019, 35 BDAs)

Schematics for a typical BDA structure as built on Cave Creek. Postless BDAs on Cave Creek range from 0.6 to 1.8 feet tall and were constructed using locally-harvested willow, rocks, sod, and gravel. In some cases, coir (coconut fiber) logs were used to build the BDA core.

Schematics for a typical post-assisted BDA structure as built on Cave Creek. Post-assisted BDAs on Cave Creek range from 1.2 to 2.2 feet tall with locally-harvested willow, rocks, sod, and gravel supported by untreated wooden posts driven into the stream bed. In some cases, coir logs were used to build the BDA core.

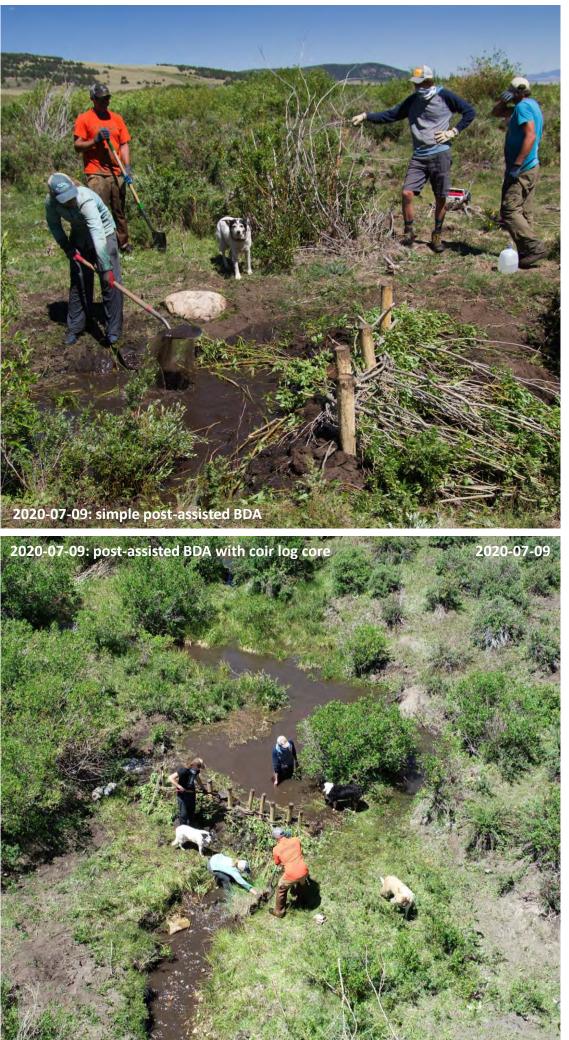
Drone image 2020-05-16 of upper reach during low flow, first season after treatment

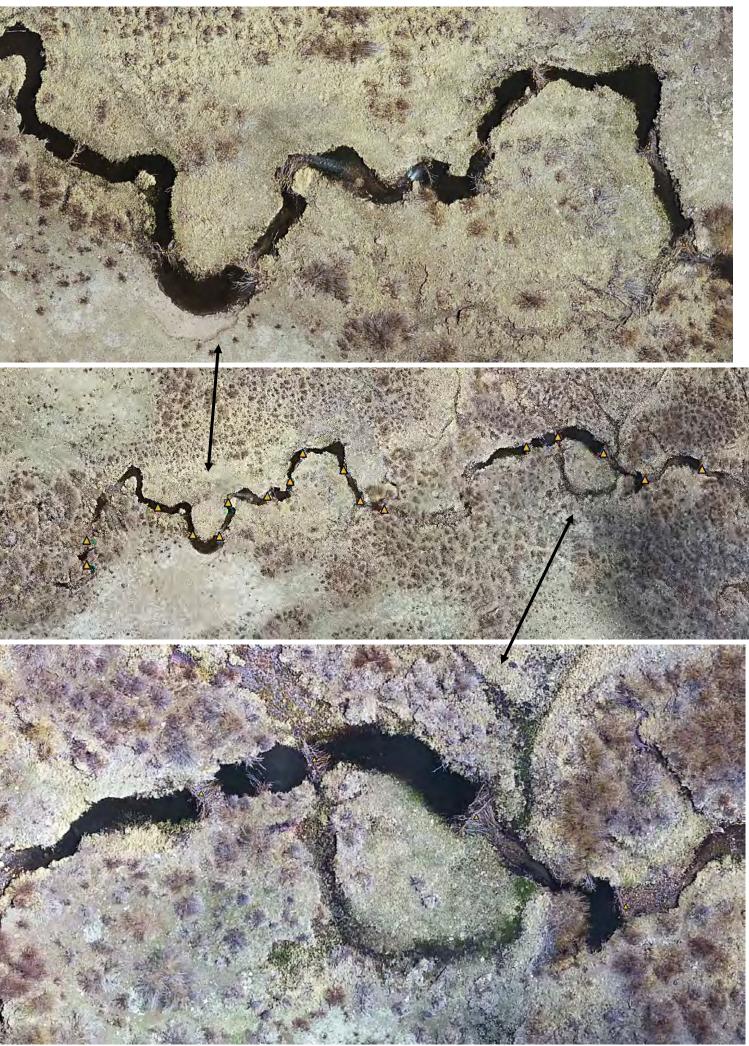
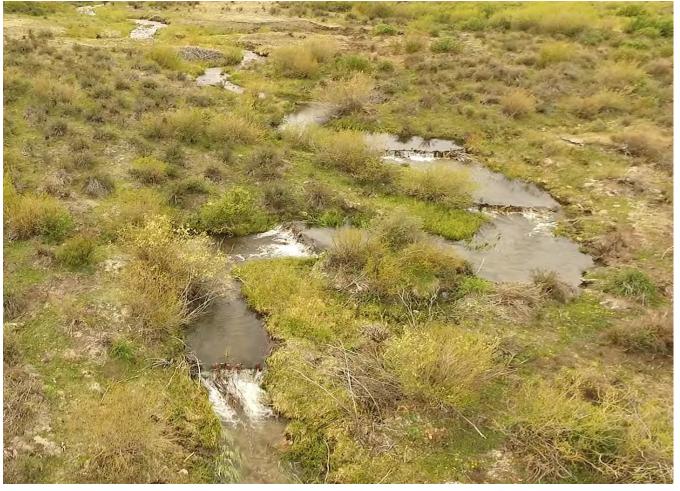
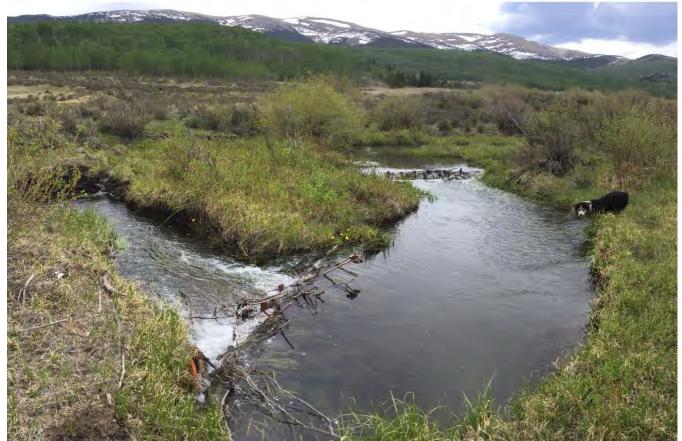
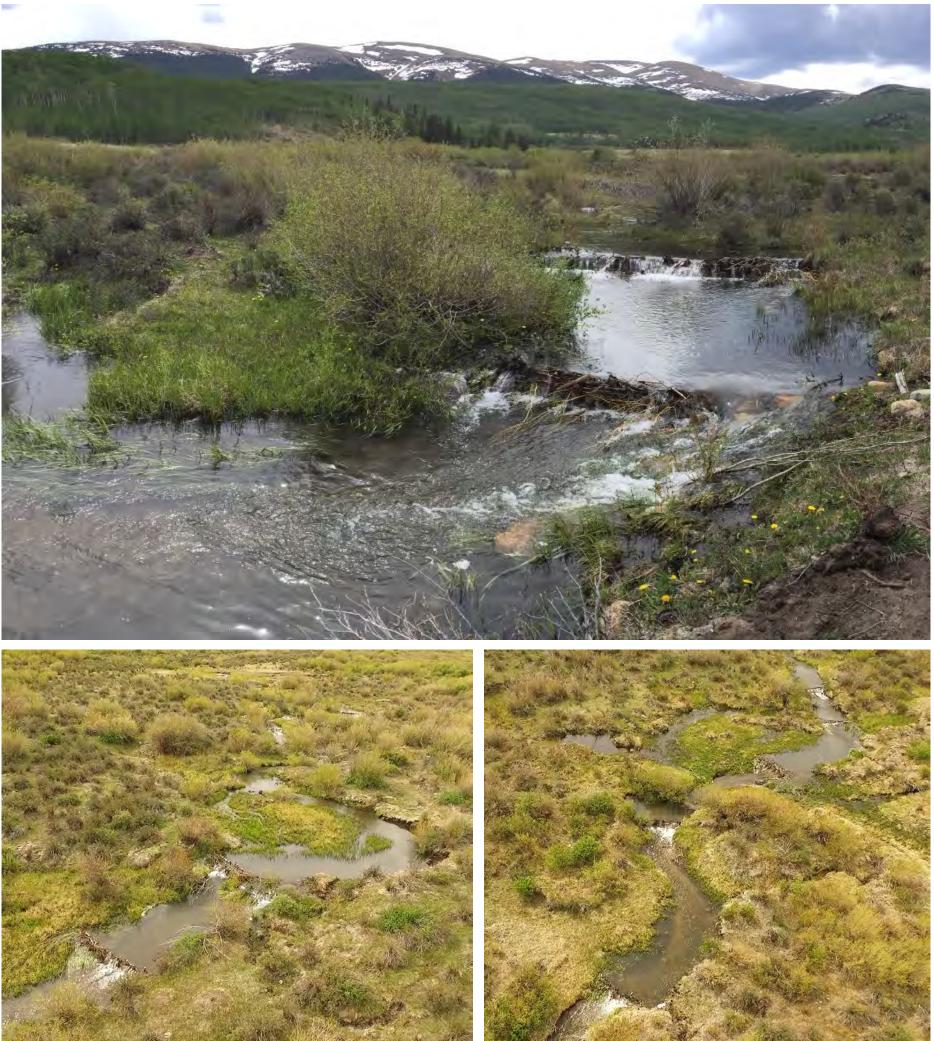
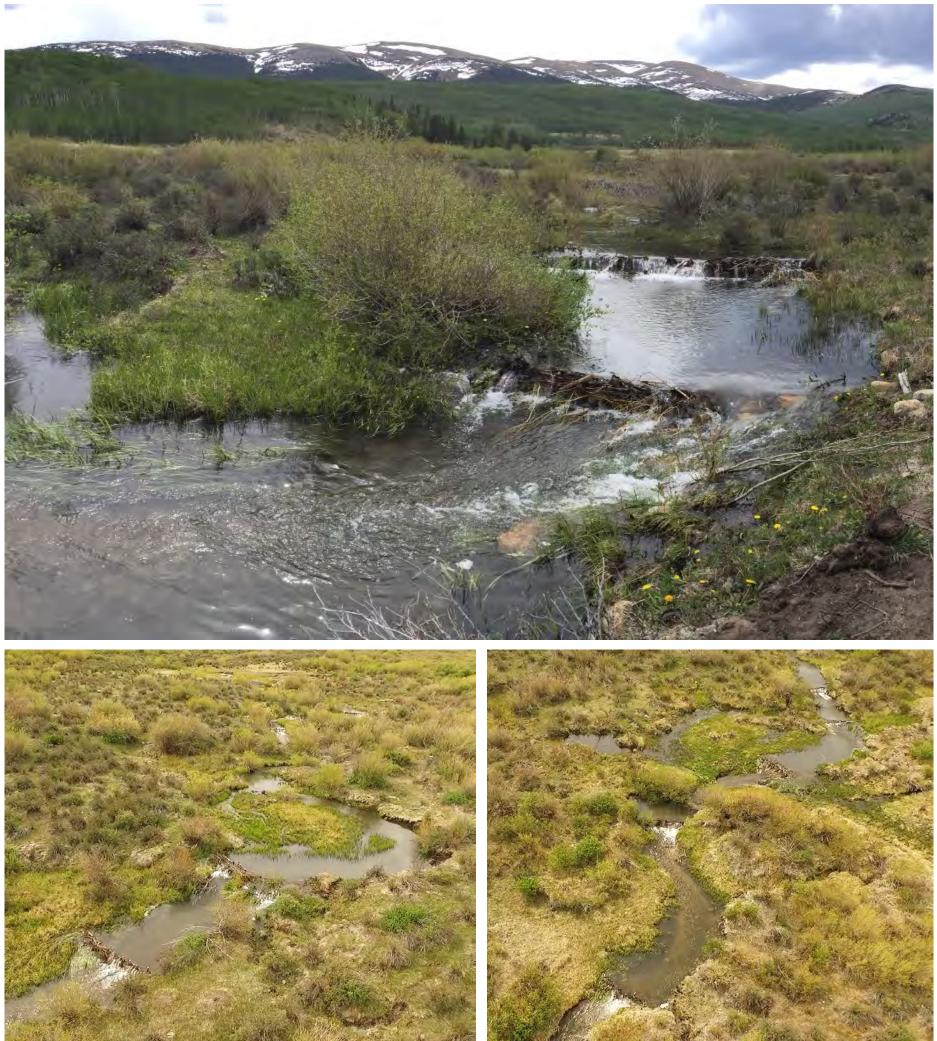
The mild runoff in spring of 2020 gave us a chance to see the performance of BDAs on Reach 2 (built in 2029) during moderate flow (approximately 8-10 CFS). Effective treatments raised stage and induced floodplain activation at this discharge. All these photos are from 2020-06-22.

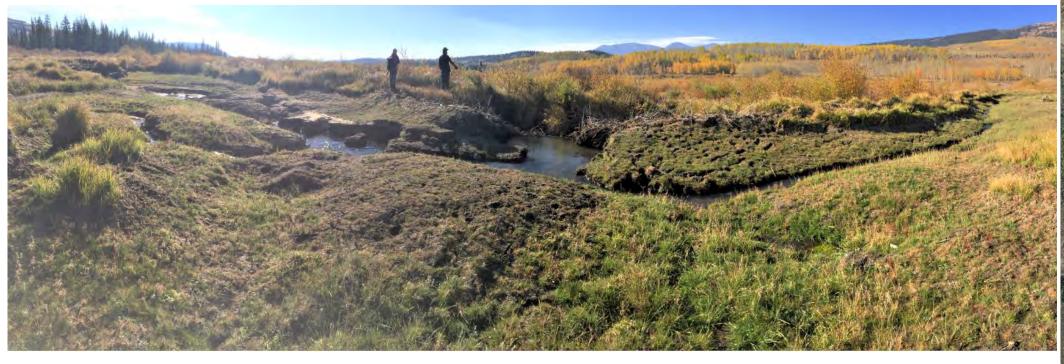
↑ Water levels dropped 2-4 feet across the wetland when beaver activity ceased and dams breached, rendering the Healey Ditch diversion point inoperable.

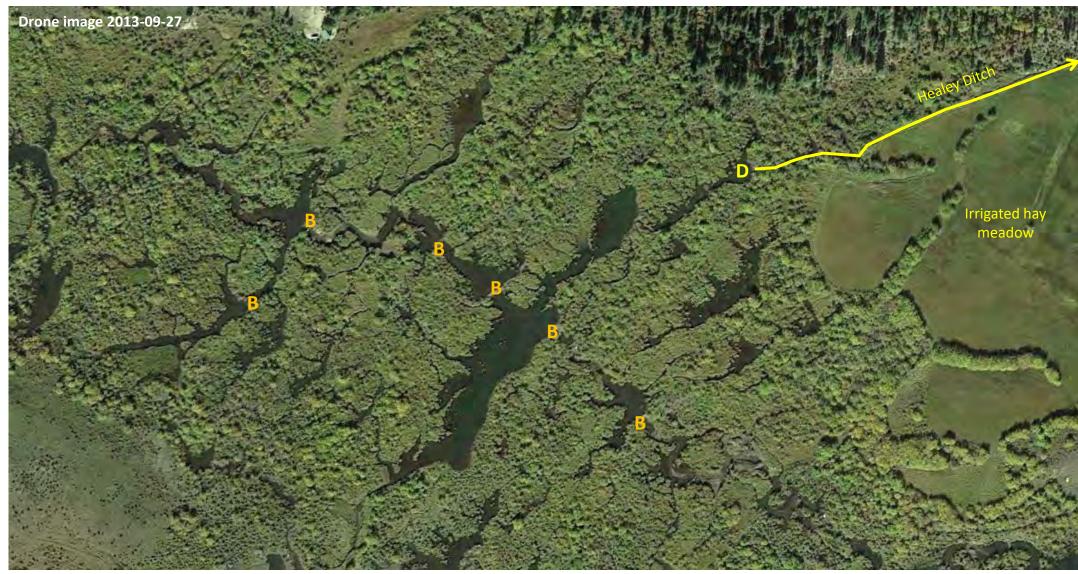
The problem

← Water for the Healey Ditch (an 11-CFS water right) has been historically diverted from the Twelvemile Creek beaver complex (at the point marked "D") as shown in this 2013 aerial image. When beaver activity decreased and beaver dams began breaching between 2014-2019, water supply to the diversion point dried up (see next sheet). As the beaver dams breached (at the points marked "B") a deeply entrenched channel formed, and this drained the wetland complex. By 2019, water was no longer dependably available at the diversion point (point D). Restoring water supply to the Healey Ditch is a top priority for Twelvemile Ranch and Colorado Open Lands. Restoring wetland habitat and preventing further habitat loss are priorities for both parties, as well. Maintaining functional headwaters streams and wetland is also important to the State, the County, and citizens who appreciate nature, fish, and wildlife. The drained wetland is therefore a problem on many fronts.

When it comes to water resources, water rights normally trump ecological benefits. So, the usual response to problems like this typically involve highcost engineering solutions aimed at controlling water supply to the ditch. We are offering an alternative solution. If the irrigation system worked fine while the beaver complex was intact; and if it failed after beaver activity subsided and beaver dams began failing; then perhaps restoring beavers and an active beaver complex can restore the irrigation system. This alternative is proposed as a way to service the water right while protecting and restoring wetland-the way it's been done for more than a century.
