Riparian Reconnect 2019-2020 Project Implementation Grant

Final Report

Tarryall Notch Ranch-Riparian Reconnect Stewardship and Restoration Project 2019-2020 project summary and initial response

Twelvemile Ranch-Riparian Reconnect Stewardship and Restoration Project 2019-2020 project summary and initial response

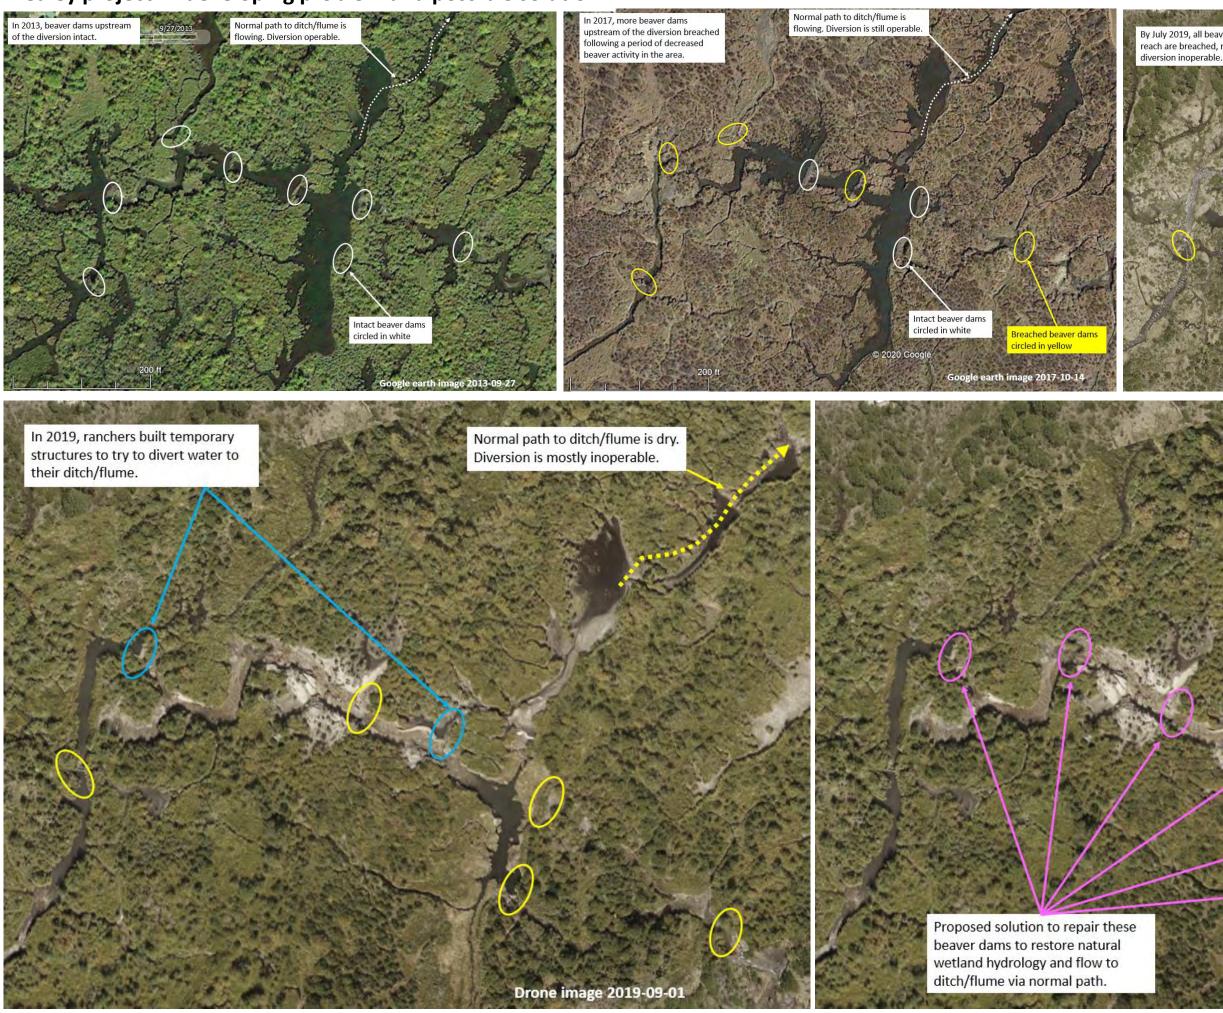
Healey project: A developing problem and possible solution

By July 2019, all beaver dams or reach are breached, making

↑ Critical dam on 2019-06-12 before it breached

↑ After the dam breached

Restore normal flow path to make diversion operable.
