# REDMESA RESERVOIR ENLARGEMENT FINAL FEASIBILITY STUDY

May 2020

SGM Project # 2018-148.001

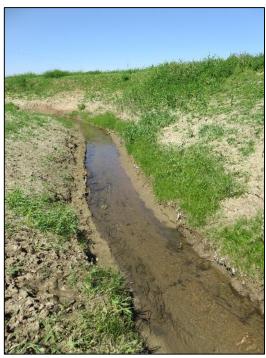
Photo 10. Hay Gulch channel towards upper end of reservoir bottom with narrow band of emergent wetland (at WDDF7).

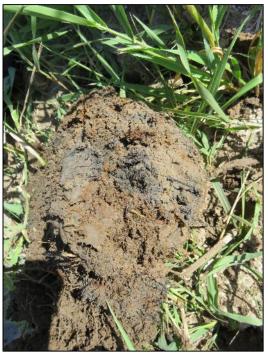
Photo 11. Distinct hydric soil at WDDF7 where the soil water saturated.

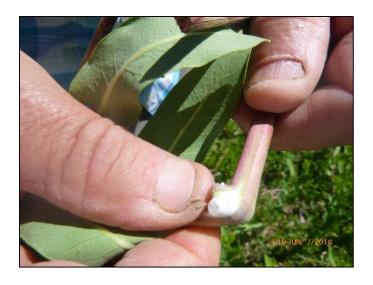
Photo 20. Broken stem of dogbane showing milky sap.

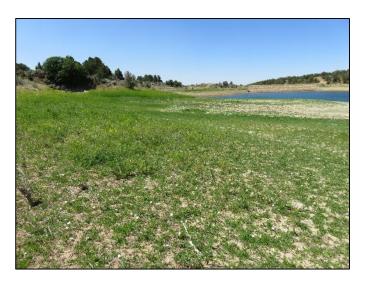
Photo 21. Area with leafy spurge and bindweed on west side of study area.
