**Telluride River Restoration & Tailings Remediation
Phase Two
Final Project Report**

**Prepared for Colorado Water Plan and Water Supply Reserve Fund Grants
Attn: Chris Strum**

June 11, 2021

Valley Floor Preservation Partners

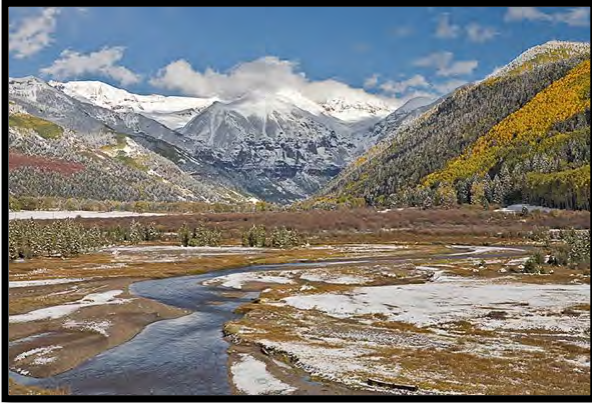
Before: Reach 6 flowed through unvegetated tailings.

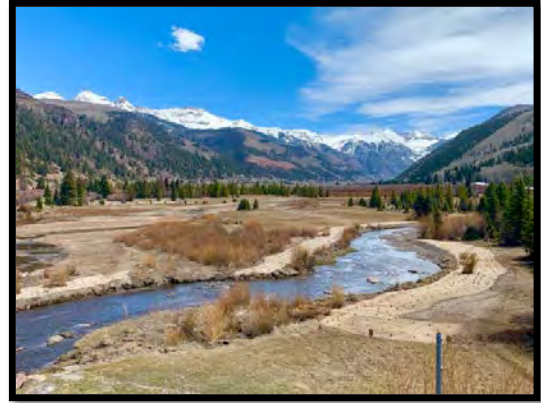
After: The restoration of Reach 6.
