RE: CWCB Water Plan Grant – Stewardship through Community Science **Final Report**  
(POGG1,PDAA,201900000060)

## 1. Project Summary and How the Project Was Completed

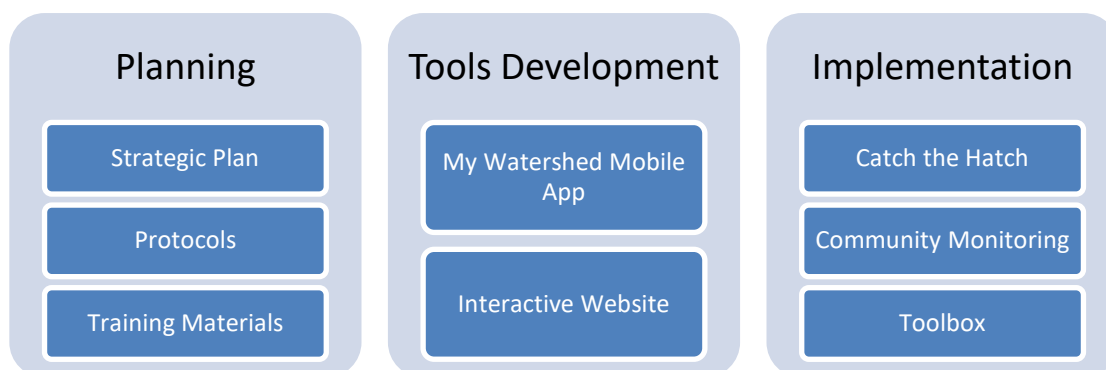
**Figure 1** shows the three key steps and associated deliverables involved in completing Stewardship through Community Science. Each of these is discussed in more detail within this report.

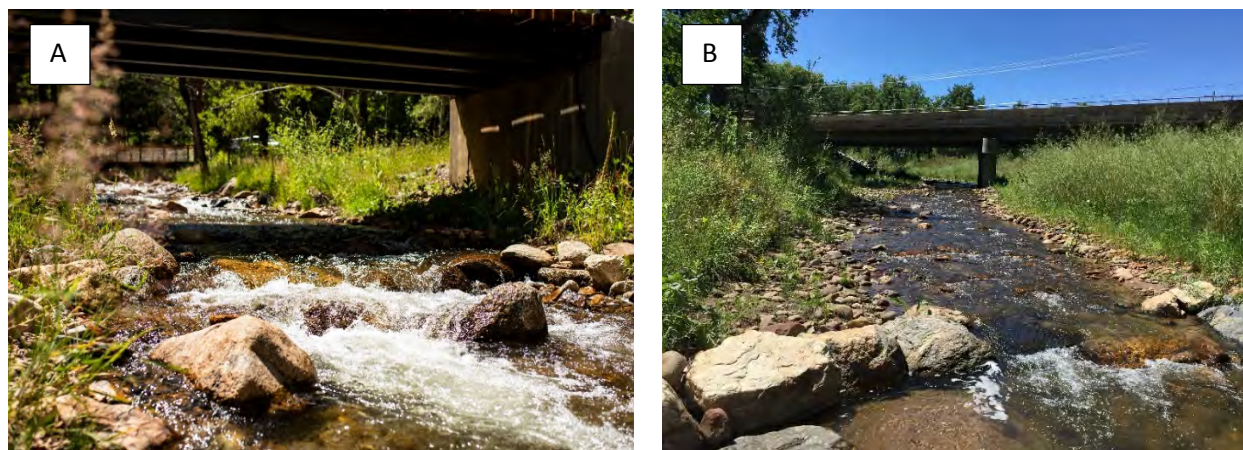
Figure 8. Pool forming cross sections at restored sites on Left Hand Creek. Photo description matches letter. A. boulder cross vane with immediate downstream pool at Upper Left Hand site in Left Hand Creek Watershed. Photo courtesy of OTAK, September 2019. B. constructed riffle at 63<sup>rd</sup> Street site in Left Hand Creek Watershed. Fine sedimentation visible immediately downstream of structure. Photo taken 8-28-2019.

In addition to design characteristics, our results for habitable percent pool area may reflect unanticipated adjustments to the original design intent. While we expect restored pools and pool-forming processes to fluctuate naturally, constructed pools were designed to maintain depth and area by promoting scouring during seasonal flushing flows (peak seasonal flows that transport sediment) (Figure 8). In 2019, we found that both 63<sup>rd</sup> Street and Upper Left Hand sites had shallow pools relative to habitable pool classification thresholds (1.0 foot in the Plains and 0.8 foot in the Canyons; Table 3). One possible explanation is that constructed riffles or boulder cross vanes, designed to promote scour and pools downstream, have adjusted or settled. We will start photo monitoring these specific locations to identify any visual adjustments that may be inhibiting pool-forming processes and require management action.

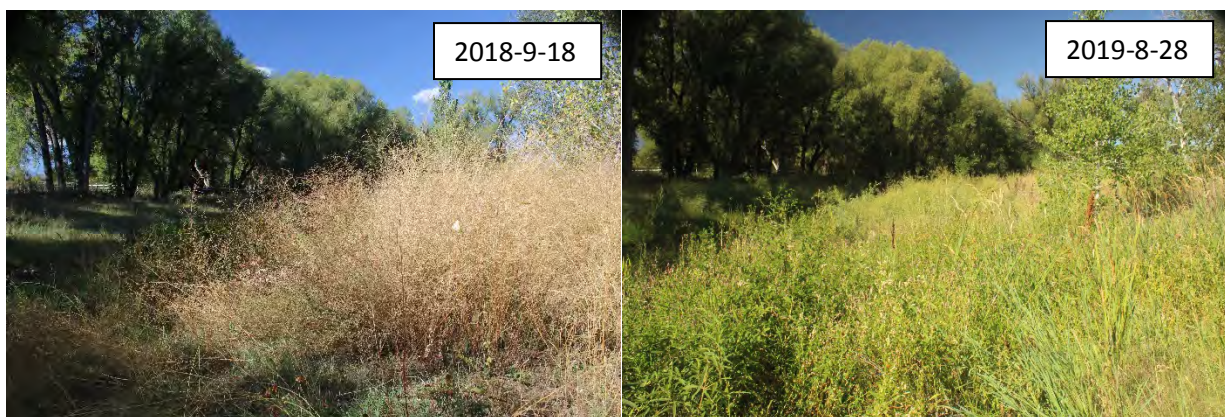
Figure 12. In 2019, wetland and riparian vegetation replaced dense sweet clover patches near the creek edge of 73<sup>rd</sup> Street restoration project in the Plains of Left Hand Creek Watershed. Sweet clover was mowed between photo dates in fall 2018.

Additionally, we implemented weed control and re-seeding best management practices during each growing season to aid native establishment (Figure 12). Though these activities are necessary to support revegetation efforts by ensuring that newly planted vegetation is not outcompeted by weeds, these activities also confound our annual monitoring results because different treatments are applied based on site-specific circumstances. For example, 73<sup>rd</sup> Street in the Plains had dense sweet clover patches in summer 2018. We mowed some of the denser areas and found that sweet clover was replaced by wetland and riparian vegetation in 2019 (Figure 12). If these activities were included in a sample plot, then our cover and richness data would reflect the weed control results in 2019.

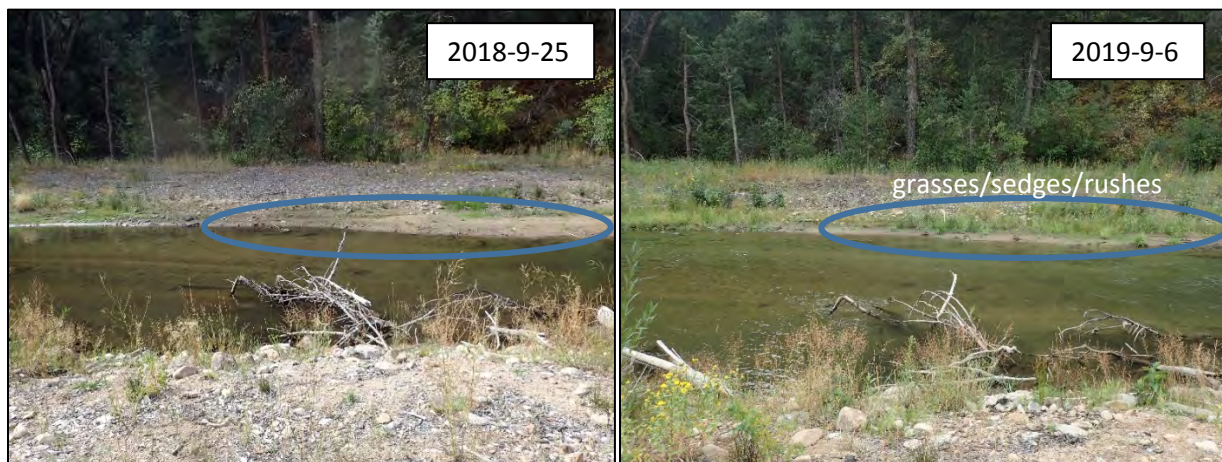
Figure 15. In 2019, wetland vegetation establishes in fine depositional area near the creek edge of Upstream Buckingham restoration project in the Canyons of Left Hand Creek Watershed.

deposition as flushing flows recede. In 2019, we observed an increase in naturally recruited wetland vegetation at depositional areas along the creek edge (Figure 15). Monthly precipitation may also impact overall survival and growth of riparian plants, especially throughout the summer and fall. While our restoration projects included drought tolerant grasses and forbs, in 2018 and 2019, total August precipitation was less than 0.25 inches (Figure 6). Low precipitation during the growing season, especially in the upland riparian zone, may increase mortality of establishing plants. Based on these results and observations, it is important to consider the vegetation characteristics along the creek edge and upland riparian zones separately.
