**UPPER GUNNISON RIVER
WATER CONSERVANCY DISTRICT**

**UPPER GUNNISON RIVER BASIN
WATERSHED ASSESSMENT AND MANAGEMENT PLANNING – PHASE I**

**Ohio Creek, East River, and the
Lake Fork of the Gunnison River Basins**

Final Report

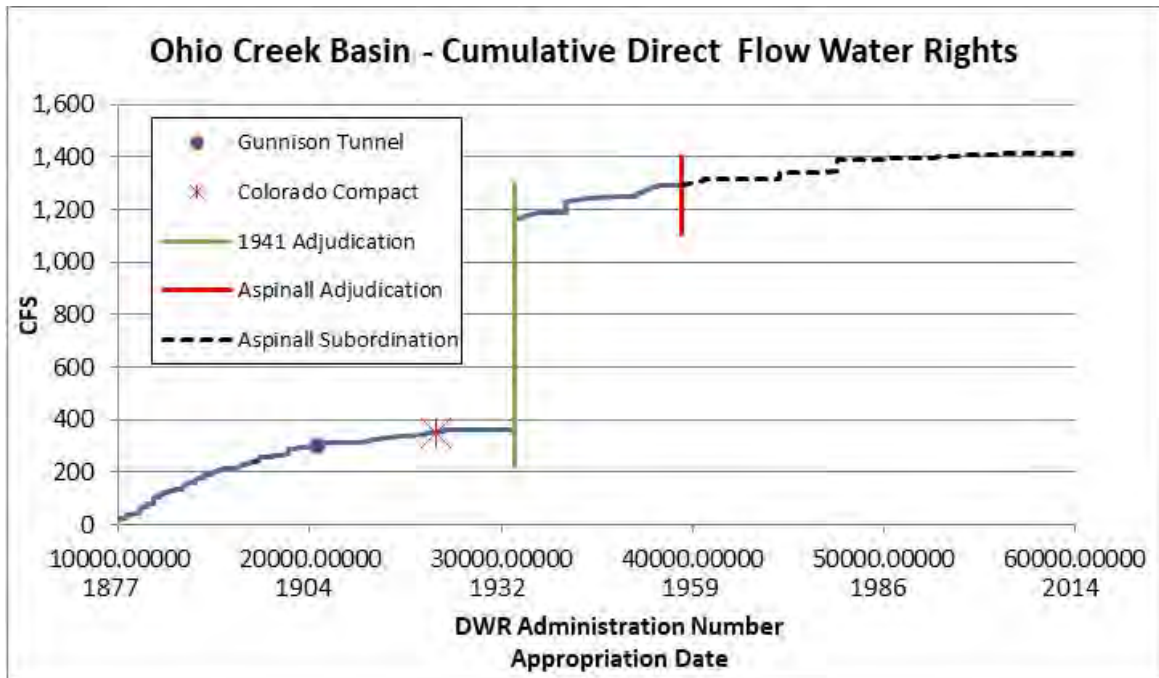
Figure 2-7: Ohio Creek Basin Cumulative Direct Flow Water Rights

Figure 2-7 presents the cumulative absolute direct flow water rights in the Ohio Creek Basin, highlighting major Basin adjudication dates and key water rights. The DWR Administration Number indicates the water right priorities based on both appropriation date and adjudication date and is used by DWR for administration throughout the state. As discussed in Section 1.1 of Chapter 2, and shown in the figure, Aspinall Unit water rights are subordinated to current and future Upper Gunnison River Basin water rights junior to the Aspinall Unit water rights up to 40,000 acre-feet of annual depletions.

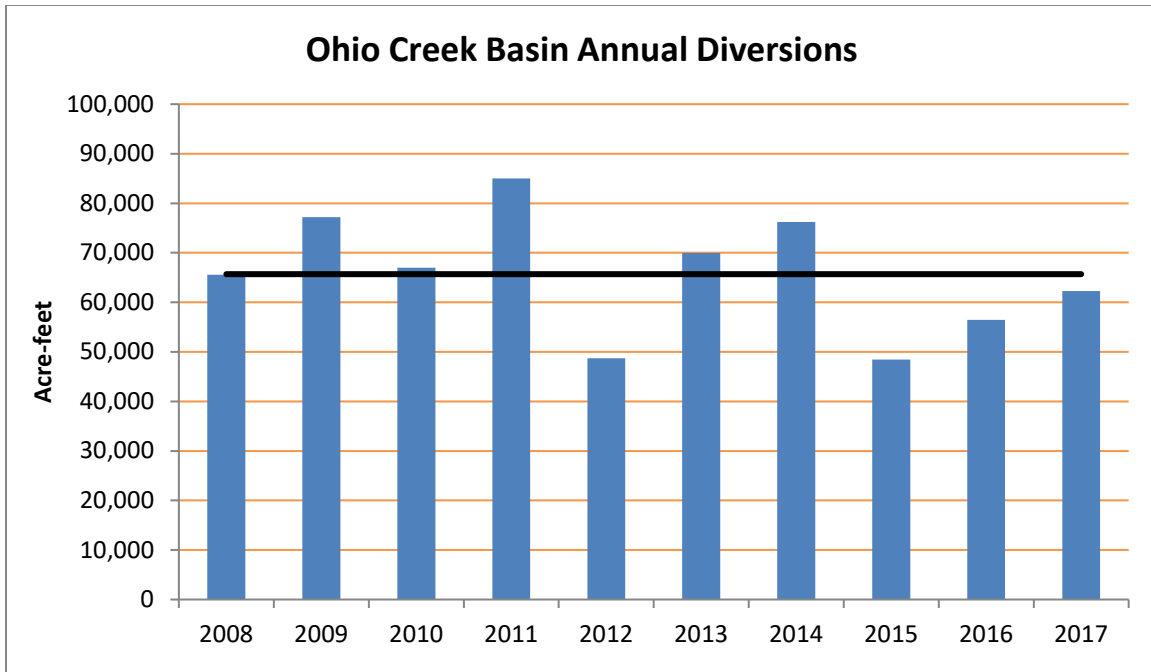
Figure 2-10: Annual Ohio Creek Basin Diversions

Despite their limitations, the diversion records maintained by DWR are the most comprehensive source of data for agricultural water use. There are 108 active ditches in the Ohio Creek Basin and, as noted above, 100 of those ditches have been associated with specific irrigated acreage. From 2008 to 2017, diversions for irrigation totaled an average of 65,700 acre-feet per year. Similar to streamflow, annual diversions are variable, as shown in Figure 2-10. On average, diversions in the Ohio Creek Basin are 40 percent greater than the streamflow measured at Ohio Creek at Mouth gage, highlighting the magnitude of irrigation in the Basin.

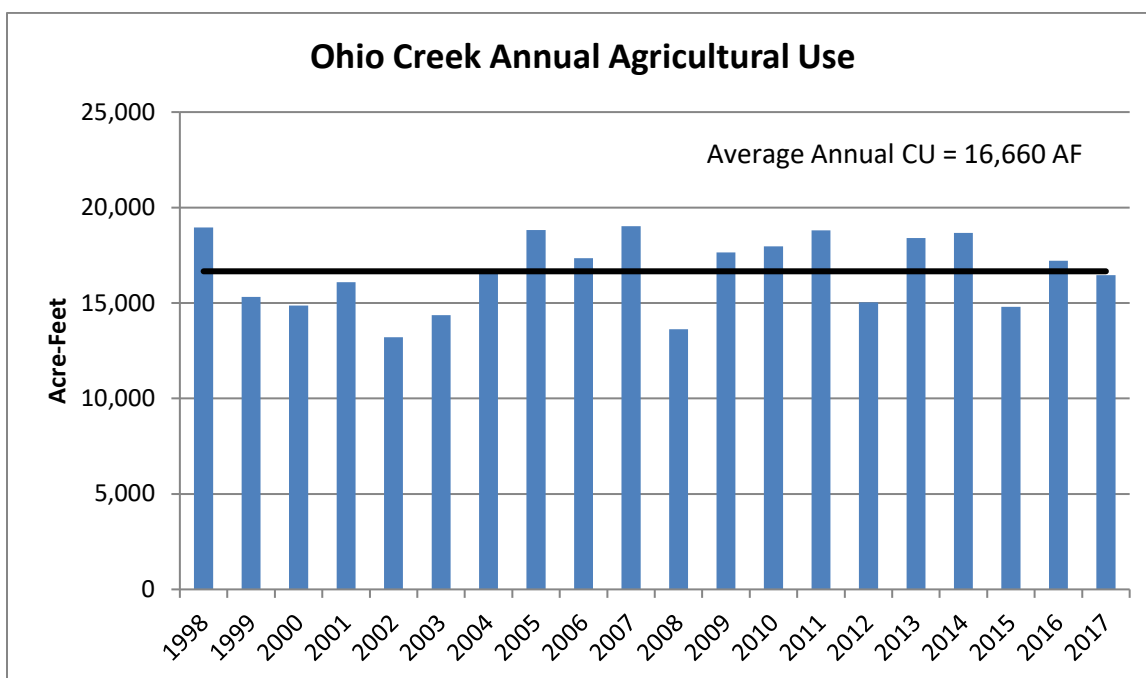
Figure 4-14: Annual Ohio Creek Basin Agricultural Water Use (1998-2017)

Irrigation water rights in the Basin exceed natural (un-depleted) flow in most months. As noted above, the soil and aquifer characteristics require that a significant amount of water be diverted above what is consumed by the crops. The excess diverted water returns to the river and is re-diverted by downstream ditches.

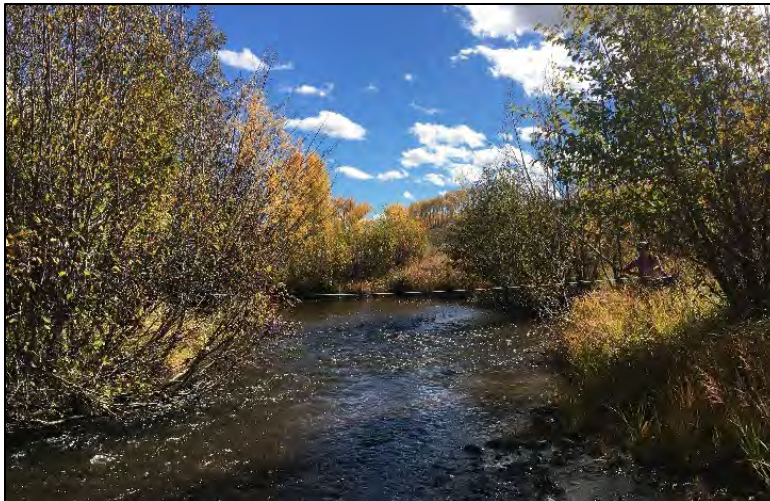
Ohio Creek immediately upstream of the confluence with Castle Creek during the field assessment in October 2018

In 2018 an R2CROSS assessment was completed in Ohio Creek immediately upstream of the confluence with Castle Creek. The R2CROSS output identified minimum flow rates of 5 and 6.5 cfs for winter and summer, respectively.

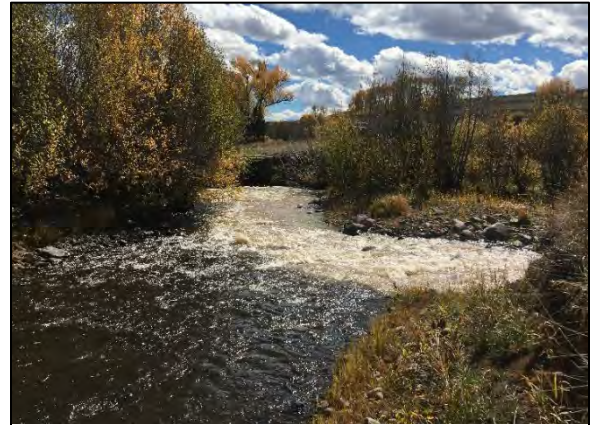
The confluence of Castle Creek and Ohio Creek following a large and intense precipitation event in the headwaters of Castle Creek in October 2018. The water in Castle Creek is sediment laden due to erosion and sediment transport following the storm.

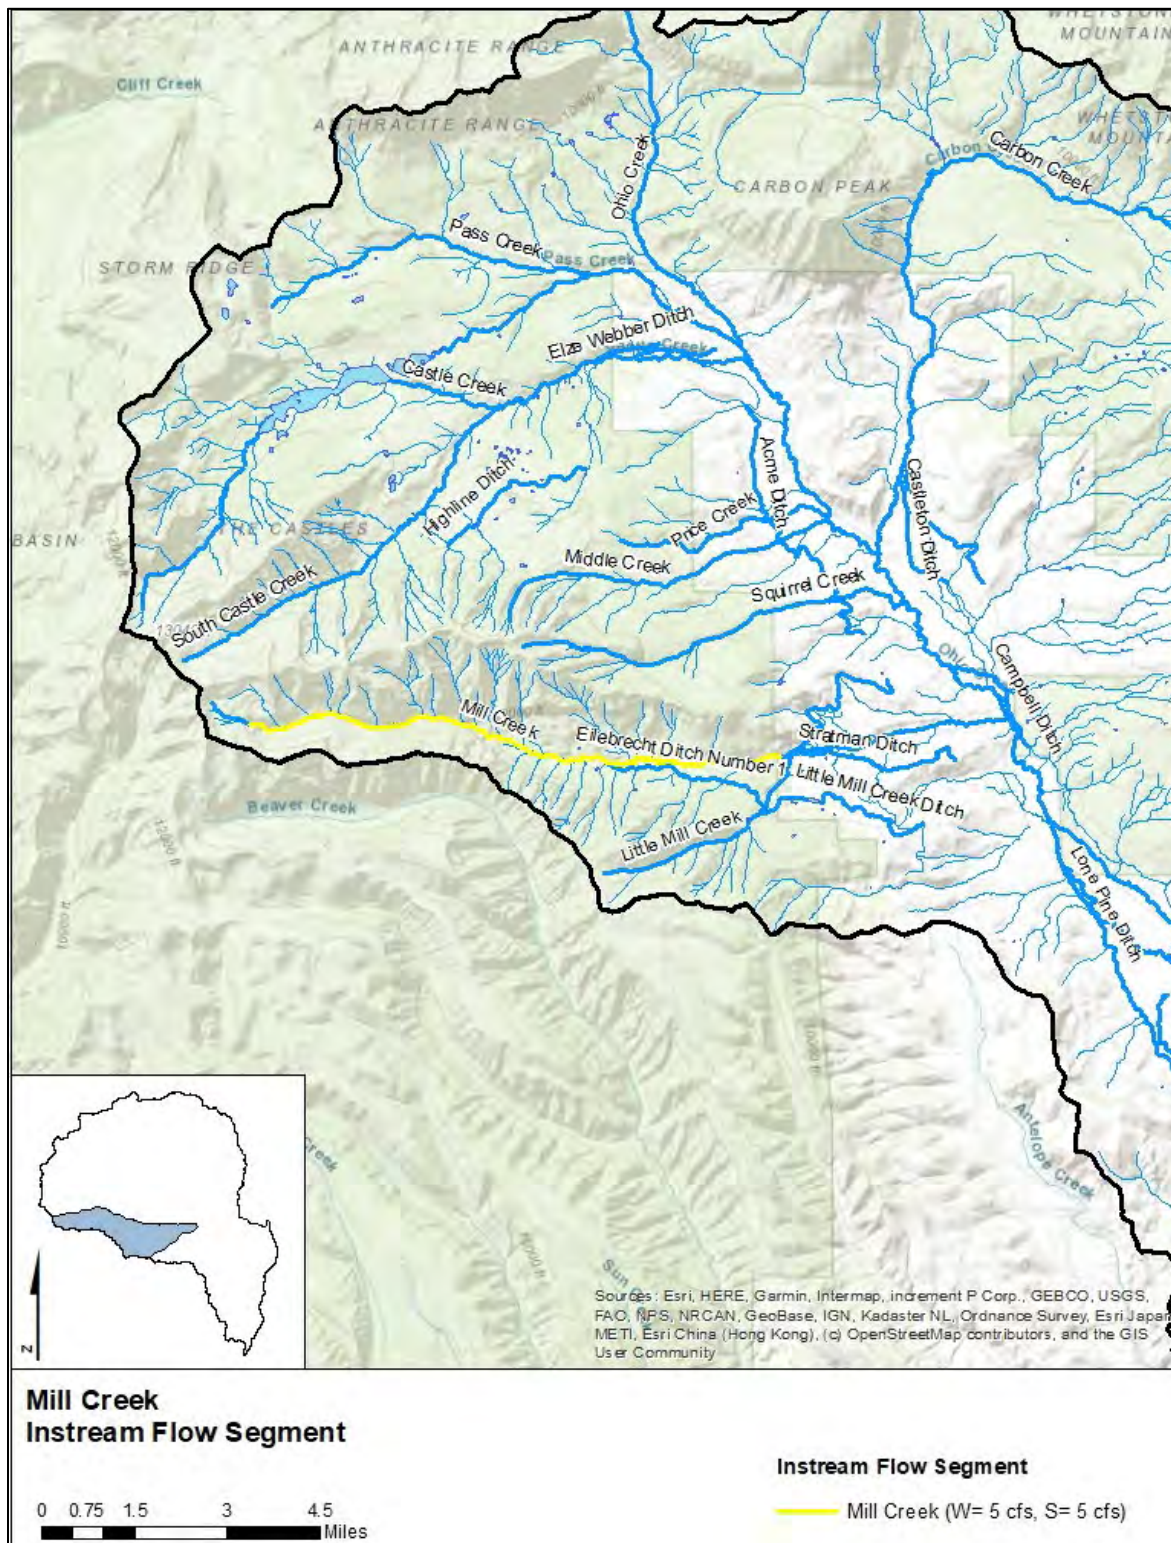
Figure 9-4: Instream flow water right for Mill Creek

Mill Creek from the headwaters to the Forest Service boundary on County Road 727 has a year-round instream flow water right of 5 cfs as shown in Figure 9-4. The instream flow proposals were developed by CWCB and CPW staff in 1980. The original proposal documents were not available during this assessment.

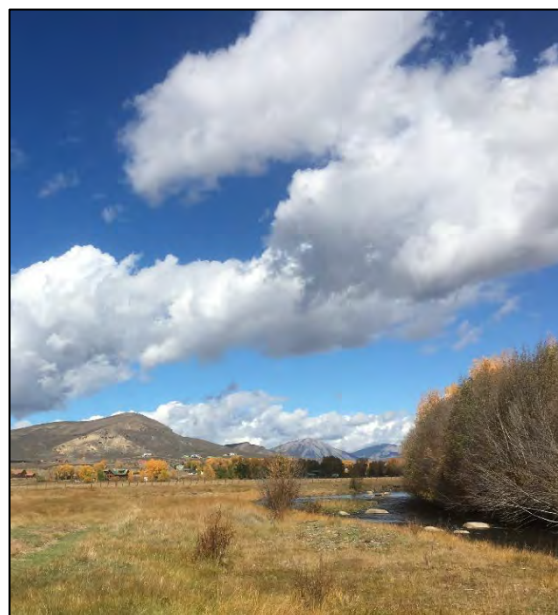
Ohio Creek downstream of Anchorman Bridge. Note the recent in-channel work including mechanically placed boulders. The channel form provides relatively good floodplain connectivity and the left bank in the photo is beginning to support willows in response.

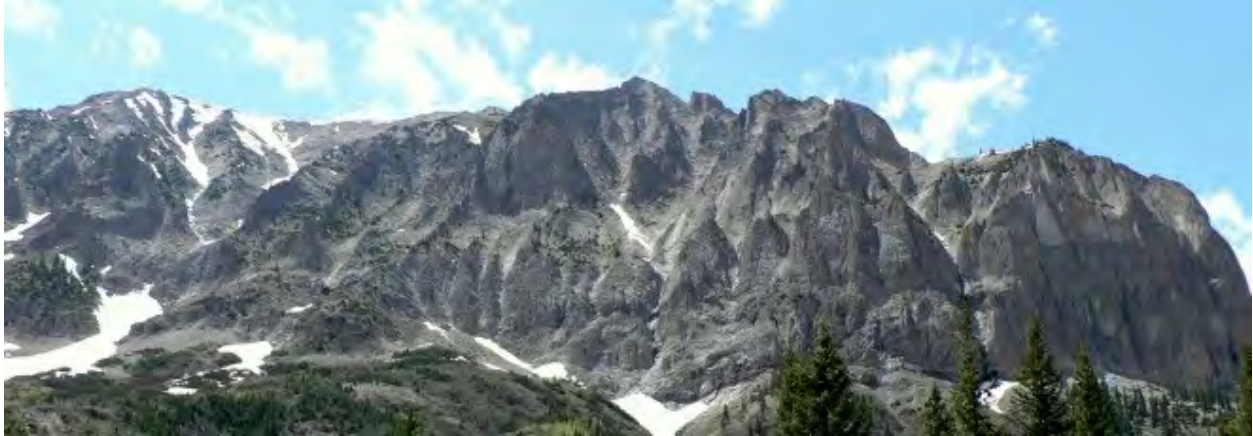
An imposing view of Gothic Mountain, as seen from the valley floor. The exposed bedrock on Gothic Mountain and other peaks are impervious surfaces that can rapidly deliver ample amounts of water to drainages below the peak. These natural conditions make mass erosion events more likely. Photo from the RMBL archives.

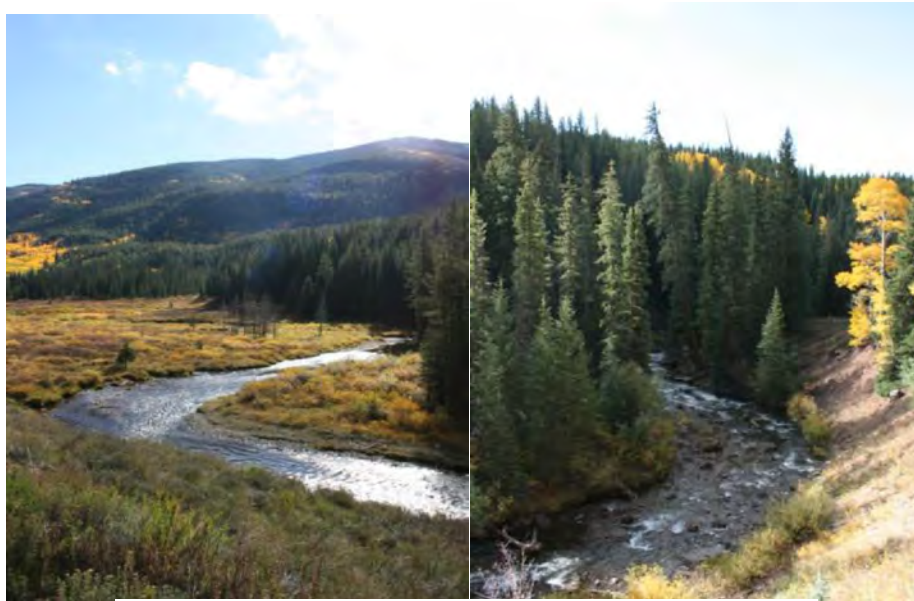
Photo 7-1: East Brush Creek. Left photo is a view upstream and includes healthy riparian wetland. The right photo is a downstream view.

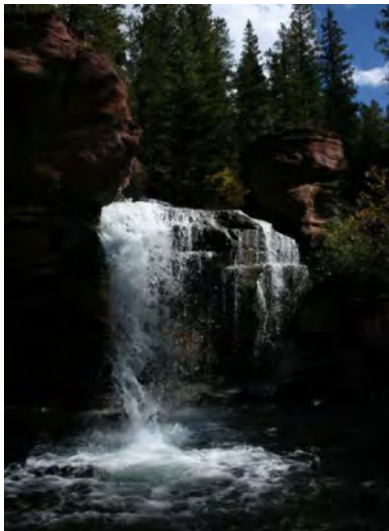
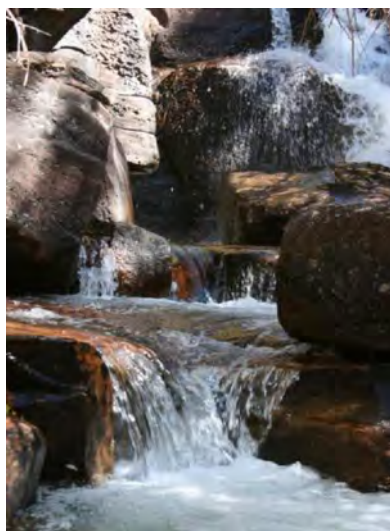
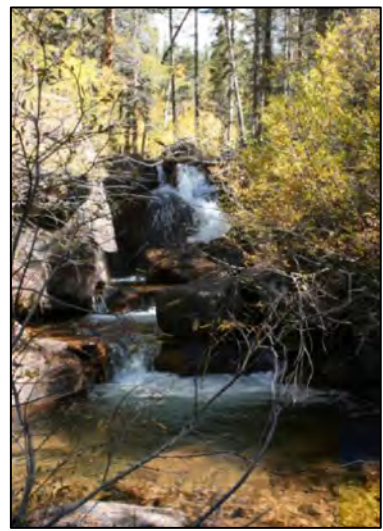
Photo 7-2. East Brush Creek above the confluence of East and Middle Brush Creek in mid-September. Notice the pools and small waterfalls which provide both high-quality habitat and breathtaking scenery.

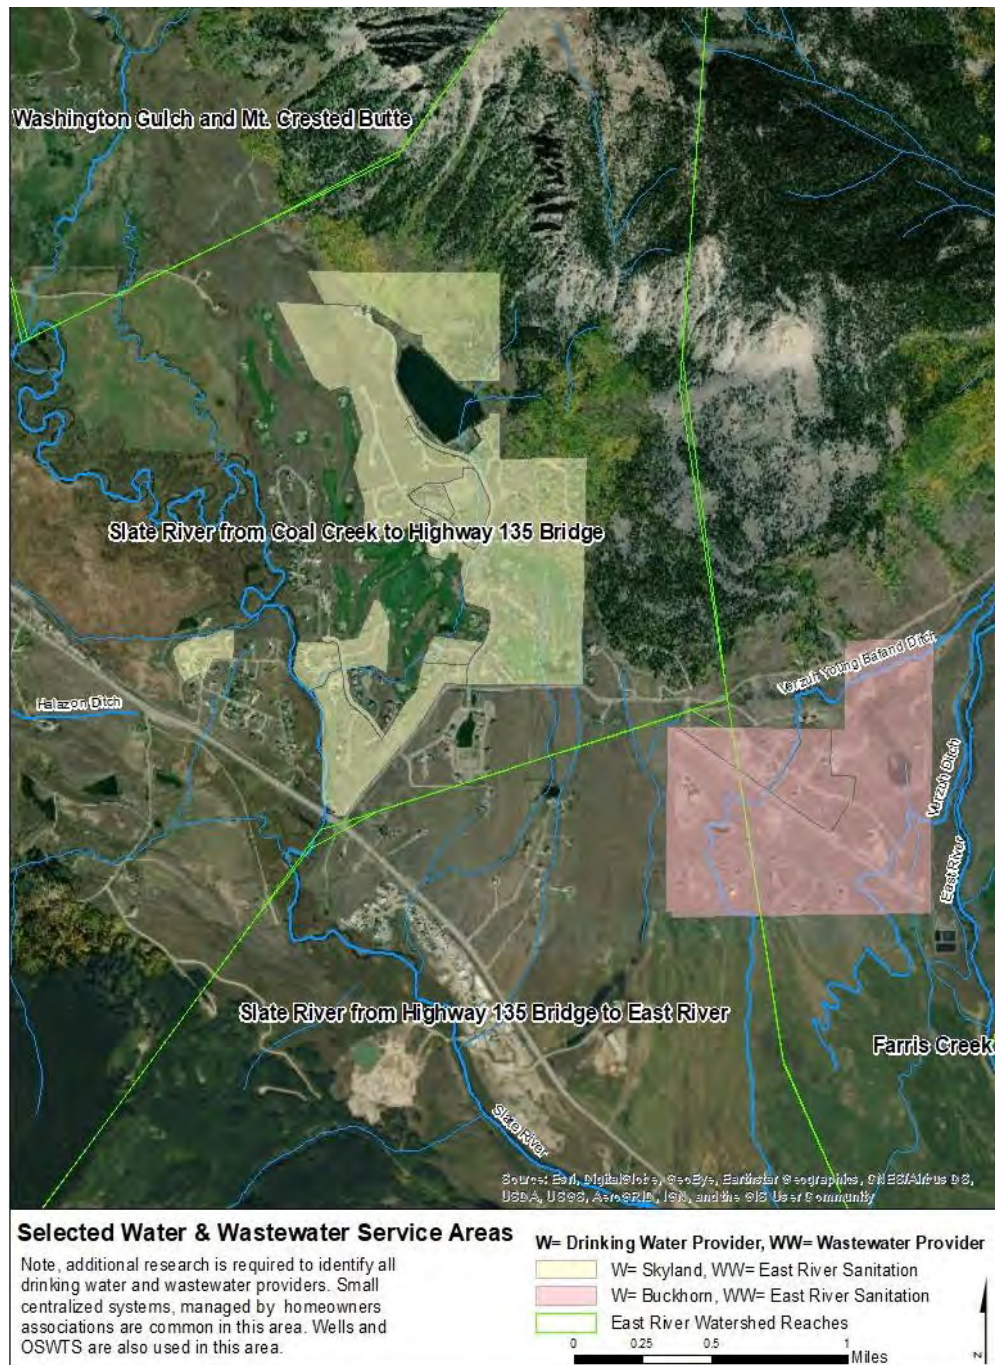
Figure 9-3: Major water and wastewater providers in the vicinity of Highway 135 and Brush Creek Road. This area includes portions of three reaches including the Slate River from Coal Creek to Highway 135, the Slate River from Highway 135 to the East River, and the East River from Brush Creek to the Slate River.

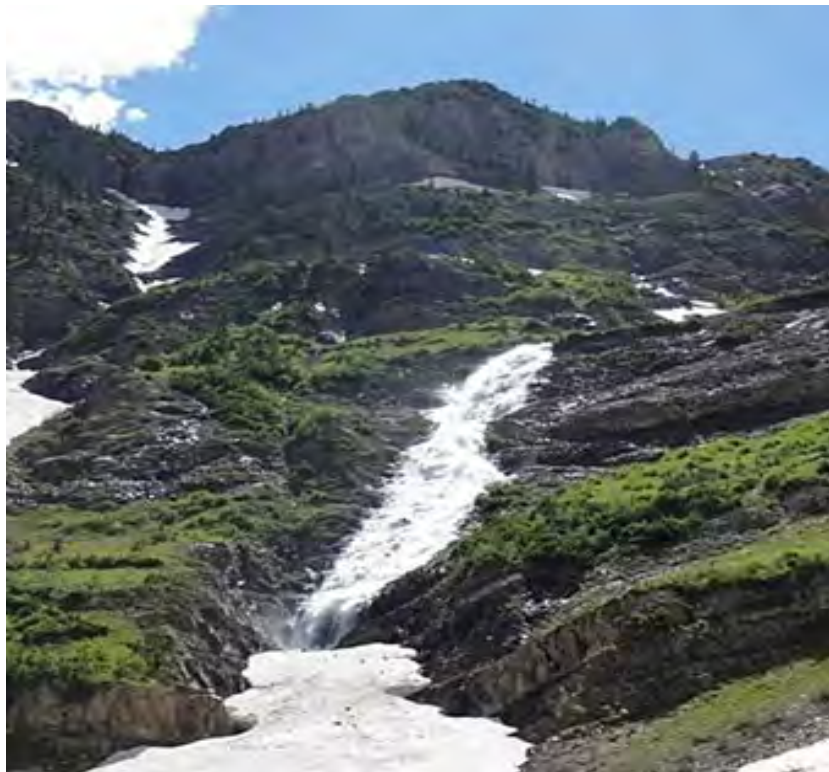
Photo 11-1: Baxter Creek (a local name for the unnamed tributary that drains Baxter Basin) upstream of the confluence with Poverty Gulch in July 2011. The extremely steep slopes and loose bedrock naturally deliver sediment to the valley floor.

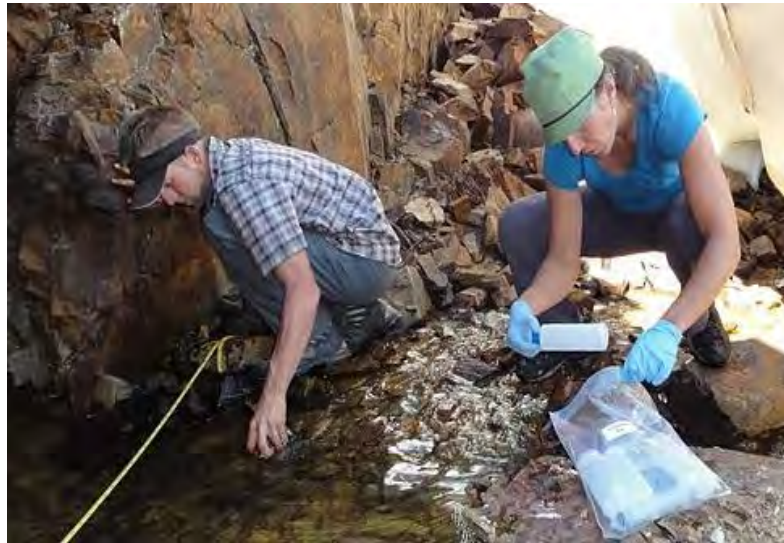
Photo 11-2: Staff from DRMS and a CCWC intern prepare to collect a water quality sample from the Augusta Mine portal in July 2011 as part of a collaborative watershed-wide sampling event to address data gaps.

Prospect pits and other small mine features are common in the headwaters of the Slate River and Poverty Gulch. Historic mining in Poverty Gulch is well-documented. The most notable mines in this reach occur in Augusta and Baxter Basins which are tributary to Poverty Gulch. The drainage from the Augusta Mine is substantial, however, metal concentrations are relatively low and typically attain the chronic standards used to protect aquatic life.

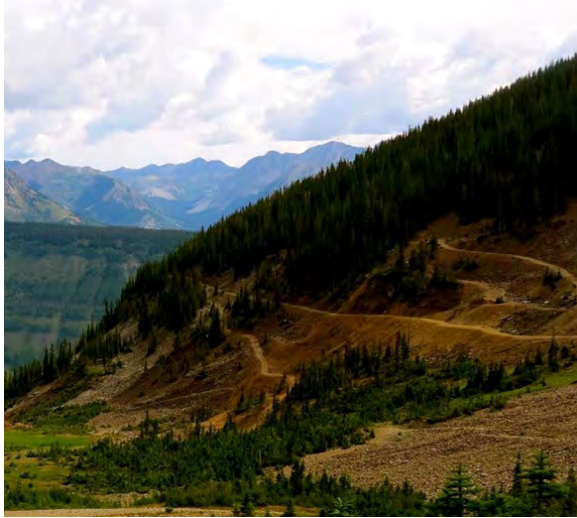
Photo 12-1: The Daisy Mine Complex and Gunsight Pass Road in Redwell Basin, a tributary to Oh-Be-Joyful Creek

Photo 12-1 shows the Daisy Mine, on the East side of Redwell Basin, which once produced silver, copper, and zinc. Exploration began in the late 1800s and the mine operated sporadically until the 1970s. The mine was abandoned prior to the adoption of modern reclamation laws. The mine has multiple levels of underground tunnels with several portals. Gunsight Pass Road traverses between the upper mine portals and the collapsed drainage tunnel. Ore was transported to the Gunsight Processing Area. Much of the mine waste is located near the collapsed tunnel and Gunsight Pass Road.

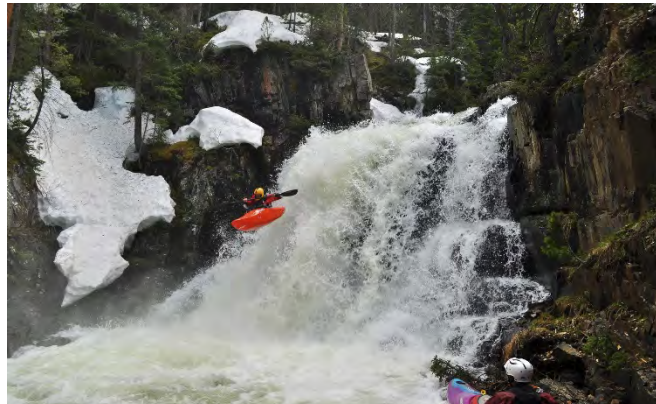
Photo 12-2: Expert kayakers enjoying Oh-Be-Joyful Creek during peak flow in late June 2019. Photo courtesy of the Oh-Be-Joyful Race.

River. The technical creek run features several large waterfall drops, as shown in Photo 12-2. An increasingly popular race, hosted by the Western Colorado University Whitewater Club, occurs when there is sufficient runoff. Recreational use is summarized below.

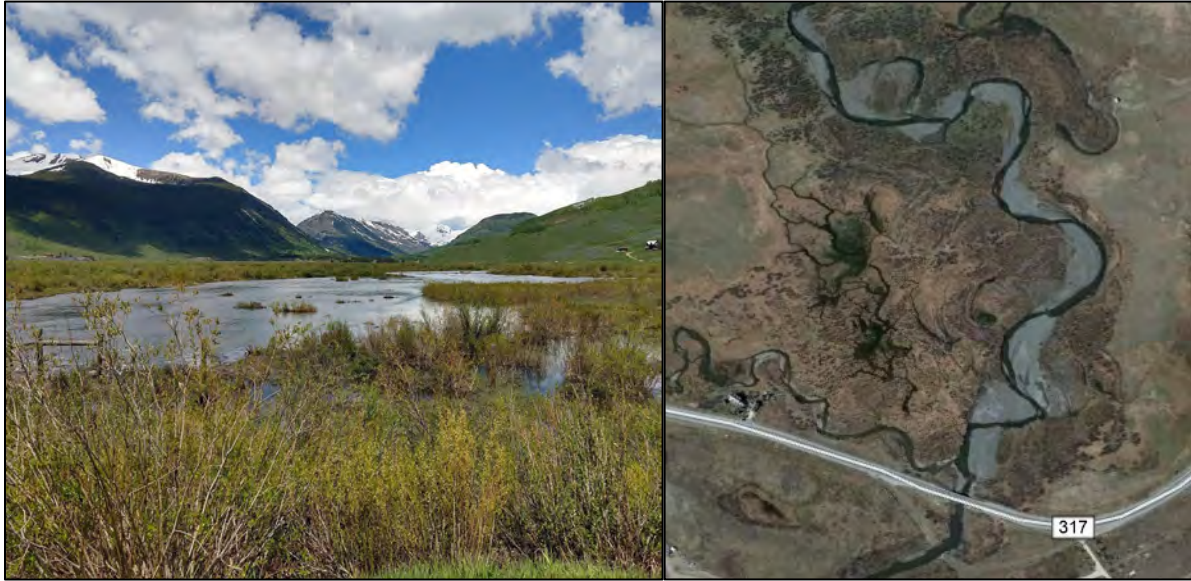
The photo on the left shows the Slate River immediately upstream of County Road 317 during peak flow. Note the pooled water flooding into the wetlands. The loss of velocity contributes to the massive gravel bars visible in the aerial imagery in the right image (image courtesy of Google Earth). The depositional area attributed to the bridge extends approximately half a mile upstream. These gravel bars may contribute to stability issues up and downstream of the bridge.

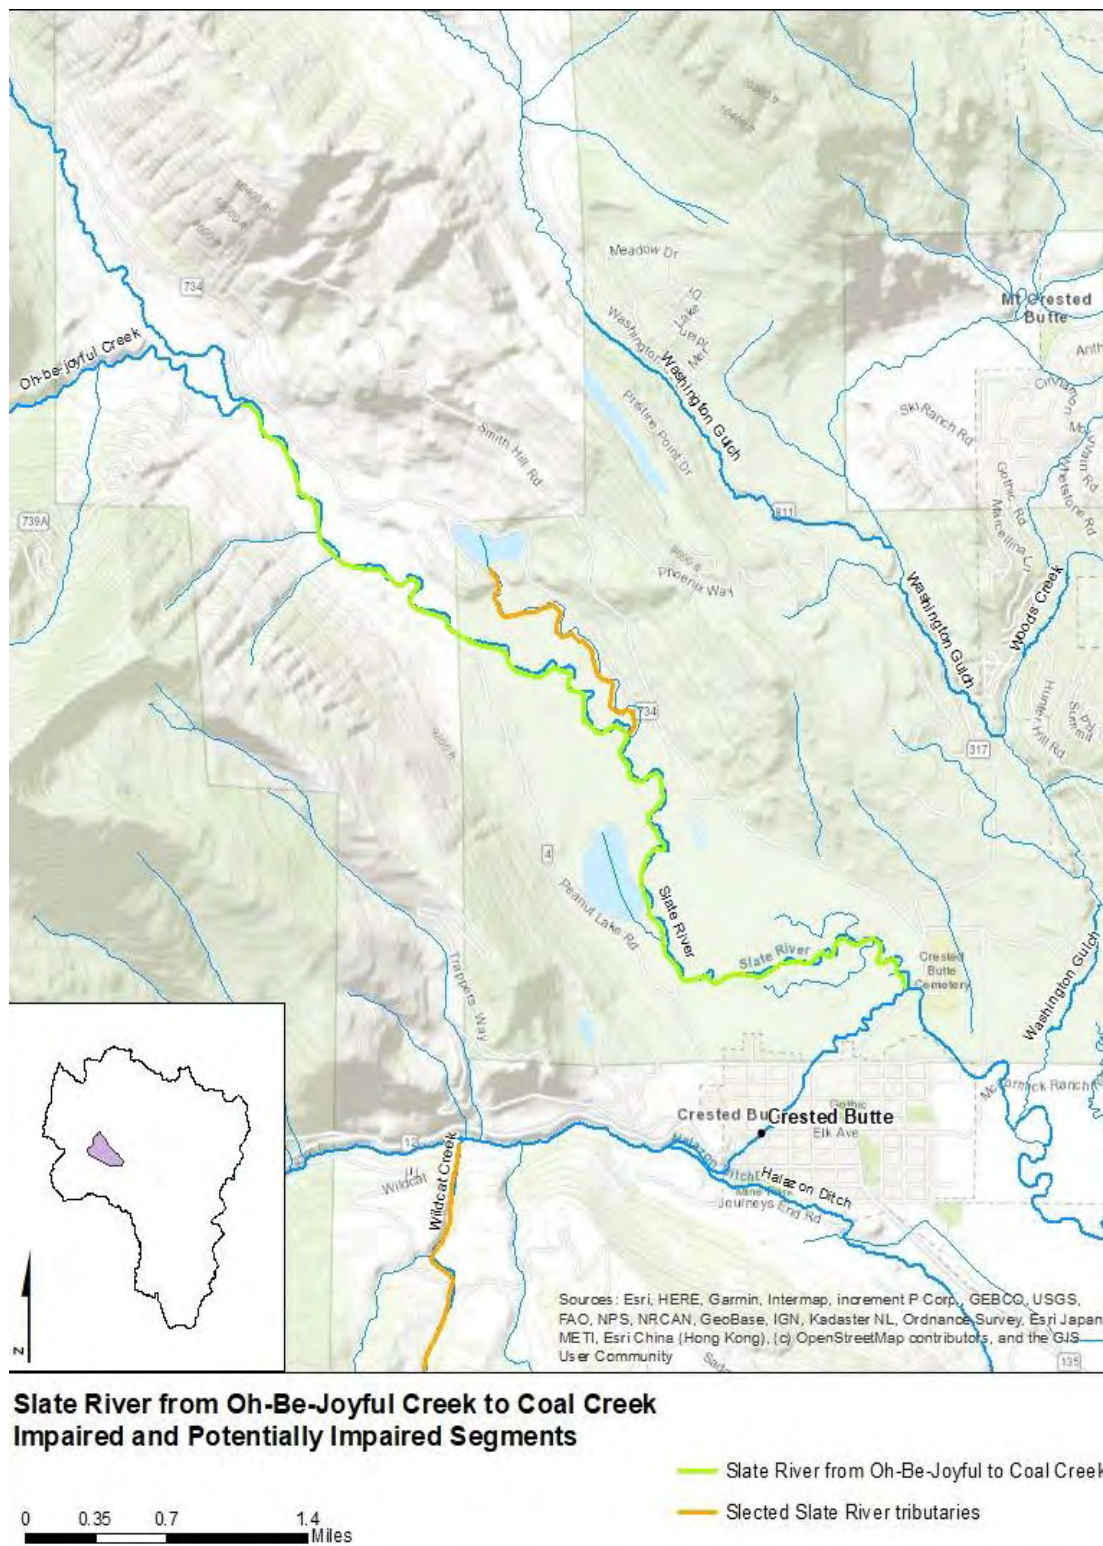
Figure 13-3: Impaired and potentially impaired stream reaches on the Slate River from Oh-Be-Joyful Creek to Coal Creek

Metals that originate from abandoned mines and natural features impair water quality in Redwell Creek. Redwell Creek delivers metals to Oh-Be-Joyful Creek. Conservatively, Redwell Basin is the origin of 85 percent of the pollution in the Slate River Watershed upstream of Coal Creek. Although Oh-Be-Joyful Creek provides dilution, it is evident that metals that originate in Redwell Creek reach the Slate River. The Slate River from Oh-Be-Joyful Creek to Coal Creek is listed as impaired for aquatic life use for arsenic, lead, and zinc and potentially impaired for cadmium, Table 13-2; Figure 13-3. Unnamed tributaries to the Slate River in this reach are also listed as impaired for arsenic. The samples that indicated impairment for the Slate River tributaries were collected in tributaries on other reaches.

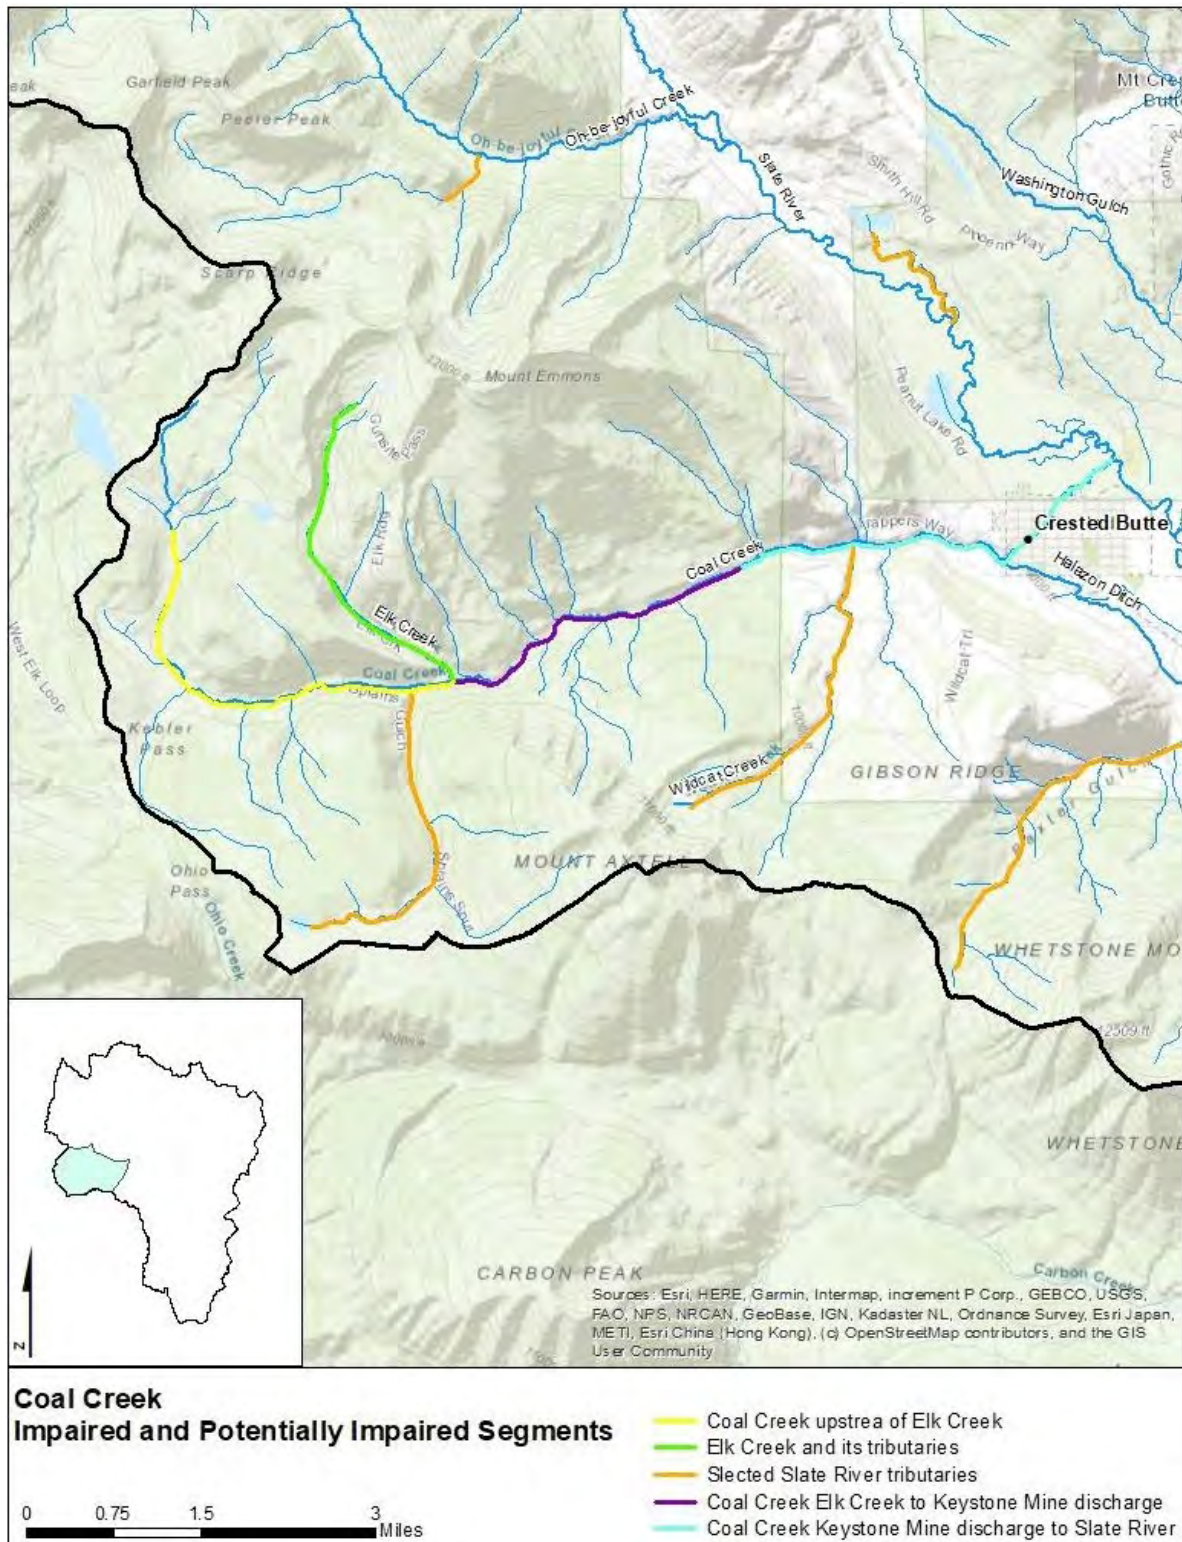
Figure 14-5: Impaired and potentially impaired stream reaches in Coal Creek

Due to the multitude of interactive metal sources summarized above, several portions of Coal Creek are considered impaired for a variety of metals. The headwaters of Coal Creek, Splains Gulch, Red Lady Watershed, and other tributaries are listed as impaired for total recoverable arsenic, as shown in Table 14-2 and Figure 14-5. This impairment has been confirmed in multiple samples and is likely attributed to a combination of mineralized geology and historic abandoned mine sites.

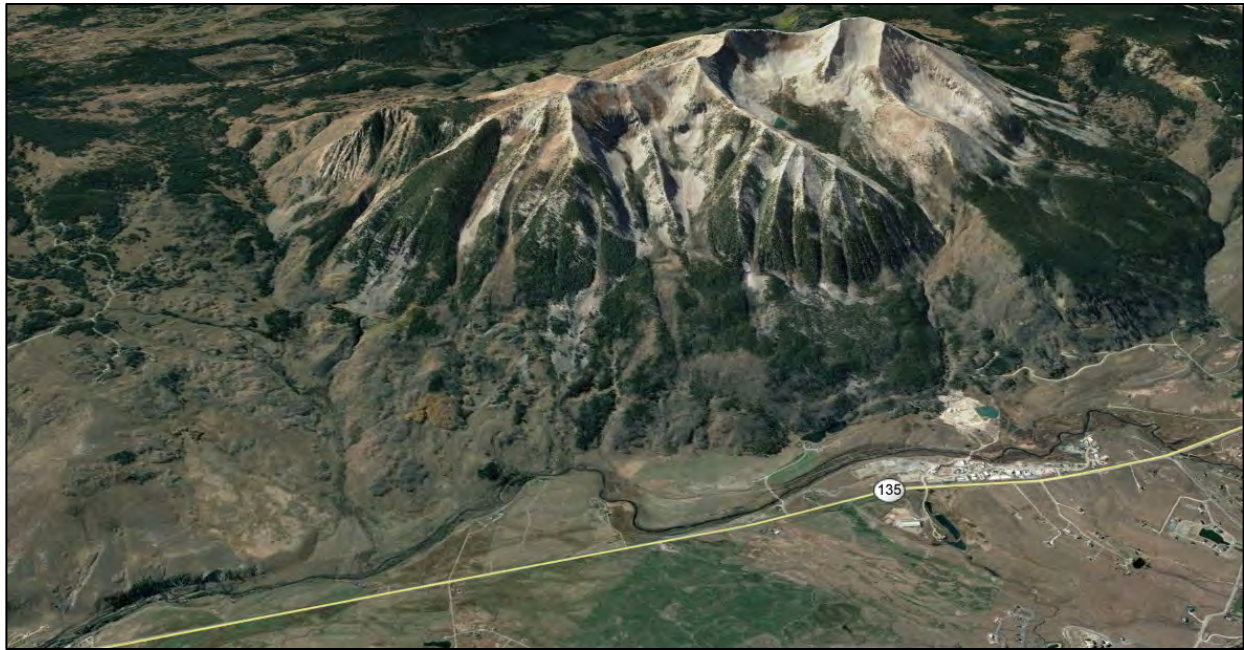
Photo 16-1: Over time the Slate River has winnowed a course through glacial sediment deposits, large alluvial fans, and landslide debris from Baxter Gulch and unnamed drainages from Whetstone Mountain. The complex topography of Whetstone Mountain is due, in part, to natural and very active erosional processes that deliver large volumes of sediment to the lower portion of the mountain and the valley floor.

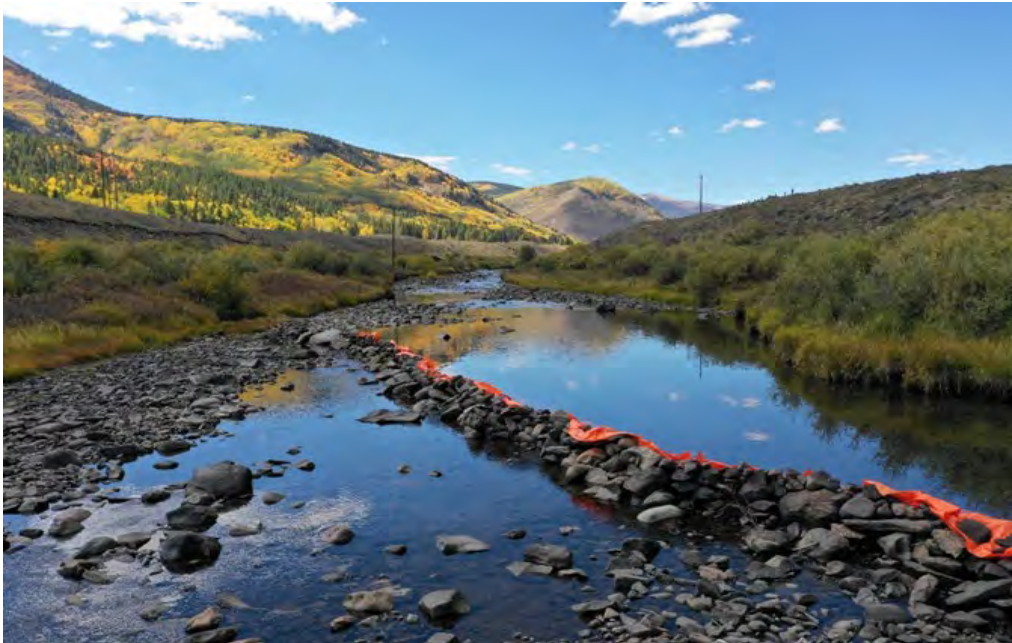
Photo 16-2: A large diversion in the Slate River caused substantial dry down during early fall 2018. The diversion structure dried a portion of the channel (see left side of photo) and the push-up dam prevented fish passage. The diversion structure also increases labor costs for the irrigator.

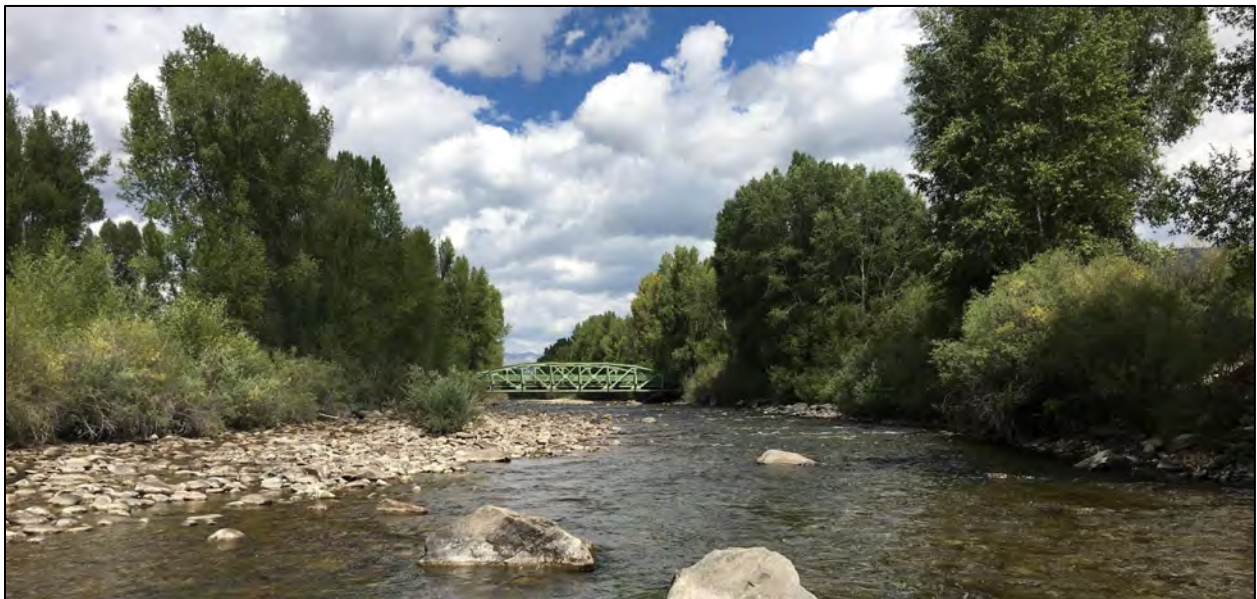
Photo 19-1. The East River downstream of Roaring Judy Road Bridge on August 27, 2018. The flow measured during the assessment was 65 cfs. The average daily flow for the East River at Almont is 158 cfs. The 2018 flow was just 41 percent of average.

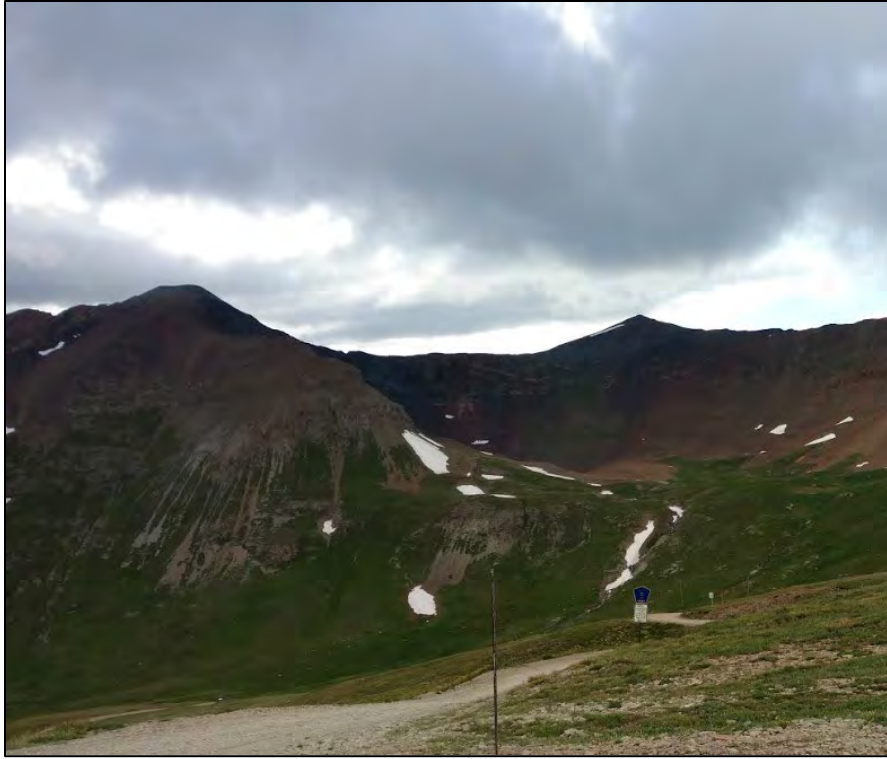
*Photo 5-1: View from the Summit of Cinnamon Pass.
Steep hillslopes covered with evidence of mass erosion.*

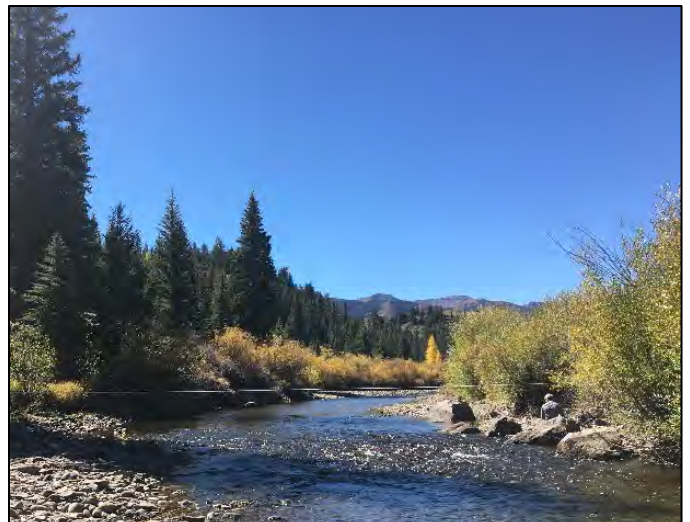
Photo 5-2. The Lake Fork River approximately 1 mile upstream of Lake San Cristobal during 2018 R2Cross and pebble count.

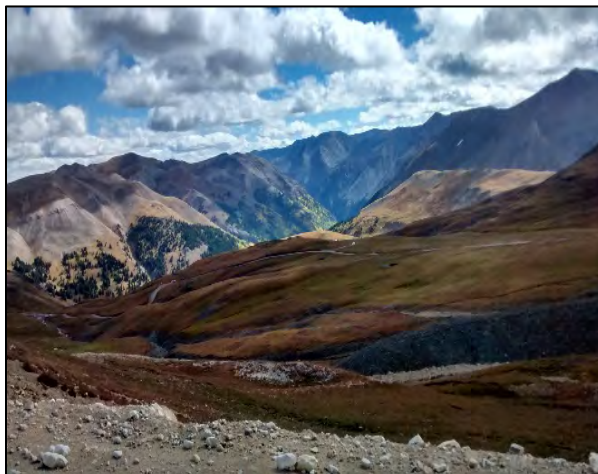
Photo 8-1. View from the summit of Engineer Pass. The drainage in the foreground is Palmetto Gulch near the Hough Mine reclamation site. The background slopes are characteristic of steep tributaries to Henson Creek.

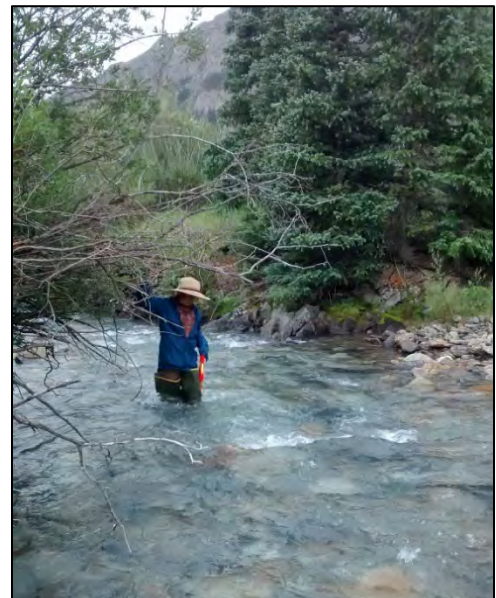
Photo 8-2: Field staff prepare transects for macroinvertebrate sample collection in the North Fork of Henson Creek in August 2015.

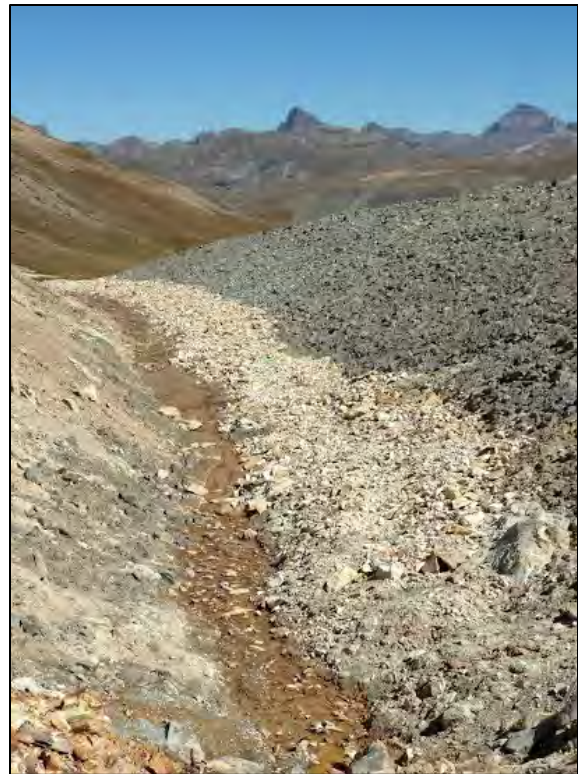
Photo 8-3: Drainage from the Hough Mine en route to North Palmetto Gulch in September 2016, one year following reclamation. The right side of the photo includes edge of the mine waste repository.

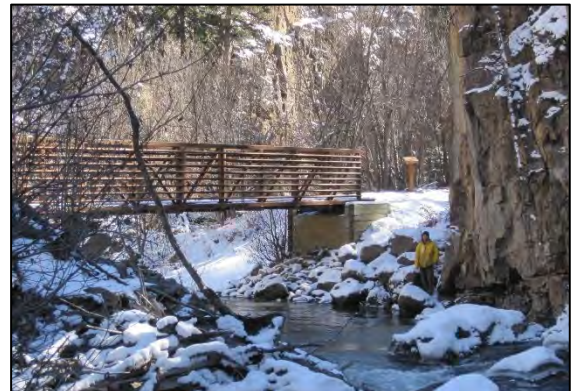
Photo 8-4: BLM employees remove the temperature sensor from Henson Creek near Alpine Gulch in October 2017.

BLM staff installed two continuous temperature sensors in the Henson Creek Basin in recent years. One sensor was installed in the North Fork of Henson Creek at the County Road 20 bridge, upstream of the confluence with Henson Creek. The other sensor was installed in Henson Creek near Alpine Gulch, shown in Photo 8-4. Water temperatures at both locations attained the aquatic life standards during all three summers that the sensors were deployed, shown in Table 8-2.

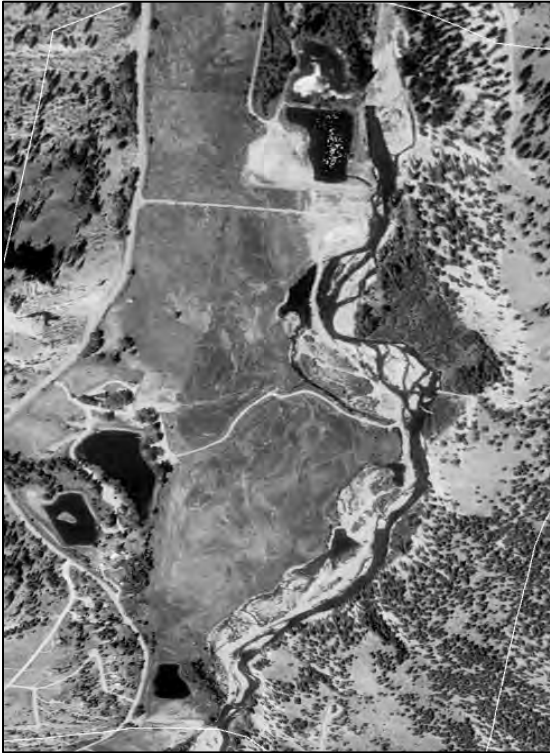
Photo 9-1: Lake Fork River in September 1998 (image by USGS via Google Earth). In the center of the image multi-thread channels navigate large, wide sediment deposits. A low-water ford allowed vehicles to cross the river. Prior stream stability and channels configurations are unknown.

Stream stability and channel manipulation on a 1.3-mile section of the Lake Fork River approximately 1.5 mile north of Lake City.

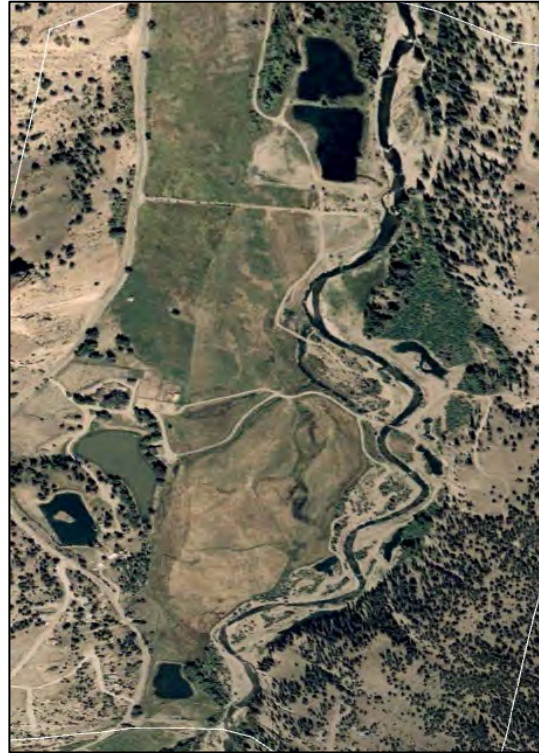
Photo 9-2: Lake Fork River in October 2005 (image by USDA Farm Service Agency via Google Earth). A large channel stabilization project was completed some time between 1998 to 2005. The project increased the channel sinuosity, narrowed the channel width, and installed many cross vanes and J-hooks throughout the reach. The project objectives were to improve fisheries. A bridge was installed across the river and a picnic pavilion was later built immediately downriver from the bridge.
