**UPPER GUNNISON RIVER
WATER CONSERVANCY DISTRICT**

**UPPER GUNNISON RIVER BASIN
WATERSHED ASSESSMENT AND MANAGEMENT PLANNING – PHASE I**

**Ohio Creek, East River, and the
Lake Fork of the Gunnison River Basins**

Final Report

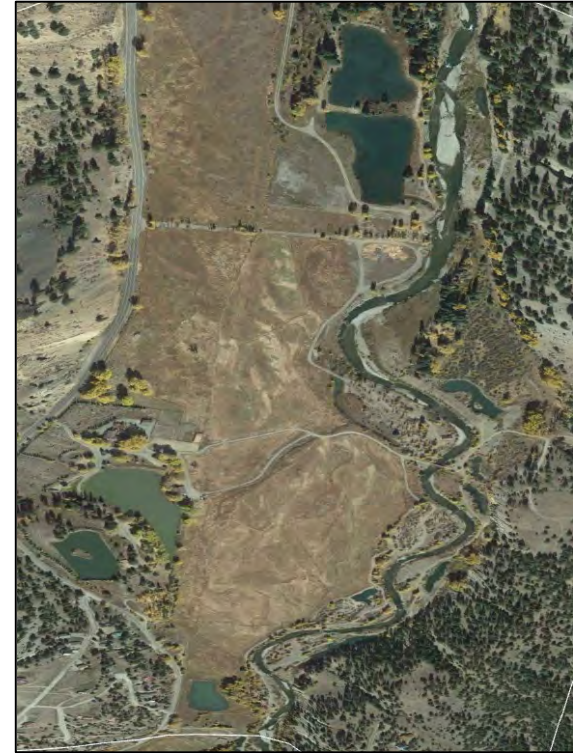
Photo 9-3: Lake Fork River in October 2015 (image by Google Earth). Notice that the channel width has increased throughout the reach. Which combined with decreased water depth likely reduces habitat quality. Sediment deposition has buried at least two cross vanes on the lower portion of the reach. It also appears that this sediment deposition has affected the performance of the diversion structure used to fill the ponds near the bottom of the reach. Access roads developed during construction remain and likely limit floodplain connectivity within the reach.

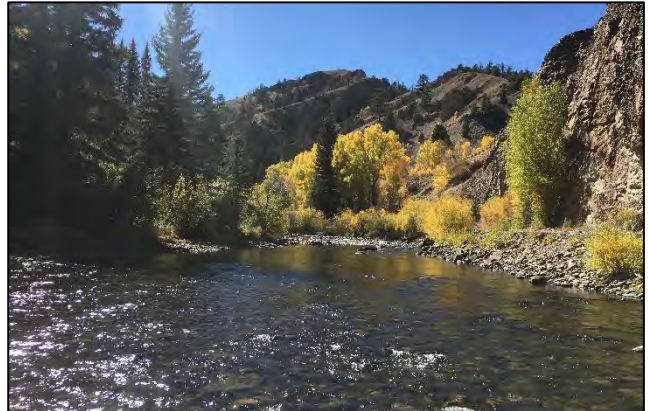
Photo 9-4: Lake Fork River near the confluence with Devil's Creek. This area is a popular fishing area.

BLM staff installed two continuous temperature sensors in the Lake Fork River in recent years. One sensor was installed in the Lake Fork River at Devil's Creek (Photo 9-4) and the other was installed in the Lake Fork River at Gateview Campground. Water temperatures at both locations attained the aquatic life standards during each of the summers that the sensors were deployed, shown in Table 9-3 and Figure 9-5.

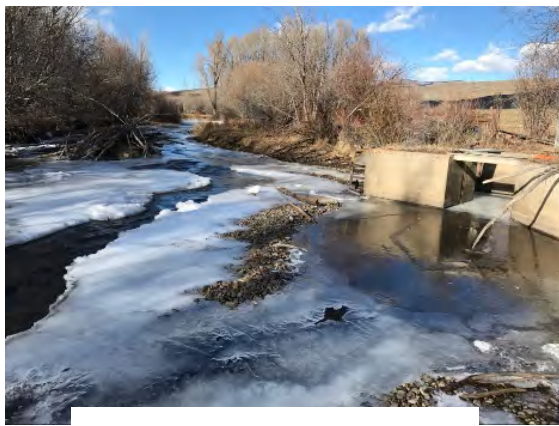
- Perrier Diversion Structure Rehabilitation – The diversion does not adequately divert water at lower flows which often happens in this area. A newly designed structure by a channel restoration specialist will be needed.
- Gooseberry Diversion Structure Rehabilitation – The diversion does not adequately divert water at lower flows. A newly designed structure by a channel restoration specialist will also be needed in this area.

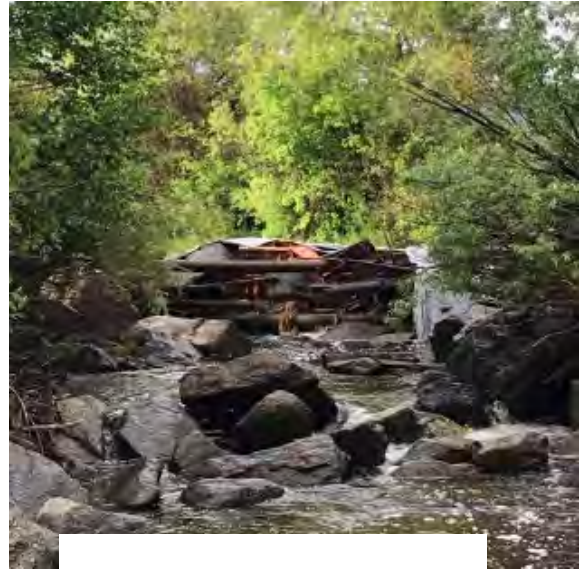
- Harris Bohm Potato Diversion Rehabilitation – This diversion is unstable and requires regular maintenance. The water users plan to replace the structure in 2019 with a newly designed structure with funds from the District’s Grant Program.
- Channel Restoration Upstream of Confluence with Mill Creek –The landowner is interested in addressing segments of Ohio Creek with bank instability on property located upstream of the confluence with Mill Creek. This project will require a contractor with channel restoration experience.

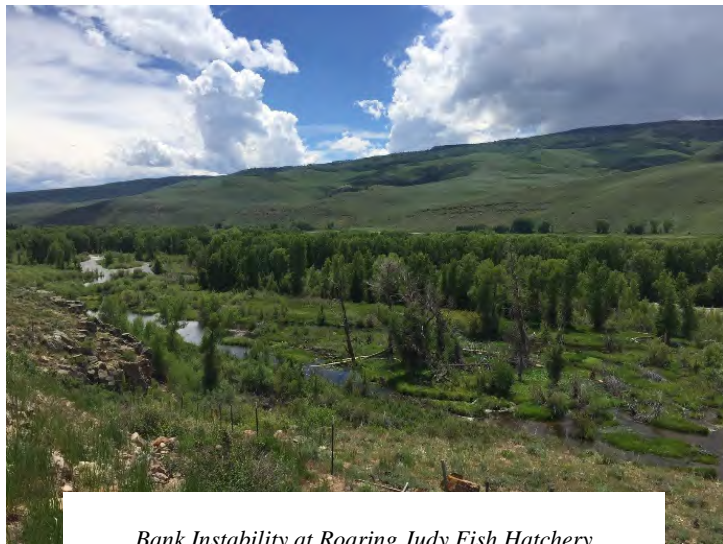
- Bank Instability at Roaring Judy Fish Hatchery – This project would address issues identified with bank instability which threatens infrastructure. This infrastructure may also be impacting stream geomorphology and habitat. The project will involve additional assessment work to identify methods to protect infrastructure and improve bank stabilization. This may include geomorphic assessment and development of riparian restoration strategies.

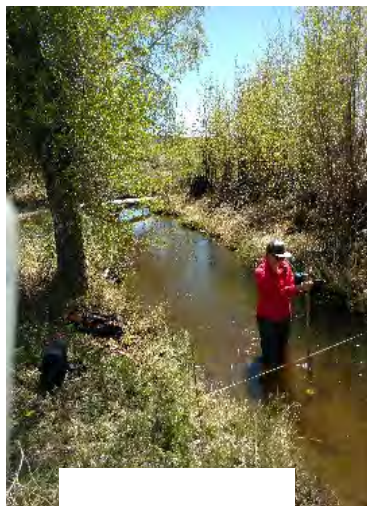
Teachout Ditch Loss

- **Teachout Mesa Ditch Conveyance Improvement** – Water right owner would like to reduce ditch losses allowing more water to be delivered to the irrigated field. This project will require a contractor with experience designing irrigation systems. Trout Unlimited has secured \$50,000 to assist in a conveyance improvement trial.
