Prepared for
Colorado Water Conservation Board
Watershed Restoration Program
Attn: Chris Sturm

Florida River Habitat Improvement Project Phase 3

Grantee: Animas Watershed Partnership
Fiscal Agent: San Juan Resource Conservation and Development Council
Grant Amount: \$32,500

Prepared by Ann Oliver, Coordinator

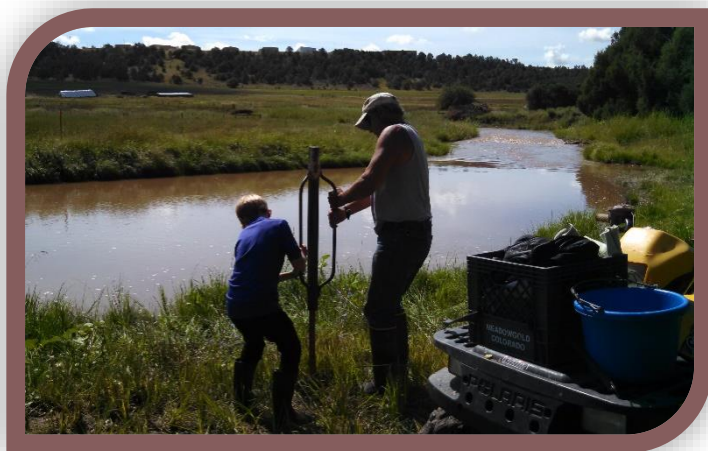
Figure 3. Marking fence line at horse pasture water gap.

An unexpected amendment of additional funds to our CO NPS grant allowed the Project to complete more fencing than originally proposed. In August, 2016, 1548 feet of 5 wire barbed-wire fence were constructed on the Phase 1 Fassbender property immediately upstream of the Phase 3 Watson Property (Figure 6). This short stretch of river had originally been left unfenced

in order to provide a substantial water gap for horses kept on the property over the winter. However, Mr. Fassbender decided in 2016 that the long water gap was not necessary and agreed to protect that additional stretch with fencing on both sides of the river. The Project Manager agreed that this was a beneficial use of the funds not only because it would expand the riparian buffer through this section, but also because it is immediately upstream of the infiltration gallery that supplies drinking water to the Durango-La Plata Regional Airport.

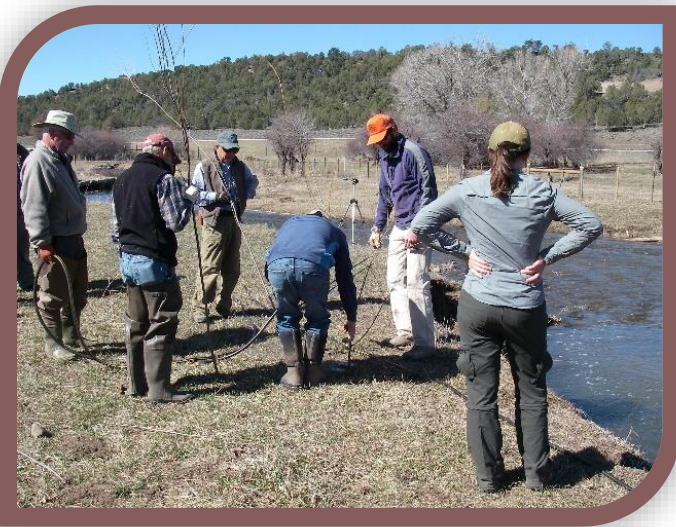
Figure 5. Volunteers planting willows on Phase 2 property, April 2016.

During the April 2016 willow plantings, we had Biscuit Boy Productions produce a video produced of these volunteer events. The video can be viewed at <https://www.youtube.com/watch?v=ZZbSOy-kqYs&feature=youtu.be> and shows the methodology we plan to employ again this year. On each day, volunteers will use loppers to harvest a large number of coyote and pacific willow cuttings from willow stands on the Watson Property. If necessary, these cuttings will be supplemented with cuttings from nearby Southern

Ute Indian Tribe land, thanks to assistance from P. Nylander, SUIT Water Quality Specialist. AWP will rent the “waterjet stinger” tool from the La Plata Conservation District, and volunteers will use this tool to plant the cuttings into and along the bank. As cuttings are inserted into “waterjetted” holes (about 3-4ft deep), volunteers will use buckets to pour a slurry of soil and water into the planted holes, and compact the soil around the step with their heels. These steps help ensure good soil to stem

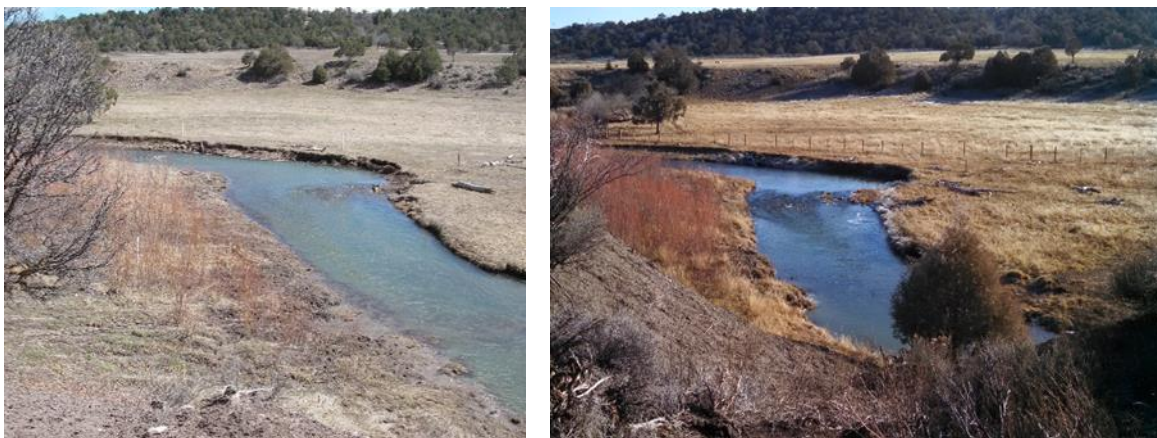
Figure 10. Phase 3 North End before (2016) and after (12/2016).

Pre- and immediate post-project monitoring photos document pre-project and early post project conditions (Figures 7-10). Subsequent post-project re-photography and RSRA surveys by AWP will help assess the effectiveness of the fencing to create a riparian buffer and improve channel shading, aquatic and riparian habitat, and improve channel bank stability.

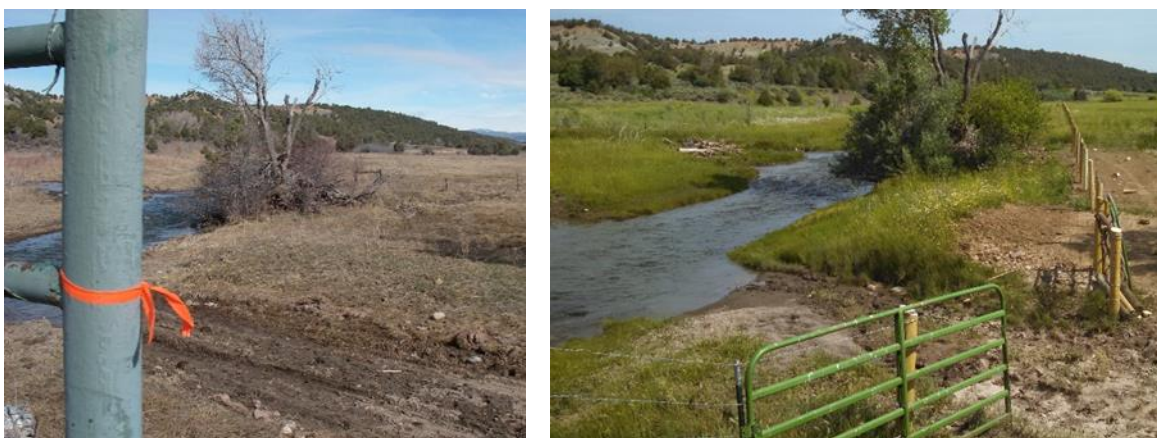
Figure 9. Phase 3 Upstream from bridge, before (2016) and after (6/2016).

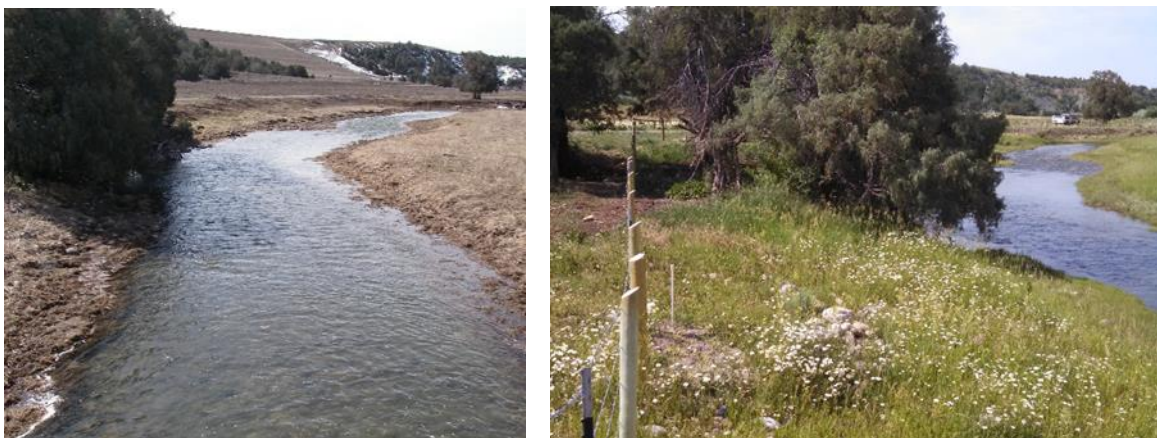
Figure 8. Phase 3 Downstream from bridge, before (2016) and after (6/2016).

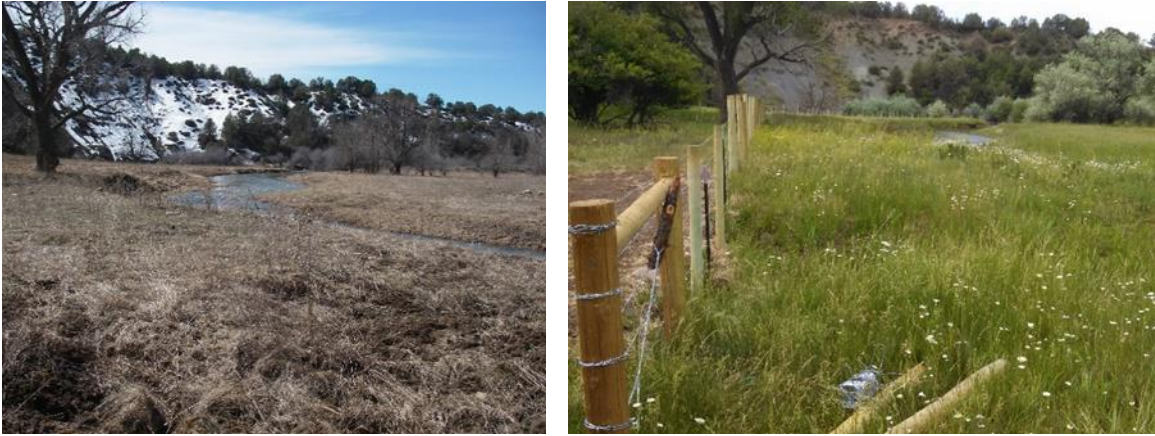
Figure 11. Phase 3 Downstream from corral, before (2016) and after (6/2016).
