# **JAMES CREEK RIPARIAN RESTORATION PROJECT**

## **Final Report**

James Creek Watershed Initiative

## James Creek Riparian Restoration Project: Photolog

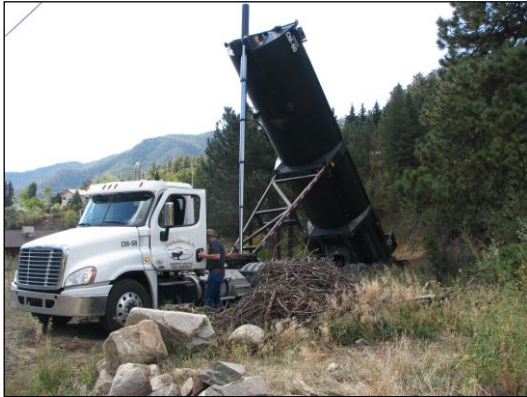
Figure 3. Topsoil delivered and staged.

Site preparation during September 2017 included tree trimming for proposed site prescribed burn (which did not happen due to high winds), weed pulling, and site clean-up of debris and trash. Top soil (76.73 tons) was delivered on September 15, 2017 and staged at three of the project sites. Back-hoe operation was completed on September 16, 2017 which included digging under cheat grass, scarifying the soil, digging holes for trees and shrubs, and spreading topsoil. Trees, shrubs, compost and seed was delivered on September 27, 2017. On September 29, 2017 tools were gathered and seed was divided into 12 packets each to be spread over

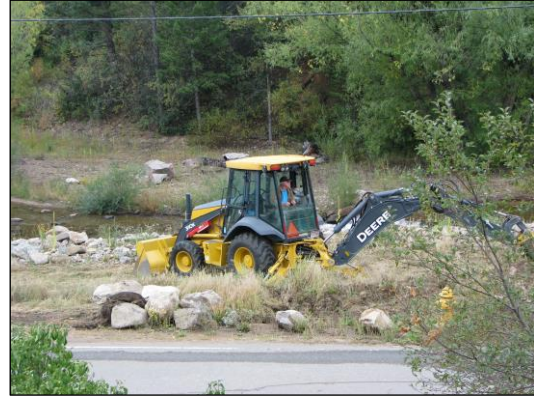
Figure 4. Backhoe operator at Site 1.

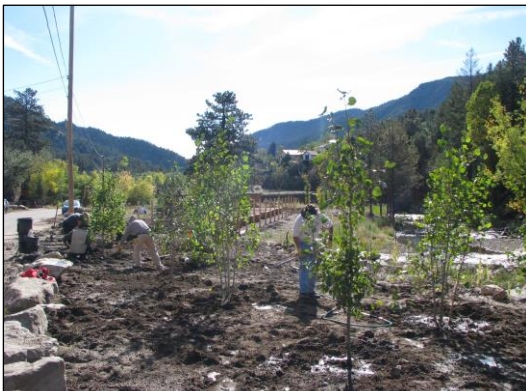
Figure 5. Volunteers planting aspen trees.

Jamestown area volunteers participated in manual restoration activities at the project site on September 30, 2017. Seventeen aspen trees/clumps were planted with an application of mulch and soil in the holes. Forty-four shrubs (11 Wild Rose, 19 Dogwood, 5 Rabbitbrush, 9 Currant) were planted. Topsoil was manually spread out over the 0.5 acre project site. Biosol fertilizer (100 lbs.) and native seed (16.60 lbs.) was applied to the soil and raked in.

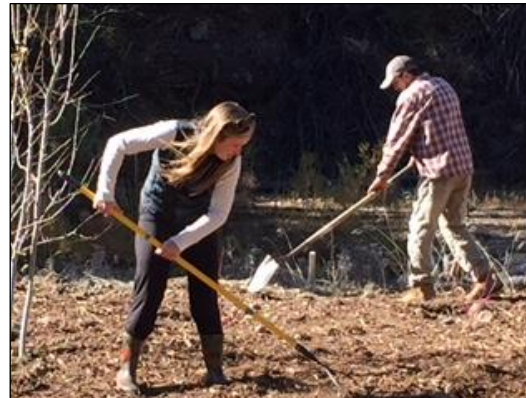
Figure 6. Volunteers spreading wood mulch.

On October 21, 2017 volunteers assisted with spreading mulch over the entire project site for erosion control and to hold in the moisture. The mulch (60 cubic yards) consisted of shredded trees and limbs from local flood debris removal that was hauled to the project site. The trees and shrubs were then watered via 400 feet of hose from the Community Garden's spigot to the three project sites. Watering continues on a weekly basis until the ground freezes in December. A liquid fertilizer was applied to the trees in November to stimulate root growth. Volunteers contributed 77 hours toward restoration activities with an in-kind match of \$2,310 toward the project.

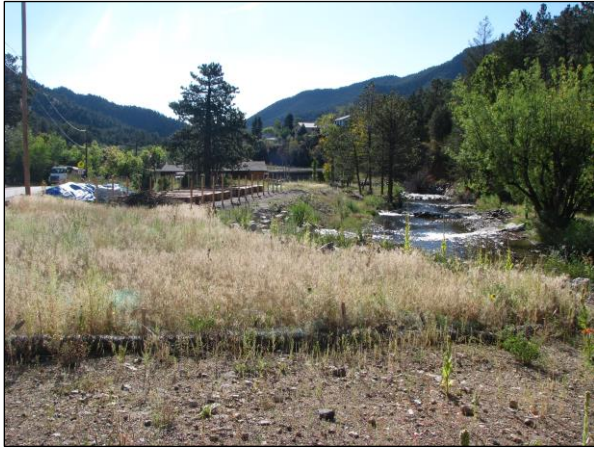
Figure 1. Project Site 1 before restoration with invasive weeds: cheat grass and thistle.

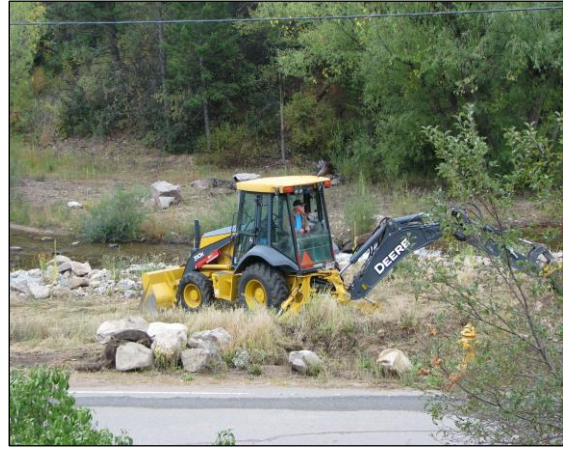
Figure 2. Project Site 1 backhoe operation to dig under invasive weeds, spread topsoil, and dig holes for planting trees and shrubs

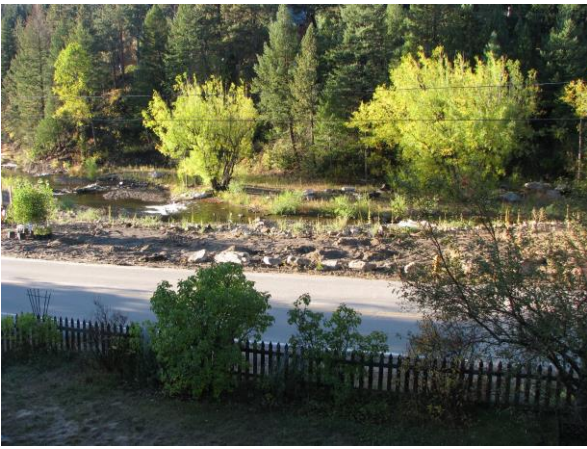
Figure 3. Project Site 1 ready for planting.

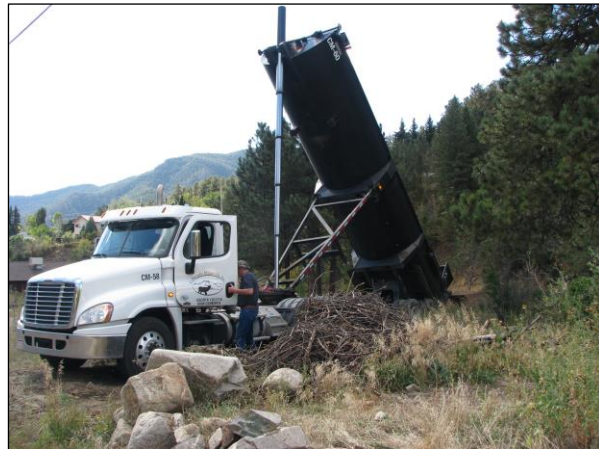
Figure 4. Topsoil delivered to project sites.

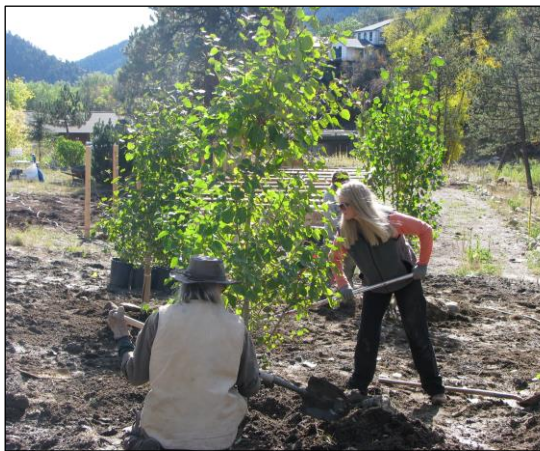
Figure 5. Project Site 1 volunteers planting trees.

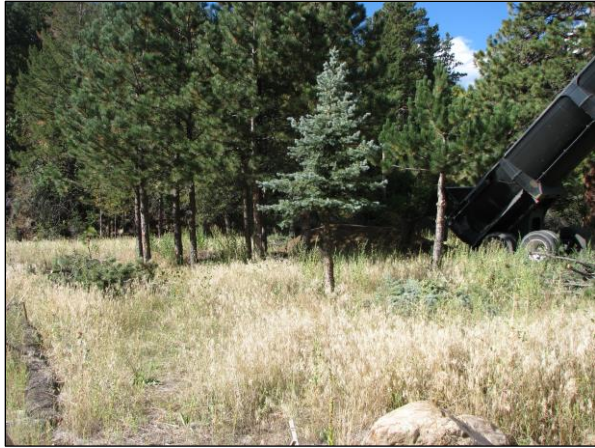
Figure 7. Project Site 2 before restoration.

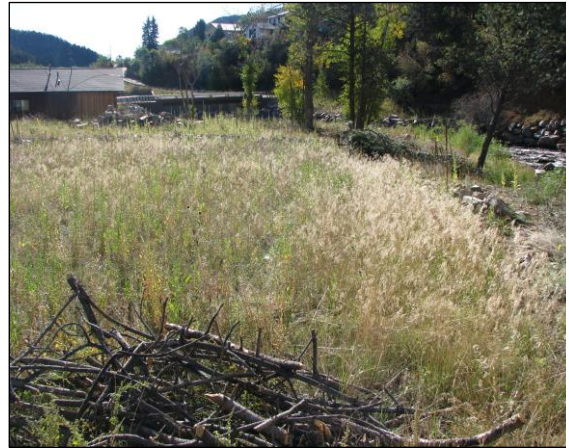
Figure 8. Project Site 2 overgrown with weeds.

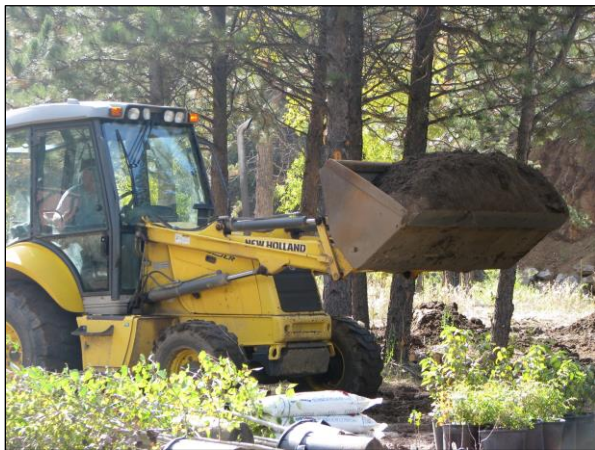
Figure 9. Project Site 2 spreading topsoil.

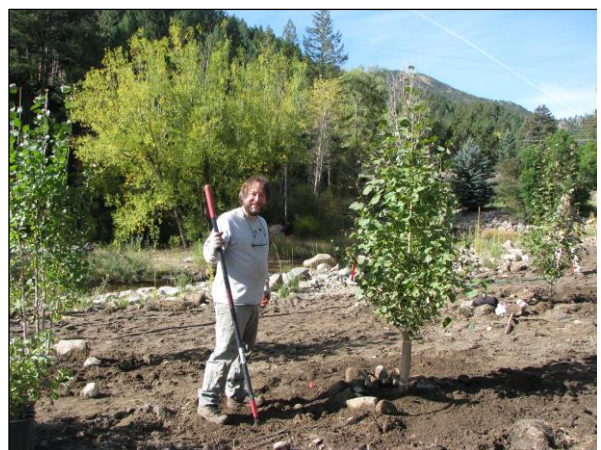
Figure 10. Project Site 2 planting trees and shrubs, scattered seed and biosol fertilizer.

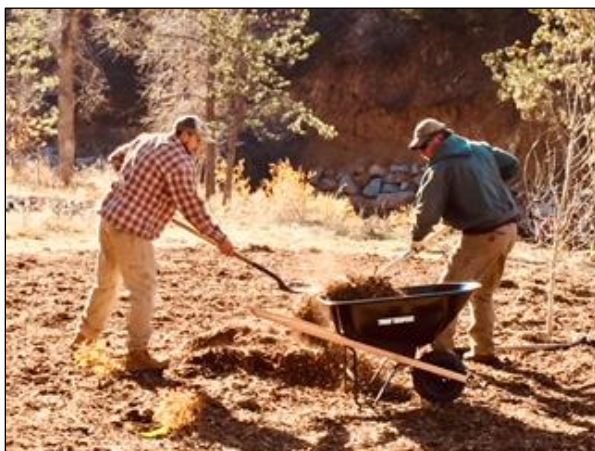
Figure 11. Project site 2 volunteers hauling mulch.

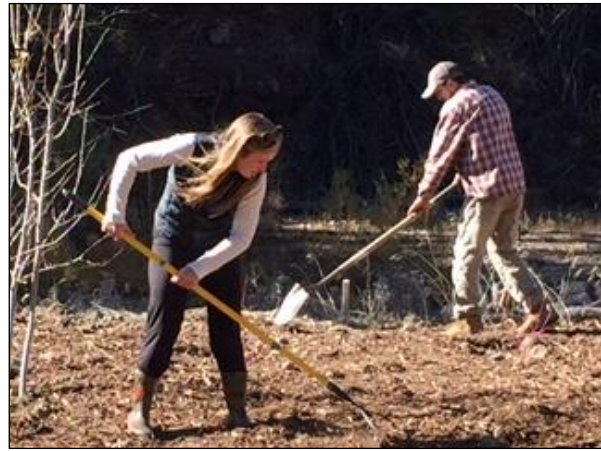
Figure 12. Project site 2 volunteers spreading mulch.

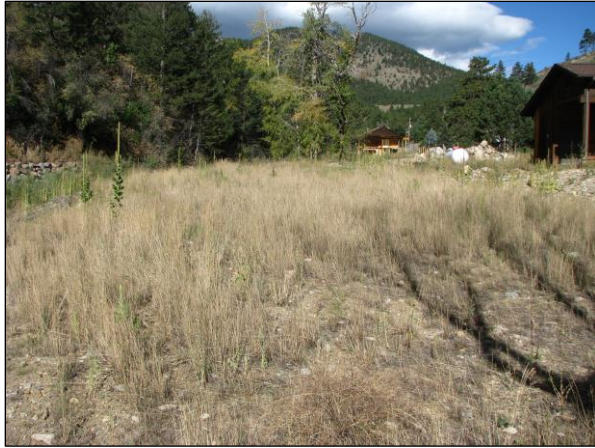
Figure 13. Project Site 3 before restoration with some vegetation. Site scarified with backhoe and topsoil spread over bare areas.

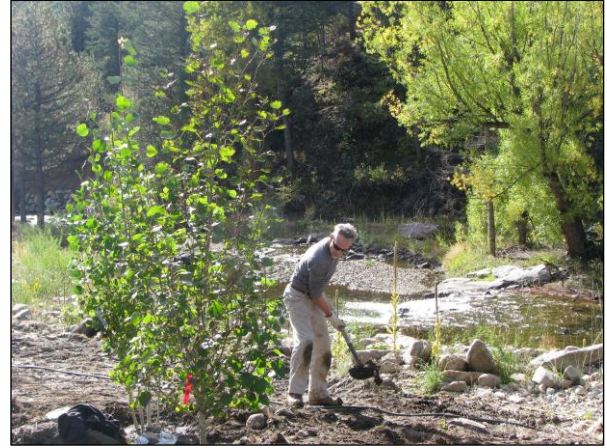
Figure 14. Project Site 3 volunteers planting trees and shrubs, spreading and raking in seed and biosol fertilizer.

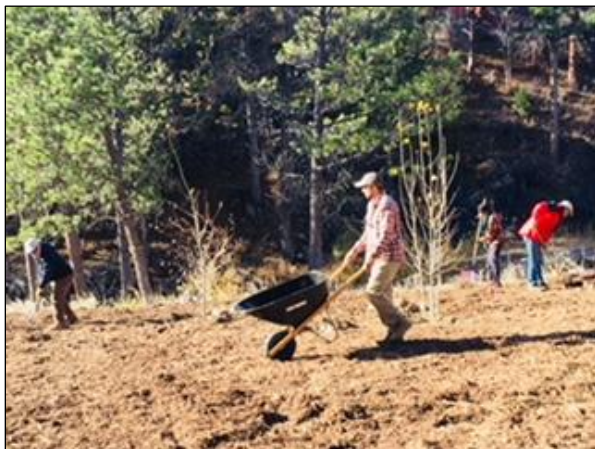
figure 15. Project Site 3 volunteers hauling and spreading topsoil.

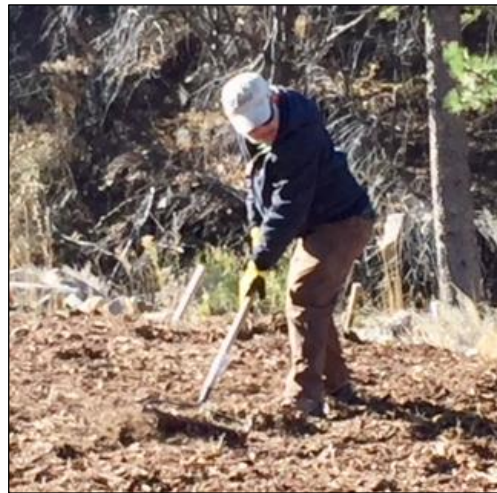
Figure 16. Project Site 3 volunteers spreading mulch.
