**RED MOUNTAIN WETLAND RESTORATION: RESTORING A RARE FEN TO  
ELIMINATE SEDIMENT INPUTS TO MINERAL CREEK, IN SAN JUAN  
MOUNTAINS, SAN JUAN COUNTY, COLORADO**

**Final Report**

**Prepared By:** Anthony Culpepper  
Mountain Studies Institute, PO Box 426, Silverton, CO 81433

*March 31, 2018*

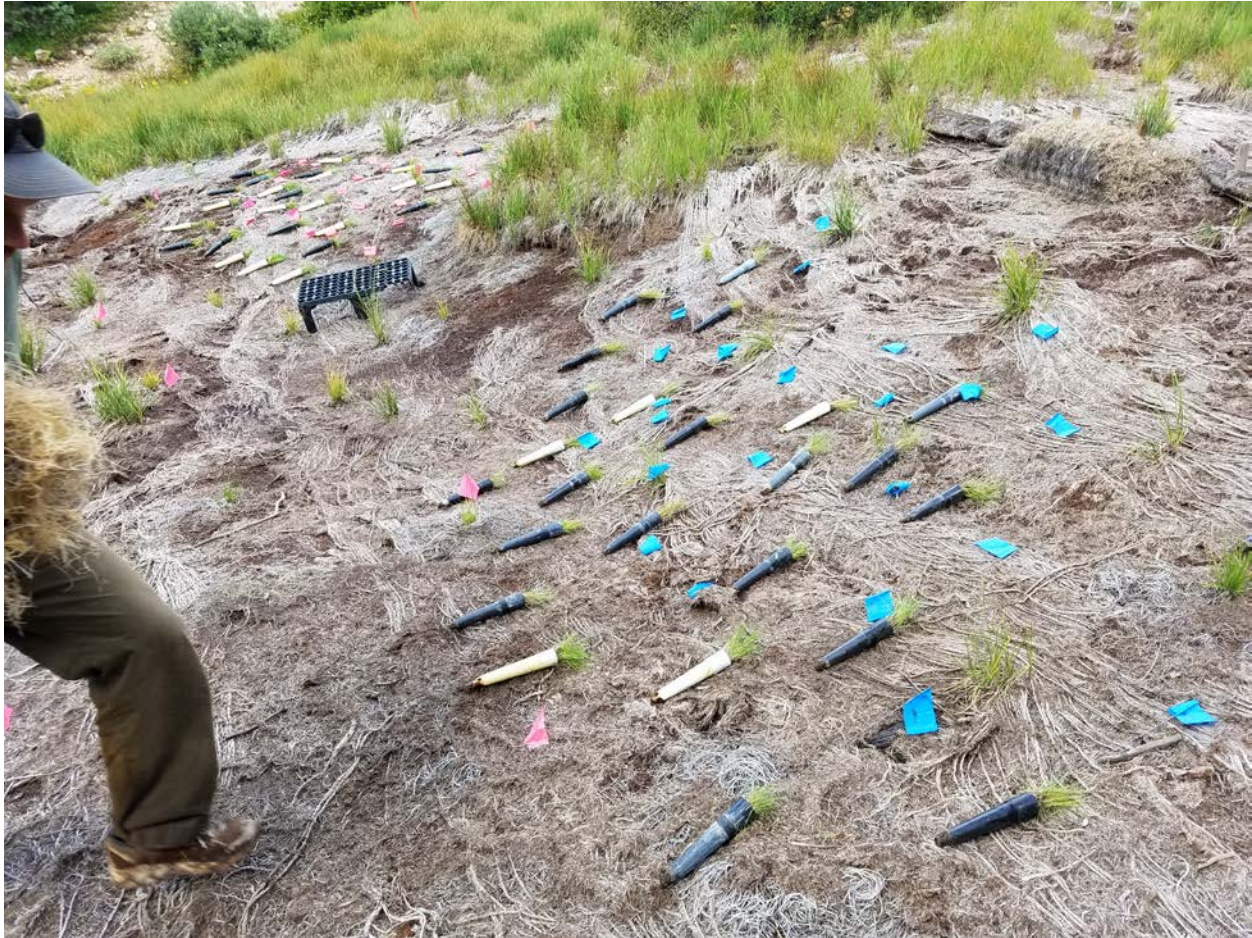
**Figure 1. Seedling Planting.** A volunteer prepares to plant *Carex* plugs, grown from local seed, at the Ophir Pass fen. Pin flag are placed to track survivorship.

Regarding the experimentation with *Carex* plugs propagated from local seed we have seen high success and survivorship. Over 100 plugs were planted in the 2016 pilot planting. 50 of these plugs were marked with pin flags and 49 out of 50 plugs were relocated in summer of 2017, Figure 1. The one “lost” plug was covered by debris during spring melt. These plugs will be located and documented for survivorship in the summer of 2018 as their second year of growth. In 2017 an expanded set of plugs was planted by volunteers. In total in 2017, over 300 *Carex* and 200 native grasses were planted. A sub set of 50 more *Carex* and 100 of the grasses were flagged to document survivorship. We expect to see good survivorship when monitored in 2018.

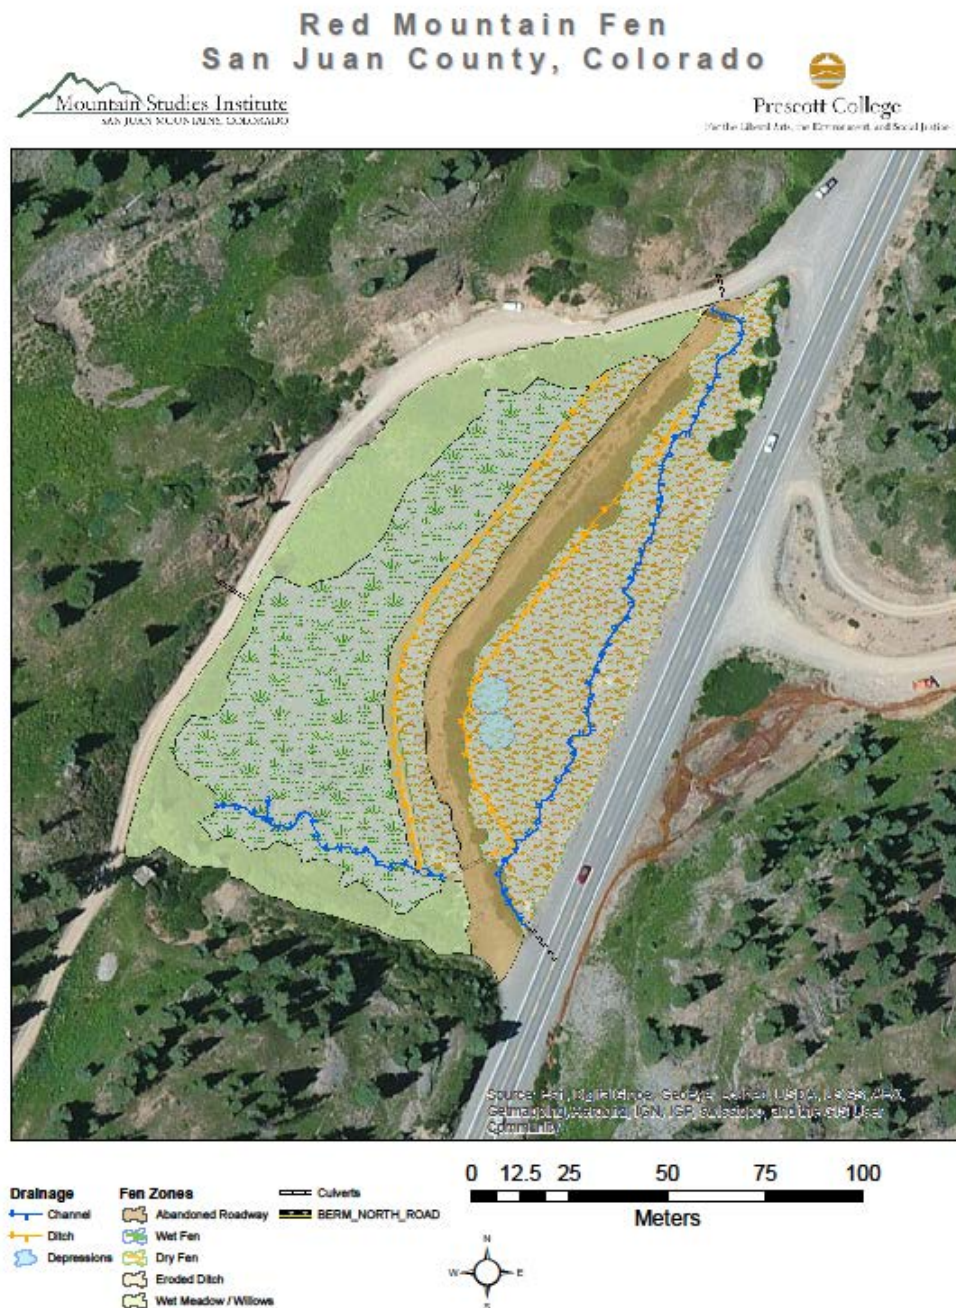
**Figure 2. Overview of Red Mountain Pass Fen Restoration Plan** showing location of wetland types, ditches, and road. Abandoned road area=0.2 ha, ditches = 0.04 ha, fen=0.46 ha, wet meadow = 0.33 ha, and degraded fen= 0.53 ha. Western ditch length = 450 ft. Eastern ditch length = 350 ft.

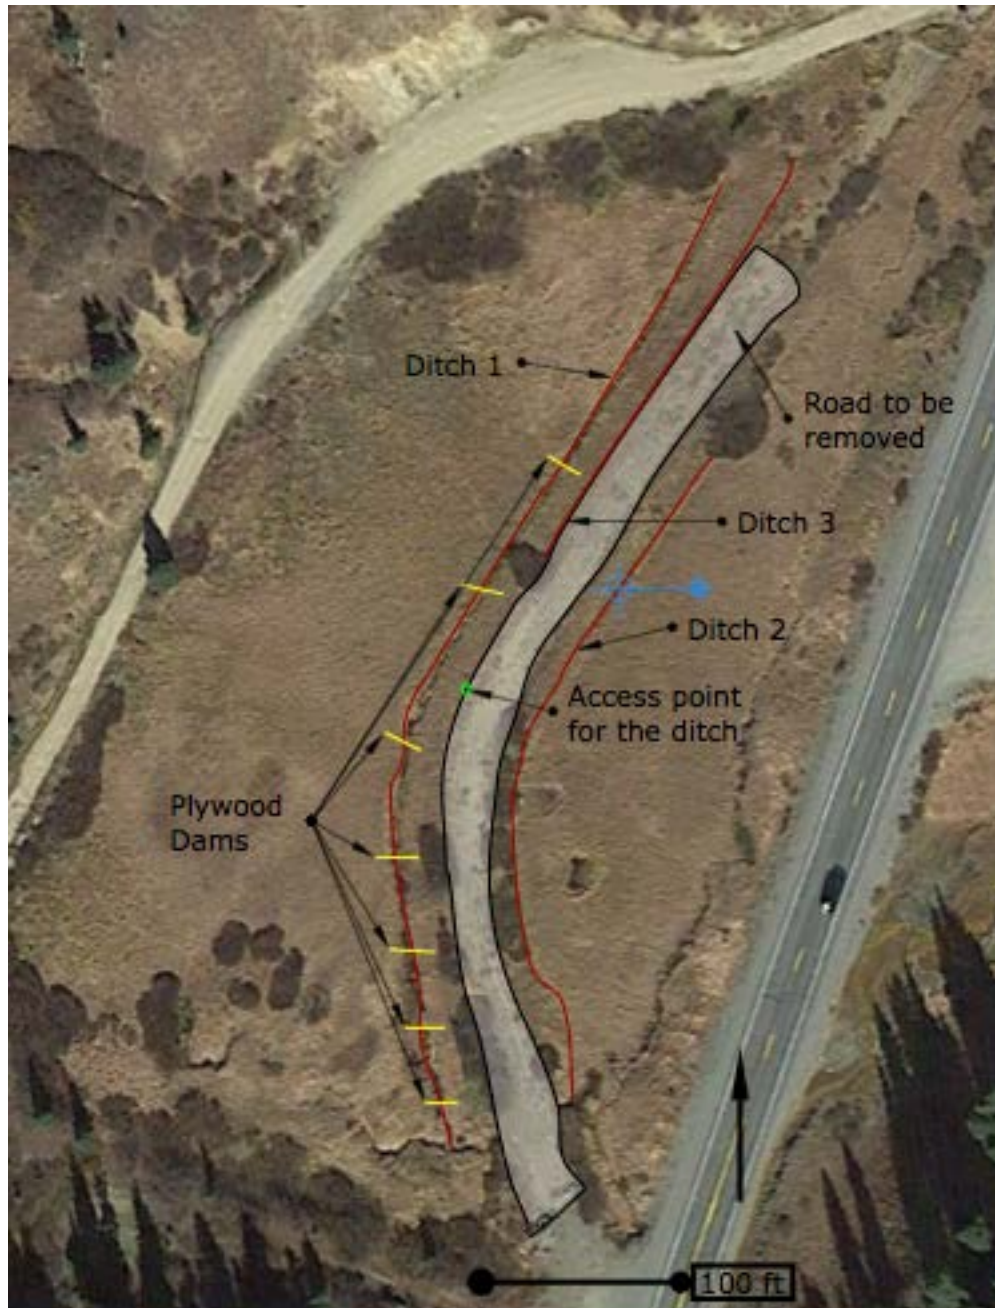
**Figure 3. Overview of Proposed Construction Plan** showing the location of plywood dams, the section of the road that will need to removed, the possible access for heavy equipment to reach the ditch, and the ditches needing damming. The snow site is not shown but lies just North of the proposed road excavation marked.

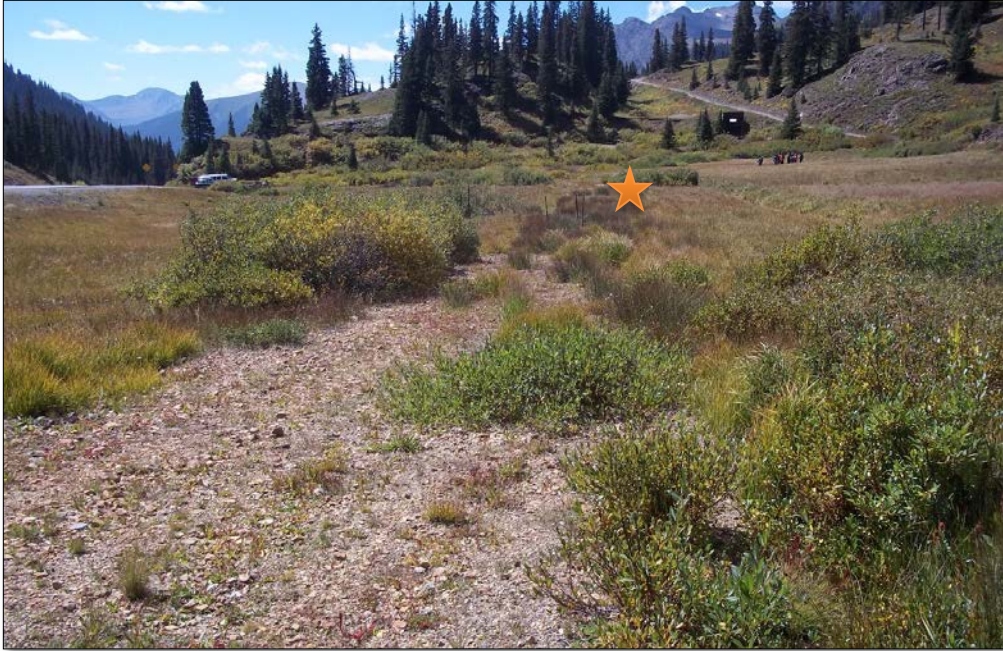
**Figure 4. Project Photo of Road to Remove.** Photo showing the abandoned road bed (gravel base) dissecting the fen that we propose to restore. The linear ditch feature is visible in the right upper corner near the orange star.

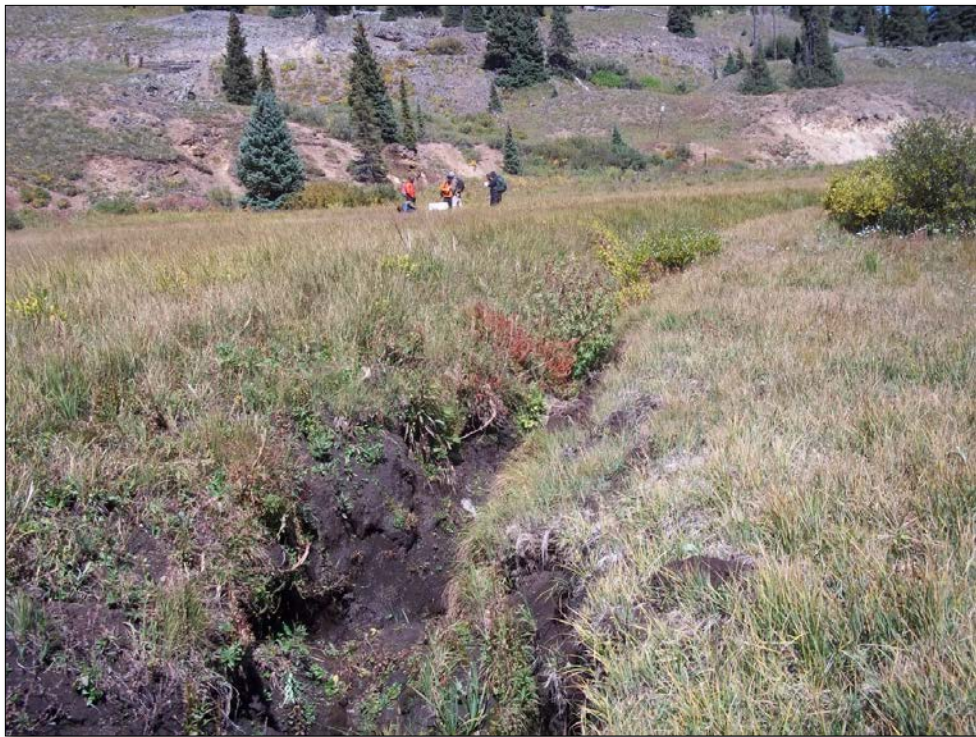
**Figure 5. Photo of east road side ditch running north.**

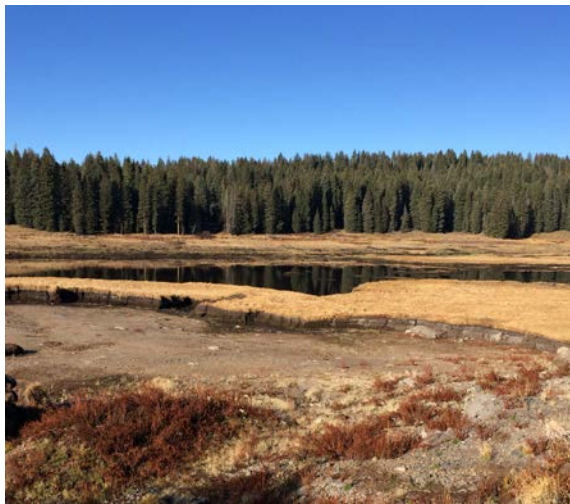
**Figure 2.** Kennicott Fen. Notice the displaced peat laying on the surface.

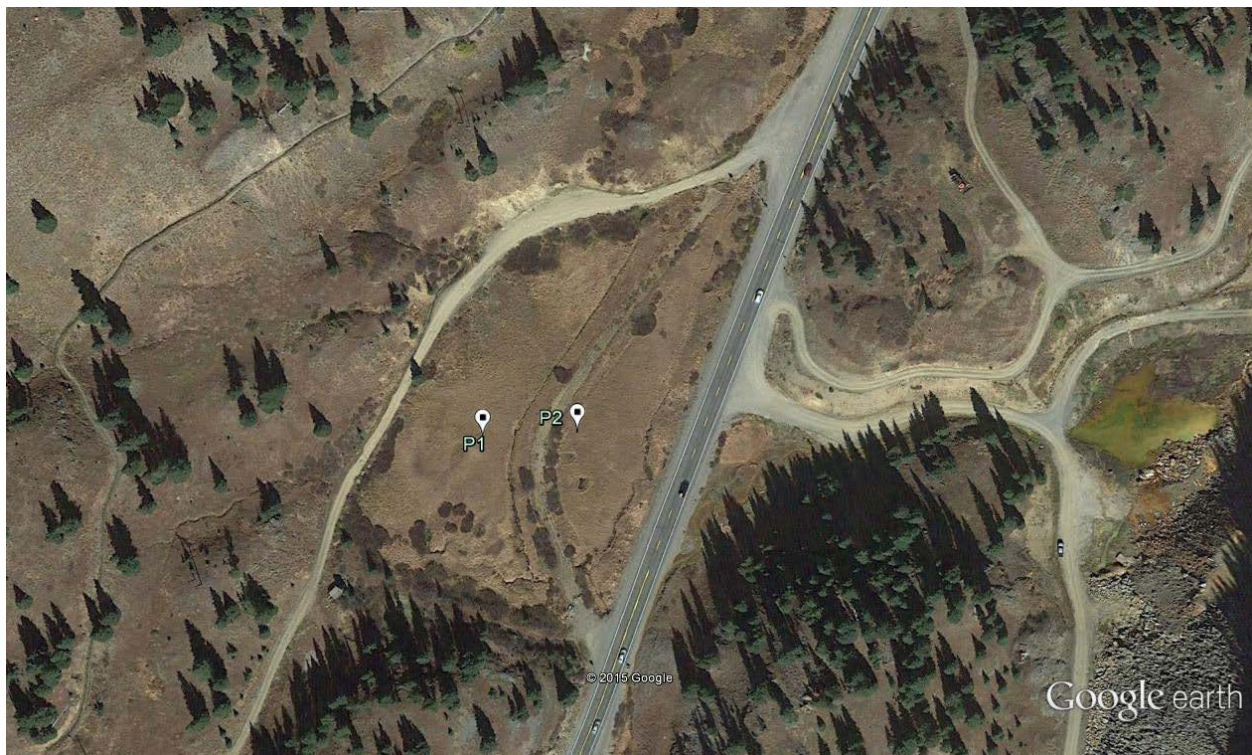
**Figure A1. Location of plots in Red Mountain Pass Fen. P2 is the drained location.**

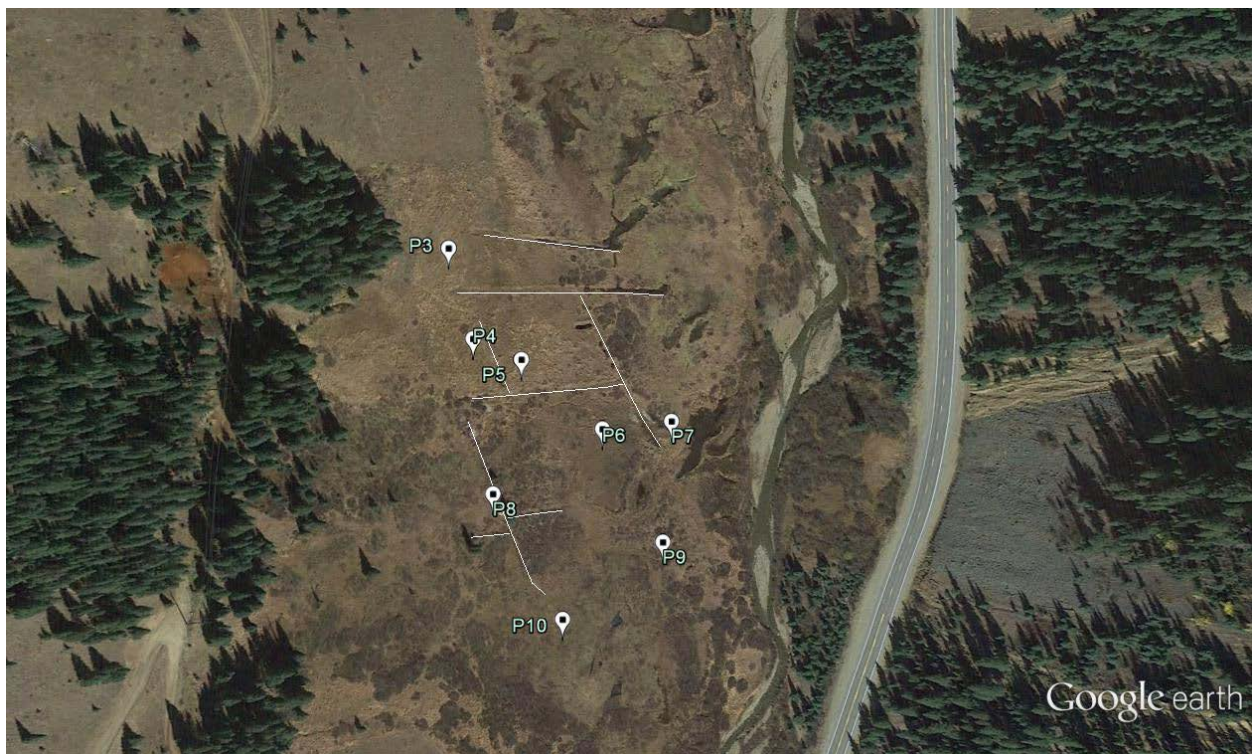
**Figure A2. Location of sampling plots in Chattanooga Fen. White lines are restored ditches.**

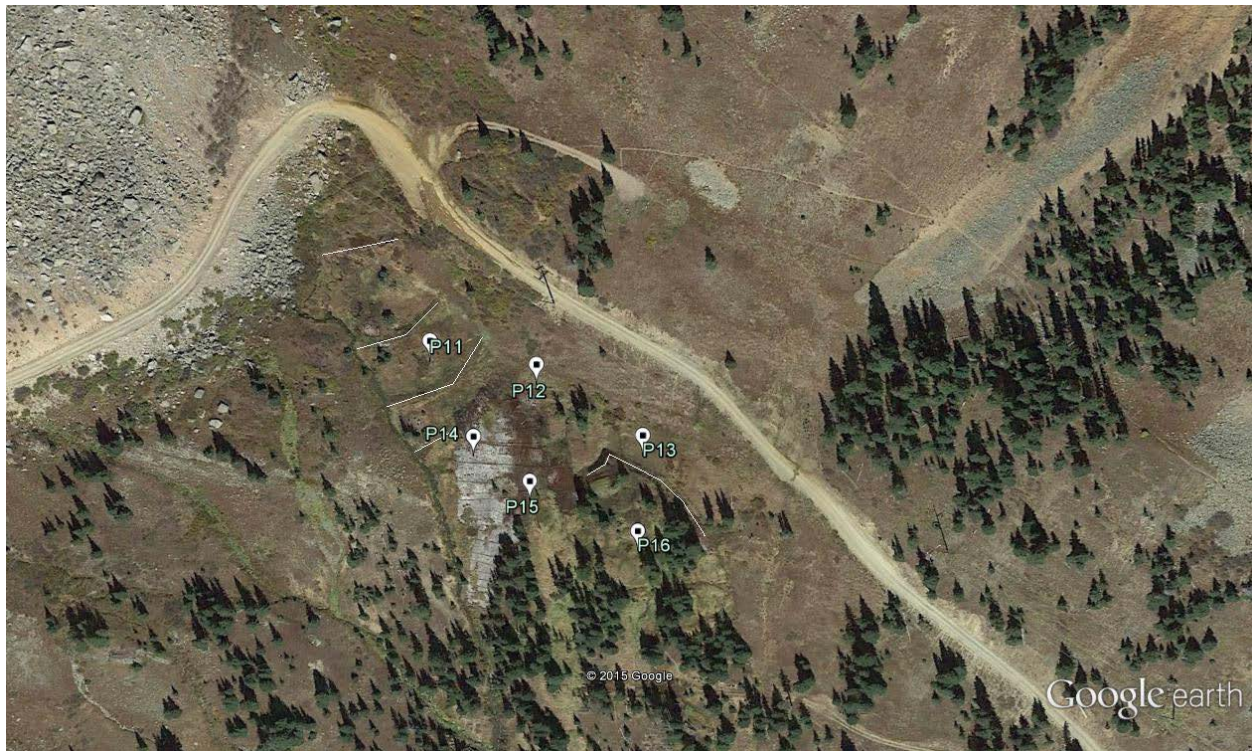
**Figure A3. Location of sampling plots in Ophir Fen. White lines are restored ditches.**
