Water Plan**Water Project Summary**

Name of Applicant	Roaring Fork Conservancy	
Name of Water Project	Project-01906 Crystal River at Riverfront Park Restoration	
Grant Request Amount		\$798,574.00
Primary Category		\$798,574.00
<i>Watershed Restoration & Recreation</i>		
Total Applicant Match		\$927,091.00
<i>Applicant Cash Match</i>		\$927,091.00
<i>Applicant In-Kind Match</i>		
Total Other Sources of Funding		\$527,091.00
<i>Colorado Parks and Wildlife</i>		\$20,000.00
<i>WaterSMART</i>		\$252,091.00
<i>Aspen Valley Land Trust R3 Fund</i>		\$10,000.00
<i>GOCO Resilient Communities</i>		\$55,000.00
<i>CPW Fishing is Fun</i>		\$30,000.00
<i>Colorado River Water Conservation District</i>		\$100,000.00
<i>Pitkin County Healthy Rivers</i>		\$10,000.00
<i>CPW Fishing is Fun 2021</i>		\$50,000.00
Total Project Cost		\$2,252,756.00

Appendix A: Master Plan Preferred Alternative

Appendix B: Recommendations from the Riparian Restoration Plan & Ecological Integrity Assessment

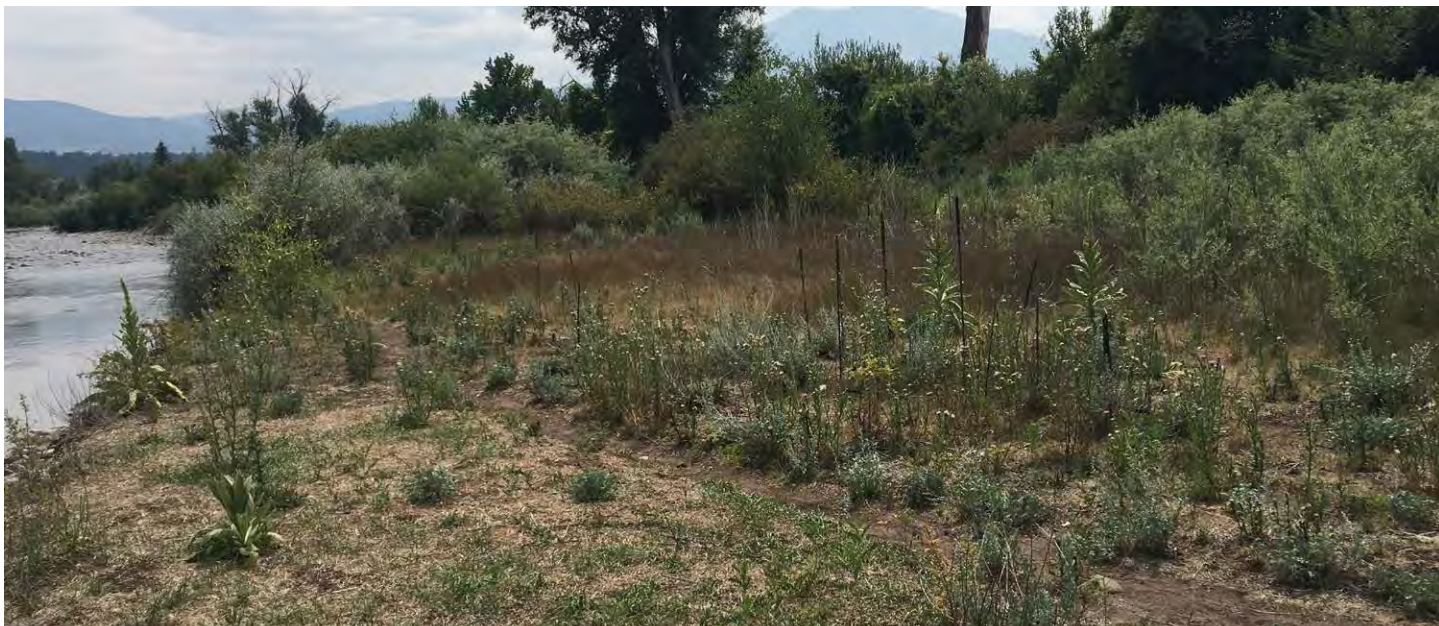
Image 4-1 This image demonstrates highly degraded ecologic conditions near the river on the left side of the photograph. This is an area recommended for riparian creation. Near the center of the photo, healthy forbes indicate an intact wetland which could be enhanced.

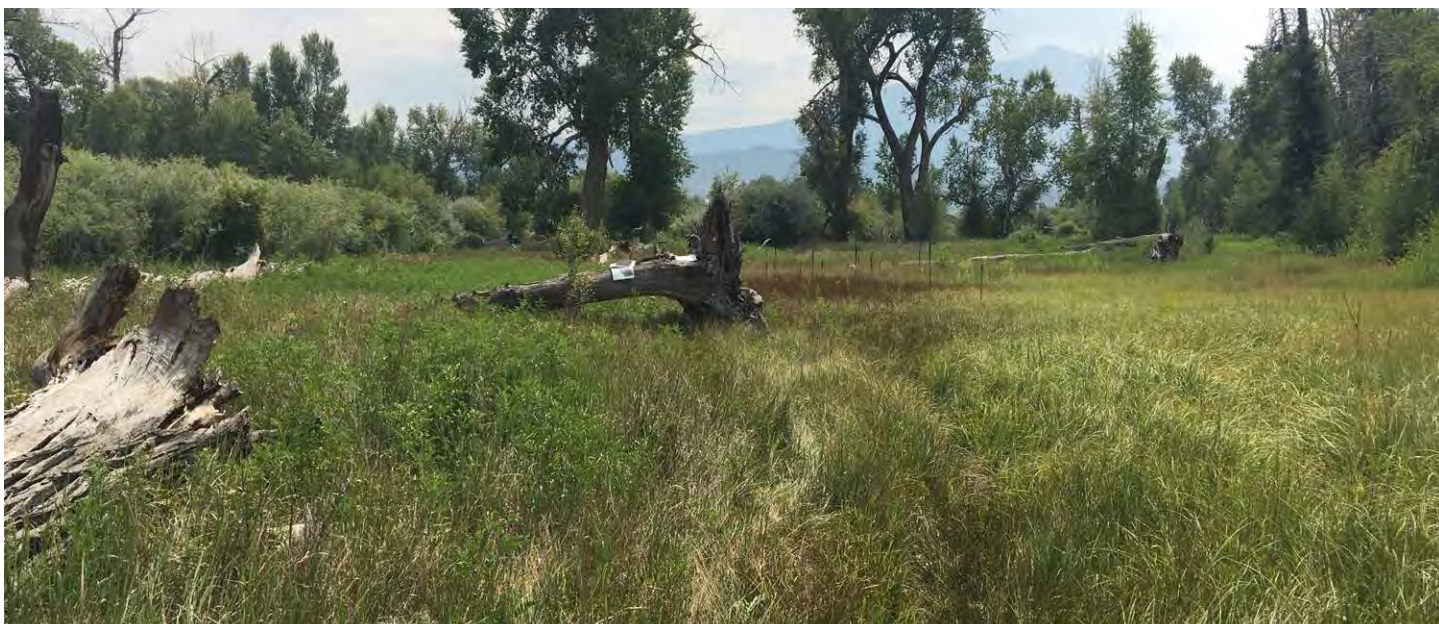
Image 4-2 A high quality wetland can be seen on the right side of the image. This area would be recommended for wetland preservation. On the left side of the image, closer to the Crystal River there is an area recommended for wetland creation

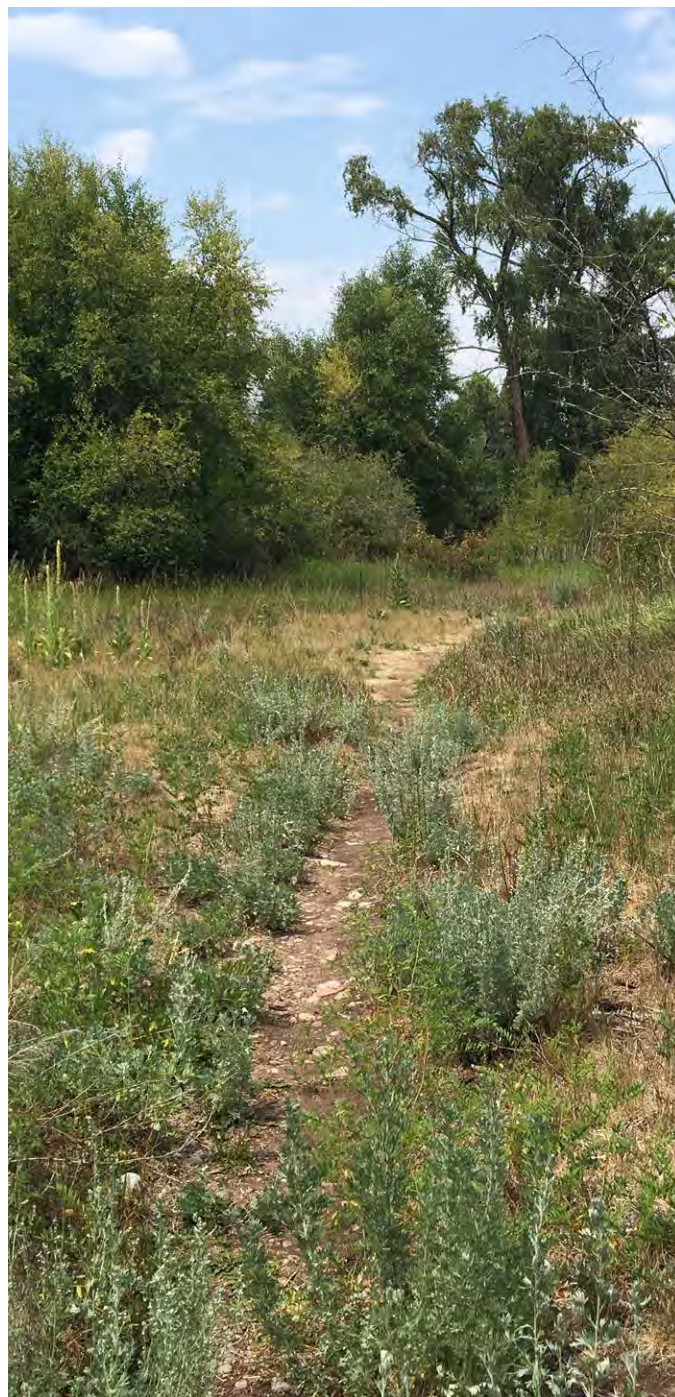
Image 4-3 This location of the assessment area has mature trees and shrubs suitable for riparian preservation. The herbaceous ground cover is mostly noxious weeds making it a candidate for riparian creation

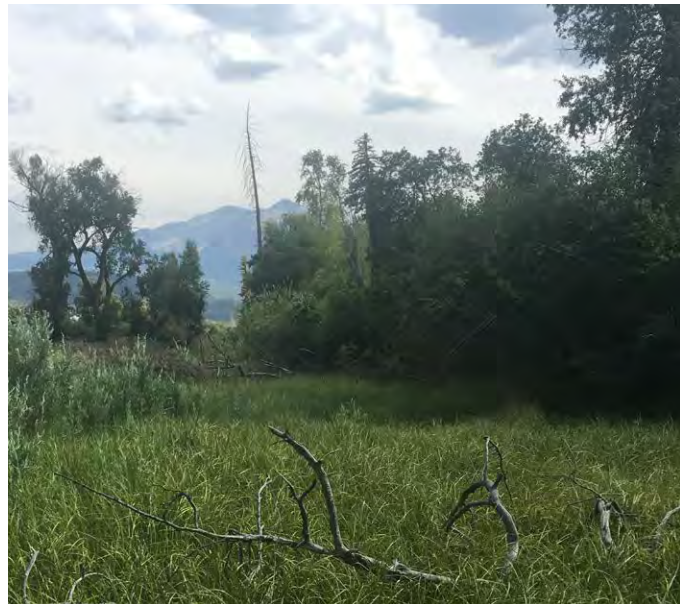
Image 4-4 An example of healthy PER wetlands and riparian shrublands. Both areas are recommended for preservation

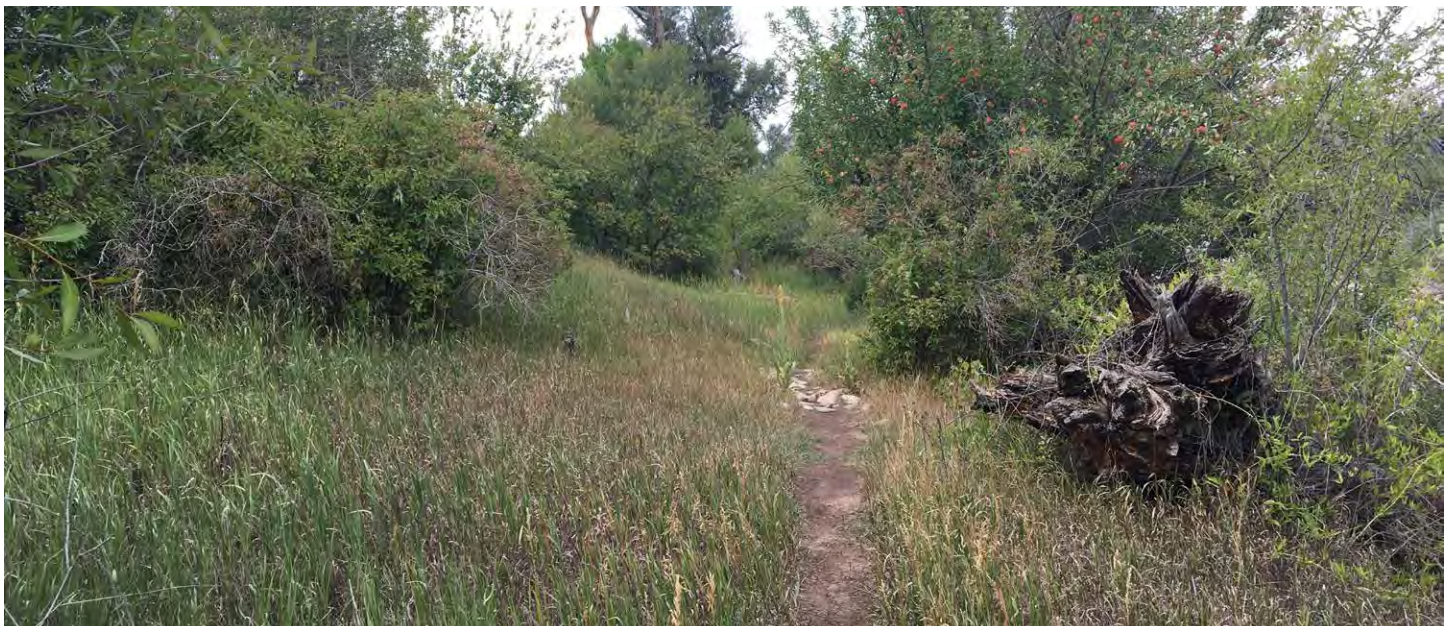
Image 4-5 The shrubs in this image are in good health and these woody vegetated zones are recommended for preservation. The wide swaths of brome in the foreground of the photograph are an opportunity for riparian enhancement.

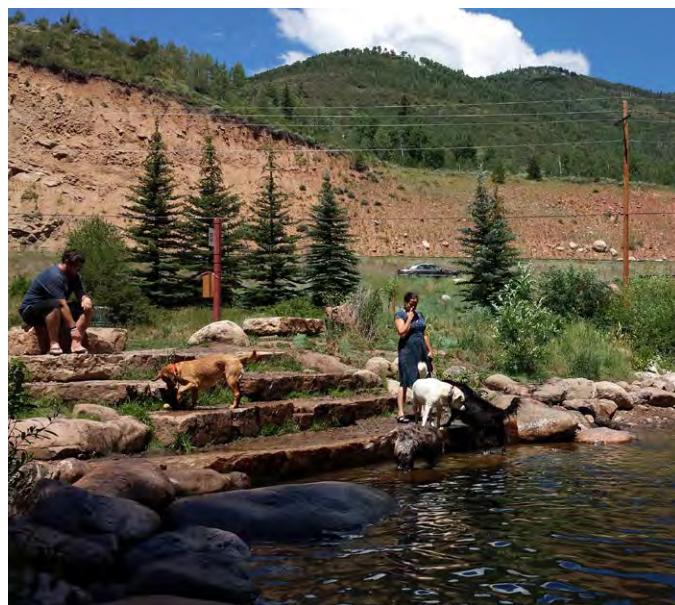
Image 4-6 An example of a bank repaired with boulders and steps

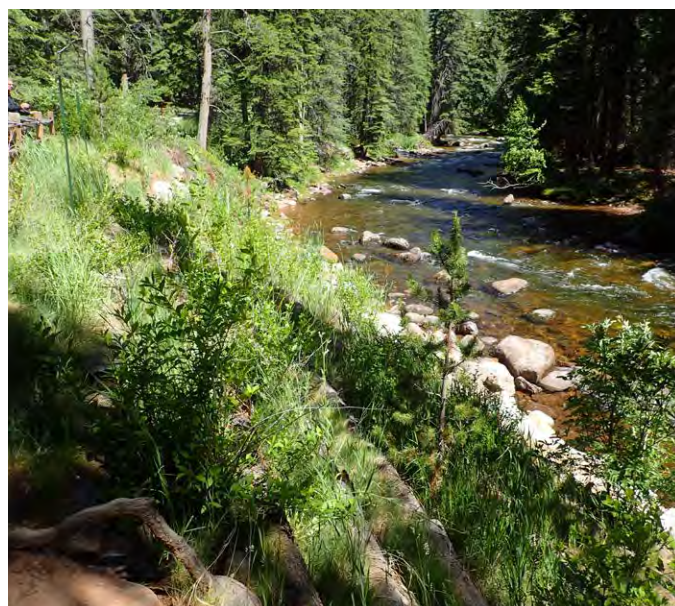
Image 4-7 An example of a bank repaired with vegetation

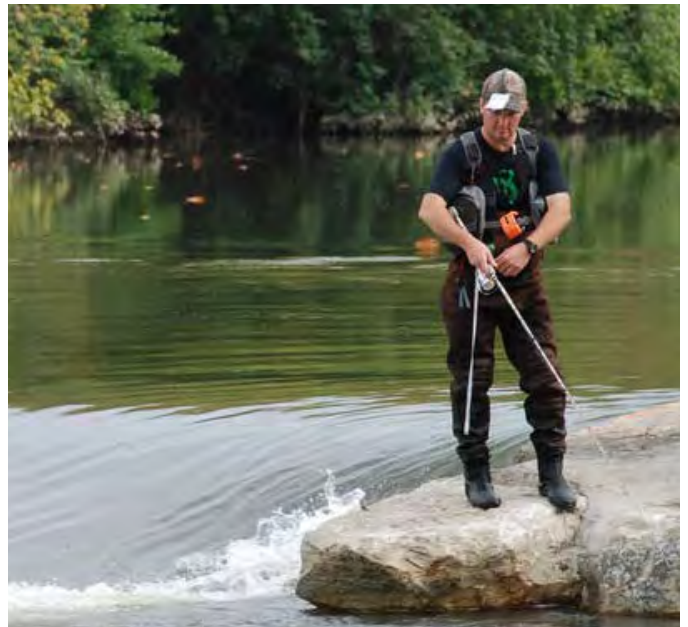
Image 5-12 Example of a durable surface used for river access, helping to prevent erosion, fisheries health and bank destabilization

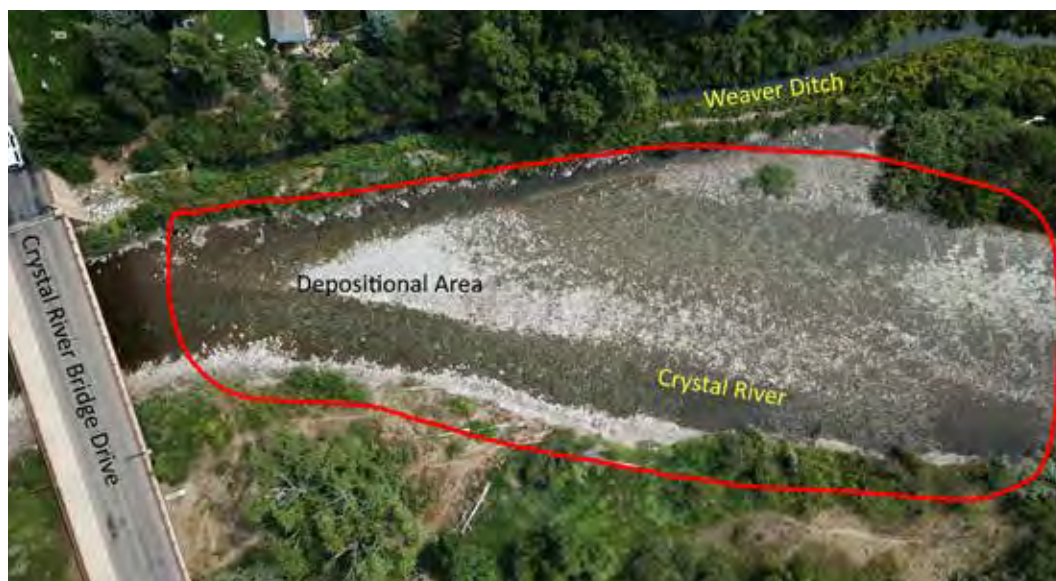
Image 3-2 Alluvium deposition area

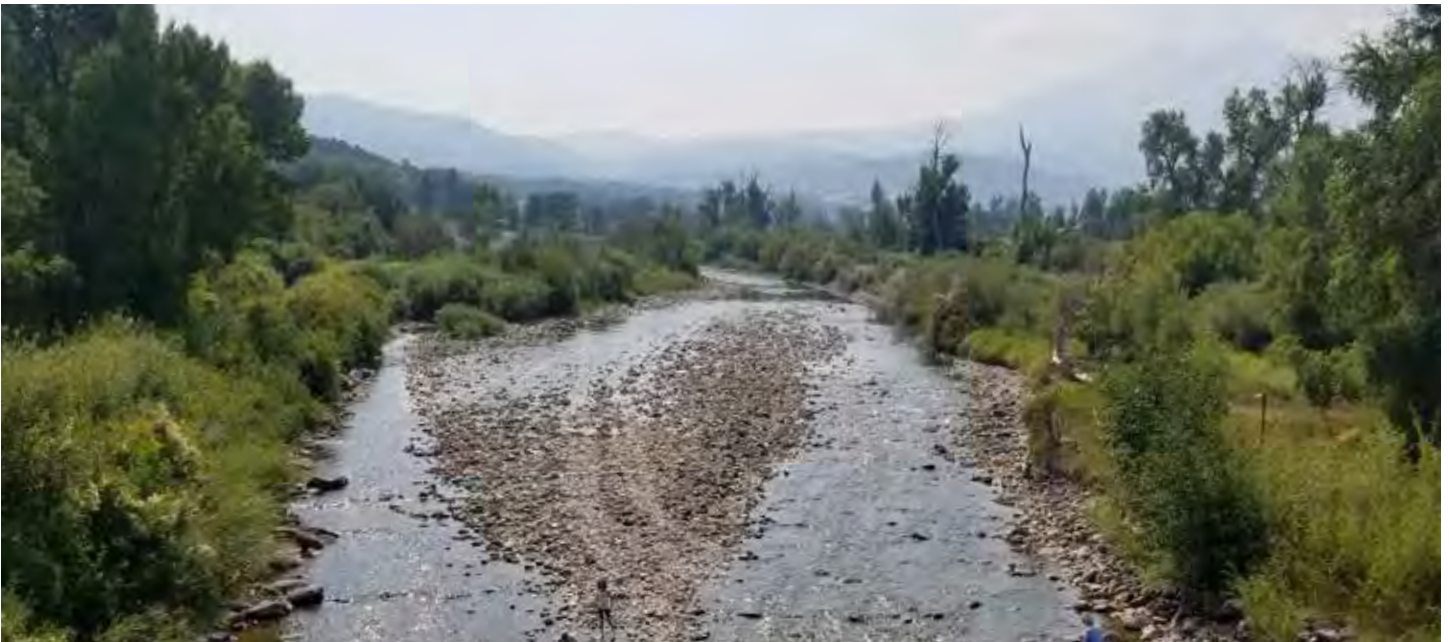
Image 3-7 The wide shallow course of the river through the project area seasonally limits fish habitat and angling potential

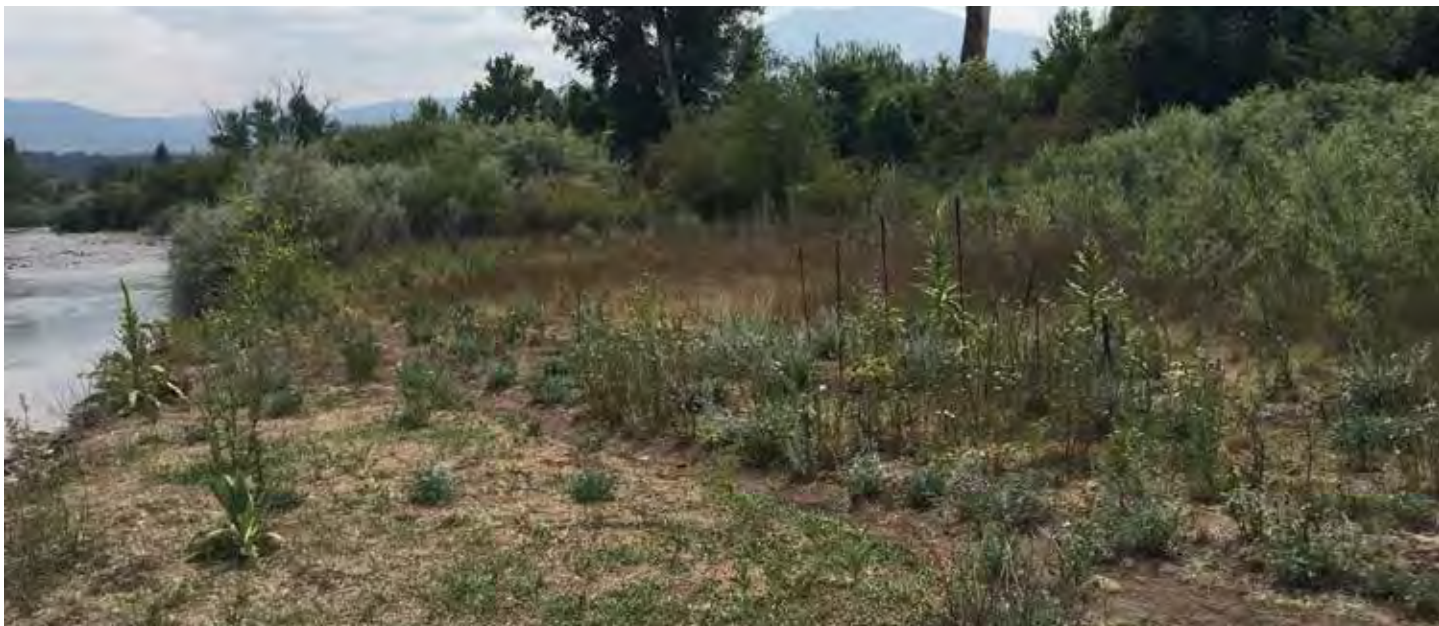
Image 4-1 This image demonstrates highly degraded ecologic conditions near the river on the left side of the photograph. This is an area recommended for riparian creation. Near the center of the photo, healthy forbes indicate an intact wetland which could be enhanced.

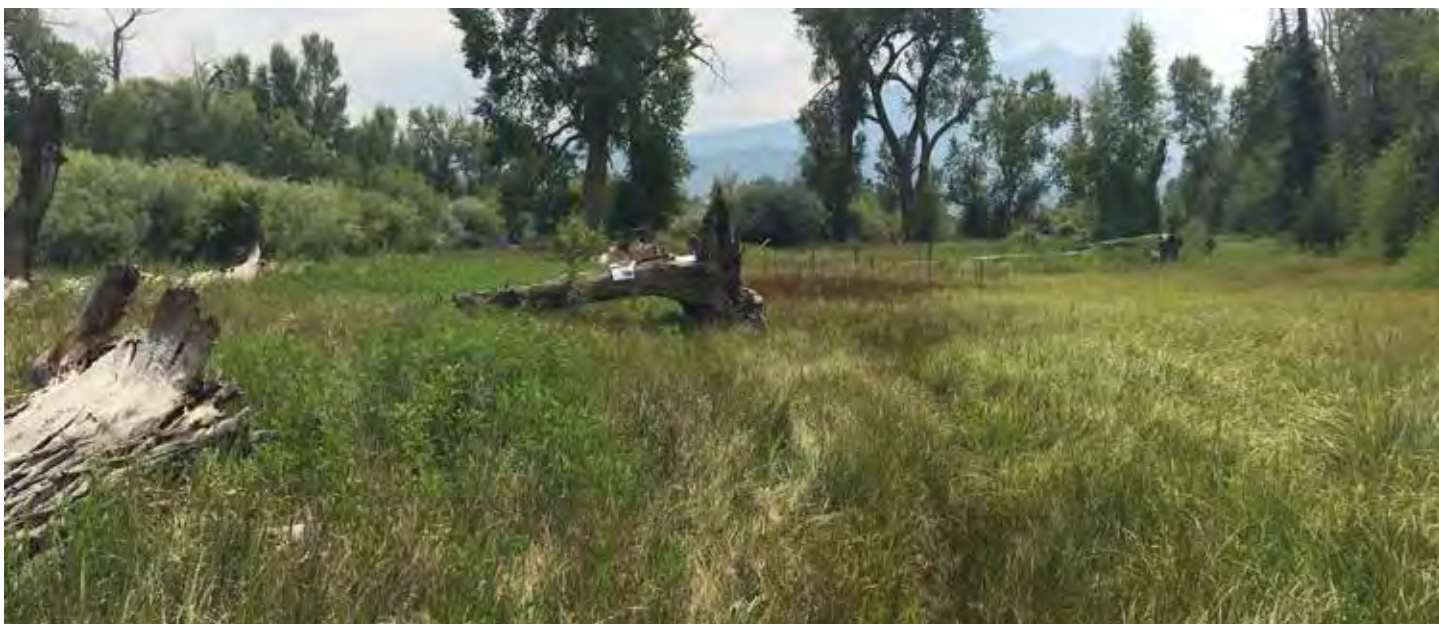
Image 4-2 A high quality wetland can be seen on the right side of the image. This area would be recommended for wetland preservation. On the left side of the image, closer to the Crystal River there is an area recommended for wetland creation

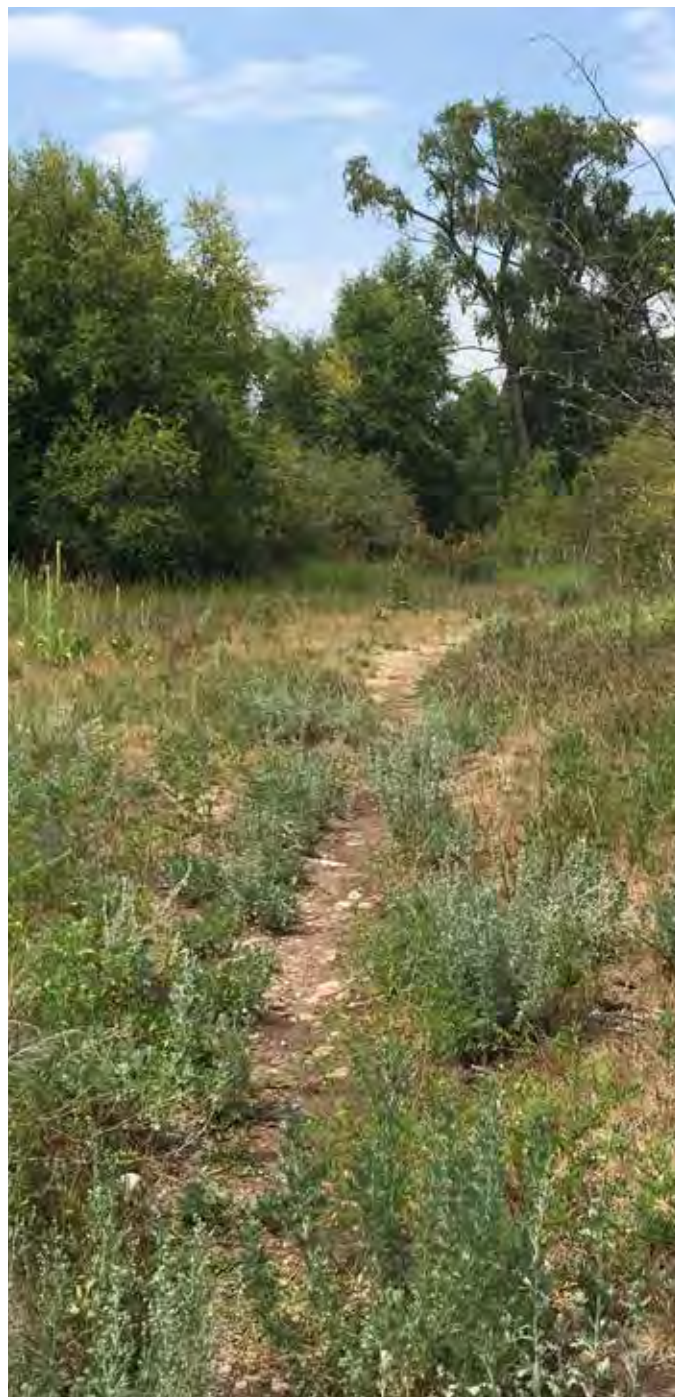
Image 4-3 This location of the assessment area has mature trees and shrubs suitable for riparian preservation. The herbaceous ground cover is mostly noxious weeds making it a candidate for riparian creation

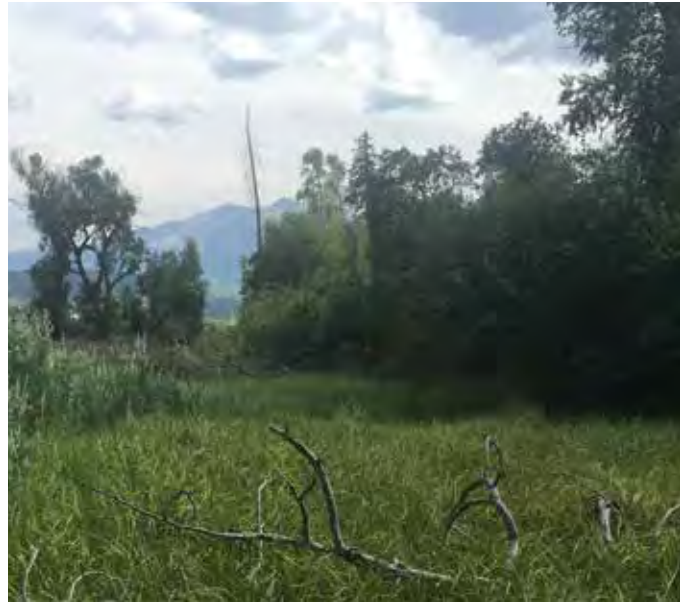
Image 4-4 An example of healthy PER wetlands and riparian shrublands. Both areas are recommended for preservation

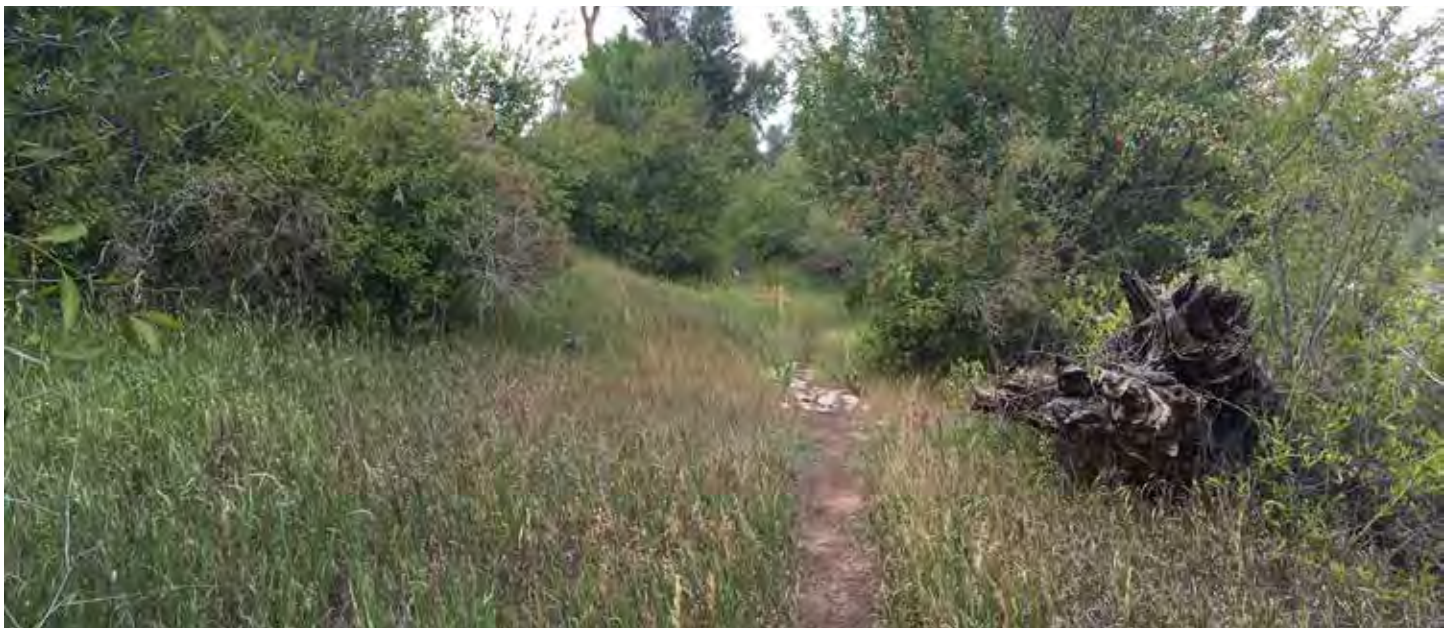
Image 4-5 The shrubs in this image are in good health and these woody vegetated zones are recommended for preservation. The wide swaths of brome in the foreground of the photograph are an opportunity for riparian enhancement.

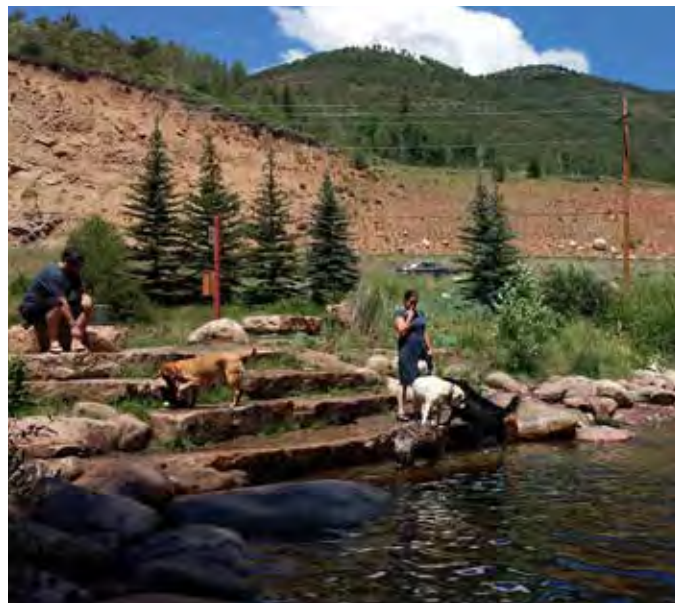
Image 4-6 An example of a bank repaired with boulders and steps

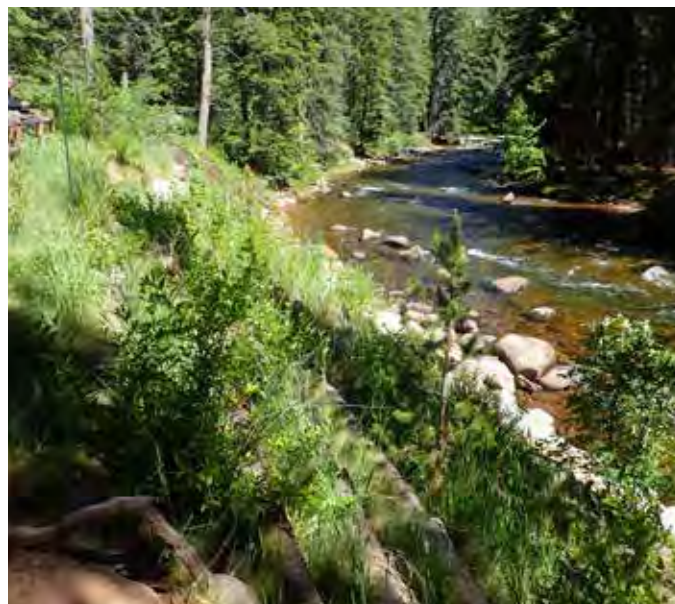
Image 4-7 An example of a bank repaired with vegetation

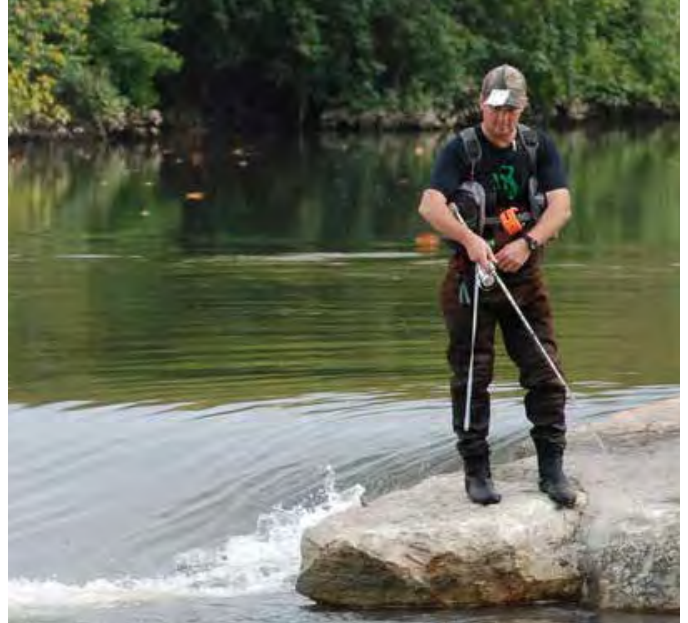
Image 5-12 Example of a durable surface used for river access, helping to prevent erosion, fisheries health and bank destabilization

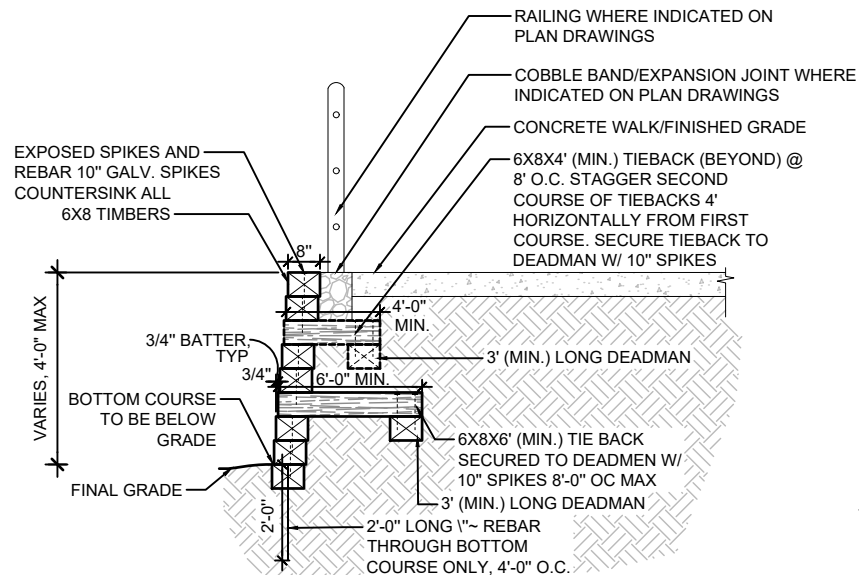
2 TIMBER WALL
D01 SCALE: 1" = 1'-0"

- NOTES:
1. ALL TIMBERS WILL BE 6"x8"x8' SELECT, PRESSURE TREATED, FREE OF MAJOR SURFACE DEFECTS, CRACKS & WARPING.
 2. EACH 8'-0" LENGTH OF TIMBER TO RECEIVE A MINIMUM OF FOUR (4)- 10" GALVANIZED SPIKES (MIN. 2" O.C.). SHORT LENGTHS WILL RECEIVE AS MANY SPIKES AS NECESSARY TO PROPERLY SECURE TIMBERS. STAGGER TIMBERS AT JOINTS 2'-0" MIN.
 3. THE ABOVE IS A STANDARD DETAIL AND ASSUMES SUITABLE SOIL CONDITIONS IN ABSENCE OF A GEOTECHNICAL REPORT.

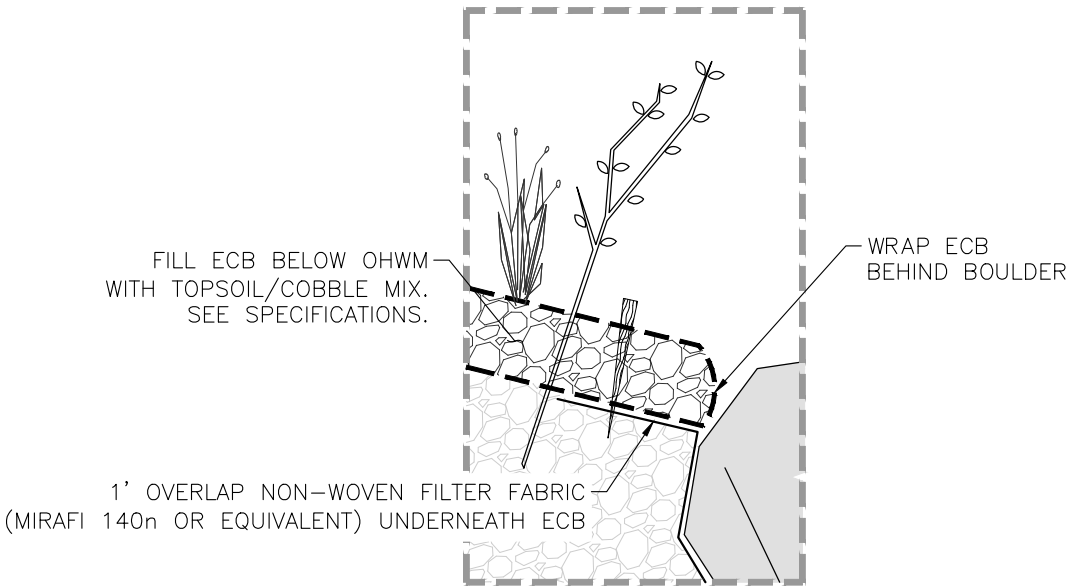
ENLARGEMENT 1: INTERFACE BETWEEN ECB AND FILTER FABRIC WRAP

- EROSION CONTROL BLANKET (ECB) SHALL BE COARSE BIODEGRADABLE WOVEN COIR 700 OR EQUIVALENT. ECB SHALL BE ANCHORED AND MODIFIED FOR PLANTINGS PER LANDSCAPE ARCHITECT DIRECTION. SEE SHEET D11.
- SEED, STRAW MULCH, AND BONDED FIBER MATRIX ARE TO BE INSTALLED BELOW ECB, RE: LANDSCAPE ARCHITECT. TO THE GREATEST EXTENT POSSIBLE, LMIT ACTIVITY IN THESE ZONES POST-SEEDING.

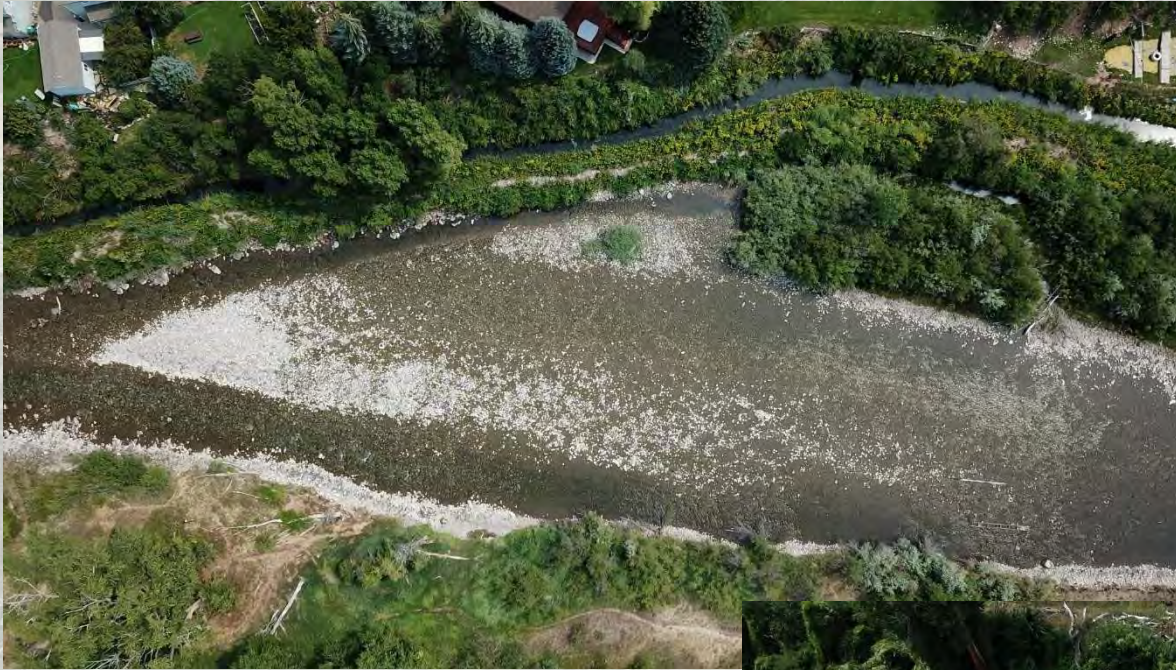
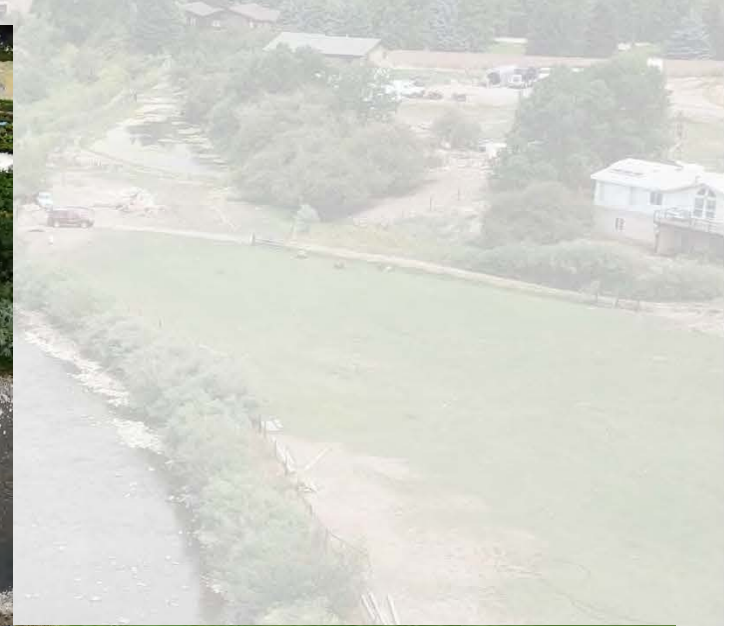
Channel widening due to sediment deposition and lack of upland vegetation has resulting in significant bank erosion.

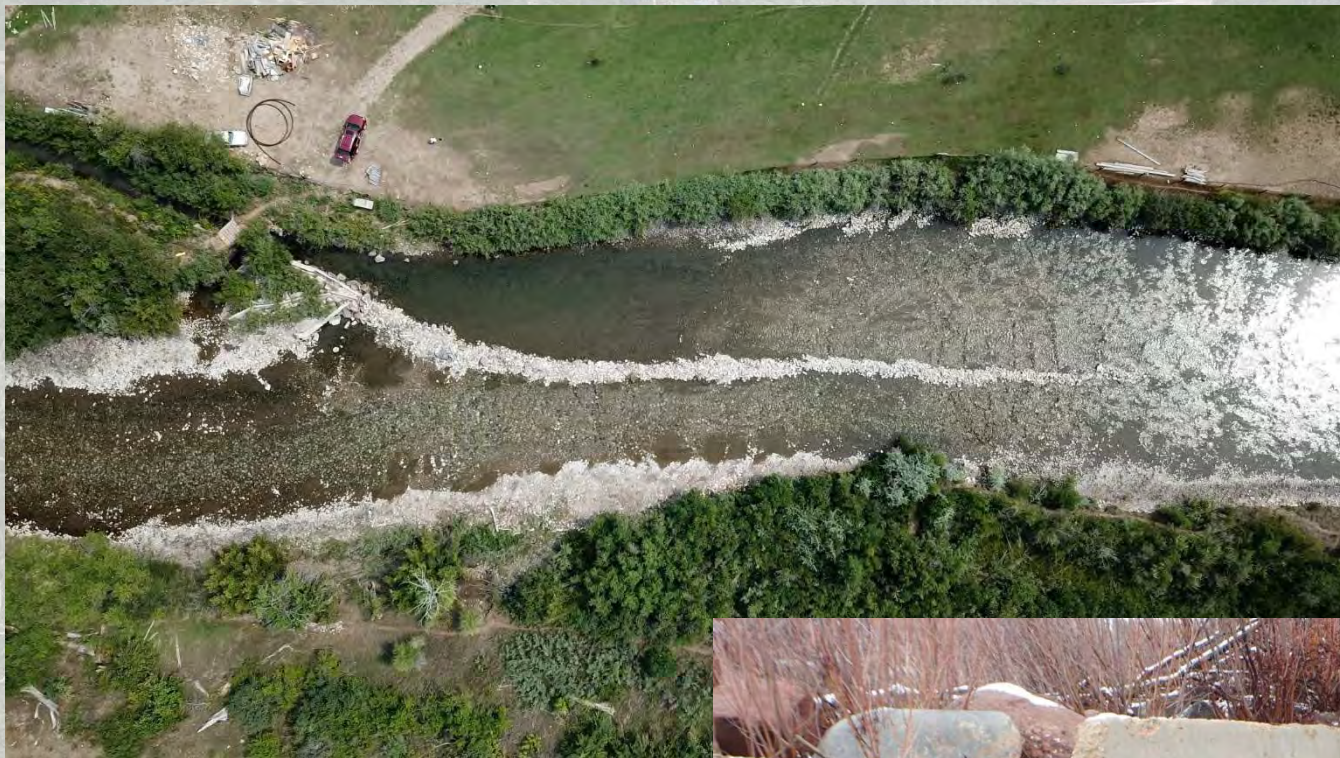
Above - Weaver Diversion requires annual channel disturbance for push up dam.
Right – headgate entrance with degrading concrete traffic barrier.

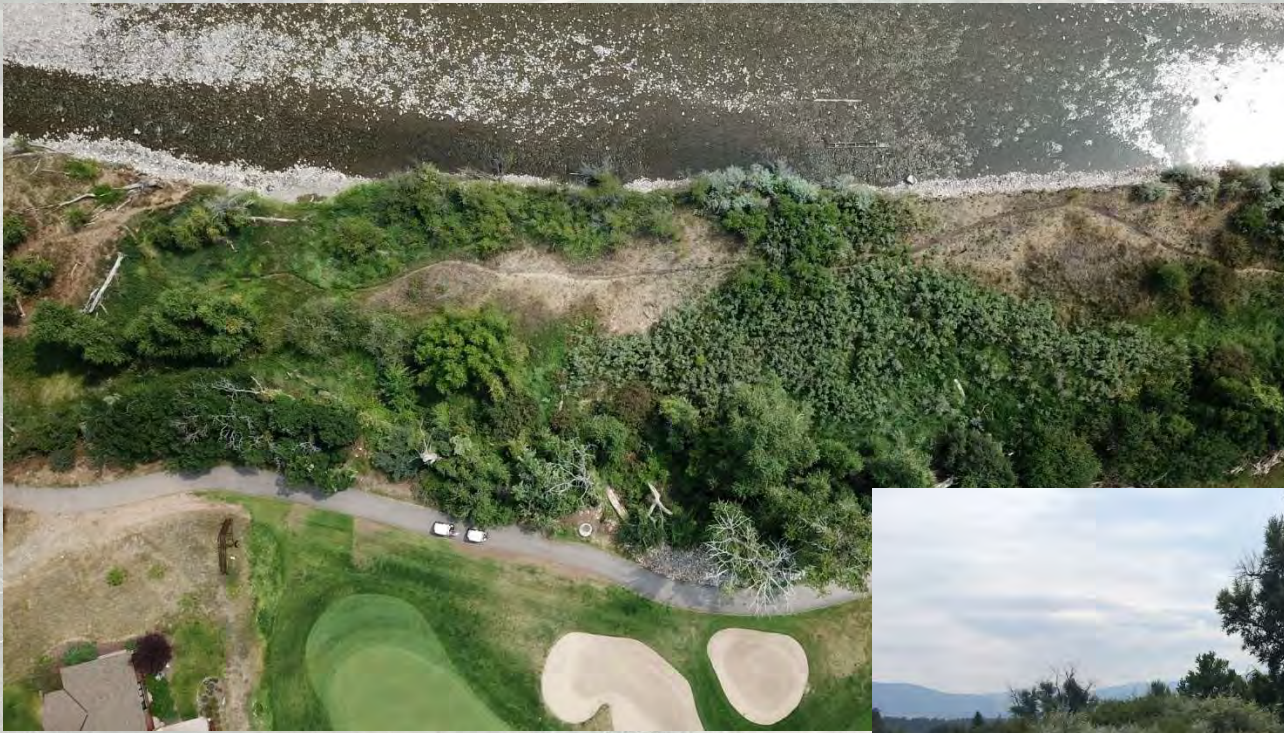
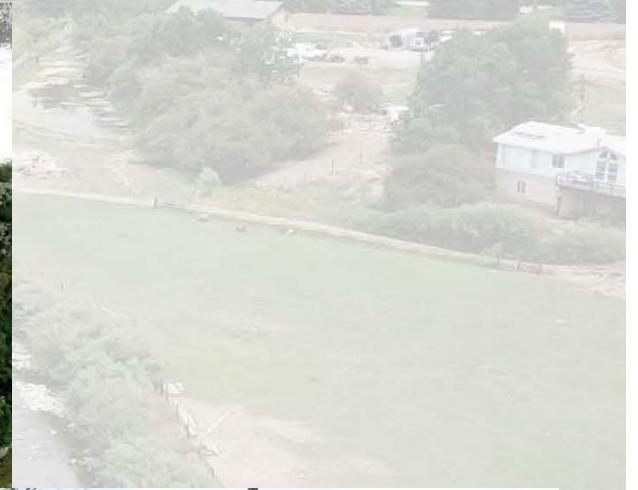
Degraded upland area near north end of project. Invasive vegetation will be removed and replaced with native plants.

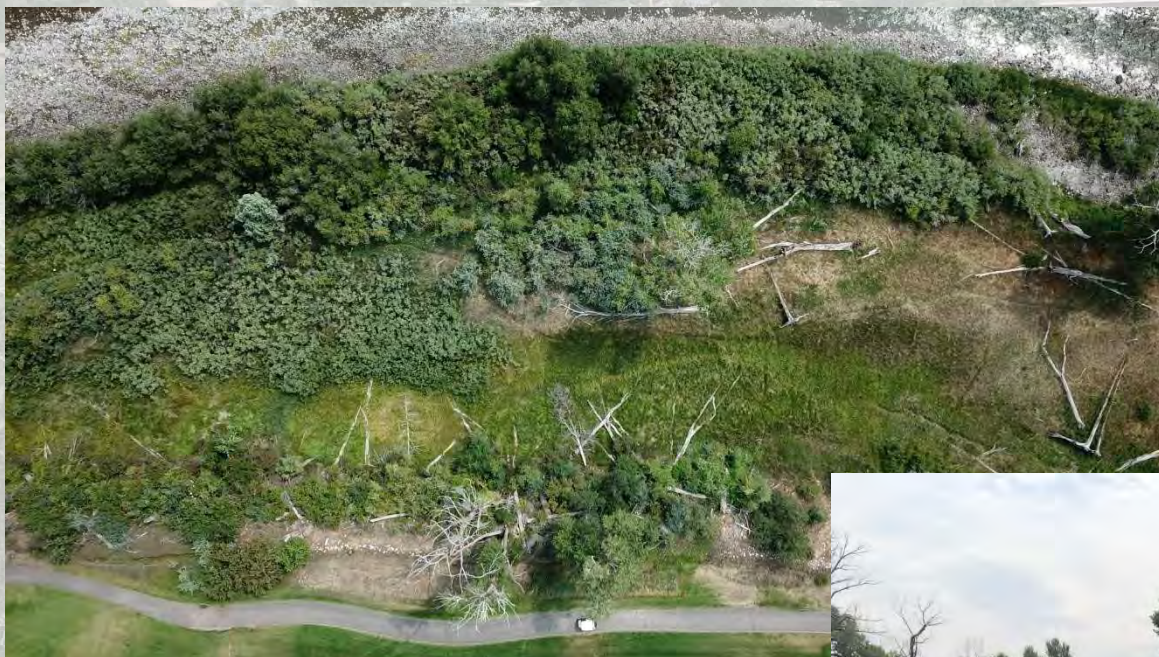
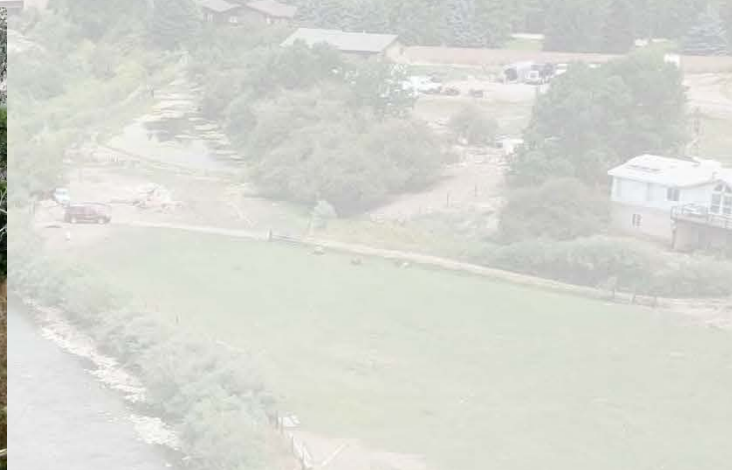
Mature cottonwood and wetland area near south end of project. Area like these will be enhanced or protect as-is.
