**Colorado Watershed Restoration
Program Application**

PROJECT SUMMARY SHEET	
Project Title	Resilient Headwaters Planning Project
Location	Boulder County: Boulder Creek watershed
Grant Request	\$375,264
Cash Match Funding	\$355,264
In-Kind Match Funding	\$20,000
Grant Type	Watershed Restoration Grant (watershed protection & monitoring)
Name of Grantee	Boulder Watershed Collective
Mailing Address	1740 Fourmile Canyon Drive, Boulder CO 80302
Position/Title	Maya MacHamer- Director
Email	maya@boulderwatershedcollective.org
Phone	303-817-2261

Monitoring Plan for Big Thompson and Fourmile Watershed Flood Recovery Projects

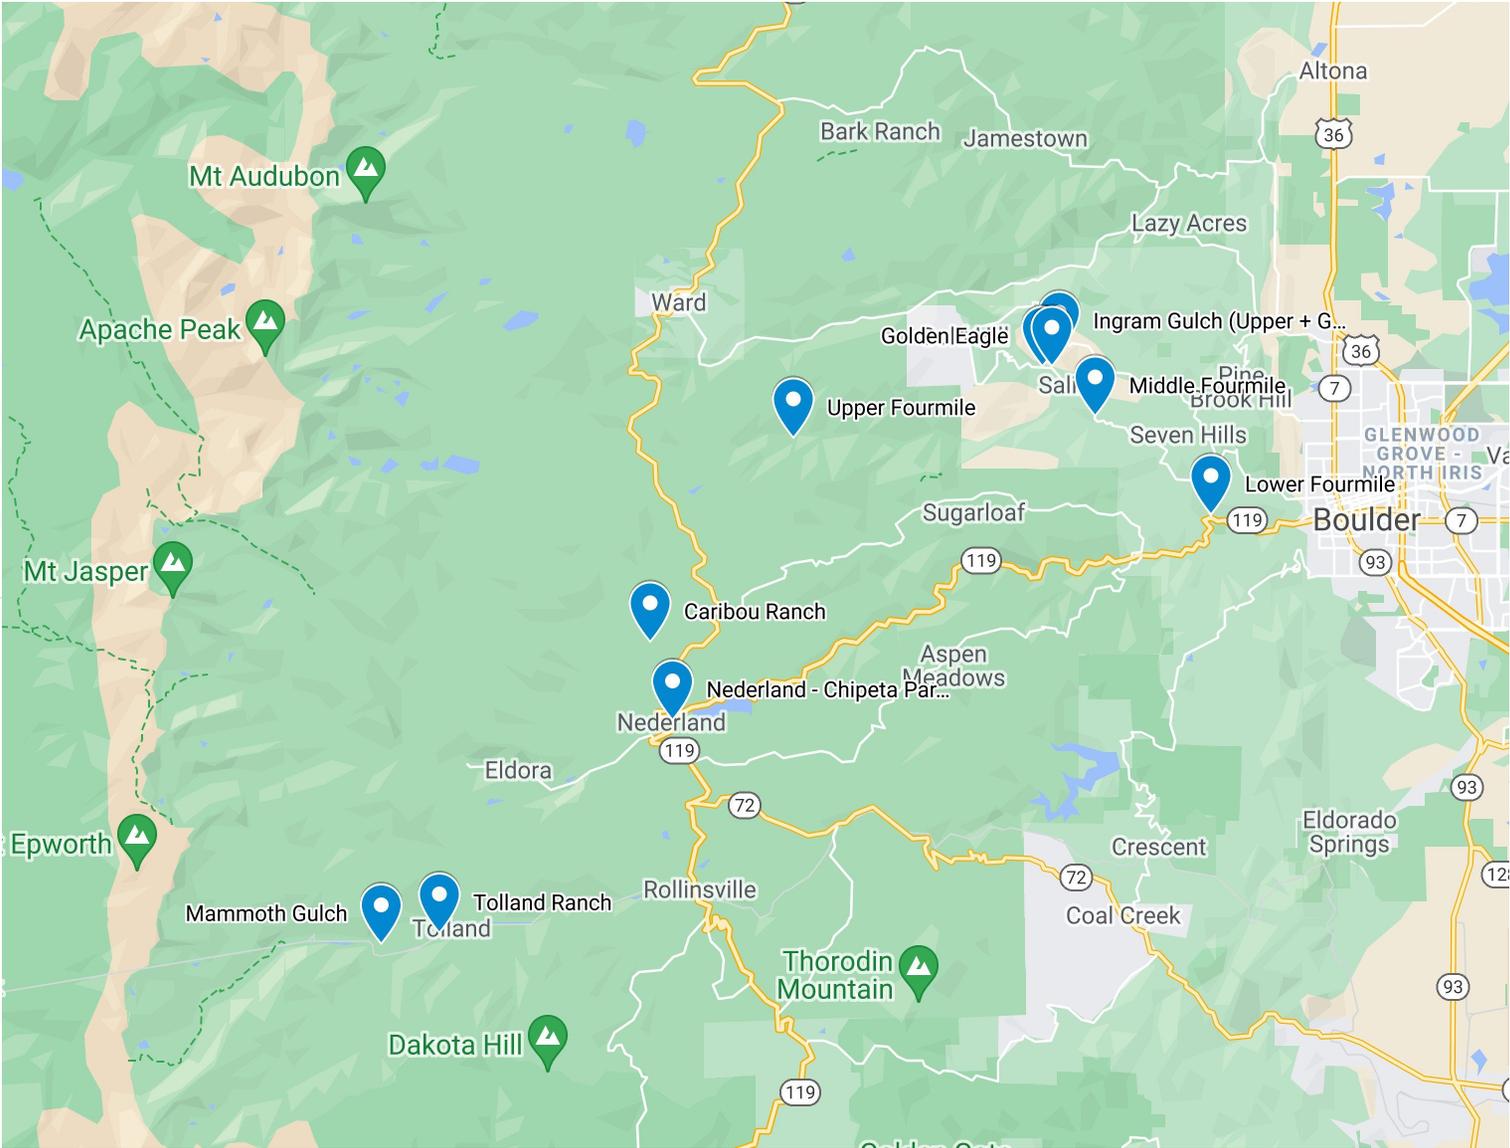
Monitoring Sites

- Lower Fourmile
- Middle Fourmile
- Upper Fourmile
- Ingram Gulch (Lower)
- Golden Eagle
- Ingram Gulch (Upper + GG)
- Caribou Ranch
- Nederland - Chipeta Park
- Tolland Ranch
- Mammoth Gulch
