## **Rocky Mountain Field Institute**

### ***Enhancing Resiliency in Critical Riparian Areas through Continuation of Willow Propagation Program – Final Report***

**Number: POGG1 PDAA 201700000767**

**June 30, 2018**

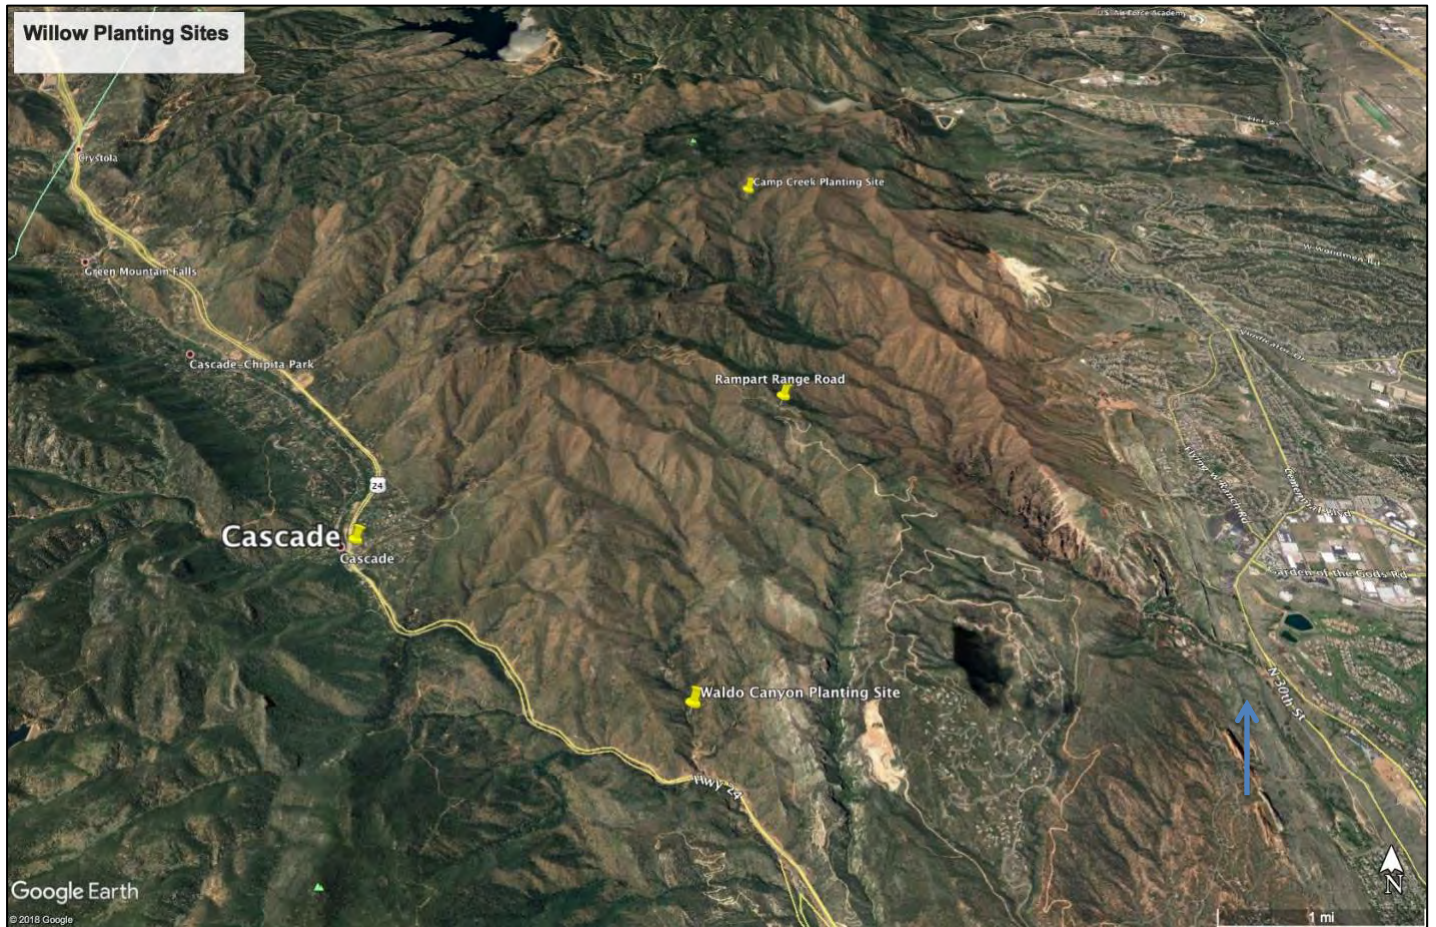
**Figure 1.** Planting areas within the Waldo Canyon Fire burn scar. Highway 24 can be viewed immediately south of the planting areas. The City of Manitou Springs is located approximately 2 miles southeast of the Waldo Canyon planting location.

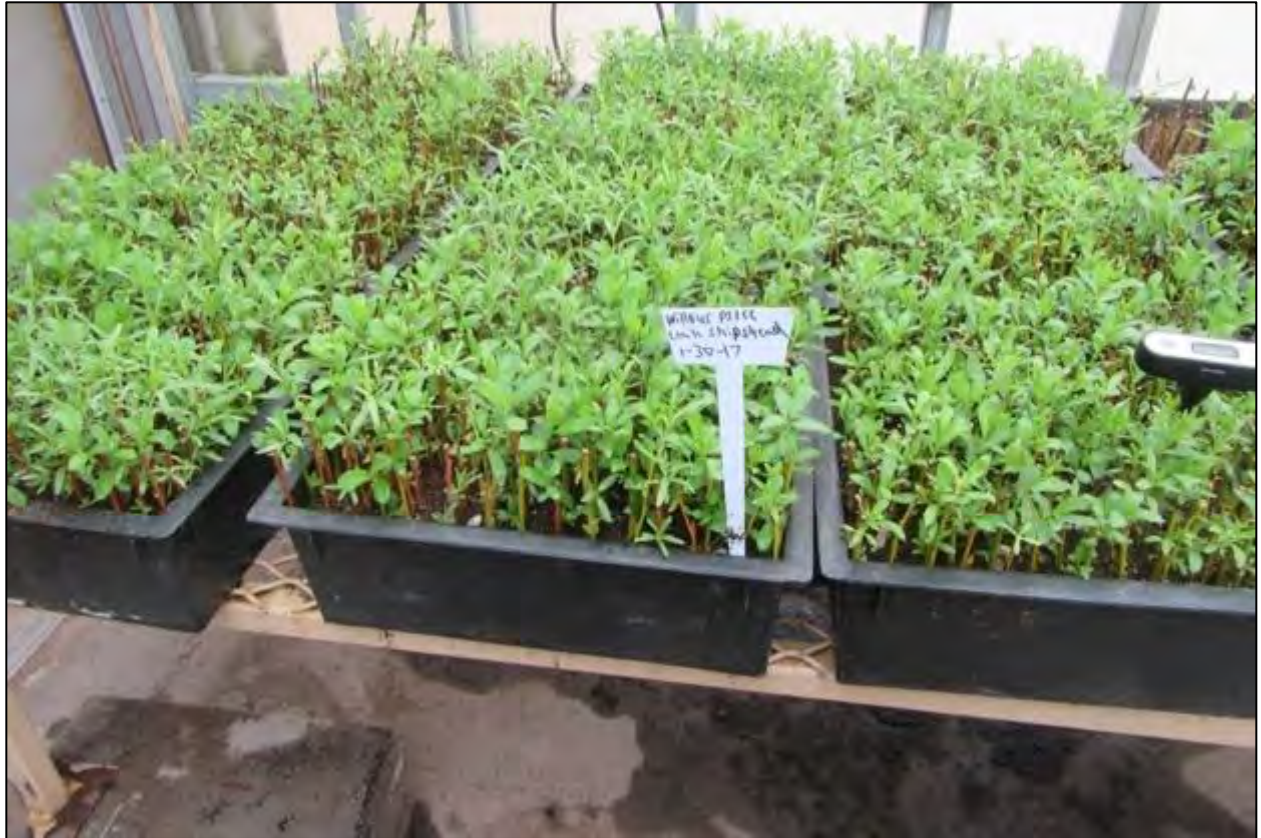
Figure 2. Willows cut to 1-foot segments and planted in containers at the Bessey Nursery in Halsey, Nebraska.

- On January 19, 2017, RMFI and USFS staff harvested dormant willow cuttings along the Pikes Peak Highway north and south of the Crow Gulch Picnic Area (Figure 2).

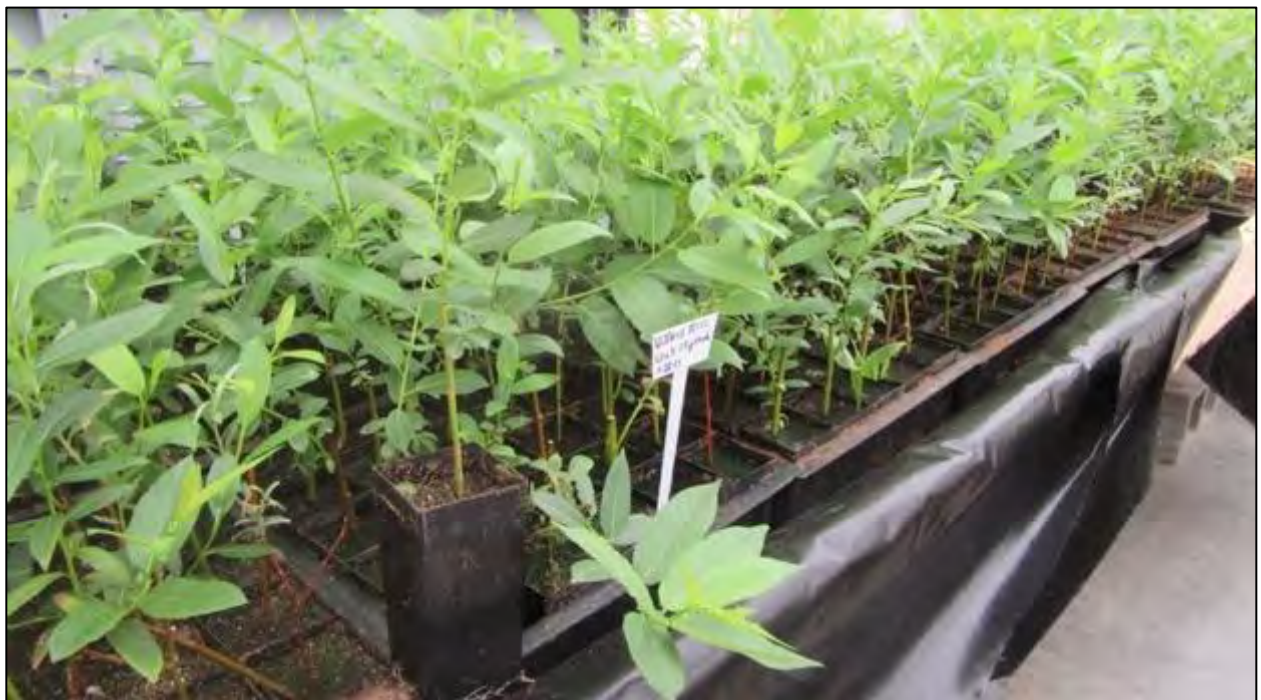
Figure 3. Willows transplanted into individual pots to continue growth and root maturation.

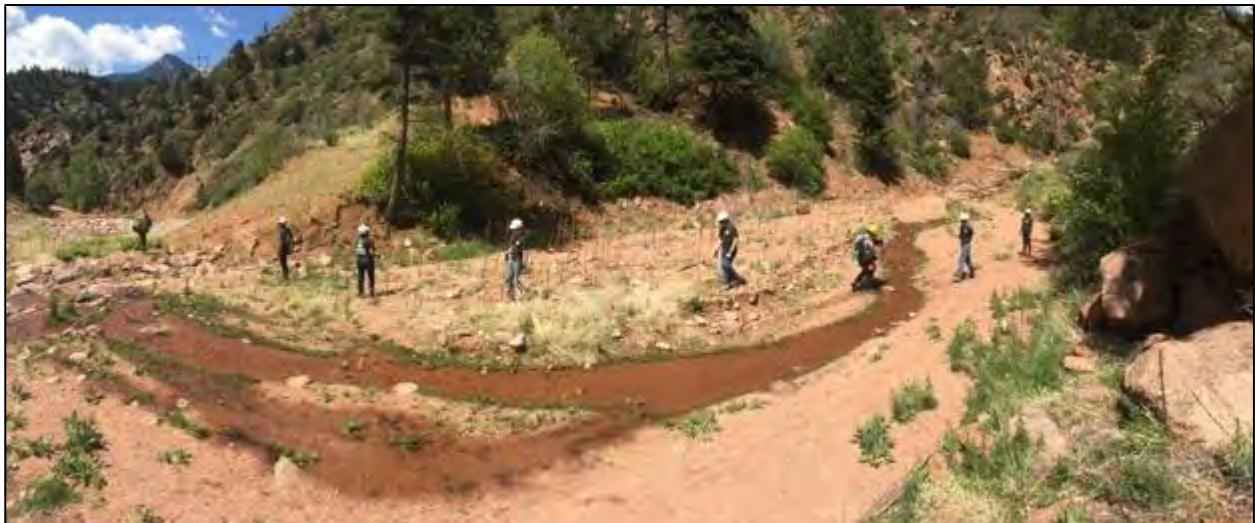
Figure 4. MHYC members help transport willows to the planting location in Waldo Canyon.

- On May 31, 2017, RMFI, the USFS, a Mile High Youth Corps (MHYC) crew, and 15 community volunteers transported 2,000 willows from the staging area off of Highway 24 and into the Waldo Canyon drainage (Figure 4). The drainage was divided into 11 sections over approximately 1,321 ft. to facilitate future monitoring efforts measuring willow survivability. The start and end of each segment was recorded with GPS waypoints. Leah Shipstead, USFS Hydrologist, completed a willow planting demonstration with all on-hand to ensure adequate planting depth and contact with the water table (Figure 5). The group then split up and began planting the willows within each of the 7 drainage sections. Approximately 600 plants were planted on May 31; the MHYC completed the willow planting that same week.

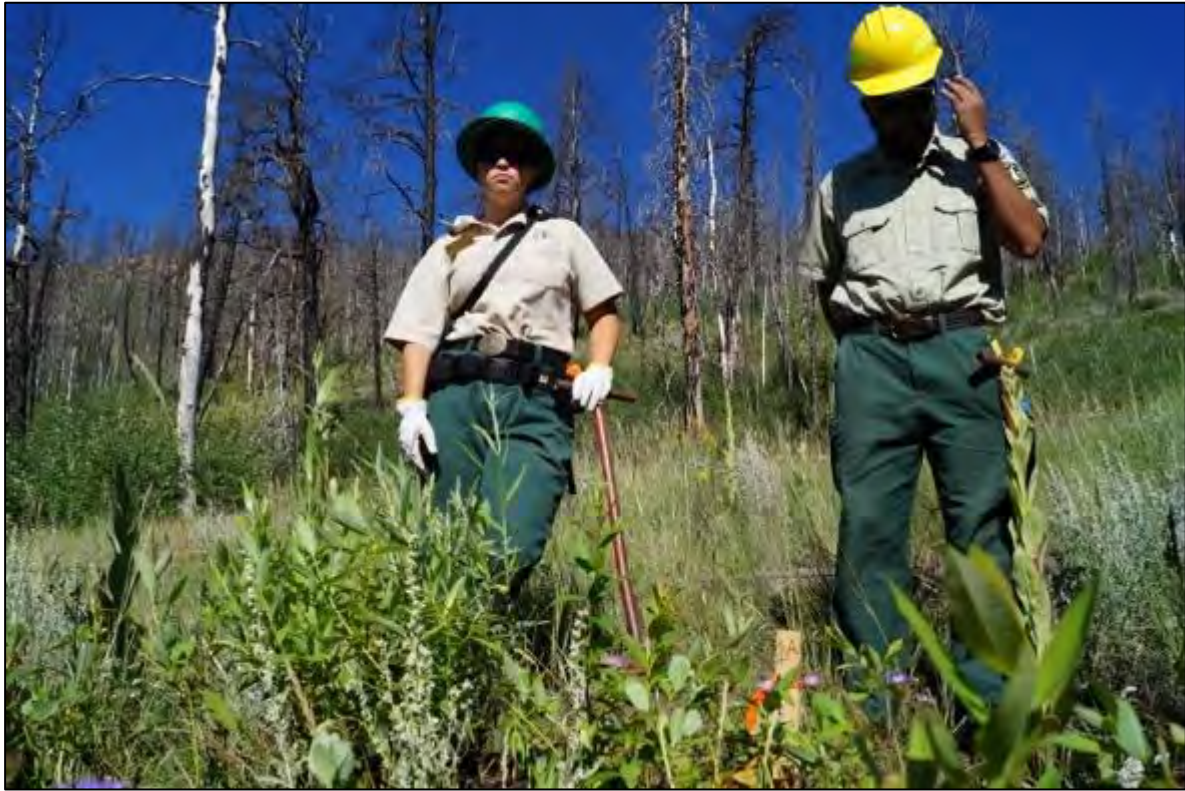
Figure 5. During the August planting, Leah Shipstead, USFS District Hydrologist, instructs volunteers on how to effectively plant the willows in the Camp Creek drainage to ensure adequate planting depth and contact with the water table.

The second planting of 850 willows took place over the course of two volunteer events in late August. This planting took place in the same section of the Camp Creek drainage as the planting in 2016. Leah Shipstead, again completed a willow planting demonstration to ensure adequate planting depth and contact with the water table (Figure 5). On August 18<sup>th</sup>, 13 volunteers planted 400 willows and on August 19<sup>th</sup>, 26 volunteers planted the remaining 450 willows (Figure 6) in addition to removing 40, 22-gallon bags of Canadian thistle (*Cirsium arvense*). Over the course of the two volunteer events, 39 volunteers worked for a total of 332 hours.

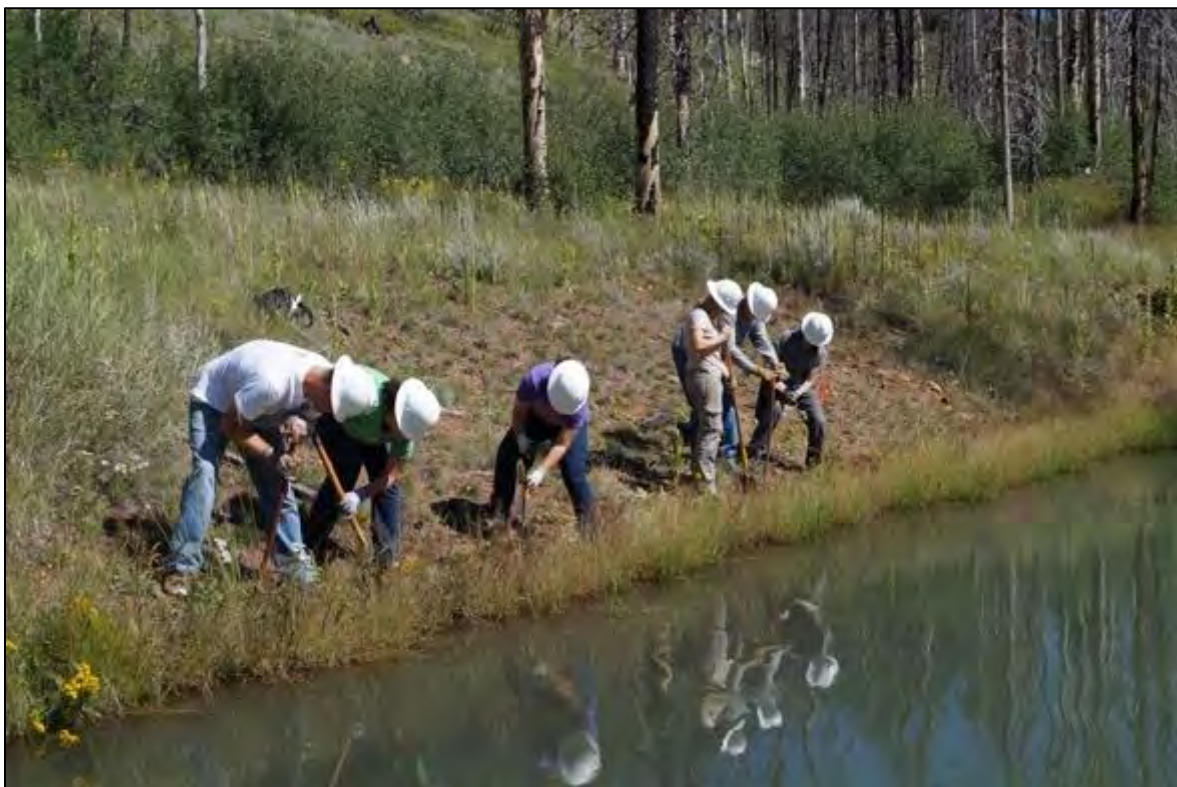
Figure 6. During the August planting, volunteers plant in Reach 0 in the Camp Creek drainage.

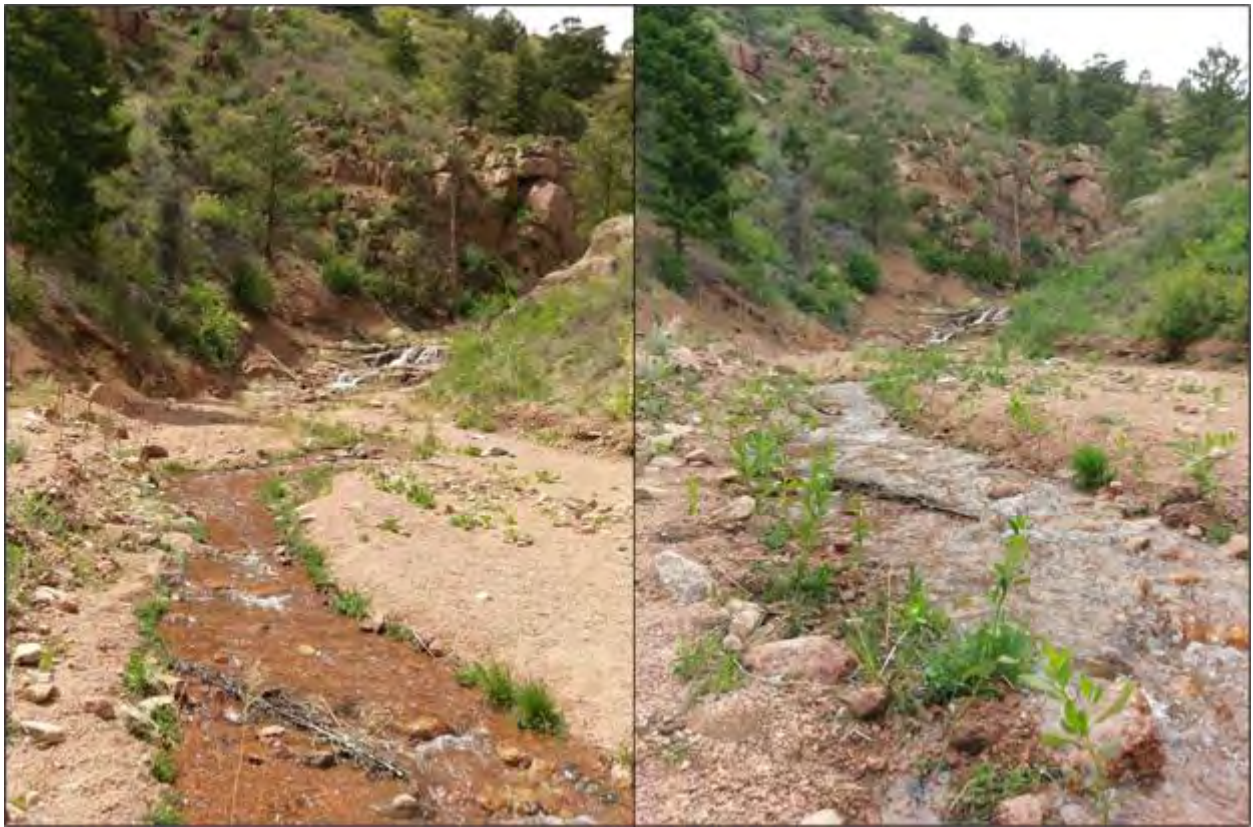
- One single dead willow was found at Site 6, likely because of its placement (located between rocks far away from any soil or water). The others found at Site 10 are likely due to the low water table but, may also have something to do with the abundant knapweed. Site 10 is the location with a sediment detention basin. The water had flowed subsurface through the majority of the reach.

Figure 7. Before and after photo showing the bottom of Reach 10 in the Waldo Canyon drainage. Photos were taken on the day of the planting, May 31, 2017.

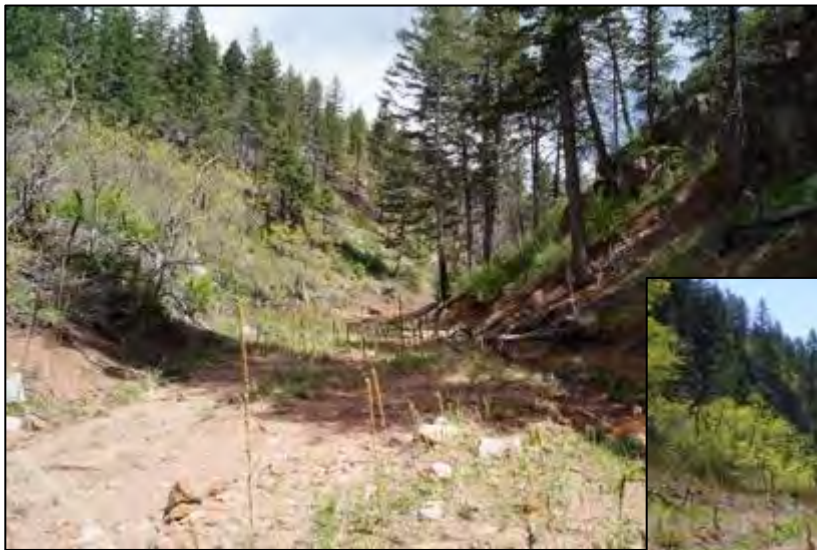
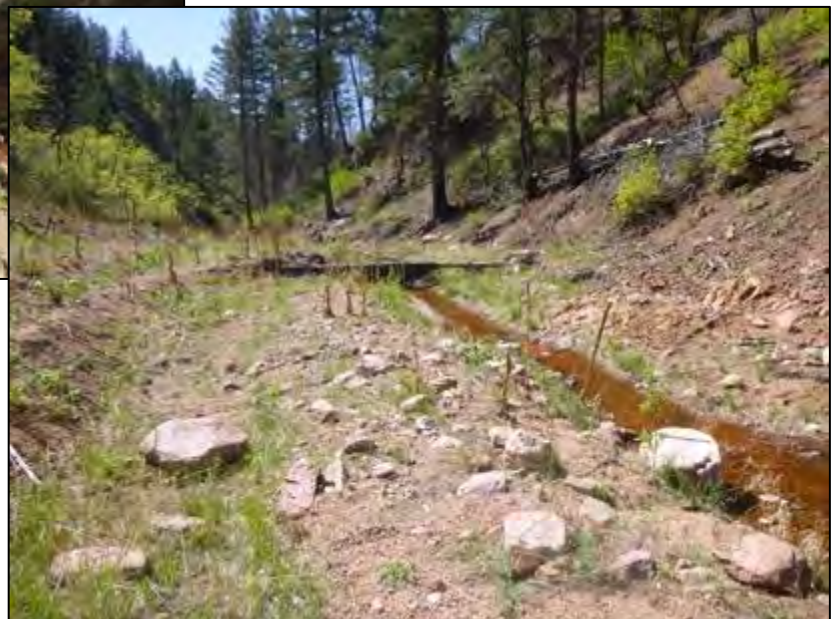
Figure 8. Before and after photo showing the bottom of Reach 4 in the Waldo Canyon drainage. Photos on the left was taken on the day of the planting, May 31, 2017. The photo on the right was taken on May 18, 2018.

After close observation by USFS and RMFI staff, it was determined the mortality rate for Waldo Canyon is less than 5%. At Site 10, the mortality rate is closer to 5% and will likely increase into the fall and next year. Monitoring will continue after the CWCB grant expires in June 2018 as willow survivability cannot be adequately assessed until 3 years post-planting. See pre/post photo of planting in Figure 8 and 9.

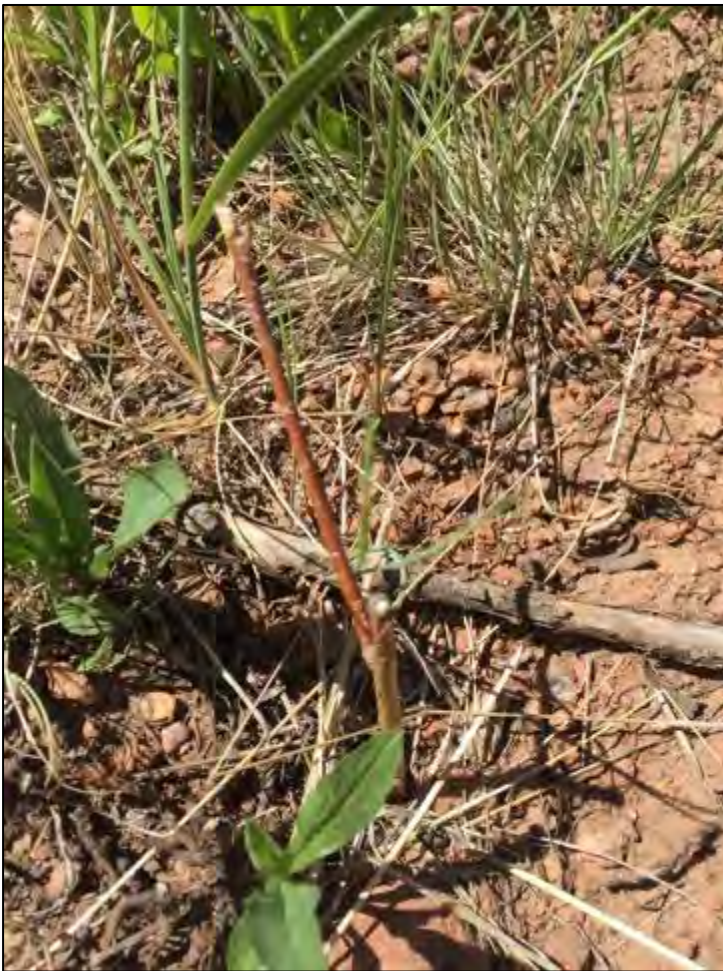
- Some of the willows in Waldo appeared dead but, their roots were still holding the soil well. Although they may not survive another year, they were not yet considered dead.

Figure 9 (left): Willow plant that appears dead however still has intact root system. This willow may likely send out shoots from the roots.

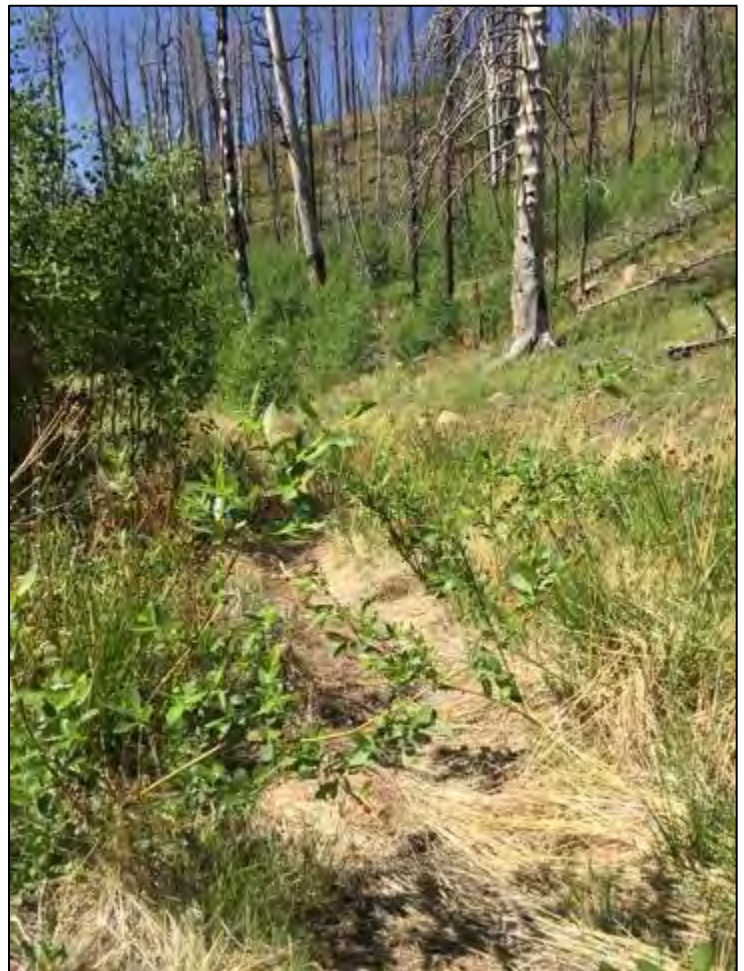
Figure 10 (right): Healthy willow growth in Reach 2.

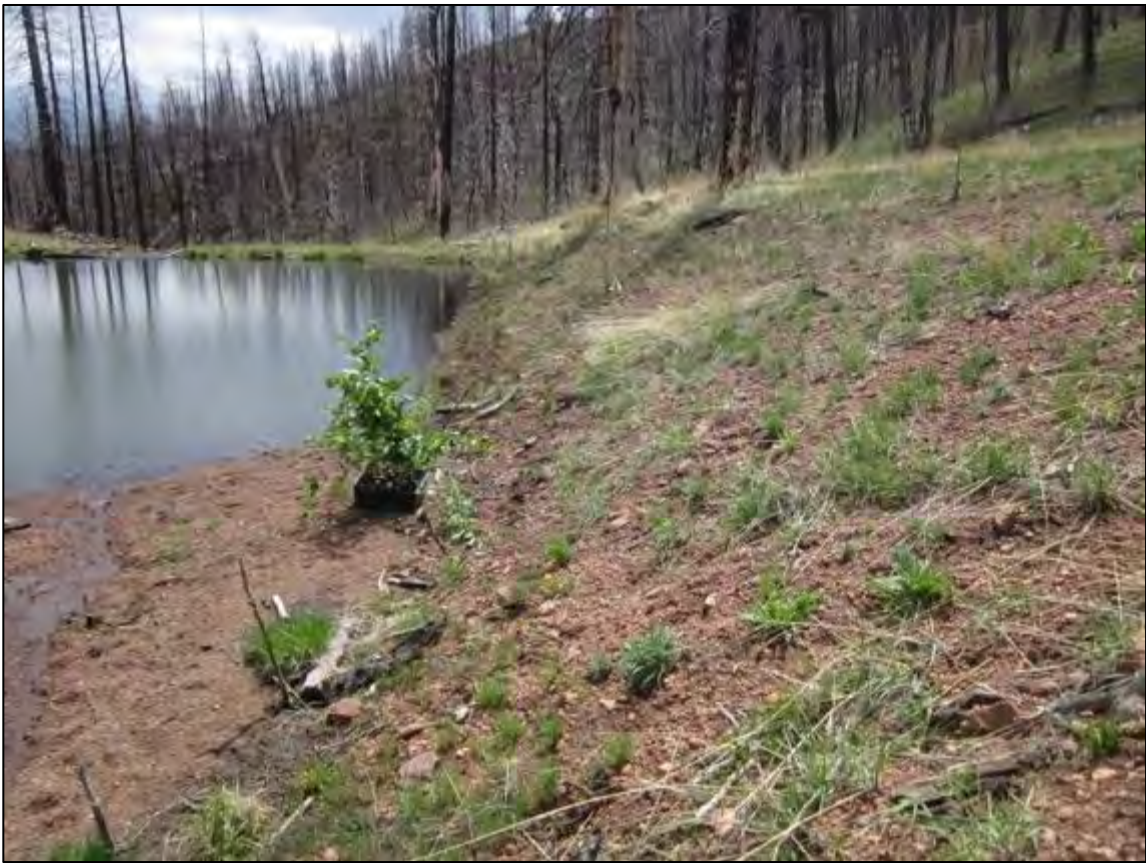
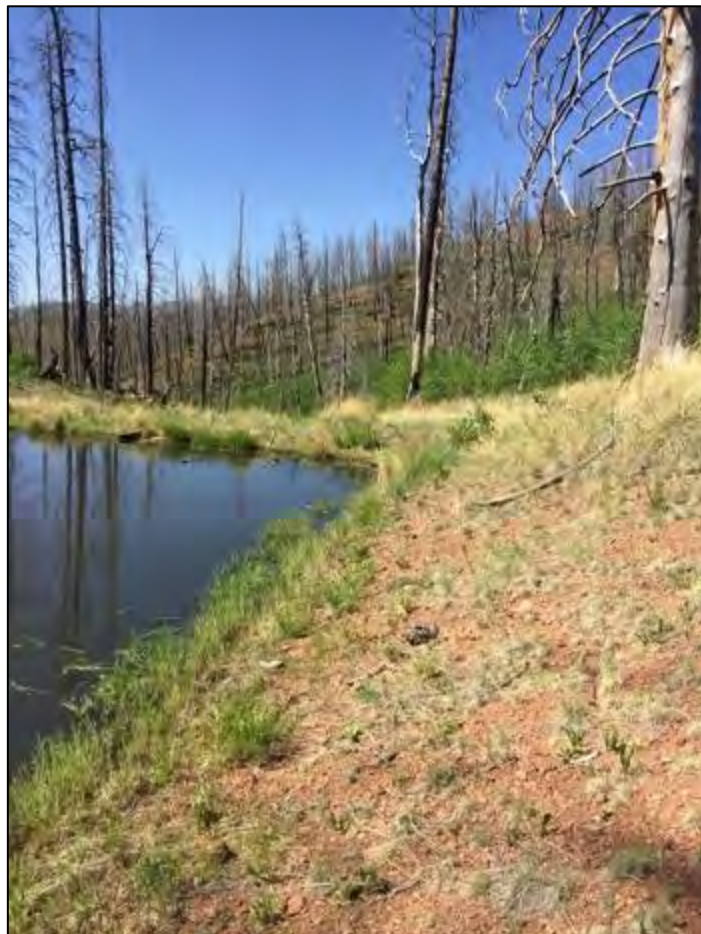
Figures 11 & 12: Reach 1 at Camp Creek Drainage. Above photo taken in May of 2016. Below photo taken in June of 2018.

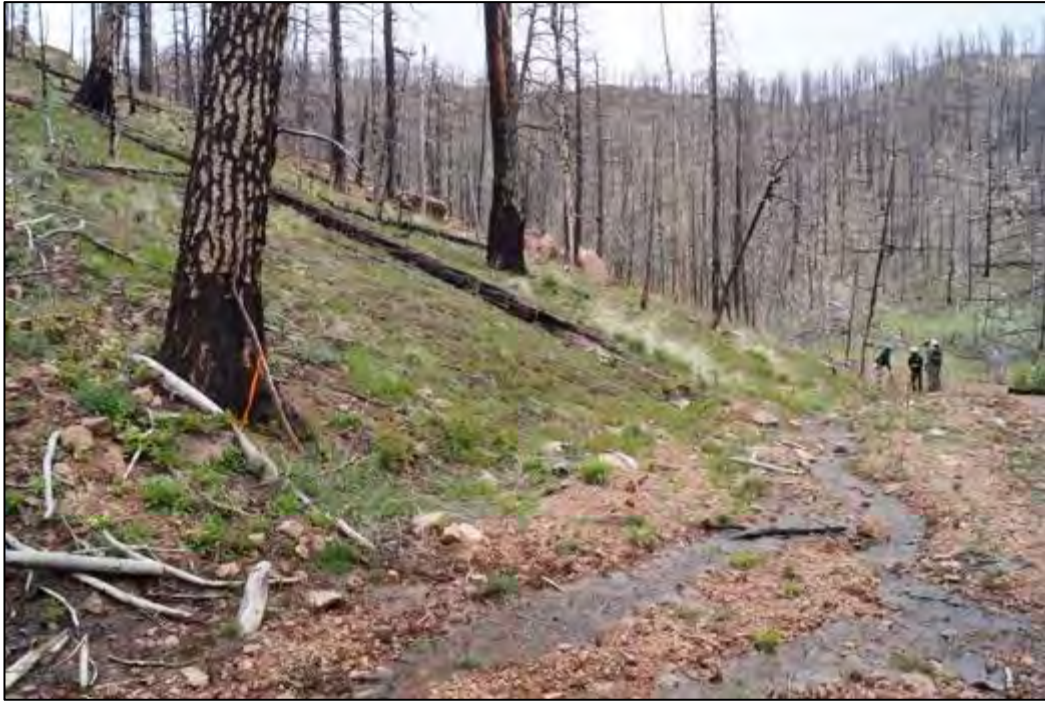
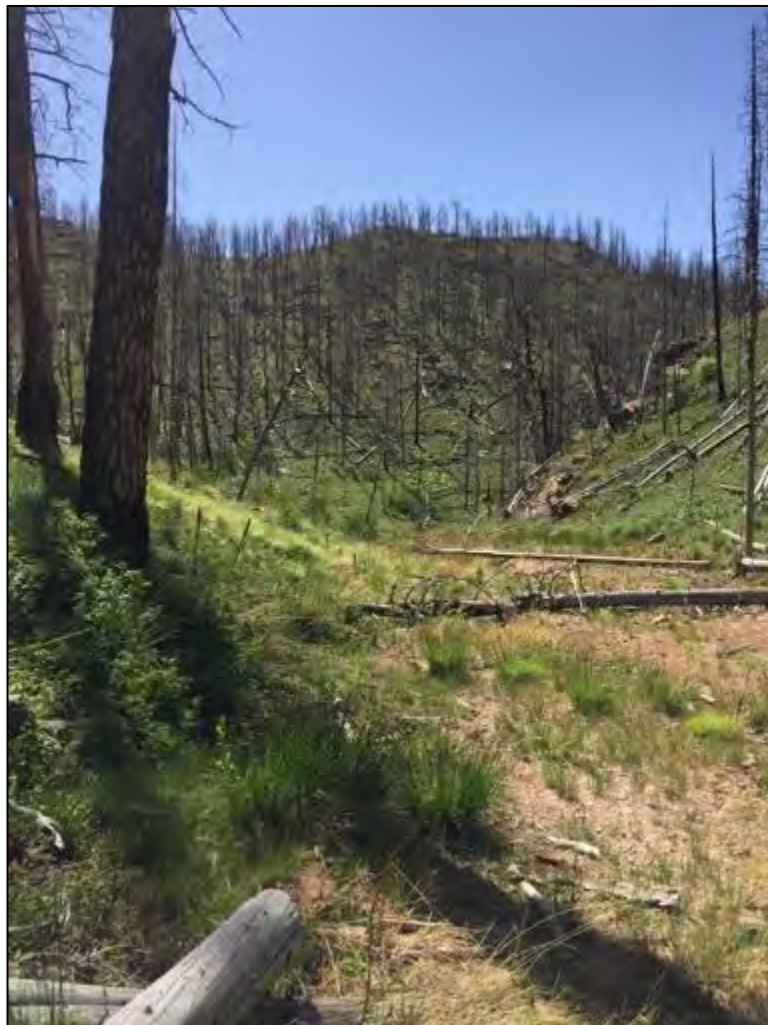
Figures 13 & 14: Reach 8 at Camp Creek Drainage. Above photo taken in May of 2016. Below photo taken in June of 2018.

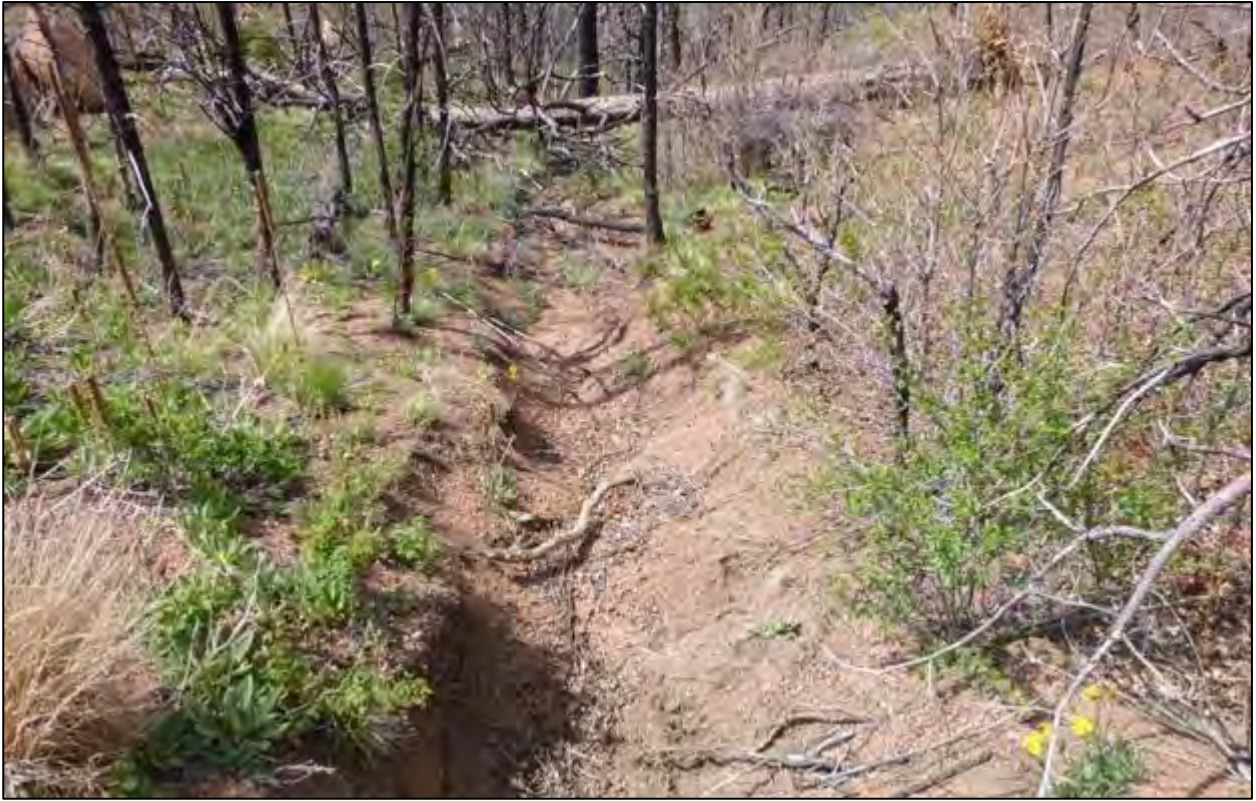
Figures 15 & 16. Before and after photo (top and bottom) showing construction of a debris filter within an eroded drainage of Waldo Canyon.

- RMFI contracted 2 weeks of MHYC beginning on May 30 and ending on June 9, 2017. In addition to planting willows in the Waldo Canyon drainage, the crews stabilized 3 head cuts and built 9 additional erosion control and stabilization structures including debris filters and log step falls, (Figures 15 - 20). In total, 10 MHYC crew members and 4 RMFI staff were engaged in the project during the 2 weeks of contracting. The MHYC crew and RMFI staff spent a combined total of 918 hours on the stabilization project over the course of 8 workdays.

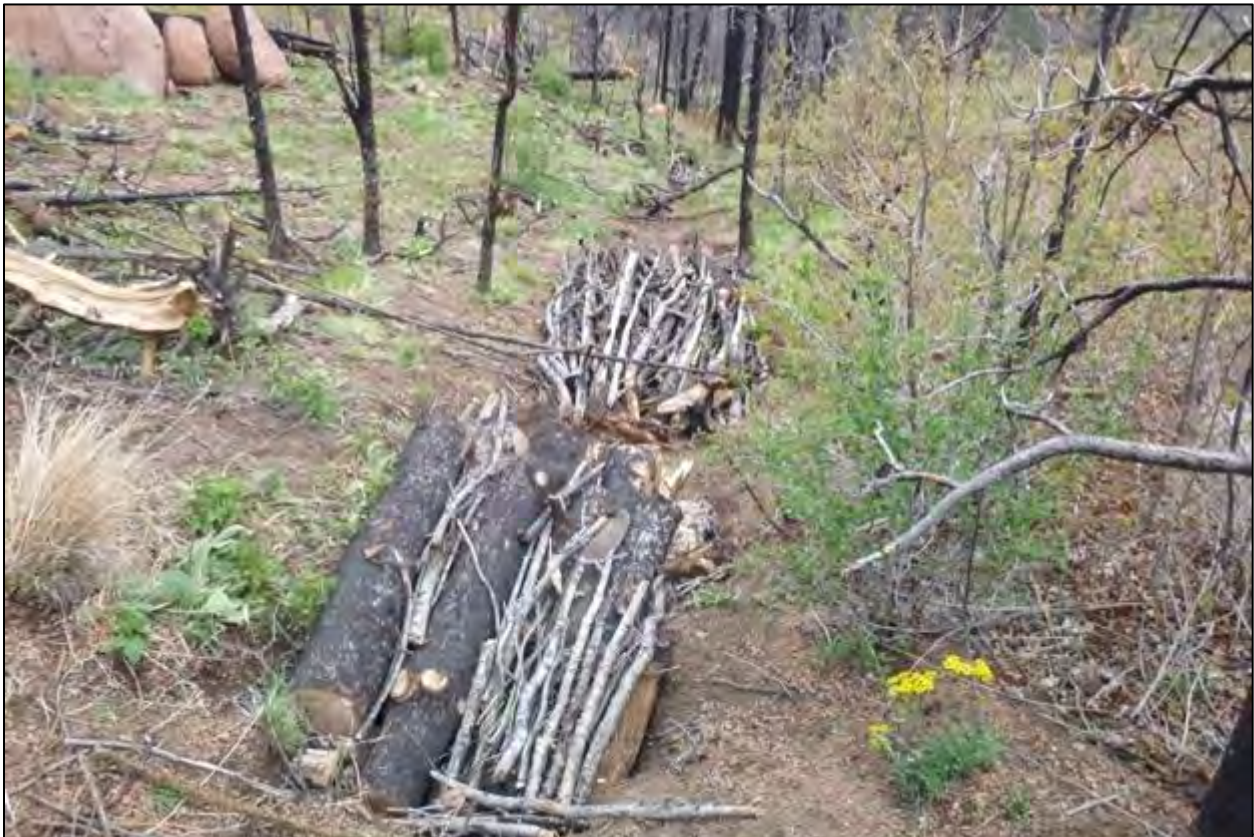
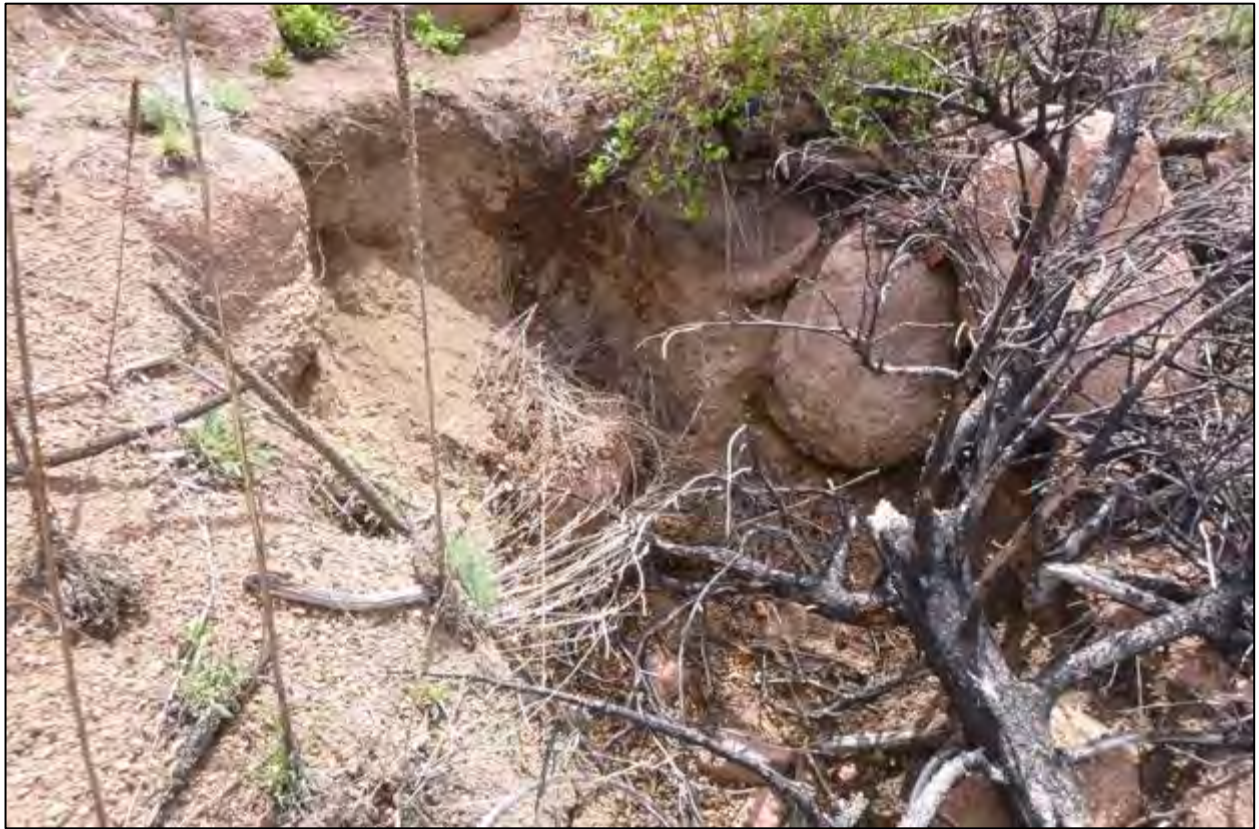
Figures 17 & 18. Before (above) and after (below) photos showing log step-fall construction to stabilize an eroding head-cut in the Waldo Canyon drainage.

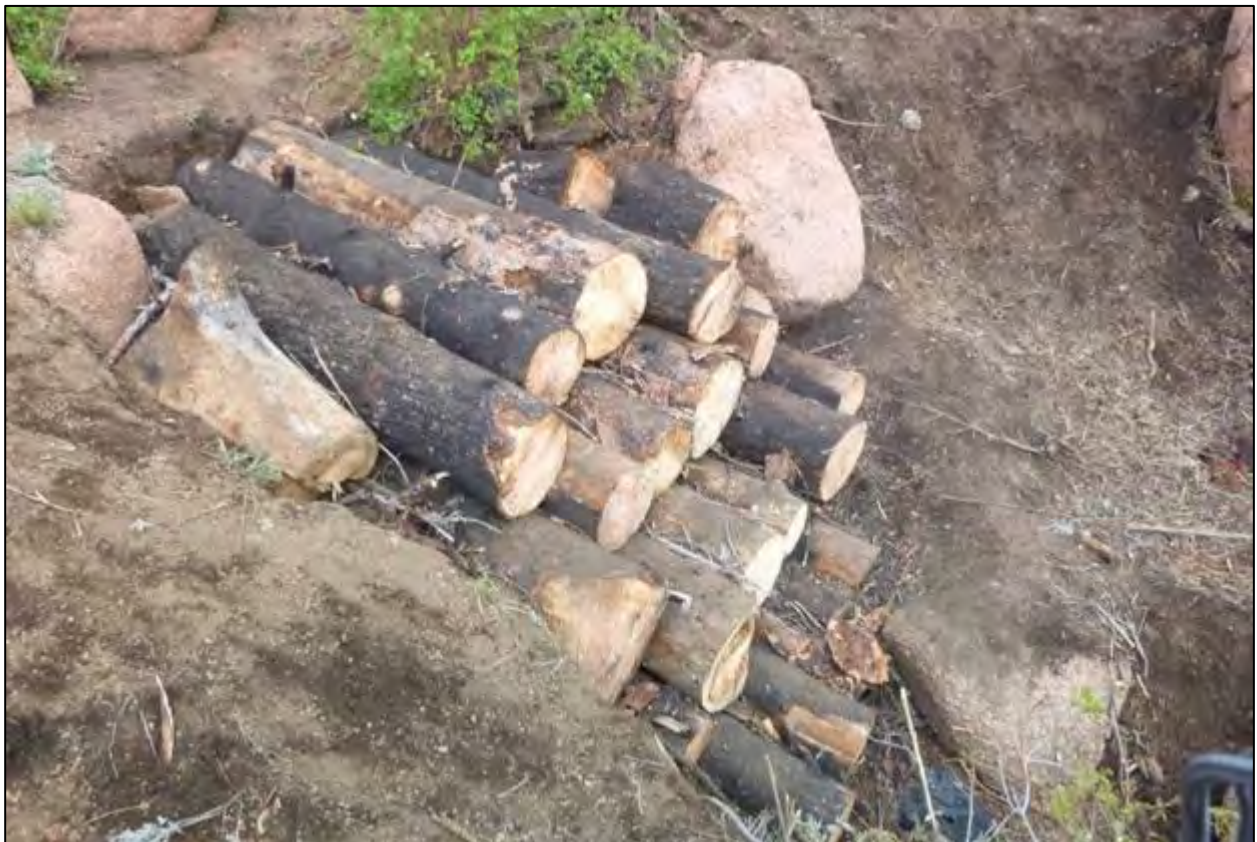
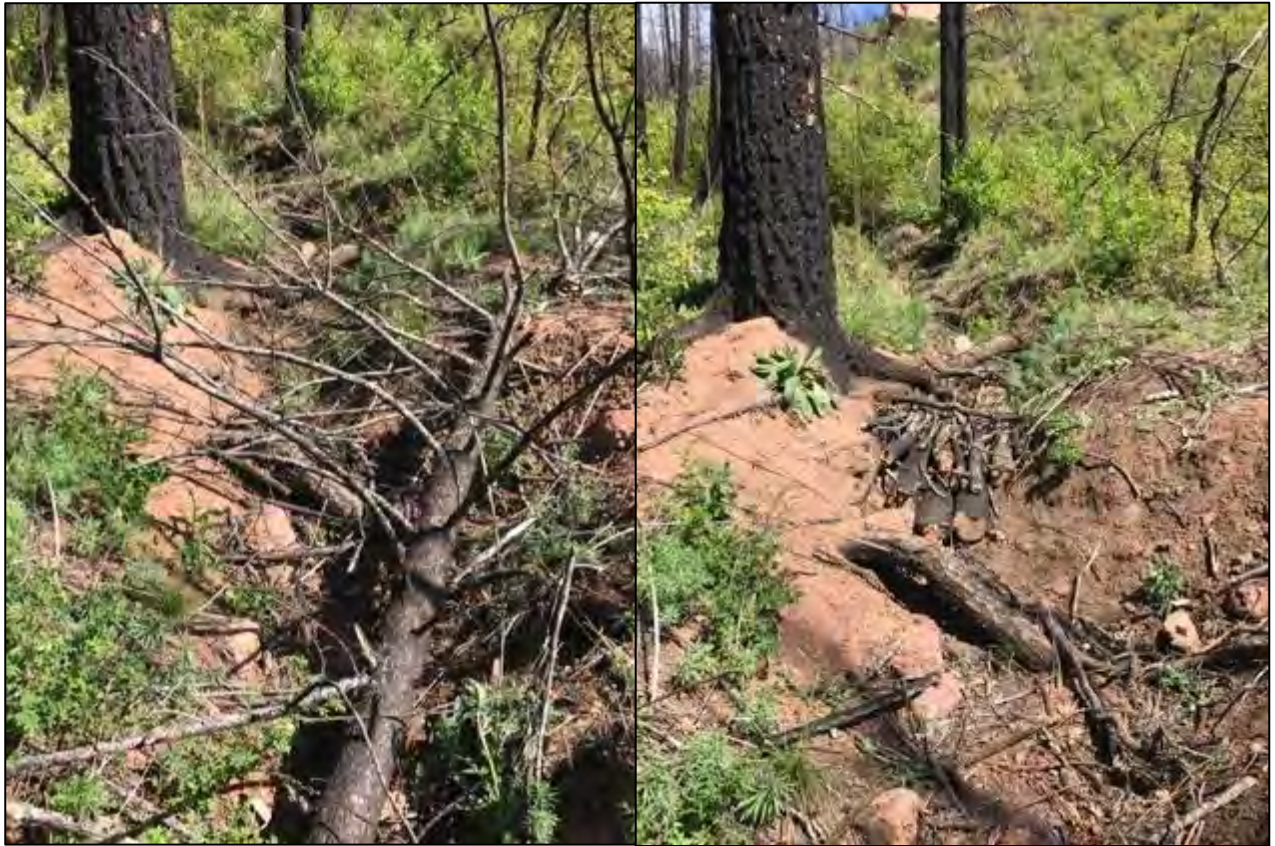
Photos 19 & 20. Before and after photo (top and bottom) showing construction of a debris filter within an eroded drainage of Waldo Canyon.
