Crested Butte Land Trust
Gunsight Bridge Replacement & Habitat Enhancement Project
Final Report

Prepared for:
Colorado Watershed Restoration Program
Attn: Chris Sturm

January 21, 2019

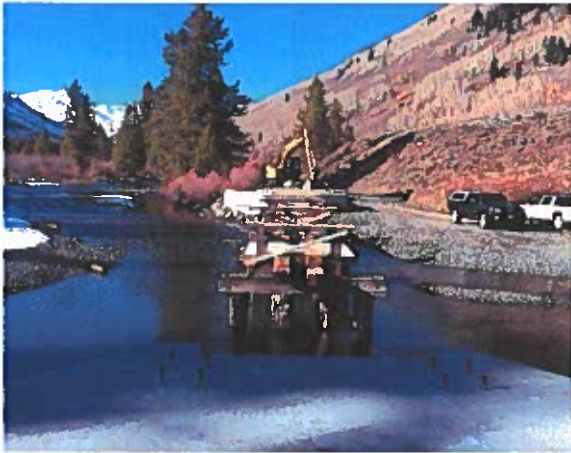
Photo 1: Scaffolding built on top of old bridge with deck and railings removed.

1. **Initial Deconstruction of Existing Bridge:** The old bridge was deconstructed in phases throughout the build to allow Chris Haaland, owner of Canyon Bridge LLC, to use the old bridge structure as scaffolding for placement of the new bridge (see photo 1). This process began with the removal of the old bridge railings and later, the decking.

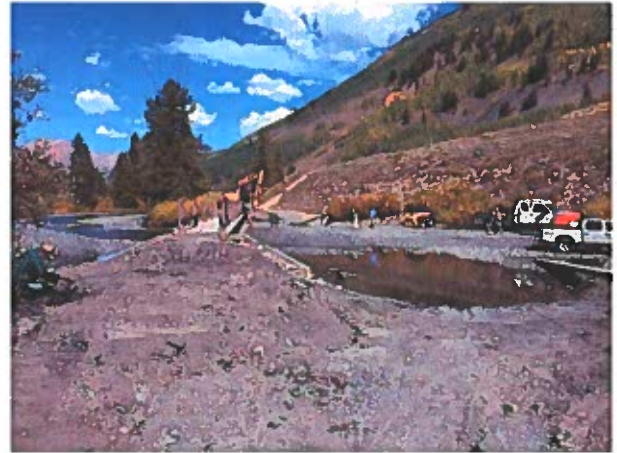
Photo 2: Project team siting location for micro piles after grading the new abutment area.

2. **Abutment Location Preparation:** Following the removal of the old bridge wingwalls, the new abutment sites were graded and prepared for the layout and installation of the micropiles (see photo 2).

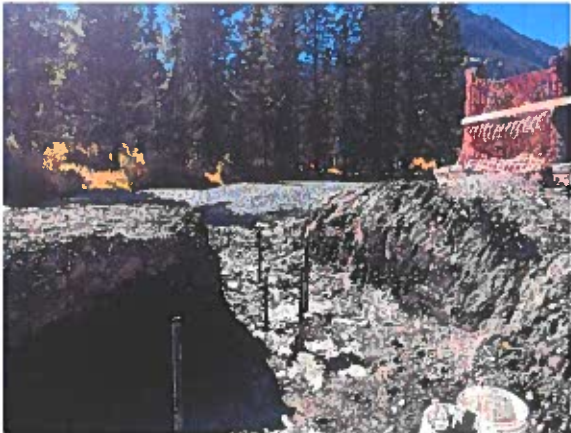
Photo 3: Micro pile installation at southern (downstream) abutment.

3. **Micropile Layout and Installation:** The micropile locations were sited on Tuesday, September 11th and installed over the course of the following six days (see photo 3). Gunsight Pass Road was temporarily closed during this time, however, pedestrian and bicycle traffic through the area was still accessible via the temporary bridge (see photo 4).

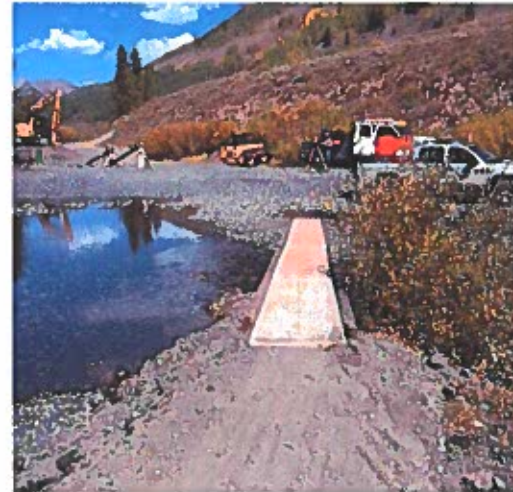
Photo 4: Temporary bridge built for trail users for duration of project.

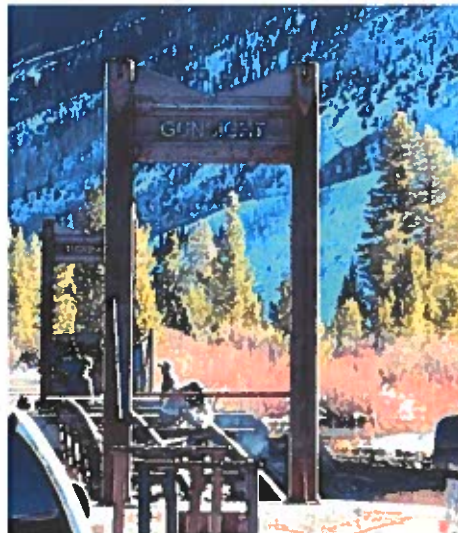
Photo 6: Support tower and bridge frame installation.

5. **Steel Installation and Welding:** The first steel bridge component installed were the two 14' tall support towers. One tower was attached to each abutment. Following the tower

installation, the bridge frame (made up of four segments) was placed (see photo 6). The frame components rested atop the bridge scaffolding as they were welded in place over the course of one week.

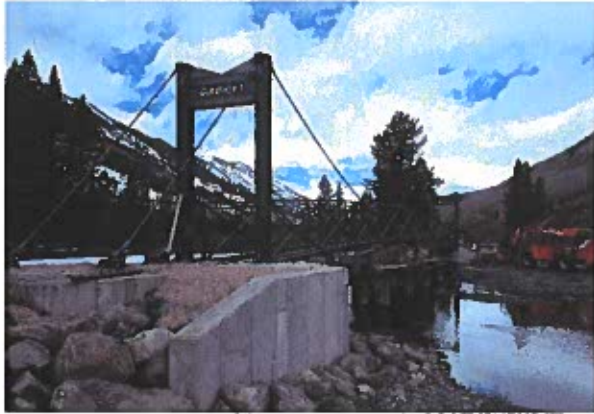
Photo 7: Main cable installation across bridge.

6. **Cable Fitting:** First, the 1 ¼” main cables were hung, from the anchor blocks to the support towers and across the bridge frame. Later, the 9/16” suspender cables of varying lengths were hung vertically from the main cables to the bridge frame (see photos 7 and 8).

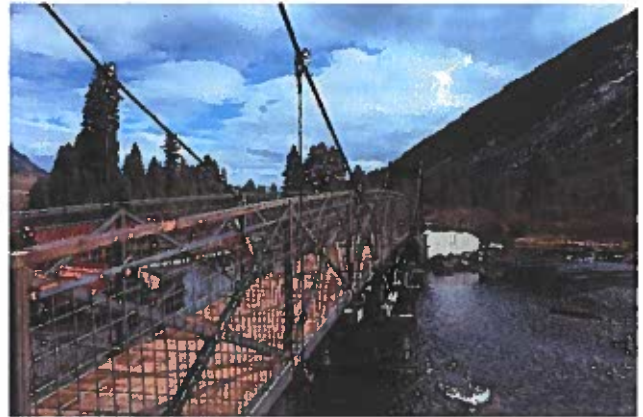
Photo 8: Suspension cable installation from main cable to bridge deck.

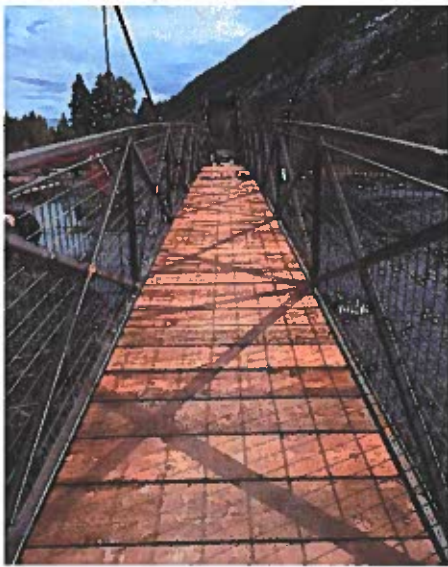
Photo 9: Wood deck installation.

7. **Hand Railing and Wood Decking Installation:** Following the cable fittings, the hand railings were placed and welded to the bridge frame. Next, the wood decking (3x12 treated timber) was installed (see photo 9).

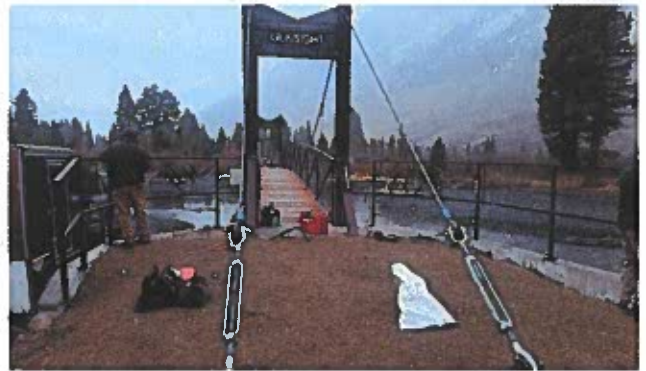
Photo 10: Hand railing installation on wingwalls.

8. **Wingwall Railing Installation:** The last bridge component to be installed were the hand railings on the wingwalls. These railings were not included in the original bridge design, but their need was realized once the concrete was poured and a distance over 30” was realized from the ground to the top of the wingwalls (see photo 10).

recreationalists and was designed to allow for the continued use of hand-cycles. Hand railings were installed on the abutment and wingwalls to create a safe space for the school groups and families that the area is known to attract (see photo 10).

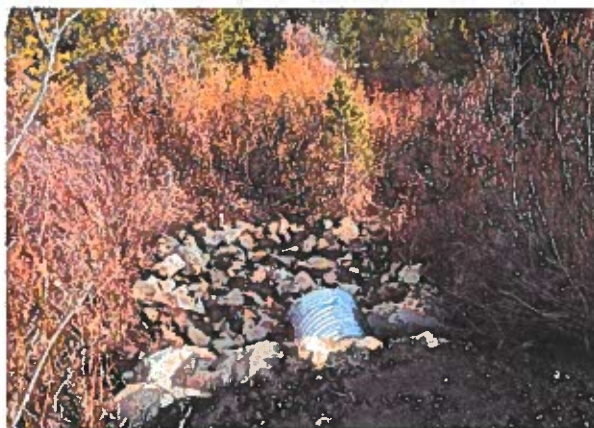
Photo 11: Rock spill pad beneath the culvert's eastern end.

9. **Culvert Installation:** The relief culvert installation was the last component of the project to be completed. An excavator was used to place the 24” wide culvert beneath the railroad grade, directly south of the bridge. A tandem load of 6-12” angular cobble was used to create the rock spill pad at the culvert’s eastern end (see photo 11). Additional loads of road base and 3” minus rock were used to fill and re-surface the railroad grade around the culvert.

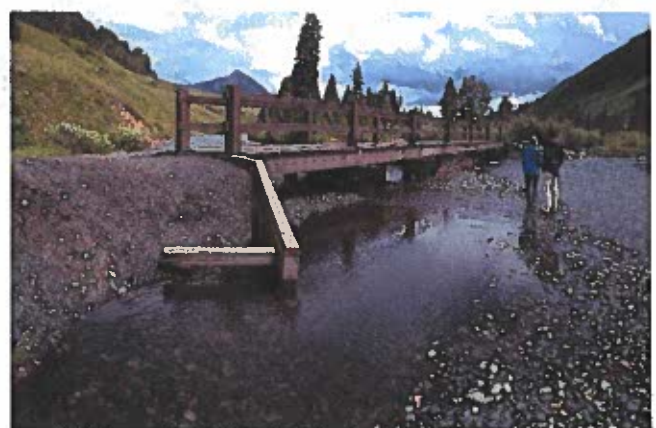
The old Gunsight Bridge was built of wood and supported by five sets of four piers each (see photo 12). The piers, aligned perpendicularly with the bridge span and exposed to direct flow, acted as a strainer for woody debris that frequently finds its way down the Slate River during high flows. Debris was regularly caught by the piers as it moved down river, acting like a dam and impounding water upstream. Additionally, the bridge's 80' span across the river was too narrow,

and constrained the river channel to an unnaturally narrow width, limiting the ability of the river to utilize its floodplain and directly exposing the bridge abutments to the erosive power of the river.

Photo 12: Former Gunsight Bridge with eroded wingwall and deteriorating support piers.

The new bridge was designed and built to accommodate the dynamic nature of the Slate River; its span across the river was lengthened by 20 feet, allowing the river channel to flow underneath the bridge naturally and unobstructed. The suspension of the new bridge eliminated the need for the instream piers, which lessened flood risk and damage caused by sediment deposition and erosion from the impounded segment of river.

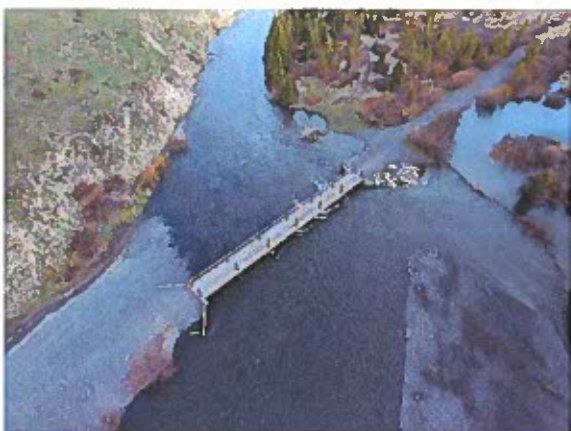
Over time, the elevated trail (old railroad grade) leading to the bridge had prevented the river from flooding onto the surrounding floodplain (see Map 2). Instead, the flow was routed through the bridge opening (see photo 13). During high water the area upstream and to the west of the trail served as backwater habitat. However, the area downstream and east of the trail had dried out due to the lack of connectivity to floodwater.

Photo 13: Former Gunsight Bridge at high-water. Backwater habitat pictured in top right of photo.

The Land Trust's plan to install two relief culverts beneath the elevated trail changed after the completion of a Class III Cultural Resource Inventory and Archaeological Recordation of the project site. A portion of the railroad grade (the Anthracite Spur of the Denver & Rio Grande Railroad) was identified as eligible to the National Register of Historic Places due to the fact that it has remained relatively undisturbed since its abandonment in 1946. Therefore, the Land Trust's plan to install a second culvert beneath the grade was not supported. However, one 24" wide relief culvert was installed beneath the "non-supporting" segment of railroad grade, closer to the bridge. Project ecologist Mark Beardsley, of EcoMetrics, supported this change in scope. Next spring, re-vegetation will occur around the graded and re-built bridge abutment areas to stabilize the river bank and to promote the growth of native plant species. Materials used will include locally sourced willow stakes and bundles, native seeds and sod plugs.

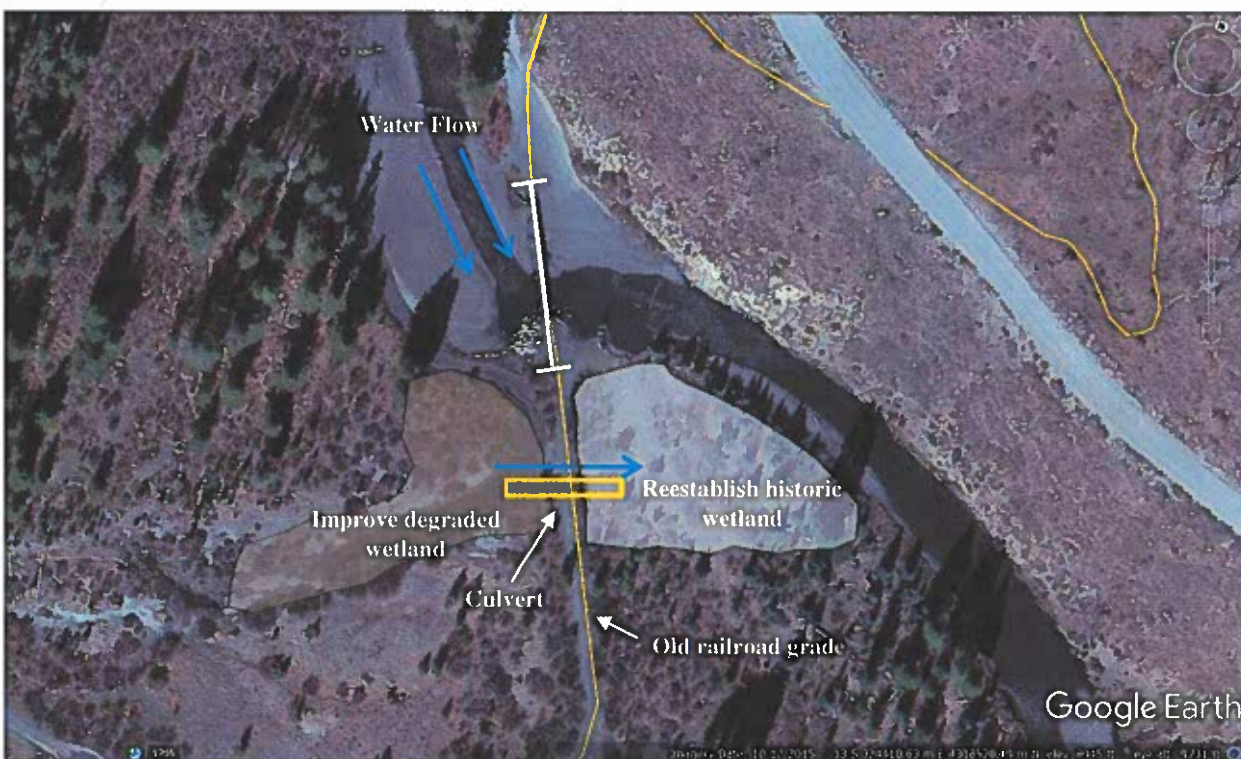
Map 2: Alignment of the new, 100' bridge, the relief culvert and improved/re-established wetlands. Water flow direction shown with blue arrows.
