B: SUMMARY OF FINDINGS AND RECOMMENDATIONS

COLORADO TROUT UNLIMITED AND BOULDER FLYCASTERS SOUTH BOULDER CREEK STREAM MANAGEMENT PLAN PHASE I FINAL REPORT E: CROSS SECTION SURVEY LOCATIONS MAP

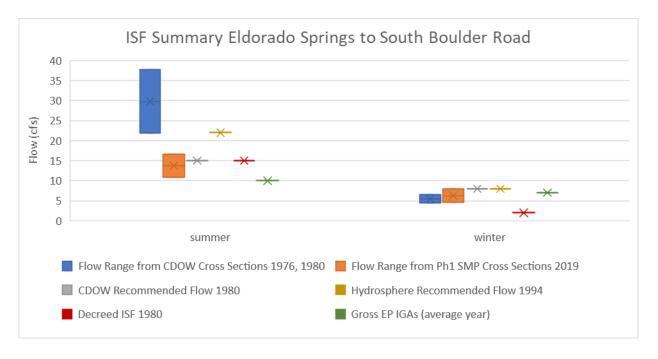
The graph below shows results for the upper reach. The largest scatter is in the summer flows ranging from 10 to 38 cfs. The values estimated for the lower reach (not shown) were even closer to one another.

These results suggest that current creek conditions indicate similar low-flow ranges as past work used to inform flow targets in the 2010 IGAs between Denver, Boulder and Lafayette.

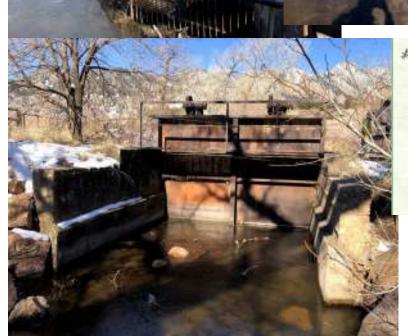
Description					
- Has monitoring station	-Has main gate & bypass				
- Corregated steel pipe	-bypass goes to unkown location				
- Weir for creek	-gate not mechanically assisted				
- Available to create head pressure	-fish can't make it up to FRICO in low flow				
	-Potential fish passage but must maintain				
- Large steel headgate	proper head pressure				
	-fish passage may not be desirable: might				
- Has bypass surrounded by rebar	leave fish stranded in low flow				
	-Monitoring station downstream ditch				
Split in creek					
eadgate exposed to wear due to age	- Concrete component shows no cracks				
rank operated	- No fish passage

Structure Number	GPS Location	Water Rights Owner and Date Associated	Priorities and I	Structure Dimensions	Approximate Flow/ Barriers to Flow	Soil Stability	Potential Habitat Improvements
SBCS 4 - Goodhue Ditch	39°57.065′ N, -	BOULDER COUNTY PARKS & OPEN SPACE DEPT, City of Lafayette	Total Decreed	See Sketch - I	Flow has potential clearance of about a foot from main steel gate	Fair	Fish Passage possible

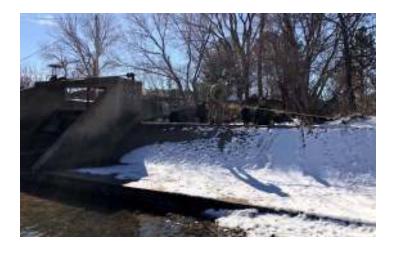
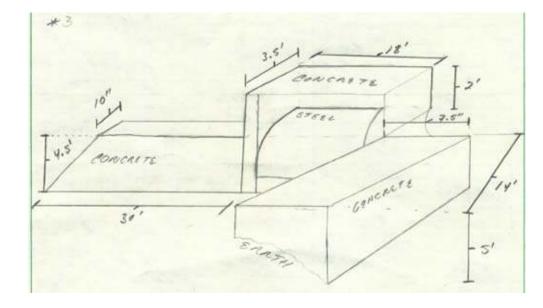
Descri	otion
s monitoring station	-Gate not mechanically assisted
ge concrete weir with headwall	
aller headgate for ditch	-Potentially make head wall smaller
ncrete footing is eroding	-decent flow
rge crack in weir	-weir at end of gate
	- Structure is composed of mainly
II seems structurally sound	concrete with steel parts
h can get through but no designated	
passage	- Ditch has pinch point

Structure Number	GPS Location	Water Rights Owner and Date Associated	Relative Priorities and Flow (X cfs)	Structure Dimensions	Approximate Flow/ Barriers to Flow	Soil Stability	Potential Habitat Improvements
SBCS 5 - Bear Creek Ditch	39°57.203′ N, - 105°14.502′ W	S BO + BEAR CK DITCH	Total Decreed Rate: 263.4811	See Sketch	Passage contains heavy debris from sedimentation	Fair	not desired. Good pooling area at gate. A lot of silt and debris

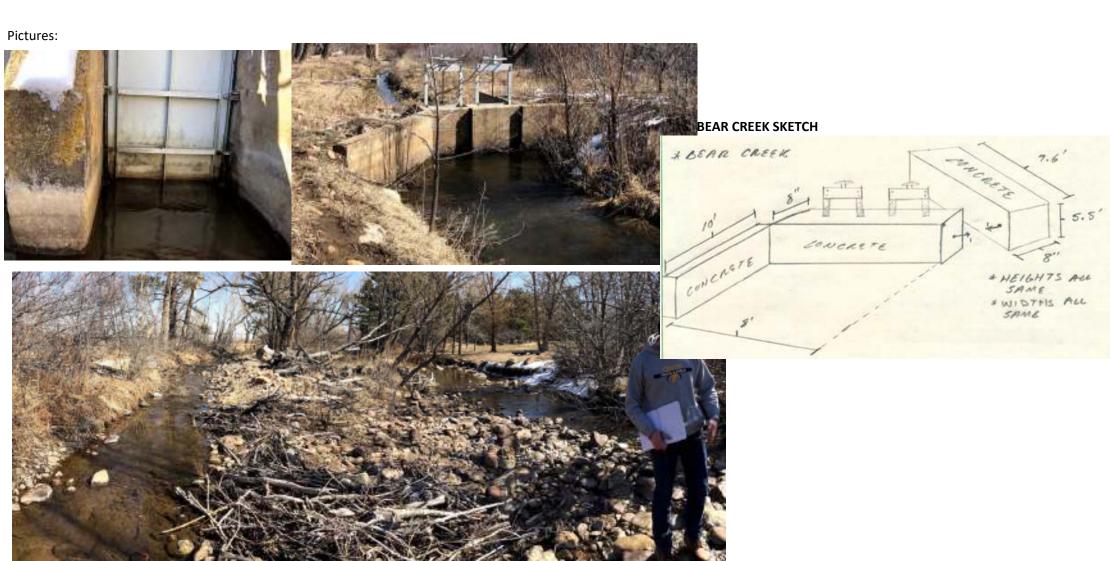
Description						
- Diversion using land	-Diversion uses rocks					
- Creates channel to ditch	-Natural diversion					
- Owned by Lafayette

Structure Number	GPS Location	Water Rights Owner and Date Associated	Relative Priorities and Flow (X cfs)	Structure Dimensions	Approximate Flow/ Barriers to Flow	Soil Stability	Potential Habitat Improvements
SBCS 6 - Upper Bear Creek Ditch	105°14.472'	TBD- TU	TBD- TU	See Sketch	Overcome heavy organic debris	Fair	Probably no fish passage wanted

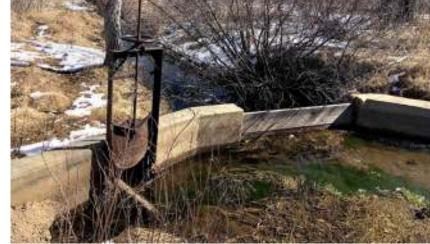
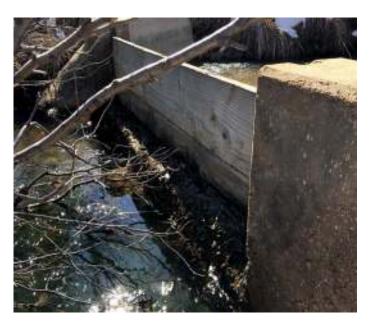
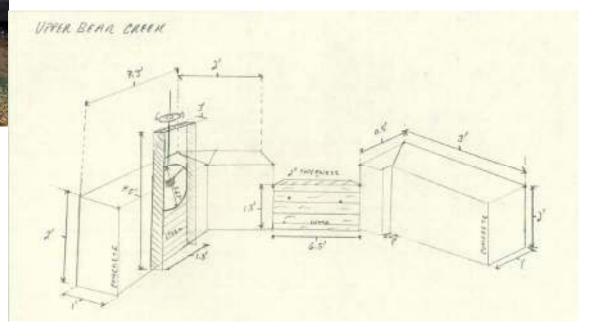
Description				
	-ditch is a primary water source for			
- Small conrete structure	Lafayette			
- 2 steel gates into ditch	-water leaking through gate			
-gate not mechanically assisted	-no fish passage needed			
-stream that goes to Laf has				
another monitoring station	-Overall goal to make easy fishing spots			
Structure is in ditch, not main	-water infiltrating groundwater after			
channel	ditch to return to South Boulder Creek			
Concrete narrows channel	-monitoring station below			
Concrete seems to be in	- Has second structure down the ditch			
acceptable conditions	but is out of scope			
Steel components seem in new				
conditions

Structure Number	GPS Location	Water Rights Owner and Date Associated	Relative Priorities and Flow (X cfs)	Structure Dimensions	Approximate Flow/ Barriers to Flow	Soil Stability	Potential Habitat Improvements
SBCS 8- MARSHALLVILLE Ditch	39°57.578'N, - 105°13.938' W	MARSHALVILLE DITCH CO	Decreed Rate: 52.734	See Sketch	N/A	Good	N/A

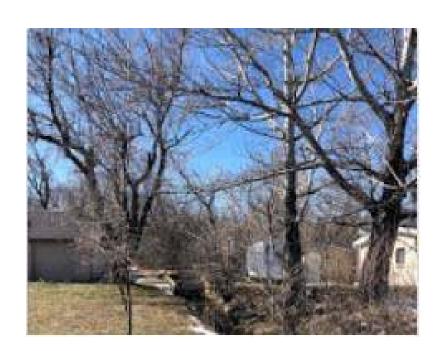
Description					
- Rock Diversion	- Life confirmed				
- Small Concrete with steel					
headgates	- Gate under diversion				
- Has monitoring station	- Monotoring station				
- Private property

Structure Number	GPS Location	Water Rights	Relative	Structure Dimensions	Approximate Flow/ Barriers to	Soil Stability	Potential
SBCS 9- SHEARER	105°13.628'W	VLEET, L W VAN	Total decreed	See Sketch	The ability of flow to get over	Fair

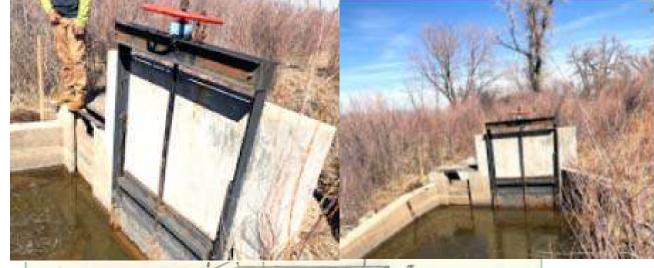
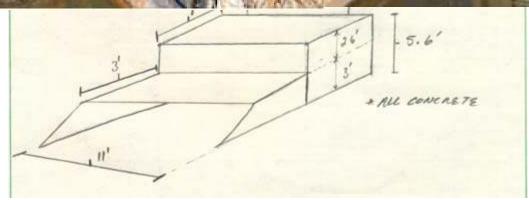
Structure Number	GPS Location	Water Rights Owner and Date Associated	Relative Priorities and Flow (X cfs)	Structure Dimensions	Approximate Flow/ Barriers to Flow	Soil Stability	Potential Habitat Improvements
SBCS 10- CANYON Ditch	39°58.340′N, - 105°13.396′W	S BO CANON DITCH CO	Total Decreed Rate:	See Sketch	None	Good	Good fish passage here

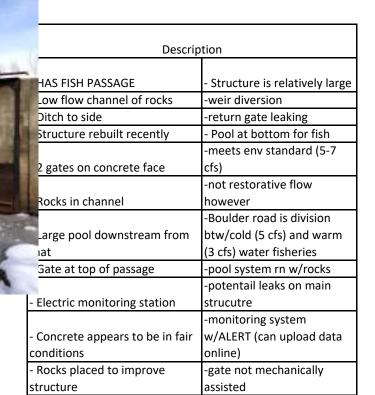
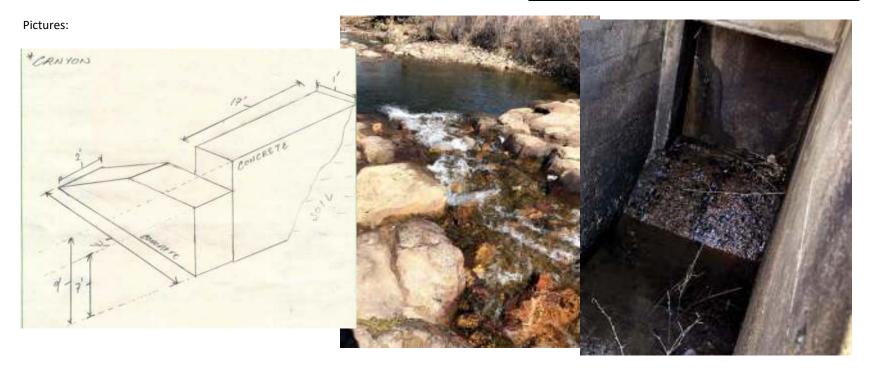
Structure Number	GPS Location	Water Rights Owner and Date	Relative Priorities and Flow (X	Structure Dimensions	Approximate Flow/ Barriers to	Soil Stability	Potential Habitat Improvements
		Associated	cfs)		Flow		
SBCS 11- MCGINN	39°58.851′N, - 105°13.263′W	MC GINN DITCH CO	Total decreed rate: 10.892	See Sketch	N/A	Good	Great fish passage

-leaks in return strucutre

-mainstructure doesn't leak

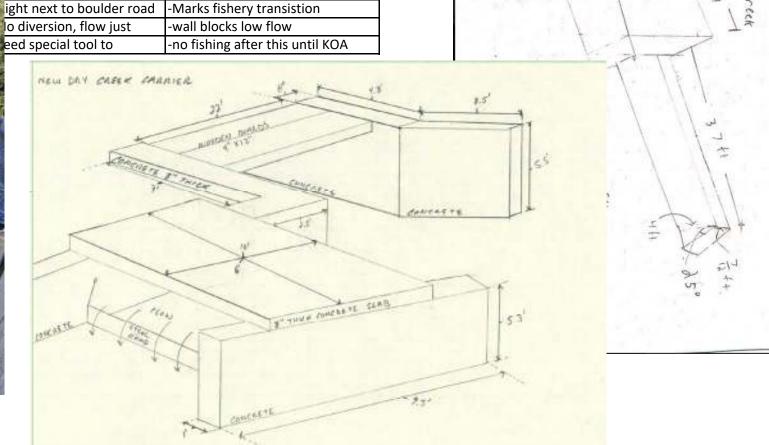
Structure Number	GPS Location Water RigI	ts Relative	Structure Dimensions	Approximate Flow/ Barriers	Soil Stability	Potential Habitat
SBCS 12- NEW DRY	39°59.166′N, - Lefevett	Total	See Sketch	Odd angle that the water	Fair	No fish passage present. Poor

Description						
	- Large weir to SBC	-potential habitat improvement					
	- No fish passage	-one of most formindable to low					
	- Large steel door into ditch	-gate not mechanically assisted					
	- Concrete in fair conditions	-leaking through passage to South					
250	- Large door into creek next	-Other passage takes water to					
	ight next to boulder road	-Marks fishery transistion					
	lo diversion, flow just	-wall blocks low flow					
1	eed special tool to	-no fishing after this until KOA					
000	U.S.	•

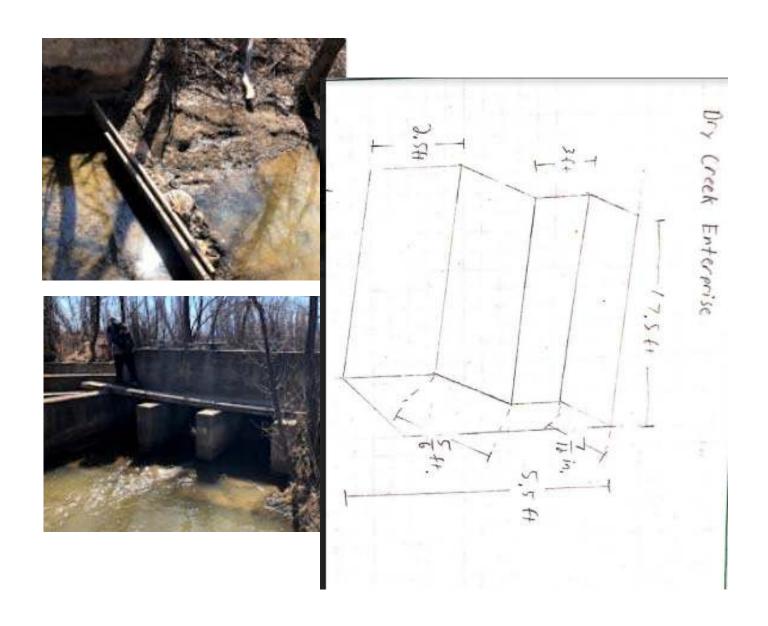
Structure Number	GPS Location	Water Rights Owner	Relative	tructure Dimension:	Approximate Flow/	Soil Stability	Potential Habitat Improvements
SBCS 13-	n/a	ENTERPRISE DITCH	Total Decreed	See Sketch	Big debris blockage	Fair	No fish passage most liekly

Description					
Description					
- 4 gates to enterprise	-4 gates				
- Wood blockage to DCD	1 gate clogged				
- Sits at seperation of the	-probably want to work on this				
- Concrete ok	-board and sandbags toi stop				
- Located in the ditch	-gate not mechanically assisted				
- Downstream from	-non operable monitoring station				
-splits downstream

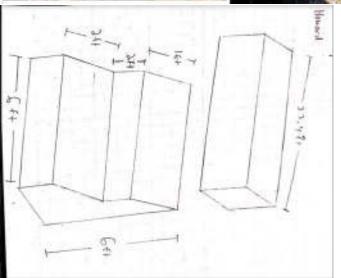
Structure Number	GPS Location	Water Rights	Relative	Structure Dimensions	Approximate Flow/ Barriers to	Soil Stability	Potential
SBCS 14- HOWARD	39°59.298'N, -	HOWARD	Total	See Sketch	no fish passage and large	Good	Fish passage

Description						
- One for most senior water rights	-two planks of wood are weirs					
- Small wier into rocks	-one plank had huge hole in it					
- Small headgate to ditch off on	-plenty of flow					
- No diversion, just off to side	-leaks on east county diversion					
- No fish passage	-gate not mechanically assisted					
- Concrete looks old	-monitoring station					
- Damaged from floods	-theditchproject.org shows					
- Cracks and missing pieces	- Has monitoring station					
- Couple wood planks in weir	- Silt backup					
aking

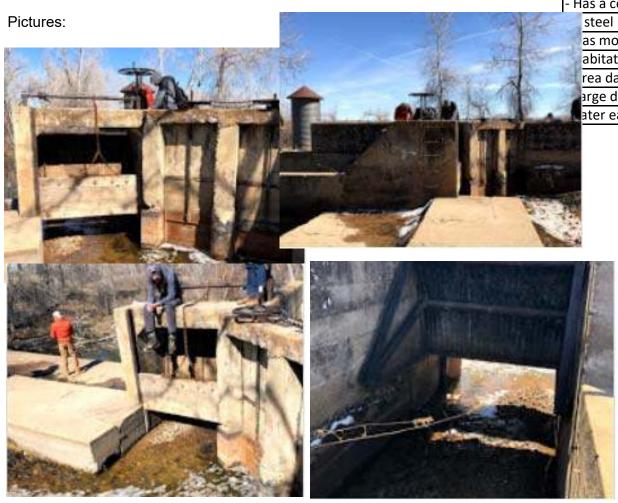
Structure Number		Water Rights Owner and Date Associated	Relative	tructure Dimension	Approximate Flow/ Barriers to Flow	Soil Stability	Potential Habitat Improvements	Description	
SBCS 15- Leggett	40°00.951′N, - 105°12.858′W	l Company of I	TBD	See sketch	Lots of trash, solids, dirt accumulation from slowing down of creek, Massive intake into leggett structure, little to no flow observed most the time	Fair	Cleaning out area, fish passage, keeping invasives out of creek		Sam:

- -Huge concrete structure
- -Massive weir on NW side
- -9 steel gates on east side
- -4 more steel gates to the north
- -Large concrete crack by weir
- -Gates create large holding pond
- -Newer concrete by gates
- -Gates look new
- -Gates are hydraulic powered
- -TU has data logger down stream

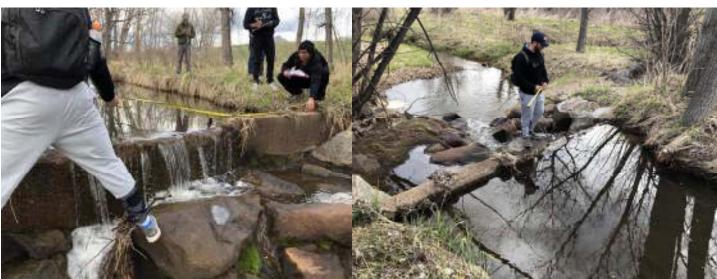
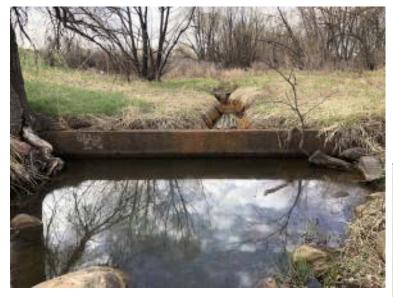
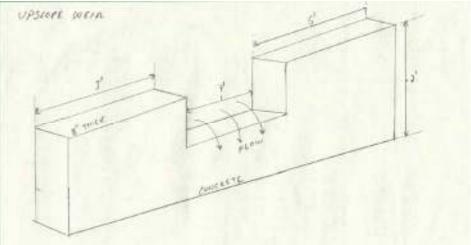
Structure Number	GPS Location	Water Rights Owner and Date Associated	Relative Priorities and Flow (X cfs)	Structure Dimensions	Approximate Flow/ Barriers to Flow	Soil Stability	Potential Habitat Improvements
SBCS 16- Upslope Weir	40°01.168′N, - 105°12.940′W	Boulder?	tbd	See sketch	N/A other than weir	Good	Fish passage in low flow, aesthetics

Descriptio	ns
James	
-Small concrete weir	
-Half is open	
-Flow into rocks	
-Channeleized into ditch and	
smaller passage	
-Wall extends entire channel

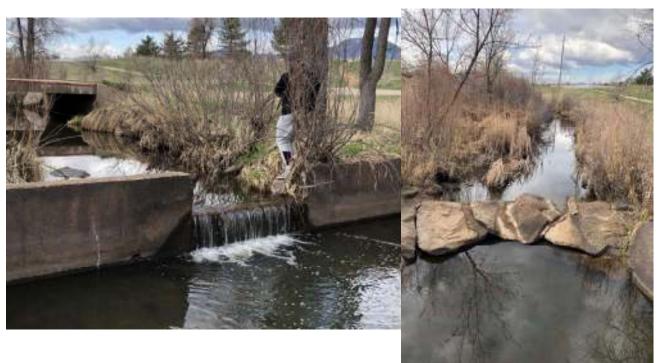
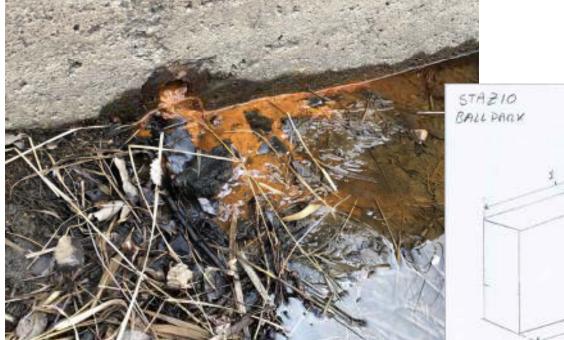
Structure Number	GPS Location	Water Rights Owner and Date Associated	Relative Priorities and Flow (X cfs)	Structure Dimensions	Approximate Flow/ Barriers to Flow	Soil Stability	Potential Habitat Improvements
SBCS 17- Stazio	40°01.332′N, -	Boulder	tbd	see sketch	Fish passage in low flow times,	docont	Improve aesthetics
Ballpark Weir	105°12.954′W	County?	ιοα	see skettii	only a small opening for flow	decent	and fish passage

Descript	tions
James	
-Man made rocks lead	
to flow under bridge	
-Flow then goes to	
concrete wier	
-Large opening with	
wood board	
-Unclear why it exists	
-Very simple	
-Manmade pools

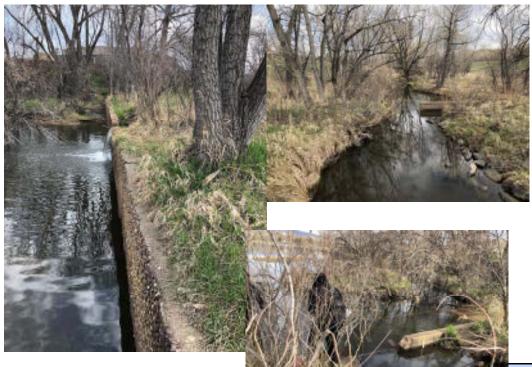
Structure Number	GPS Location	Water Rights Owner and Date Associated	Relative Priorities and Flow (X cfs)	Structure Dimensions	Approximate Flow/ Barriers to Flow	Soil Stability	Potential Habitat Improvements
SBCS 18- KOA Inlet Weir	40°01.552′N, - 105°13.035′W)	tbd	see sketch	only one inlet here along concrete weir	decent	Fish passage if needed, concrete aesthetics

Descr	iptions
James:	
-Large concrete weir	
-Boat ramp 50' west	
-2 weirs	
-Large busted	
opening	
-Concrete in poor	
condition	
-No fish passage	
-Has staff gauge	
-Lots of sediment

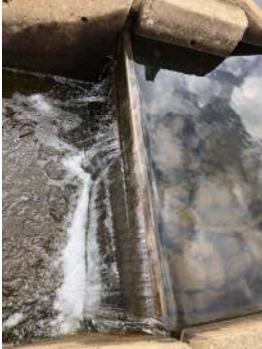
Structure Number	GPS Location	Water Rights Owner and Date Associated	Relative Priorities and Flow (X cfs)	Structure Dimensions	Approximate Flow/ Barriers to Flow	Soil Stability	Potential Habitat Improvements
SBCS 19-	40°01.725′N, -	Western Mobile -	11.2 acre-ft	see sketch	Wooden weir is	N/A all concrete	Better fish passage
KOA Outlet	105°13.111′	Boulder Inc. (1993)	stored in lake	see sketch	getting old	N/A all colletete	better fish passage

ď	Descri	otions
	James:	
	-Weir for overflow	
	-Steel headgate for	
	control of flow	
	Nooden board next to	
	headgate	
	e is problem in winter	
Z.	-Last structure befor	
	confluence	
	-Concrete looks ok	
	-2 ramp arms lead to	
	headgate	
	ake owned by Boulder	
10	-Water owned by	
	multiple groups
