## Spring Fire Phase 1

### Final Report

Huerfano County Water Conservancy District/ Arkansas River Watershed Collaborative

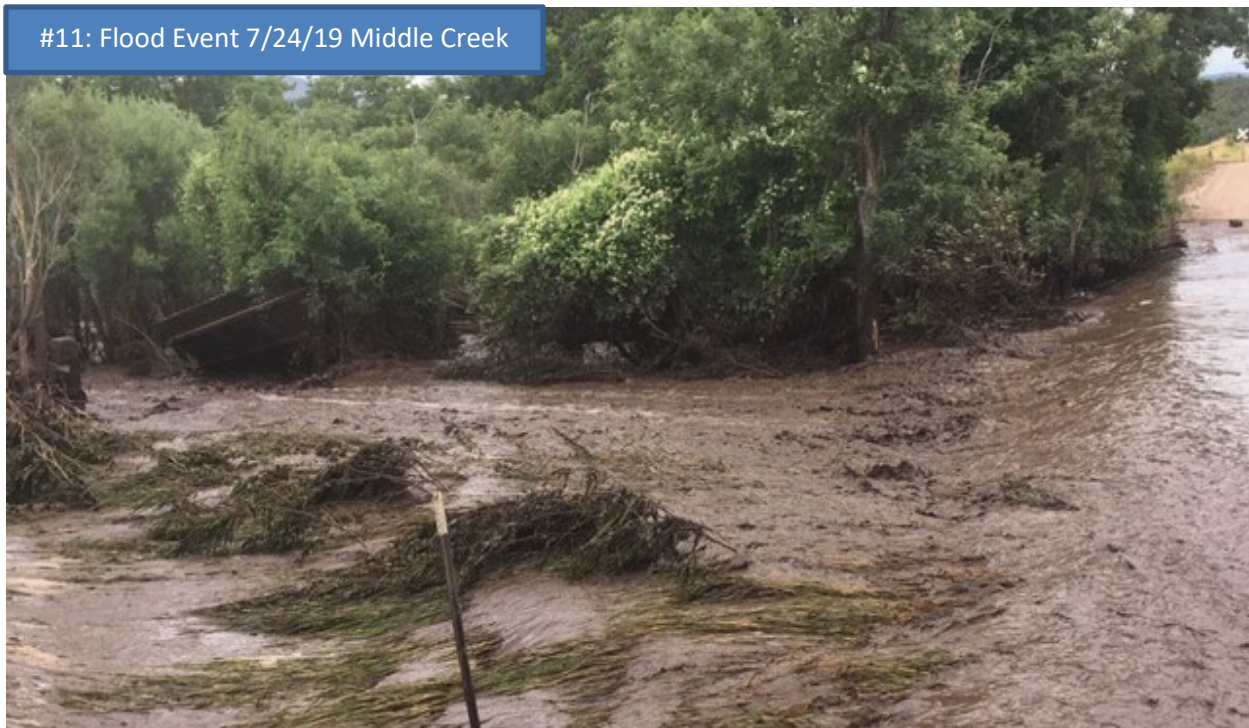
#11: Flood Event 7/24/19 Middle Creek

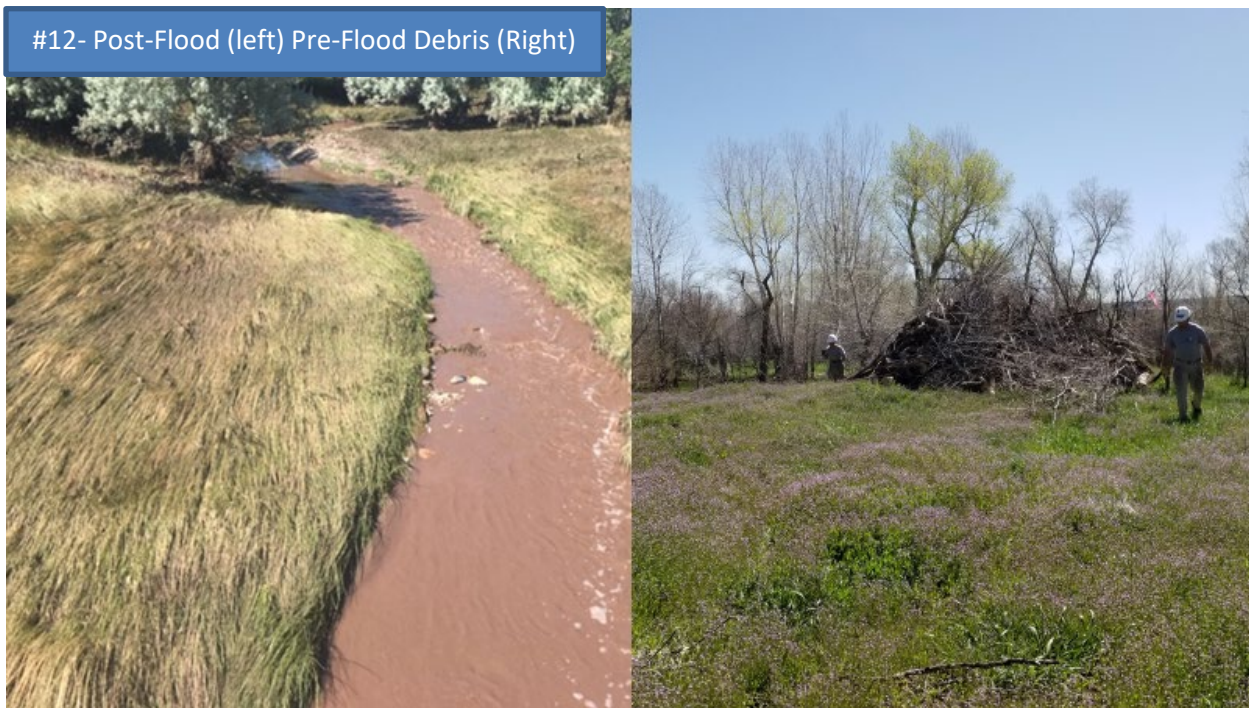
#12- Post-Flood (left) Pre-Flood Debris (Right)

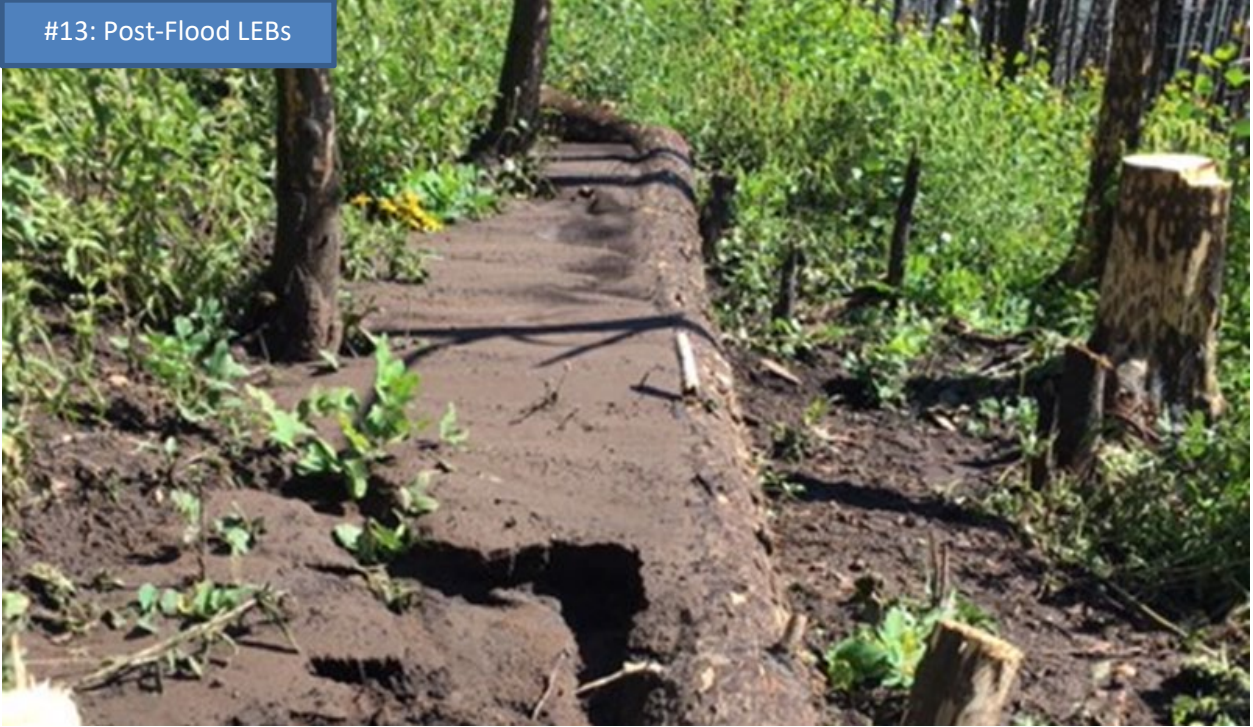
The LEBs that were constructed by the Crew’s functioned well in holding back sediment and preventing erosion rills from forming on steep slopes. Monitoring of the structures was conducted after several flood events by the ARWC team. The structures were highly successful in trapping sediment, preventing cuts, and slowing the flow off the burn scar. The results can be seen in the photos below. The seeding and mulching activities were also successful in stabilizing high-intensity burn areas. It was accomplished early enough that the grass was sprouted by the time the monsoon rains came.

#13: Post-Flood LEBs

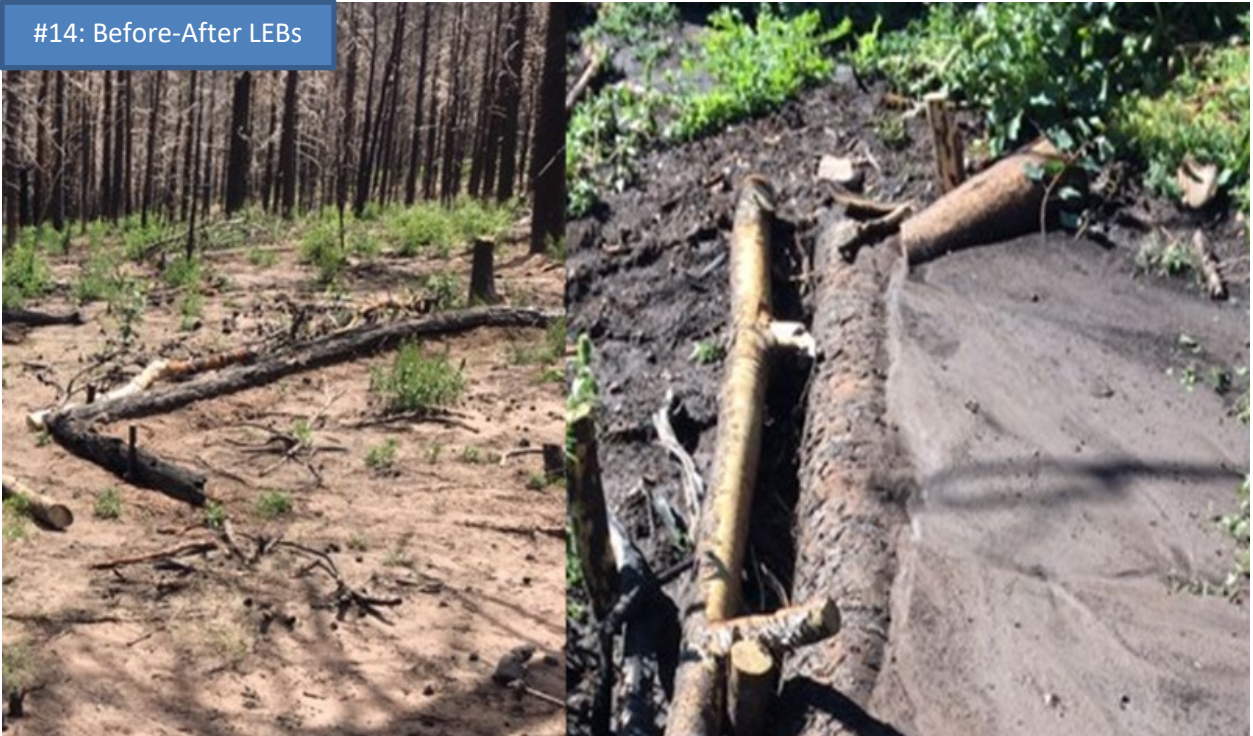
#14: Before-After LEBs

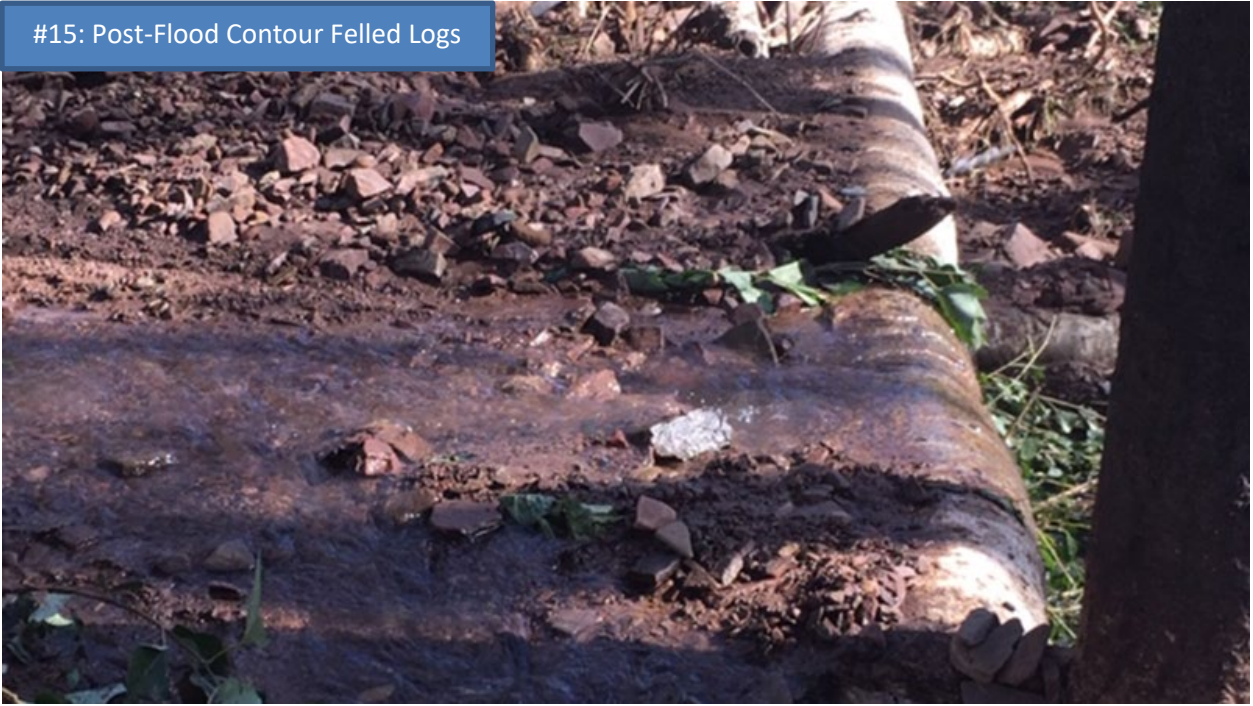
#15: Post-Flood Contour Felled Logs

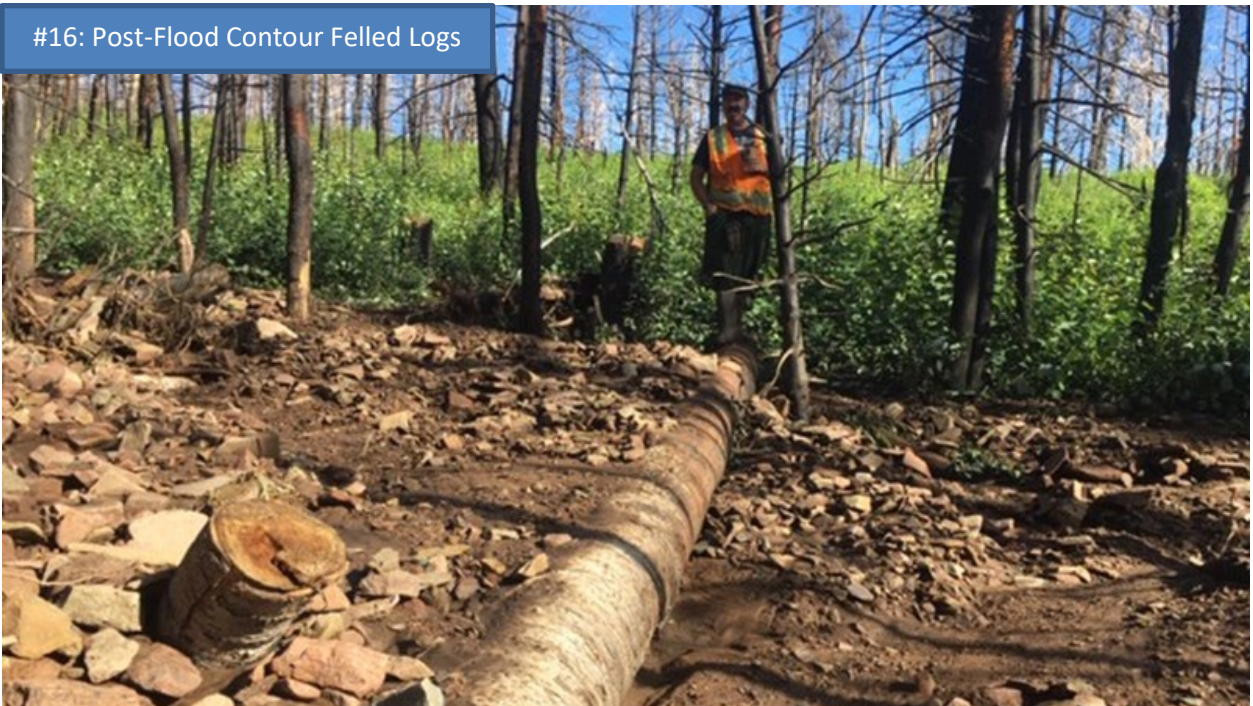
#16: Post-Flood Contour Felled Logs

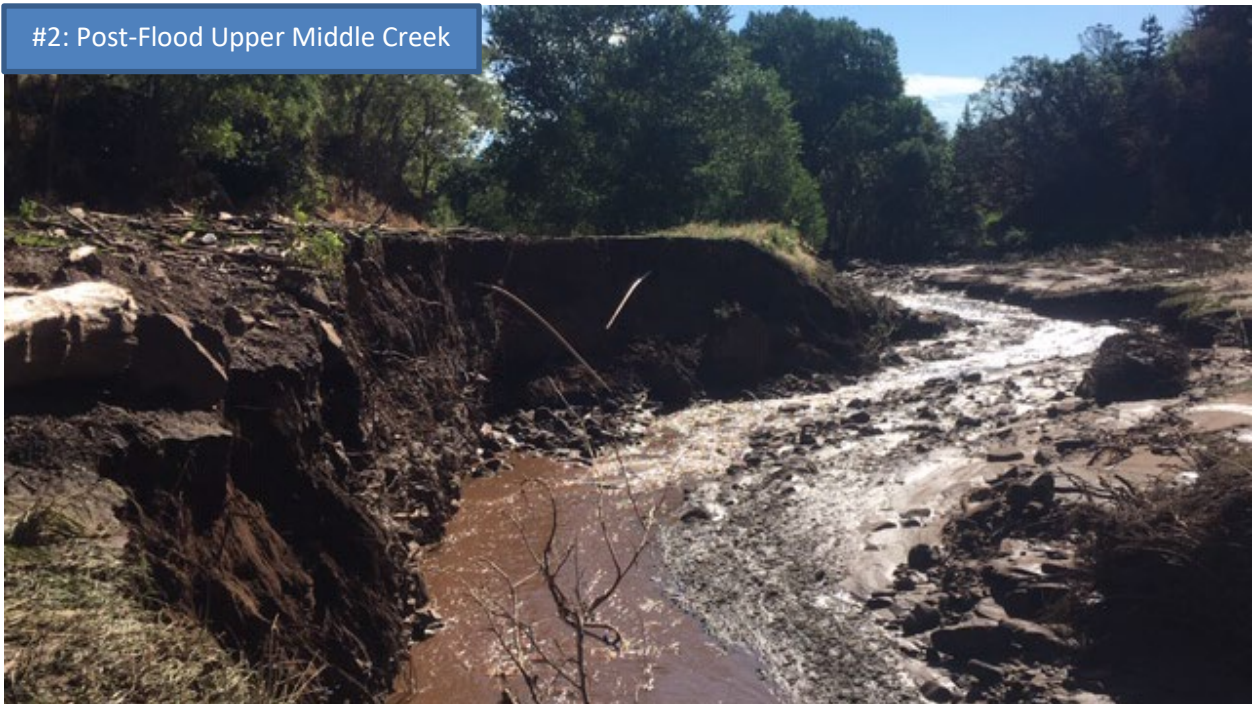
- Photo #1: Largest flood event that took place on July 24<sup>th</sup>, 2019. Photo taken on the middle reach of Middle Creek. Our primary stream clearing treatments were conducted directly below this location and continued to La Veta.
- Photo #2: Upper reach of Middle Creek. The road is on the left of the picture and significantly eroded.
- Photo #3: Upper reach of Middle Creek. This is directly above the previous photo and the road is completely gone.
- Photo #4: The backside of the Middle Creek drainage. This is the only access road that remains for the upper reaches of the Middle Creek drainage and only escape route for those who live in the upper reaches of the drainage.

#2: Post-Flood Upper Middle Creek

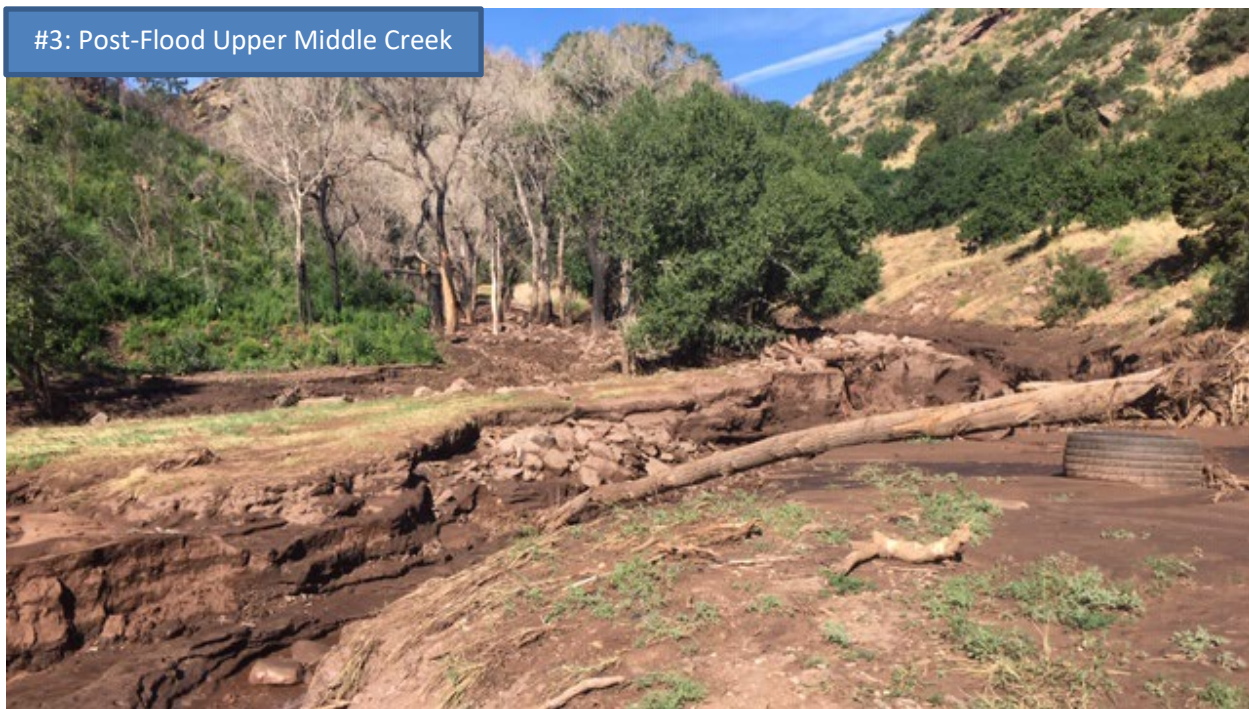
#3: Post-Flood Upper Middle Creek
