# **East Vail Riparian Habitat and Floodplain Restoration**

## **Final Report**

**Prepared for:**  
**Colorado Watershed Restoration Grants**  
**Attn: Chris Sturm**  
**PO# POGG1, PDAA, 201900002727**  
**September 12, 2019**

**Eagle River Watershed Council**  
**Grant Amount: \$53,400**  
**Prepared by: Kate Isaacson**

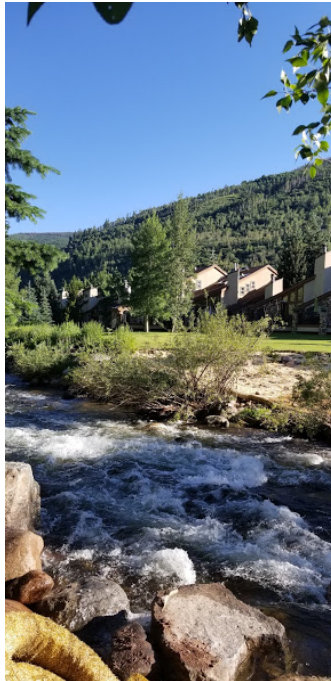
### Sundial from Vucich property

Photos have been the most impactful measurement tool we were able to use. As you will see in our coversheet photos and the images below the before and after images reflect a vast difference in grade of the slope and numerous new riparian plants to aid with filtration and stabilization of the creek. True metrics will come over several years as we see macroinvertebrate scores improving and trout pools repopulating.

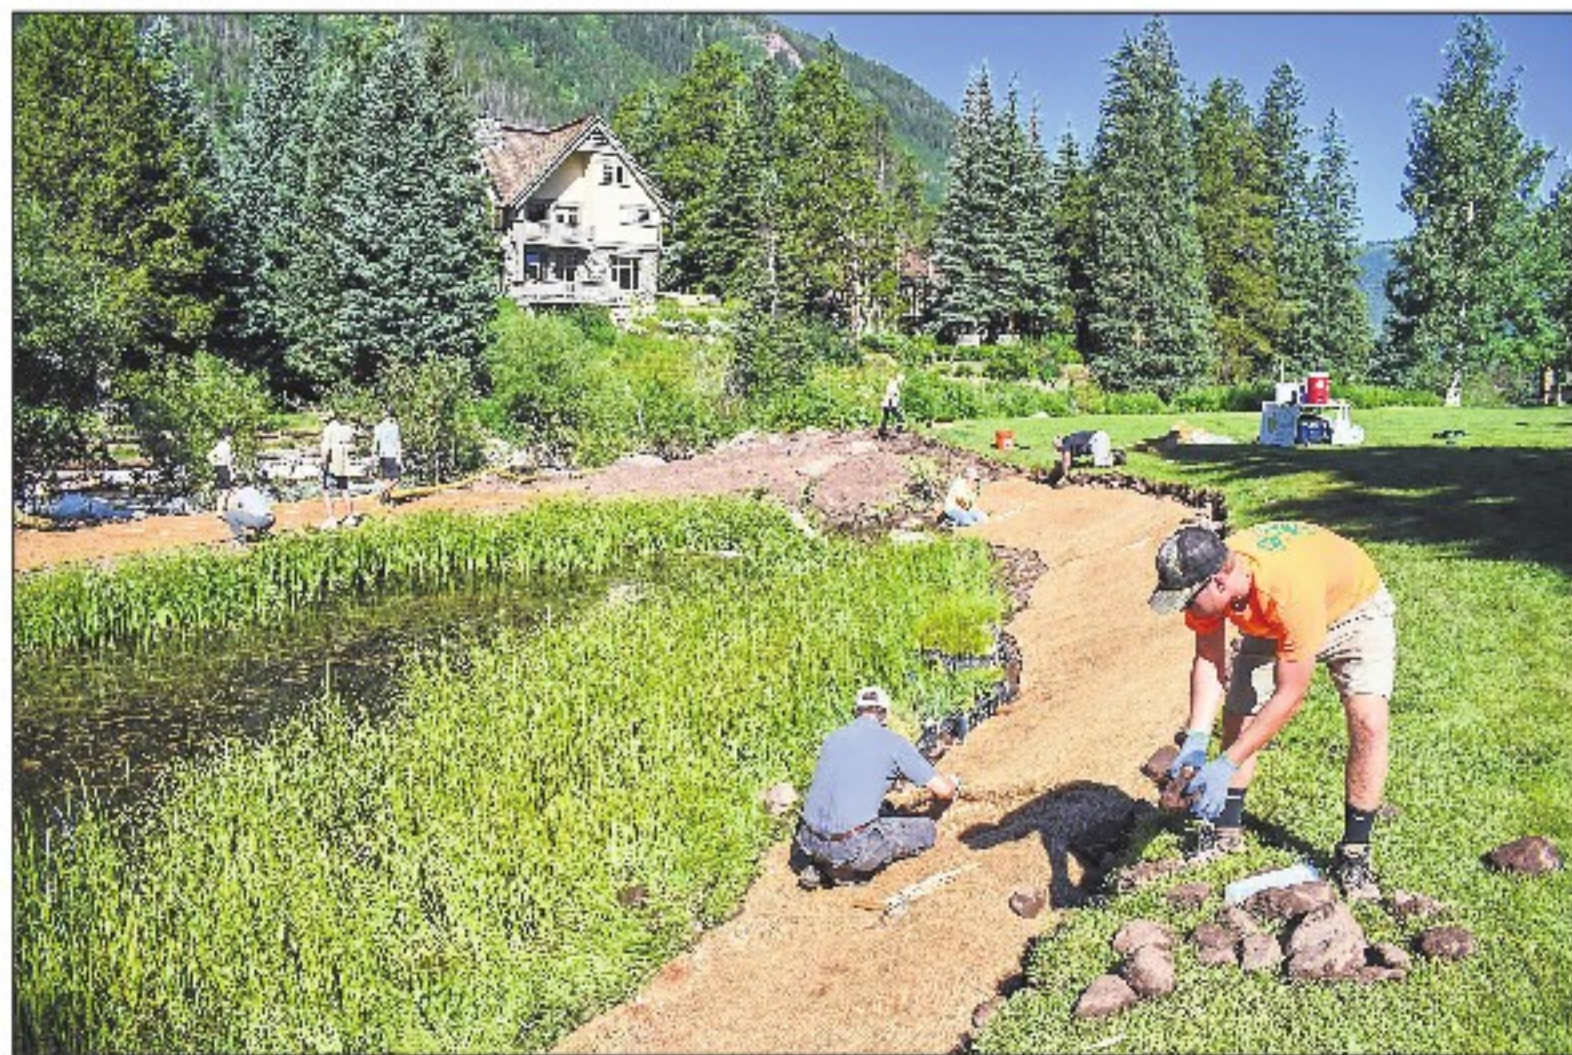
Parker Rodeen places rocks while Peter Wadden, the town of Vail's water quality education coordinator, hammers in stakes during Monday's Restore the Gore workday on the banks of Gore Creek. About 15 volunteers helped with streamside improvements near the Sundial properties in East Vail.
