**COLORADO HEALTHY RIVERS FUND**  
**Uncompahgre River Restoration – City of Montrose**  
Final Report

May 2021

City of Montrose  
Grant Amount: \$500,000  
Prepared by: Ecological Resource Consultants on behalf of Scott Murphy

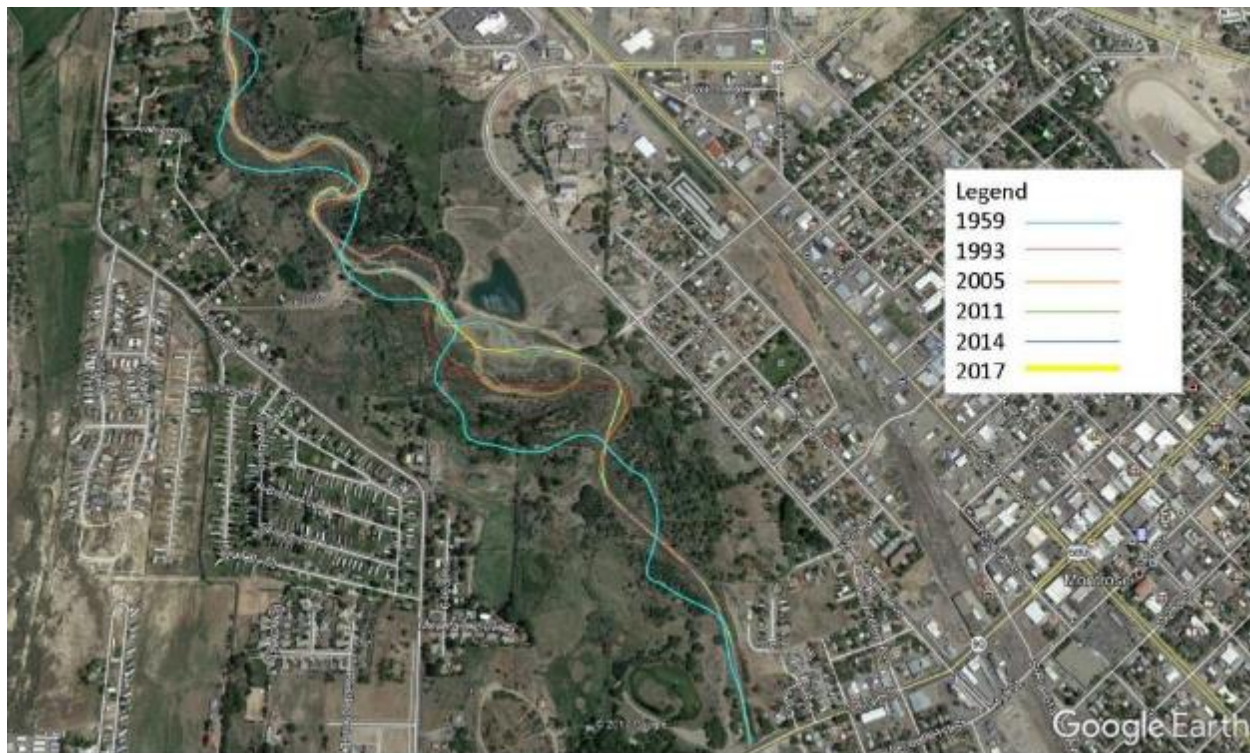
**Figure 2** *Comparison of Recent Channel Alignments*

An evaluation of historical channel planforms was conducted as part of evaluating existing conditions. Review of historic photos suggest that the River has been unstable and prone to migration through the years as depicted in the different channel alignments that are presented in **Figure 2**.

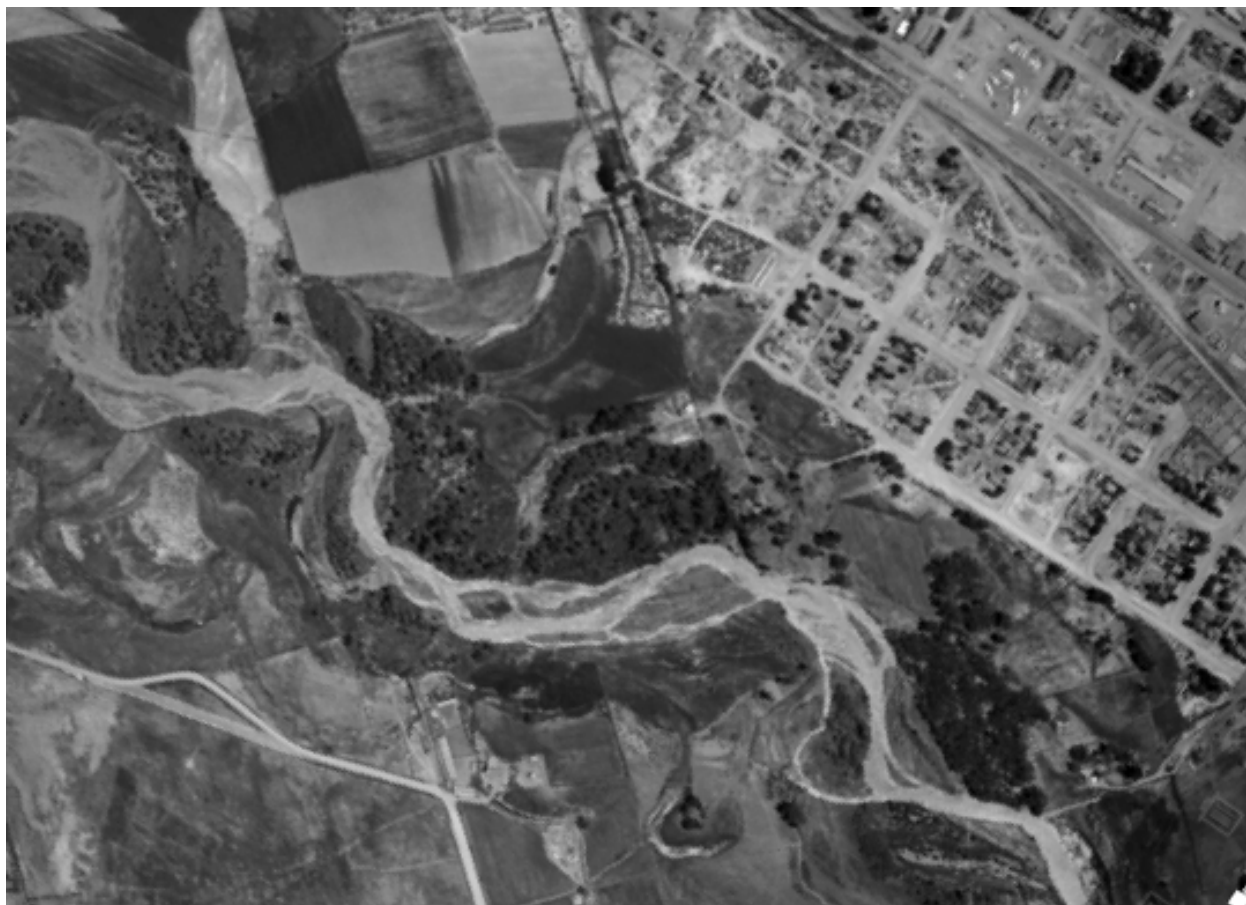
**Figure 3** 1959 Aerial Illustrating a Relatively Stable Planform

What was evident from historic photos is at times when the River was stable for an extended period, the River through the Project Reach took the form of what would be considered more typical of an ecological reference condition, with a distinct narrow main channel, a more uniform meandering channel planform (higher sinuosity, larger meander radii and wavelengths), numerous smaller side channel and a well-vegetated floodplain. During periods of instability the Project Reach form deviates from a more typical ecological reference condition, with extremely wide bankfull width and an irregular meander channel planform (straighten sections, tight meander radii and wavelengths).

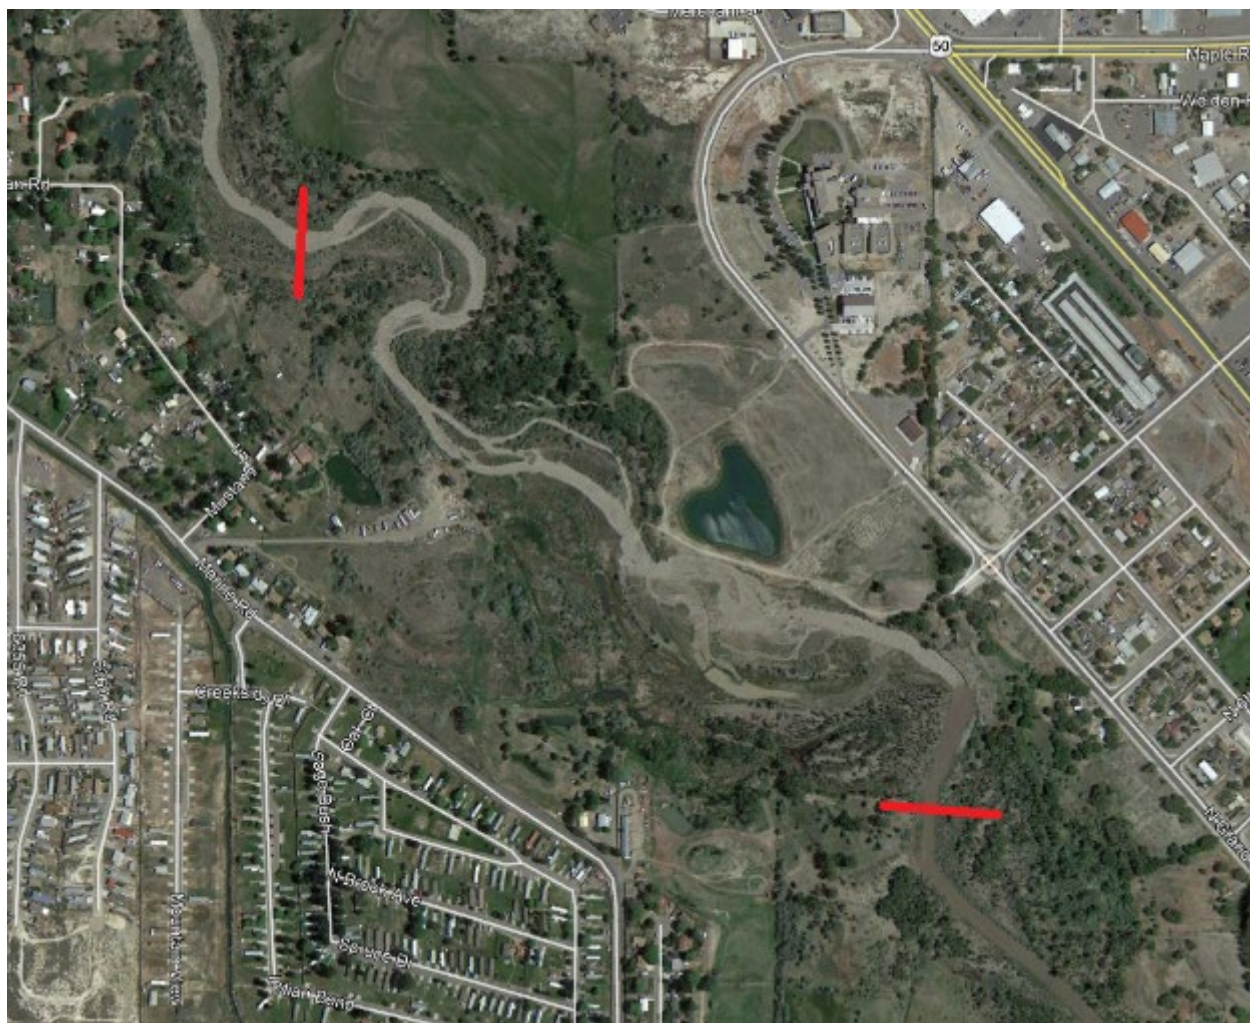
**Figure 6** River Extents for Geomorphologic Comparison

A summary of some of the pre-project channel characteristics is given in **Table 1** with values are derived for River extents identified in **Figure 6** below.

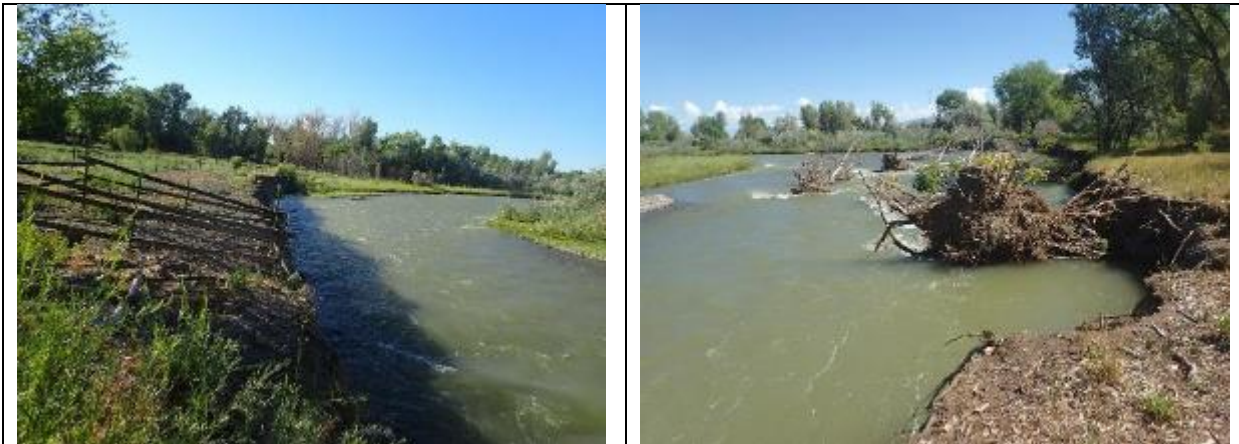
**Photos 1 (left) and 2 (right)** provide examples of the unstable with channel widening and lateral instability (bank erosion).

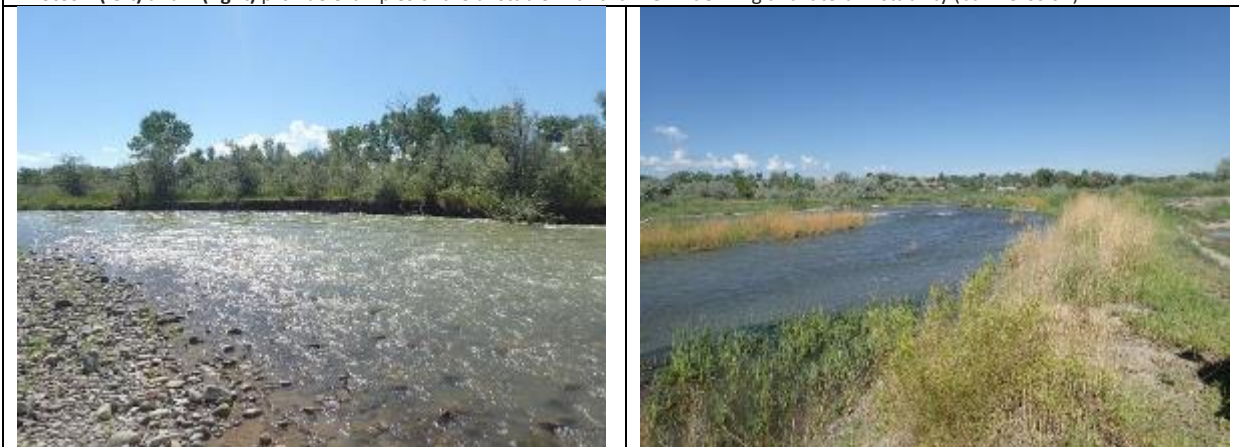
**Photos 3 (left) and 4 (right)** provide example of a section within the Project Reach that exhibits a wide channel bottom with limited channel diversity and instream aquatic habitat under typical high summer flow conditions.

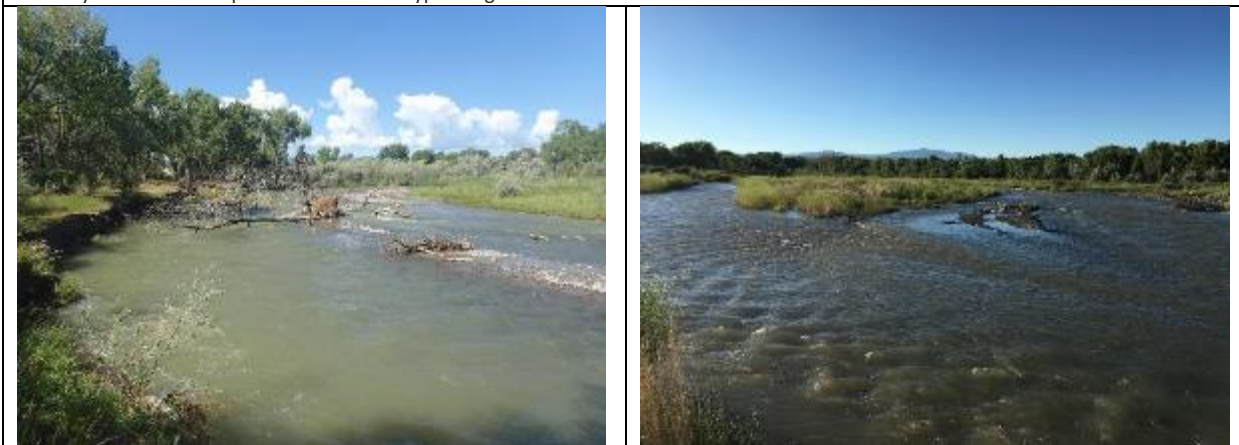
**Photos 5 (left) and 6 (right)** provide example of a section within the Project Reach that exhibits the unstable condition with bank erosion and channel widening.

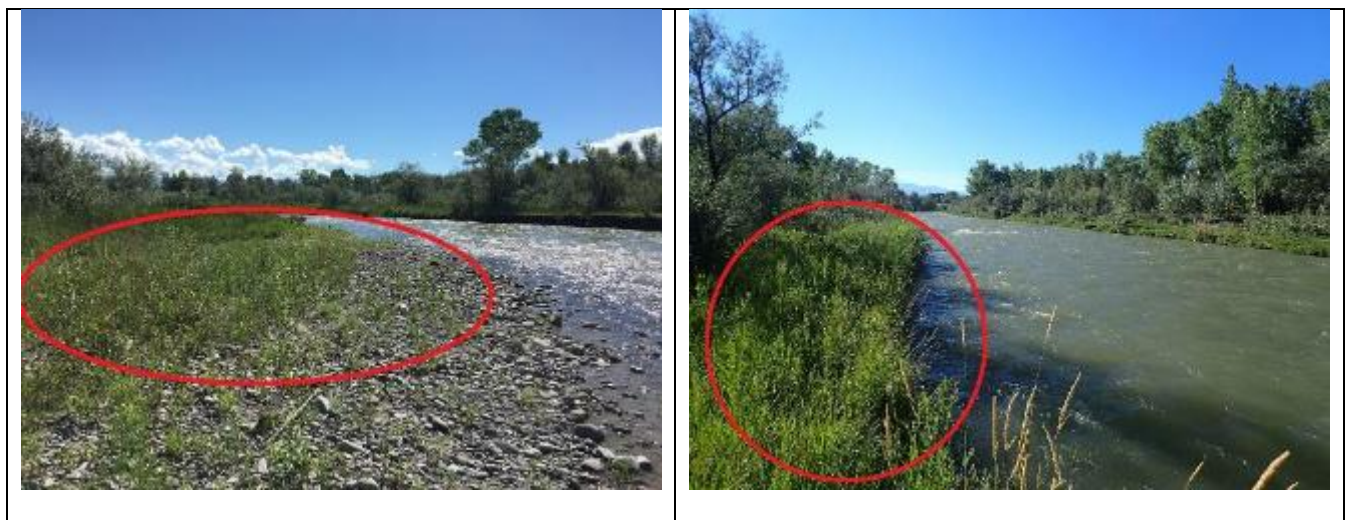
**Figure 8** Ecological Reference (red circle) and Target Plant Communities

Within the Project Reach, the reference standard communities would occur on low terraces and along the immediate streambanks of the Uncompahgre River through the riparian zone within the floodplain. The unconfined, active stream channel would frequently inundate vegetation through the riparian zone and active floodplain forming a complexity of habitats which support a variety of plant communities. The riparian zone vegetation community would be dominated by open to moderately open tree canopy of cottonwood (25-50% cover) with thickets of narrowleaf willow in the mid-story. A dense herbaceous understory layer comprised of graminoids would be present along portions the streambanks above the ordinary high water mark. The presence of narrowleaf willow indicates that the water table is relatively high and the community floods at least occasionally (NatureServe 2020. **Figure 8** depicts the examples of a properly functioning and structurally diverse riparian community along the Uncompahgre River considered as an ecological reference and target plant community for the Design Plan.

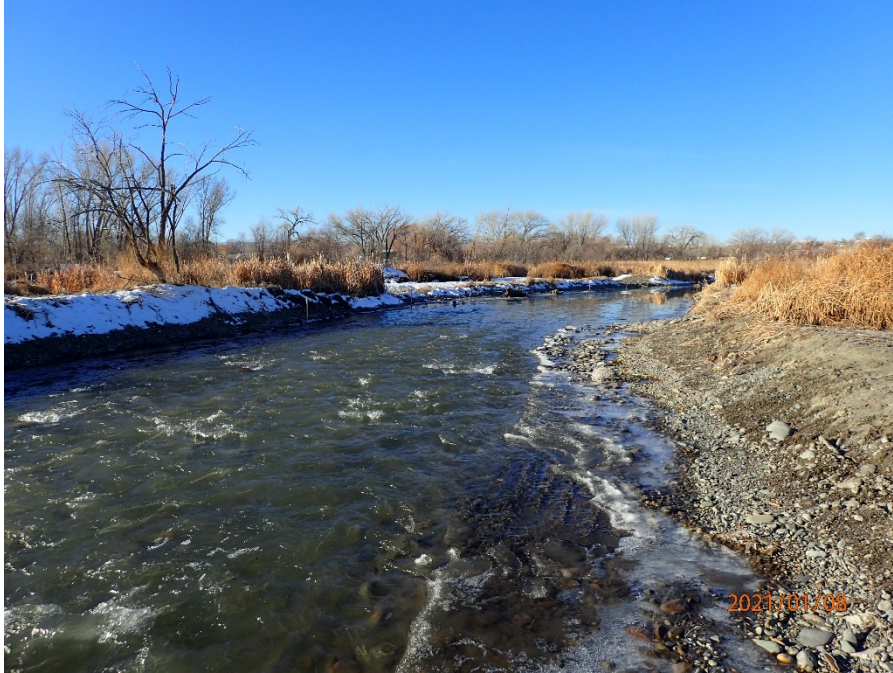
*Constructed Riffle*

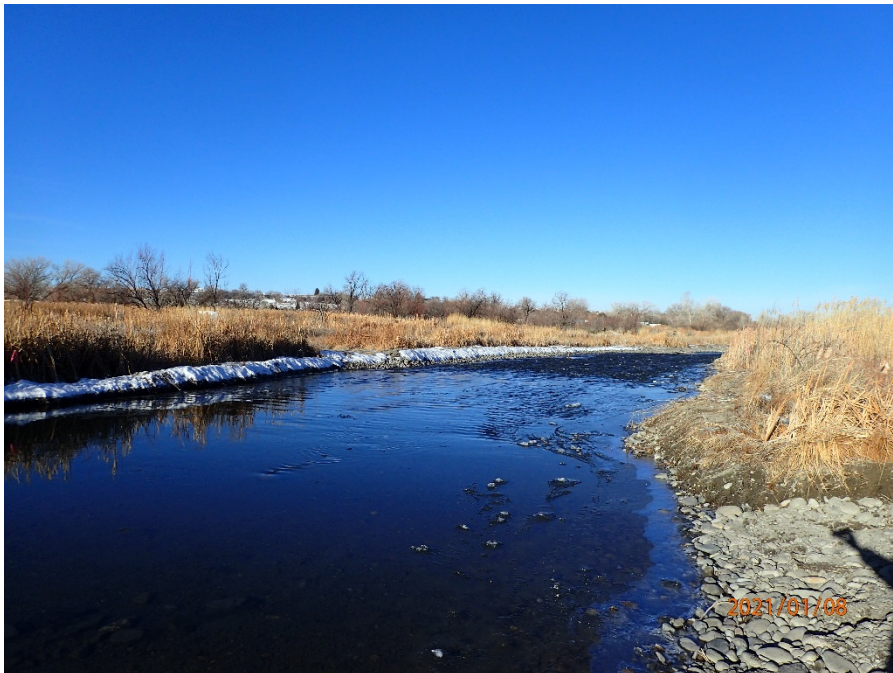
*Constructed Pool*

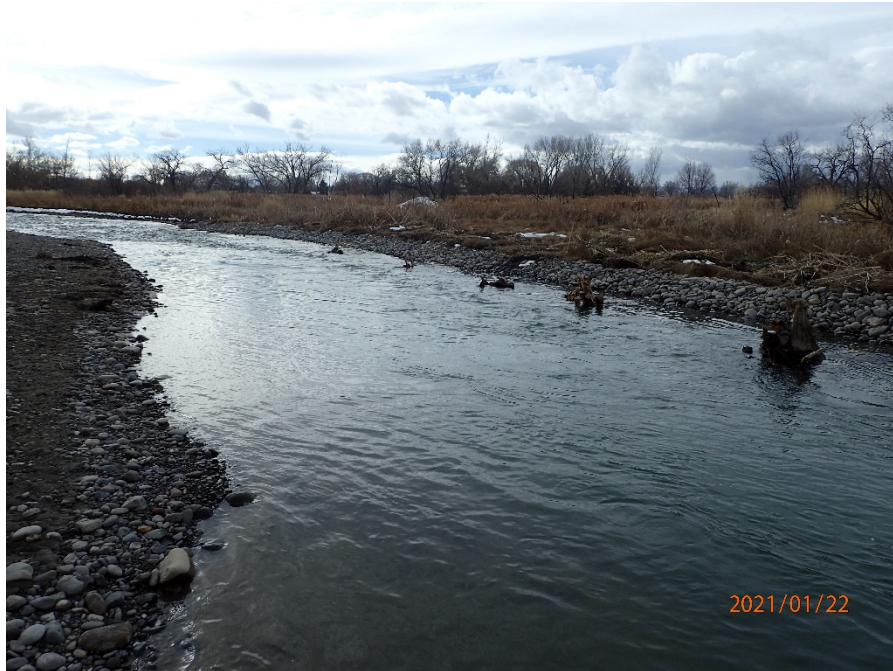
*Glide*

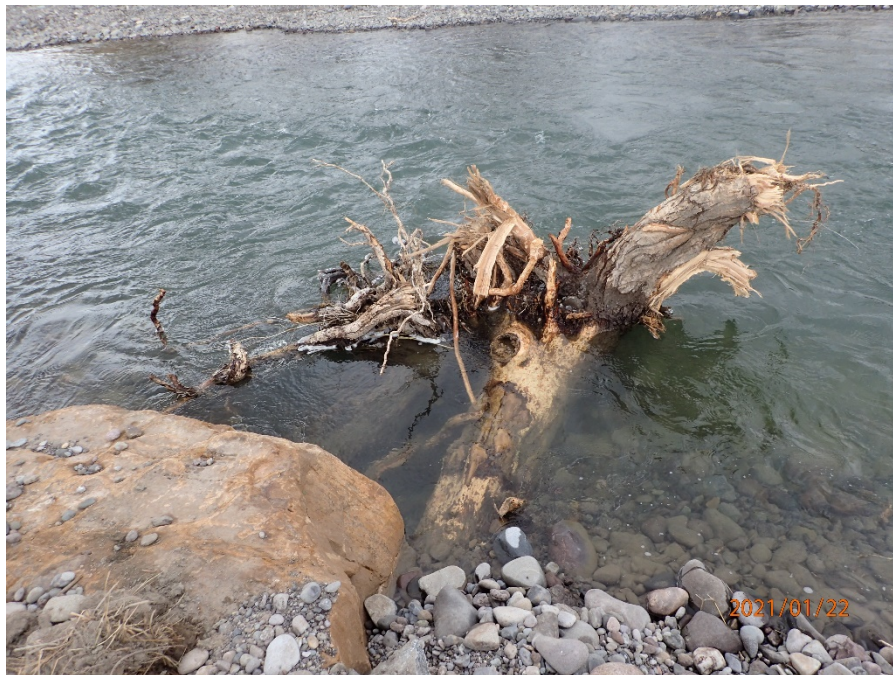
*Micro Habitat Feature*

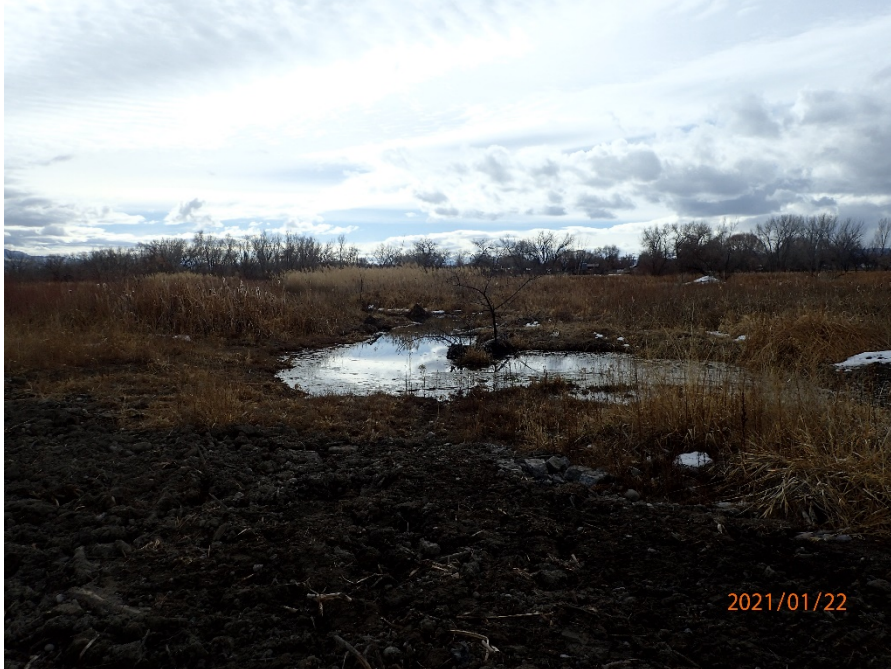
*Backwater*

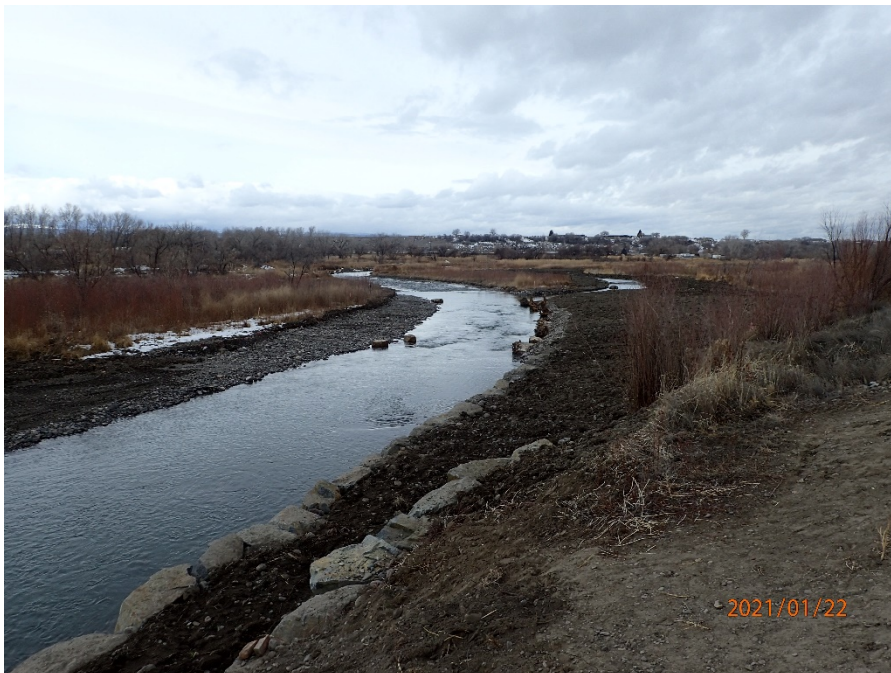
*Rock Wall Stabilization (foreground) and Log Stabilization (background)*

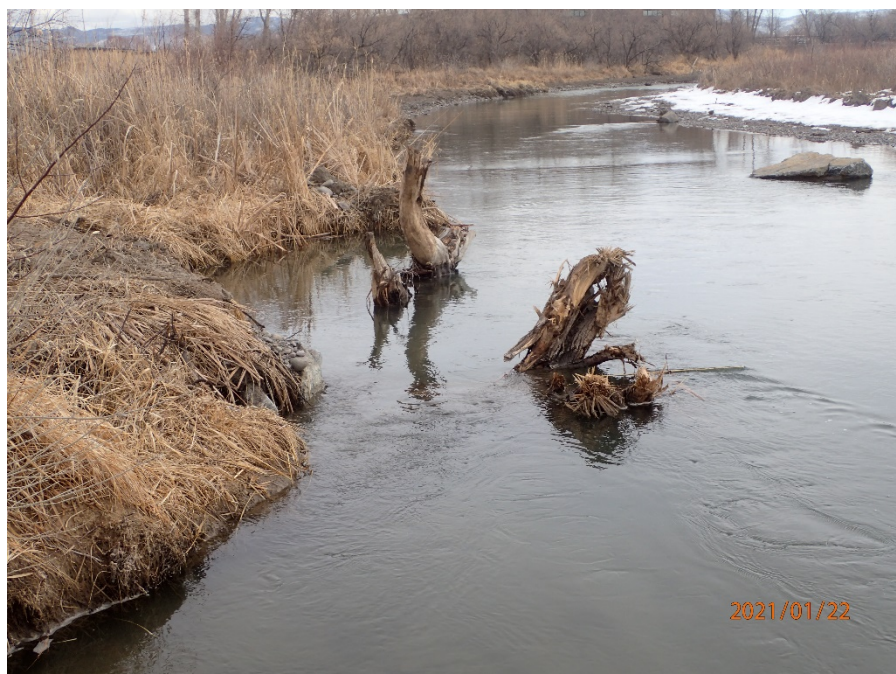
*Micro Habitat*

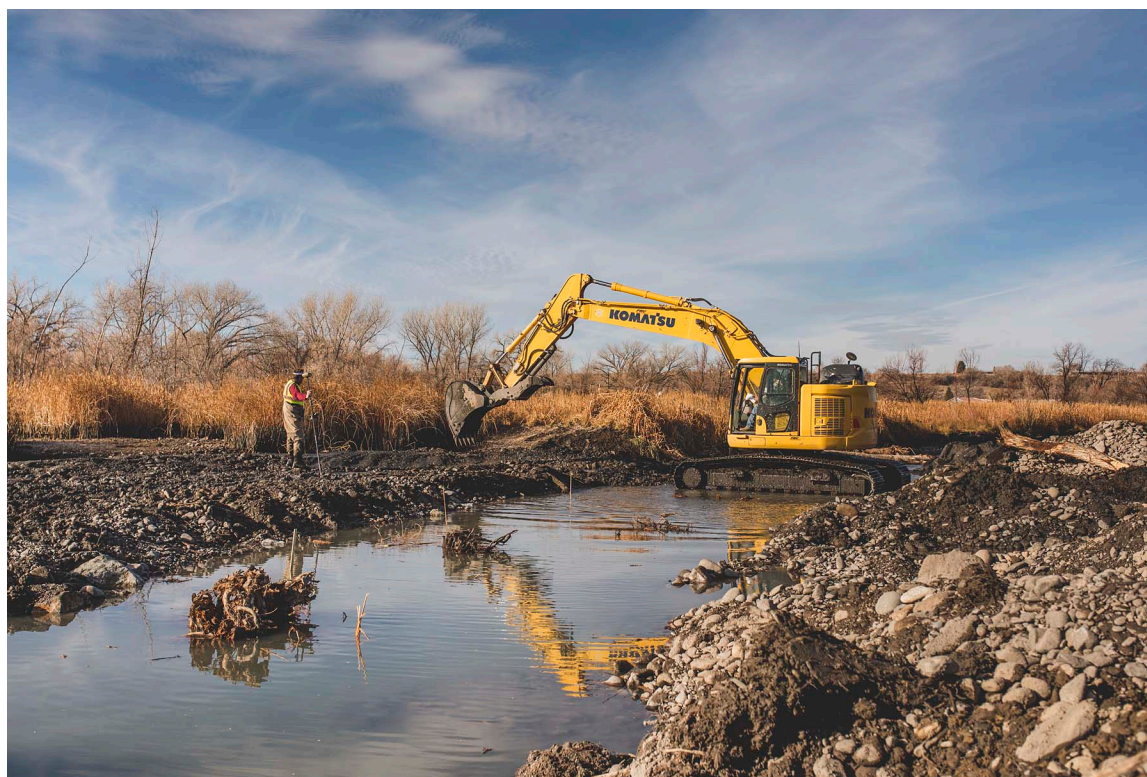
*Bank Stabilization*

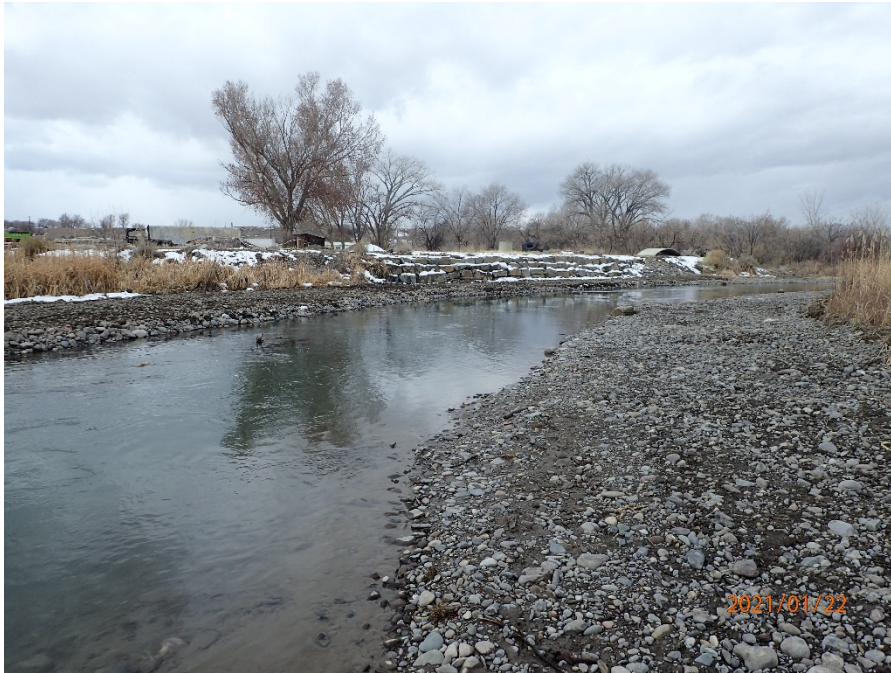
*Rock Wall Stabilization*

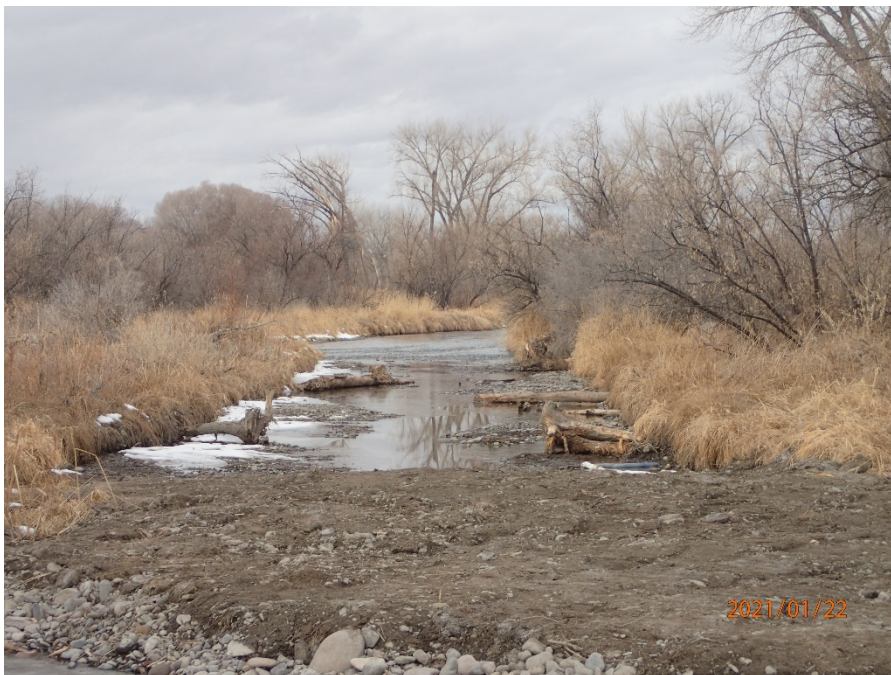
*Constructed Backwater*

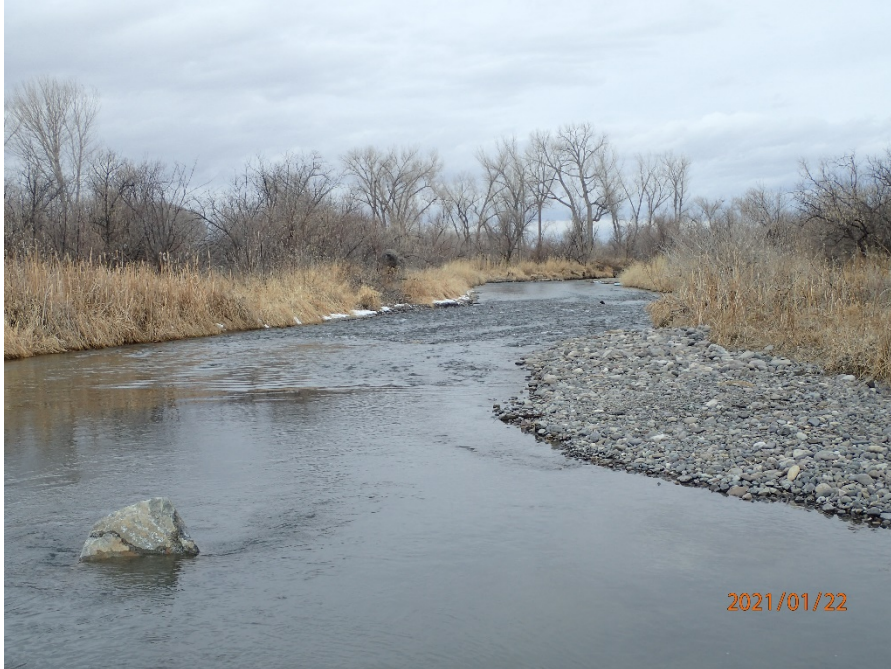
*Natural Channel Form*

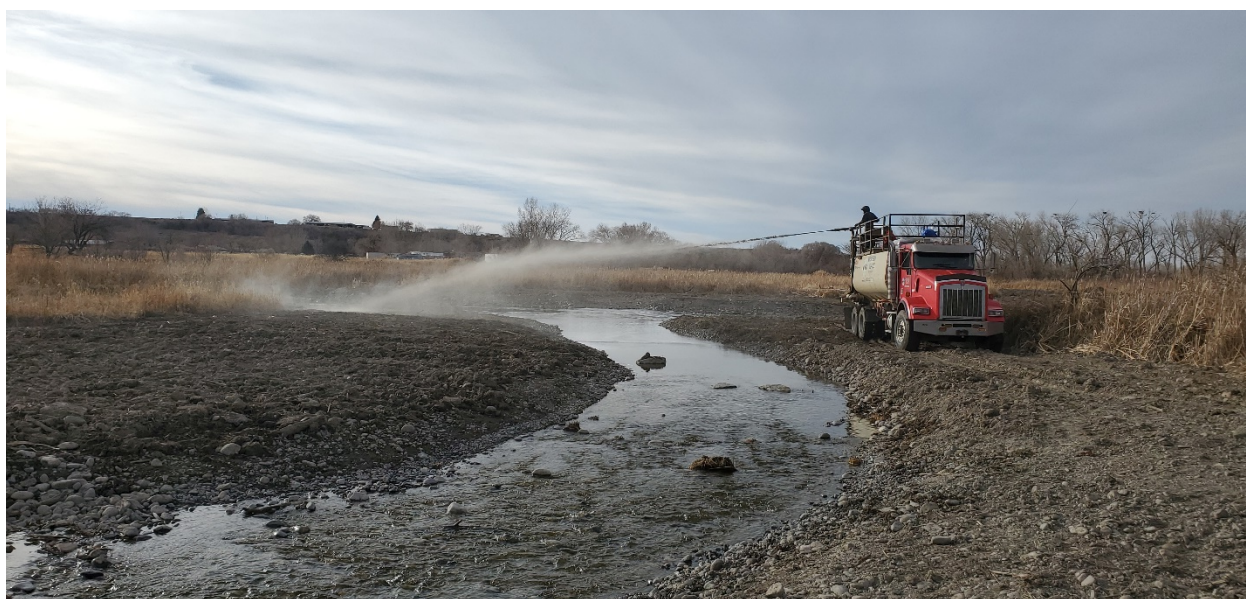
*Seeding*

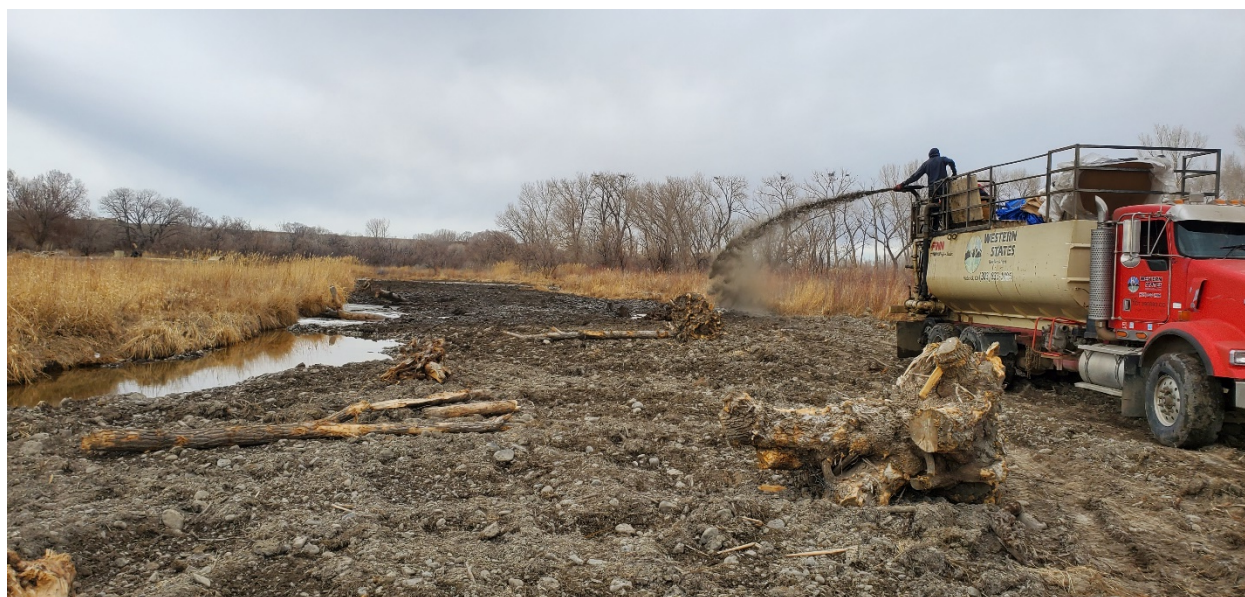
*Reclamation Seeding*

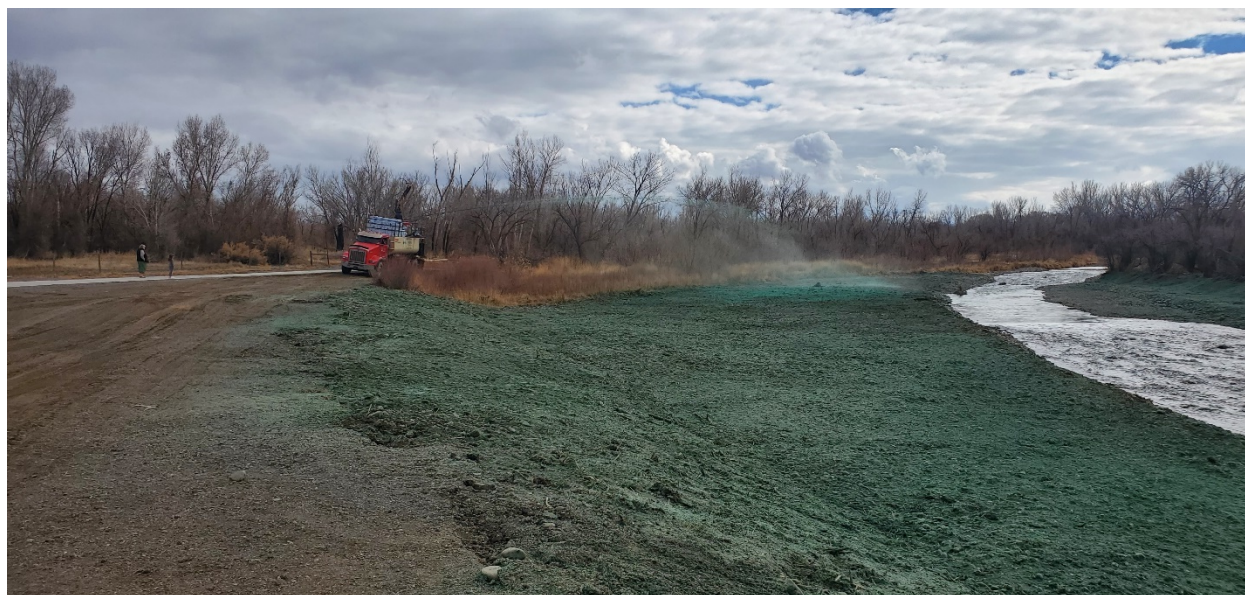
*Hydromulching*

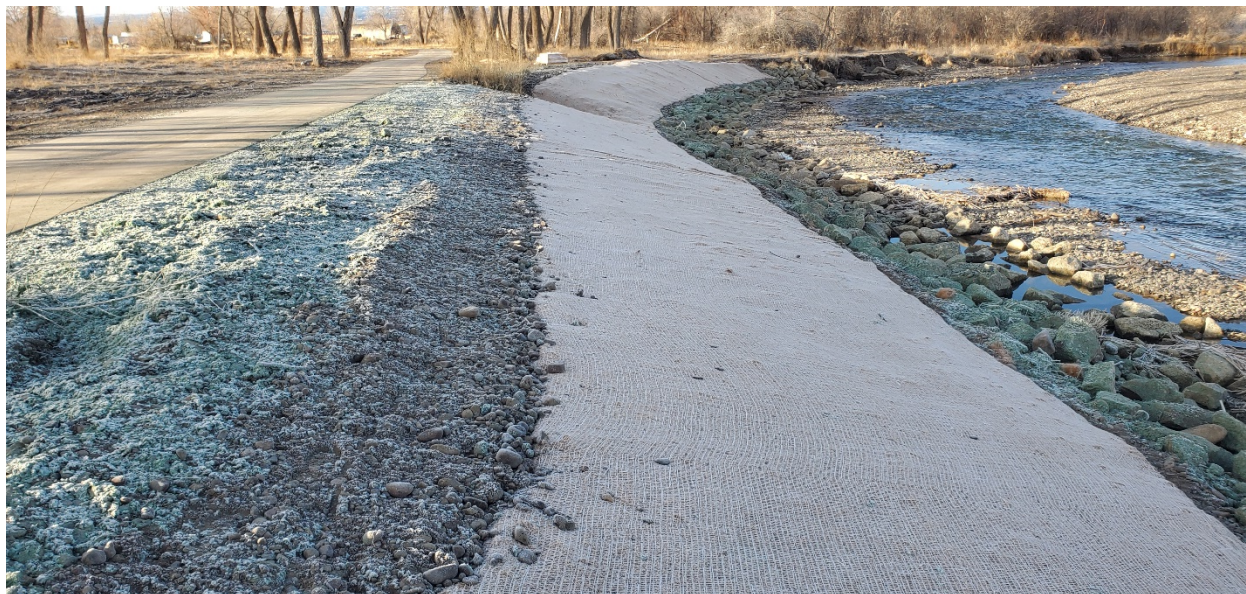
*Installed Blanket*

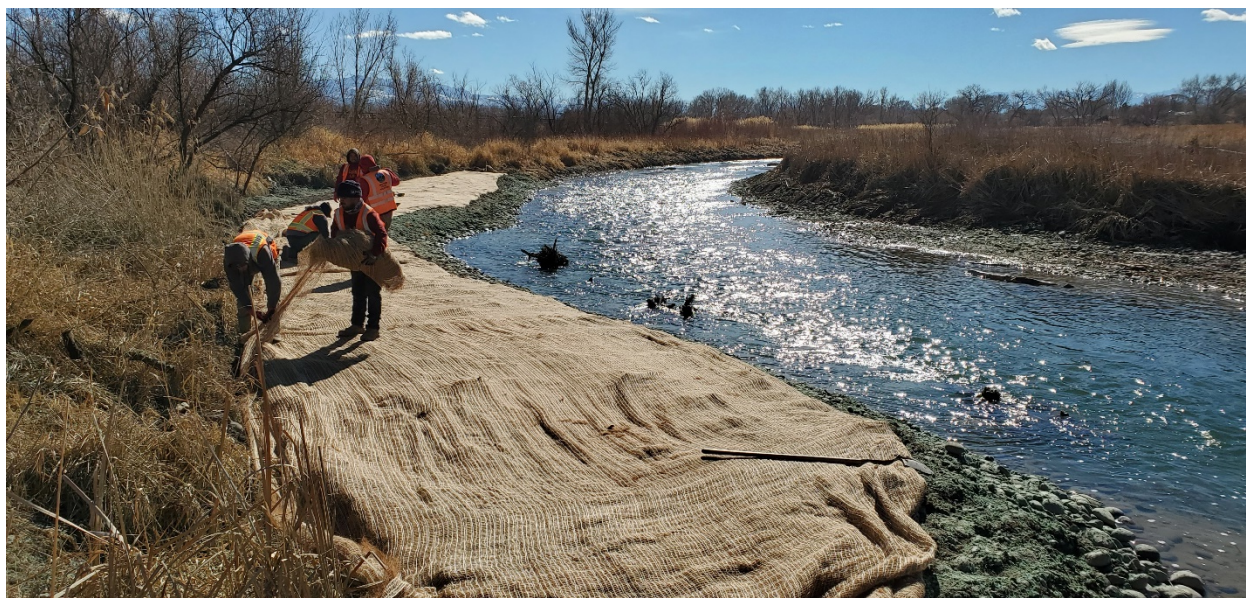
*Blanket Installation*

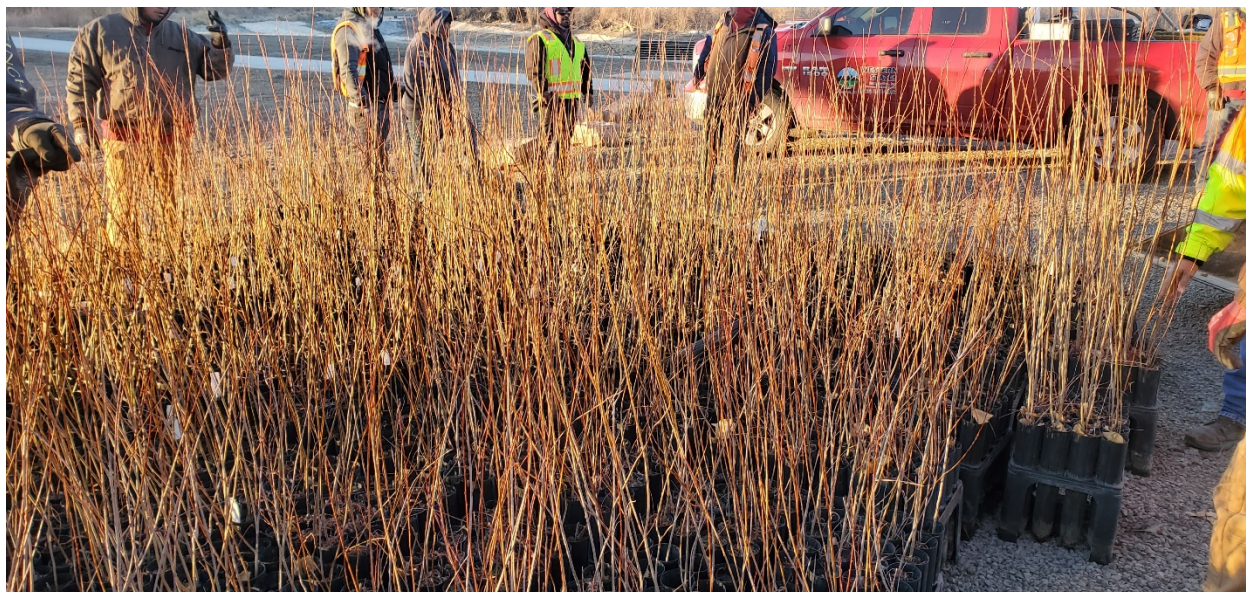
*Smaller Potted Material*

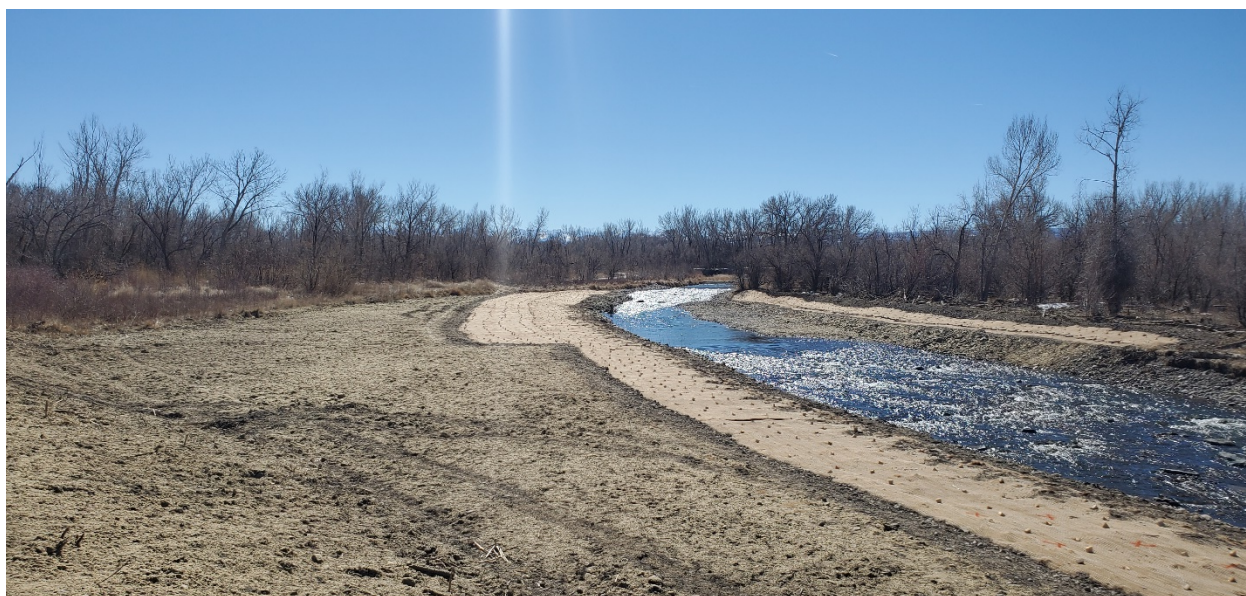
*Terrace Grading with Seeding and Fabric*

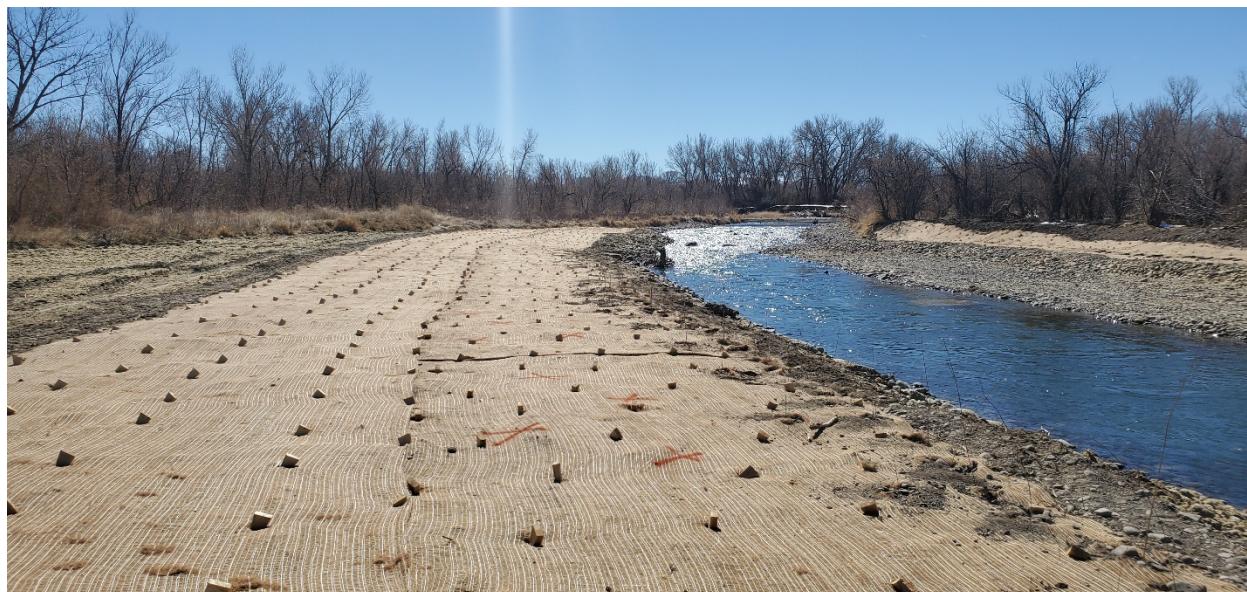
*Fabric for Stabilization*

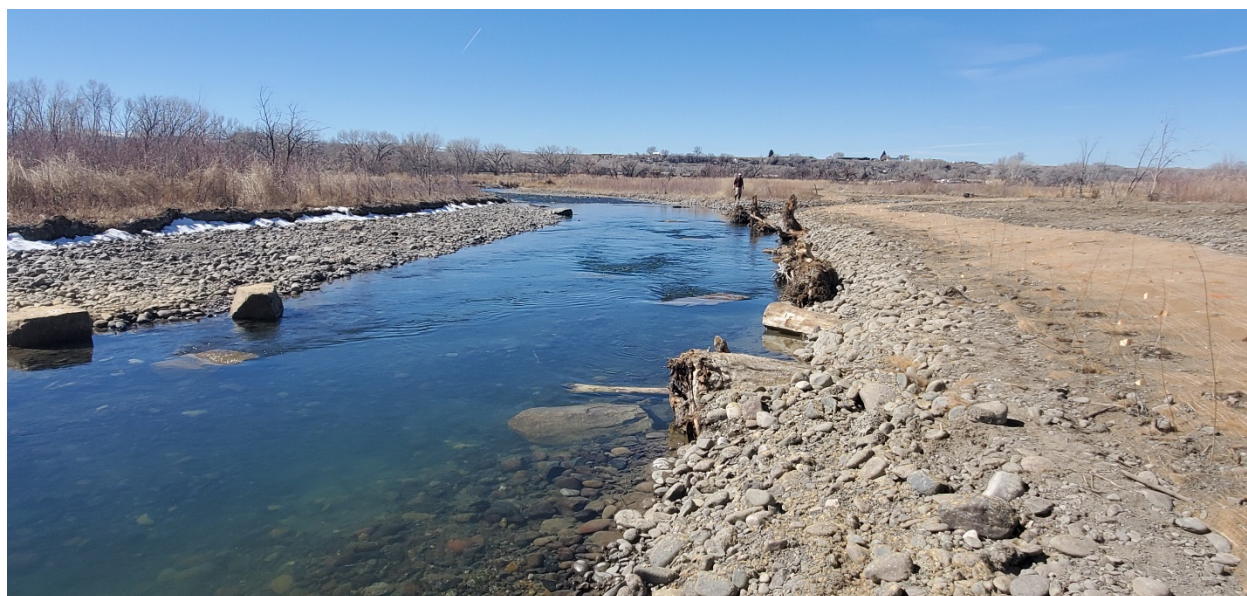
*Rootwad Stabilization with Plantings*

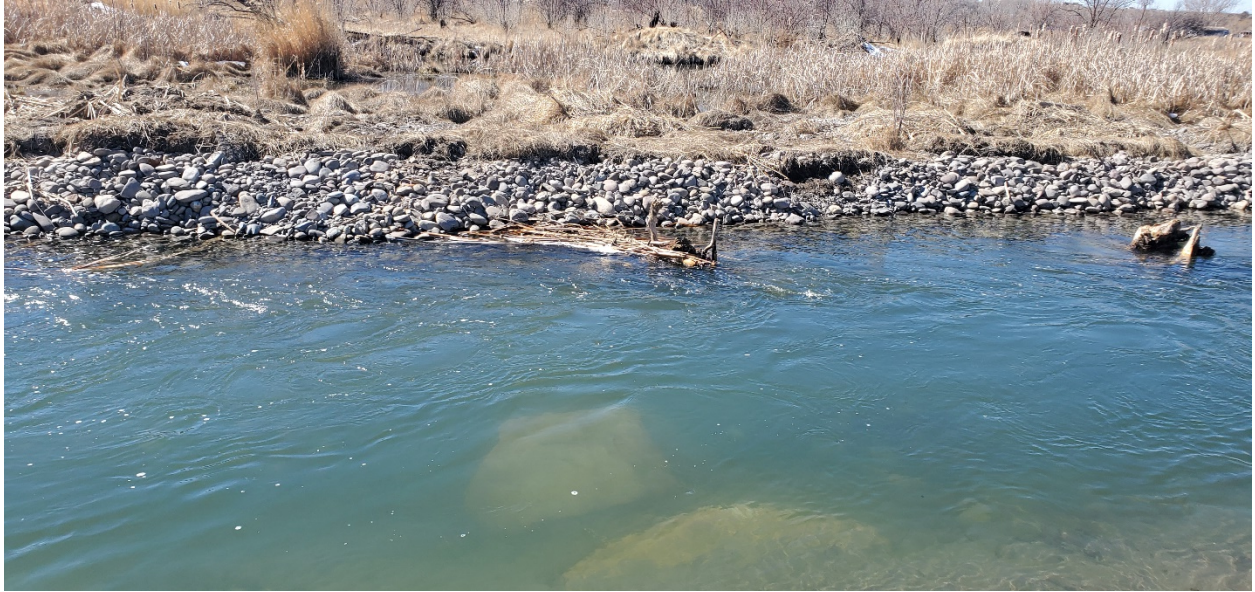
*Bank Stabilization with Habitat Features*

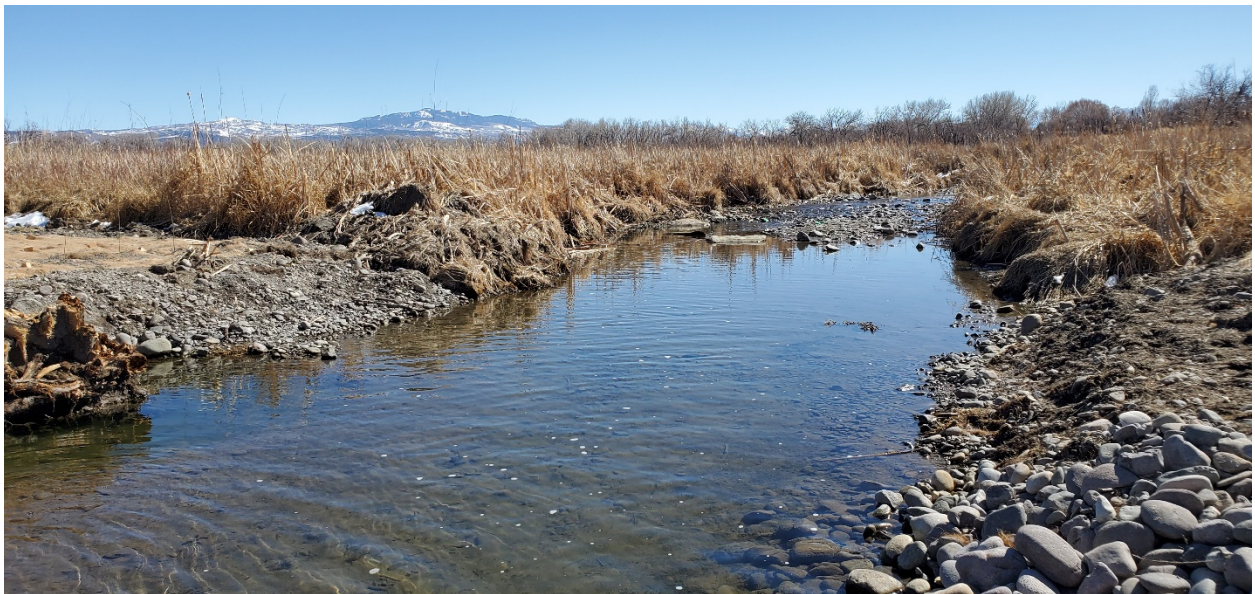
*Side Channel*

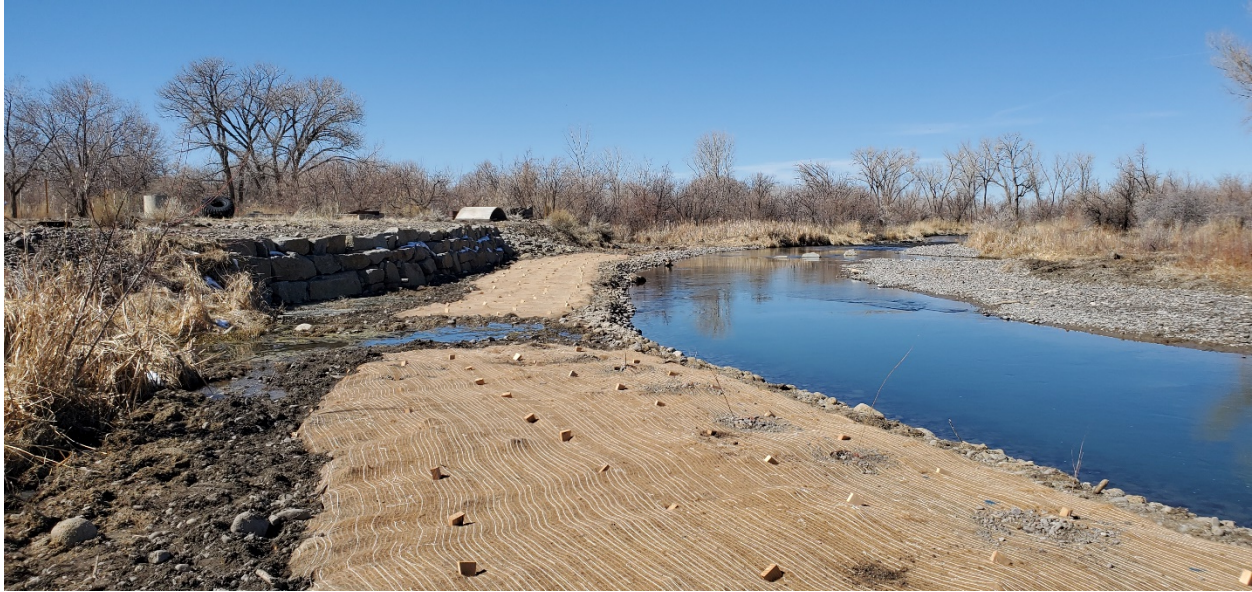
*Native and Rock Wall Stabilization along Glide*

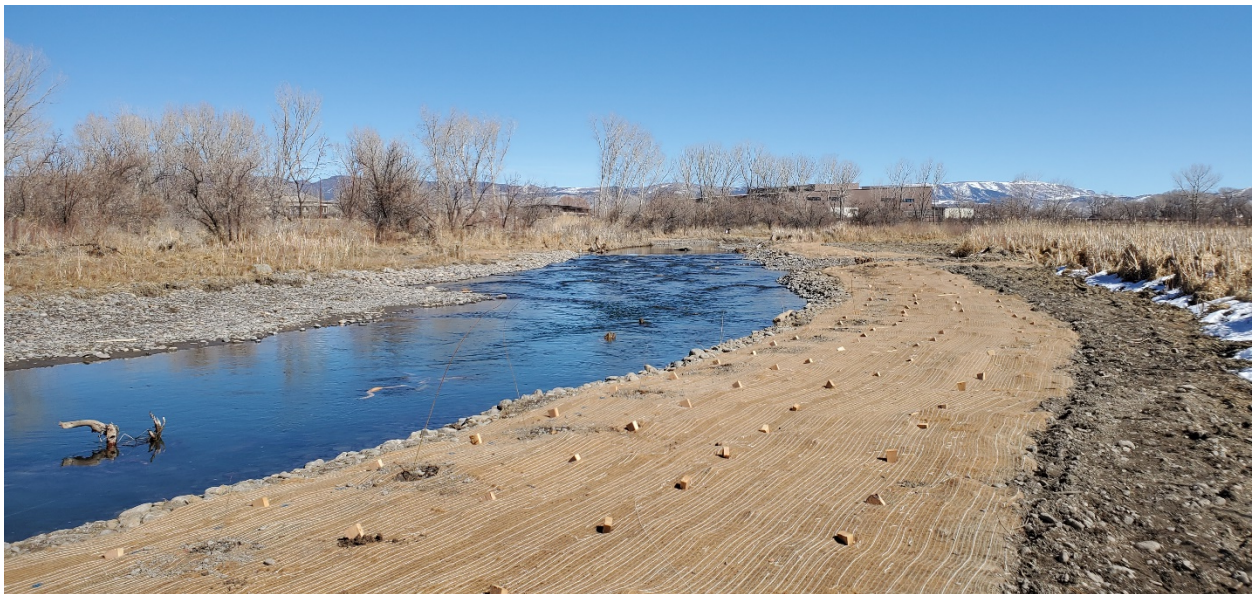
*Overbank Grading and Stabilization with Habitat Features*
