**COLORADO HEALTHY RIVERS FUND**  
**Uncompahgre River Restoration – City of Montrose**  
Final Report

May 2021

City of Montrose  
Grant Amount: \$500,000  
Prepared by: Ecological Resource Consultants on behalf of Scott Murphy

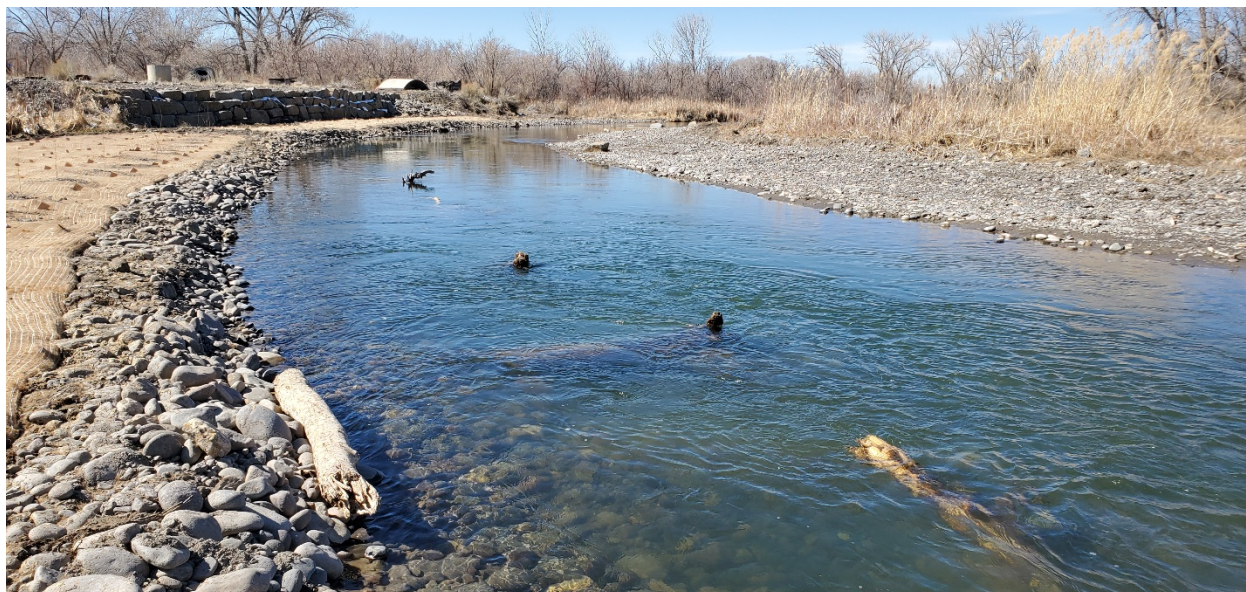
*Micro Habitat Features and Log Stabilization*

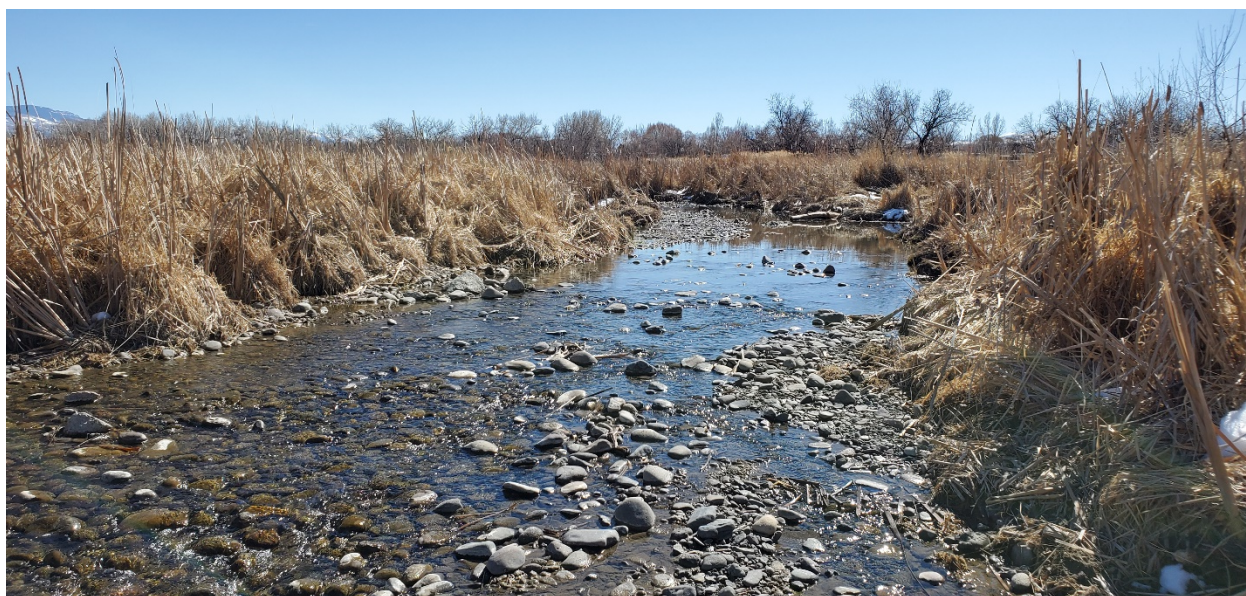
*Created Side Channel*

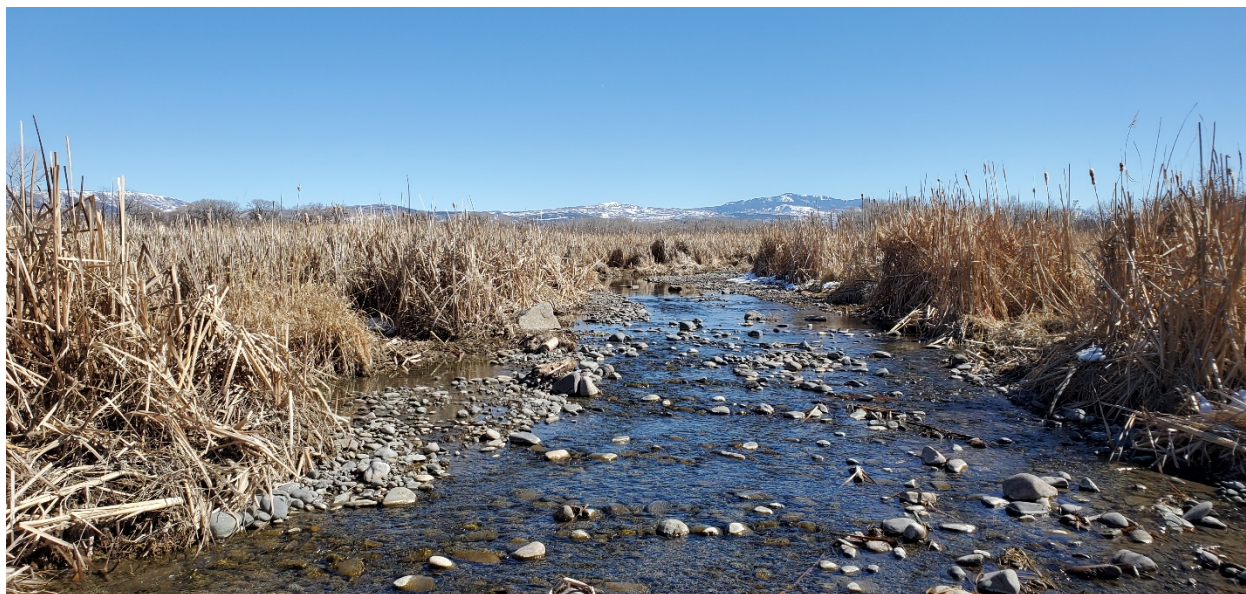
*Created Side Channel*

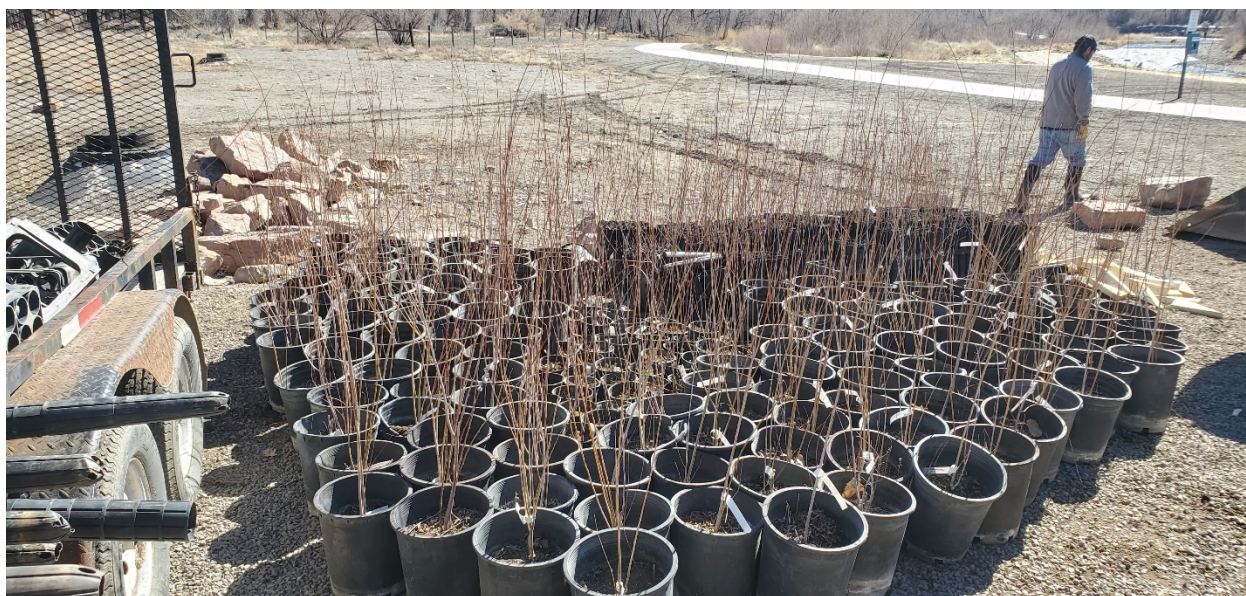
*5 Gallon Willows*

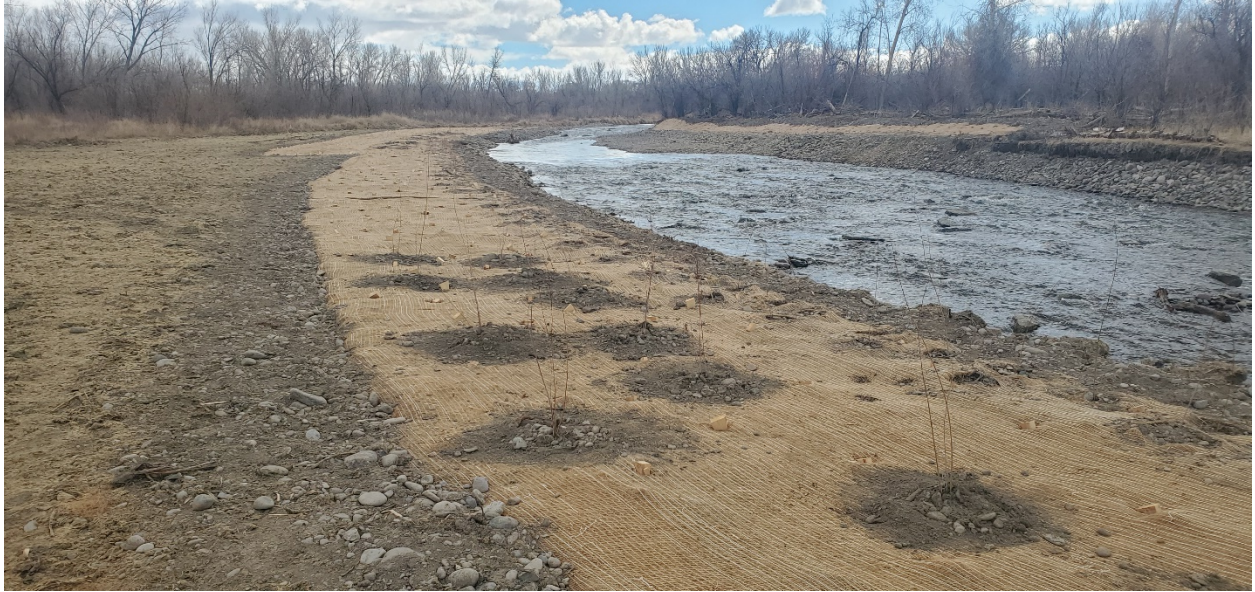
*5 Gallons Installed*

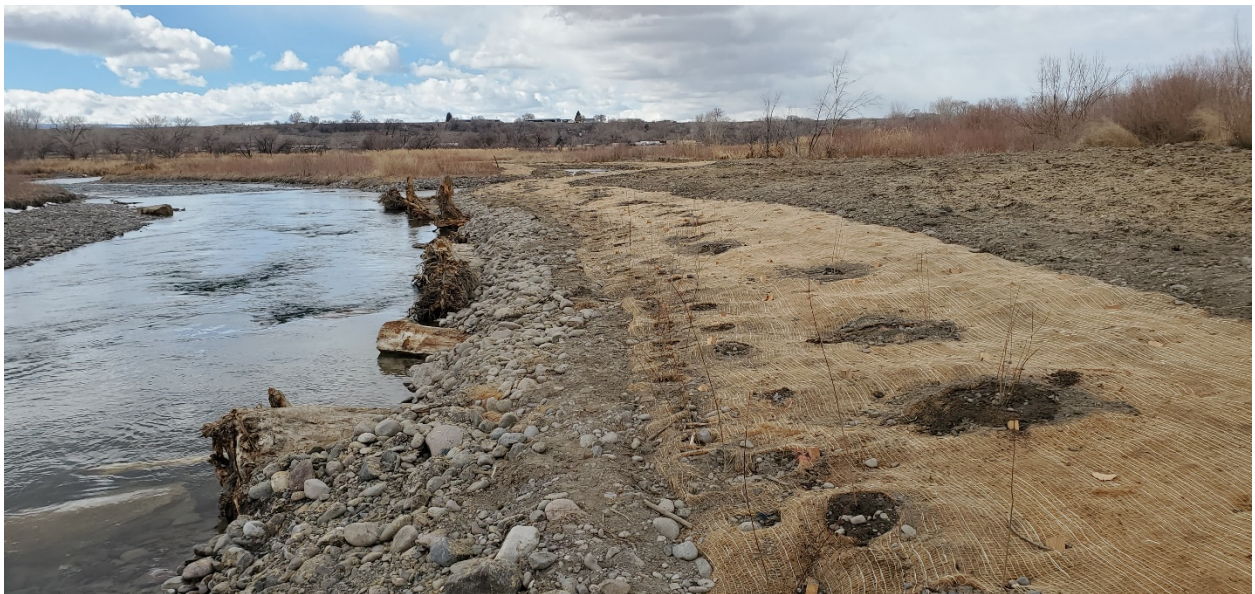
*Bank Stabilization with Roots and Vegetation*
