## East Troublesome Fire Watershed Recovery

Final Report  
CTGG1 2023\*2041

**Subject:** ETF 2022 Aerial Mulching

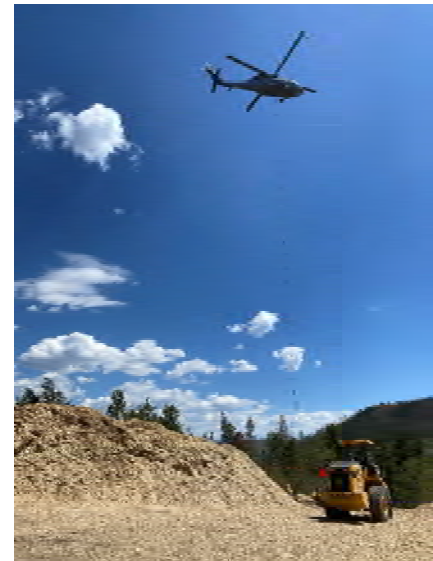
*Helicopter Loading at Mulch Staging Area*

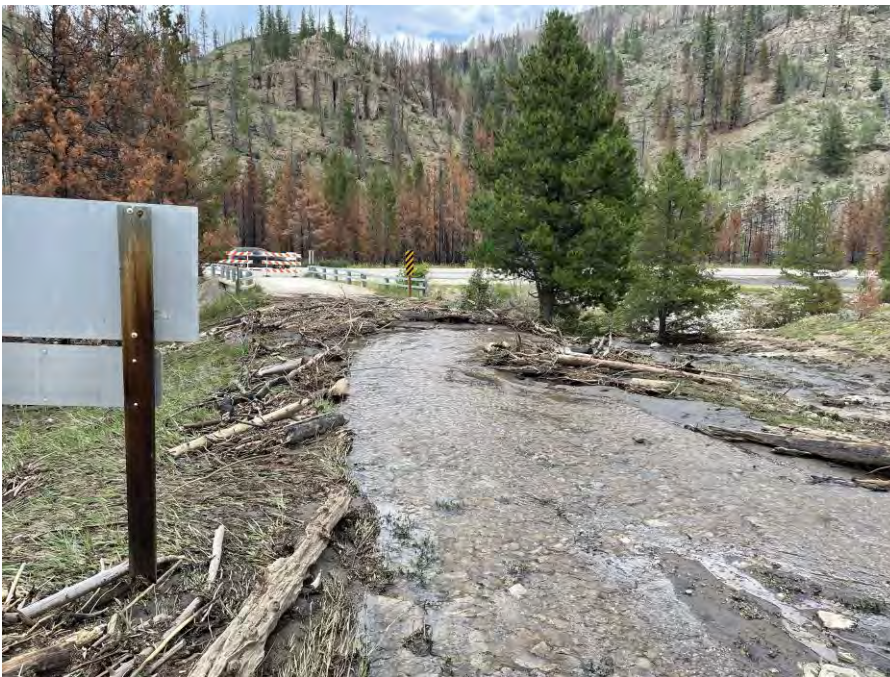
**Figure 1. Cabin Creek running down the road just above Willow Creek**

Upper Cabin Creek was not visited in the field, except for the outlet, or mulched in 2021. The stream conditions are currently poor in the lower portions and good/fair in the upper portions based on Matrix Design Group's analysis. The outlet of Cabin Creek was visited in July 2021 (Figure 1). The Creek was running down the road, and debris and sediment were being transported and deposited onto the road and into Willow Creek. Upper Cabin Creek has an extensive road network which may be contributing to post-fire watershed response. The upper watershed has some concentrated areas with potential mulch polygons.

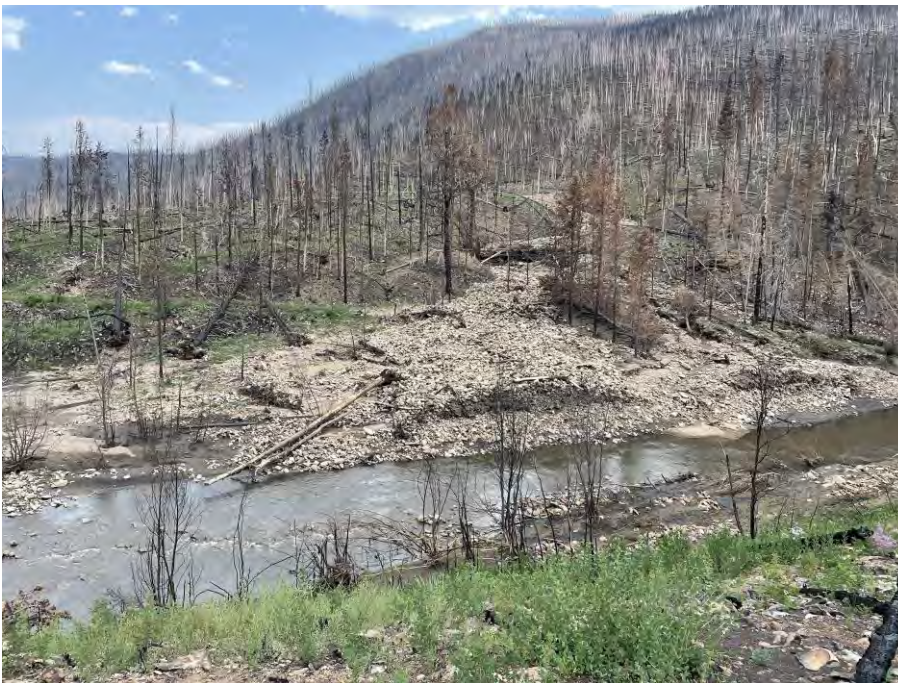
Figure 2. Debris Flow from Adams Creek at Willow Creek

Adams Creek was not visited in the field or mulched in 2021. However, the outlet was viewed in July as a debris flow entered Willow Creek and is modifying channel conditions (Figure 2). The stream conditions are currently poor. Adams Creek has some large areas of north-facing slopes that appear to have burned hot. These are connected and are located from the ridgeline to the stream in two locations. There appear to be only small areas of aspen. Adams Creek is expected to continue to deliver substantial amounts of sediment to Willow Creek. Stream channel processes are the dominate source of material to Willow Creek and point treatments are recommended to manage these sources.
