**Animas River Removal and Replacement of Invasive Phreatophytes,  
Phase II Continuation and Strategic Mapping**  
Final Report

Prepared for:  
Colorado Water Plan Grant Program  
Attn: Chris Sturm

# Mapping the Distribution of Russian Olive in the Animas Valley

A Workflow using Object-Based Image Classification, NAIP Imagery, and LiDAR

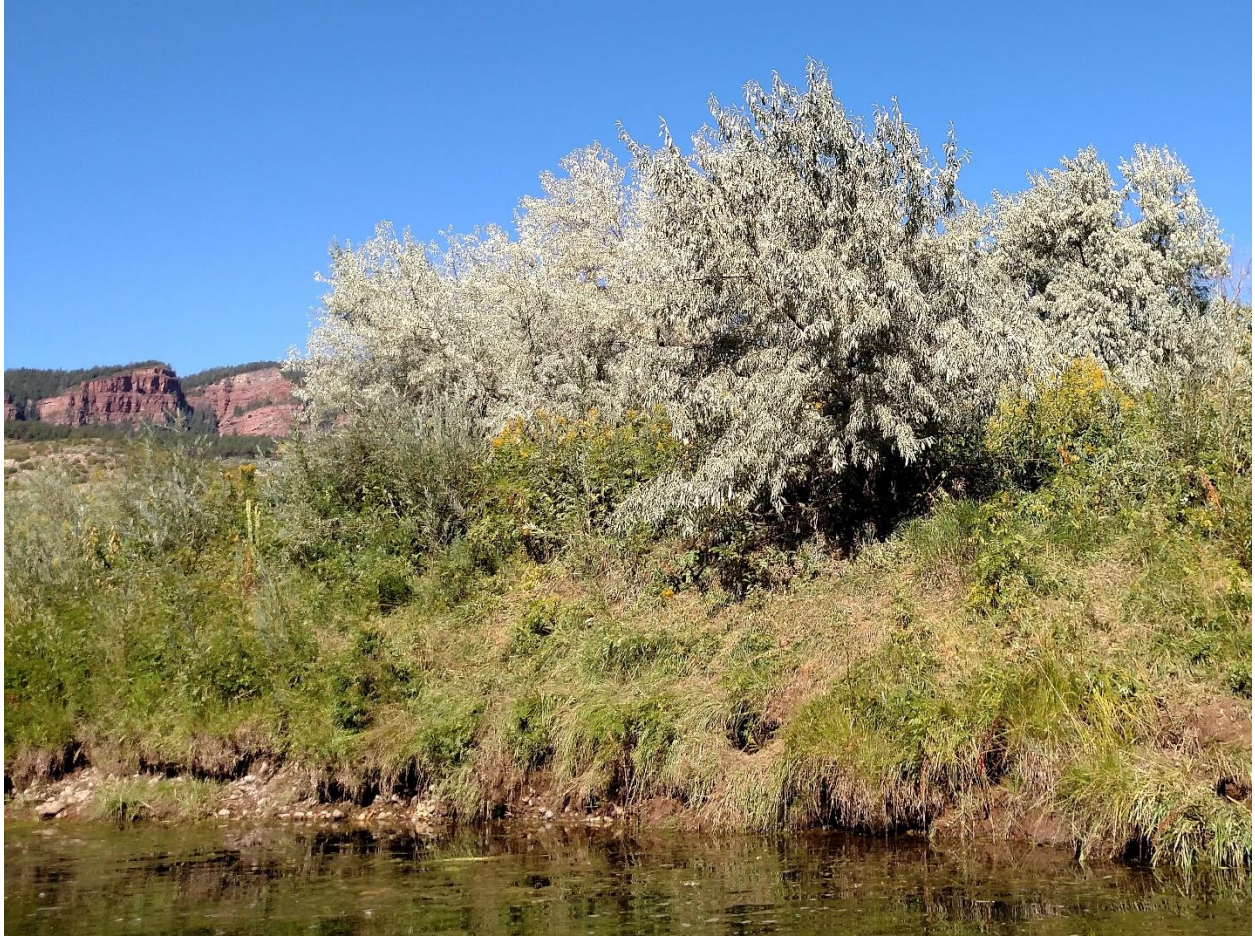
*Figure 1 Russian olive on the bank of the Animas River. Its silvery leaves and broad canopy make it distinguishable in both the field and remote sensing imagery (Photo: Amanda Kuenzi, MSI Staff).*

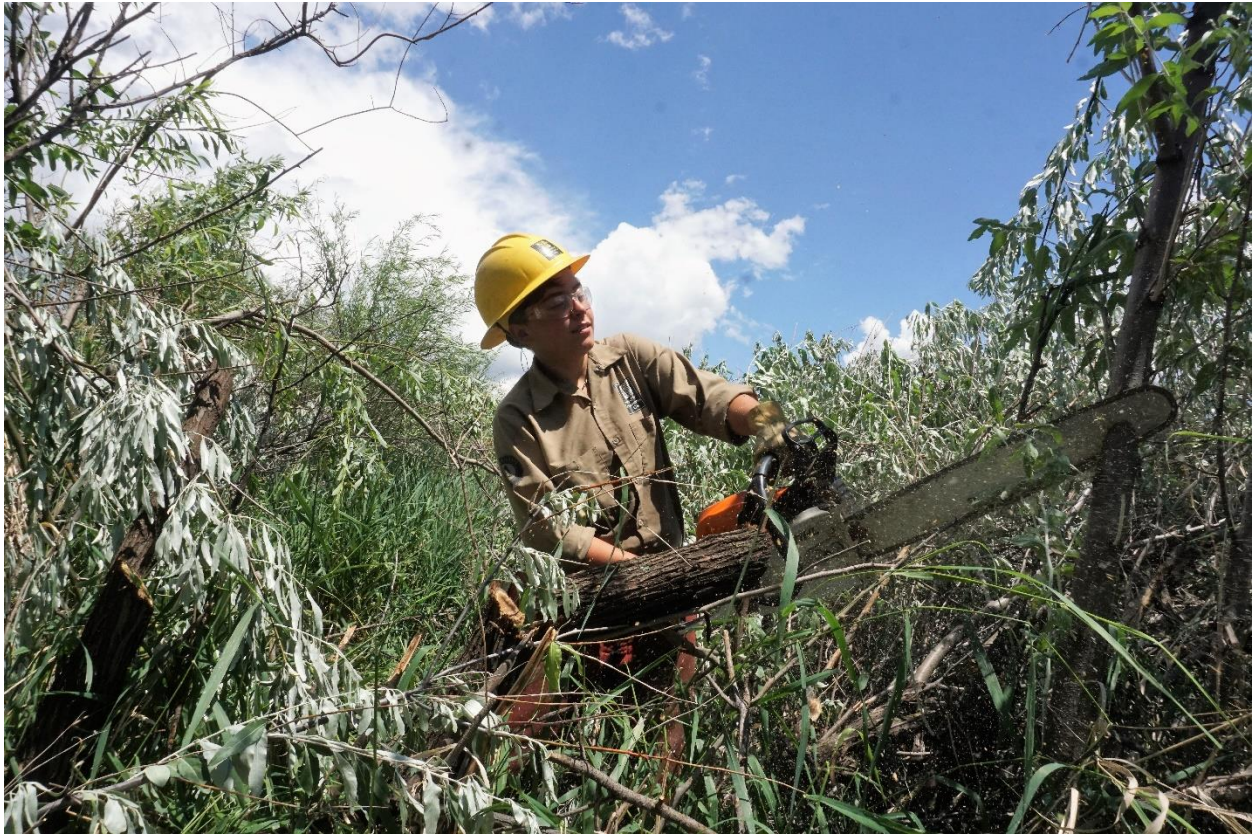
*Figure 2. A Student Conservation Corps member under the direction of MSI removes a dense stand of Russian Olive. (Photo: MSI)*

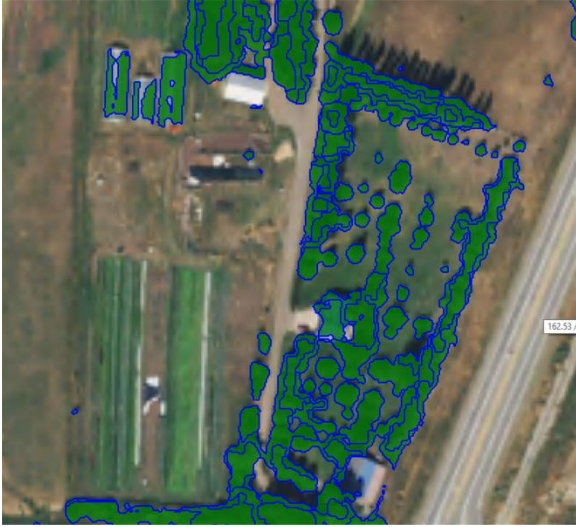
Figure 10 Several roof tops misclassified as Canopy.

Following segmentation, the *pixel-based object resizing* algorithm was applied to refine the segmented objects. Based on visual observation of the imagery, there were several roof tops with NDVI greater than 0.1 that were misclassified as Vegetation and/or Canopy. These roof tops typically had a Blue value of greater than 105. Pixels in these objects with a Blue value of greater than 105 were “shrunk” from the Canopy class and assigned to the class “Structure”. See Figure 10 and Figure 11.

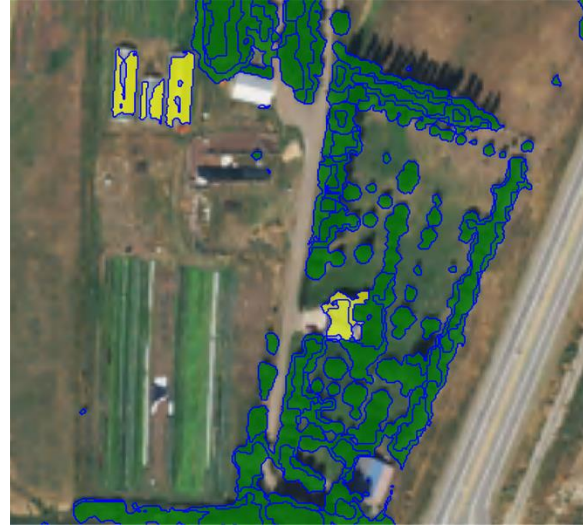
Figure 11 Misclassified roof tops with Blue values greater than 105 reclassified as Structure.

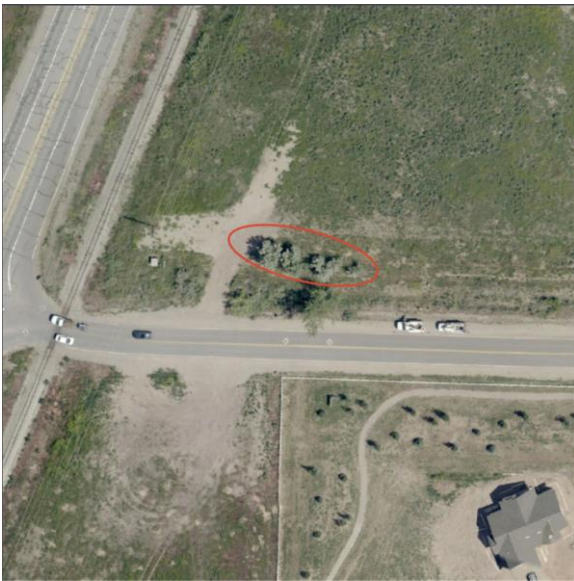
Figure 12 Russian olive trees adjacent to trees of a different species (La Plata County 2019 imagery).

algorithm resulted in a processing time of several hours for some scenes. The *watershed segmentation* algorithm typically provided a better segmentation result of tree crowns with fewer, more compact objects in a fraction of the time than *multi-resolution segmentation*. For instance, in the case of a single tree in a field, the watershed segmentation usually produced a single object, while the multi-resolution segmentation produced several based on spectral intensity. For these reasons, *watershed segmentation* was used for this project. Examples of these segmentation algorithms are depicted in Figure 12 through .

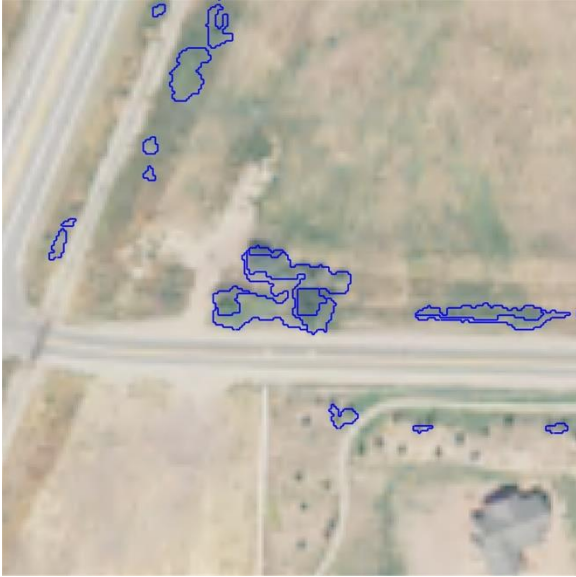
*Figure 14 Canopy segmentation using the multi-resolution segmentation algorithm (scale = 25, shape = 0.1, compactness = 0.5). Objects are spectrally grouped, causing other classes to be grouped with RO.*

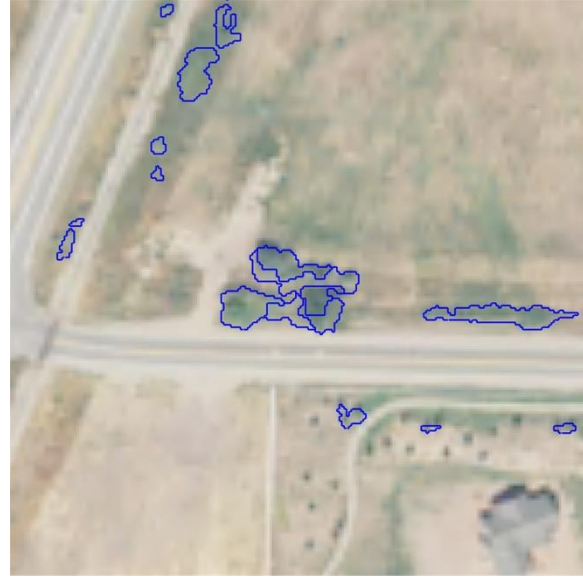
*Figure 15 Canopy segmentation using the multi-resolution segmentation algorithm (scale = 25, shape = 0.4, compactness = 0.5). Shaded and bright areas occupy their own objects regardless of if the areas represent the same tree.*

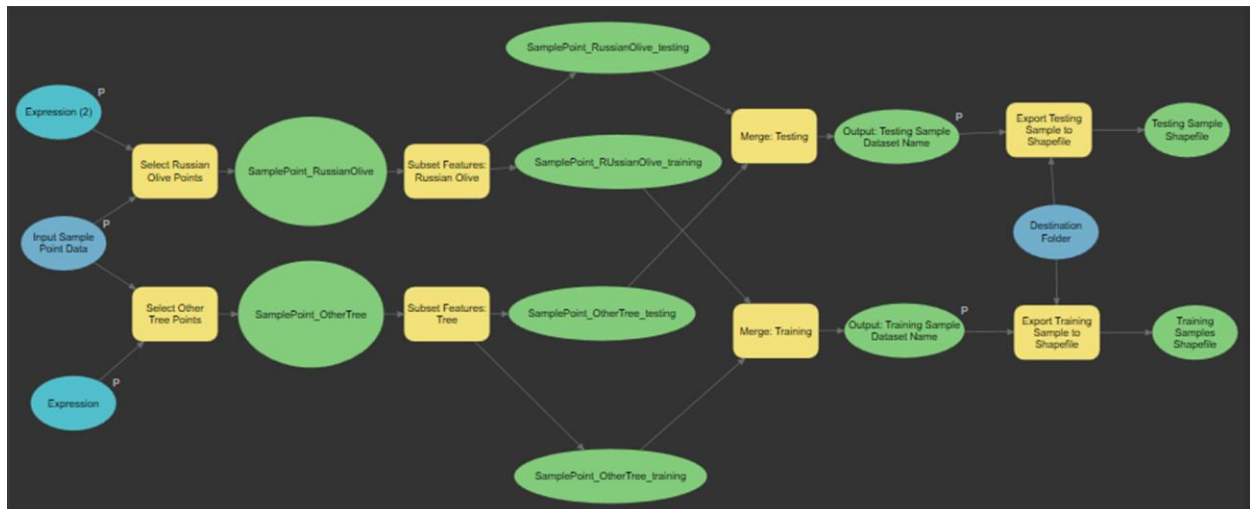
Figure 17 Select Training and Testing Samples Model.

Next, another model was created (“Select Training and Testing Samples”) to combine the RO and OT sample feature classes, then partition those into training and testing datasets. Twenty percent of the samples were reserved for testing samples for use in assessment of classification accuracy.

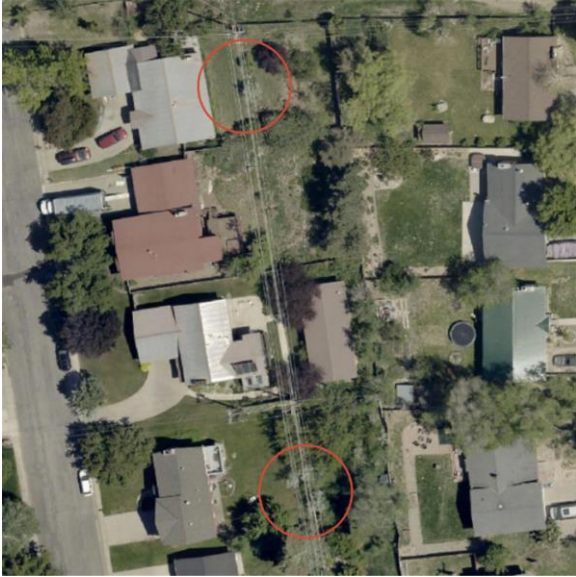
Figure 21 RO growing beneath overhead electric transmission lines in the Lightner Creek-Animas River scene in Durango northwest of the intersection of Holly Ave and Florida Rd.

Several distribution patterns of RO were observed, including riparian areas adjacent to rivers, streams, oxbows, and ponds; alongside manmade water sources such as ditches and stock ponds; as windrows at the edges of agricultural fields; and in landscaping applications. RO trees were also observed growing beneath overhead electric transmission lines, assumedly in a utility easement or alley where there might be disturbed ground or a fence. Aerial images (La Plata County 2019 imagery) of RO distribution patterns are depicted below in Figure 21 through Figure 30.

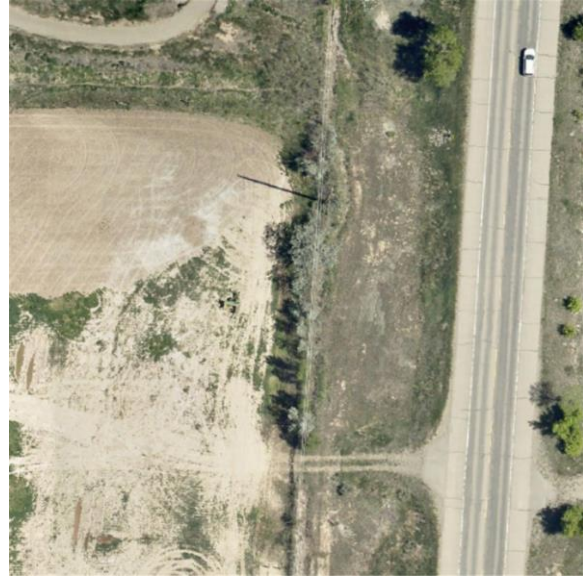
Figure 22 RO growing beneath overhead electric transmission lines adjacent to US 550 in the Electra-Cascade-Animas River Canyon scene in the Animas valley north of Durango.

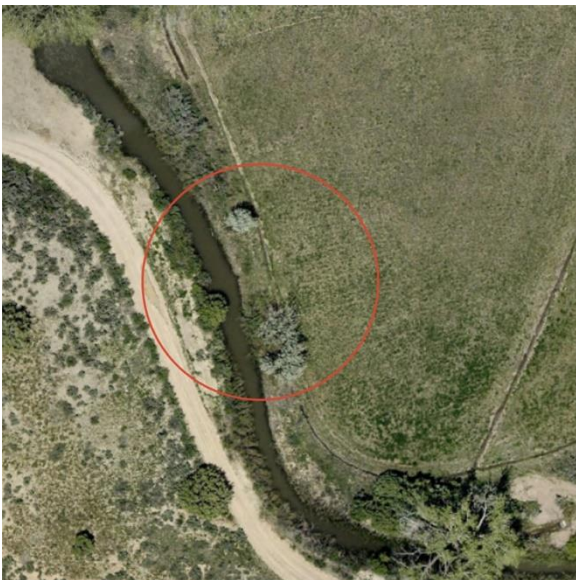
Figure 23 RO growing adjacent to the Citizens Animas Ditch in the Middle Animas Valley scene.

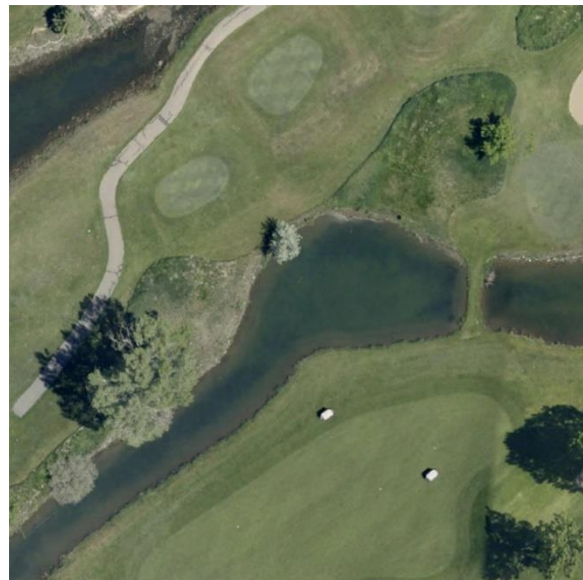
Figure 24 RO growing at the edge of a manmade pond in a golf course in the Electra-Cascade-Animas River Canyon scene in the Animas valley north of Durango.

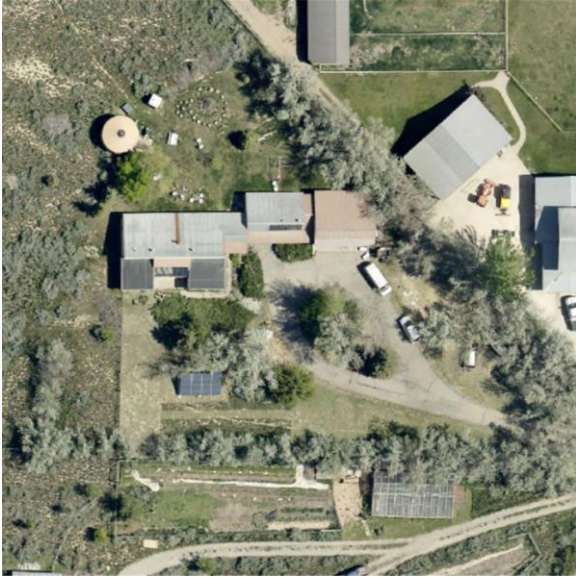
Figure 25 Abundant RO as windrow plantings surrounding a home in the Animas River floodplain in the Lightner Creek-Animas River scene.

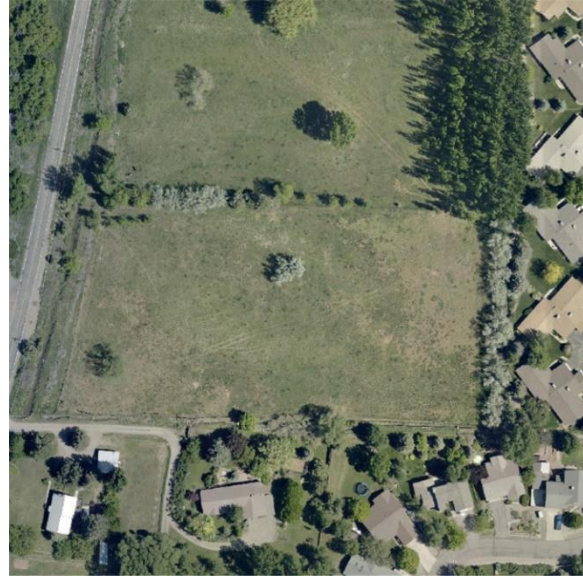
Figure 26 RO as windrow plantings at the edges of fields in the Electra-Cascade-Animas River Canyon scene in the Animas valley between CR 203 and US 550 north of Durango.

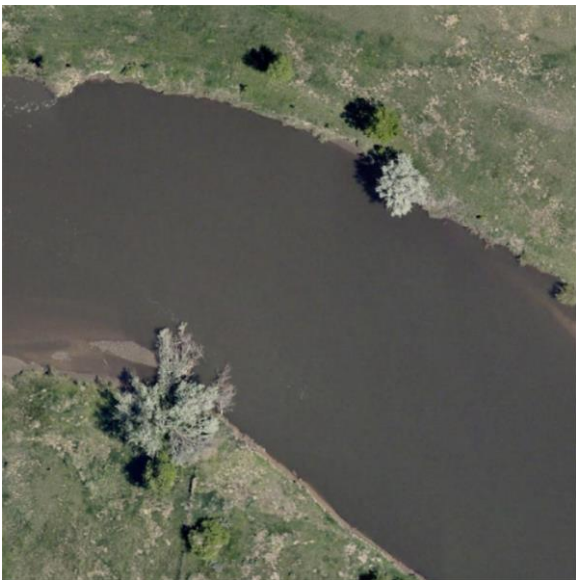
Figure 27 Riparian growth of RO along the banks of the Animas River upstream from the 32<sup>nd</sup> St boat launch in the Electra-Cascade-Animas River Canyon scene.

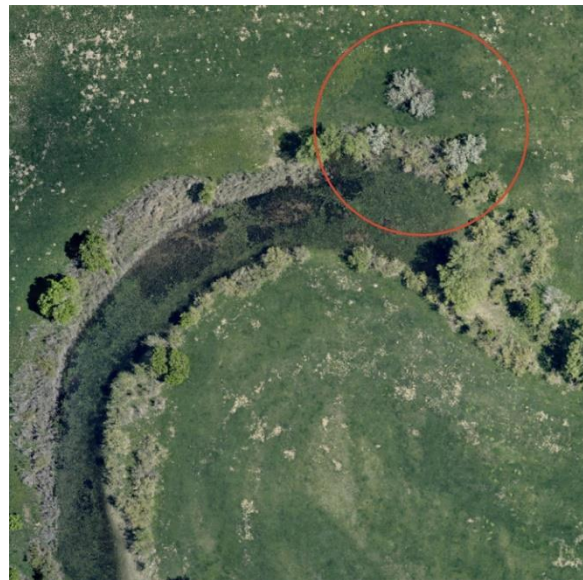
Figure 28 RO growing at the edges of an oxbow lake in the Animas River floodplain in the Electra-Cascade-Animas River Canyon scene.

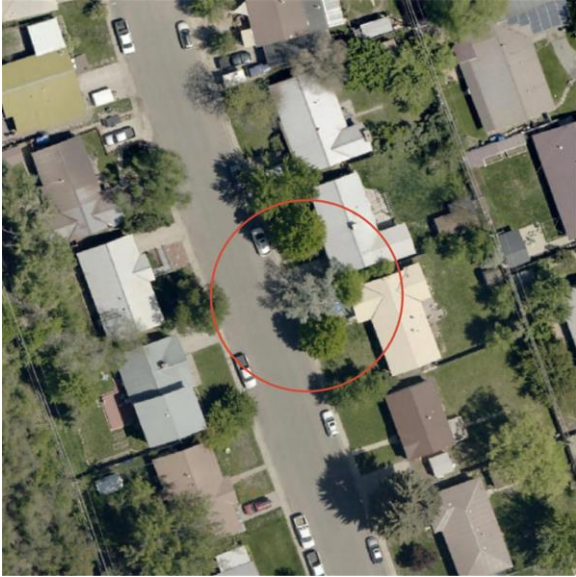
Figure 29 RO as landscaping in a residential area west of Needham Elementary School in Durango in the Lightner Creek-Animas River scene.

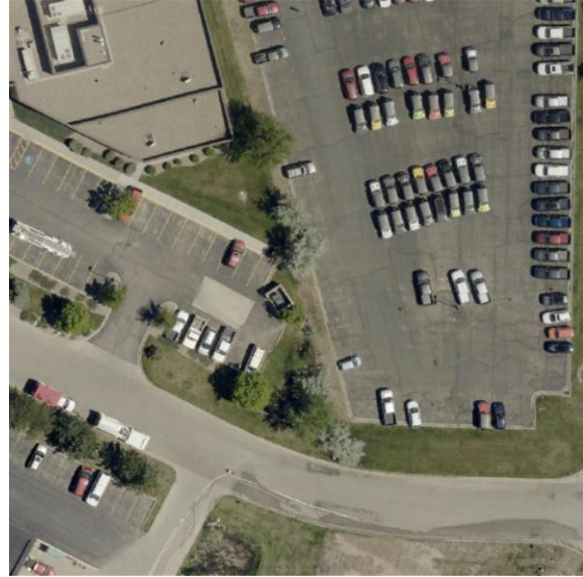
Figure 30 RO is used prolifically in the Bodo Industrial Park area as landscaping, Middle Animas Valley Scene.

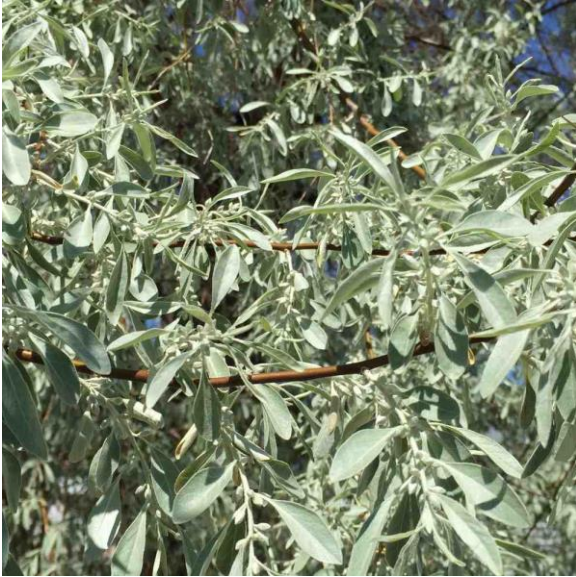
*Figure 31 Russian olive: Alternate leaf pairs.*

Finally, the invasive RO tree is often confused both in the field and in aerial imagery with the closely related, native Silver Buffaloberry (*Shepherdia argentea*). The Silver Buffaloberry is a native species and its distinction from the invasive RO is vital to avoid accidental removal of an important native tree during RO mitigation efforts (Kuenzi 2018b). The leaves of both have a similar silver-green hue in visible imagery, and often can only be distinguished in the field by close inspection of plant characteristics (Figure 31 and Figure 32). It was not possible to distinguish the two types of trees from aerial imagery for this study, and there is a probability that some of the RO identified in this classification is in fact Silver Buffaloberry.

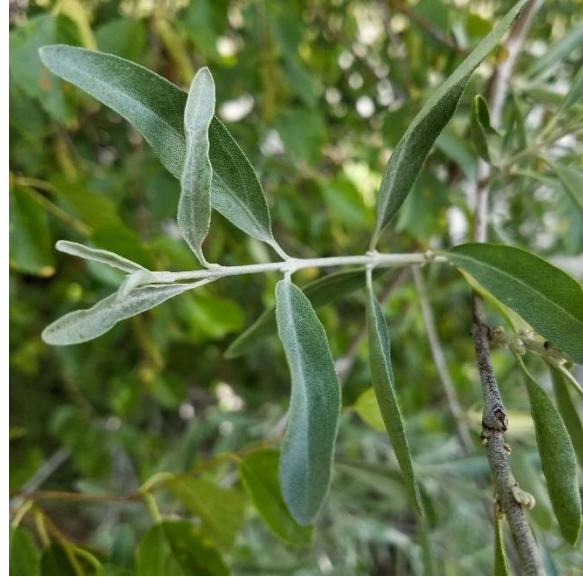
*Figure 32 Native Silver Buffaloberry: Opposite leaf pairs.*
