The Bureau of Land Management (BLM) is writing this letter to formally communicate its recommendation for a natural lake level water right on Hack Lake, located in Water Division 5.

# **Cutthroat Trout Studies**

Characterize the bathymetry and water volume in Hack Lake, Colorado

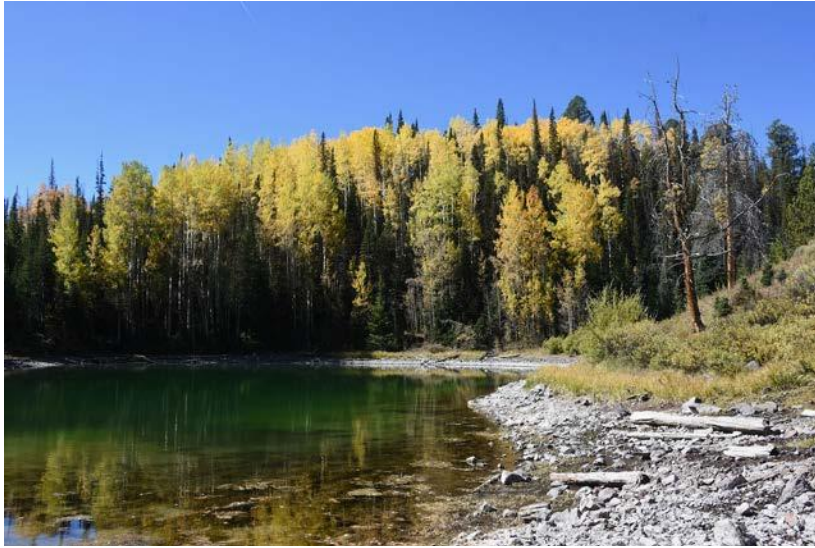
**Figure 1.** Hack Lake bathymetry was surveyed on September 22, 2021 with a surface elevation 2.9 ft below full pool elevation estimated by shoreline vegetation.

All mapping gear was packed 3.5 miles into Hack Lake, Garfield County, Colorado from the Hack Lake trailhead on September 22, 2021. Gear included a Humminbird model 597ci HD (Humminbird, Eufaula, Alabama) depth finder with a transducer deployed off the bow of an 8.5 lb pontoon boat (Figure 1; Model ODC 420 ULT, Creek Company, Steamboat Springs, Colorado) to acquire position and depth measurements every several seconds while using fins to propel the boat around the lake at about 0.8 kmph. This unit draws 550 mA, and was powered with a lightweight 12v lithium iron phosphate 9.6 AH battery (K2 Energy Solutions, Inc, Henderson, Nevada) that provided adequate power for the three-hour survey. The transducer face was set 10 in below the water surface, so all depth readings were increased by that amount. Two perimeters were established by walking the Humminbird unit (without the transducer attached) around the shoreline with the sonar feature disabled (Setup Menu tab → Sonar → Off) and depth values defaulting to 0 ft. The first perimeter traced the existing waters edge at time of survey while the second approximated the full pool elevation, clearly visible during the time of the survey by changes in vegetation ringing the lake (Figure 1). BLM staff used standard survey procedures reveal that the lake elevation during the time of the survey was 2.9 feet lower than full pool levels on which the water rights should be filed. As such, this too was added to recorded depths, so that bathymetry and volumetric measurements reflect full pool conditions.

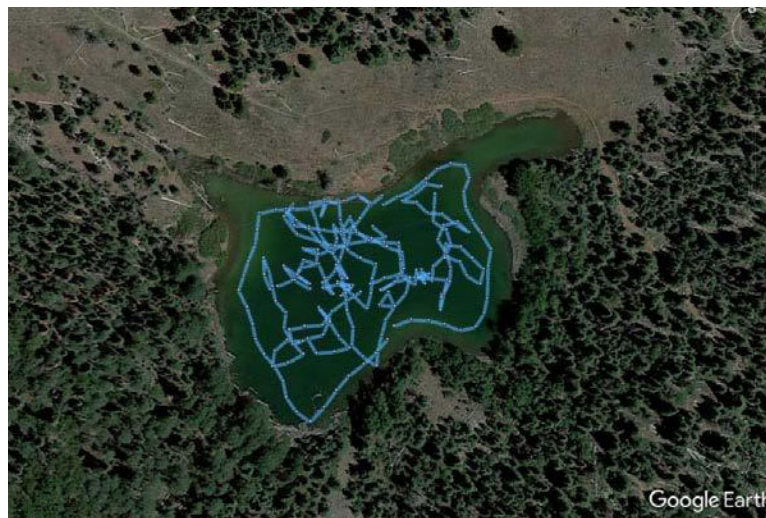
A total of 403 depth measurements were recorded while running 13 transects on Hack Lake on September 22, 2021. Survey track placements are shown (Figure 2), but only represent 9 of the 13 tracks as 3.5 tracks had to be culled due to poor GPS coverage during approximately 45 min of the survey.

**Figure 2.** Nine depth tracks were run on Hack Lake and combined with a track of the wetted perimeter on September 22, 2021, projected in Google Earth.

A total of 403 depth measurements were recorded while running 13 transects on Hack Lake on September 22, 2021. Survey track placements are shown (Figure 2), but only represent 9 of the 13 tracks as 3.5 tracks had to be culled due to poor GPS coverage during approximately 45 min of the survey.

**Figure 2.** Nine depth tracks were run on Hack Lake and combined with a track of the wetted perimeter on September 22, 2021, projected in Google Earth.

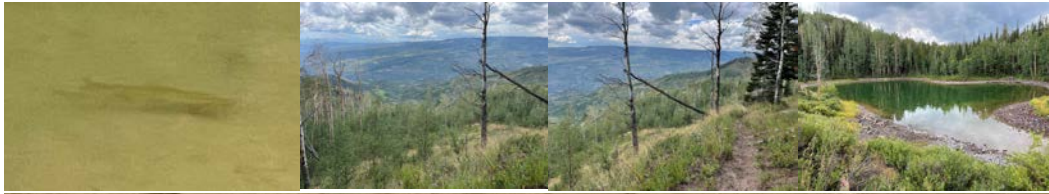
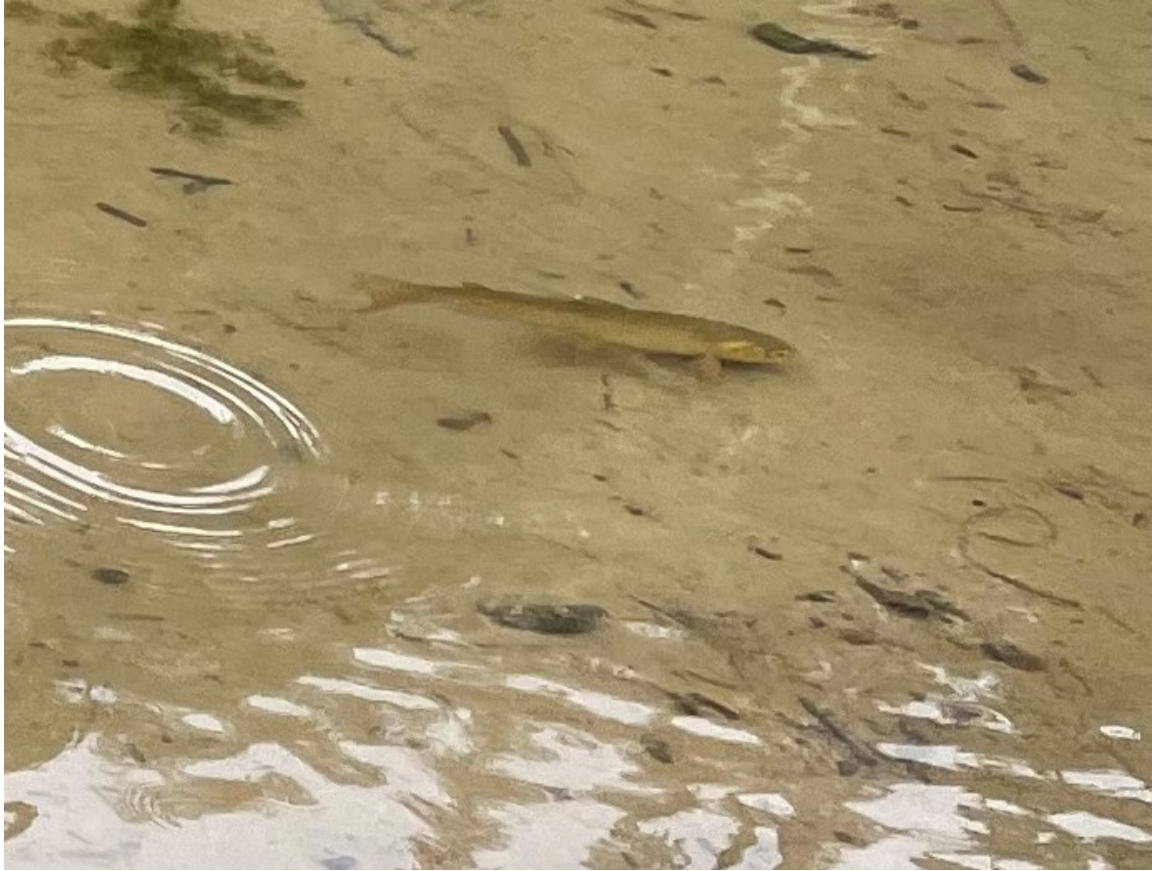
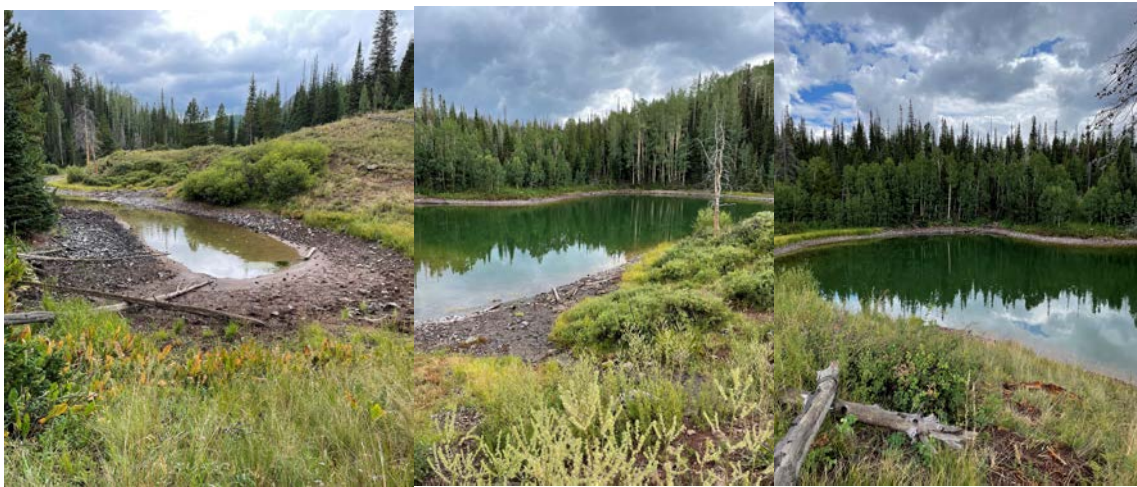
General Site Field Visit Data Report (Filters: Name begins with Hack Lake;)

Type		Div	Name	UTM X	UTM Y	Segment ID	Visit Date	Location Description	Watershed Name
Lake		5	Hack Lake	316873	4410033	23/5/A-004	8/20/2022	Periphery of Hack Lake	Colorado Headwaters
	Remarks	Date	Remark						
		20/08/22 13:00	Visual measurement of water level: 10 ft from top of ring formed by woody debri and plant growth.						
		20/08/22 13:25	At least two of the springs inflowing at over 1cfs.

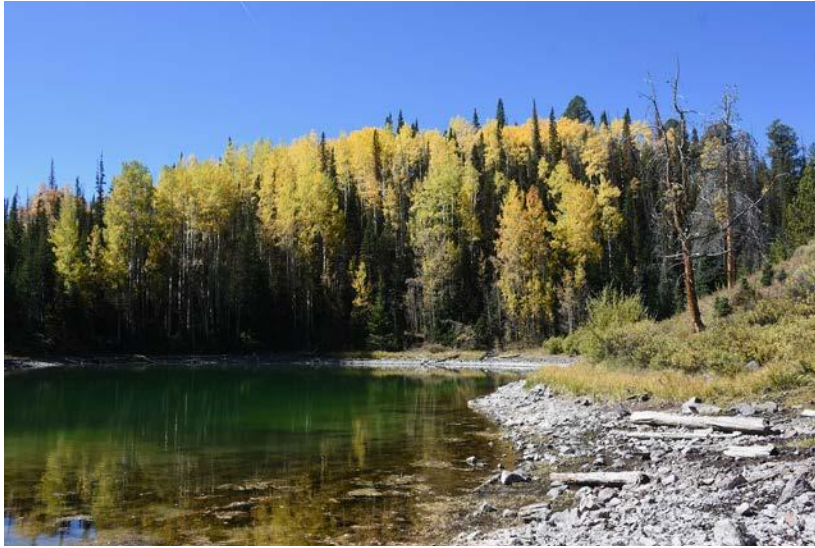
**Figure 1.** Hack Lake bathymetry was surveyed on September 22, 2021 with a surface elevation 2.9 ft below full pool elevation estimated by shoreline vegetation.

All mapping gear was packed 3.5 miles into Hack Lake, Garfield County, Colorado from the Hack Lake trailhead on September 22, 2021. Gear included a Humminbird model 597ci HD (Humminbird, Eufaula, Alabama) depth finder with a transducer deployed off the bow of an 8.5 lb pontoon boat (Figure 1; Model ODC 420 ULT, Creek Company, Steamboat Springs, Colorado) to acquire position and depth measurements every several seconds while using fins to propel the boat around the lake at about 0.8 kmph. This unit draws 550 mA, and was powered with a lightweight 12v lithium iron phosphate 9.6 AH battery (K2 Energy Solutions, Inc, Henderson, Nevada) that provided adequate power for the three-hour survey. The transducer face was set 10 in below the water surface, so all depth readings were increased by that amount. Two perimeters were established by walking the Humminbird unit (without the transducer attached) around the shoreline with the sonar feature disabled (Setup Menu tab → Sonar → Off) and depth values defaulting to 0 ft. The first perimeter traced the existing waters edge at time of survey while the second approximated the full pool elevation, clearly visible during the time of the survey by changes in vegetation ringing the lake (Figure 1). BLM staff used standard survey procedures reveal that the lake elevation during the time of the survey was 2.9 feet lower than full pool levels on which the water rights should be filed. As such, this too was added to recorded depths, so that bathymetry and volumetric measurements reflect full pool conditions.
