MEMORANDUM

To: Virginia Gazzetti and Kelly Watson, Boulder County Community Planning and Permitting(CPP)
cc:
From: Cameron Wobus and Laura Keys, Lynker Technologies
Subject: Boulder County FHZ Analysis
Date: June 30, 2022

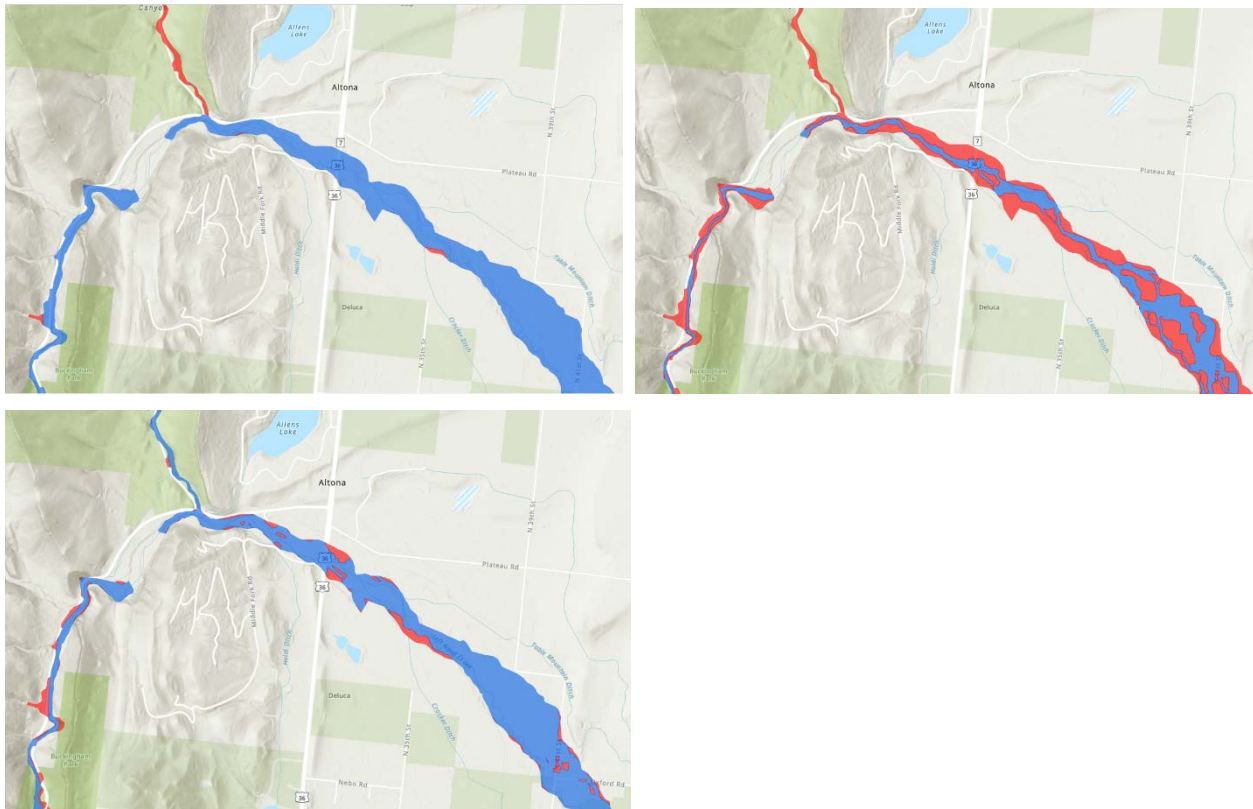
Figure 1. Comparisons of flood risk delineations along Left Hand Creek, with “hits” (blue) and “misses” (red) compared against 2013 flood inundation along Left Hand Creek A) FHZ, B) Floodway, and C) combined 100-year floodplain (combining 2013 and preliminary 2019 FIRMs). Note that 2013 flood inundation extent data was missing for one large stream segment, which is the cause for the large gap in each image.

The FHZ provides only one of several metrics of flood risk in Boulder County. Delineations that are more commonly used by Boulder County CPP in a regulatory context include the regulatory floodway, 100-foot setbacks from active channels, and the “100-year” (1% annual exceedance probability, AEP) floodplain. Each of these flood risk delineations provides a different picture of flood risk within Boulder County. To help both CPP and the residents of Boulder County understand these different depictions of risk, we developed maps highlighting similarities and differences among these delineations. **Figures 1 and 2** provide comparisons of how each of these

delineations of flood risk relate to the 2013 flood extent in two parts of Boulder County. Blue areas denote “hits” where the delineation matched with the presence of inundation. Red areas denote “misses” where actual inundation occurred in 2013 that was not anticipated by the respective delineation. (Note: the 2013 flood extents are based on aerial imagery from after the flood and may not always represent the actual inundation boundary.)

Qualitatively, as shown in Figures 1 and 2, the FHZ provides a higher degree of correspondence to the 2013 flood extent than either the floodway or the 100-year floodplain. Specifically, the floodway and 100-year floodplain each underestimate the spatial extent of flooding when compared to the 2013 floods. This is not unexpected: the fluvial hazard zone is broadly defined as “the area that a stream has occupied in recent history, may occupy, or may physically influence” (CWCB, 2020) as it transports its load of water, sediment and debris. Because the 2013 flood in Boulder County was a major event characterized by significant volumes of water and sediment, the flood occupied nearly all of the FHZ as it carried this load from the foothills to the plains.

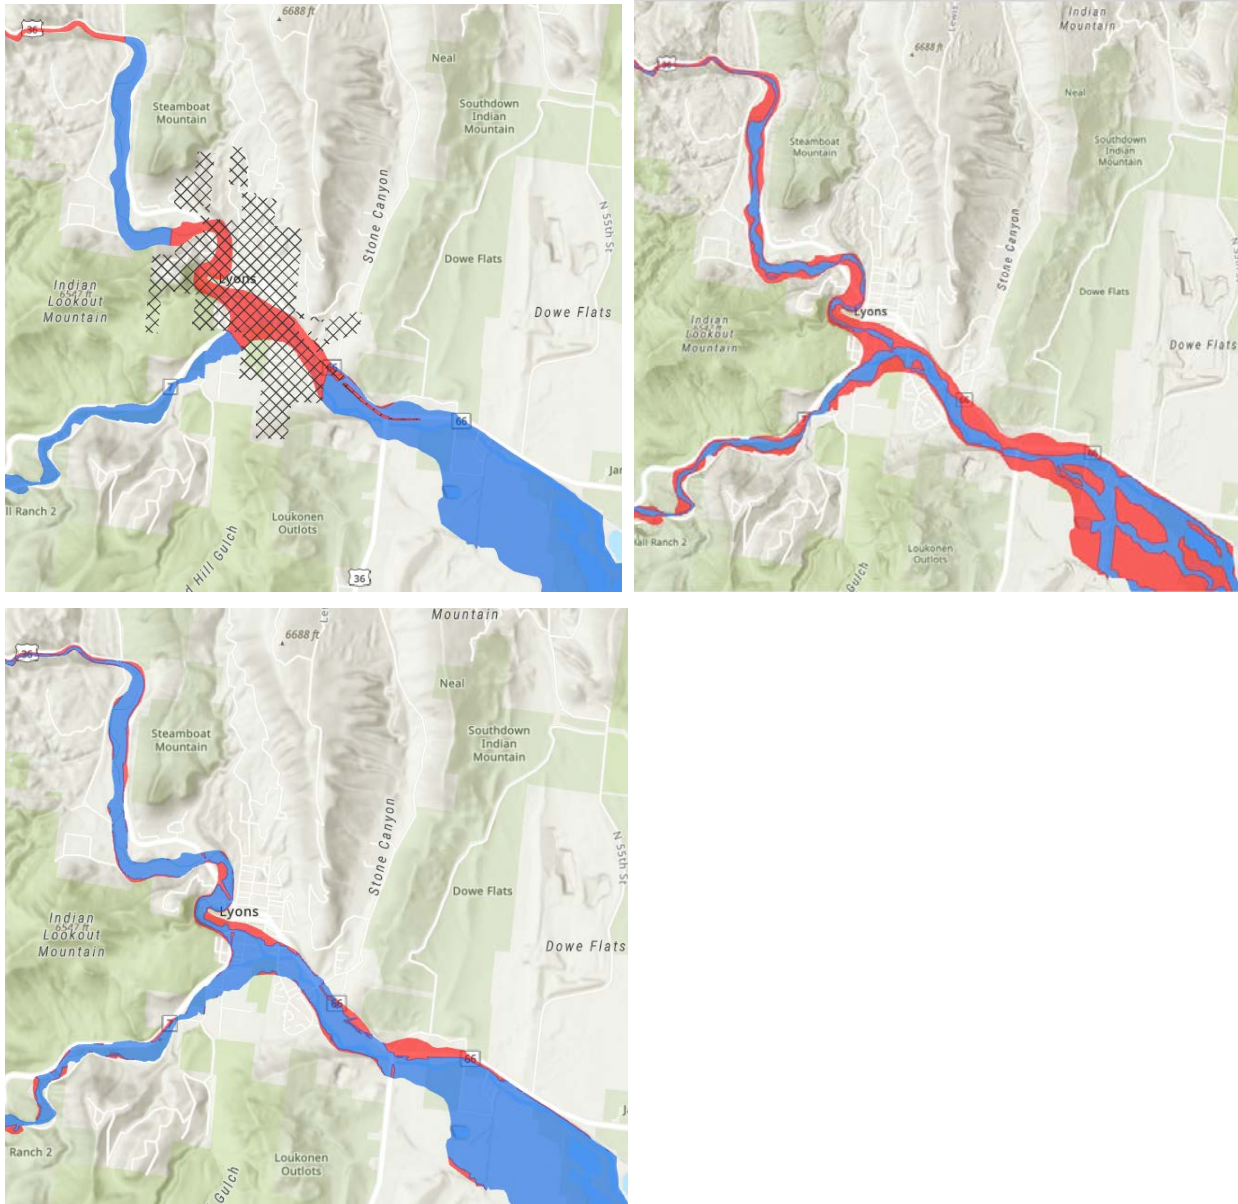
Figure 2. Comparisons of flood risk delineations, with “hits” (blue) and “misses” (red) compared against 2013 flood inundation along St. Vrain Creek. A) FHZ, B) Floodway, and C) combined 100-year floodplain (combining 2013 and preliminary 2019 FIRMs). Crosshatching in the FHZ image denotes areas that were excluded from the FHZ maps (FHZ mapping was focused on unincorporated Boulder County, which excludes Lyons city limits).

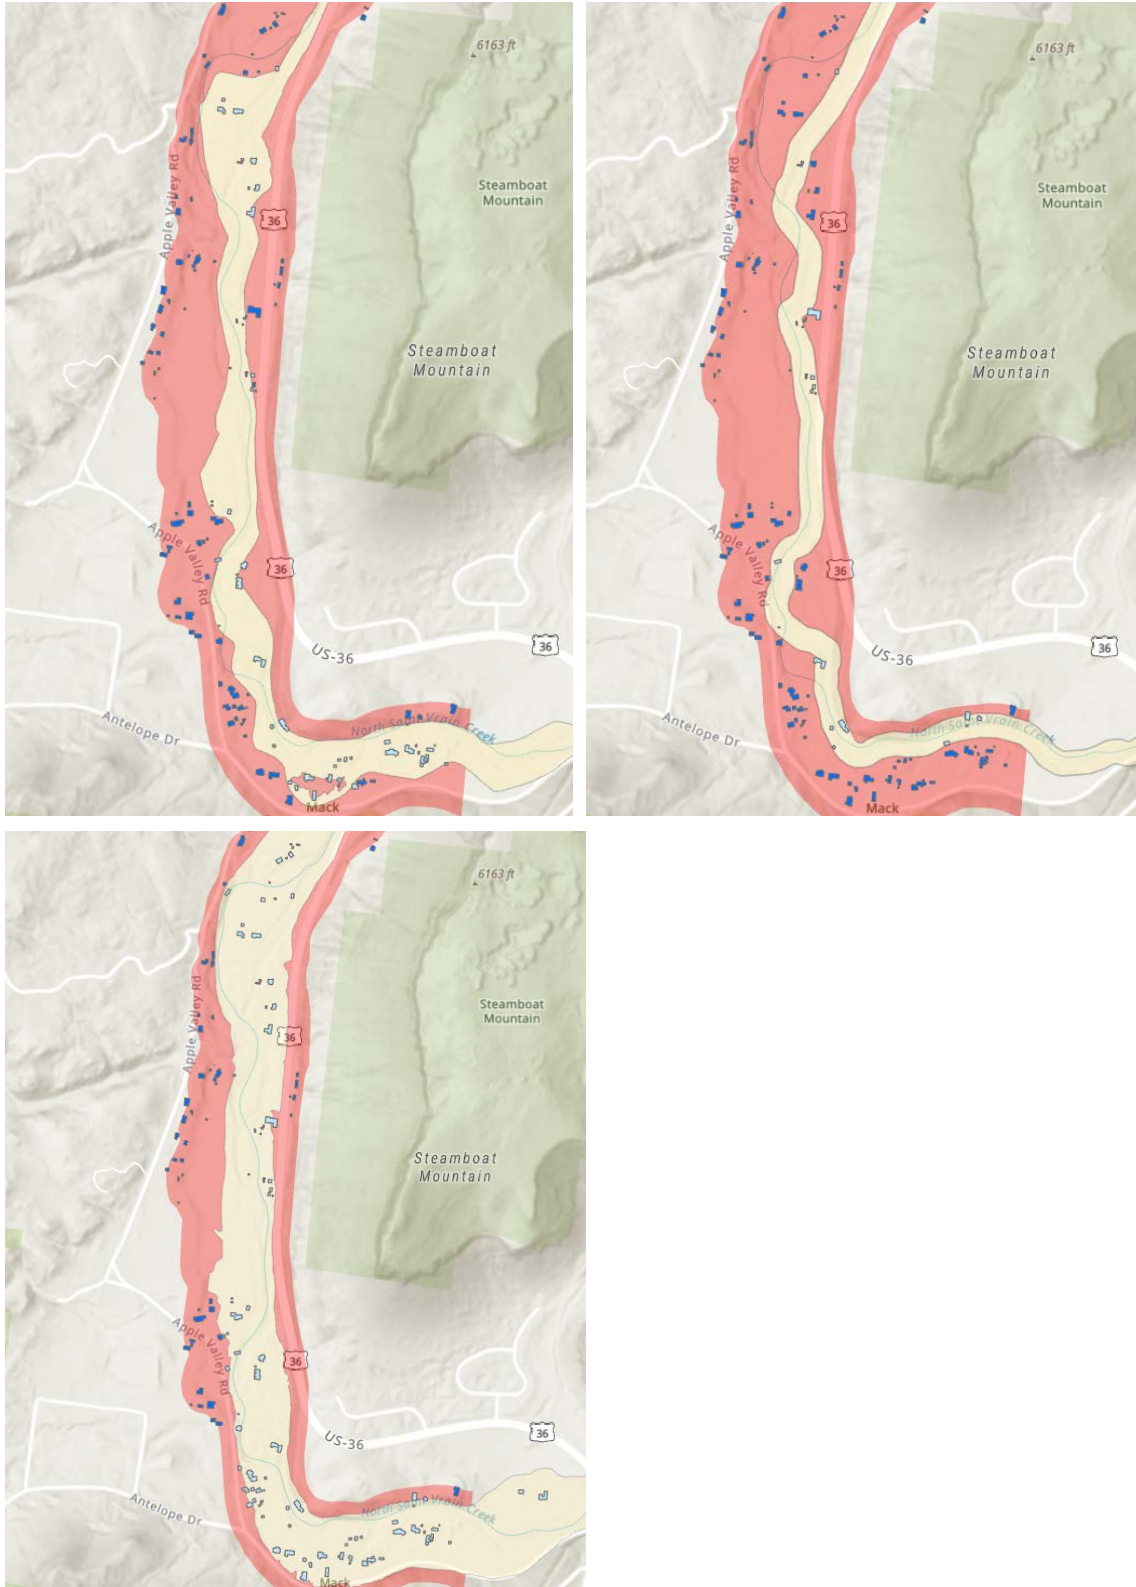
Figure 3. Buildings located along North Saint Vrain Creek in the FHZ (buildings in dark blue, zone in red) compared to buildings located in various regulatory zones (buildings in light blue, zone in light yellow). A) buildings in Floodway, B) 100-foot setbacks, and C) combined 100-year floodplain.

Figure 3 shows an example of building footprints within the FHZ and each of the other flood risk boundaries mapped along a segment of North St. Vrain Creek, and **Figures 4-5** provide examples of bridges, roads, and culverts intersecting with each of these flood risk boundaries along two segments of Lefthand Creek. **Table 2** tabulates the number of buildings, bridges and culverts, and miles of roads contained within the FHZ and each of the regulatory boundaries commonly used by CPP.

As shown in Figure 3 and summarized in **Table 2**, the FHZ encompasses many more buildings than the other regulatory flood risk boundaries, illustrating the extent to which there are properties at risk outside of these regulatory zones. There are a total of 1,979 buildings within the newly mapped FHZ in Boulder County. Of these, 1,604 buildings, or 81%, are outside of the floodway, and 744 buildings, or 38%, are outside of the FEMA combined 100-year floodplain. As noted above, the FHZ is defined as the area that rivers have occupied in the recent past and may occupy in the future. Thus all of the properties within the FHZ are at some risk of impact from flooding, erosion and sedimentation, or debris hazards. However, properties that lie outside the regulatory floodplain are not required by law to purchase flood insurance. Homeowners whose properties fall into the buffer between the regulatory floodplain and the edge of the FHZ may therefore bear a unique financial risk relative to those inside more traditional flood risk boundaries. Section 3 of this report describes these risks in more detail, in the context of actual losses during the 2013 flood.

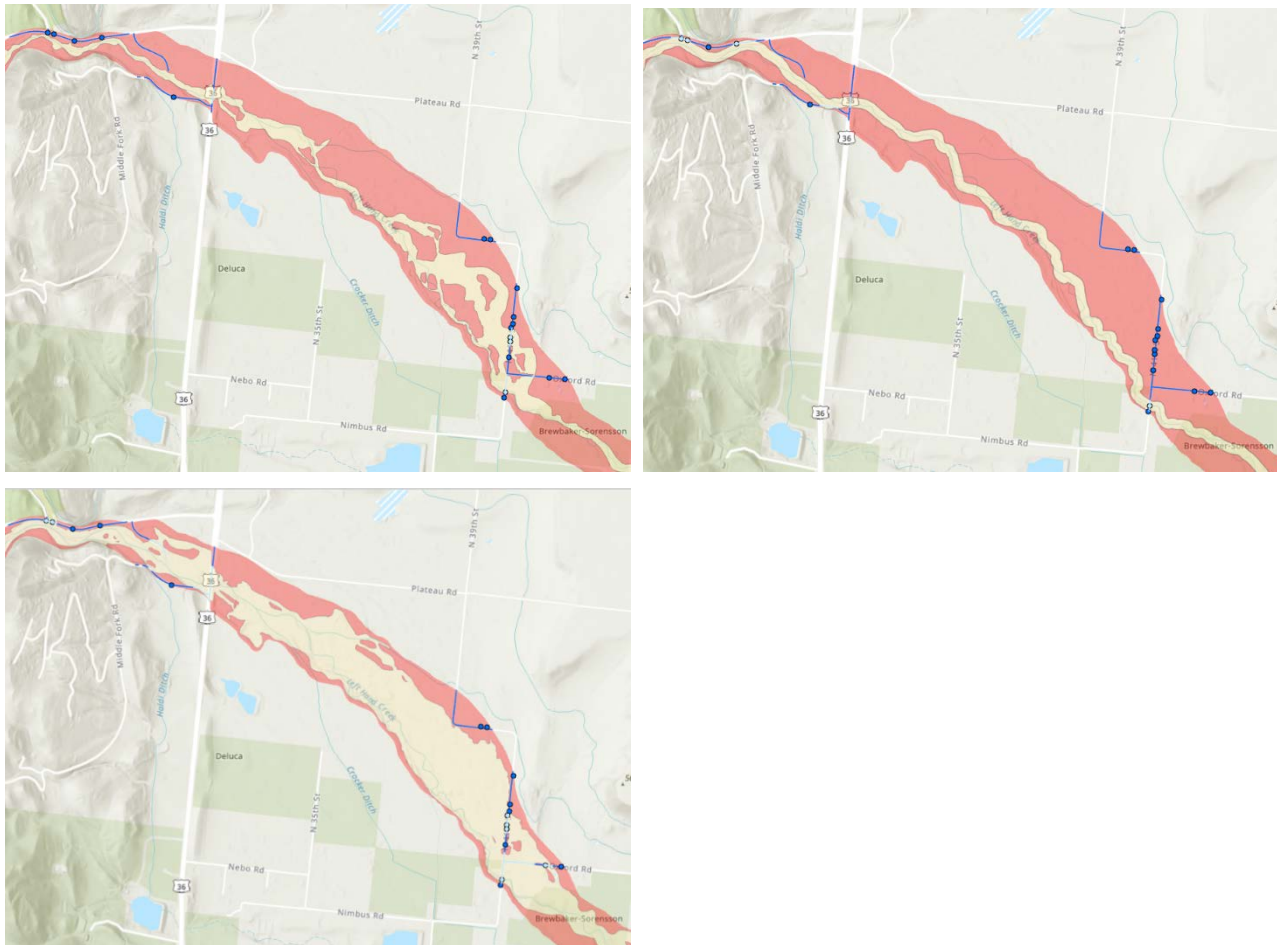
Figure 4. County infrastructure (bridges, culverts, and roads) located along Left Hand Creek in the FHZ (infrastructure in dark blue, zone in red) compared to infrastructure located in various regulatory zones (infrastructure in light blue, zone in light yellow). A) Floodway, B) 100-foot setbacks, C) combined 100-year floodplain.

The distribution of infrastructure like roads, bridges and culverts also illustrates the degree of risk outside of traditional regulatory boundaries. There are a total of 38 miles of roads and 409 bridges and culverts within the mapped FHZ boundaries of Boulder County. Of these, 31 miles of roads, or 82%, are outside of the floodway, and 19 miles of roads, or 50%, are outside the 100-year floodplain. 304 bridges/culverts, or 74%, are outside of the floodway, and 152 bridges/culverts or 37%, are outside of the 100-year regulatory floodplain.

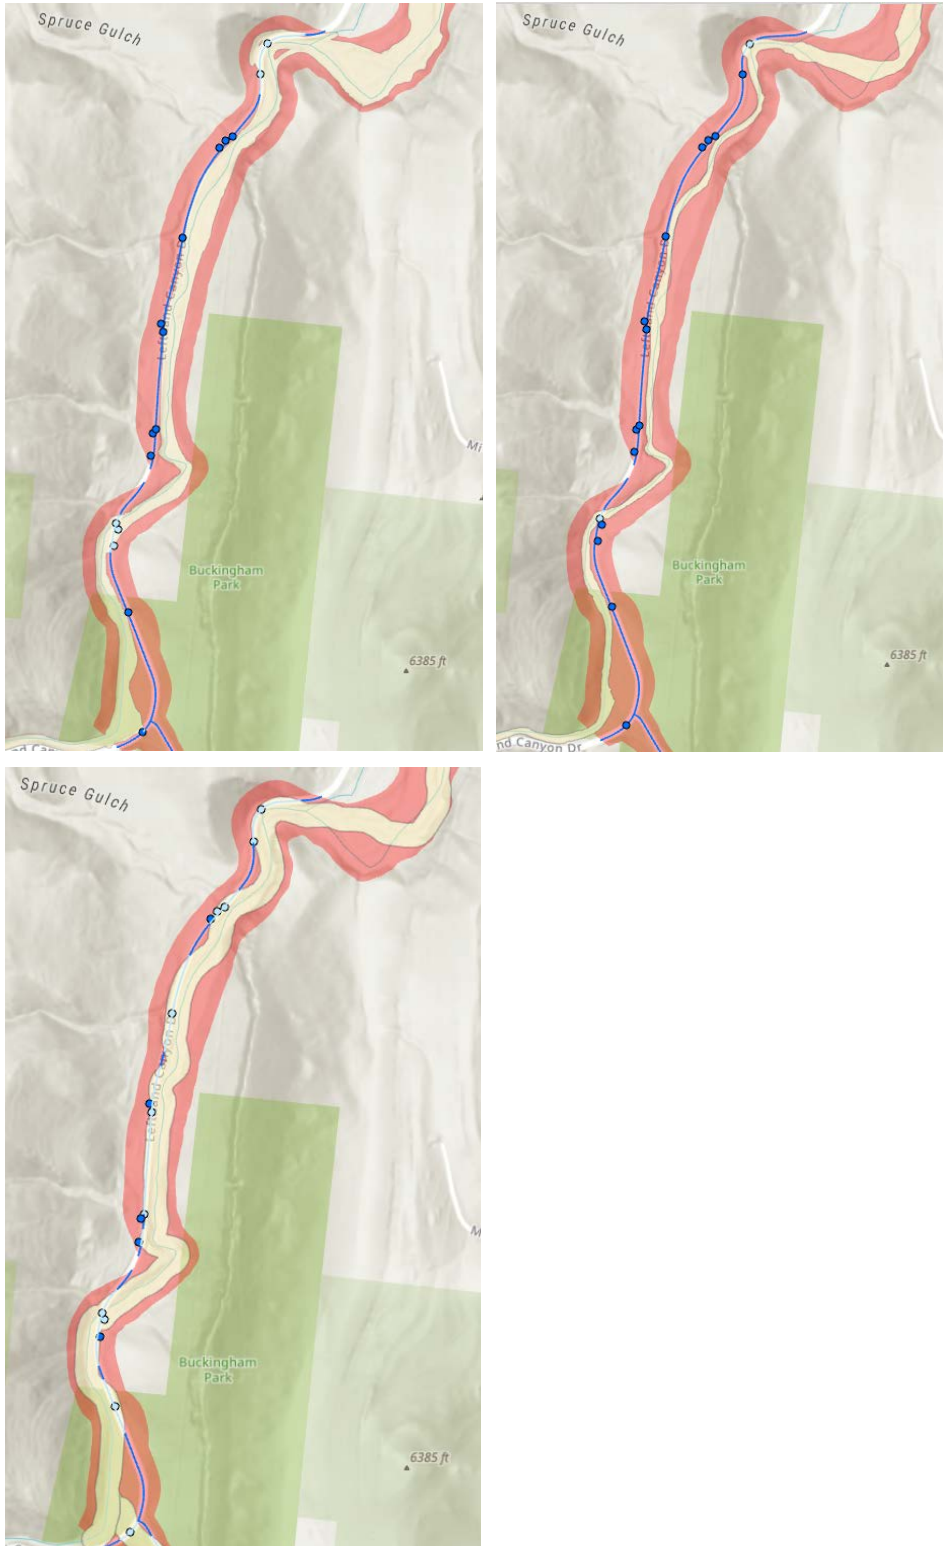
Figure 5. County infrastructure (bridges, culverts, and roads) located along Left Hand Creek in the FHZ (infrastructure in dark blue, zone in red) compared to infrastructure located in various regulatory zones (infrastructure in light blue, zone in light yellow). A) Floodway, B) 100-foot setbacks, C) combined 100-year floodplain.

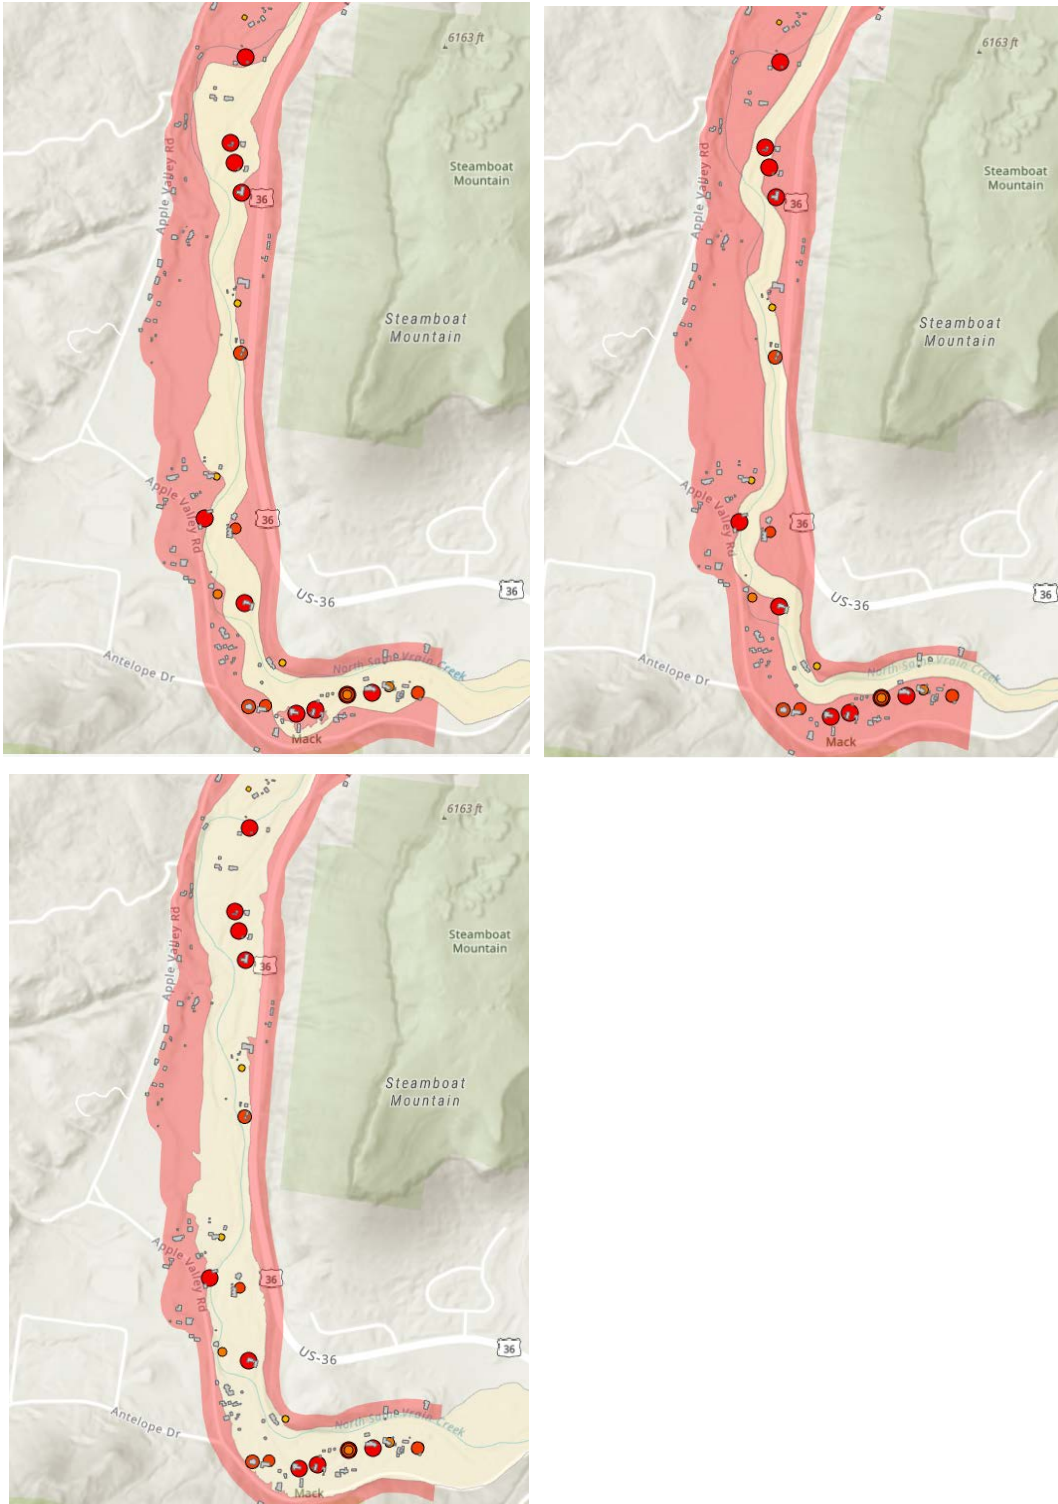
Figure 6. Damage estimates from the 2013 floods along North Saint Vrain Creek, with larger redder points meaning more complete damage and smaller orange and yellow points meaning less damage. The damage estimates are shown overlaid with the various regulatory zones (light yellow) and the wider FHZ (light red). All building footprints in the FHZ are shown in light grey. A) Floodway, B) 100-foot setbacks, C) combined 100-year floodplain.

A retrospective analysis of property damage following the 2013 floods illustrates this point. **Figure 6** shows data from post-disaster Substantial Damage Estimate (SDE) reports overlaid with each of the regulatory flood zones. The Floodway and 100-foot setback areas do not sufficiently cover many properties that sustained up to 100% damage, but all of the points with SDE reports fall within the FHZ. The 100-year floodplain, which includes the floodplain mapped after the 2013 flood, also appears to cover the points that sustained damage in this area on the North Saint Vrain, though the FHZ has a wider coverage area.

Collectively, the information contained in Figures 6 and 7 demonstrate that Boulder County properties that lie within the FHZ but outside of regulatory boundaries like the floodway and the 100-year floodplain are at potential risk of damage from large flood events. However, the degree of risk is not uniform within the FHZ: more than half of the homes in the FHZ that reported damage from the 2013 floods were within the floodway, and nearly three quarters of the damage reports came from homes within the 100-year floodplain. While the FHZ delineates a broader zone of flood risk than these regulatory boundaries, the probability of a home sustaining damage from flooding, and the degree of damage that is likely to be sustained, increases with proximity to the active stream channel and associated mapped regulatory floodplains.

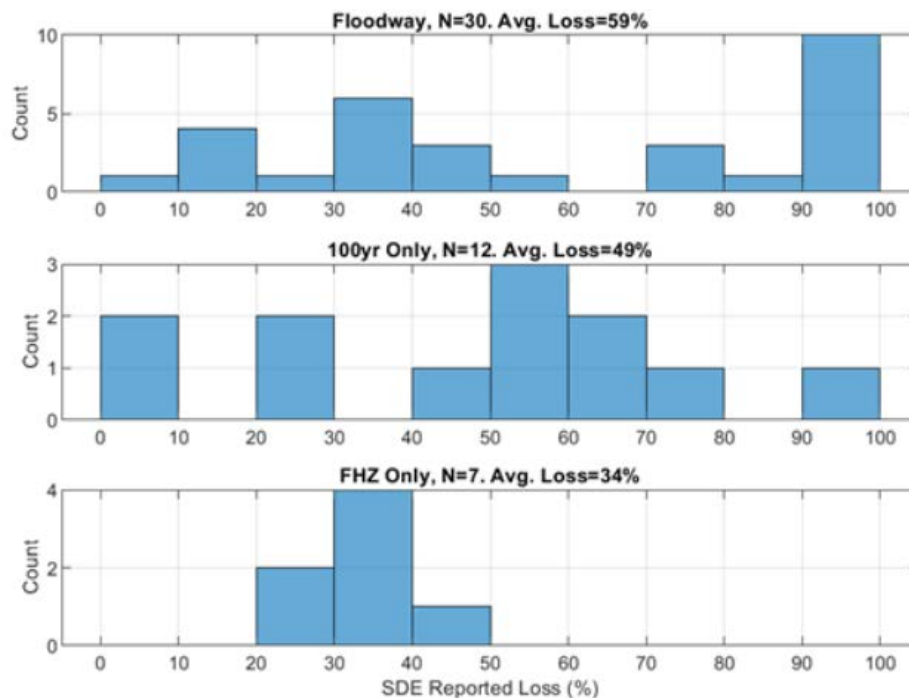
Figure 7. Distribution of all property damage estimates from the 2013 floods within the FHZ based on their location relative to regulatory boundaries A) properties within the floodway, B) properties outside the floodway but within the 100-year floodplain; C) properties outside all regulatory boundaries but within the FHZ.

Figure 7 shows the SDE information graphically, illustrating the distribution of 2013 damage data within the FHZ and each of the different regulatory boundaries within Boulder County. Within the area of the mapped FHZ in Boulder County, there are a total of 59 properties that sustained damage and reported this information on SDE reports. Of these, 30 properties (51%) were within the floodway. These properties sustained losses ranging from 10% to 100%, with an average loss of 59%. 12 properties (20%) were outside of the floodway but inside the 100-year floodplain. Those properties also sustained losses ranging from 10% to 100%, with an average loss of 49%. Finally, seven properties (12%) were within the FHZ but outside of all regulatory boundaries. Those properties sustained losses ranging from 20% to 50%, with an average loss of 34%.

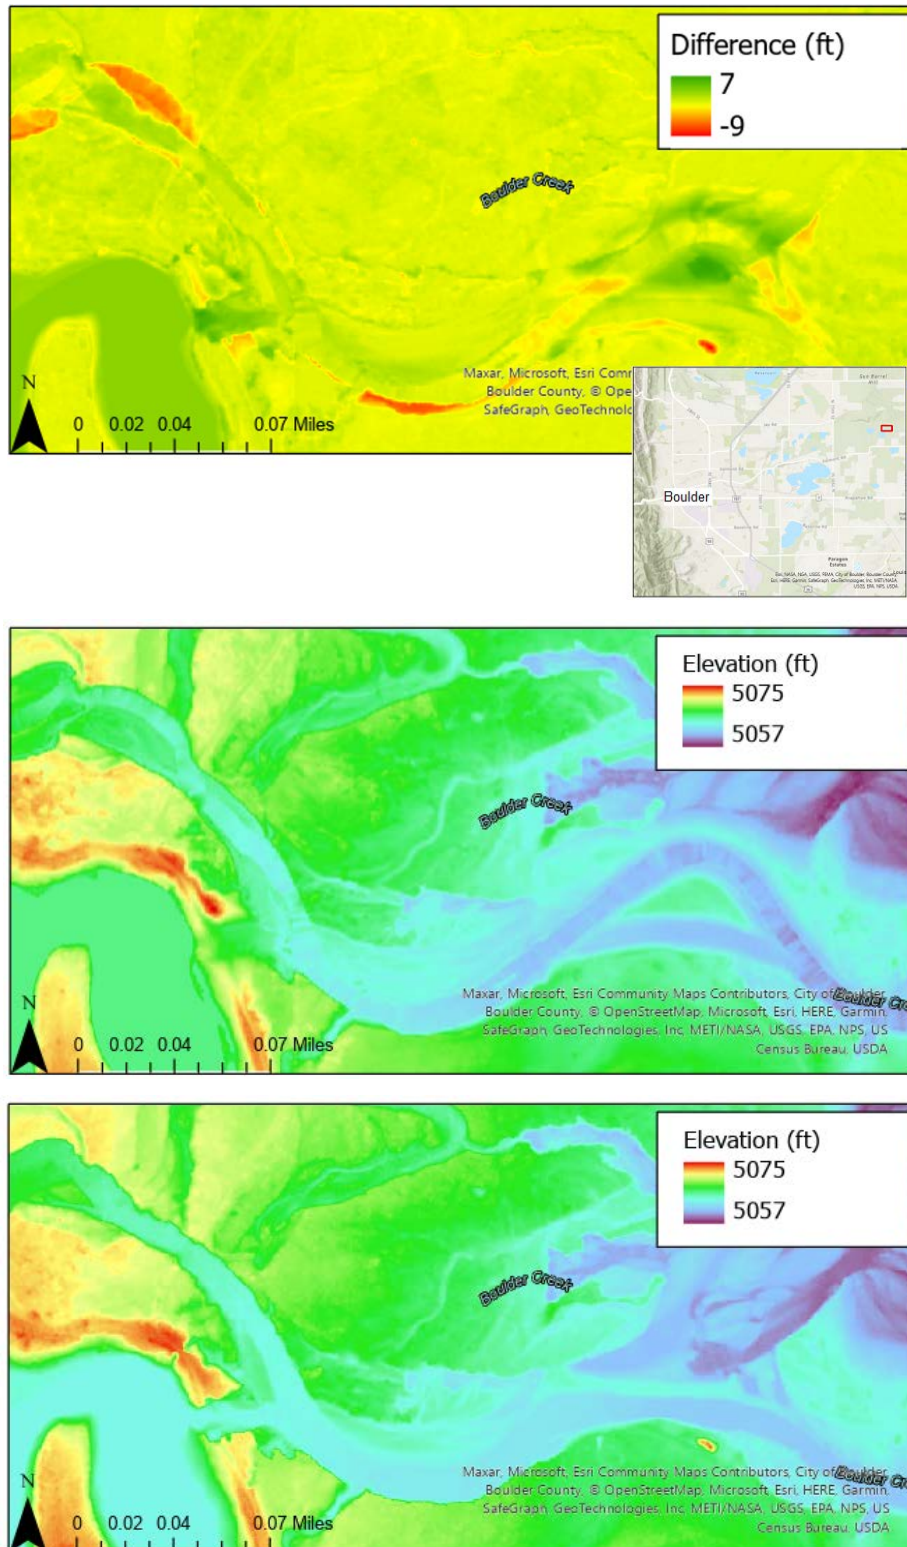
Figure 8. Channel movement along Boulder Creek. Top: Difference between 2020 and 2013 LiDAR data with location shown relative to the City of Boulder in red rectangle. Positive values indicate higher elevation in 2020 than in 2013, and negative values indicate lower elevation in 2020. Middle: 2020 elevation data. Bottom: 2013 elevation data.

Boulder County provided Lynker with LiDAR datasets that were collected in 2013 after the Boulder County flooding and an updated one collected in 2020. We analyzed differences in the datasets and found that the stream channels exhibited high amounts of migration and dynamism over the seven years, during which time no major floods occurred. Such channel movement can be seen in the example in **Figure 8**, where a clear shift in Boulder Creek's stream path is visible in the eastern section of the image.

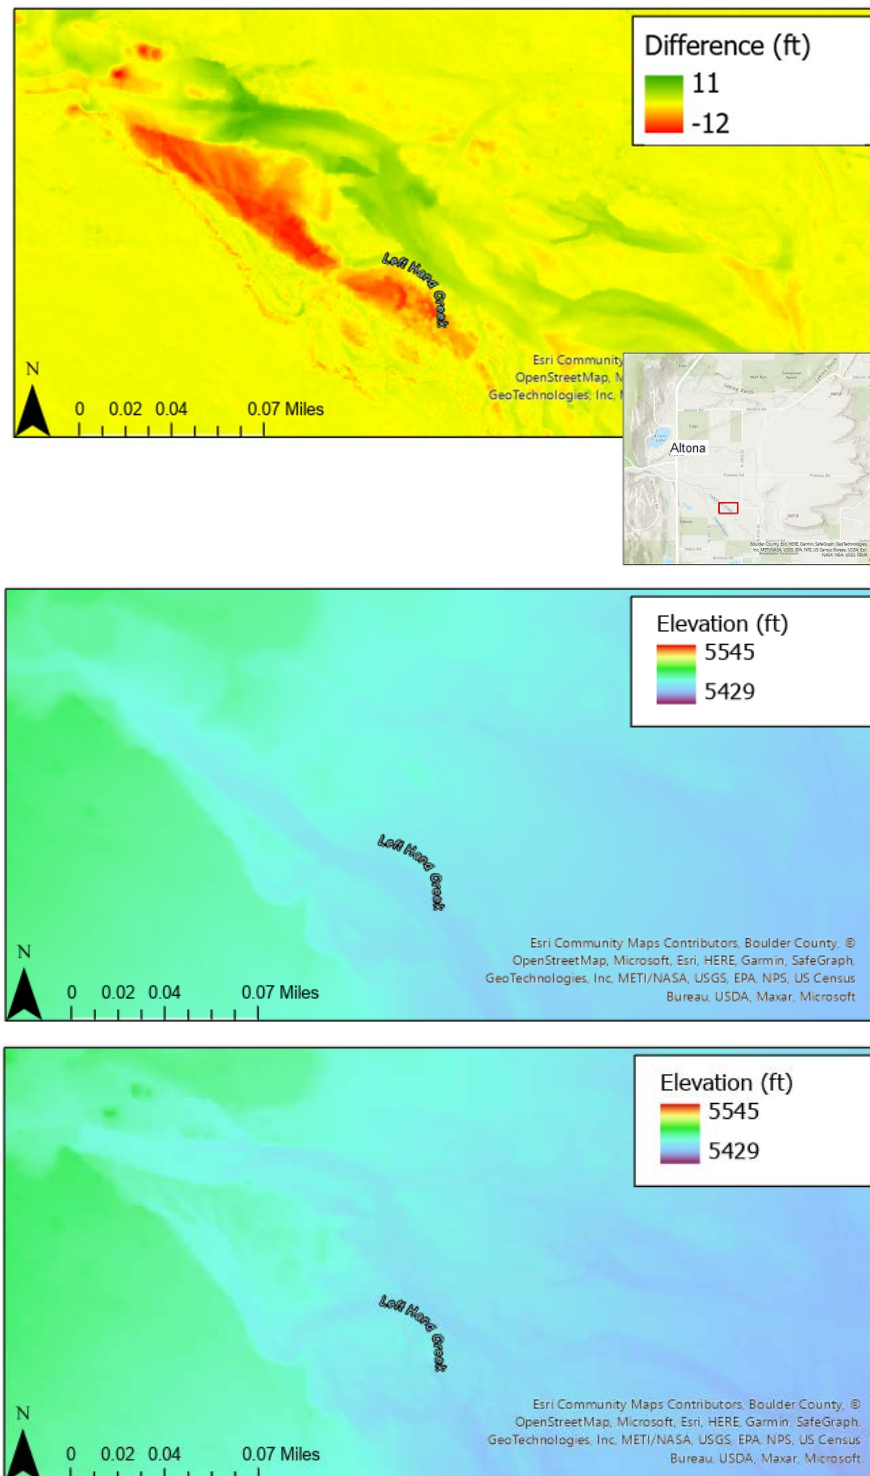
Figure 9. Channel movement along Left Hand Creek. Top: Difference between 2020 and 2013 LiDAR data with location shown relative to Altona in red rectangle. Positive values indicate higher elevation in 2020 than in 2013, and negative values indicate lower elevation in 2020. Middle: 2020 elevation data. Bottom: 2013 elevation data.

Similarly, **Figure 9** shows sediment movement between 2013 and 2020 across the plains area of Left Hand Creek. A similar pattern emerged generally across the plains areas of the FHZ, wherein streams in 2013 appeared to have a more braided appearance with spread-out fans of sediments, which then collated into a more singly-defined channel in the 2020 dataset.

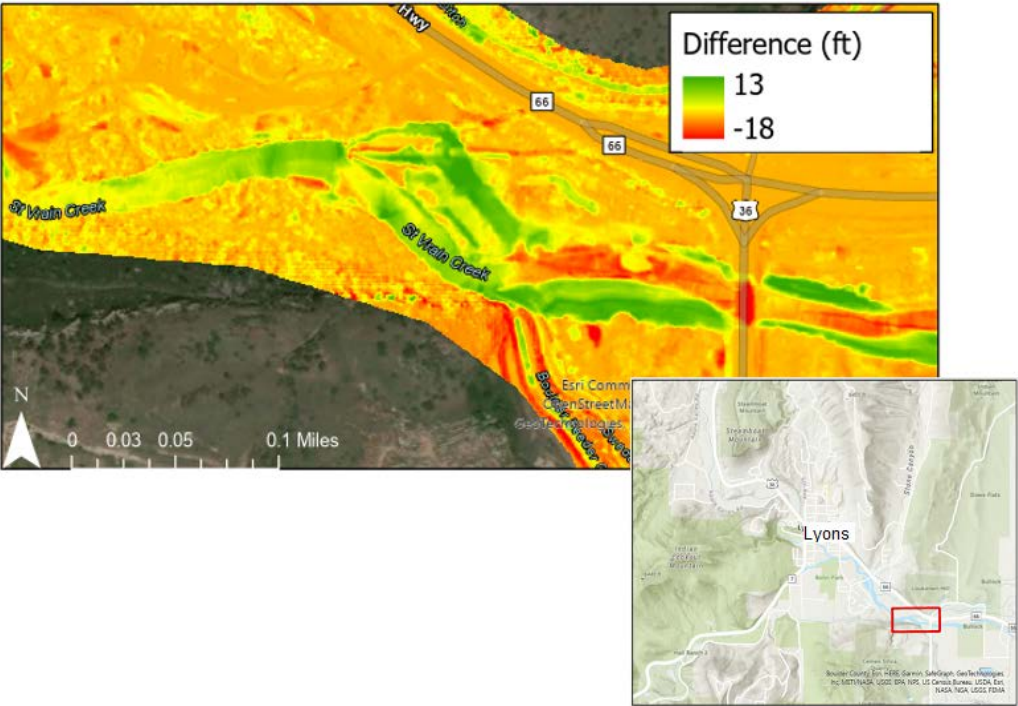
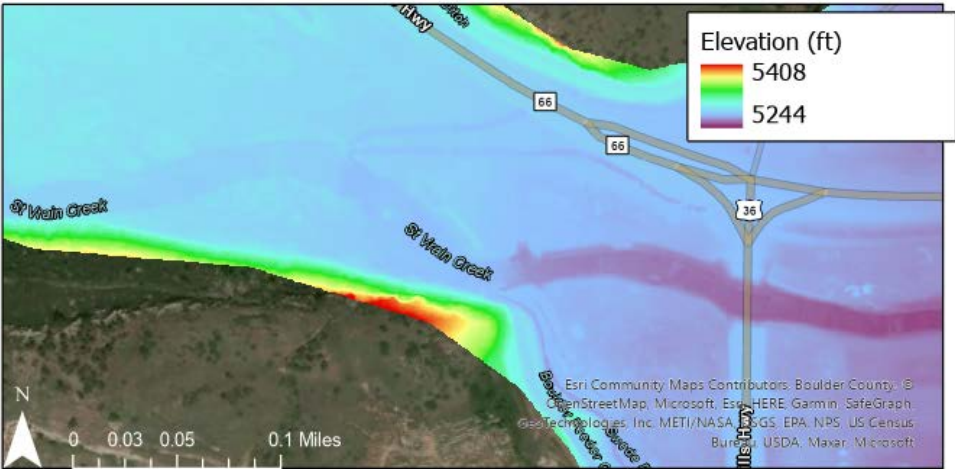
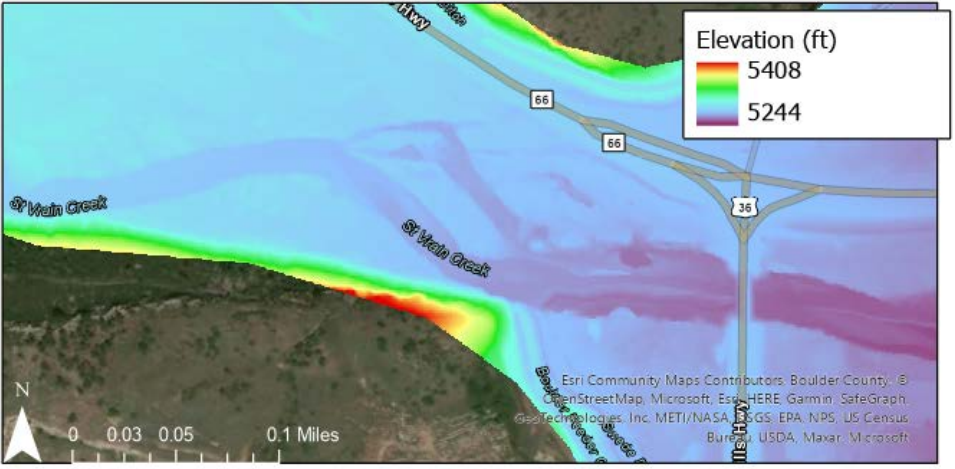
Figure 10. Channel deepening at bridge across St. Vrain Creek with location shown relative to Lyons in red rectangle. Top: Difference between 2020 and 2013 LIDAR data. Positive values indicate higher elevation in 2020 than in 2013, and negative values indicate lower elevation in 2020. Middle: 2020 elevation data. Bottom: 2013 elevation data.

We also found numerous examples of sediment buildup and scouring that occurred near infrastructure such as bridges and streambanks near roads. **Figure 10** shows an example of channel deepening that occurred around a bridge over St. Vrain Creek near Lyons. The pattern noted above in the plains areas is also relevant in this example, with spread-out sediments deposited by the 2013 flood eventually being worked into a single, more defined channel.

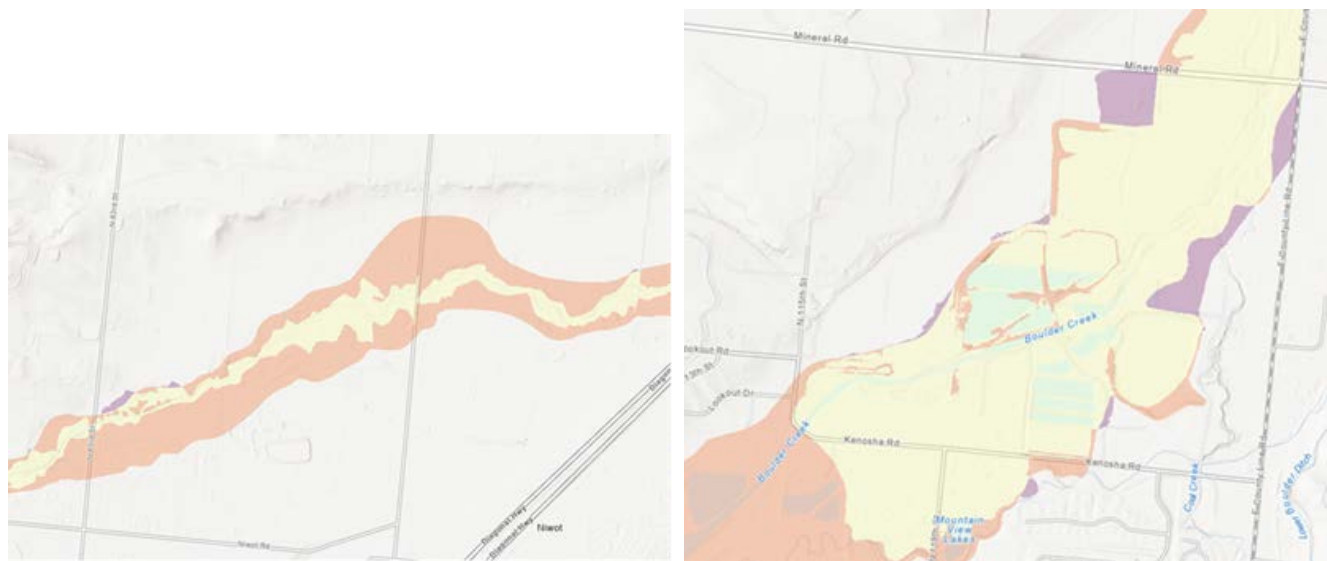
Figure 11. Left: Left Hand Creek FHZ versus Floodway, with some very small segments where the FHZ has a smaller extent (purple areas show presence of Floodway only, red is FHZ only, and yellow is both FHZ and Floodway coverage). Right: Boulder Creek near Erie, with FHZ and Floodway having some inconsistency but the FHZ extent still appearing reasonable.

The FHZ was at least as wide as the regulatory floodplain in the St. Vrain Creek area of Boulder County and in the western mountainous area of Left Hand Creek. In the far east area along Left Hand Creek, east of Haystack Mountain Golf Course, the FHZ was smaller in a few areas than the Floodway (Figure 11). The FHZ has narrower boundaries than the Floodway near the eastern FHZ boundary, close to Erie. Comparing these results to underlying imagery, the FHZ seems to follow the terrain and erodibility of the area fairly well. Both the FHZ and Floodway offer reasonable extents despite the FHZ being less conservative.

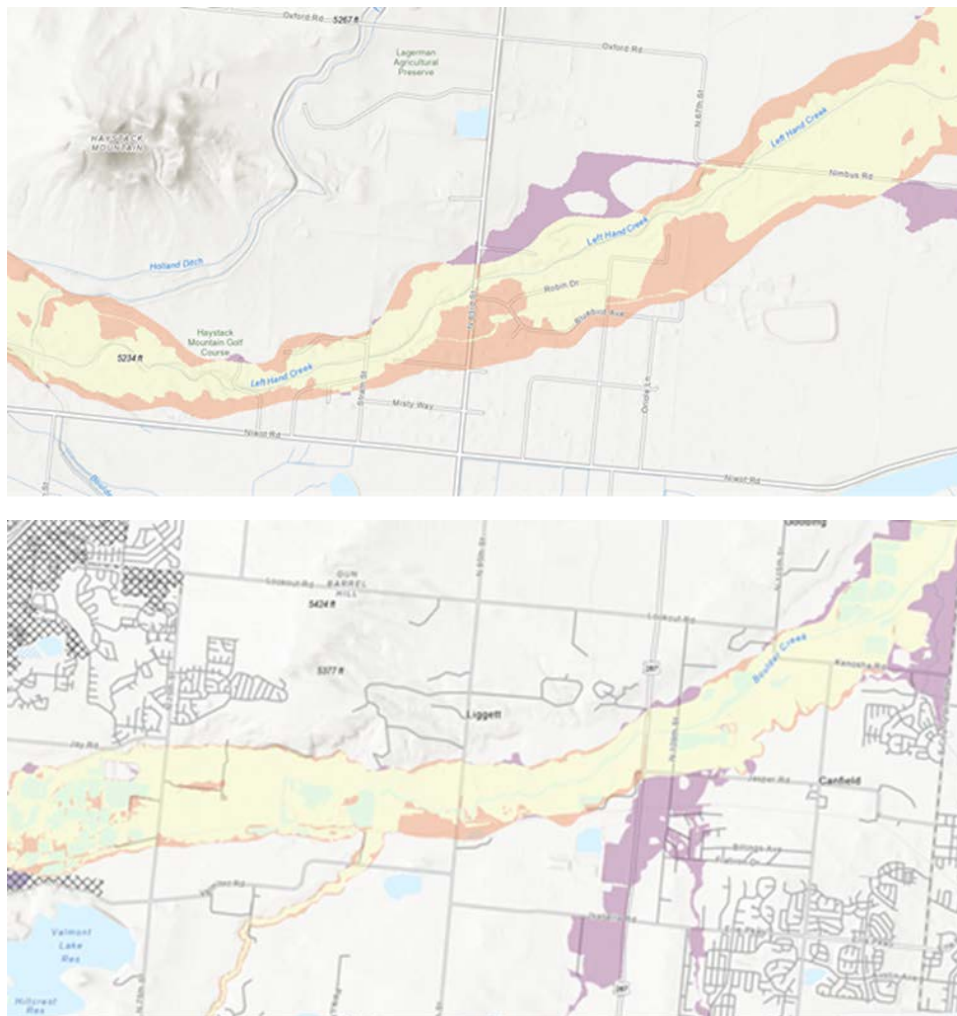
Figure 12. Top: Plains section of Left Hand Creek where the FHZ is not as conservative as the 100-year floodplain (with FHZ + floodplain in yellow, FHZ-only in light red, and floodplain-only in purple). Bottom: Boulder Creek with FHZ compared to 100-year floodplain.

The FHZ was at least as wide as the combined 100-year floodplain for the North and South St. Vrain Creeks, for most of the St. Vrain, and for most of Left Hand Creek. The largest area of discrepancy occurs in an area along the easternmost part of Left Hand Creek near the FHZ boundary **Figure 12**). The floodplain appears to better match the terrain in this area, which also corresponds to an area of higher erodibility soils. The FHZ is possibly not conservative enough in this area east of Haystack Mountain Golf Course. Additionally, the FHZ has numerous segments in the Boulder Creek area where it has a smaller extent than the floodplain, largely in the eastern section. The large offshoot of the floodplain in the southeastern section of Boulder Creek is due to the presence of Bullhead Gulch, a nondefined channel and significant drainage area; side channels and drainages outside of the main stream channel were not included in the FHZ generation, which is why the FHZ is notably lacking in that location.

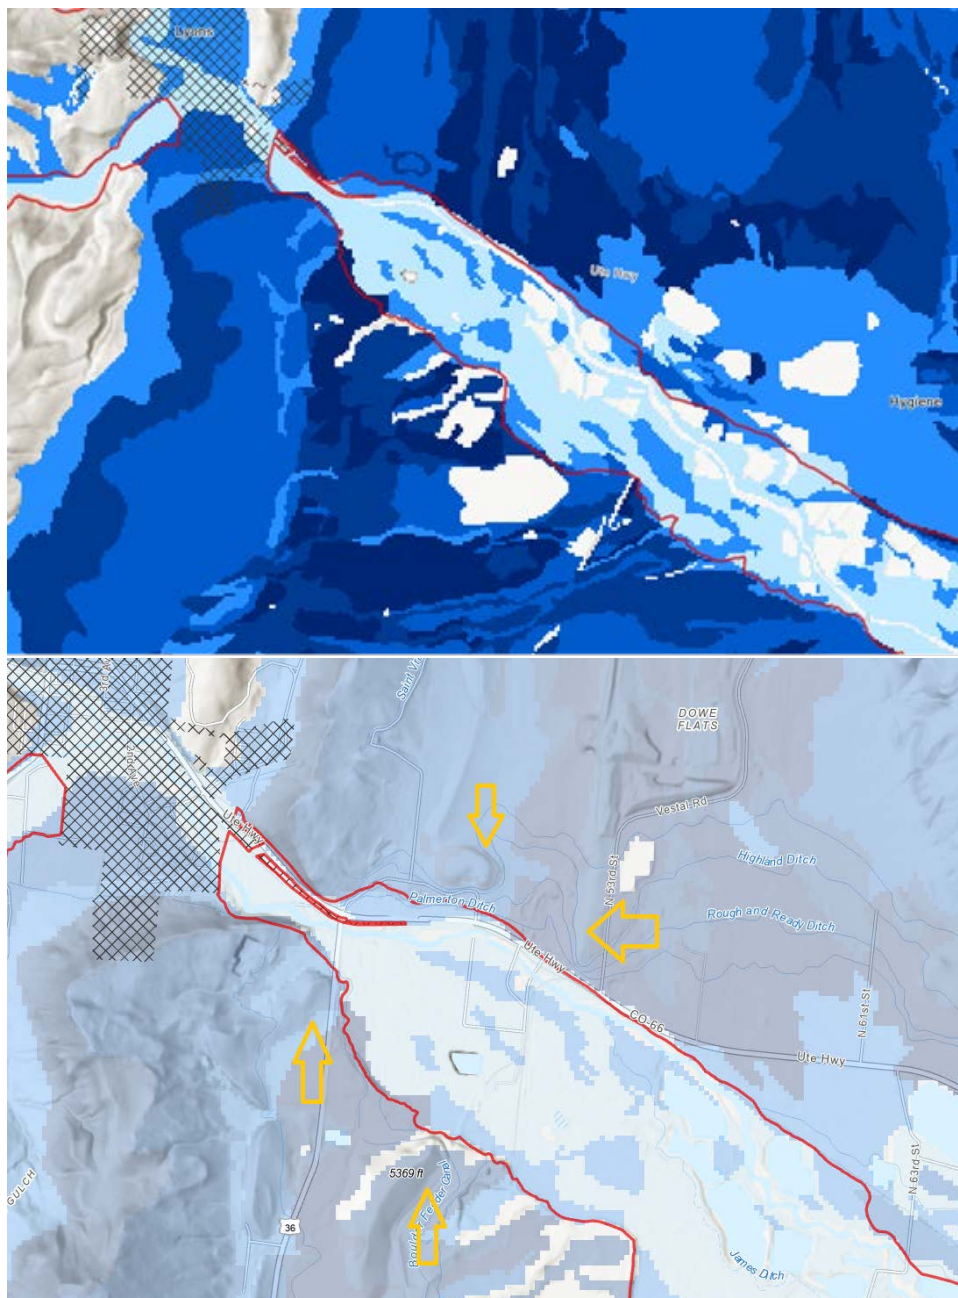
Figure 13. Top: SSURGO Soil Erodibility Index with FHZ boundaries overlaid in red, near Lyons. Lighter shades of blue are lower erodibility, darker shades of blue are higher erodibility. Bottom: Transparent SSURGO data overlaid

on terrain. Higher erodibility soils next to the FHZ tend to correspond with various higher-elevation landforms (noted by yellow arrows).

We overlaid the FHZ layer on the SSURGO dataset to examine whether the FHZ boundaries were well aligned with soil erodibility. In general there were areas of higher erodibility outside of the boundaries of the FHZ, likely due to the scouring river action leaving only lower erodibility soils within the active stream channel (**Figure 13**).

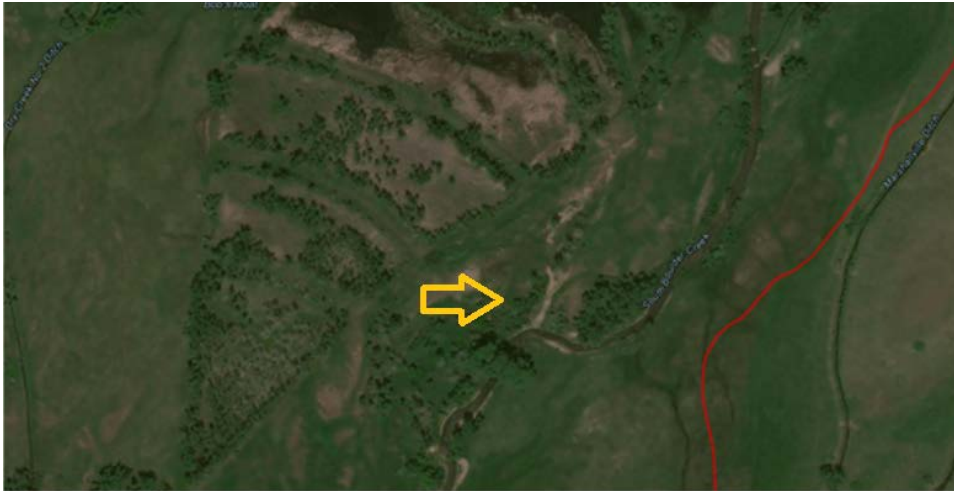
Figure 14. South Boulder Creek with former flow path covered in sediment (noted by yellow arrow).

There were no fans visible in imagery in the St. Vrain or Left Hand Creek areas, though there are plenty of dams, former river channels, and cutoffs visible. There were a few locations along South Boulder Creek where the creek makes very sharp turns, possibly with a fan in place (**Figure 14**). This area of Boulder County was particularly noteworthy in terms of the presence of visible historical or potential alternative paths for the stream.
