MEMORANDUM

To: Virginia Gazzetti and Kelly Watson, Boulder County Community Planning and Permitting(CPP)
cc:
From: Cameron Wobus and Laura Keys, Lynker Technologies
Subject: Boulder County FHZ Analysis
Date: June 30, 2022

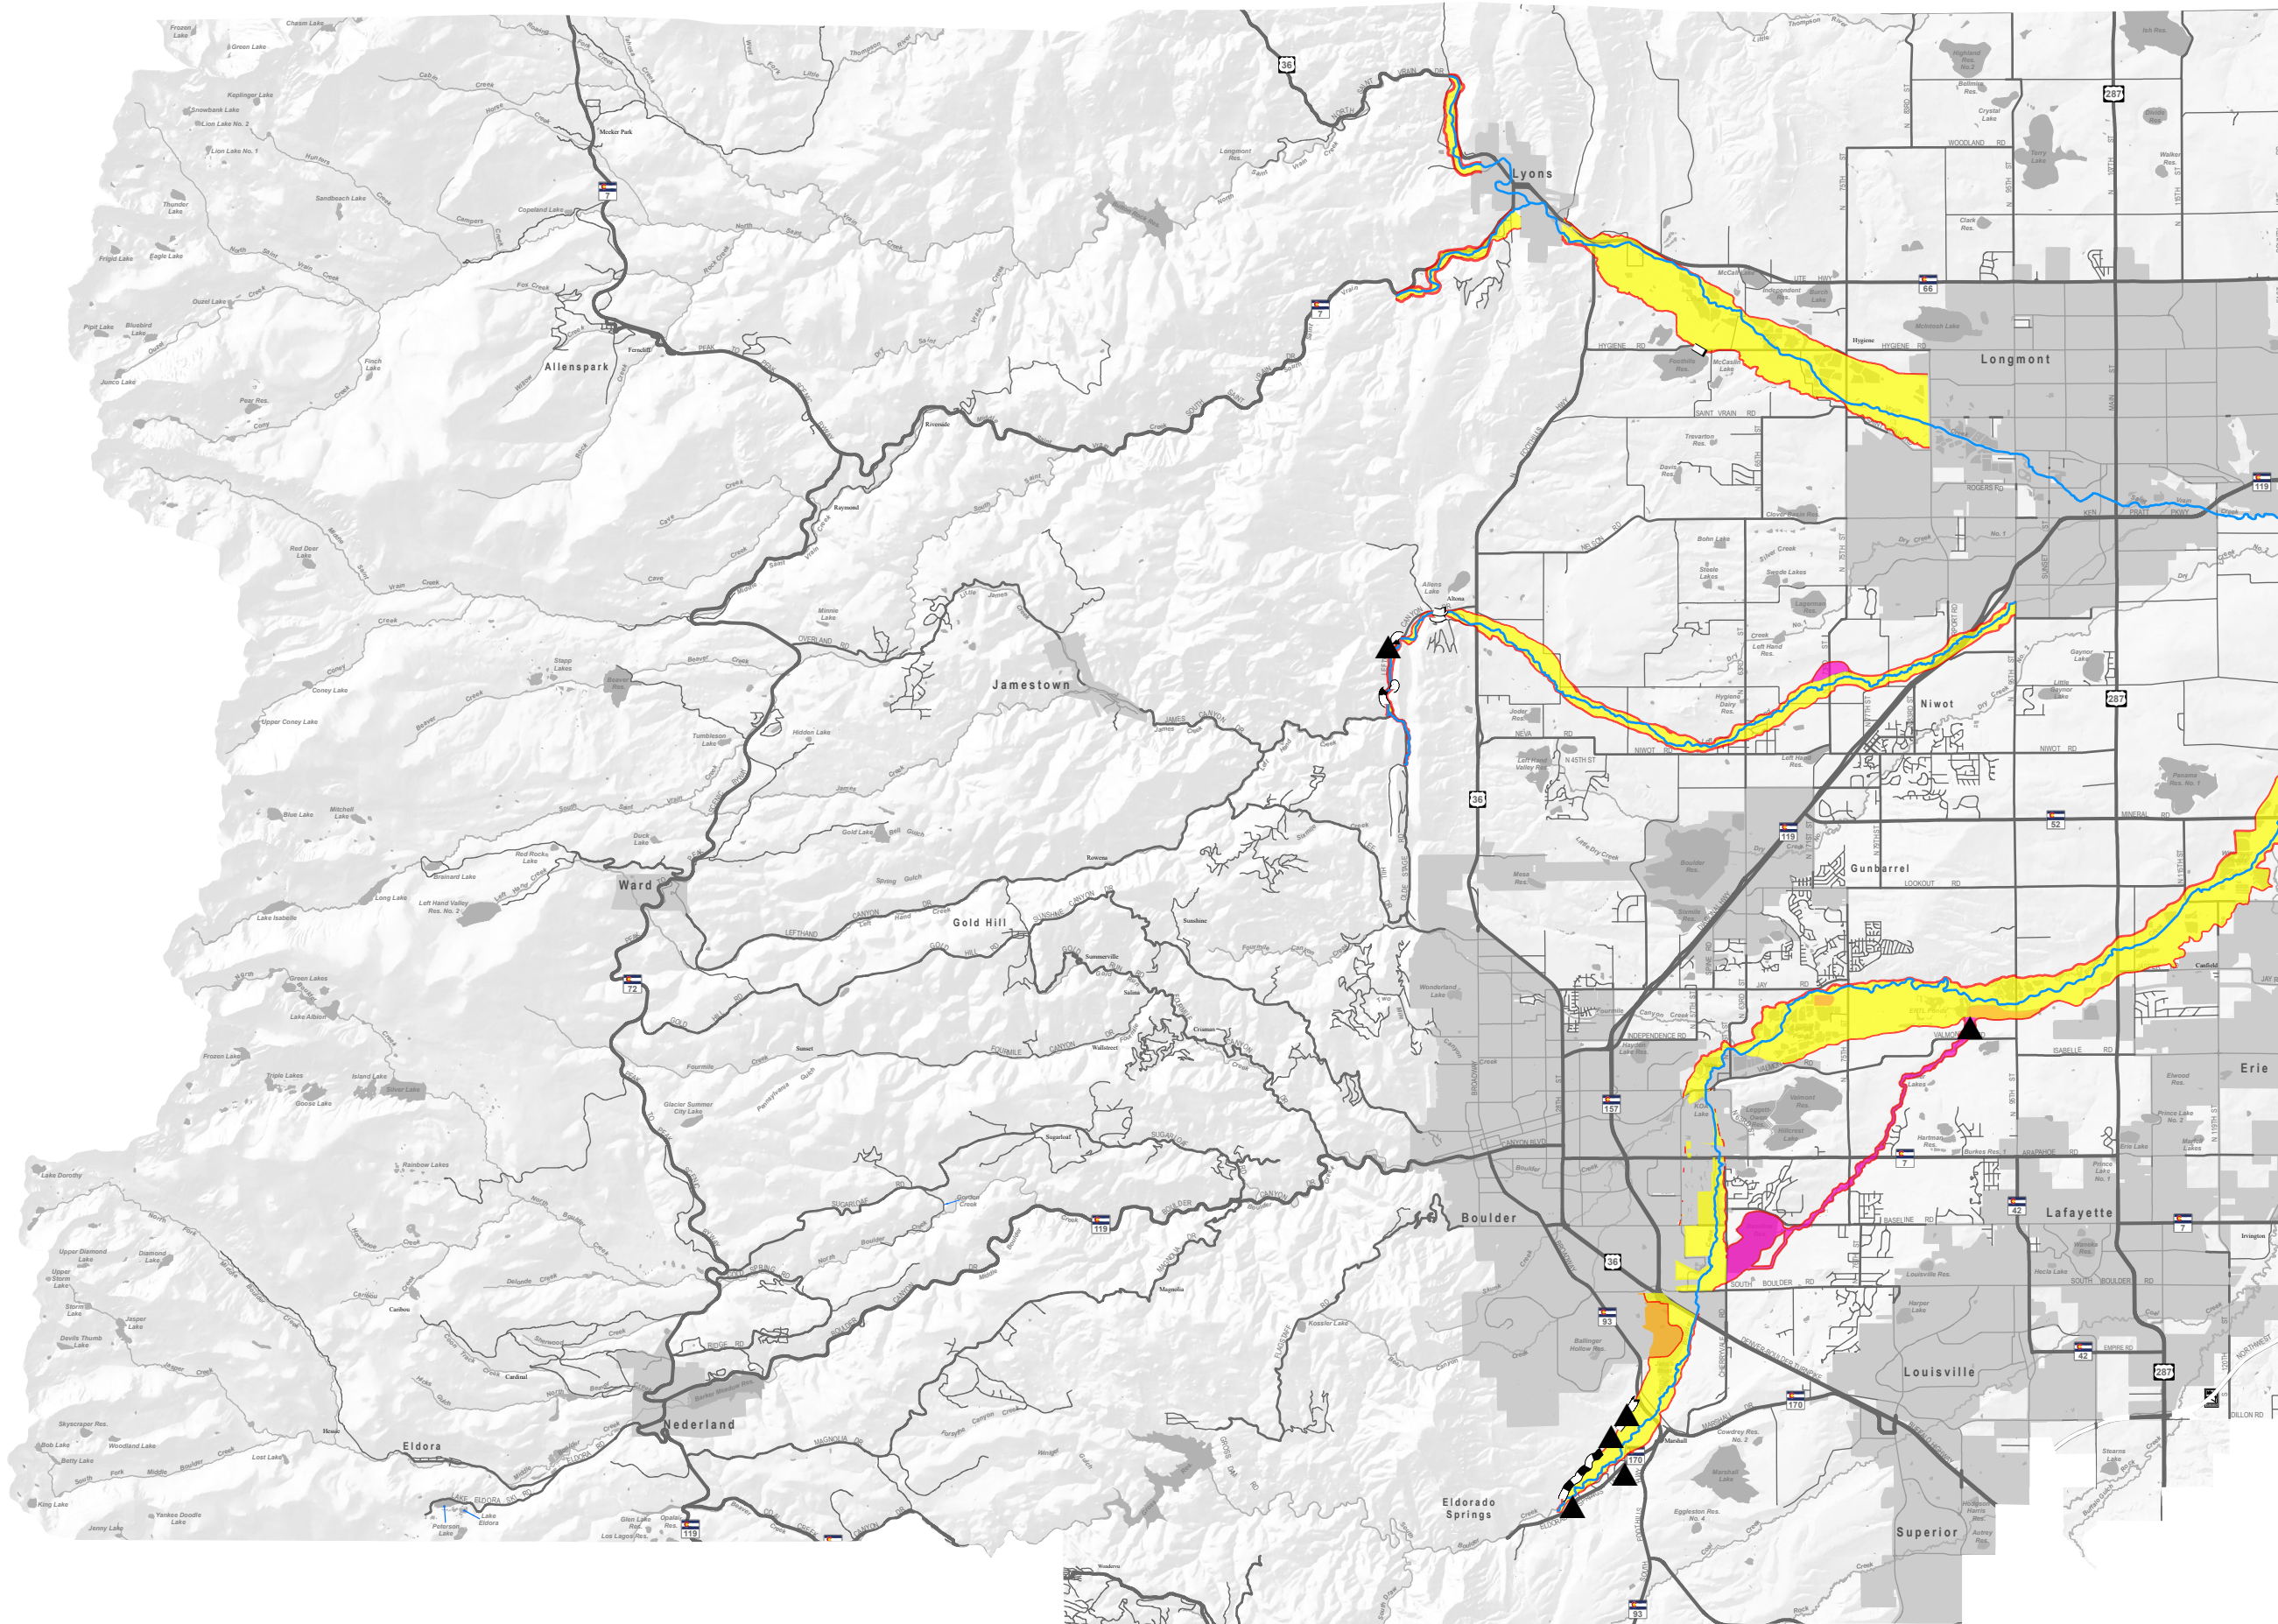
Fluvial Hazards in Boulder County

This map is intended to delineate the area a stream has occupied in recent history, may occupy, or may physically influence as it stores and transports water, sediment, and debris. This map does not predict the magnitude, frequency, or rate of fluvial geomorphic hazards. The intended use of this map is to inform land use planning, emergency planning, floodplain management, and stream corridor conservation efforts.
