Titan Lake Executive Summary

CWCB STAFF INSTREAM FLOW RECOMMENDATION January 29-30, 2024

CWCB ID: 24/2/A-003

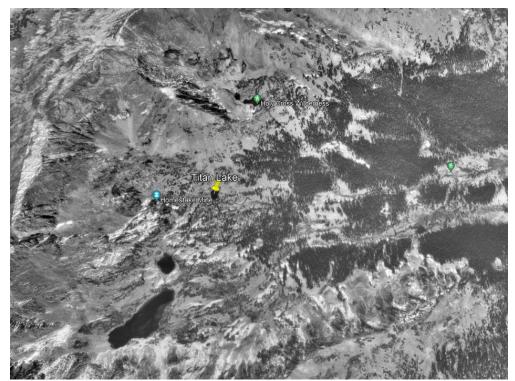
Google Earth Pro Historical Imagery 1999, Titan Lake label added by CWCB staff.

There is no historic lake level or lake volume information for Titan Lake. Titan Lake also does not show up as named feature on most maps, but a review of historical aerial photography shows the lake is a persistent feature. The website "Historical Aerials" has imagery showing the lake's presence in 1944, 1951, 1968, 1983, 1999, 2005, 2009, 2011, 2013, 2015, 2017, 2019, and 2021 (*Nationwide Environmental Title Research*, 2023)). In addition, Google Earth Pro has imagery showing the lake for the years 1985, 1999, 2005, 2006, 2011, 2012, 2015, 2018, 2019, and 2023 (see examples below). Although the image from 1985 is of lower quality than years after, the lake is still visible. The USGS National Map also shows an unnamed water feature in the location of Titan Lake (USGS, 2023). CWCB staff made one site visit to Titan Lake on 9/21/2023.

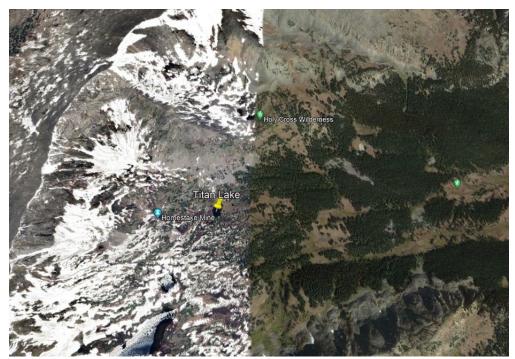
Google Earth Pro Historical Imagery 2023, Titan Lake label added by CWCB staff.

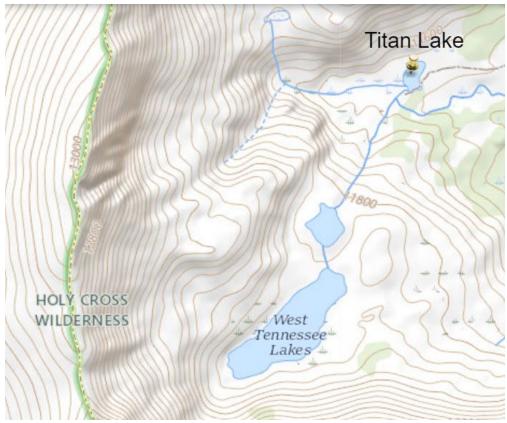
USGS National Map, Titan Lake label added by CWCB staff.
