POGG1,PDAA,201900002117
FOURMILE – MONITORING & ADAPTIVE MANAGEMENT
FINAL REPORT

PREPARED FOR
COLORADO WATERSHED RESTORATION PROGRAM GRANT

JUNE 30, 2022

PREPARED BY: CAT PRICE

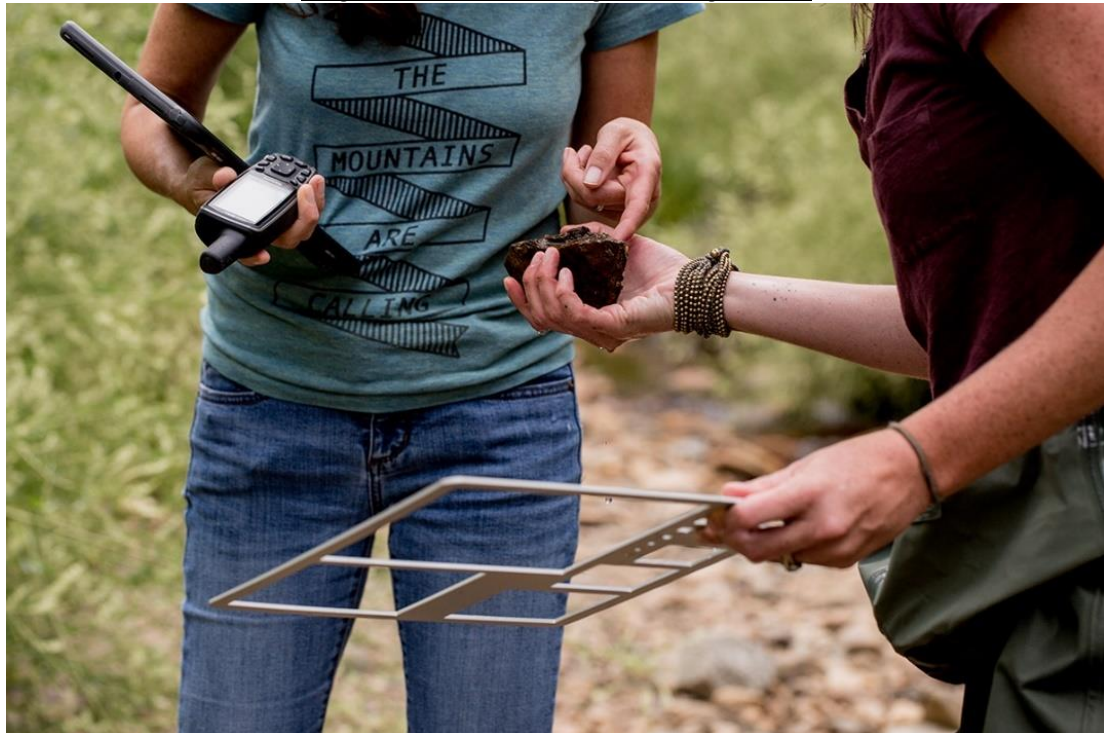
Image 2. FWC Staff Conducting Monitoring Activities

Logan Mill, Monitoring Activity: Pebble Count, Early Fall 2019

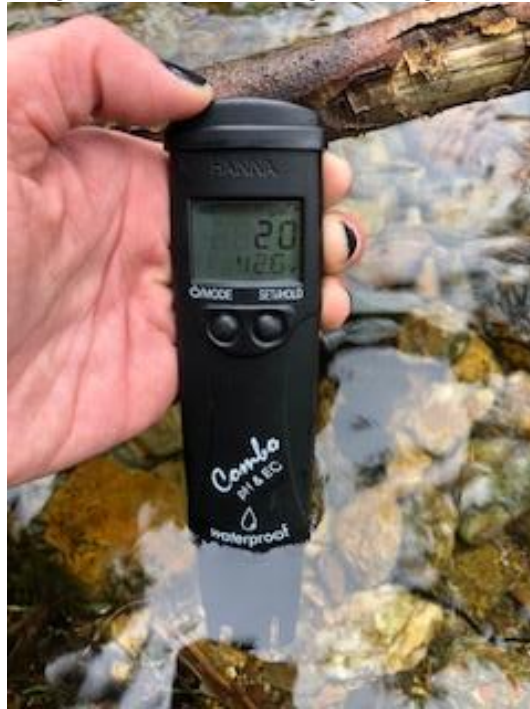
Image 3. FWC Staff Conducting Monitoring Activities

Some parameters incorporated into the plan and monitored each year include substrate surveys (pebble counts and point bar surveys), water quality sampling, in-stream feature surveys (pools, habitat, thalweg), vegetation monitoring, flow measurements, fish population, benthic macroinvertebrate studies, and photo point documentation. A full list of parameters, methods, and procedures can be found in the Monitoring Plan in the [shared drive project folder](#). Due to the large file size and robust data sets from three years of collection, the comprehensive data files are not included in this report and are kept separately in the [shared drive project folder](#).

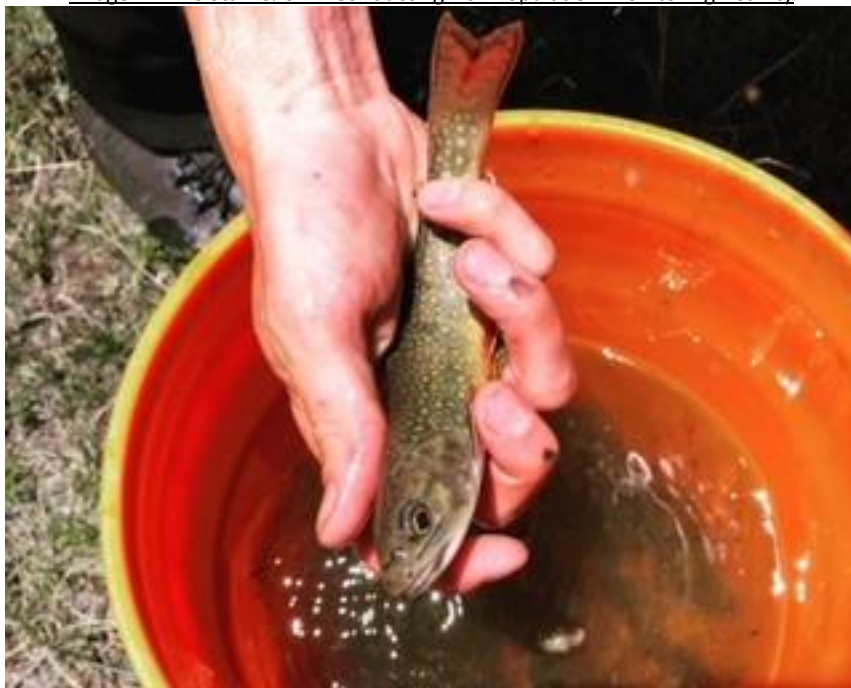
Image 4. FWC Staff & CPW Conducting Fish Population Monitoring Activity

Upper Fourmile, Monitoring Activity: Fish Population, June 2019

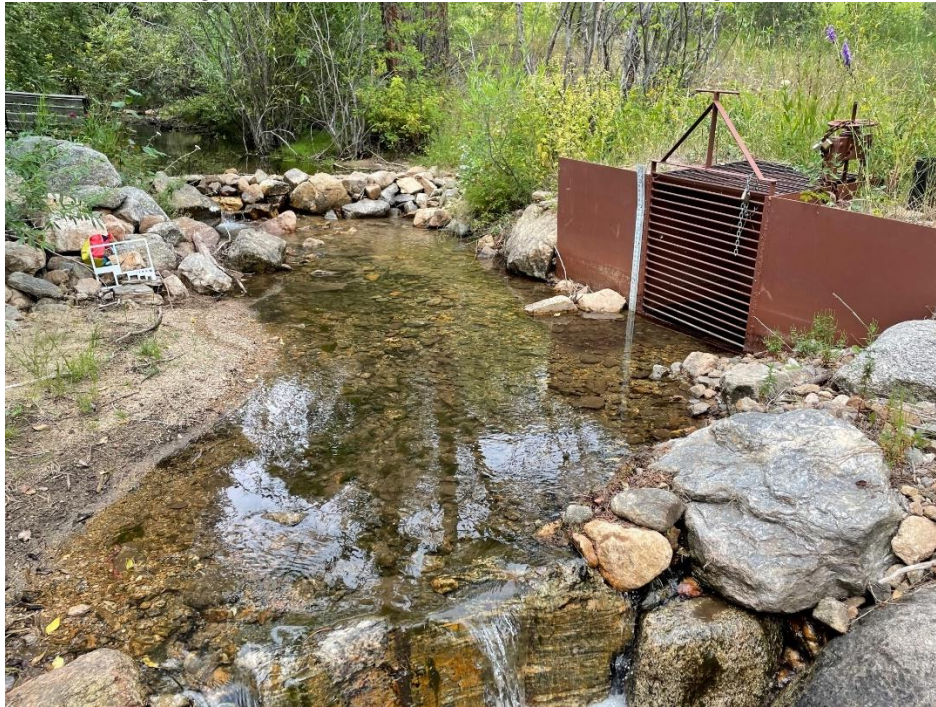
Image 6. Sunset Pond Cross Vane in Post Adaptive Management

Sunset Pond, Upper Cross Vane, August 2021

Most stream restoration project sites did not require extensive Adaptive Management strategies to structural features, except for one cross-vane nearest a diversion structure at the Sunset Pond site. Construction completed in 2017 and the following year's runoff (2018) caused multiple boulders to shift and dislodge. After discussing options with the designer and contractor, the decision was made to repair the cross-vane to protect the diversion. Originally round, locally sourced boulders had been installed; the contractor repaired the cross vane with more angular boulders for reinstallation.

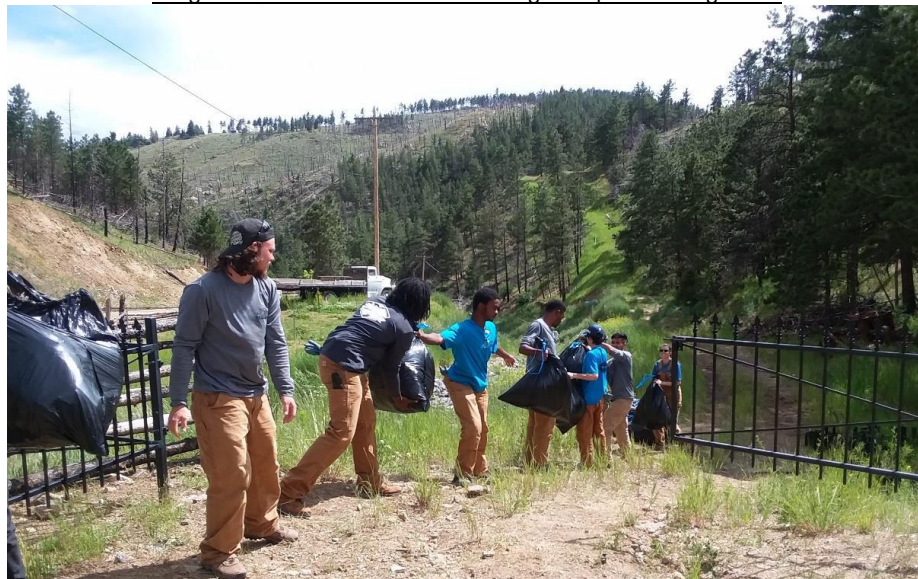
Image 7. Teens Inc Youth Core Weeding - Adaptive Management

Ingram Gulch, Cheat Grass & Weed Management, July 2019

The most common adaptive management activities that occurred were weed management, re-seeding and planting. At most sites, one or two seasons of re-seeding and/or weed management occurred before the native species outcompeted the weeds and no additional management was necessary. FWC typically used mechanical weed management with volunteers but did hire contractors for herbicide use where there were larger invasive species issues. The following sites received seeding and weed management: Sunset Pond, Wall Street, Logan Mill, Lower Fourmile Bank Protection locations, Ingram Gulch and Black Swan. Overall, each year displayed a healthy and diverse riparian zone moving farther up slope, while weeds and invasives were seen moving out of the system.

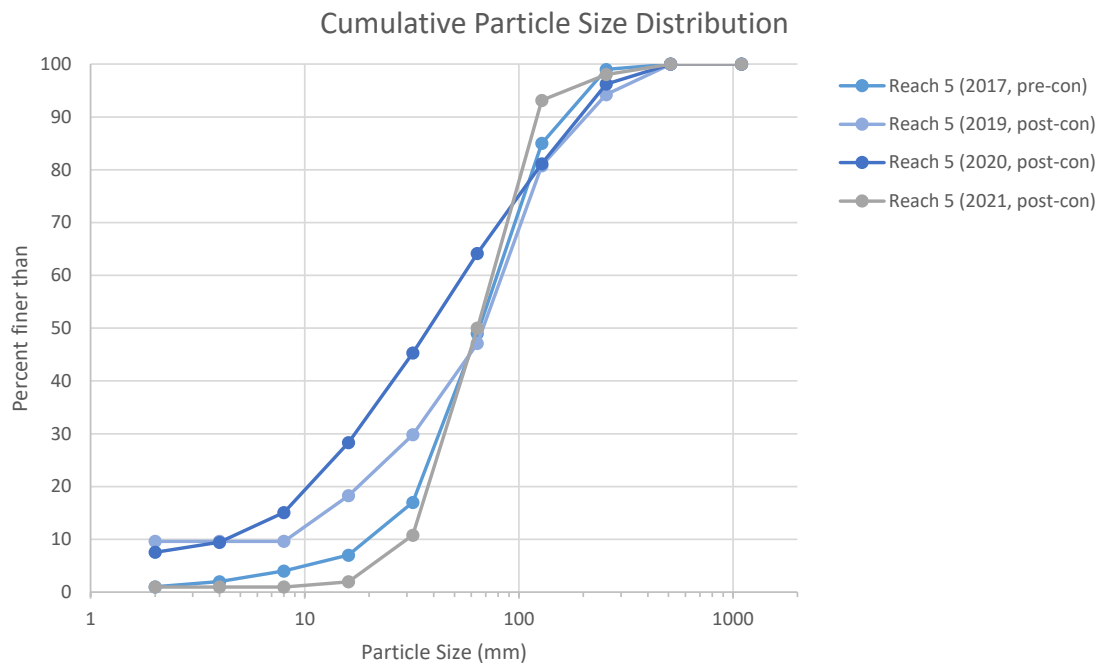
Figure 1. Cumulative Particle Size Distribution – Wall Street – 2017-2021

Comparison of pre-construction (2017) to post-construction (2021) grain-size distributions indicates that fine sediments that may have accumulated in the interim years (late 2017 through 2020) due to construction activities or inadequate flushing flows have been significantly reduced by 2021. The D50 and D84 particle sizes of 77 and 128, respectively, in 2021 indicate that cobbles and coarse gravels comprise most of the stream bed substrate.
