Debris Flow Early Warning System Final Report

Prepared for: Colorado Water Conservation Board; Watershed Restoration Program
Attn: Chris Sturm
June 24, 2022

Boulder Watershed Collective (previous fiscal agent: Four Mile Fire Protection District)

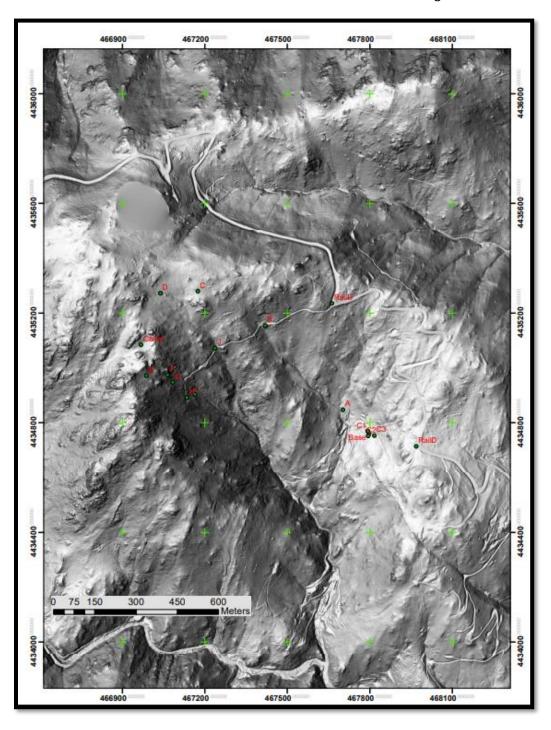
Figure 1: Lidar of Ingram Gulch with proposed monitoring locations and/or soil sample locations indicated.

Numerous data sources were evaluated prior to selecting the monitoring sites at Ingram Gulch. These data were also used to inform decisions on which instrumentation should be installed for monitoring. Evaluations of slope, geology, precipitation, previous storm footprints, values at risk and soil characterization occurred. At Calwood, the USGS Burn Area Emergency Report (BAER) was used to determine high priority monitoring locations where high probability of debris flows was indicated and there were downstream values at risk. Lidar was also used to inform monitoring location decisions.

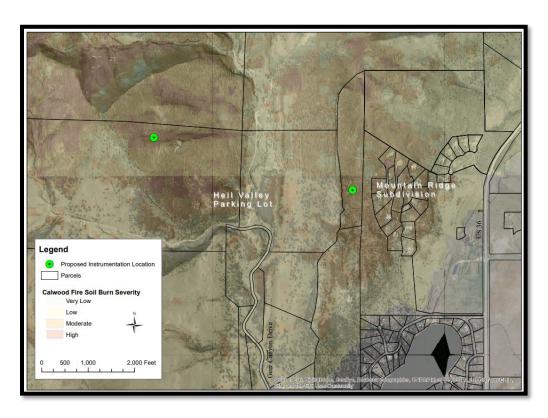
Figure 2: Monitoring sites within the Calwood burn scar.

After the 2020 fire season, the project was expanded, and two additional monitoring stations were installed in the Calwood burn scar. Calwood provided an opportunity to evaluate a new burn scar and collect data in a location with different soil types.

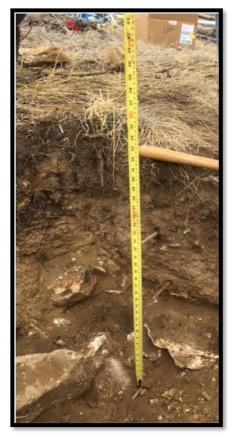
Figure 3: Example of soil horizons

Two soil sampling events occurred prior to equipment installation. Samples were collected and analyzed by both the Natural Resource Conservation Service and at the School of Mines laboratories. The soil results assisted in selecting appropriate monitoring equipment for installation. A soil pit was dug by hand at each site and soil was collected from each soil horizon. The following soil properties were measured, which are necessary to properly calibrate the sensors before installation: specific gravity, moisture content, Atterberg limits (liquid limit, plasticity index), absorption, clay content and particle size distribution. The soil results assisted in selecting appropriate monitoring equipment for installation.

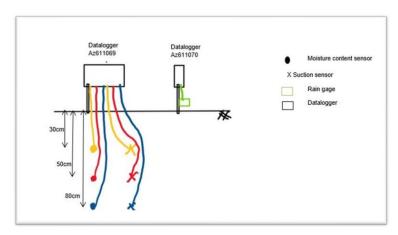
Detail of connections to datalogger (Figure 4), Schematic of subsurface instrumentation (Figure 5)

Monitoring equipment was installed at seven sites in Ingram Gulch and two sites at Calwood. Equipment includes: a) One Rain gauge (ECRN-100) to measure precipitation; connected to a solar powered datalogger. b) Tensiometers (TEROS 32) to measure matric suction in kPa; connected to solar powered dataloggers. c) Three volumetric water content sensors (EC-5); connected to datalogger. As shown in Figure 5 below, a pair of volumetric water content – suction sensors are installed at three depths: 30cm (yellow, ports 1 and 4), 50cm (red, ports 2 and 5), and 80cm (blue, ports 3 and 6). No sensors were installed deeper than 80 cm because at that point most of the hillslope material is likely to consist of larger rocks. Holes were excavated by hand. After equipment is installed, all removed material was backfilled to bury the equipment. The logged data is uploaded every 15 minutes and then sent via a 5G data transmitter to off-site computers and posted to the cloud.

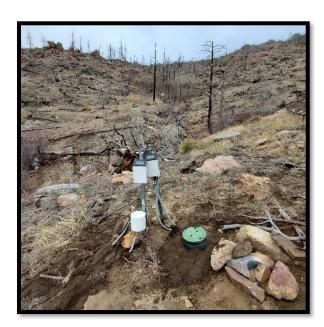
Figure 6: Monitoring station with rain gauge and data loggers visible.

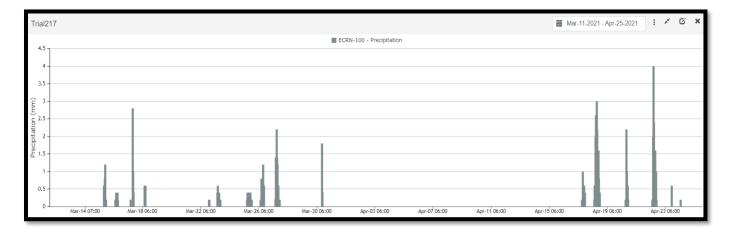
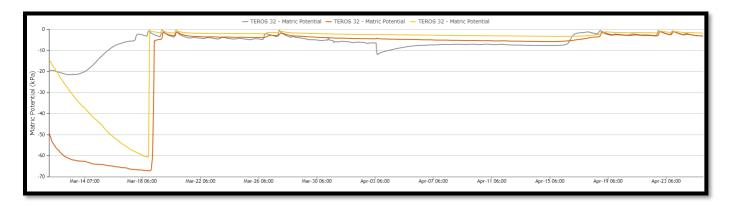
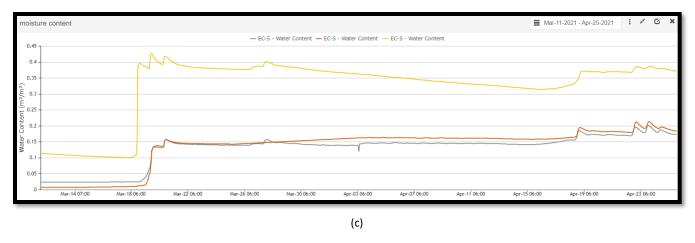
The figures below represent an example of data obtained from March 11 to April 25, 2021. Note that there was significant snow at the site on March 13-14. As the snow melts, moisture content increases and suction decreases. The moisture content sensor at z=50cm was disconnected on March 20 and reconnected on April 3. These data are available for each monitoring site. The data is remotely available through Zentra Cloud. While the soil is too dry during some months of the year (and air breaks in the tensiometers), the relevant soil behavior for slope stability is captured when water starts infiltrating into the soil. Colorado School of Mines is analyzing data in a calibrated model used for debris-flow (shallow landslide) prediction. The model synthesizes results by simulating stress and two-dimensional flow in a variably saturated cross-section and is based in numerical synthesis that is validated (calibrated) with the active field monitoring of soil suction and moisture content data. Once there is sufficient field data which has been modeled, preliminary warning system thresholds can be developed and tested. It is estimated that one to two years of data is required to make well informed threshold ranges for alerts.

Figure 6. (a) Precipitation vs. time, (b) Matric potential vs. time, (c) volumetric moisture content vs. time.

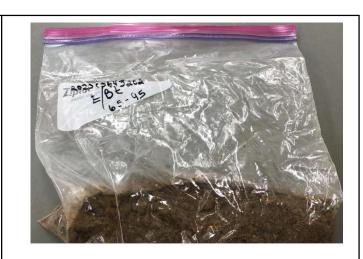
Soil Sample Picture

Code	20:	20CO6432	202
Denomination	E Bt		
Date		-	
ITEM		Test No.	
I I CIVI	1	2	3
1. Can No.	C-19	C-20	C-21
2. Mass of can, M1 (g)	12.19	12.67	11.60
3. Mass of can + wet soil, M ₂ (g)	37.16	33.01	32.32
4. Mass of can + dry soil, M ₃ (g)	35.28	31.42	30.64
5. Mass of moisture, M_2 - M_3 (g)	1.88	1.59	1.68
6. Mass of dry soil, M ₃ - M ₁ (g)	23.09	18.75	19.04
7. Water content, w (%) = $((M_2 - M_3)/(M_3 - M_1)) \times 100$	8.14%	8.48%	8.82%
Average water content		8.48%

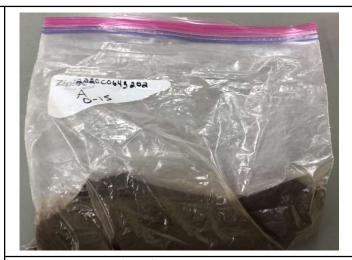
Soil Sample Picture

Code	20	20CO643	203
Denomination	A O-15		
Date		-	
ITEM		Test No.	
I I CIVI	1	2	3
1. Can No.	C-10	C-11	C-12
2. Mass of can, M1 (g)	12.50	12.57	11.00
3. Mass of can + wet soil, M ₂ (g)	35.54	35.89	36.45
4. Mass of can + dry soil, M ₃ (g)	33.85	34.54	33.60
5. Mass of moisture, M_2 - M_3 (g)	1.69	1.35	2.85
6. Mass of dry soil, M ₃ - M ₁ (g)	21.35	21.97	22.60
7. Water content, w (%) = $((M_2 - M_3)/(M_3 - M_1)) \times 100$	7.92%	6.14%	12.61%
Average water content		8.89%

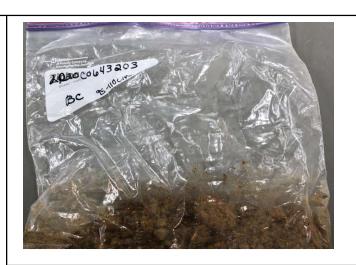
Soil Sample Picture

Code	20	20CO6432	203
Denomination	ВС		
Date	-		
ITEM	Test No.		
I I CIVI	1	2	3
1. Can No.	C-16	c-17	c-18
2. Mass of can, M1 (g)	12.41	12.54	11.52
3. Mass of can + wet soil, M ₂ (g)	32.99	35.28	35.78
4. Mass of can + dry soil, M ₃ (g)	30.87	32.95	33.45
5. Mass of moisture, M_2 - M_3 (g)	2.12	2.33	2.33
6. Mass of dry soil, M_3 - M_1 (g)	18.46	20.41	21.93
7. Water content, w (%) = $((M_2 - M_3)/(M_3 - M_1)) \times 100$	11.48%	11.42%	10.62%
Average water content		11.17%

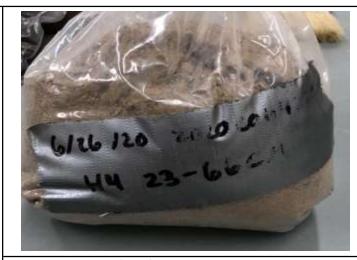
Soil Sample Picture

Code	2020CO643206		
Denomination			
Date		6-26-20	
ITEM		Test No.	
I I CIVI	1	2	3
1. Can No.	C-7		
2. Mass of can, M1 (g)	12.79		
3. Mass of can + wet soil, M ₂ (g)	65.91		
4. Mass of can + dry soil, M ₃ (g)	65.09		
5. Mass of moisture, M ₂ - M ₃ (g)	0.82		
6. Mass of dry soil, M ₃ - M ₁ (g)	52.30		
7. Water content, w (%) = $((M_2 - M_3)/(M_3 - M_1)) \times 100$	1.57%		
Average water content		1.57%

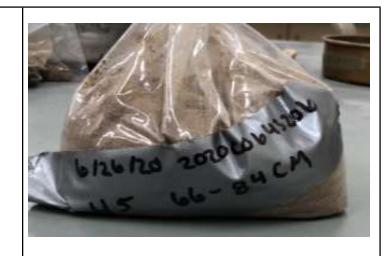
Soil Sample Picture

Code	2020CO643206		
Denomination	H5		
Date	6-26-20		
ITEM	Test N		
I I E IVI	1	2	3
1. Can No.	C8		
2. Mass of can, M1 (g)	11.60		
3. Mass of can + wet soil, M ₂ (g)	64.70		
4. Mass of can + dry soil, M ₃ (g)	62.88		
5. Mass of moisture, M ₂ - M ₃ (g)	1.82		
6. Mass of dry soil, M ₃ - M ₁ (g)	51.28		
7. Water content, w (%) = $((M_2 - M_3)/(M_3 - M_1)) \times 100$	3.55%		
Average water content		3.55%

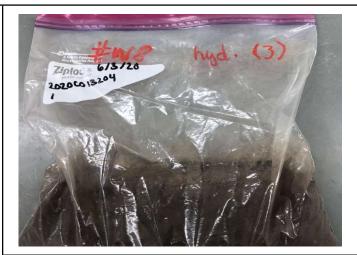
Soil Sample Picture

Code	2020co13204		
Denomination	#W8-1		
Date	-		
ITEM	Test No.		
II LIWI	1	2	3
1. Can No.	C-22	C-23	C-24
2. Mass of can, M1 (g)	12.43	12.50	11.83
3. Mass of can + wet soil, M_2 (g)	39.49	34.36	39.30
4. Mass of can + dry soil, M_3 (g)	38.35	33.19	38.19
5. Mass of moisture, M_2 - M_3 (g)	1.14	1.17	1.11
6. Mass of dry soil, M_3 - M_1 (g)	25.92	20.69	26.36
7. Water content, w (%) = $((M_2 - M_3)/(M_3 - M_1)) \times 100$	4.40%	5.65%	4.21%
Average water content		4.75%

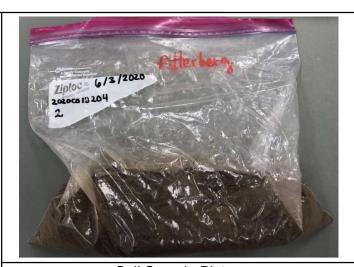
Soil Sample Picture

Code	2020CO13204		
Denomination	2 (Atterberg)		
Date			
ITEM		Test No.	
I I CIVI	1	2	3
1. Can No.	C-3		
2. Mass of can, M1 (g)	12.28		
3. Mass of can + wet soil, M ₂ (g)	45.77		
4. Mass of can + dry soil, M_3 (g)	43.93		
5. Mass of moisture, M_2 - M_3 (g)	1.84		
6. Mass of dry soil, M_3 - M_1 (g)	31.65		
7. Water content, w (%) = $((M_2 - M_3)/(M_3 - M_1)) \times 100$	5.81%		
Average water content	5.81%

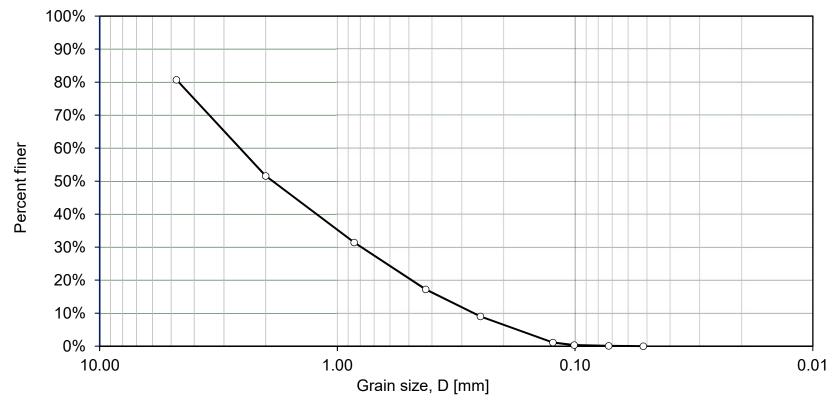
PLOT OF PERCENT FINER VS. GRAIN SIZE

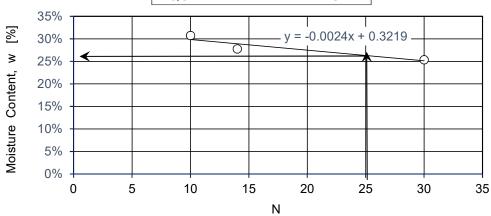
LIQUID LIMIT TEST RESULTS

w=a*N+b			$(N)^{0,121}$
N=	25	a =	-0.0024	b=	0.3219	$\left({25}\right)$

Liquid limit = 26.19%

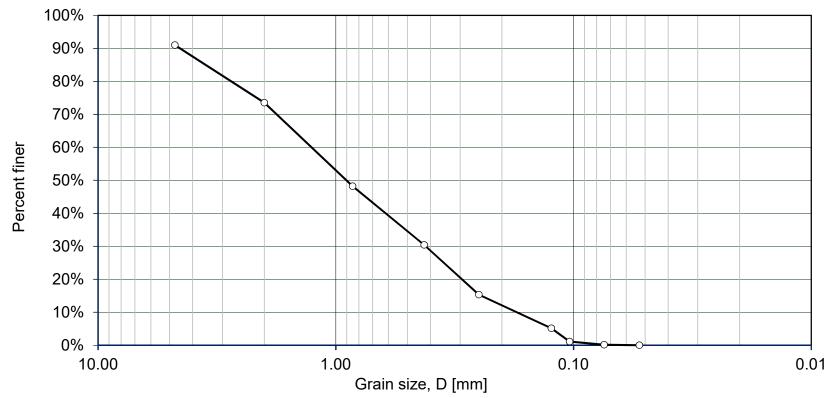
PLOT OF PERCENT FINER VS. GRAIN SIZE

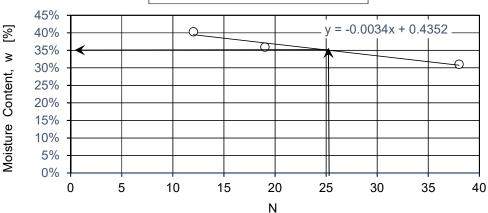
LIQUID LIMIT TEST RESULTS

w=a*N+b			$(N)^{0,121}$
N=	25	a =	-0.0034	b=	0.4352	$(\frac{1}{25})$

Liquid limit = 35.02%

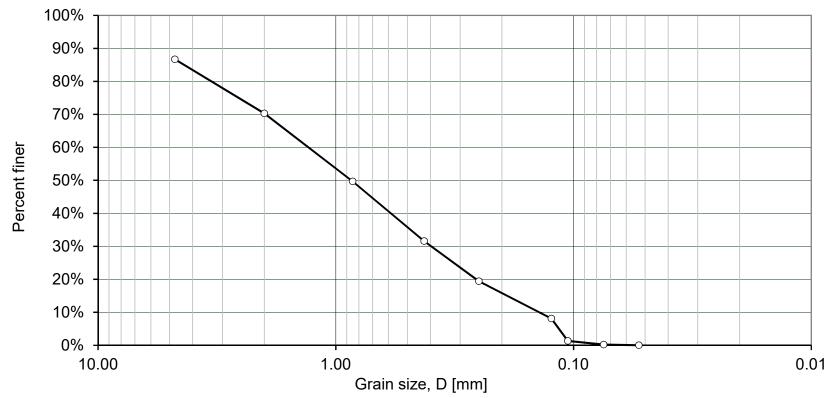
PLOT OF PERCENT FINER VS. GRAIN SIZE

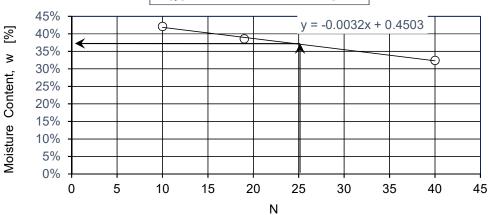
LIQUID LIMIT TEST RESULTS

w=a*N+b			$(N)^{0,121}$
N=	25	a =	-0.0032	b=	0.4503	$\left({25}\right)$

Liquid limit = 37.03%

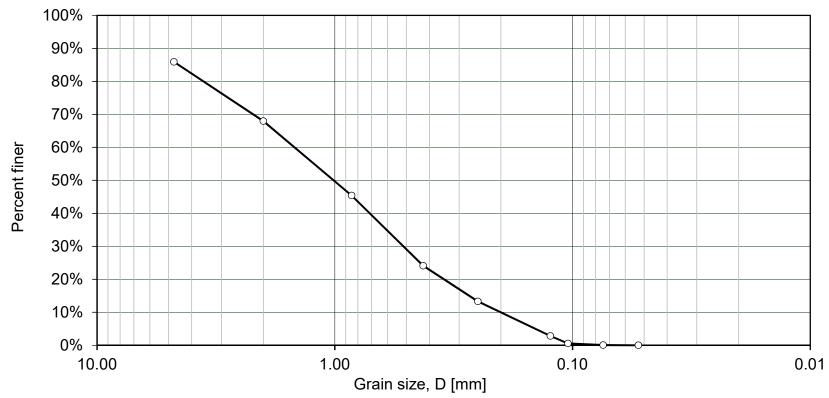
PLOT OF PERCENT FINER VS. GRAIN SIZE

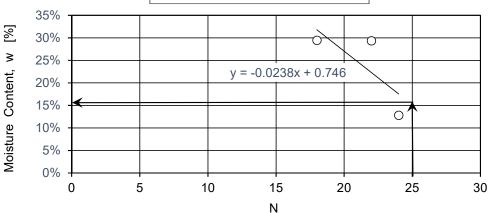
LIQUID LIMIT TEST RESULTS

w=a*N+b			$(N)^{0,121}$
N=	25	a =	-0.0238	b=	0.746	$\left({25}\right)$

Liquid limit = 15.10%

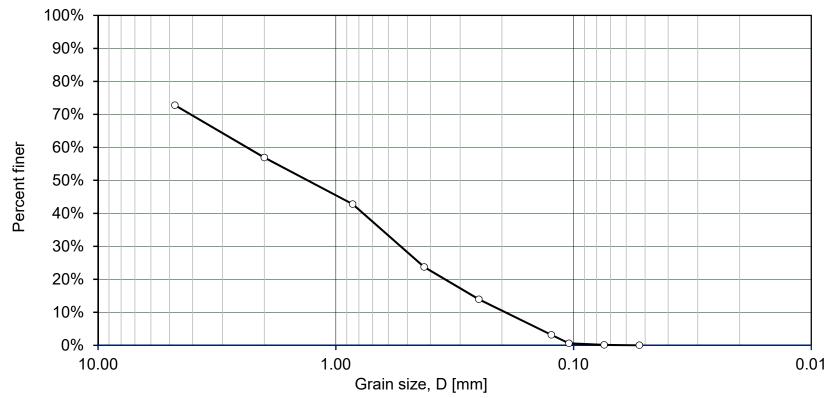
PLOT OF PERCENT FINER VS. GRAIN SIZE

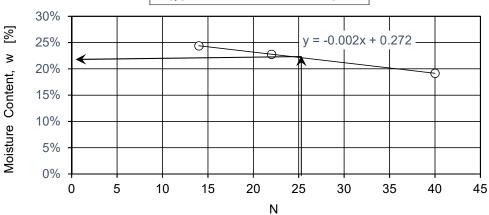
LIQUID LIMIT TEST RESULTS

,	w=a*N+b			$(N)^{0,121}$
N=	25	a =	-0.002	b=	0.272	$\left({25}\right)$

Liquid limit = 22.20%
