**Enhancing Watershed Resiliency in the Pike National Forest Through the Implementation
of Multi-Year and Multi-Faceted Watershed Health Improvement Projects**
Final Report

Prepared for:
Colorado Watershed Restoration Program
Attn: Chris Sturm

December 17, 2021

Grantee
Rocky Mountain Field Institute

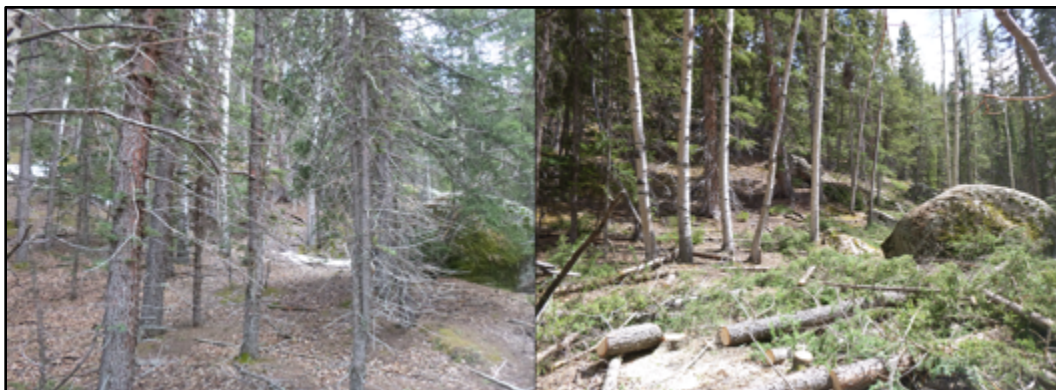
Figure 13. Before (left) and after (right) of TSI work completed at Rainbow Gulch.

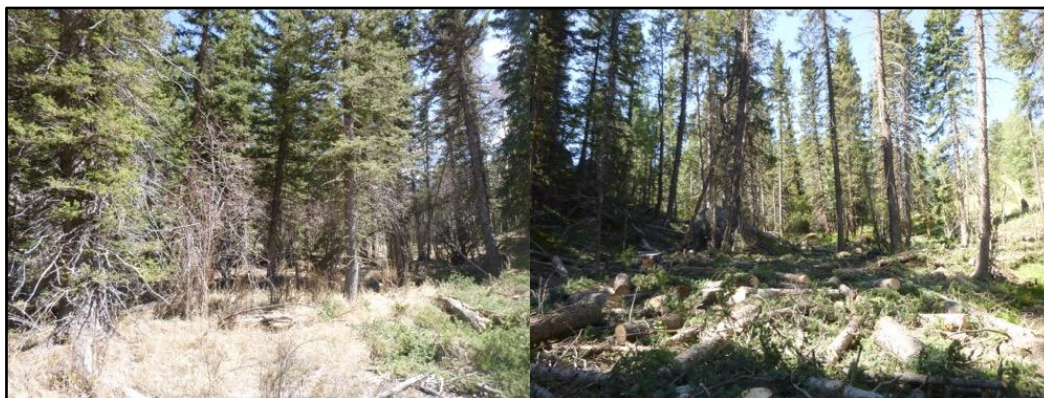
Figure 14. Before (left) and after (right) of TSI work completed at Rainbow Gulch.

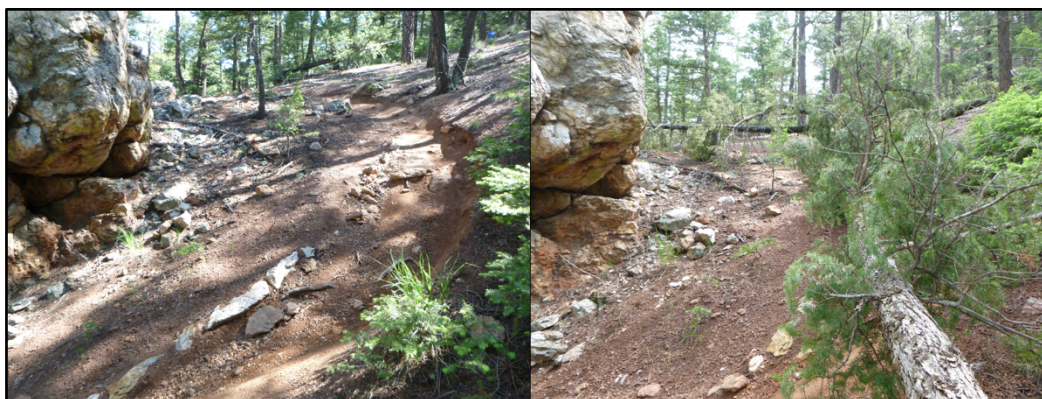
Figure 16. Before (left) and after (right) of social trail access closure.

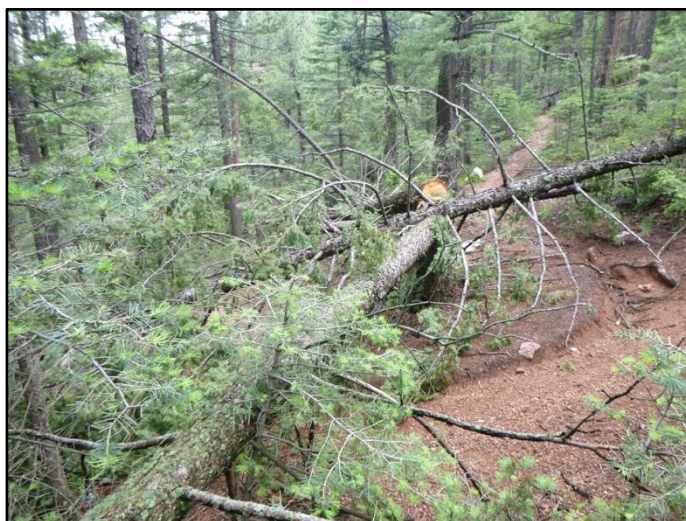
Figure 17. Example of strategic felling to obstruct and disguise social trail access.

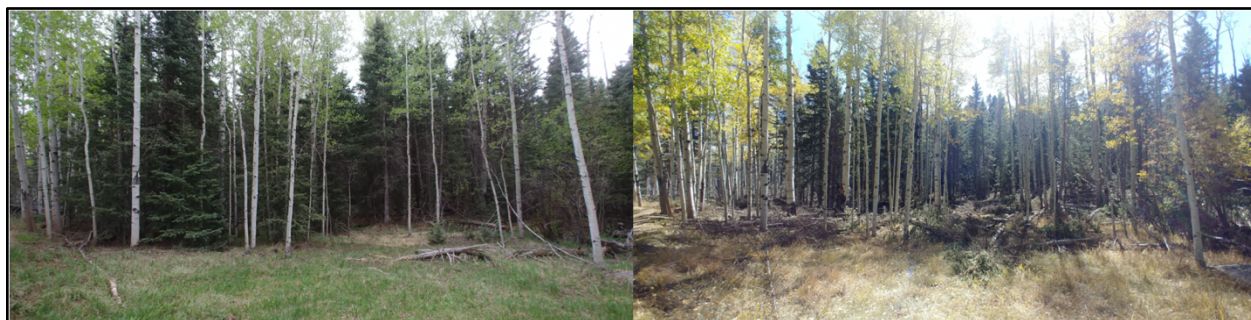
Figure 18. Before (left) and after (right) of TSI work at Goat Creek Camp.

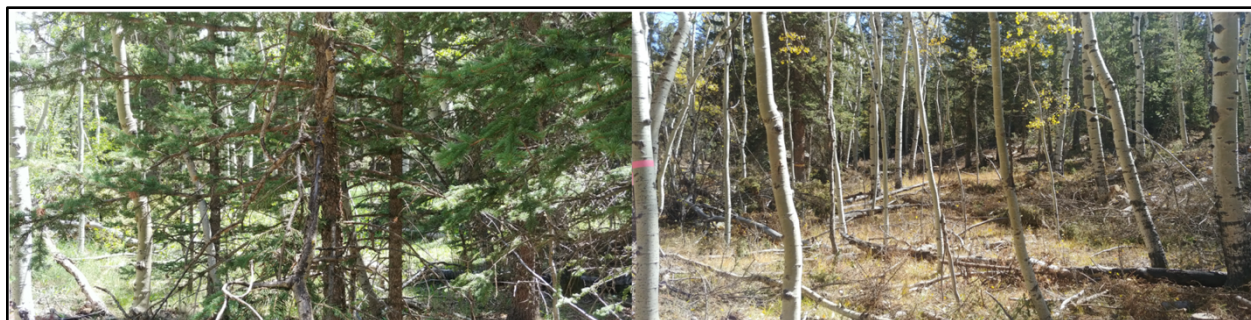
Figure 19. Before (left) and after (right) of TSI work at Goat Creek Camp.

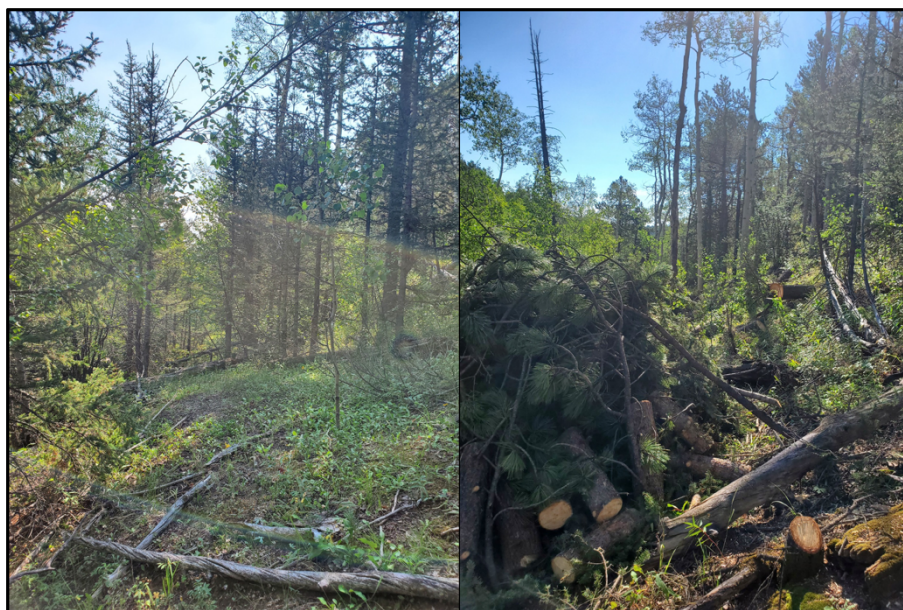
Figure 20. Before (left) and after (right) of TSI work and burn pile construction at Cascade Creek.

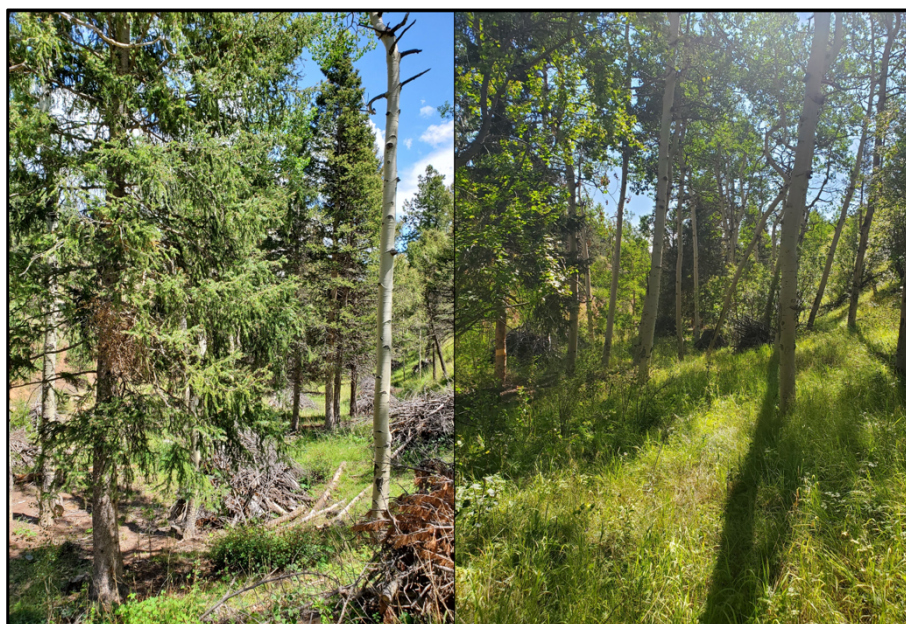
Figure 21. Before (left) and after (right) of TSI work at Cascade Creek.

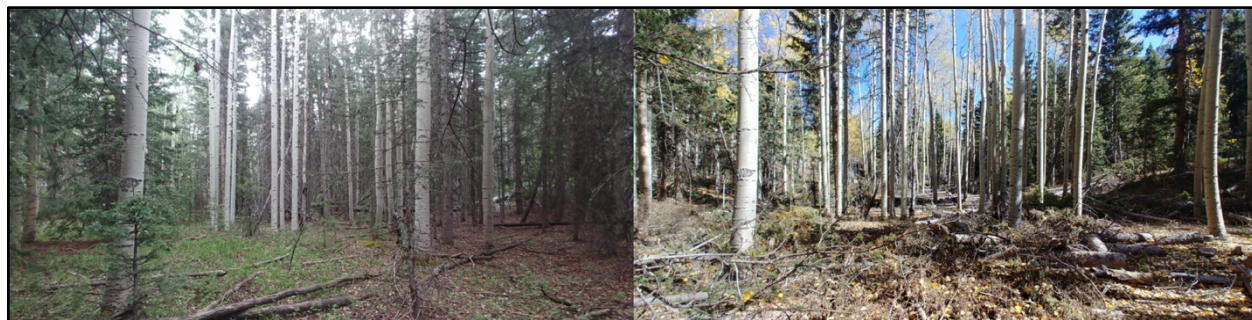
Figure 23. Before (left) and after (right) of conifer encroachment removal at Harris Park.

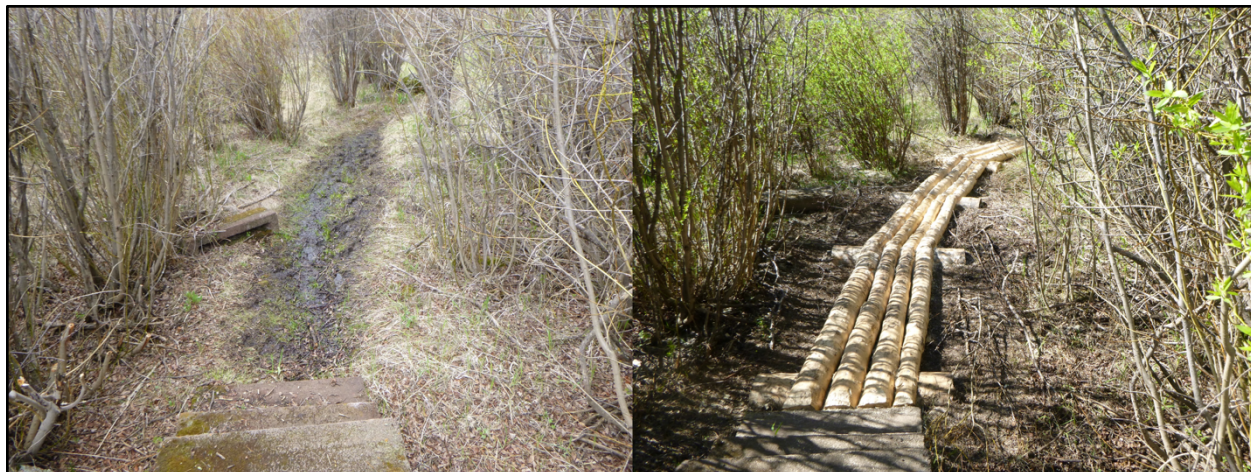
Figure 24. Before (left) and after (right) of puncheon constructed through wetland area.

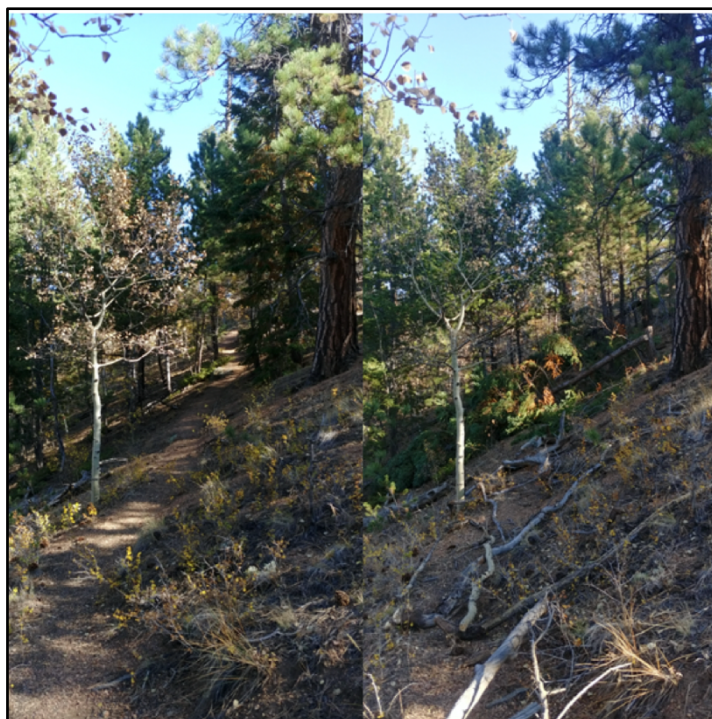
Figure 25. Before (left) and after (right) of social trail closure and restoration.

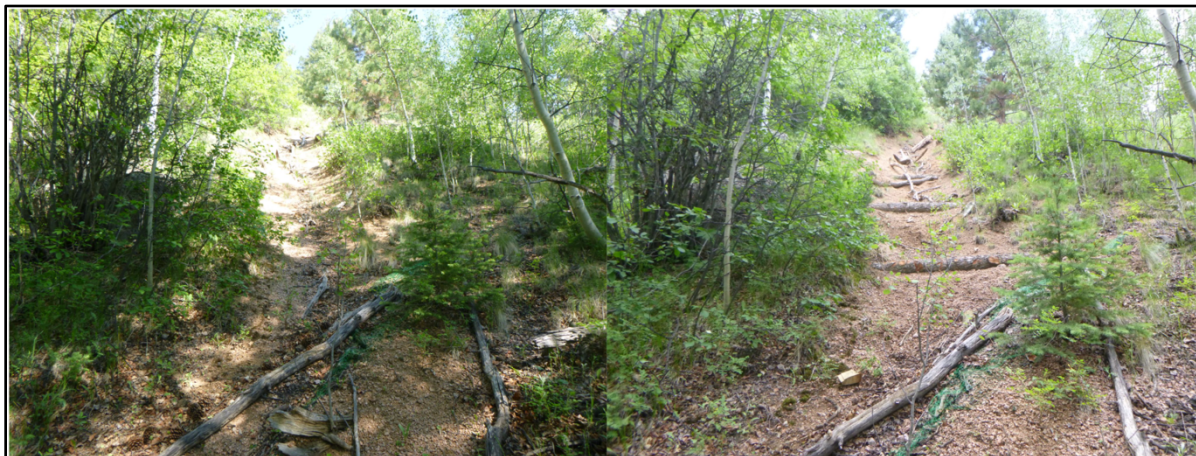
Figure 26. Before (left) and after (right) of check dam construction at Nichols Trail.

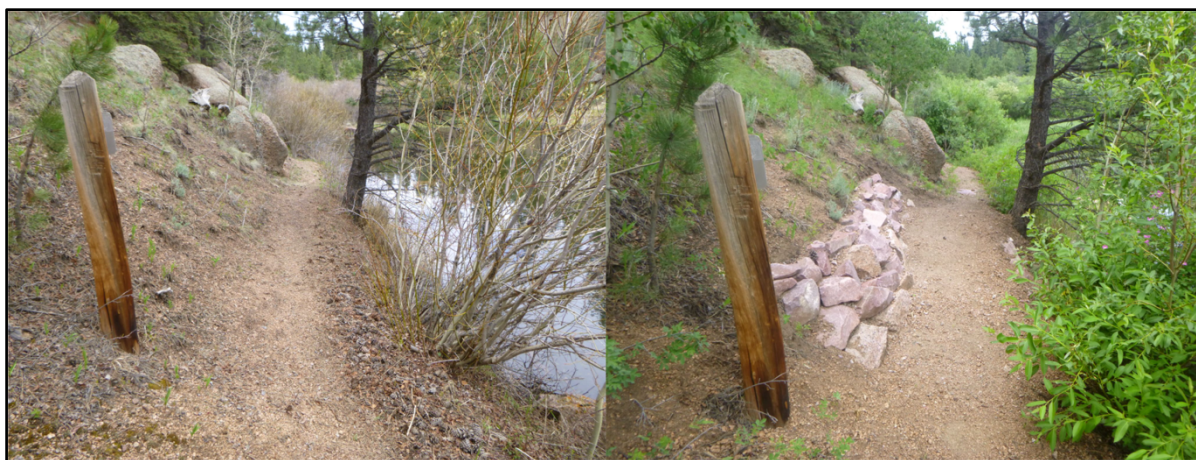
Figure 27. Before (left) and after (right) of retaining wall constructed to mitigate erosion adjacent to a pond.

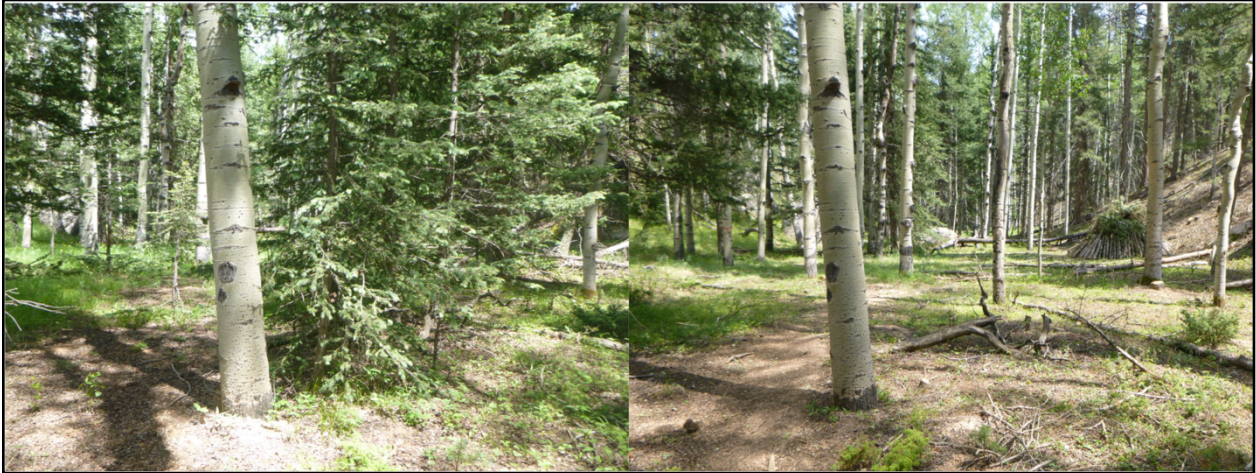
Figure 28. Before (left) and after (right) of TSI work at Ensign Gulch.

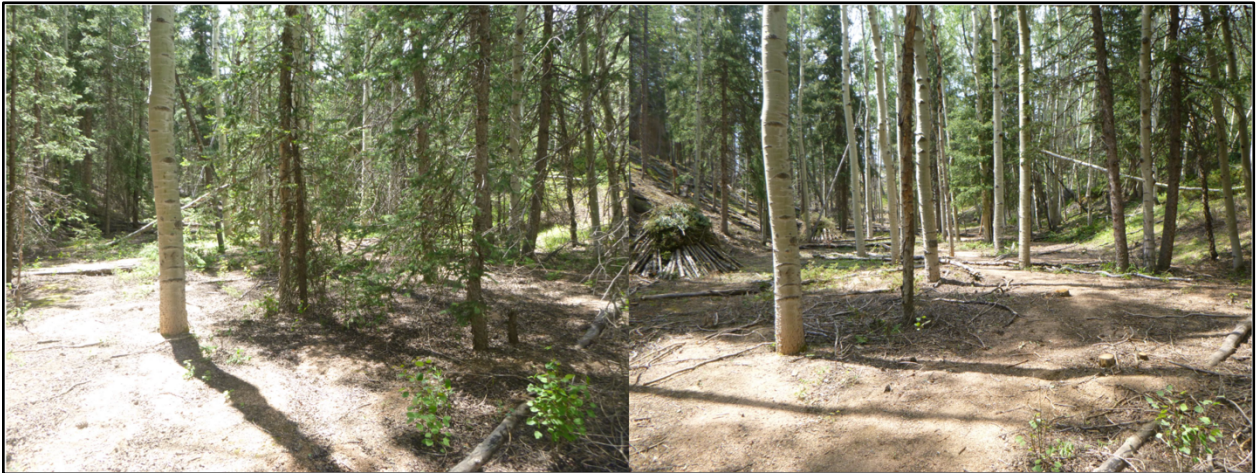
Figure 29. Before (left) and after (right) of TSI work and burn pile at Ensign Gulch.

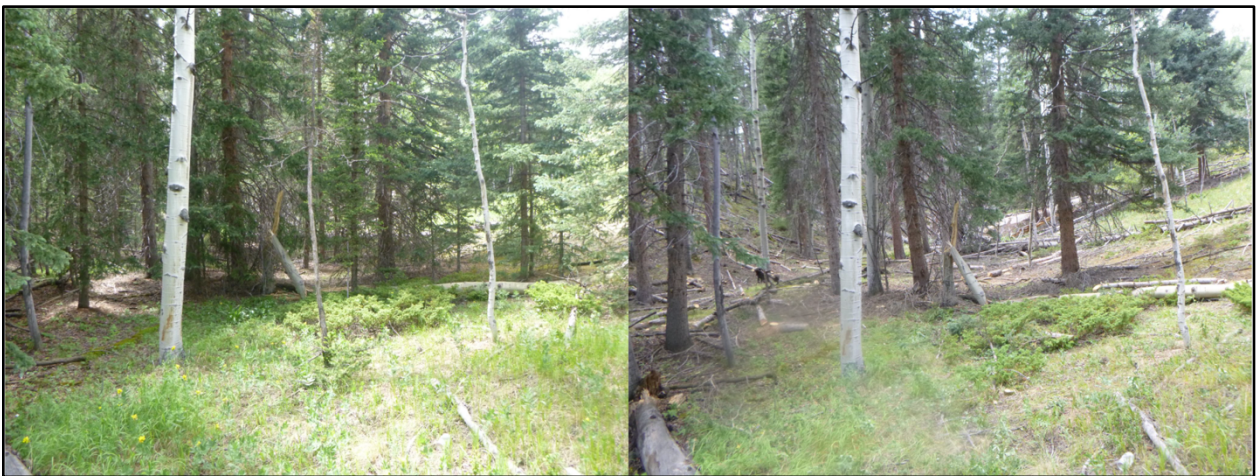
Figure 30. Before (left) and after (right) of TSI work at Ensign Gulch.

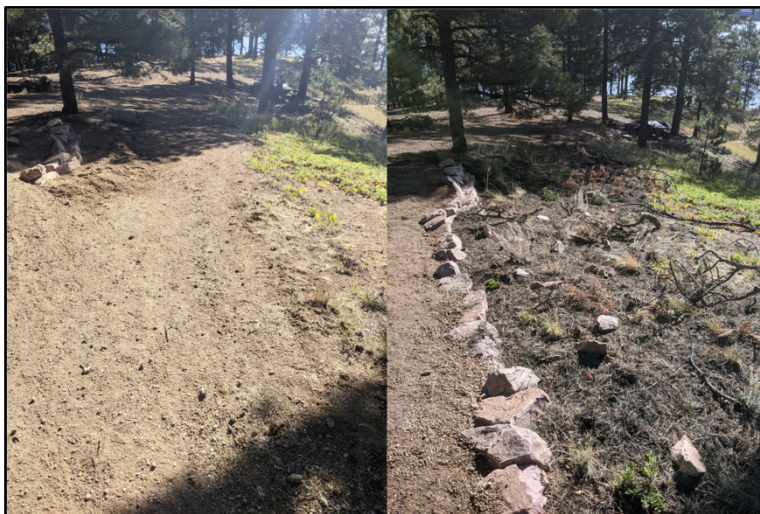
Figure 31. Before (left) and after (right) of barrier wall construction and restoration.

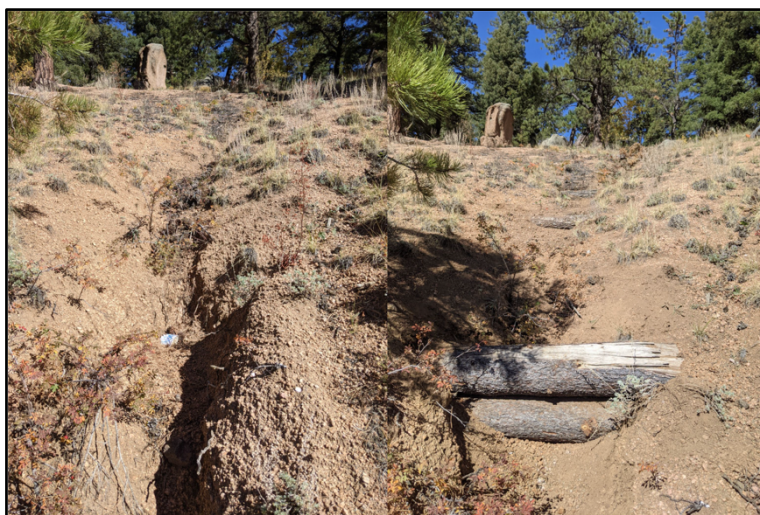
Figure 32. Before (left) and after (right) of check dam installation. An example of a 2-tiered check dam center right.

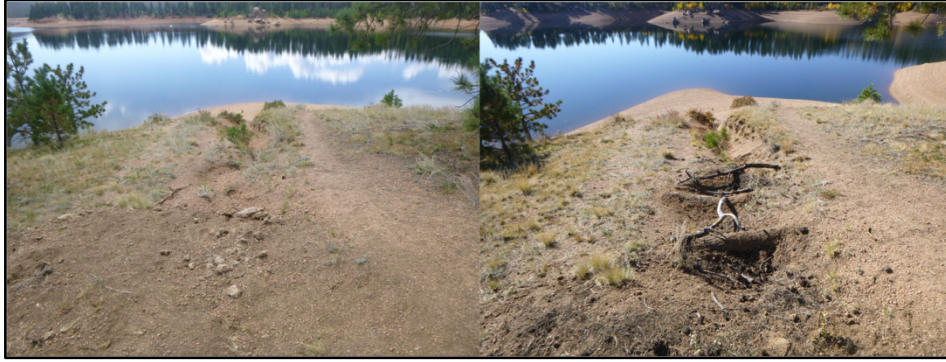
Figure 33. Before (left) and after (right) of check dam installation in a gully flowing towards the reservoir.

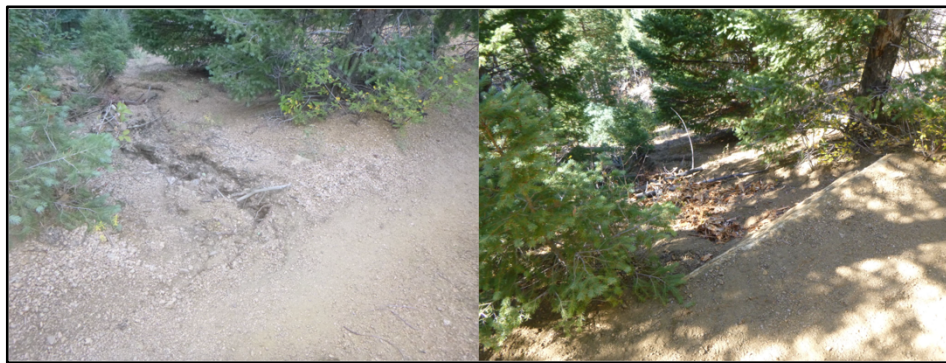
Figure 34. Before (left) and after (right) of timber retaining wall construction.

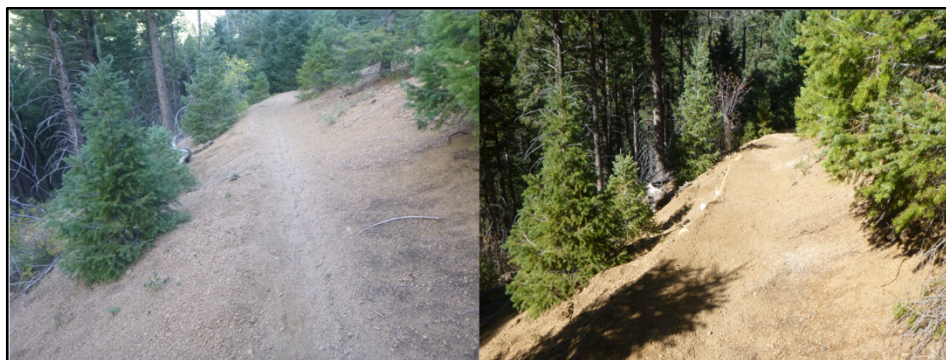
Figure 35. Before (left) and after (right) of trail improvement and timber retaining wall.
