Calwood Fire Recovery Grant – Final Report

Colorado Department of Natural Resources

Colorado Water Conservation Board

October 1, 2021

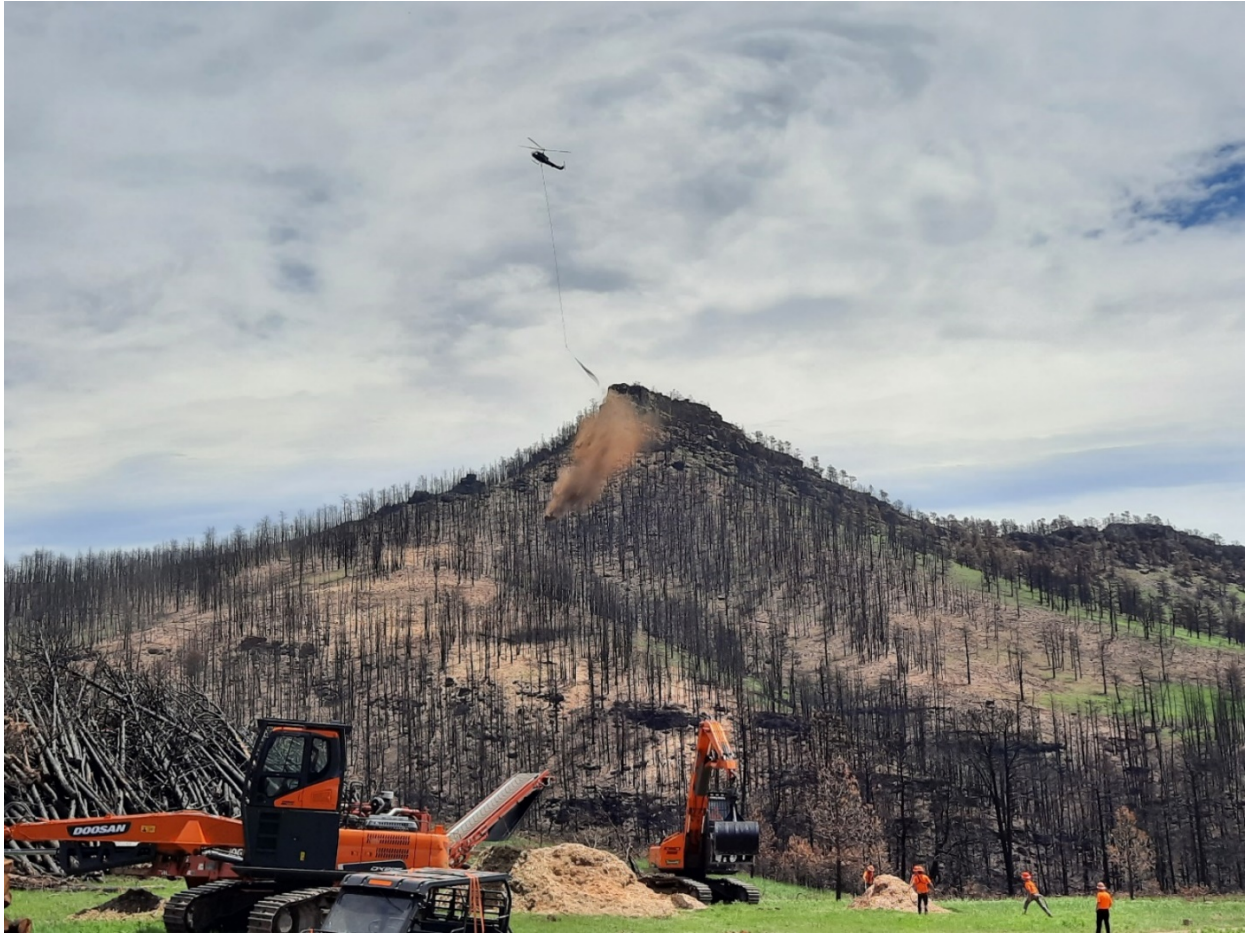
Aerial mulch drop in Unit 22, as seen from Landing 4, at Heil Valley Ranch Open Space, Boulder County, Colorado.

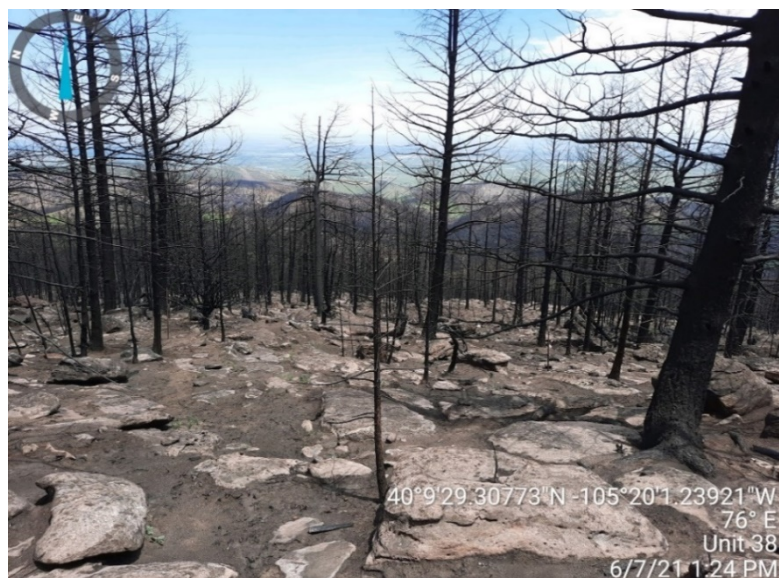
Figure 2. An example of a high priority unit in the Geer Creek watershed. Unit 38 with very little vegetative recovery in early June, was situated above NRCS treated private parcels.

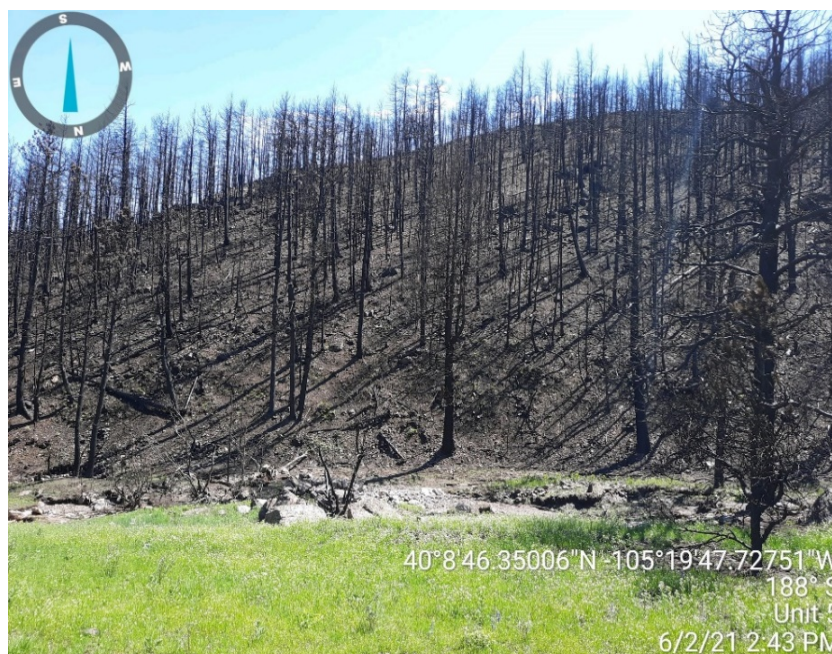
Figure 3. Looking across meadow in Unit 5 to Unit 33c showing completely bare soils above Geer Creek in early June.

Geer Creek. From anecdotal evidence, it appeared that the north slopes that comprised Unit 33 were recovering much more slowly than south facing slopes and were contributing more sediment directly into the creek than the more remote upper units that had longer flow paths to the waterway. This was likely due to the thick stands of timber on the north slopes, the accompanying deep litter layer that burned extremely hot, and the lack of pre-fire understory vegetation. To that end we identified some small areas directly along Geer Creek, within the suitable slope range for mulching (Units 33a, b, and c – Fig. 3).

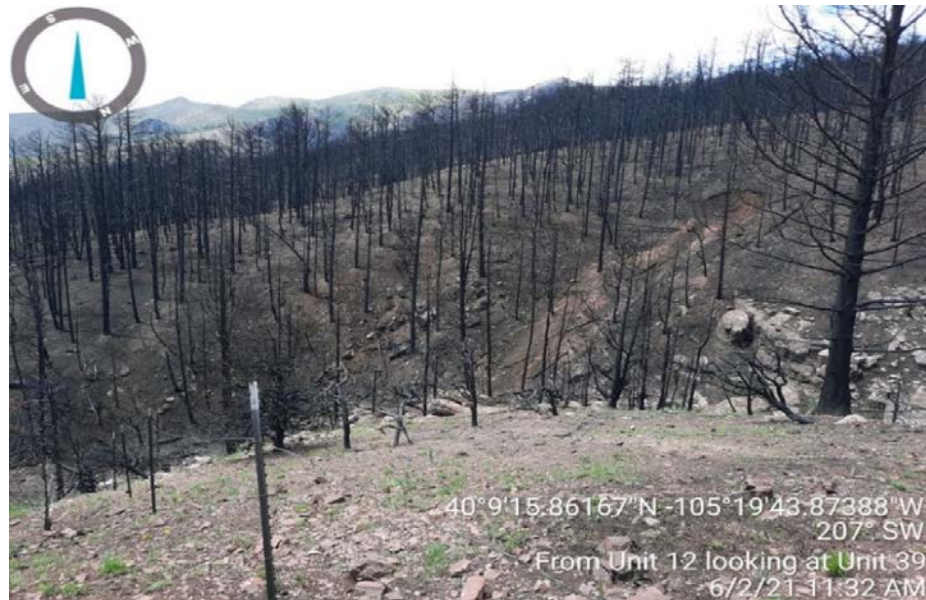
Figure 4. View of what became Unit 39 on far hillslope. Mulching this small unit (17.9 acres) addressed a severely burned, north facing hillslope, above a drainage, with little regeneration, that was adjacent to treated areas on three sides.

We also added a severely burned north slope within Unit 39 (Fig. 4), that abutted previously mulched areas on three sides, as well as two small areas (Units 40 and 7c) (Fig. 11) that were adjacent to larger NRCS funded units and helped to extend the mulch coverage to the top of a ridgeline, assuring the full slope was protected. These three units, totaling 37.4 acres, were the only units not within the top 5 priority sub-basins of each watershed. Final acreage for each unit is included in Table 1.

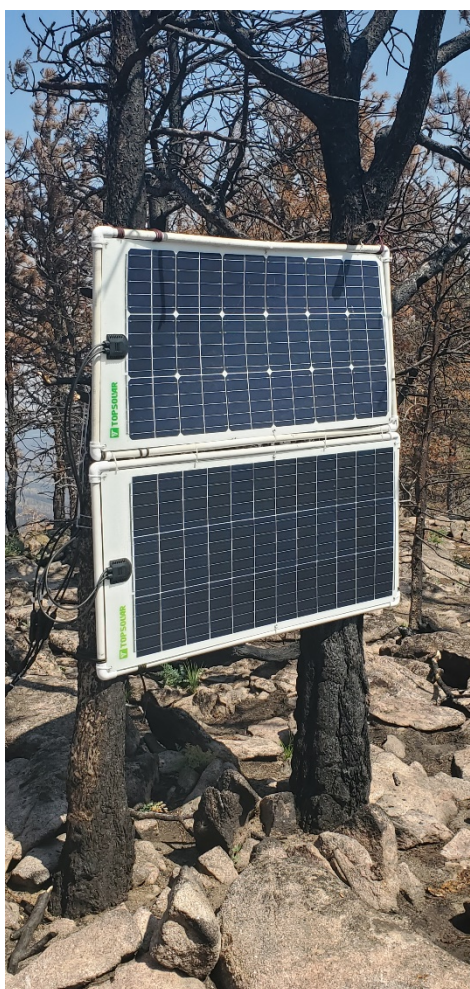
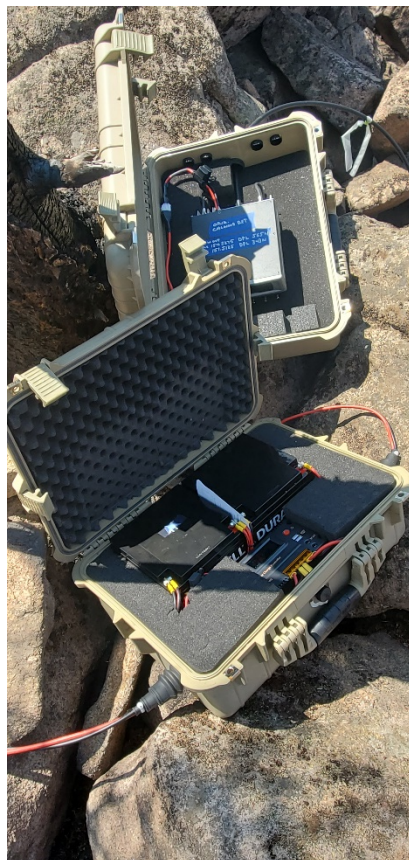
Figures 5a,b. Radio repeater equipment (upper right) and solar panels atop Fairview Peak.

For an operation this size and scope, effective communication is a necessity. The rugged terrain of the fire area made communications across much of the project site impossible. Furthermore, the contractor found that the dedicated radio frequencies they use out of state did not guarantee a dedicated channel along the Front Range of Colorado. Frequent use by other parties on the same frequency led the contractor to change channels multiple times in the early stages of the project, which made communication even more difficult. Thankfully, the Boulder County Sheriff's Office (BCSO) Communication Division, working with a local radio representative, and with permission from the USFS, was able to install a radio repeater atop Fairview Peak that allowed for communications across the project site, and across the two watersheds (Figs. 5a,b). Additionally, the BCSO donated 20 radios to BCPOS, programmed with the repeated channel, two dedicated channels, an internal Boulder County channel, and dispatch for emergency situations. The radios were used by staff and checked out to contractors and sub-contractors working on site, and despite some ongoing 'traffic' on the dedicated channels, allowed for

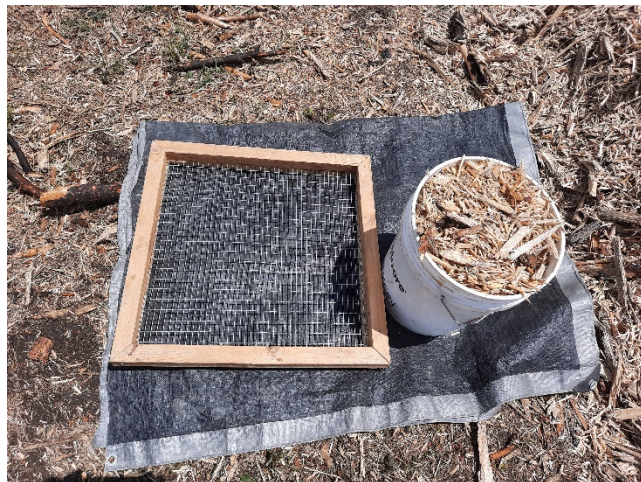
Figure 6. Screen for wood shred mulch quality control.

Much has been written about the size and quality of wood mulch. Ideal mulch can be described as long, linear, and angular. Typical specifications call for no more than 30% fines, and the remaining material to be from 2-8" in length. BCPOS staff used a ½" x 1" wire mesh screen to sift sample buckets of mulch (Roubichaud, P. 2013c) (Fig. 6). Fines that passed through the screen were caught on a tarp and then placed back into the bucket to measure against a line denoting 30% of the bucket's volume. The initial

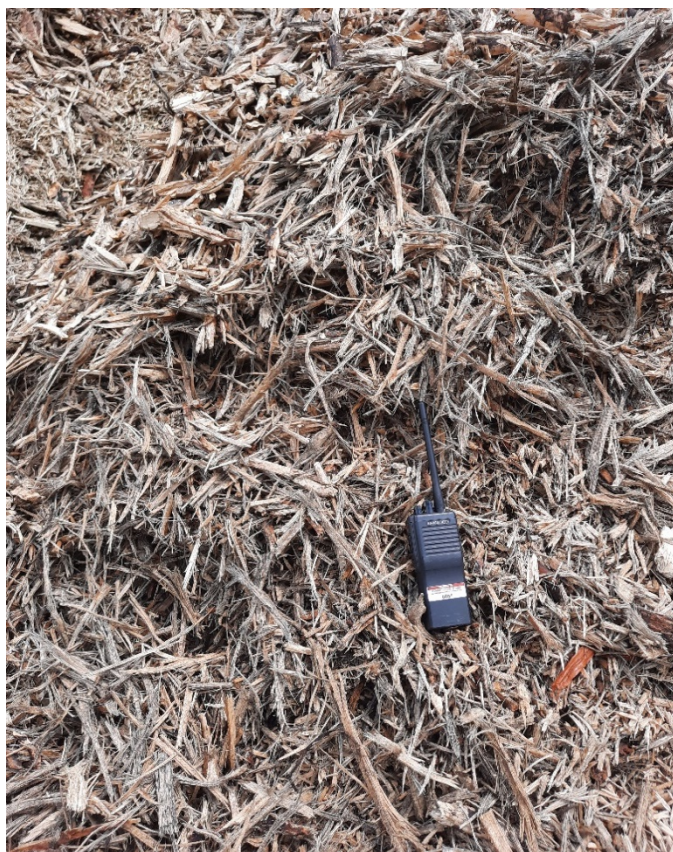
Figure 7. Quality and size of wood shred at Landing 3.

grinder on site produced wood shreds that easily met the specification, with some of the batches measured with as little as 12-20% fines. That grinder, a Morbark Woodhog 3400XT, had two mechanical failures, which led to nearly two weeks of down time for grinding operations. The second mechanical failure was severe enough that the contractor had to source a new grinder. The second grinder, a Bandit 3680XP, initially appeared to produce mulch that was finer than the Morbark grinder. Fine mulch is much more susceptible to washing downslope in storm events.

company representatives from Michigan, spent two days on site, removing screens, adjusting speeds, and replacing cutter teeth with shredding 'cats-claw' teeth in order to produce the highest quality material (Fig.7). In the end, rather than a 5" and 4" screen we used a single 4" screen. Despite these modifications, many samples of mulch were just at or under the 30% fines ratio. It appeared that the trees themselves had more impact on the finished size of the material than did adjustments to the grinder.

Drier trees, as well as larger trees, that fed more slowly through the grinder, produced more fines. Wetter trees and smaller diameter trees that fed through quickly, produced larger and stringier shreds. The contractor was also encouraged to feed trees singly or staggered into the grinder, rather than 3-4 small trees at once, which tended to mimic a larger tree and hence feed more slowly. Small adjustments such as these helped produce better material.

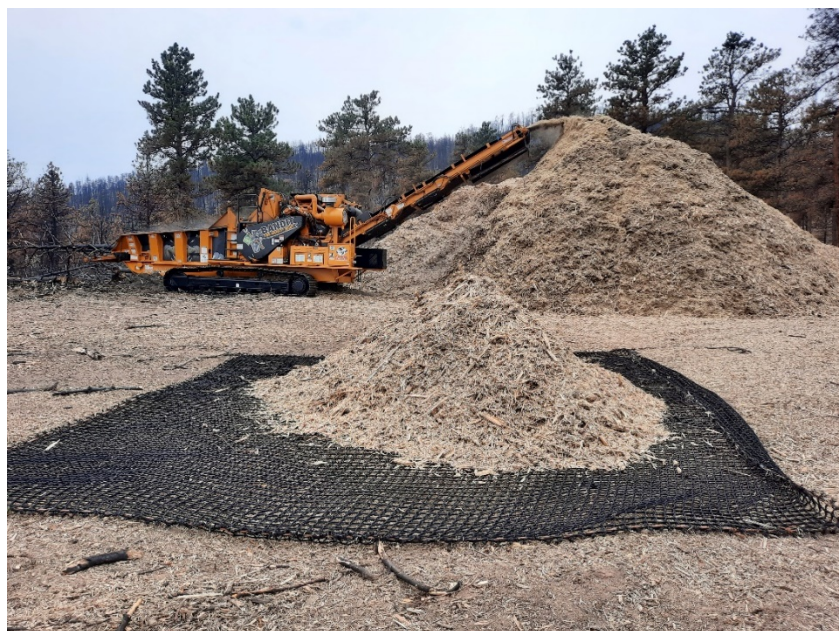
Figure 8. Net of mulch ready for aerial application. Landing 4, Cal-Wood Education Center.

Central Gulch/South St. Vrain watershed. Harvesting and processing trees on-site, as this operation did, was the only feasible solution to treat the units from Landing 4, as transporting material in from off-site would not be possible due to the remote location and difficult access (Fig. 8).

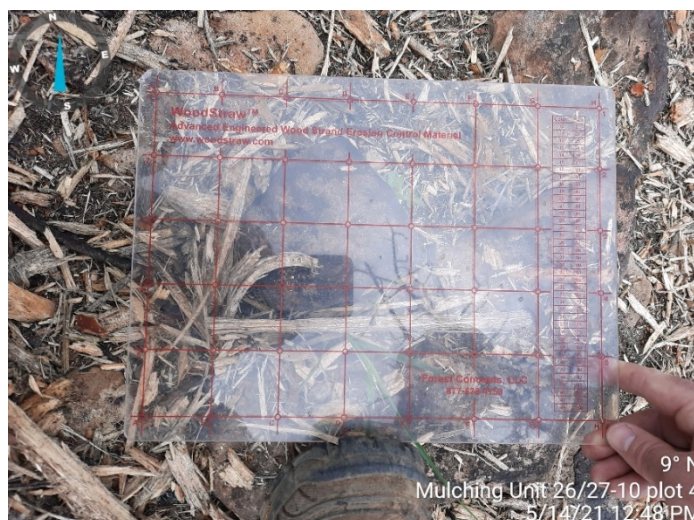
Figure 9. Mulch coverage monitoring grid (Forest Concepts LLC, Auburn, WA).

assurance to verify that the mulch was applied to contract specifications. These specifications called for an average of 70% coverage across each unit. Staff utilized randomly generated points within each treatment unit as a transect start point. From that point, a direction, either left or right across slope, was randomly chosen, and a cover plot utilized every ten paces, for a total of ten plots per transect. Plot data was collected utilizing a Wood Straw cover grid (Forest Concepts LLC, Auburn, WA) (Fig. 9). In addition to the wood shreds, live vegetation, and rock larger than 1.5" was included as cover. In all, 29

transects were completed, comprising 290 data plots. Average cover for each individual unit is shown in Table 3 below. Individual monitoring spreadsheets, including plot data and transect photos for each unit are included in Appendix A.

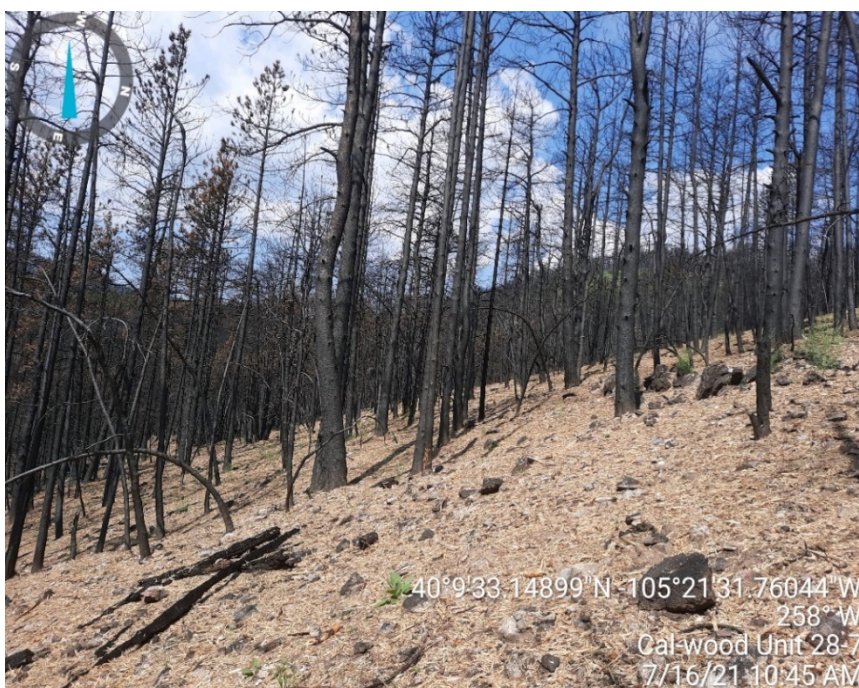
Figure 10. Good, consistent mulch coverage within Unit 28, Central Gulch watershed.

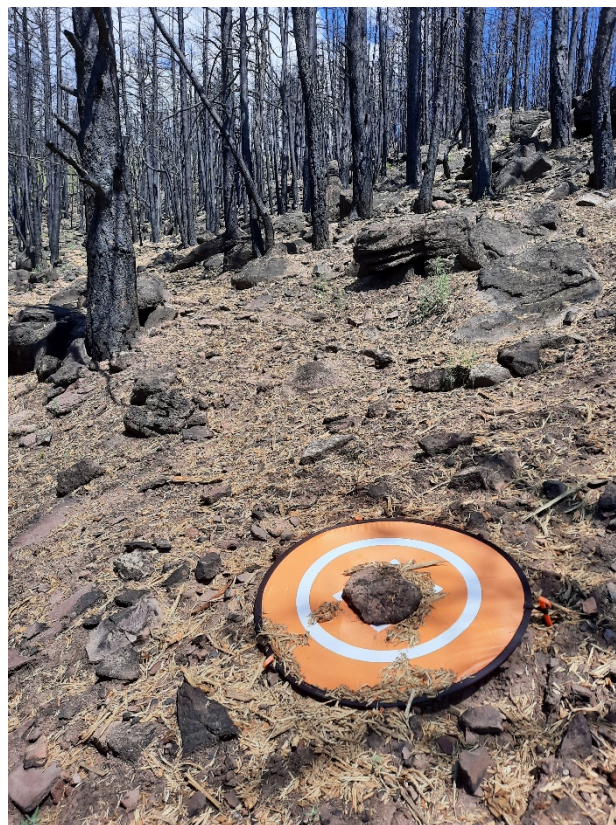
Figure 11. Visible target for pilot to spot areas for touch up mulch drops.

Points dropped on Avenza Maps and shared with the contractor, or hard copy drawn maps, helped pinpoint areas where mulch coverage may have been inadequate. Staff also utilized orange targets, highly visible to the pilots to highlight areas on the ground for additional mulch drops (Figure 11).

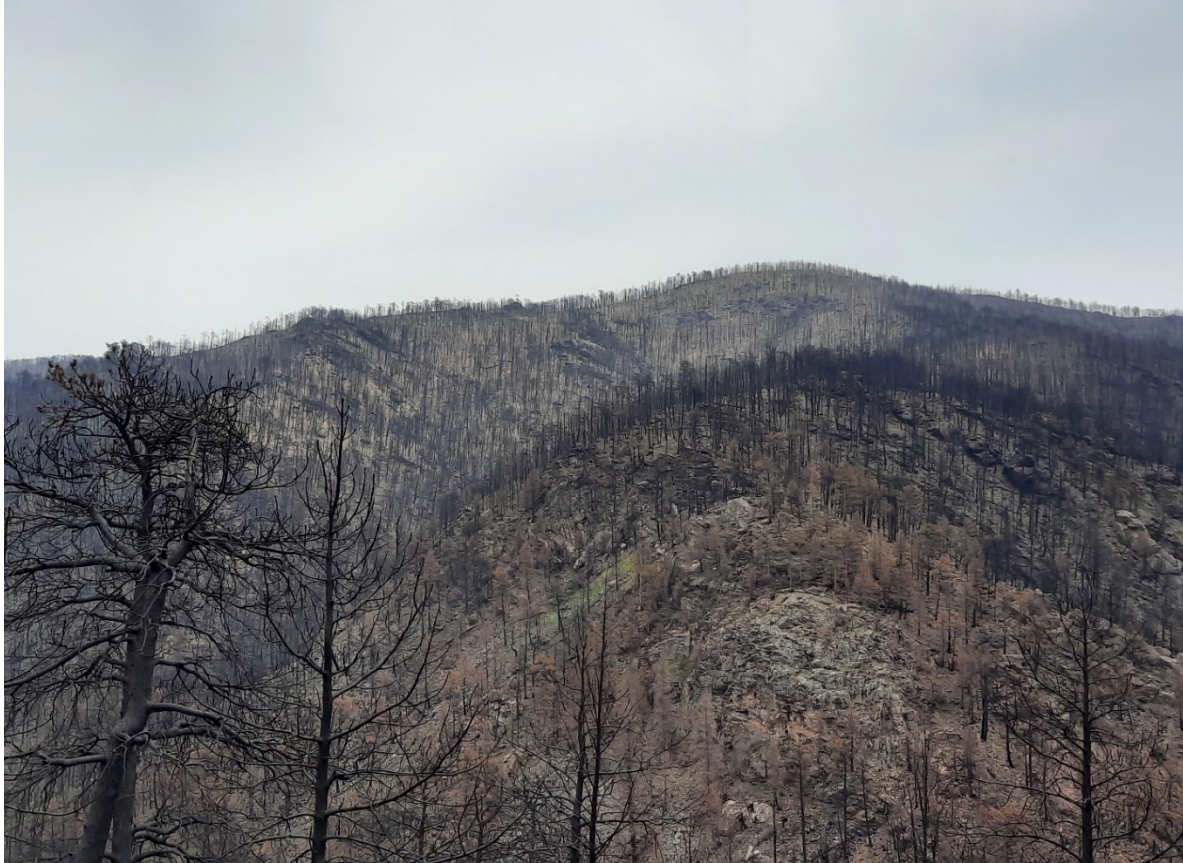
Figure 13. Distant view of mulch application within Unit 29 in Central Gulch watershed. Basin includes slopes below high point on ridge and behind knoll in foreground.

unit data (i.e. Unit 2 for Unit 40) (Fig. 12). Unit 29 was the most remote unit within the project area (both NRCS and CWCB funded), and very difficult to physically reach (Fig. 13). Mulch was applied at five tons/acre within this unit, which on average, in our experience on site, was the amount of mulch required to get us to our 70% cover.

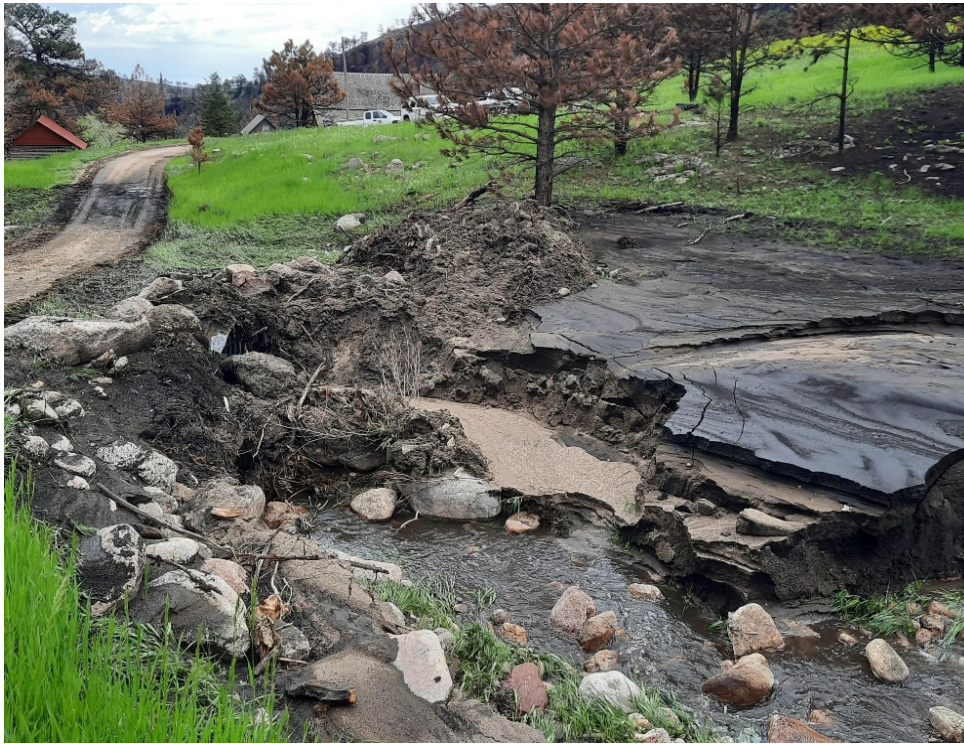
Figure 14. Clogged culvert and sediment deposition following May 30 rain event on Heil Valley Ranch.

A severe storm occurred on May 30, prior to much mulch being applied. This led to plugged culverts along Geer Canyon Drive that overtopped the road in multiple locations, and black water in both Lefthand and Saint Vrain Creeks (Figs. 14,15,16). Additional high intensity storms occurred on June 25 and July 31 (Fig. 17), with multiple other rain events in between, though none saw the impacts to culverts

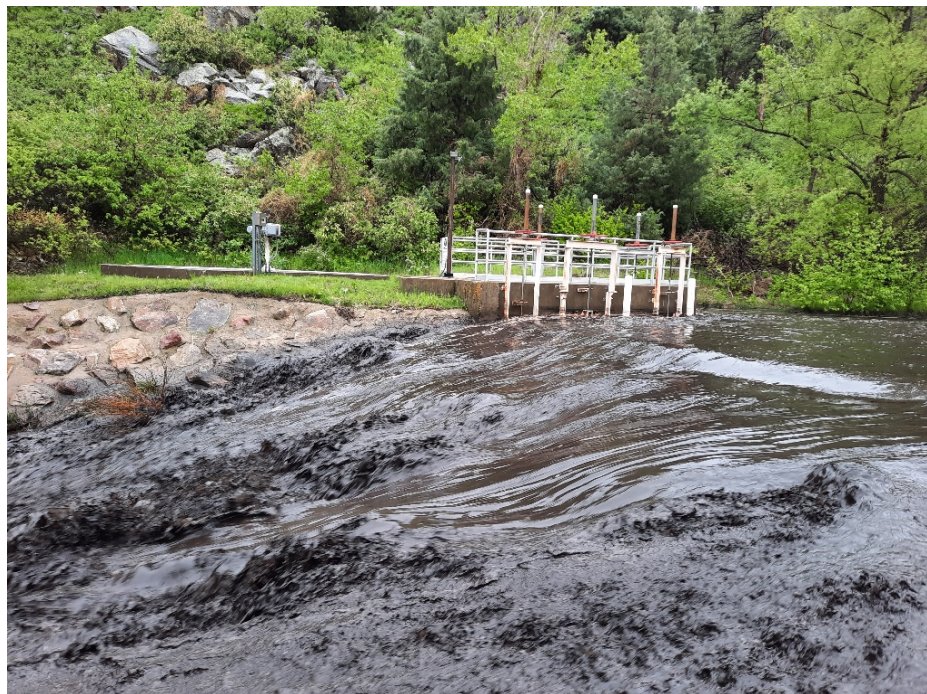
Figure 15. Ash laden flows from May 30 rain event at the Lefthand Water District intake on Lefthand Creek.

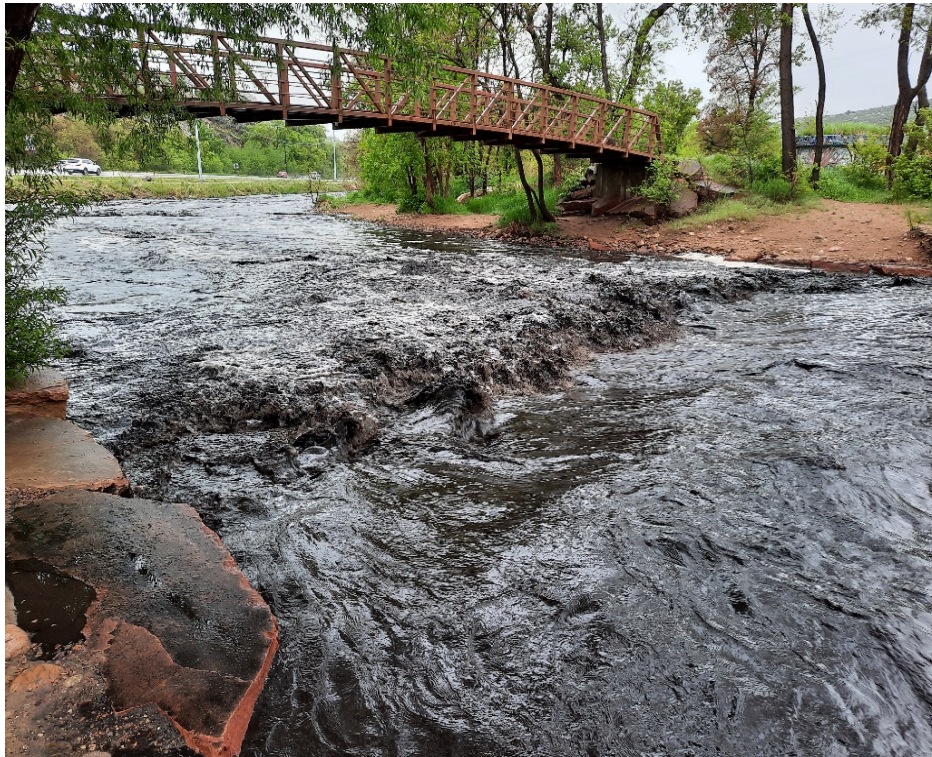
Figure 16. Ash laden flows in the mainstem St. Vrain Creek in Lyons, Colorado during the May 30 rain event.

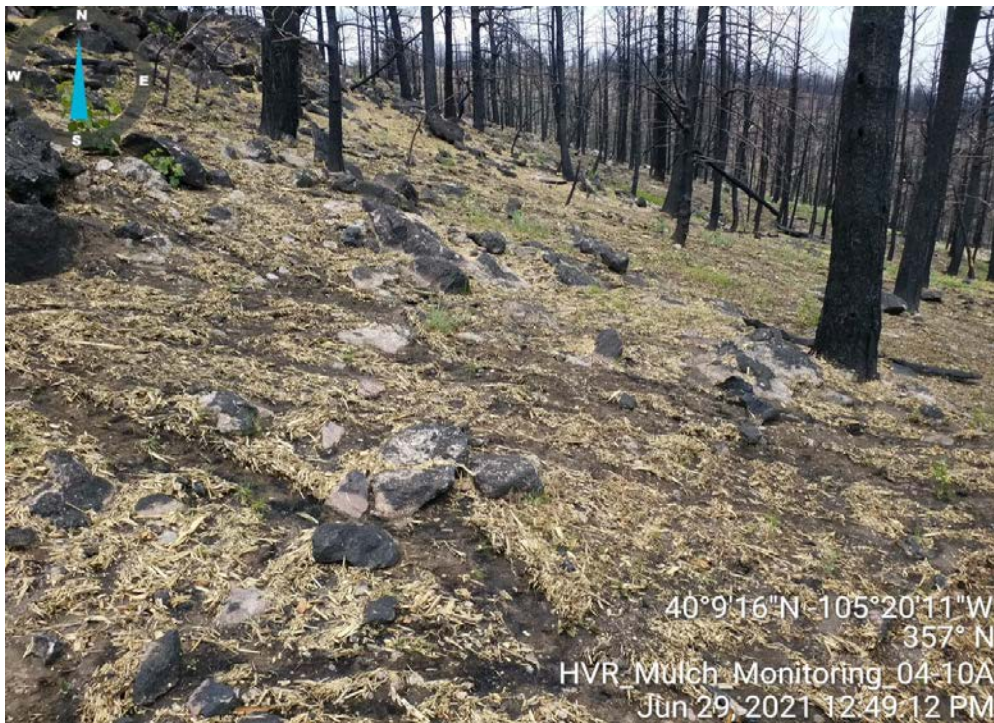
Figure 18. Evidence of minor mulch displacement after June 25 rain event on Unit 5 within Heil Valley Ranch. Not a CWCB funded USFS unit.

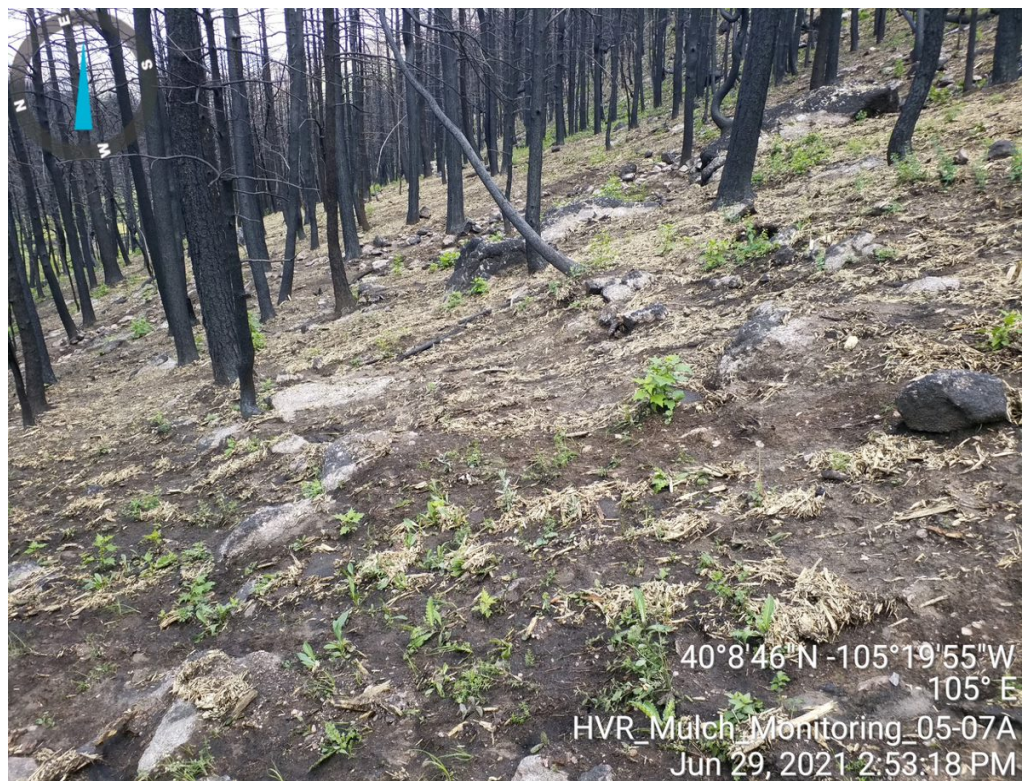
Figure 19. Evidence of more extreme mulch displacement on steeper slopes of Unit 5 on Heil Valley Ranch. Not a CWCB funded unit.

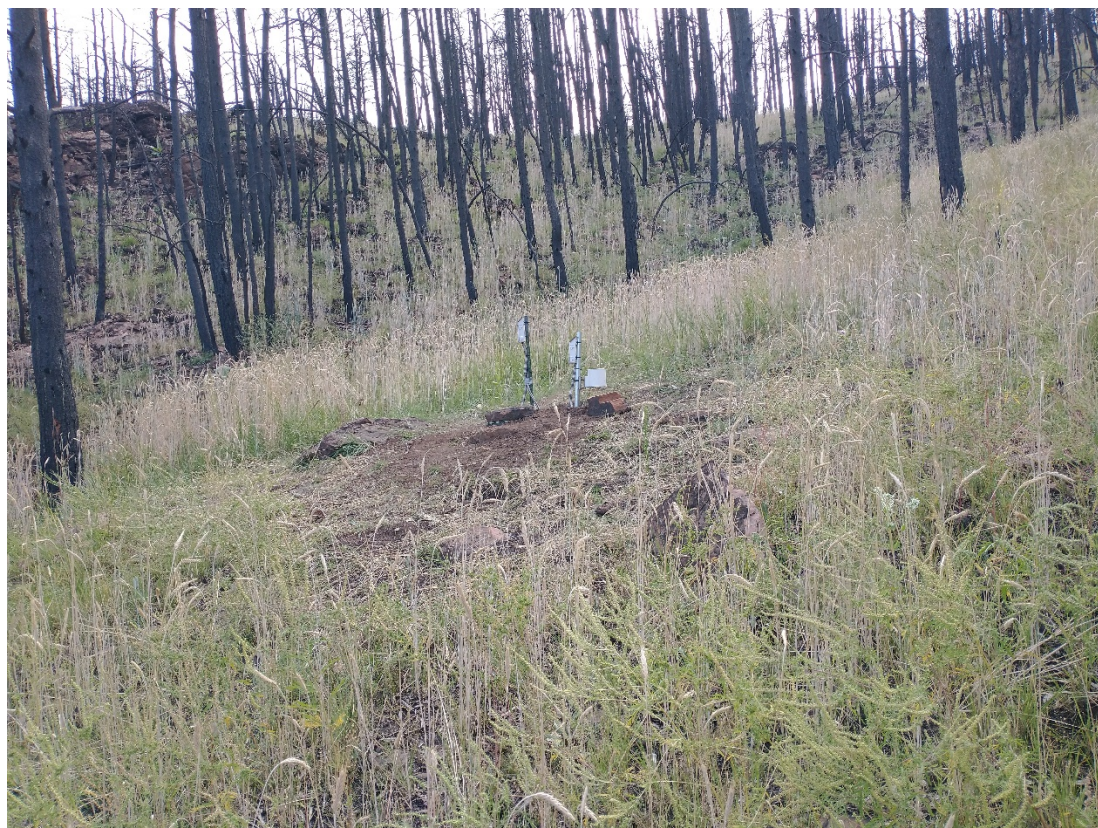
Figure 22. Installed data logger and rain gauge in mulching Unit 23, at Heil Valley Ranch.

Tensiometers and volumetric water content sensors were installed at three depths (30, 50, and 80cm) (Figs. 21,22) and along with an associated rain gauge will report data to off-site computers. Data is available through the Zentra Cloud web interface, and via an app that is accessible from a phone in the field. The additional sensor units will provide further points of calibration for the hydrologic modeling that drives the larger overall warning system (Vflo) for Boulder County emergency operations. Ultimately this data will directly feed into the National Weather Service and the Boulder County Office of Disaster Management's (ODM) Advanced Warning system to provide 10 to 15 minutes of advanced warning to emergency responders and to the public in potential debris flow paths, to allow them to safely evacuate.

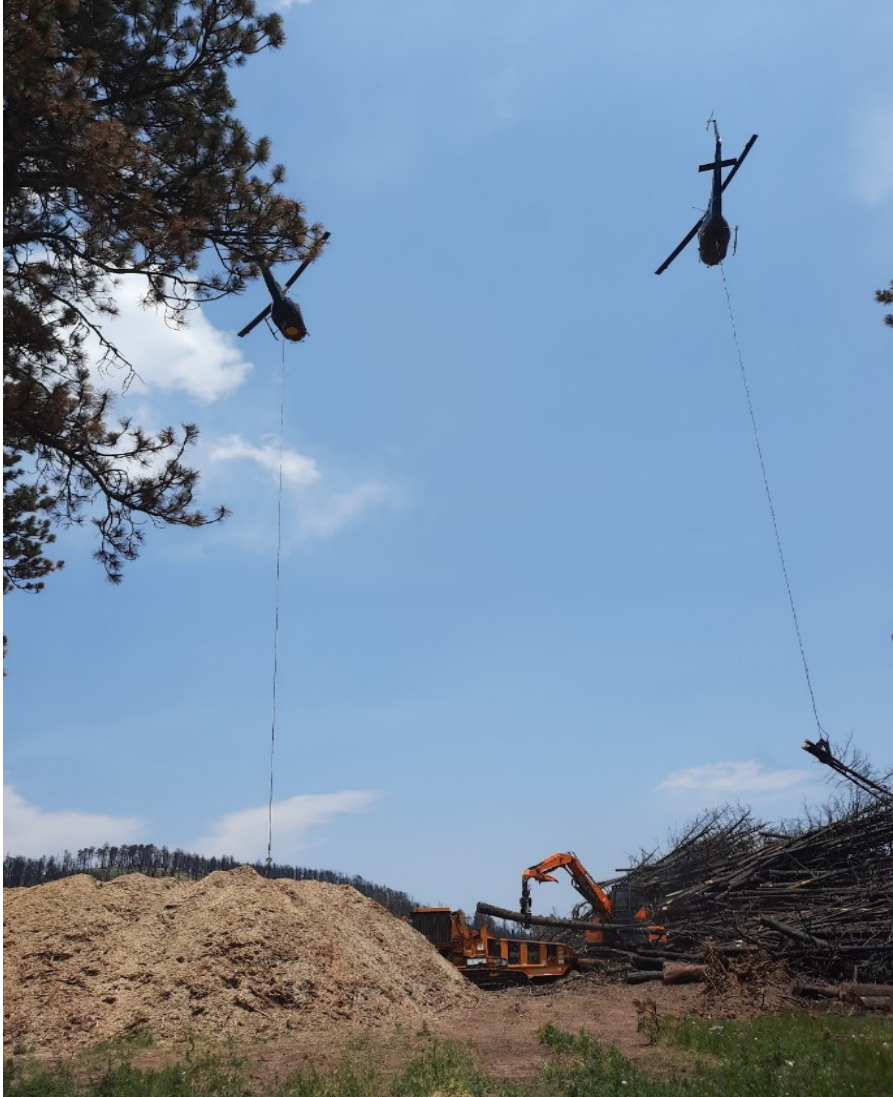
Dueling helicopters at Landing 4 on the Cal-Wood Education Center. When and where feasible, one helicopter would transport logs to a landing for processing while another simultaneously flew mulch onto hillslopes.

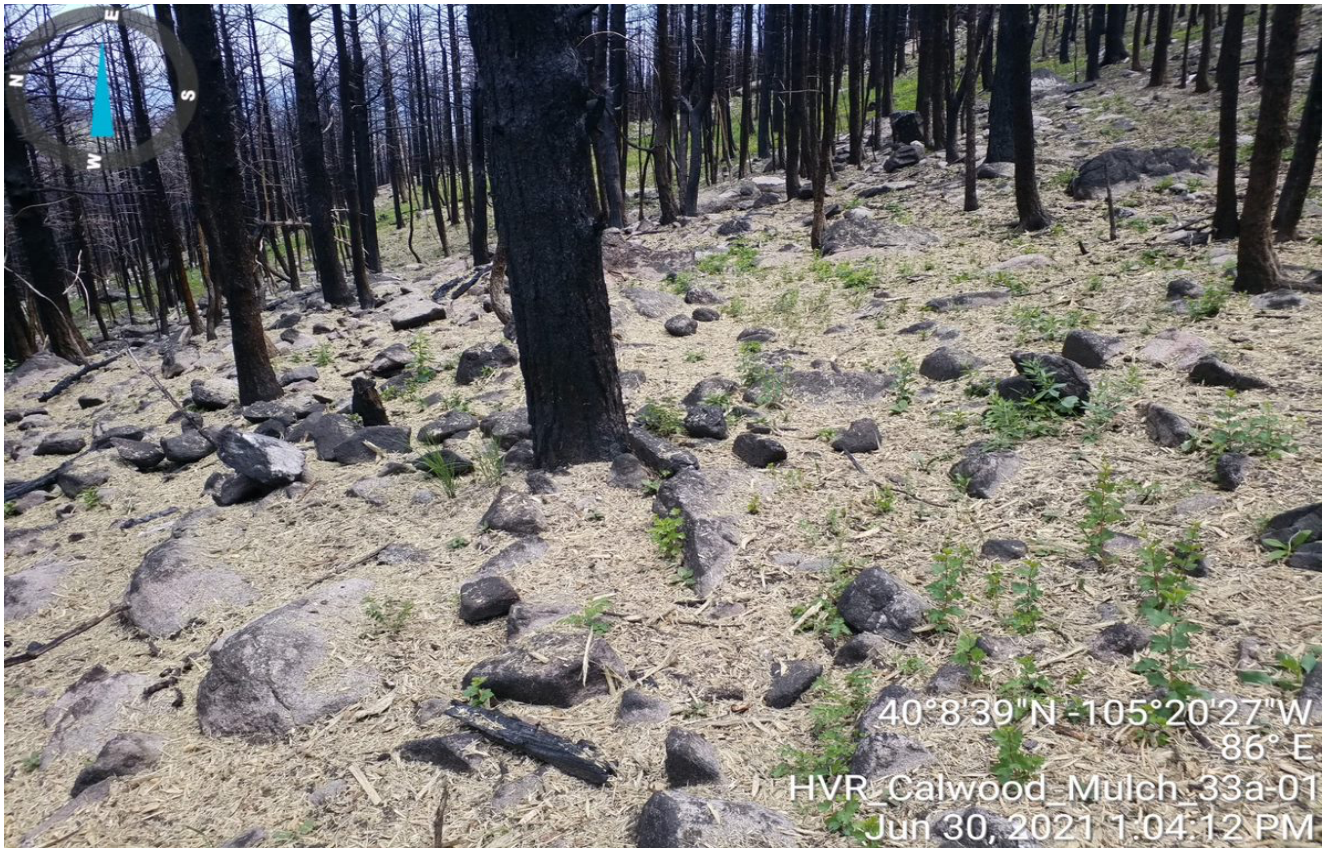
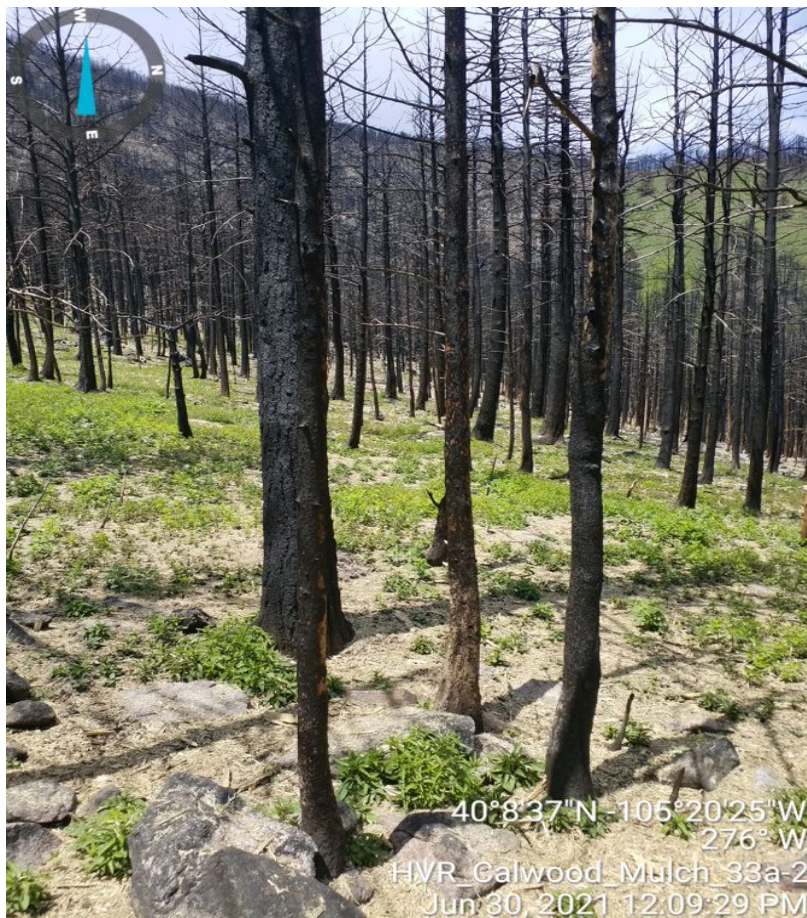
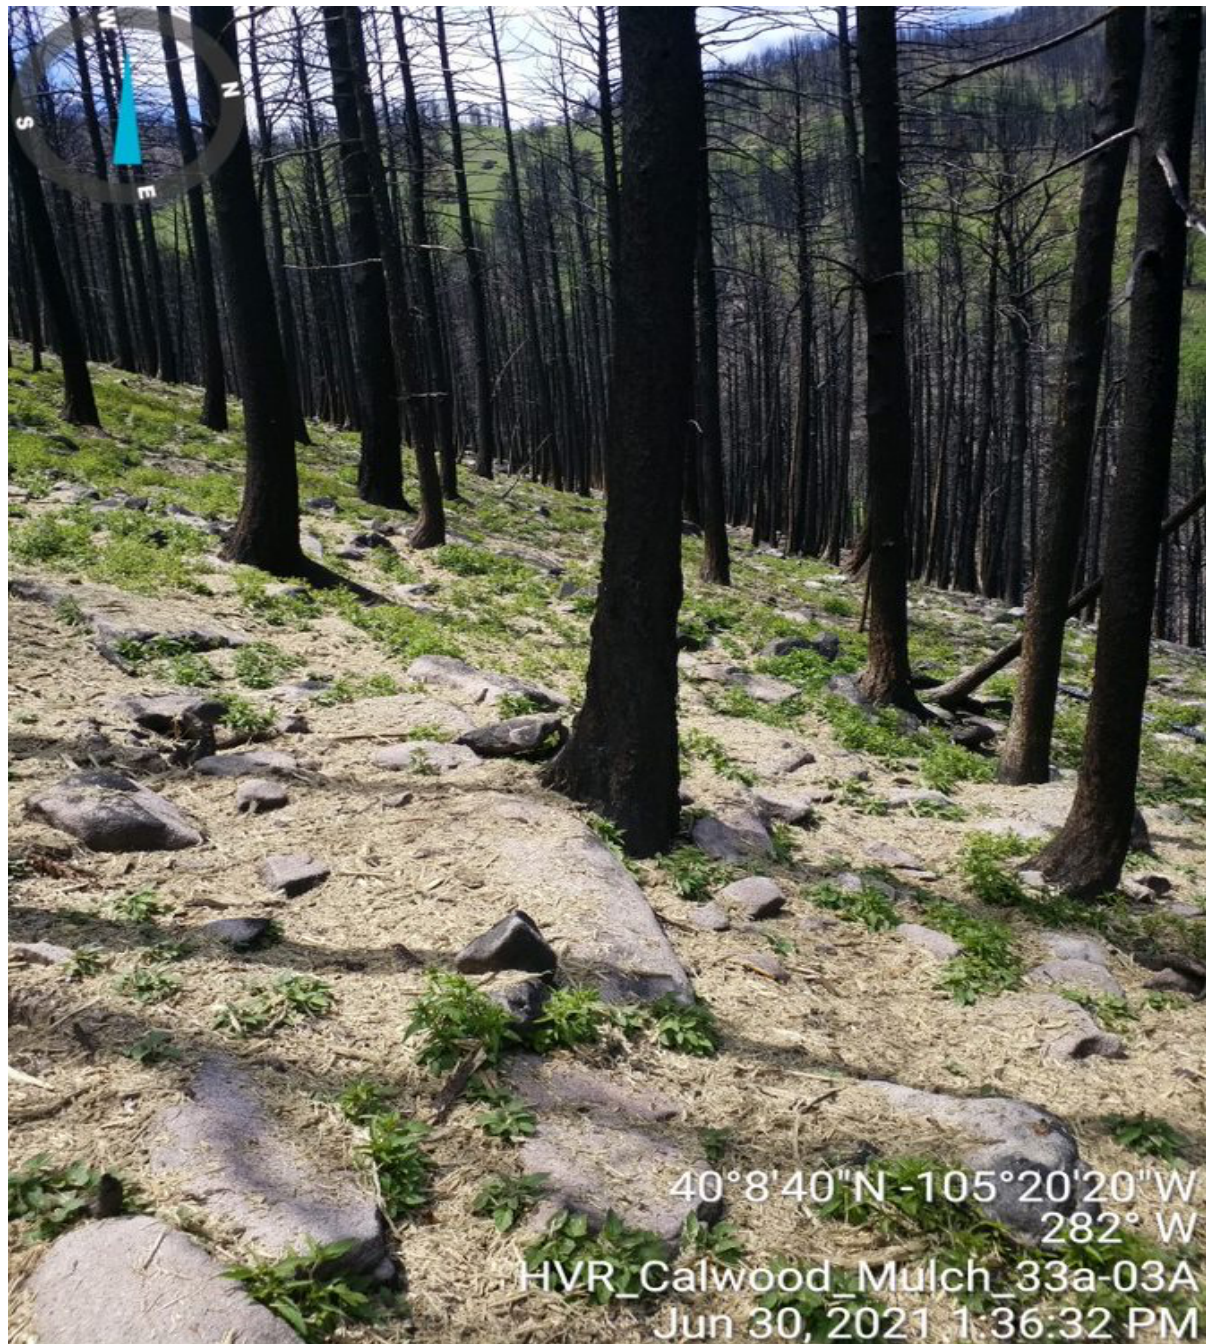
Unit 33a

Treatment Unit: 33A			Monitors: SH,SB								Date: 6/30/21	
Transect #	L or R	Plot 1	Plot 2	Plot 3	Plot 4	Plot 5	Plot 6	Plot 7	Plot 8	Plot 9	Plot 10	Average % Cover
1	L	83%	56%	33%	75%	88%	98%	85%	90%	67%	56%	73%
2	R	100%	98%	96%	100%	92%	65%	54%	81%	60%	44%	79%
3	R	100%	100%	54%	60%	48%	79%	79%	35%	52%	27%	63%
4												
5												
6												
7												
8												
9												
10												72%
Averages

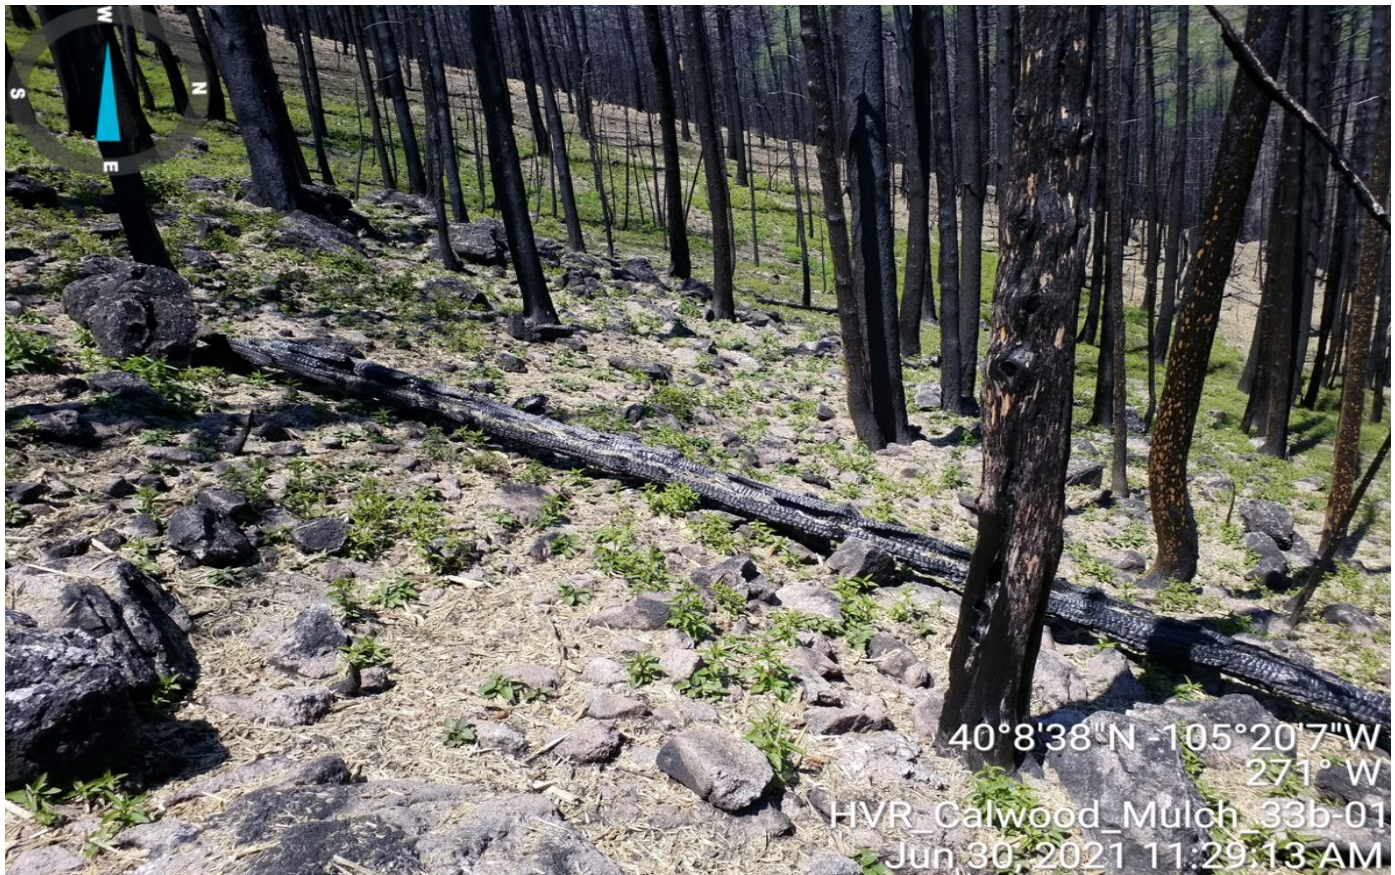
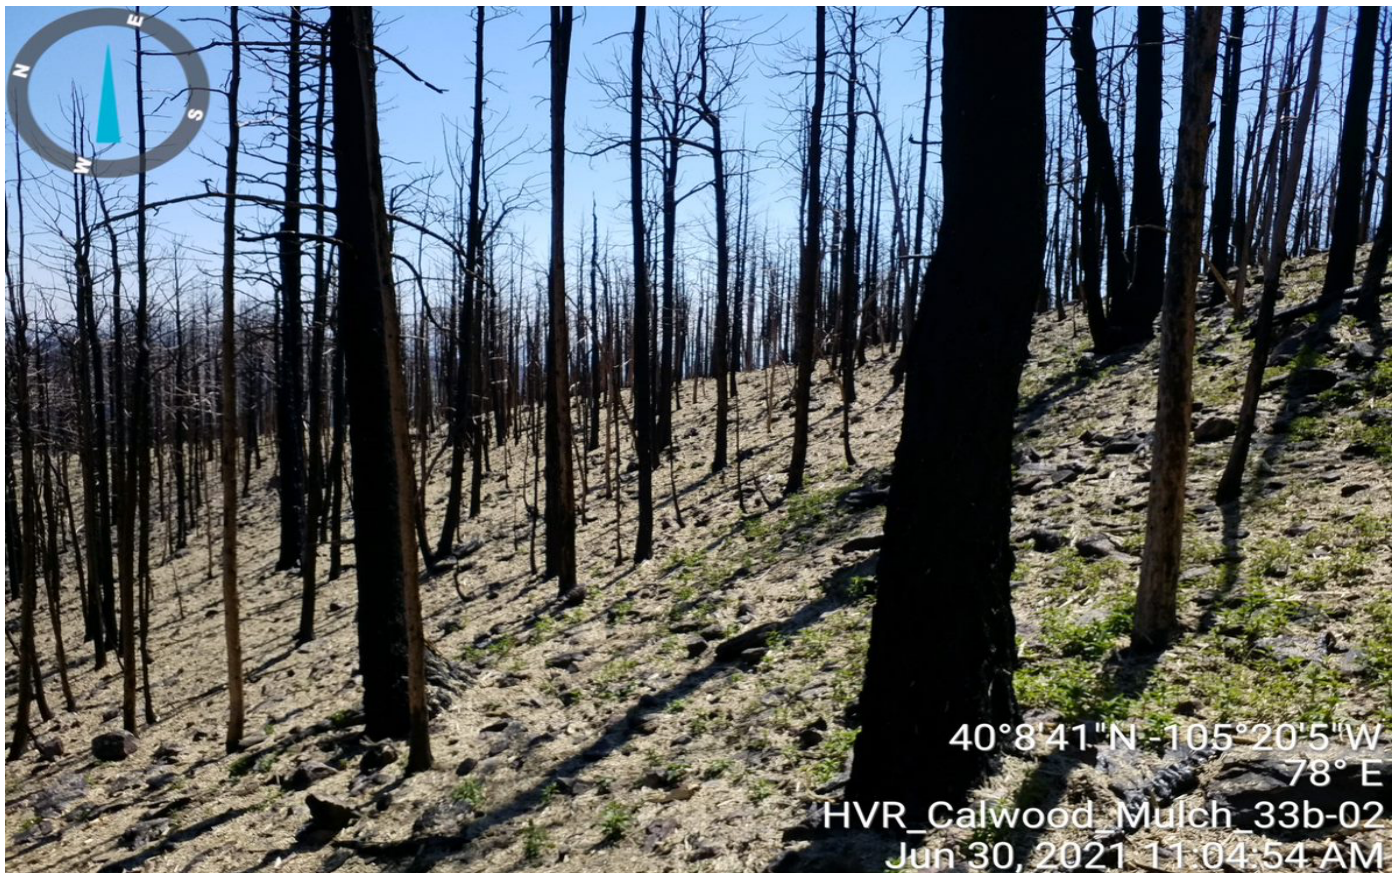
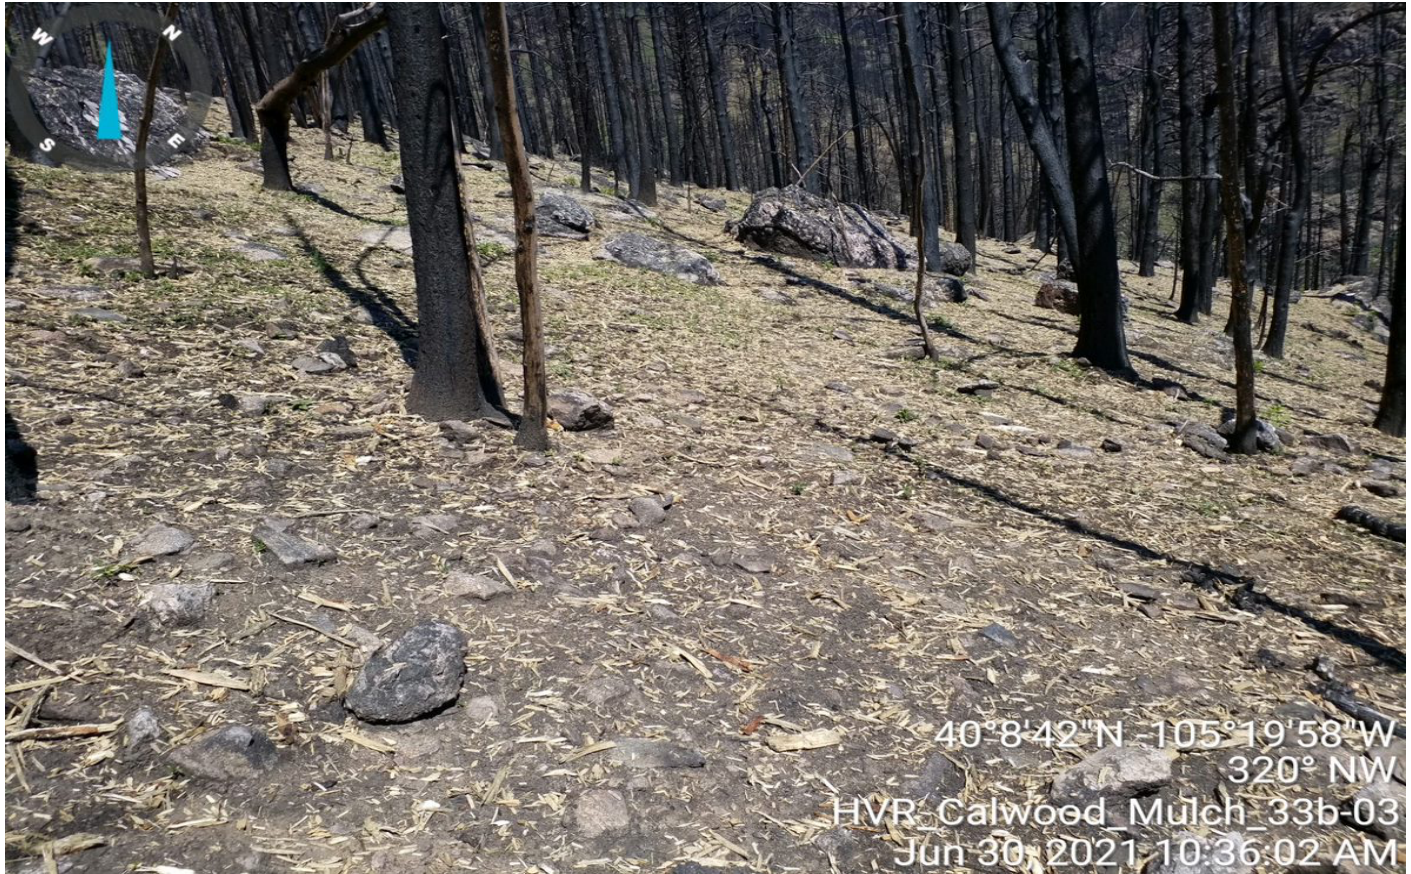
Unit 33b

Treatment Unit: 33B			Monitors: SB,SH								Date: 6/30/21	
Transect #	L or R	Plot 1	Plot 2	Plot 3	Plot 4	Plot 5	Plot 6	Plot 7	Plot 8	Plot 9	Plot 10	Average % Cover
1	R	85%	63%	23%	56%	81%	98%	21%	25%	69%	79%	60%
2	L	92%	96%	94%	94%	90%	79%	100%	96%	96%	98%	93%
3	R	54%	65%	65%	46%	58%	77%	54%	52%	71%	75%	62%
4												
5												
6												
7												
8												
9												
10												
Averages		77%	75%	61%	65%	76%	85%	58%	58%	79%	84%	72%

Notes: 33B-03 added 2 points at the end of the transect to replace points 8 & 9 (original plots: 03-08 = 27 & 03-09 = 12) which landed in bare spots not representative of the area.
