Calwood Fire Recovery Grant – Final Report

Colorado Department of Natural Resources

Colorado Water Conservation Board

October 1, 2021

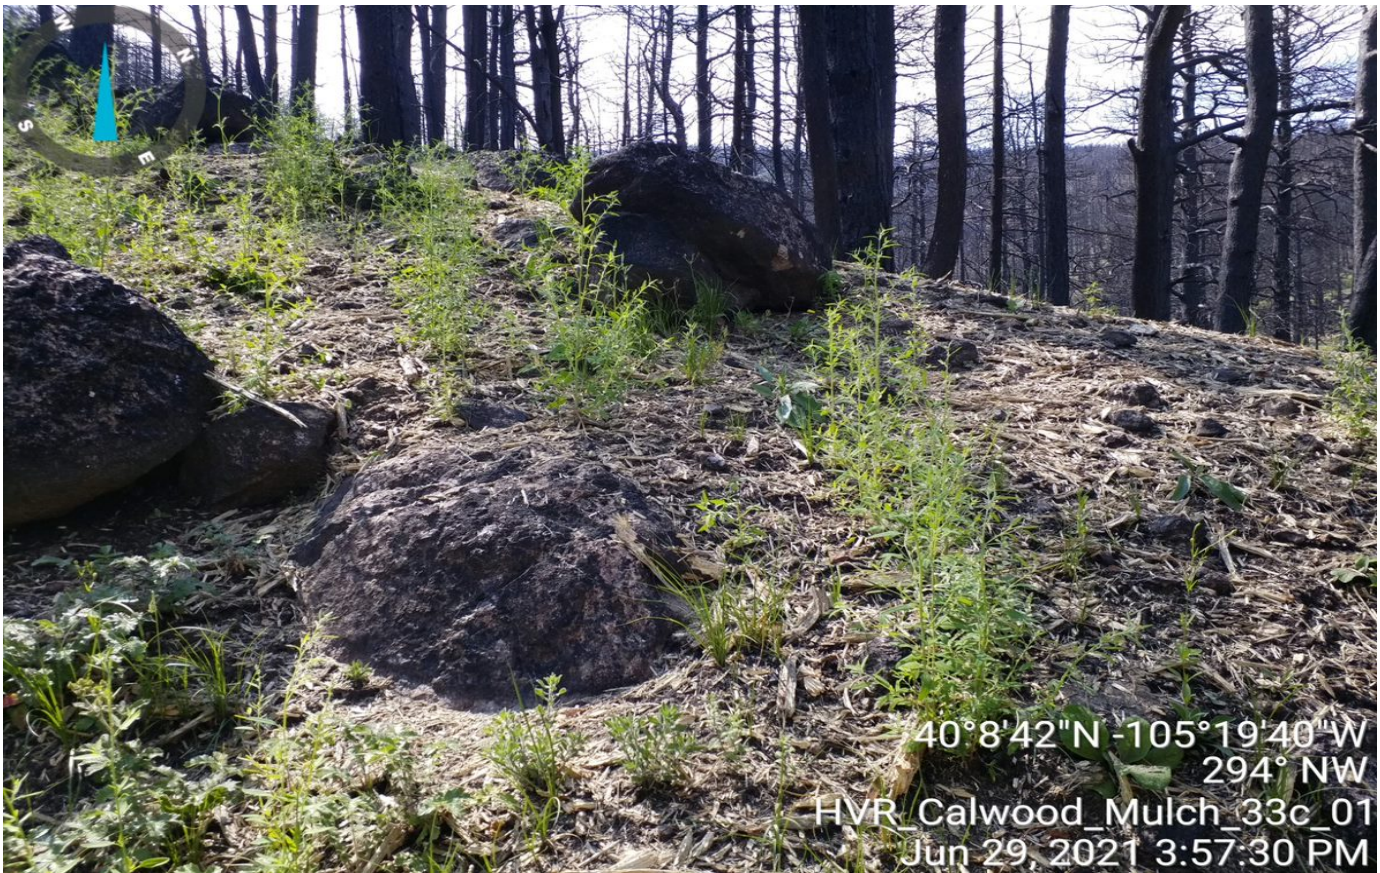
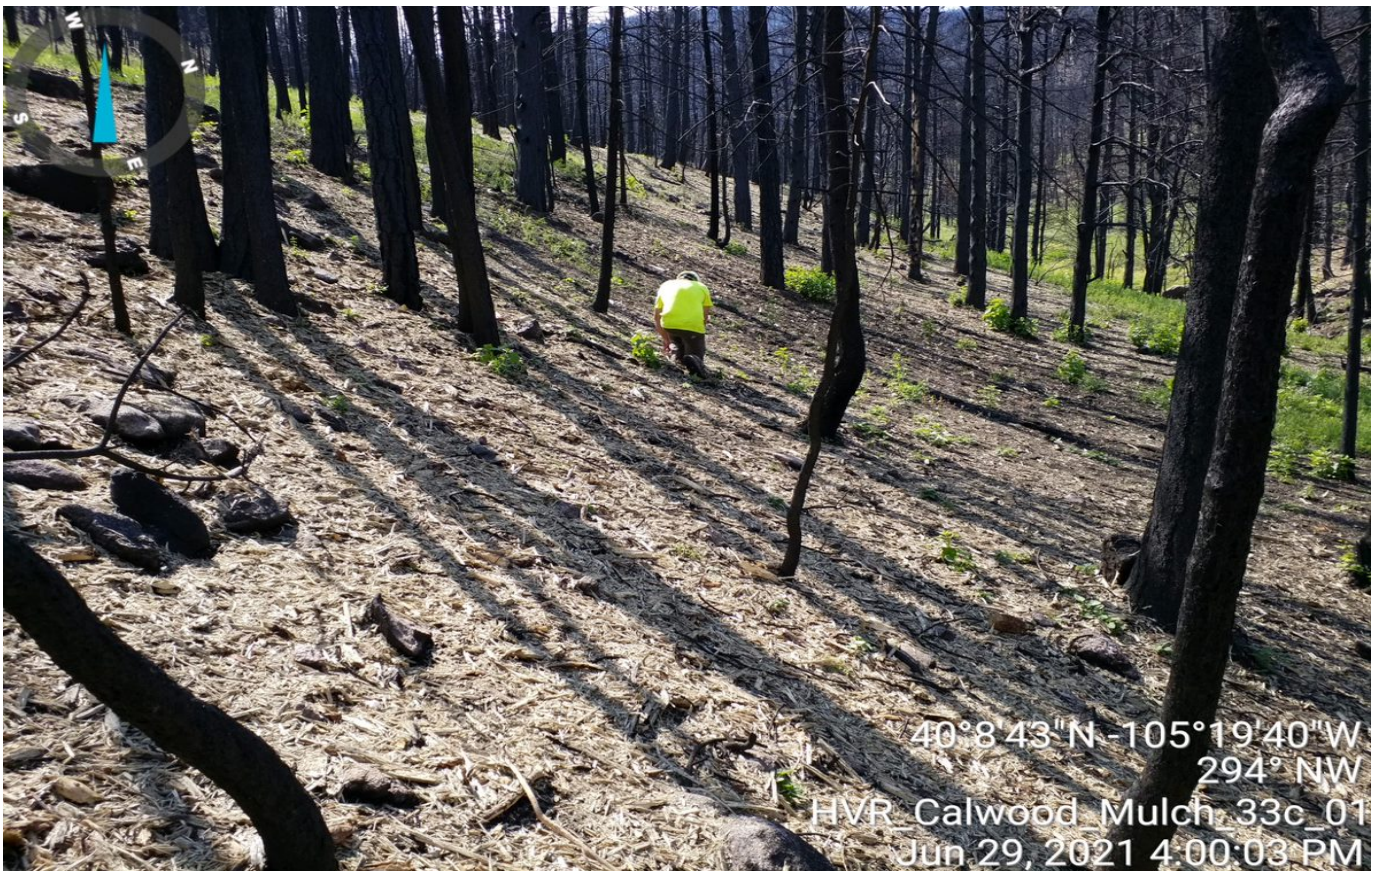
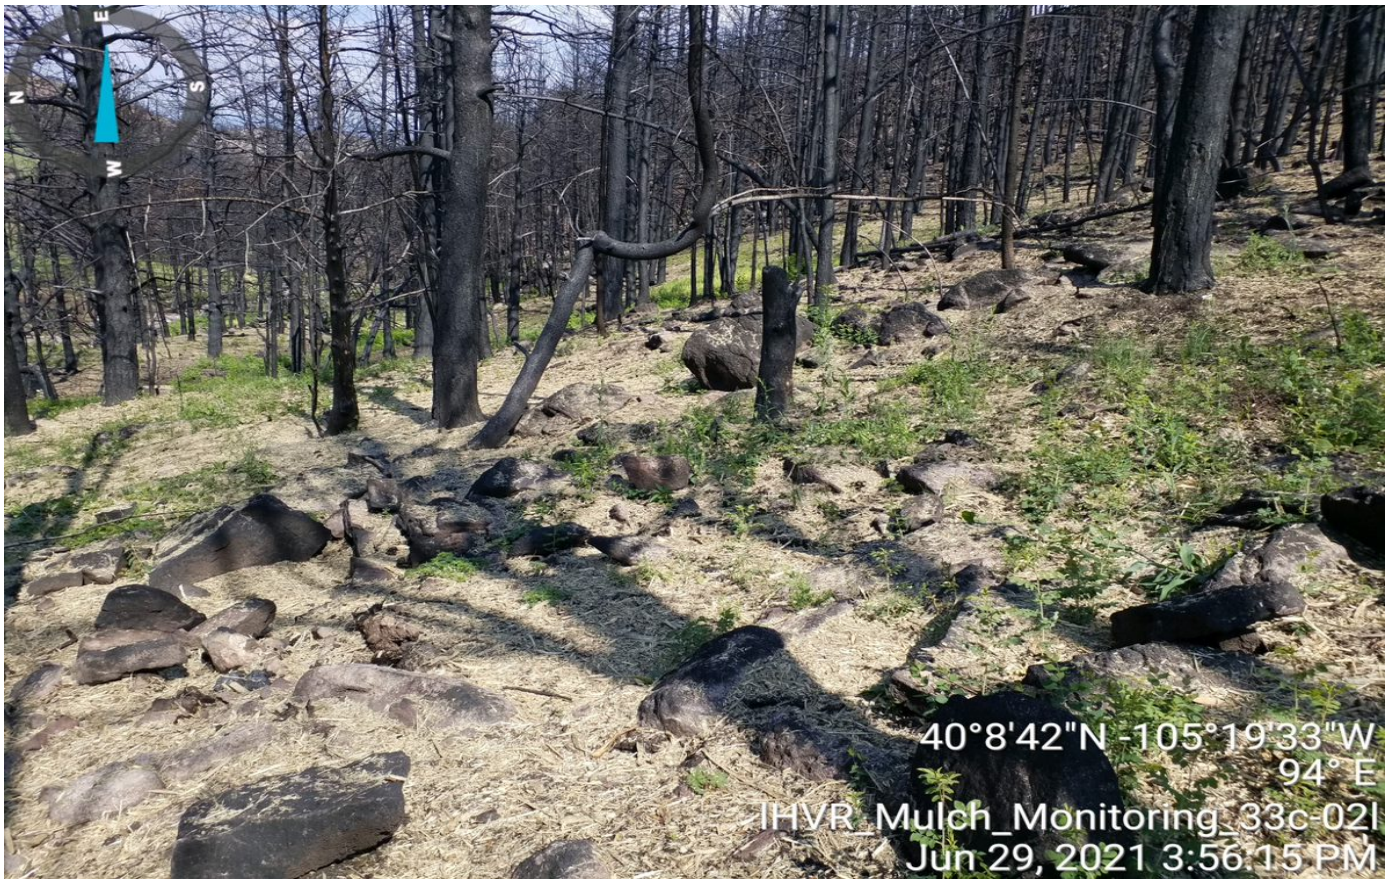
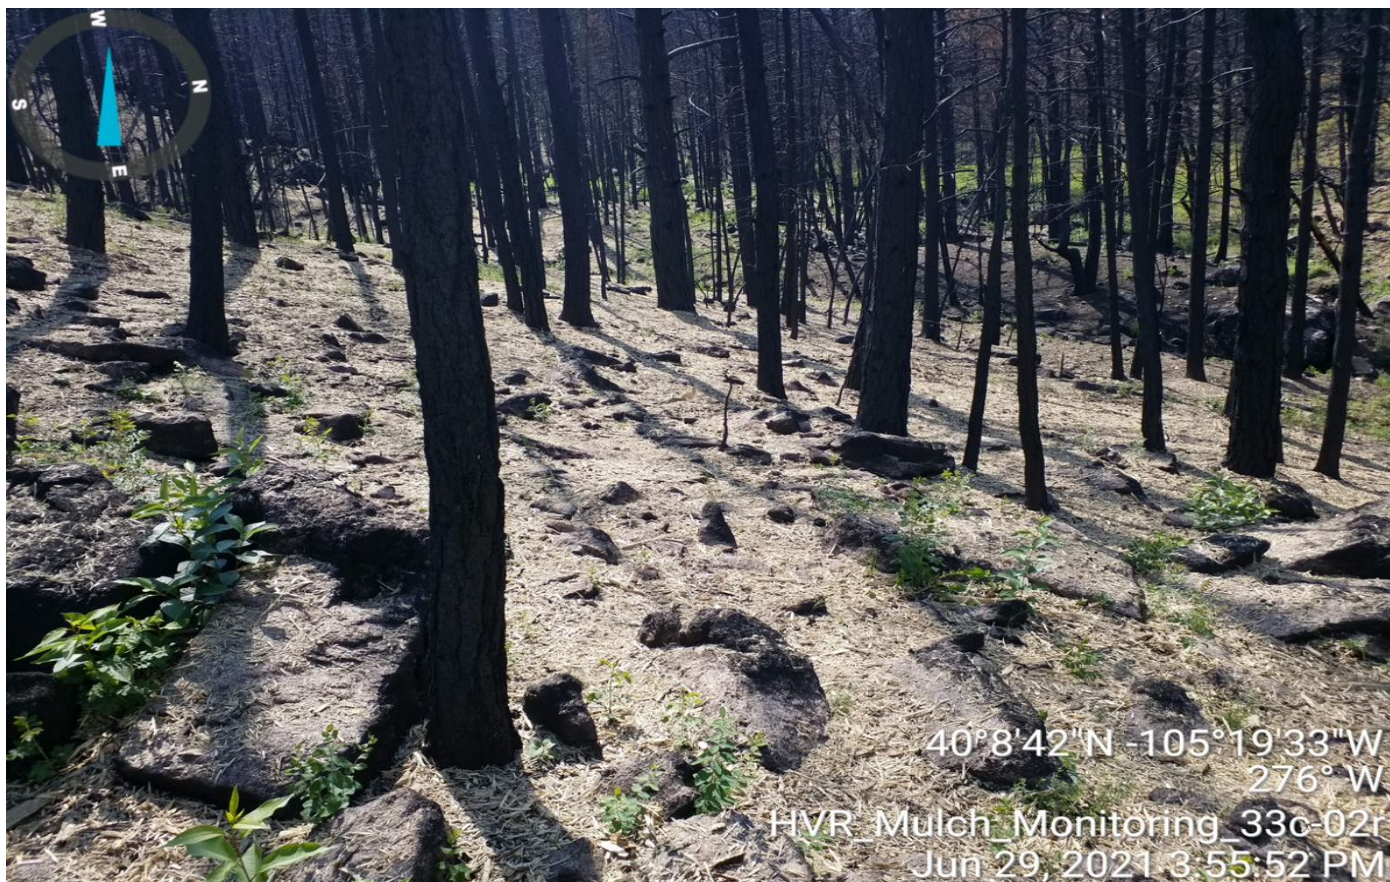
Unit 33c

Treatment Unit: 33C			Monitors: SB,BW,CB,KB								Date: 6/29/21	
Transect #	L or R	Plot 1	Plot 2	Plot 3	Plot 4	Plot 5	Plot 6	Plot 7	Plot 8	Plot 9	Plot 10	Average % Cover
1	R	79%	100%	75%	19%	52%	67%	83%	88%	75%	59%	70%
2	R&L	75%	77%	56%	21%	42%	69%	75%	63%	79%	75%	63%
3												
4												
5												
6												
7												
8												
9												
10												
Averages		77%	89%	66%	20%	47%	68%	79%	76%	77%	67%	66%

Notes: 33C-01 moved 10 paces from origin to avoid creek. 33C-02 had to take points to the right and left of the origin to avoid leaving the boundary. Small acreage of unit required only another 4 tons of mulch to bring up to specification. No record of additional drops, but may have been included in helicopter logs for extra mulch dropped in 33a.

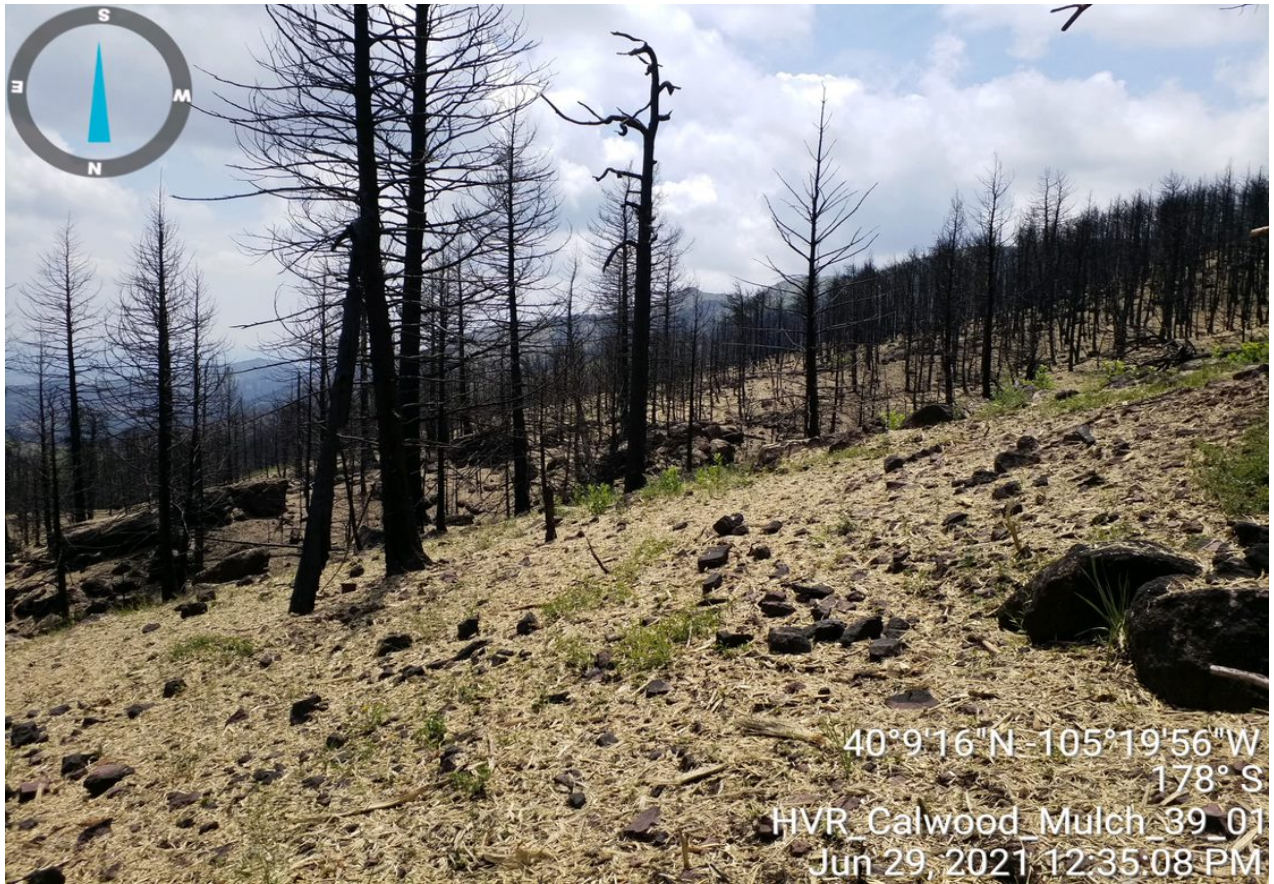
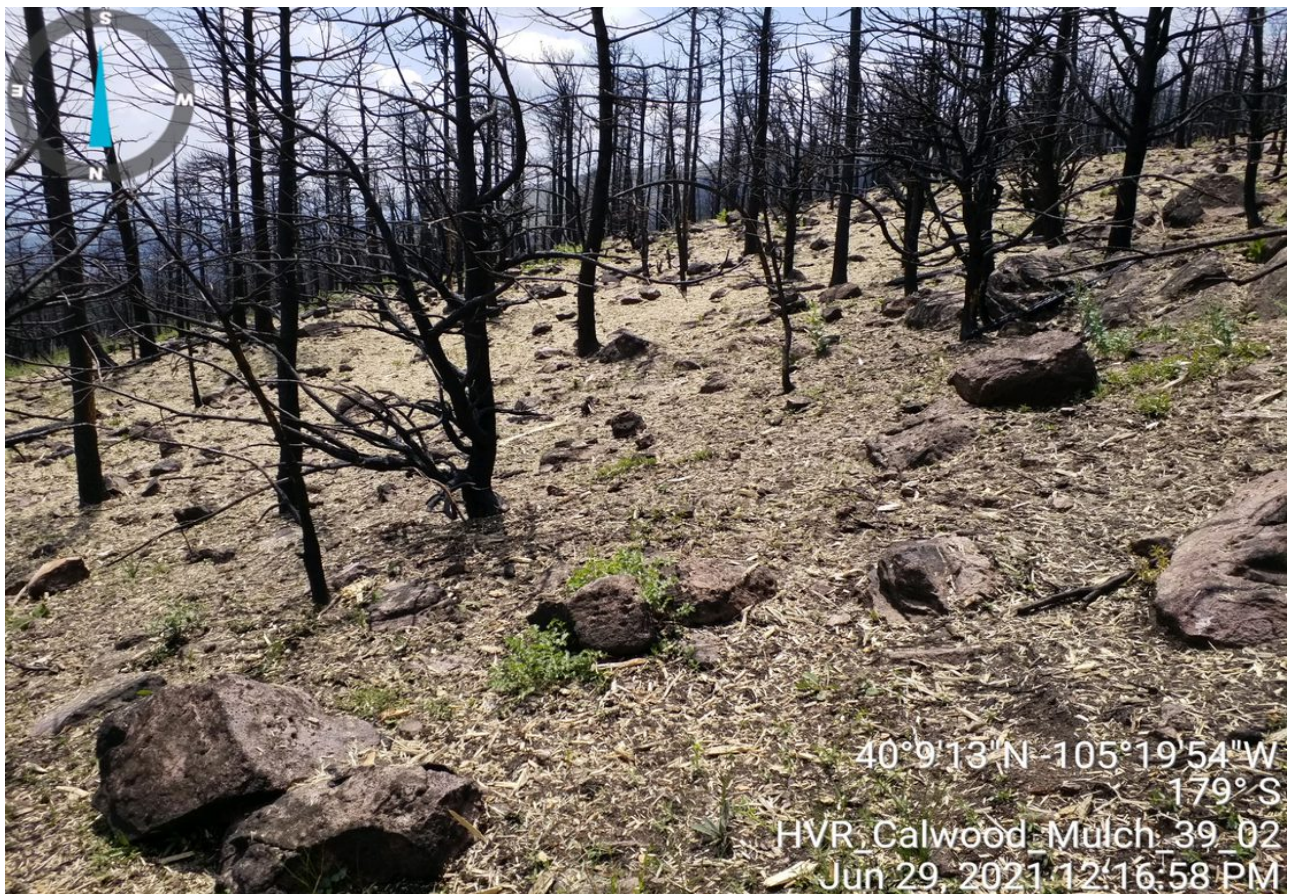
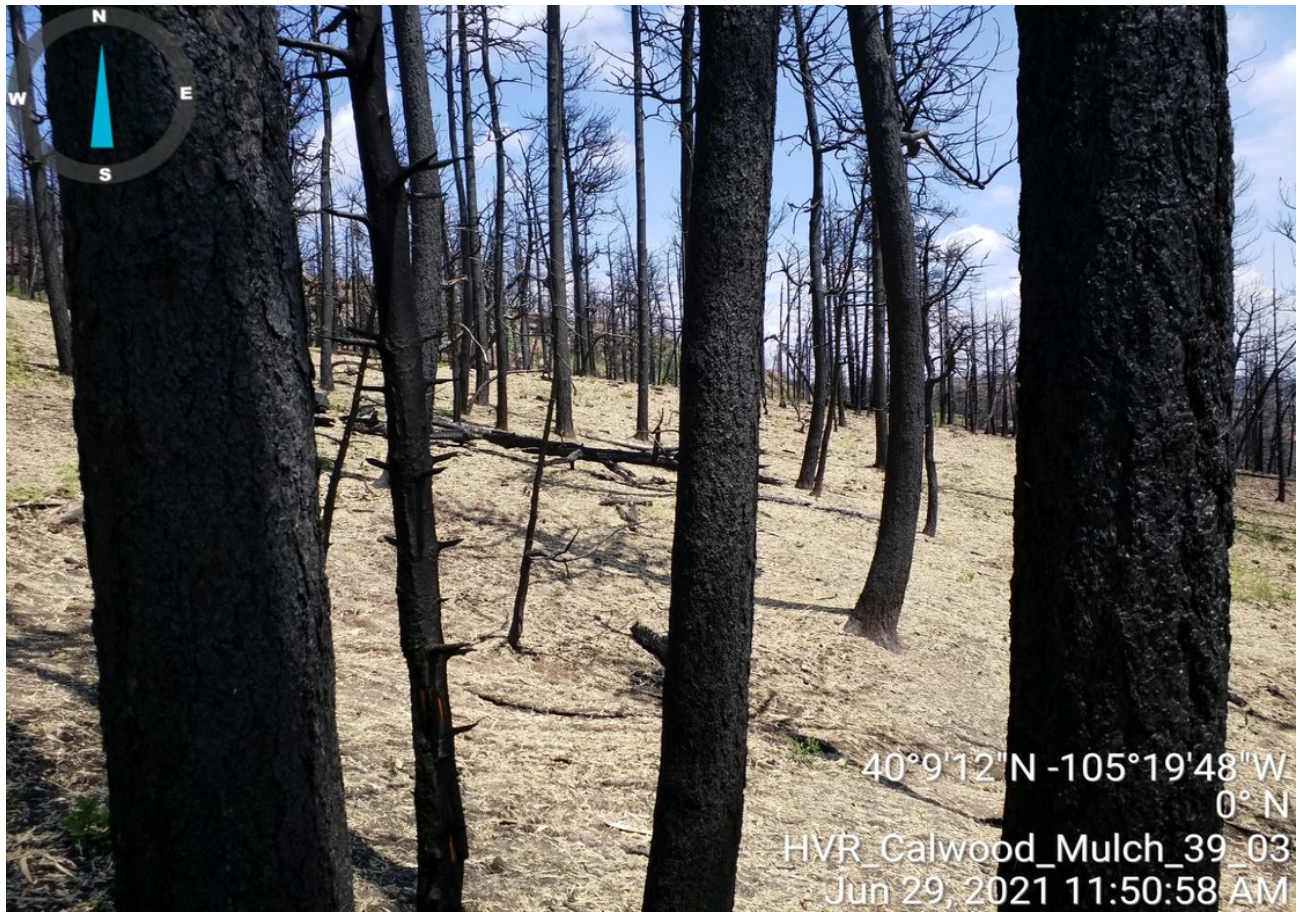
UNIT 39

Treatment Unit: 39			Monitors: KB,CB								Date: 6/29/21	
Transect #	L or R	Plot 1	Plot 2	Plot 3	Plot 4	Plot 5	Plot 6	Plot 7	Plot 8	Plot 9	Plot 10	Average % Cover
1	L	94%	88%	90%	92%	96%	90%	79%	61%	79%	88%	86%
2	L	50%	77%	100%	81%	88%	88%	96%	65%	46%	96%	79%
3	R	67%	77%	88%	69%	90%	65%	65%	67%	92%	88%	77%
4												
5												
6												
7												
8												
9												
10												
Averages												80%
Notes:
