ESTES VALLEY WATERSHED COALITION

**WPG ENVIRO & REC- FISH CREEK AT
CHELEY CAMP RESTORATION**

FINAL REPORT

**PREPARED FOR: COLORADO WATER
CONSERVATION BOARD, WPG PROGRAM
ATTN: ANDREA HARBIN-MONAHAN**

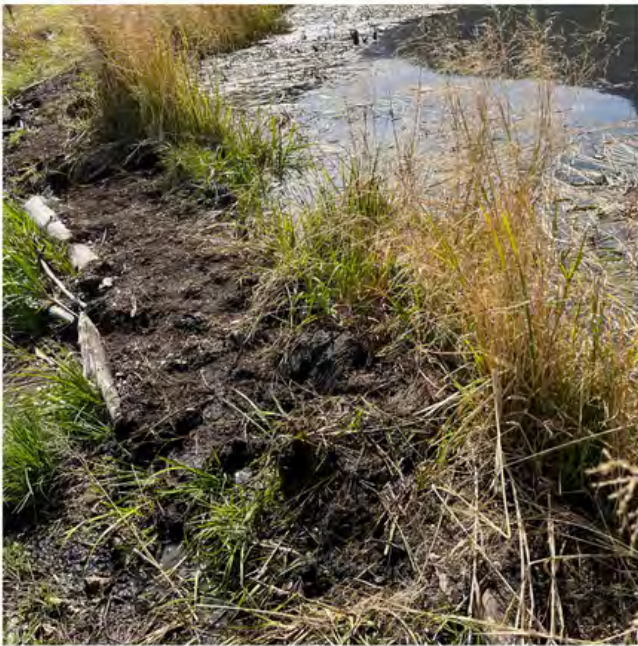
Water overtopping the existing lower beaver pond after August work (September 2022).

Area 1: Repair existing lower beaver pond - In August, EVWC, Stillwater, and volunteers moved fill and sod mats to this area to repair the area on the west side of an existing beaver dam. This has helped to stop some of the water overtopping the dam and has also allowed water flow back to the east side of the meadow and floodplain. During the September visit, we added more fill and sod mats to build up the dam on the west side.

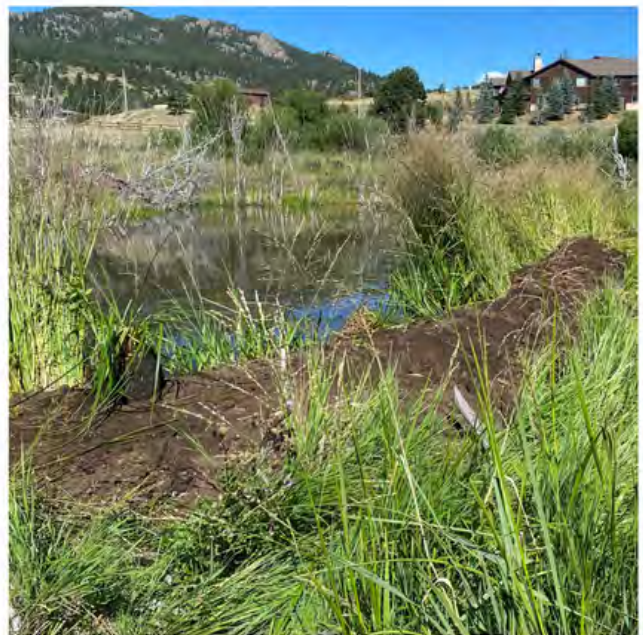
Existing pond repair after more sod mats and fill added in September 2022 (view is facing opposite direction).

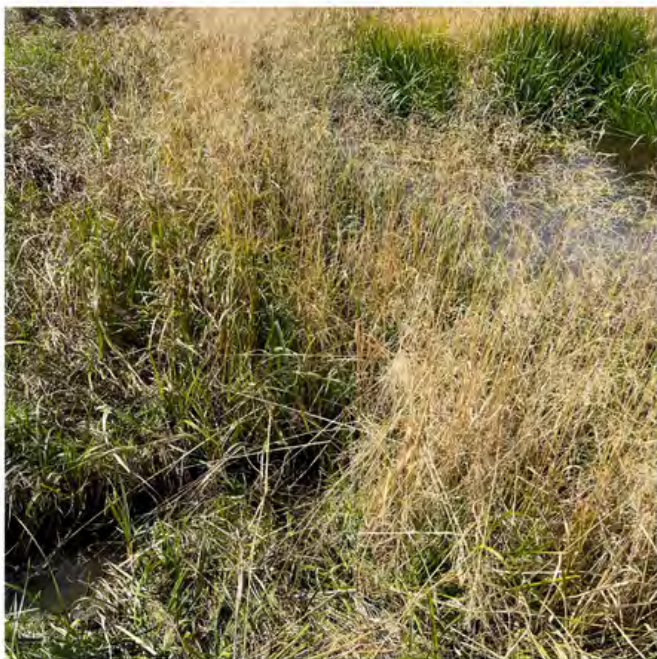
Area 1 continued: Dug pilot channels to redirect water from lower pond

Pilot channel with water and good vegetation establishment (September 2022).

- We also dug channels in and near the east side of the dam in August. This helped to re-direct water flow back into the beaver meadow and also supports existing and new vegetation growth for both habitat and food sources. In September, we made some adjustments on the channels and added one more channel to the beaver pond.

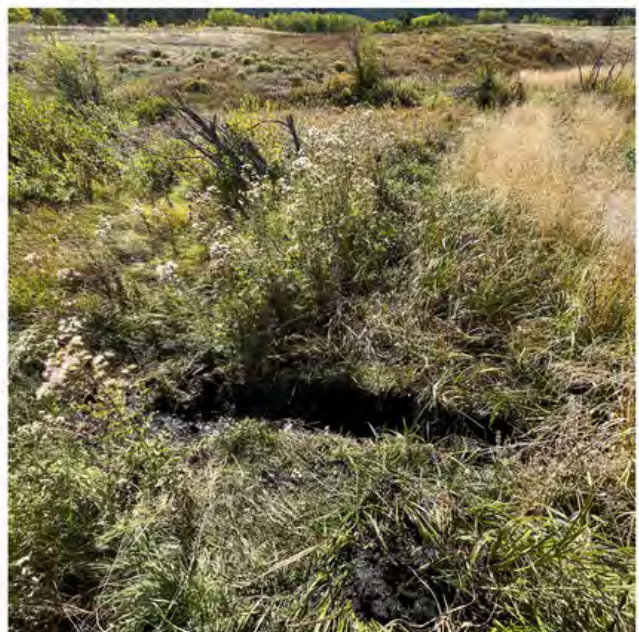
Pilot channels are narrow (less than 6" wide) channels that help distribute runoff the beaver meadow.

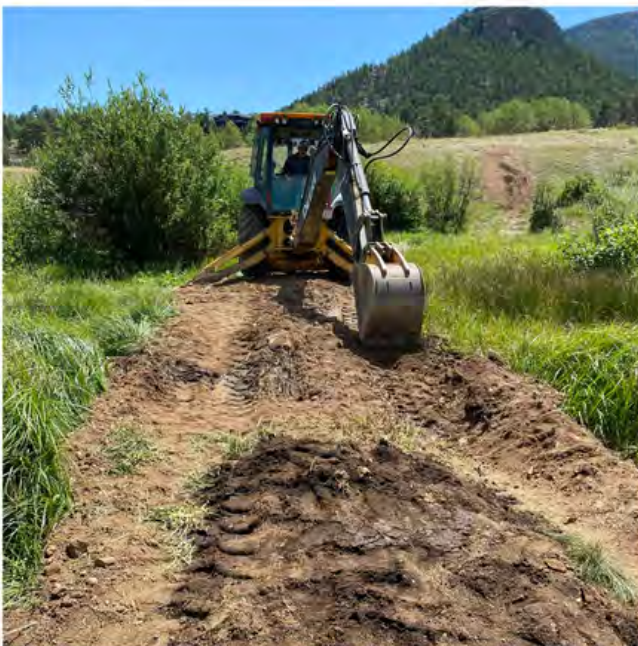
Area 2: Upper Earthen Berm - In August, EVWC, the Stillwater team, and volunteers were able to use a combination of equipment and handwork to build an earthen berm, fill a headcut, and add pilot channels to continue to re-direct water towards the beaver meadow. This area is just below the lower pond in Area 1. In September, EVWC and Stillwater determined that the berm needed more fill and we were able to add this using handwork.

Excavator helping to build berm (August 2022).

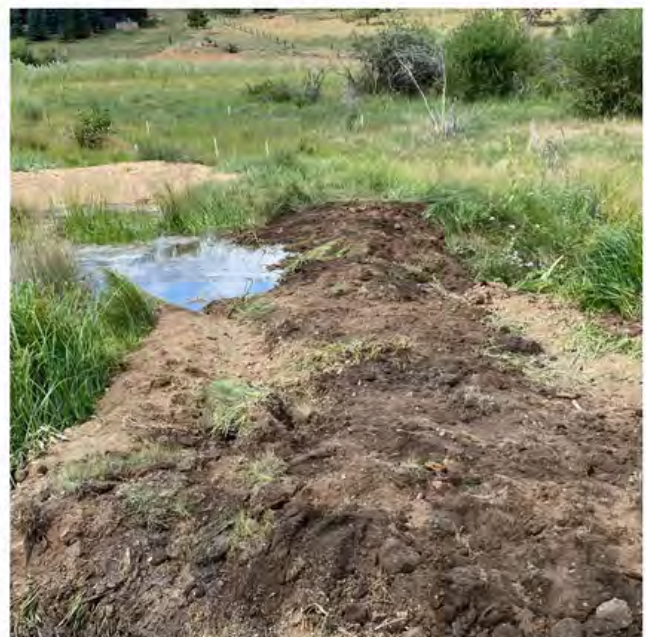
Same location facing the other direction showing berm and headcut filled in (August 2022).

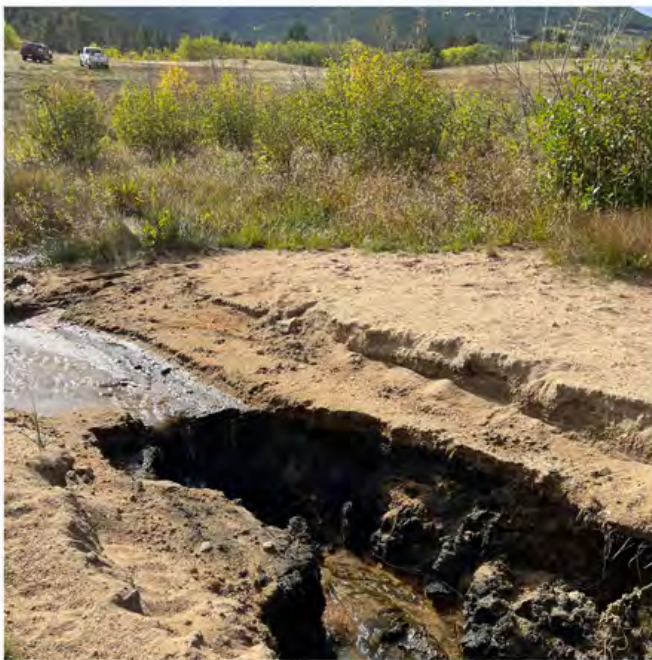
Back side of the headcut that needed repairs (September 2022).

Area 2 continued: Headcut repair near upper earthen berm - Due to some heavy rains between the August and September visits, the previously filled headcut needed repairs. We also adjusted the pilot channels to help direct water flow back into the beaver meadow and away from the headcut repairs.

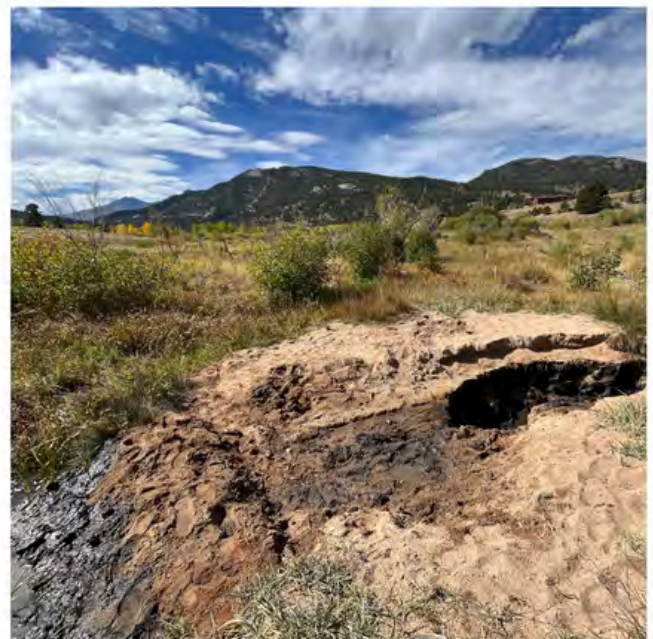
Repaired headcut using fill and handwork (September 2022).

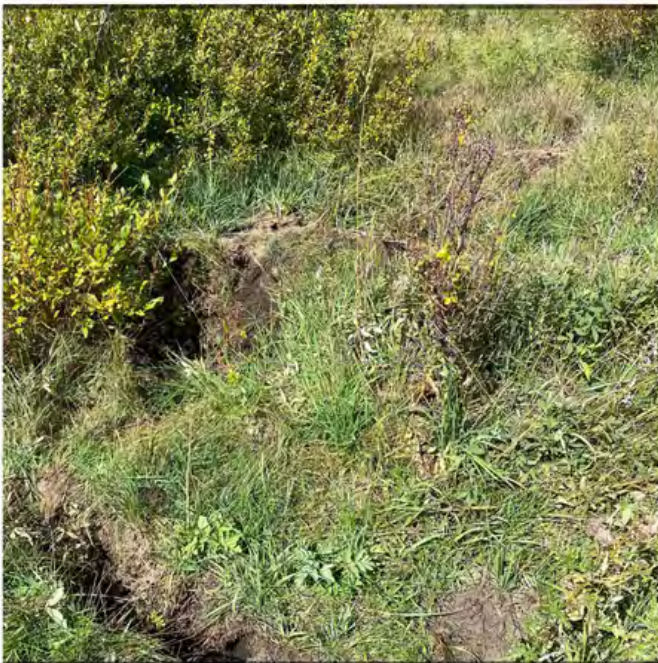
Area 3: Lower earthen berm - In August, EVWC, the Stillwater team, and volunteers built a second earthen berm and dug pilot channels to continue re-directing the water. During the September 2022 visit, we used more fill in this area to reinforce the berm.

Second earthen berm (August 2022).

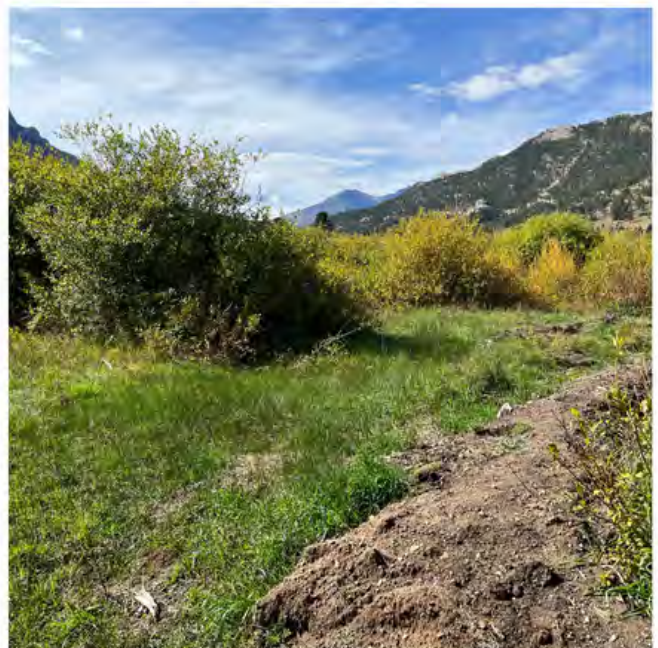
Backside of second earthen berm after fill was added (September 2022).

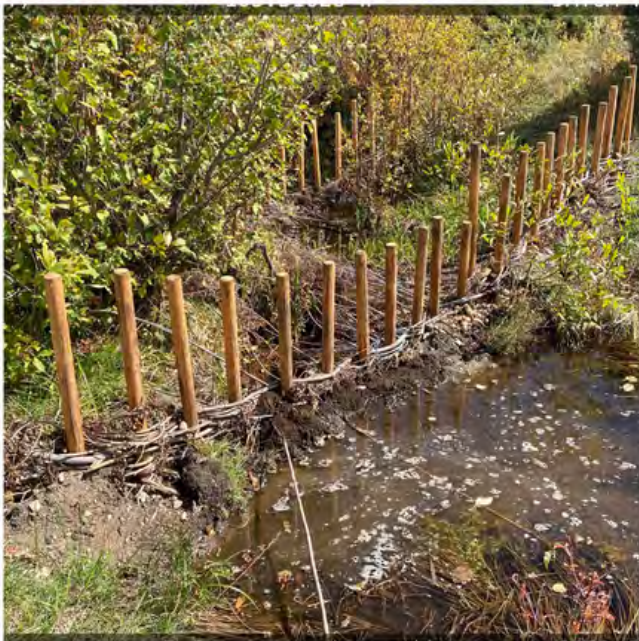
Area 4: Priority beaver structures - In August, EVWC, the Stillwater team, and volunteers also built three simulated beaver structures outside of the 100-year floodplain. This was done in a steep area to help slow the velocity and keep water in the meadow. We used the willow-weave technique along with coarse and fine fill to complete the structures. The upper two structures needed to be reinforced with more fill during the September site visit.

Beaver structures before fill (September 2022).

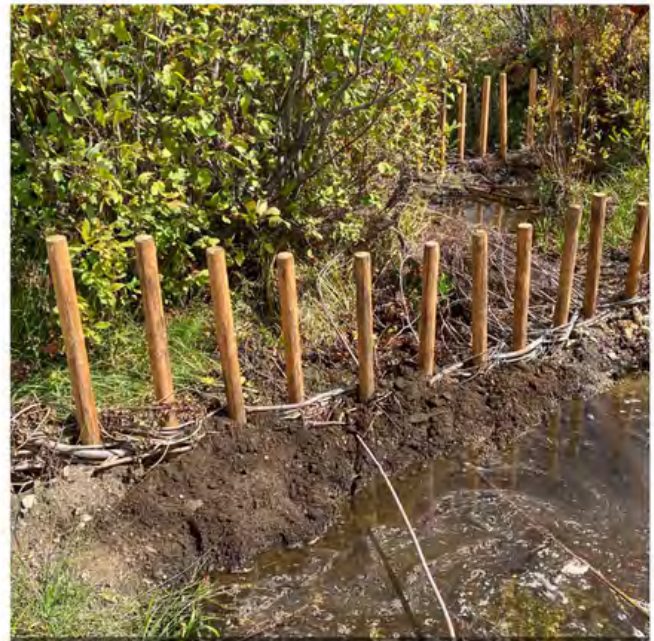
Beaver structures after more fill was added (September 2022).

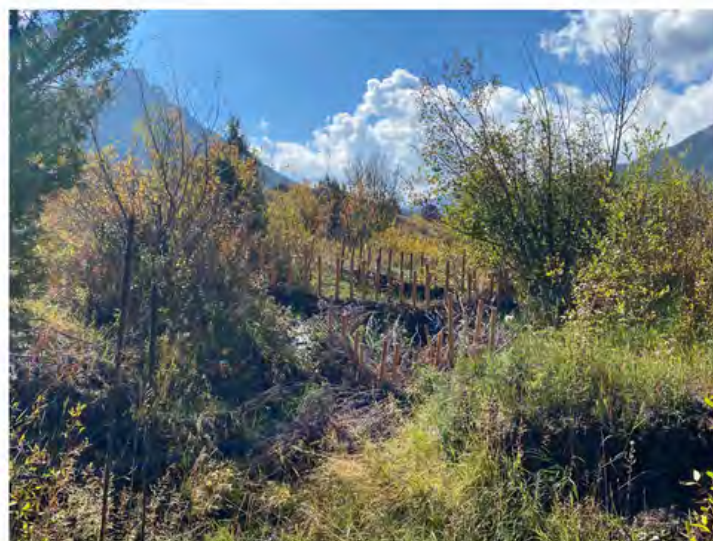
Beaver structures from below (October 2022).

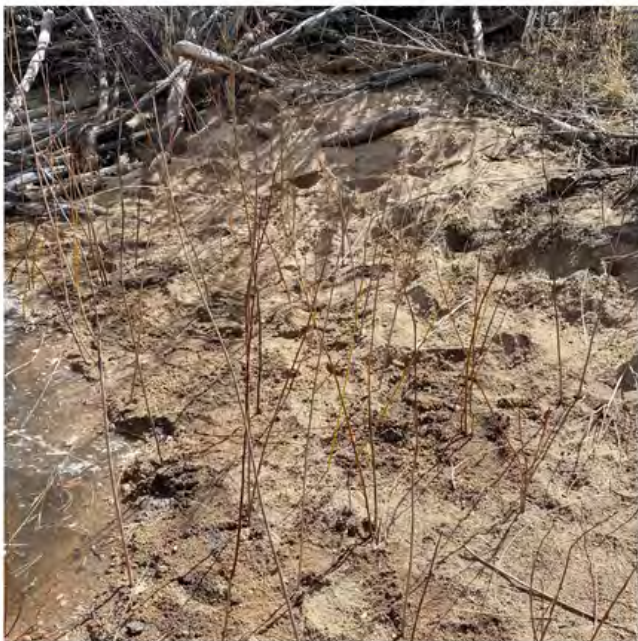
Area 5: Willow stake replanting - In April, EVWC, the Stillwater team, and volunteers planted 175 willow stakes along the banks of Fish Creek in an area downstream from where the priority beaver structures (Area 1) were installed. The willows are thriving and will provide habitat and a food source that had been previously removed by the 2013 flood and subsequent redirection of Fish Creek following the flood of September 2013.

Some of the willow stakes planted along the banks (photo in May 2022).

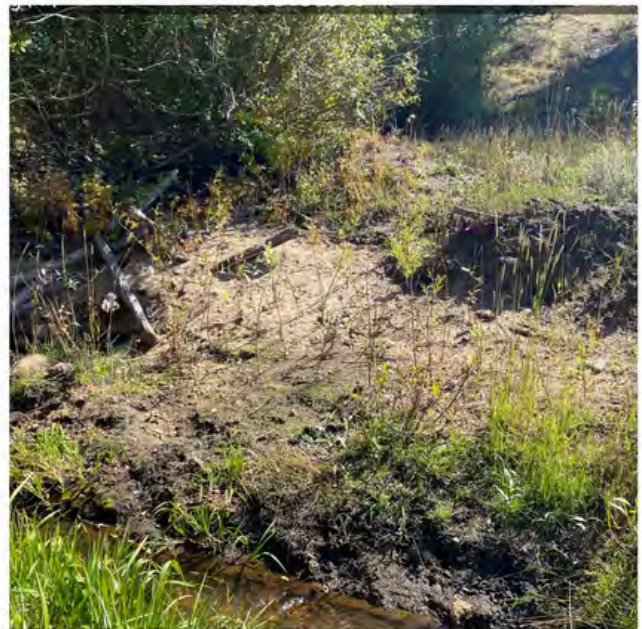
Good willow establishment along the banks (photo in October 2022).

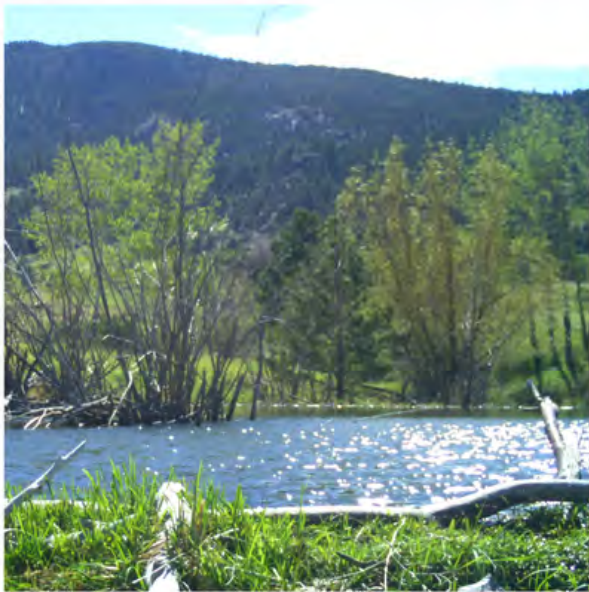
Wildlife and beaver colony on Fish Creek at Cheley Camp - using game camera footage we have been able to monitor the wildlife in the project site. There is an active beaver pond and at least one beaver in that pond. Game camera monitoring also helps us with the adaptive management of the project and knowing where we need to use exclosure fencing to protect vegetation and habitat for the beaver colony.

Active beaver pond (June 2022).

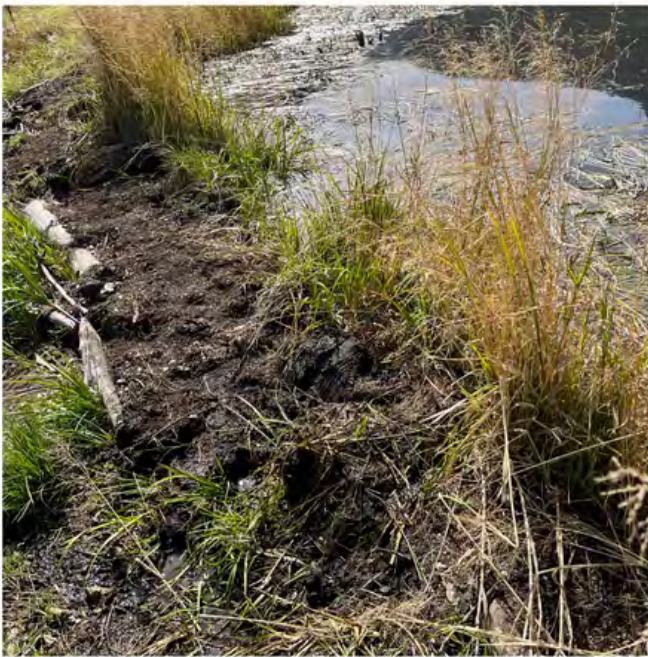
Water overtopping the existing lower beaver pond after August work (September 2022).

Area 1: Repair existing lower beaver pond - EVWC, Stillwater, and volunteers moved fill and sod mats to this area during both site visits (2022 & 2023) to repair the west side of an existing beaver dam. This has helped to stop some of the water overtopping the dam and has also allowed water flow back to the east side of the meadow and floodplain. This pond is filled by the main tributary of Fish Creek and is a main source of water.

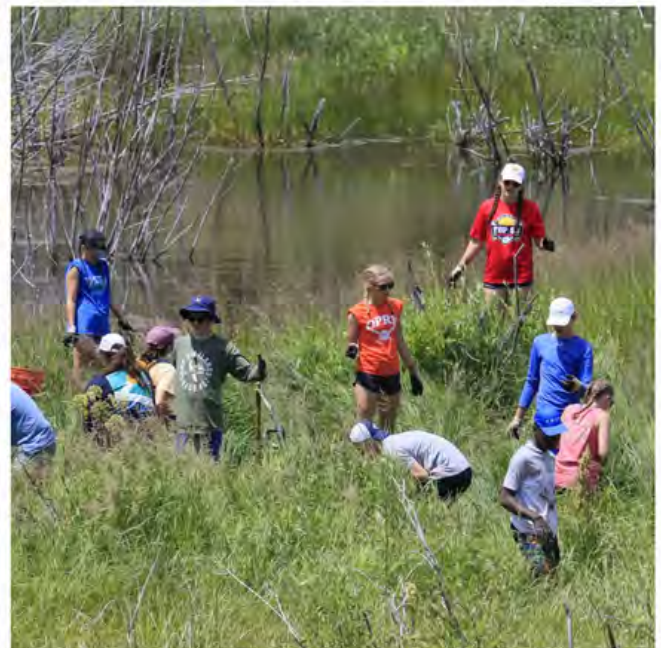
Volunteers in July 2023 adding more sod mats and native plants to the beaver pond (view is facing opposite direction).

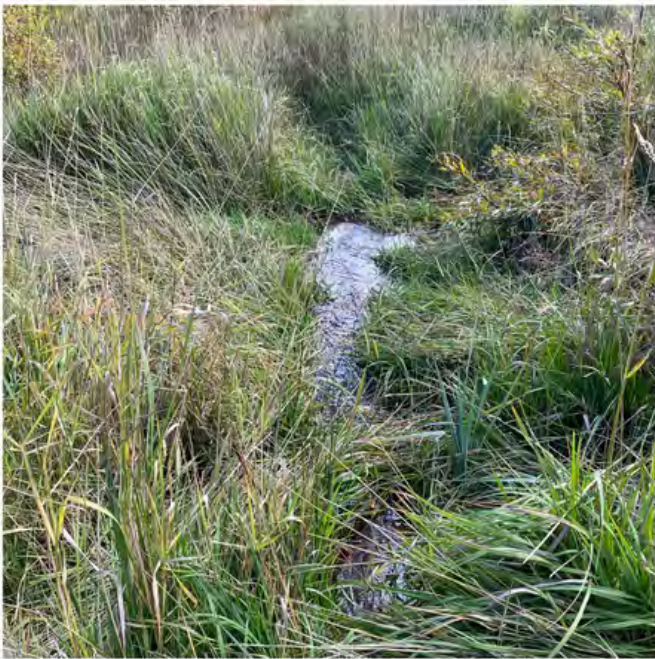
- Channels were dug near the east side of the dam at the start of the project (2022) to help re-direct water flow back into the beaver meadow. Adaptive management techniques supported adding additional channels to promote existing and new vegetation growth for both habitat and food sources.

Pilot channels are narrow (less than 6" wide) channels that help distribute runoff the beaver meadow (September 2023).

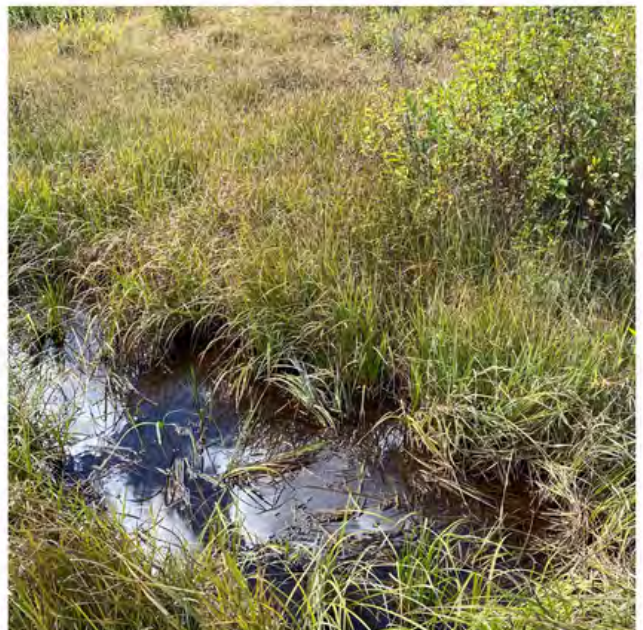
Ponded water from the hand dug channels has increased vegetation in the meadow restoration site (September 2023).

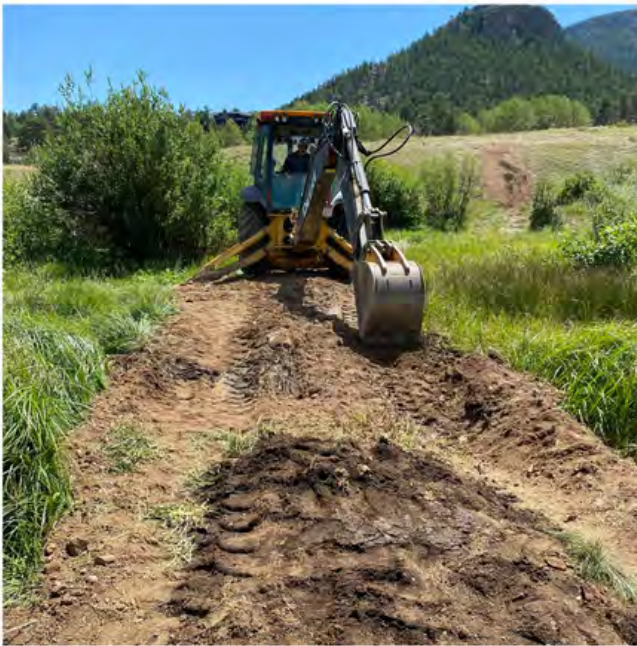
Area 2: Upper Earthen Berm - Initially, EVWC, the Stillwater team, and volunteers were able to use a combination of equipment and handwork to build an earthen berm, fill a headcut, and add pilot channels to continue to re-direct water towards the beaver meadow. High water movement in Spring 2023 washed out the headcut filled area. We were able to add in a series of 5 willow weave simulated beaver structures secured with sod mats and native vegetation in July 2023 that appears to be holding.

Excavator helping to build berm (August 2022).

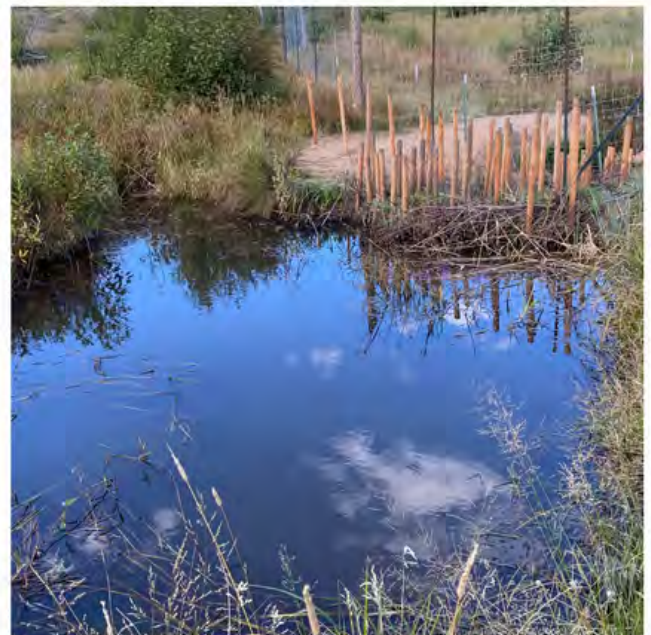
Same location facing the other direction showing berm and headcut filled in with 5 simulated beaver structures (Sept 2023).

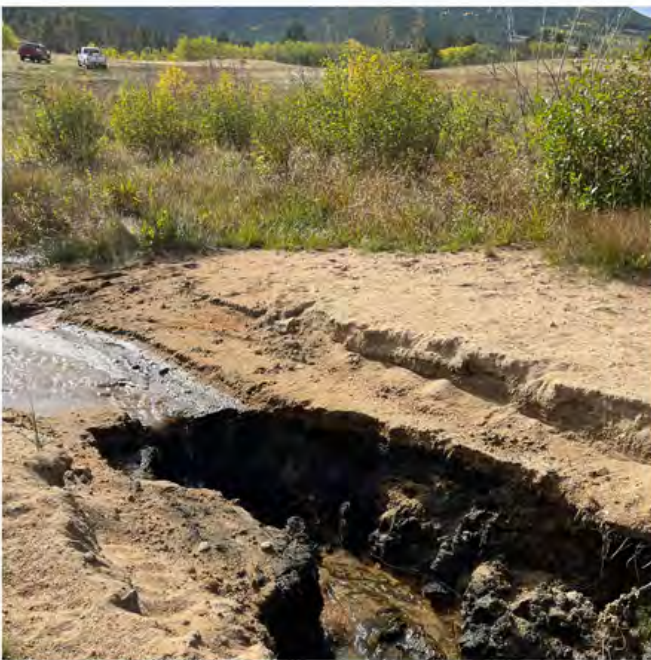
Back side of the headcut that needed repairs, second wash out of the earthen berm (September 2022).

Area 2 continued: Headcut repair near upper earthen berm - Due to some heavy rains in 2022 and 2023, the previously filled headcut needed repairs. The team and volunteers added in a series of simulated beaver structures secured using a willow weave technique, sod mats, and native vegetation. We also adjusted the pilot channels to continue to help direct water flow back into the beaver meadow and away from the headcut repairs.

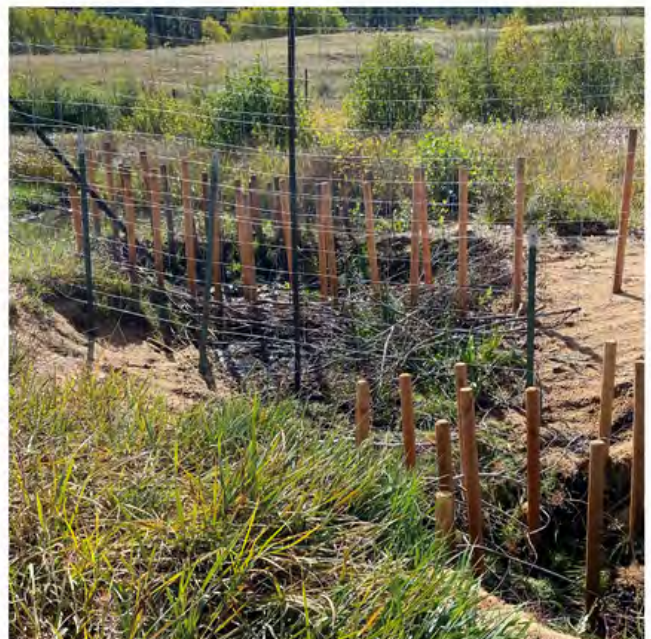
Repaired headcut using willow weave simulated beaver structures, sod mats and native vegetation (Sept 2023).

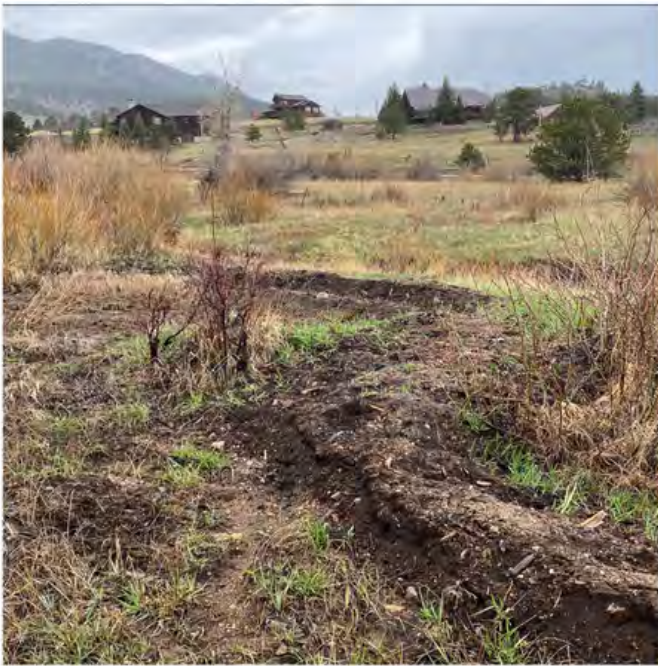
Area 3: Lower earthen berm - In August, EVWC, the Stillwater team, and volunteers built a second earthen berm and dug pilot channels to continue re-directing the water. These were reinforced by hand during work days in 2022 and 2023. Native vegetation and native willow stakes were added to provide additional stability to the berms in 2023.

Second earthen berm (May 2023).

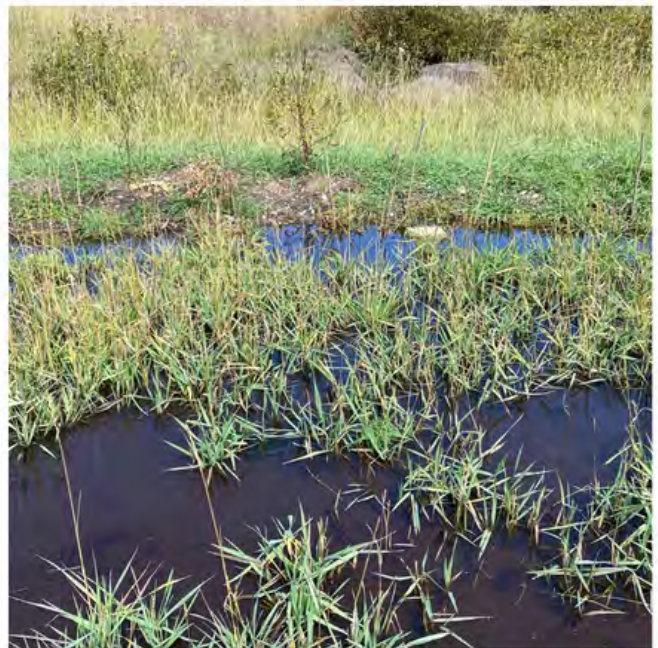
Second earthen berm after fill and native vegetation were added (September 2023).

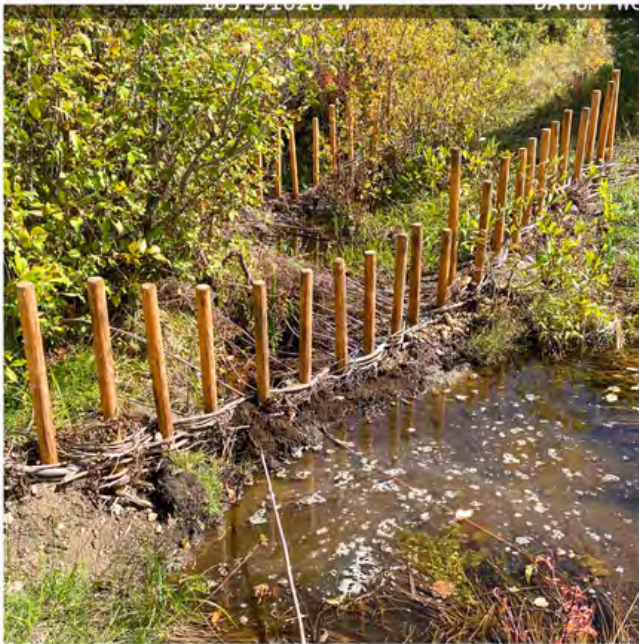
Area 4: Priority beaver structures - In August, EVWC, the Stillwater team, and volunteers also built three simulated beaver structures outside of the 100-year floodplain. This was done in a steep area to help slow the velocity and keep water in the meadow. We used the willow-weave technique along with coarse and fine fill to complete the structures. The upper two structures needed to be reinforced with more fill and willow stakes during the various site visits.

Beaver structures before fill (September 2022).

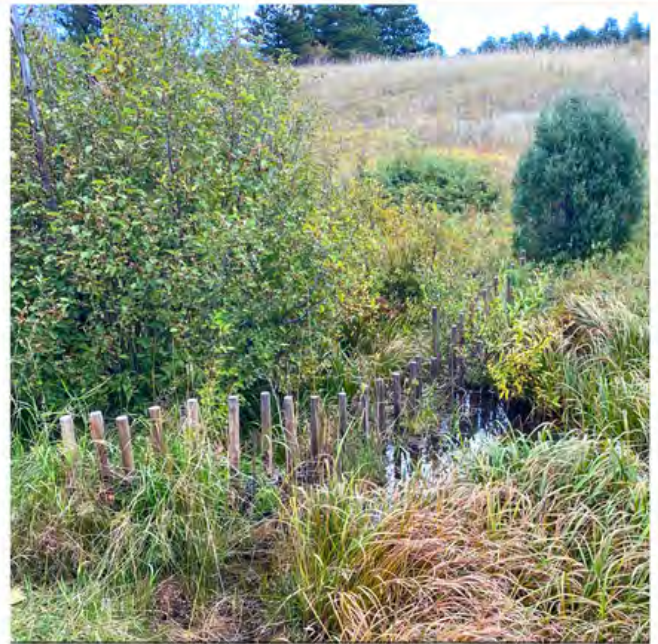
Beaver structures after more fill and willow stakes were added (Sept 2023).

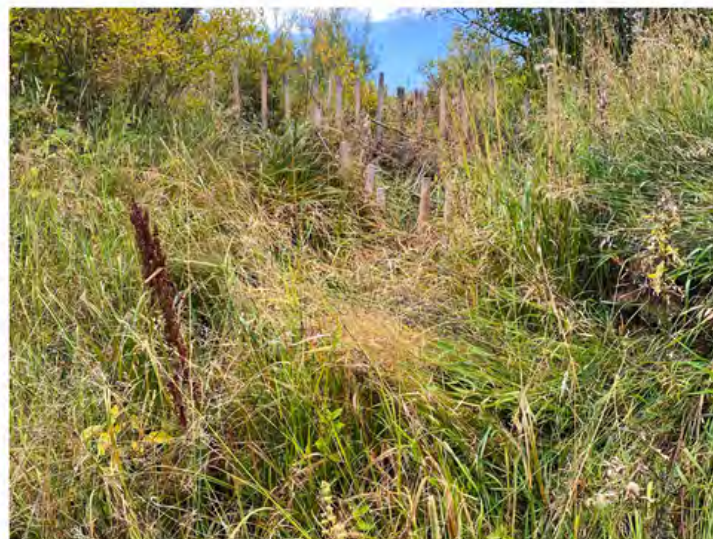
Beaver structures from below (September 2023).

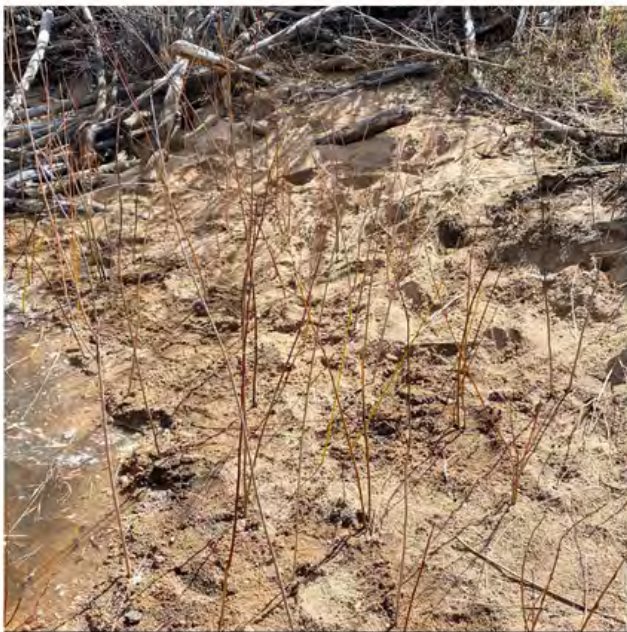
Area 5: Willow stake replanting - In April 2022, EVWC, the Stillwater team, and volunteers planted 175 willow stakes along the banks of Fish Creek in an area downstream from where the priority beaver structures (Area 1) were installed. The willows are thriving and will provide habitat and a food source that had been previously removed by the 2013 flood and subsequent redirection of Fish Creek following the flood of September 2013. During the last site visit we noticed an additional beaver structure downstream of this location as well.

Some of the willow stakes planted along the banks (photo in May 2022).

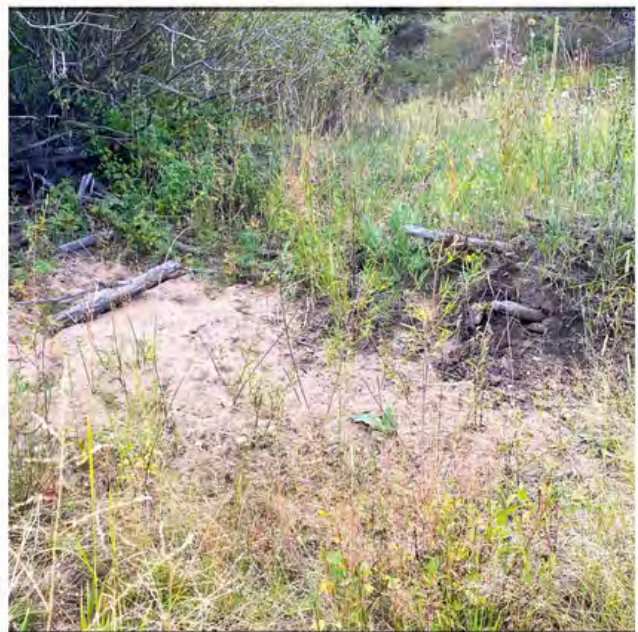
Good willow establishment along the banks (photo in Sept 2023).

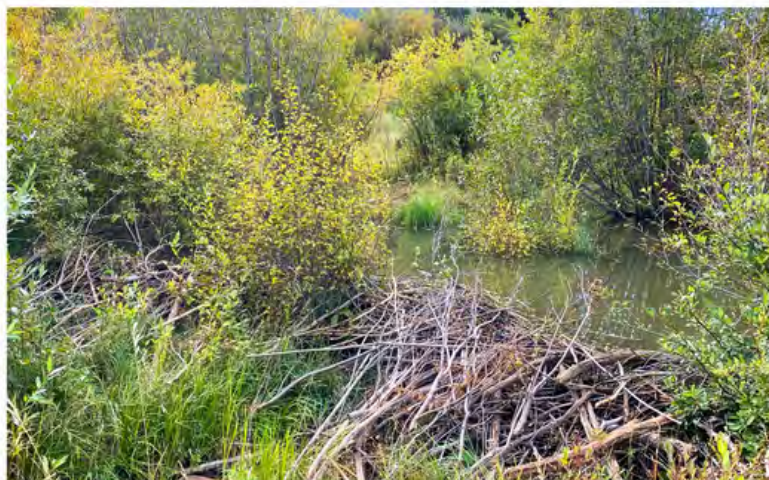
New beaver dam downstream of project site (photo in Sept 2023).

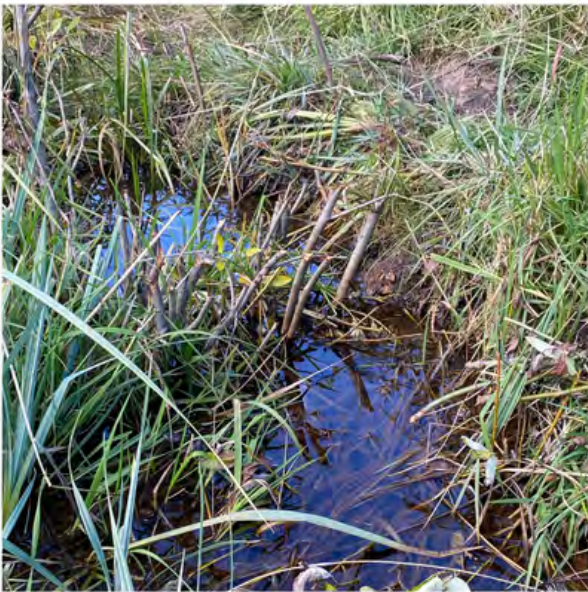
Beaver activity in restoration area (Sept 2023).

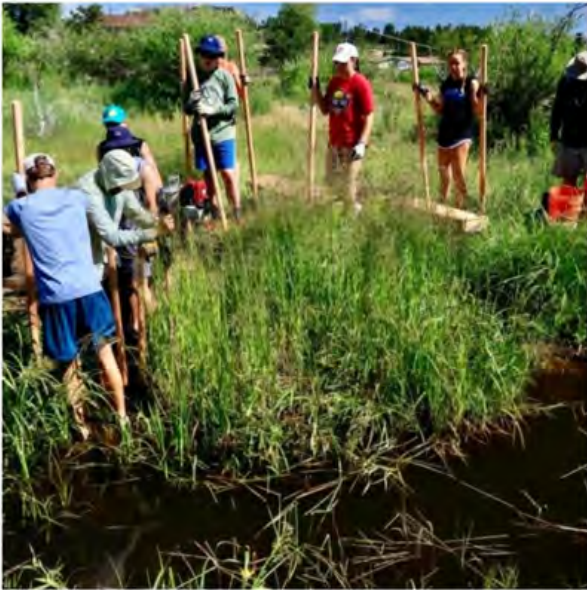
Volunteers helping to build SBS (July 2023).

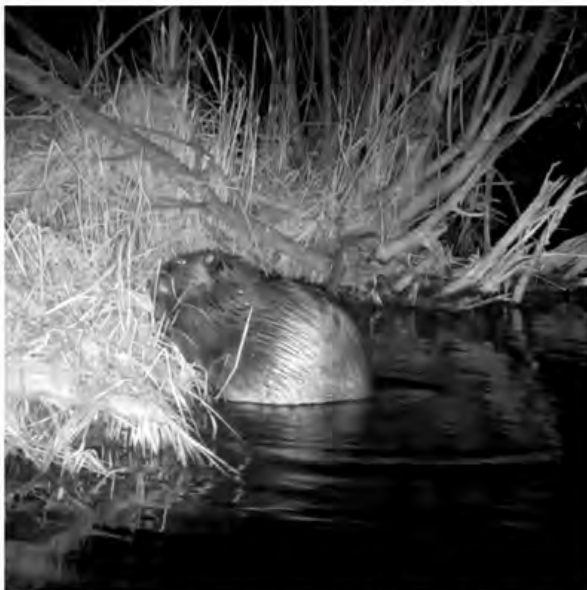
Beaver in the active pond (June 2023).

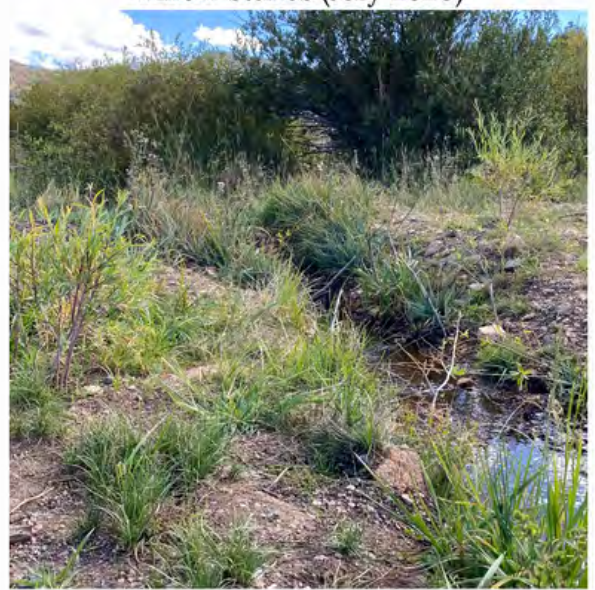
Native vegetation and willow stakes in project area (Sept 2023).

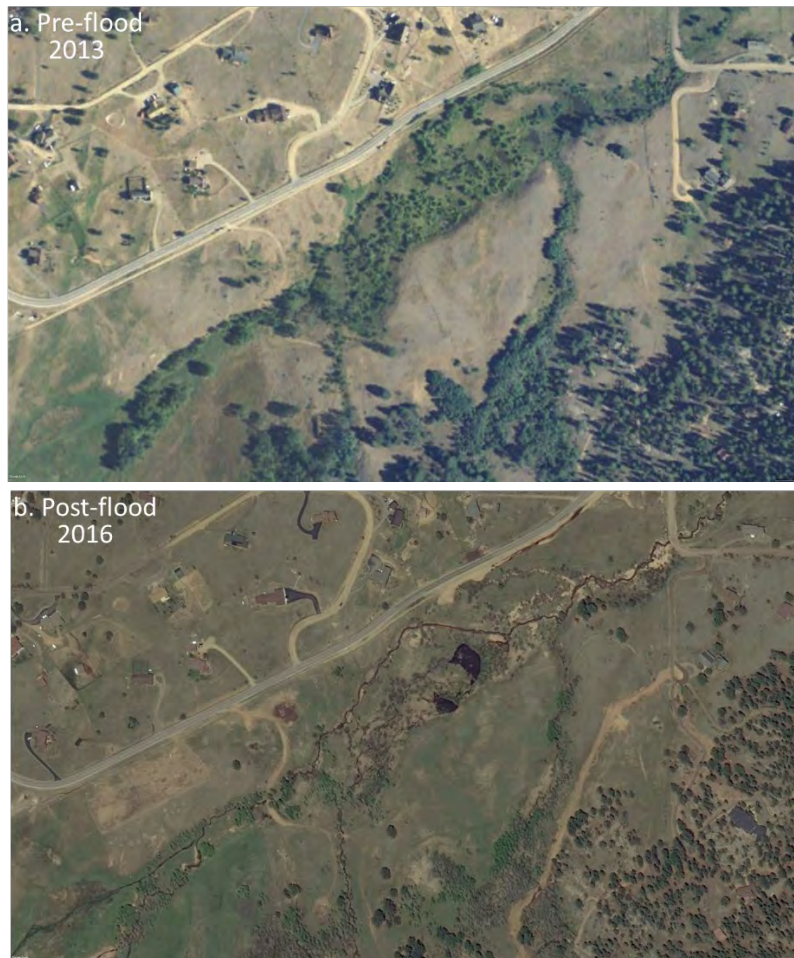
Figure 1: Aerial imagery (a.) pre-2013 flood with the channel in its historic alignment and (b.) post-2013 flood with the new straighten emergency repair channel alignment.

During the 2013 Flood, Fish Creek jumped out of its channel and ran down Fish Creek Road. As an emergency repair, a new straight channel was excavated down the middle of an existing beaver meadow within the Cheley Camp property to move it away from Fish Creek Road (Figure 1). As a result of the shortened channel length, Fish Creek incised, and most of the surrounding beaver meadow became disconnected and dried out. Recent observations (refer to Section 3.1.1) suggest that only one beaver remains on the property today, which is unsurprising given the reductions of habitat and food source associated with the emergency channel.

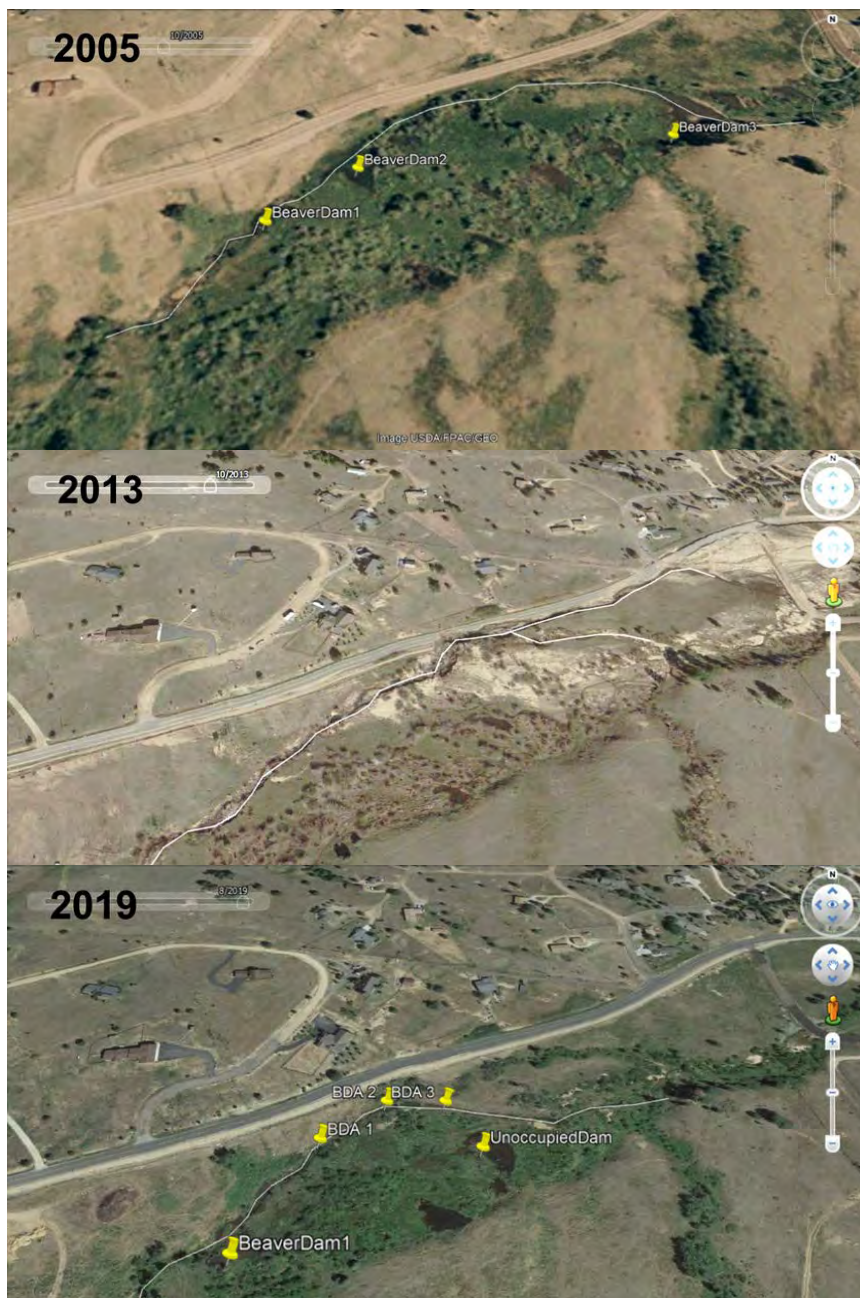
Figure I: Maps of Fish Creek showing its transformation through the years with the 2013 flood included.

However, the beavers disappeared after the flood and most of the water was diverted into a single incised stream after emergency action was taken by the county.

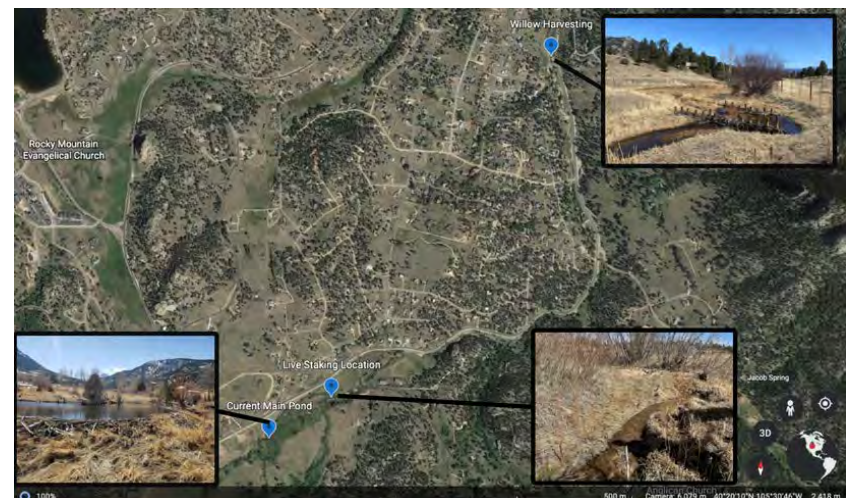
Figure II: Map of where the willow was harvested and staked.

area north of Brook Lane off of Fish Creek, an area rich in willows shown in Figure II. The area we chose for revegetation was a short distance downstream from the active beaver lodge. We chose a spot where the stream was shallower and flowed more slowly than in other areas, marking a suitable location for the beavers to dam. The location was also far enough away from the pond to reduce the likelihood that the beavers would forage them before the transplanted willows had a chance to root. This new vegetation ideally will spread through the area providing resources to encourage the beaver population to seek new sites for lodges and dams downstream. The willows were staked into the banks downstream and next to a BDA nearby. Figure III shows the locations of the stakes. They were staked on the banks so the root systems would be close to the water and would hold sediment. This would hopefully slow the stream to allow more time for the groundwater to recharge.

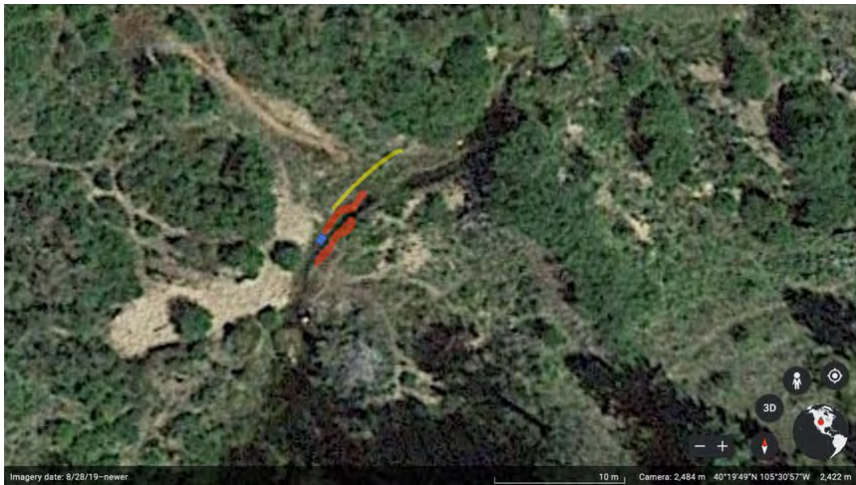
Figure III: Map of where the willows were staked at Fish Creek.

Our team also helped the EVWC and its consultant firm, Stillwater Sciences, stake willows at the site to slow the water flow from the main tributary and influence the beaver population to move downstream. Live staking willows at the site consisted of taking sections of willows and replanting them along the creek in areas where the beavers were building dams. The first step in live staking involved harvesting willow cuttings from an

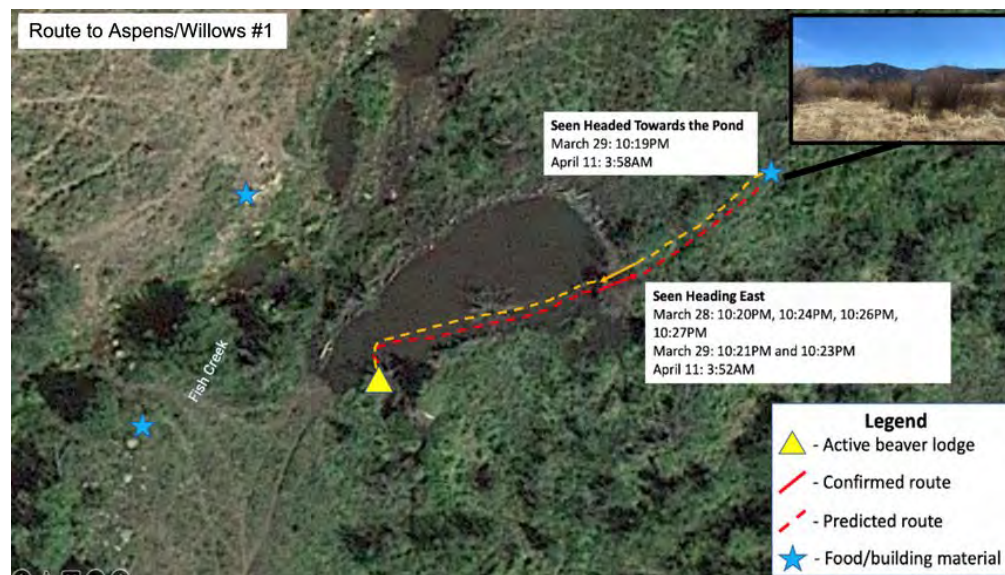
Figure IV: Routes the beaver is likely to have traveled to get to resources. Maps made by Michelle Pan.

The routes we predicted the beaver was most likely to take to get resources are shown in Figure IV. We found evidence of elk and mule deer on the site in the form of scat, marks on aspen trees, and through some of our camera footage. This indicates a potential need to fence off some of the beaver's foraging sites to ensure that the beaver will have adequate resources. We also assessed the effectiveness of the BDAs located on the downstream portion of the site. Most of the BDAs are placed in incised channel locations. There was scant evidence of recent beaver activity on these BDAs, implying that the beaver population is not interested in moving further downstream even with the food and material caches that the EVWC had previously placed there.

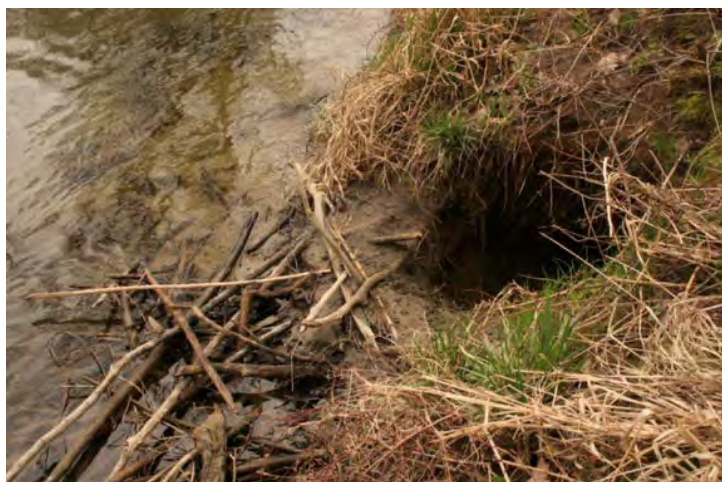
Figure 2.1: Bank burrow that leads to a canal. (Life Beaver).

Beavers influence not only the water flow but also the surrounding geomorphological banks. In addition to dams, beavers excavate bank burrows where they reside and dig shallow channels, or canals, which extend from beaver ponds and are used for access to food and building resources. These burrows and canals contribute greatly to the hydrogeomorphology of floodplains. Hydrogeomorphology is defined as the “interdisciplinary science that includes the linkage among various hydrologic and geomorphic processes” (Sidle and Onda, 2004, p. 597). Bank excavation also acts as a large source of erosional

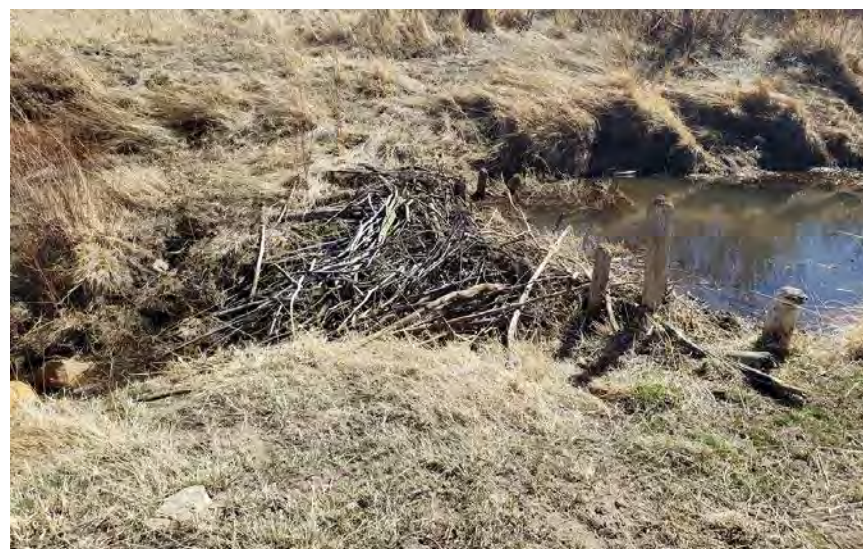
Figure 2.2: Beaver Dam Analog on Fish Creek. Image taken by Michael Beskid.

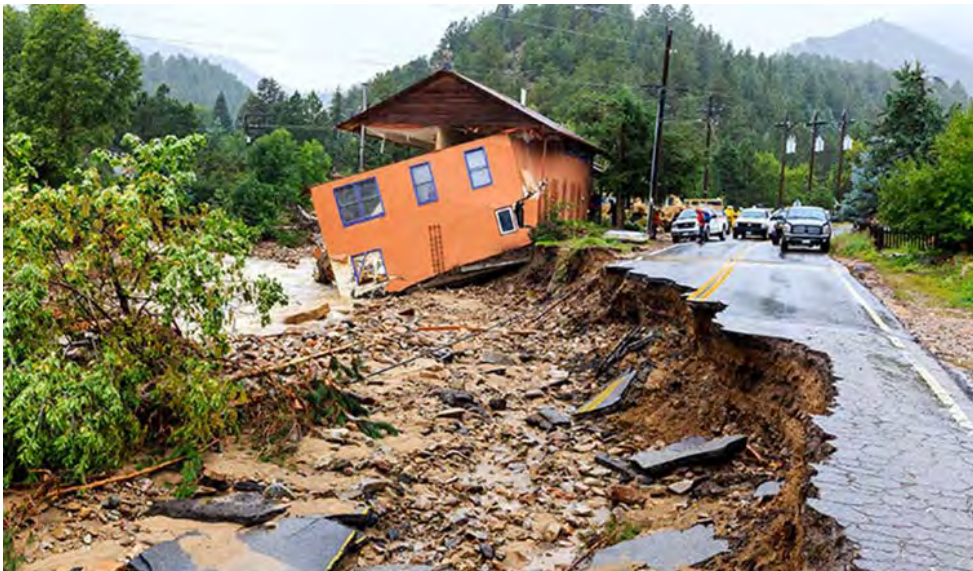
Figure 2.4: Building that collapsed into the stream following the flood in 2013 (Kwak-Hefferan).
