ESTES VALLEY WATERSHED COALITION

**WPG ENVIRO & REC- FISH CREEK AT
CHELEY CAMP RESTORATION**

FINAL REPORT

**PREPARED FOR: COLORADO WATER
CONSERVATION BOARD, WPG PROGRAM
ATTN: ANDREA HARBIN-MONAHAN**

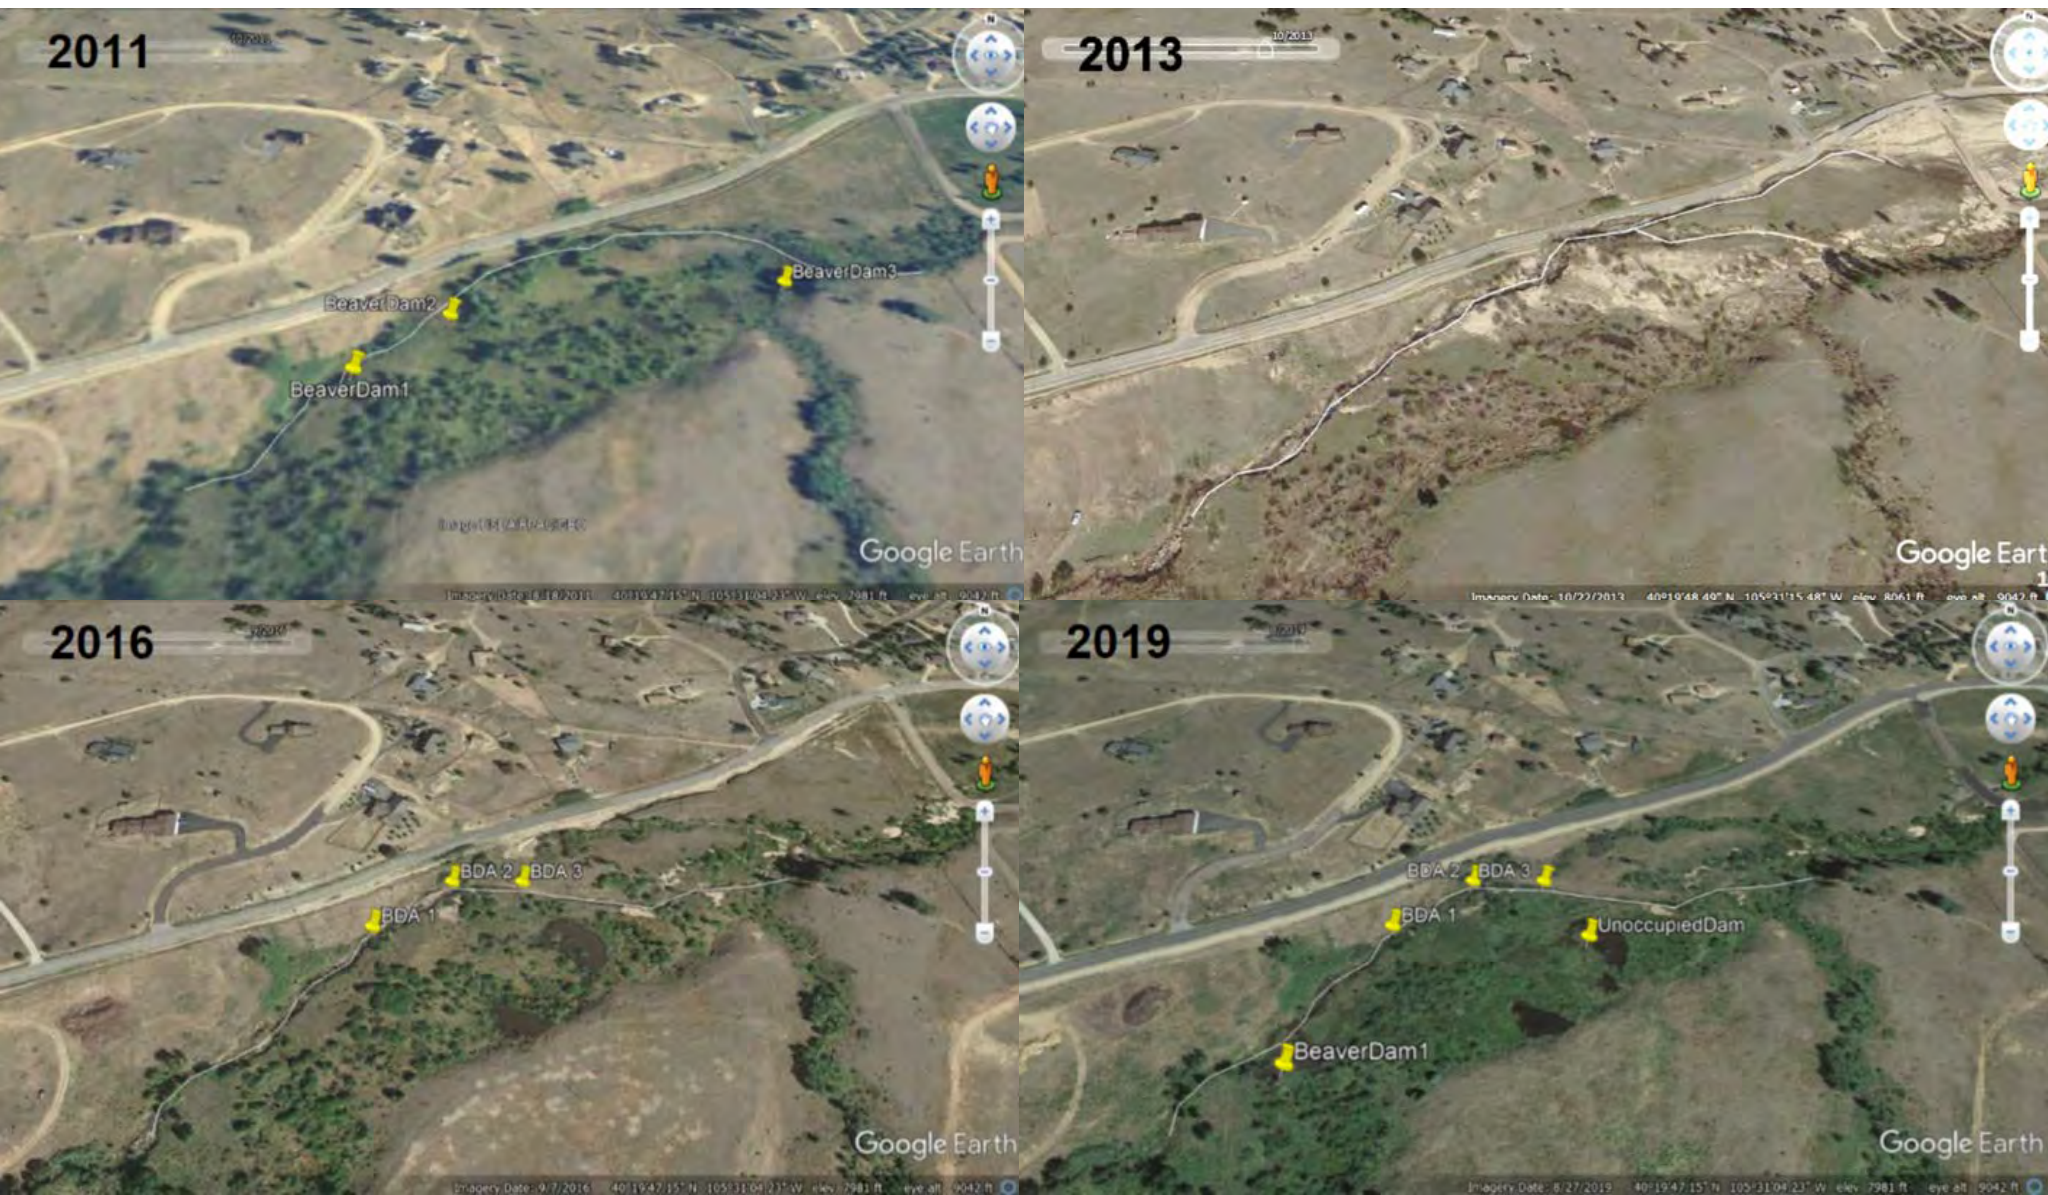
Figure 2.7: Maps of the Fish Creek riparian corridor over the last 20 years highlighting stream direction and beaver activity.

The results of the 2013 flood are seen in the third photo within Figure 2.7. The flood ripped out much of the corridor’s vegetation, including many aspen trees and willow bushes. This left the ground without a strong root system to contain the steady flow of the floodwater. The course of Fish Creek was altered considerably when the town dug the emergency channel to direct the stream away from the road. Despite the immediate success that the channel had in mitigating flood damage, the long-term consequences of this action have had a negative effect on the landscape. The channel funneled water out of the environment incredibly quickly, not allowing adequate time for the groundwater to recharge. This lower groundwater

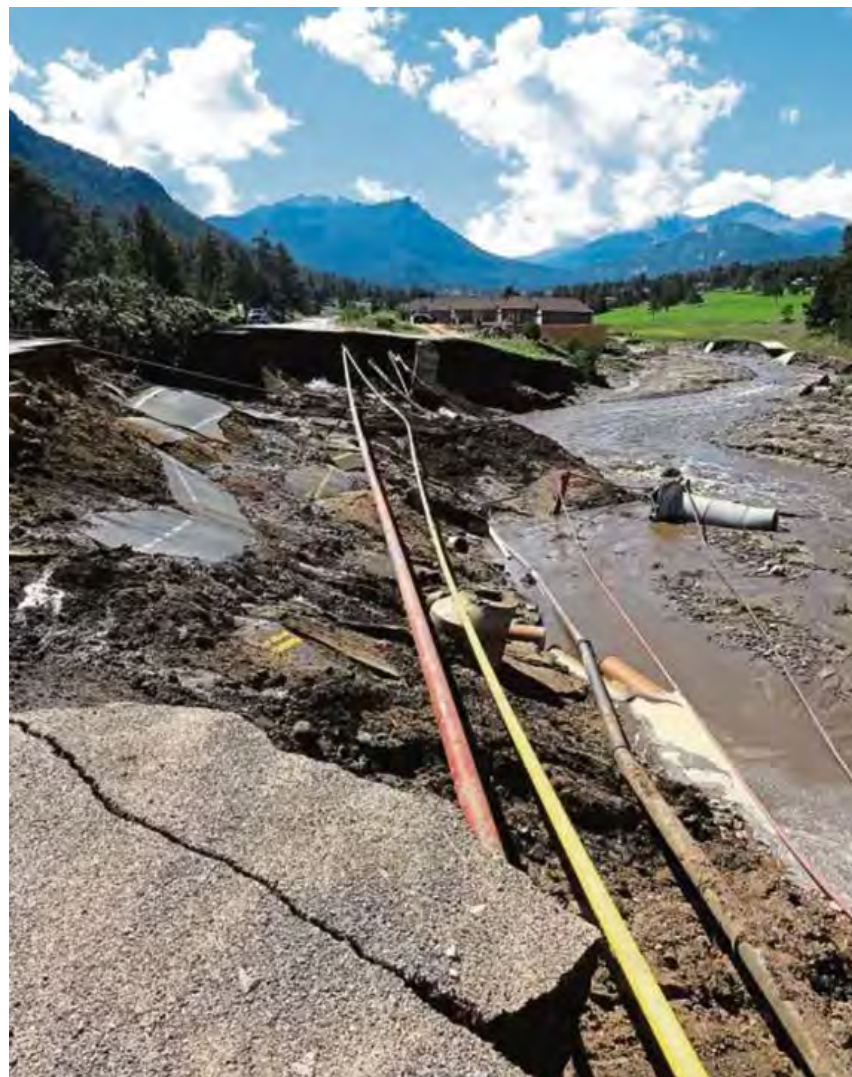
Figure 2.9: Collapsed road after the 2013 flood exposing unearthed pipelines (Town of Estes Park).

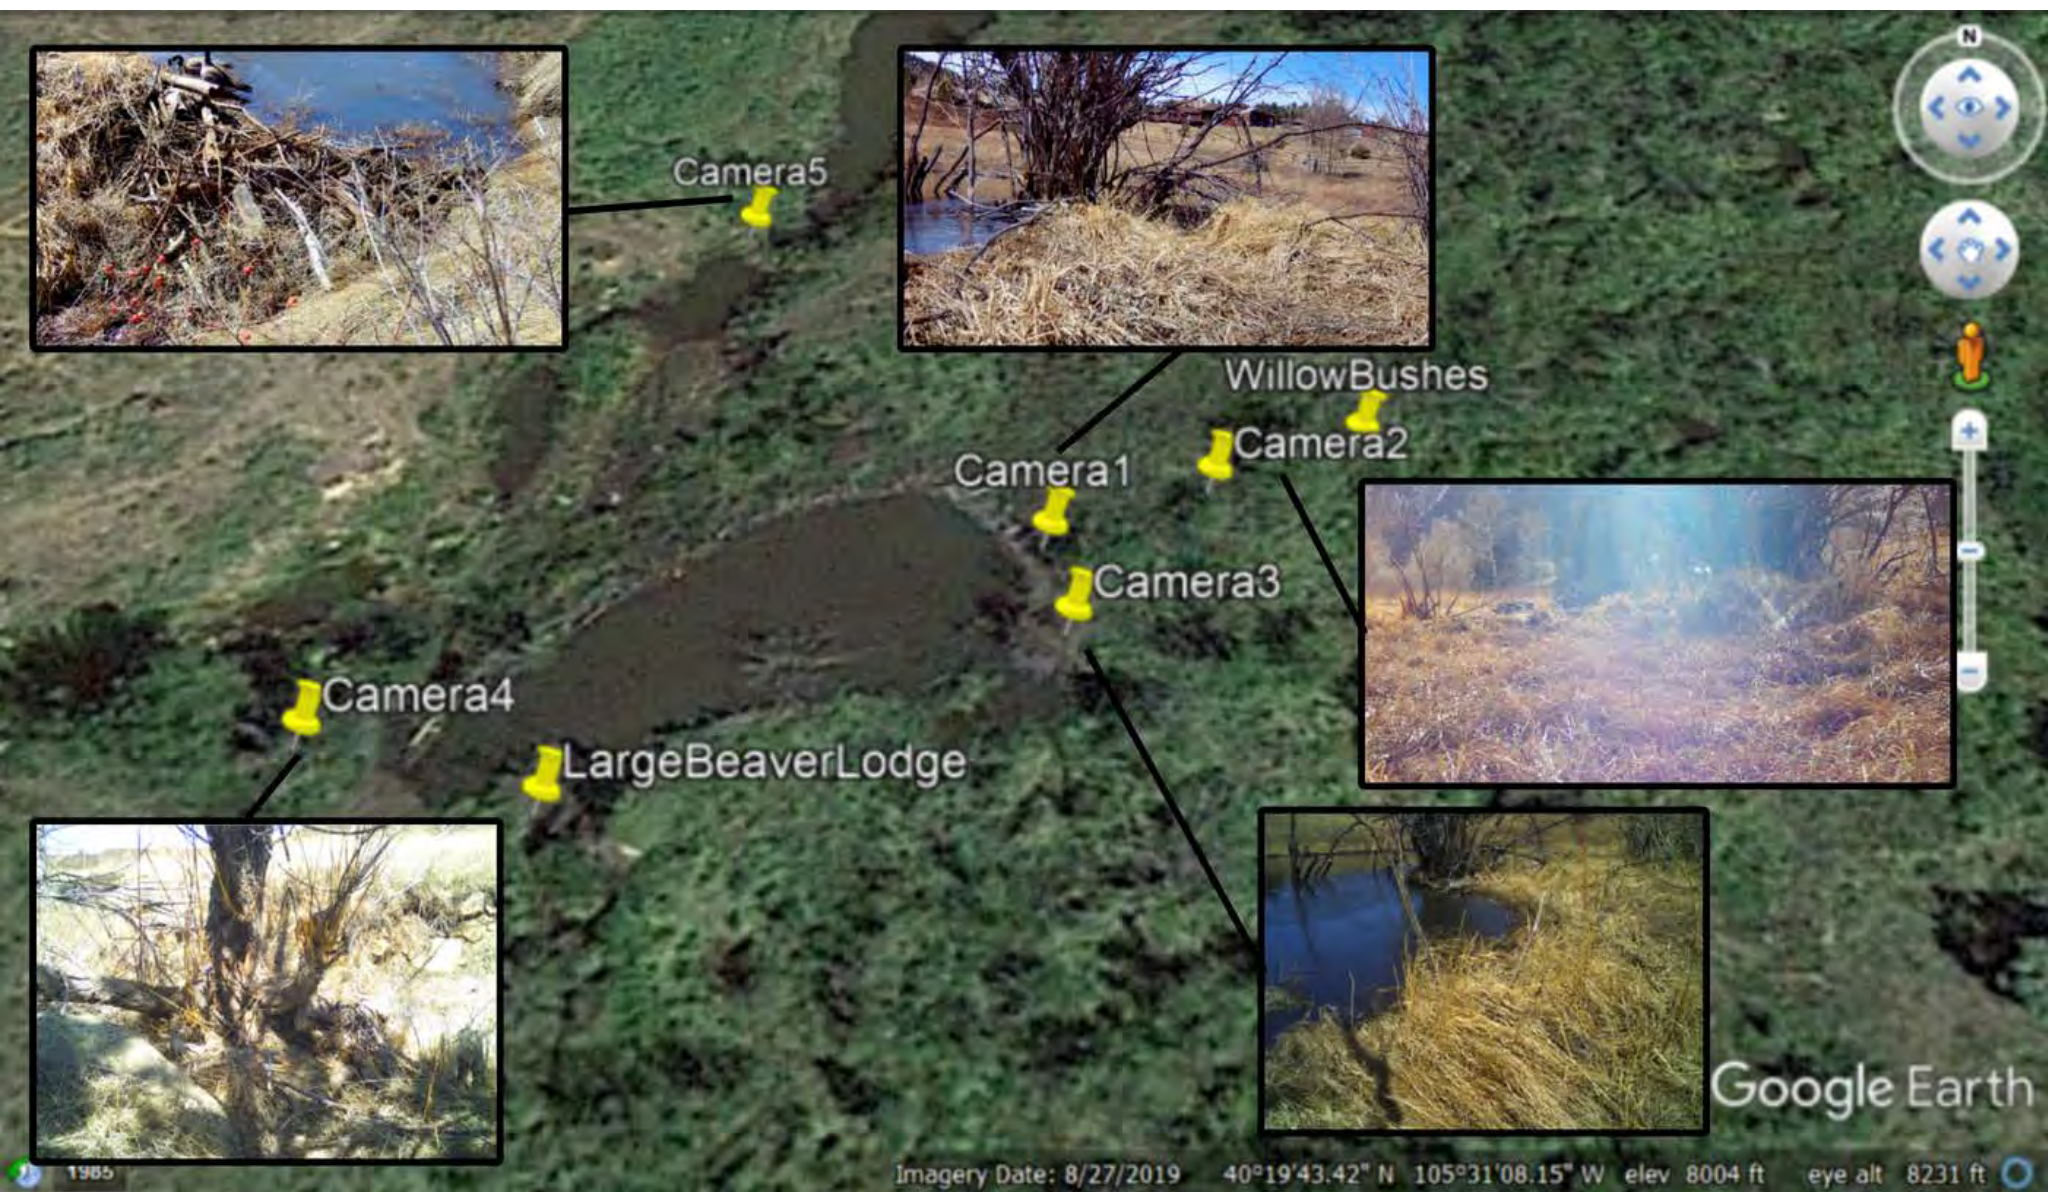
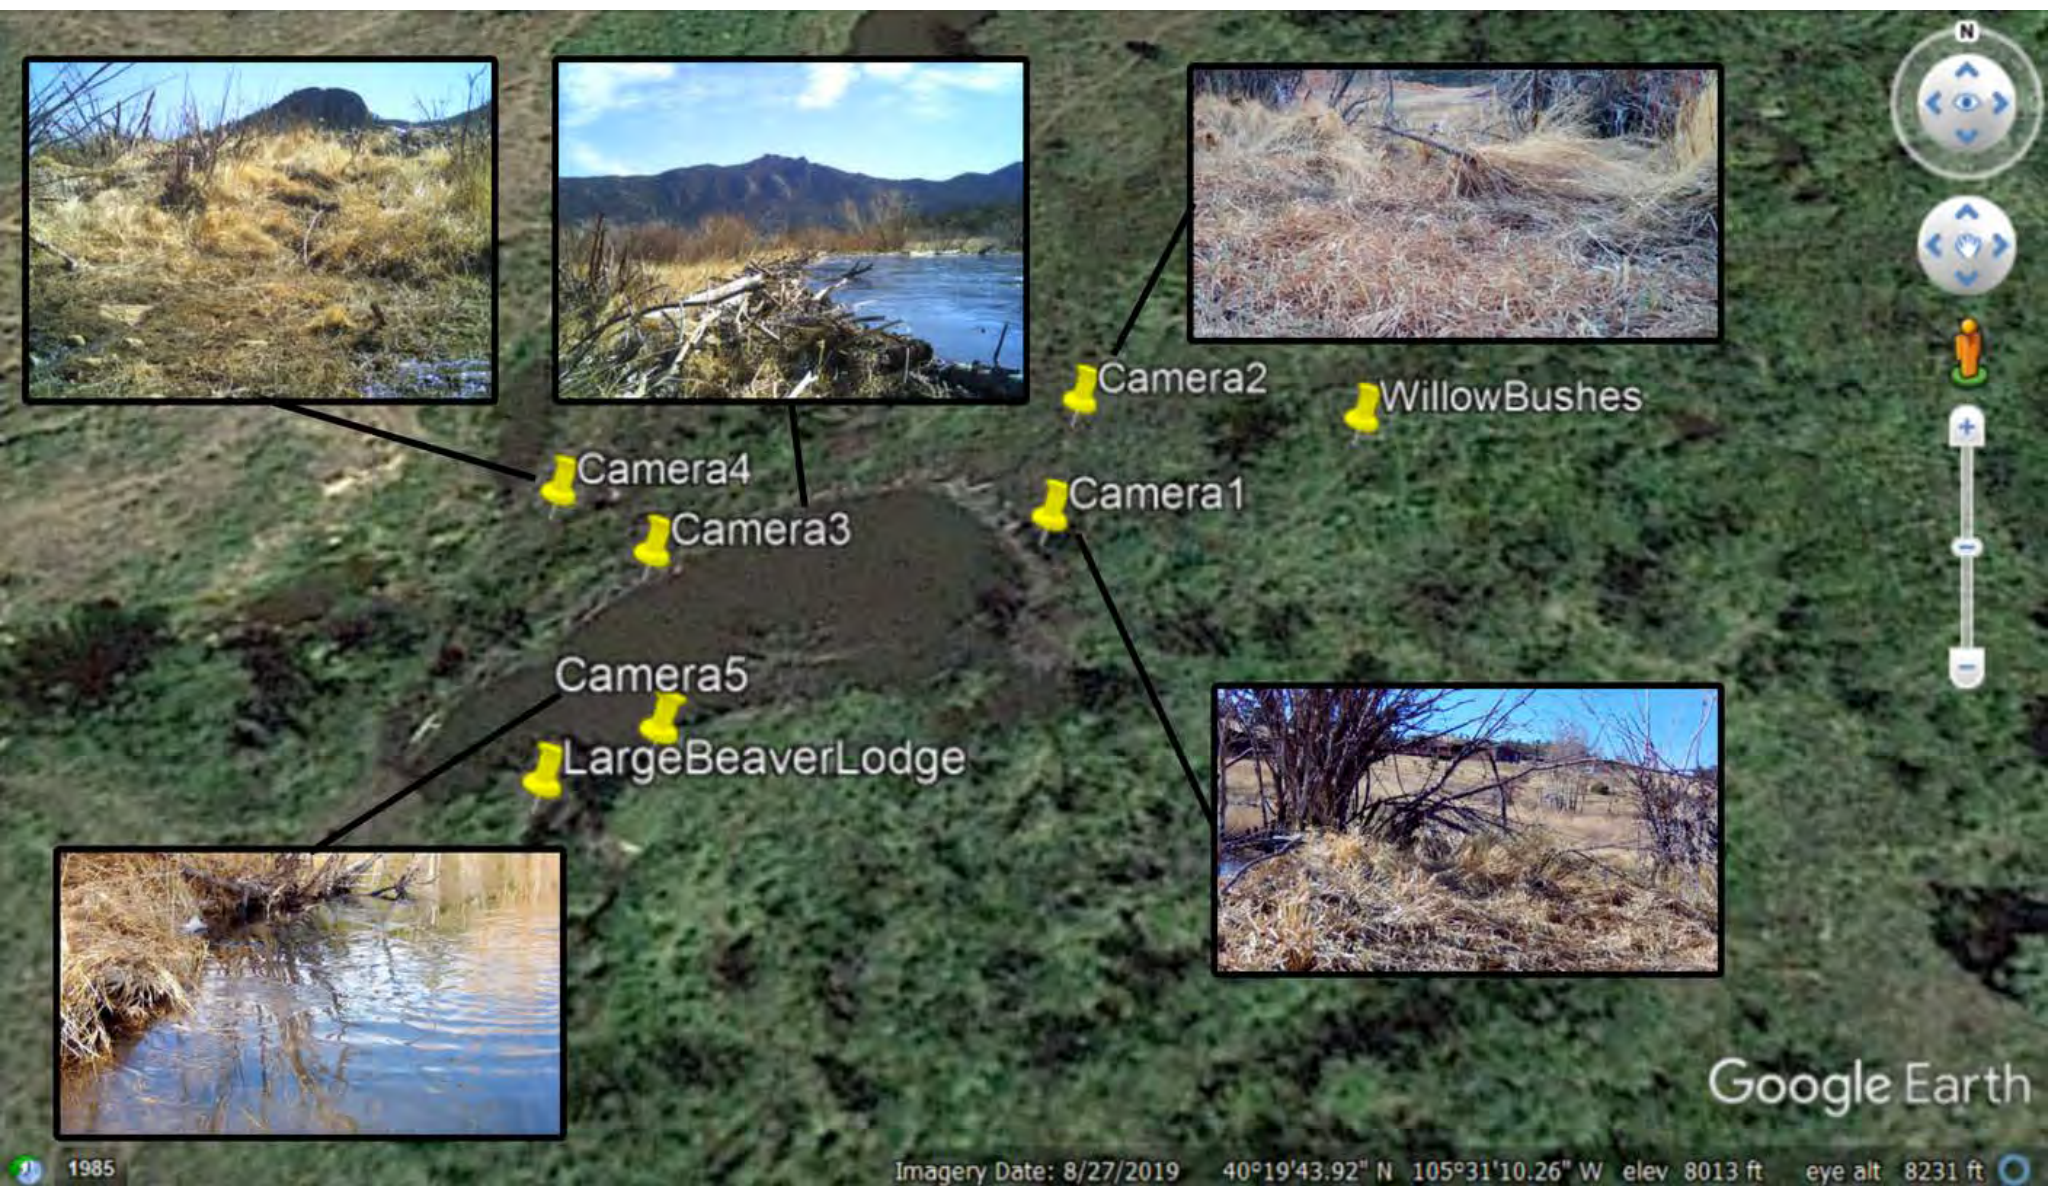
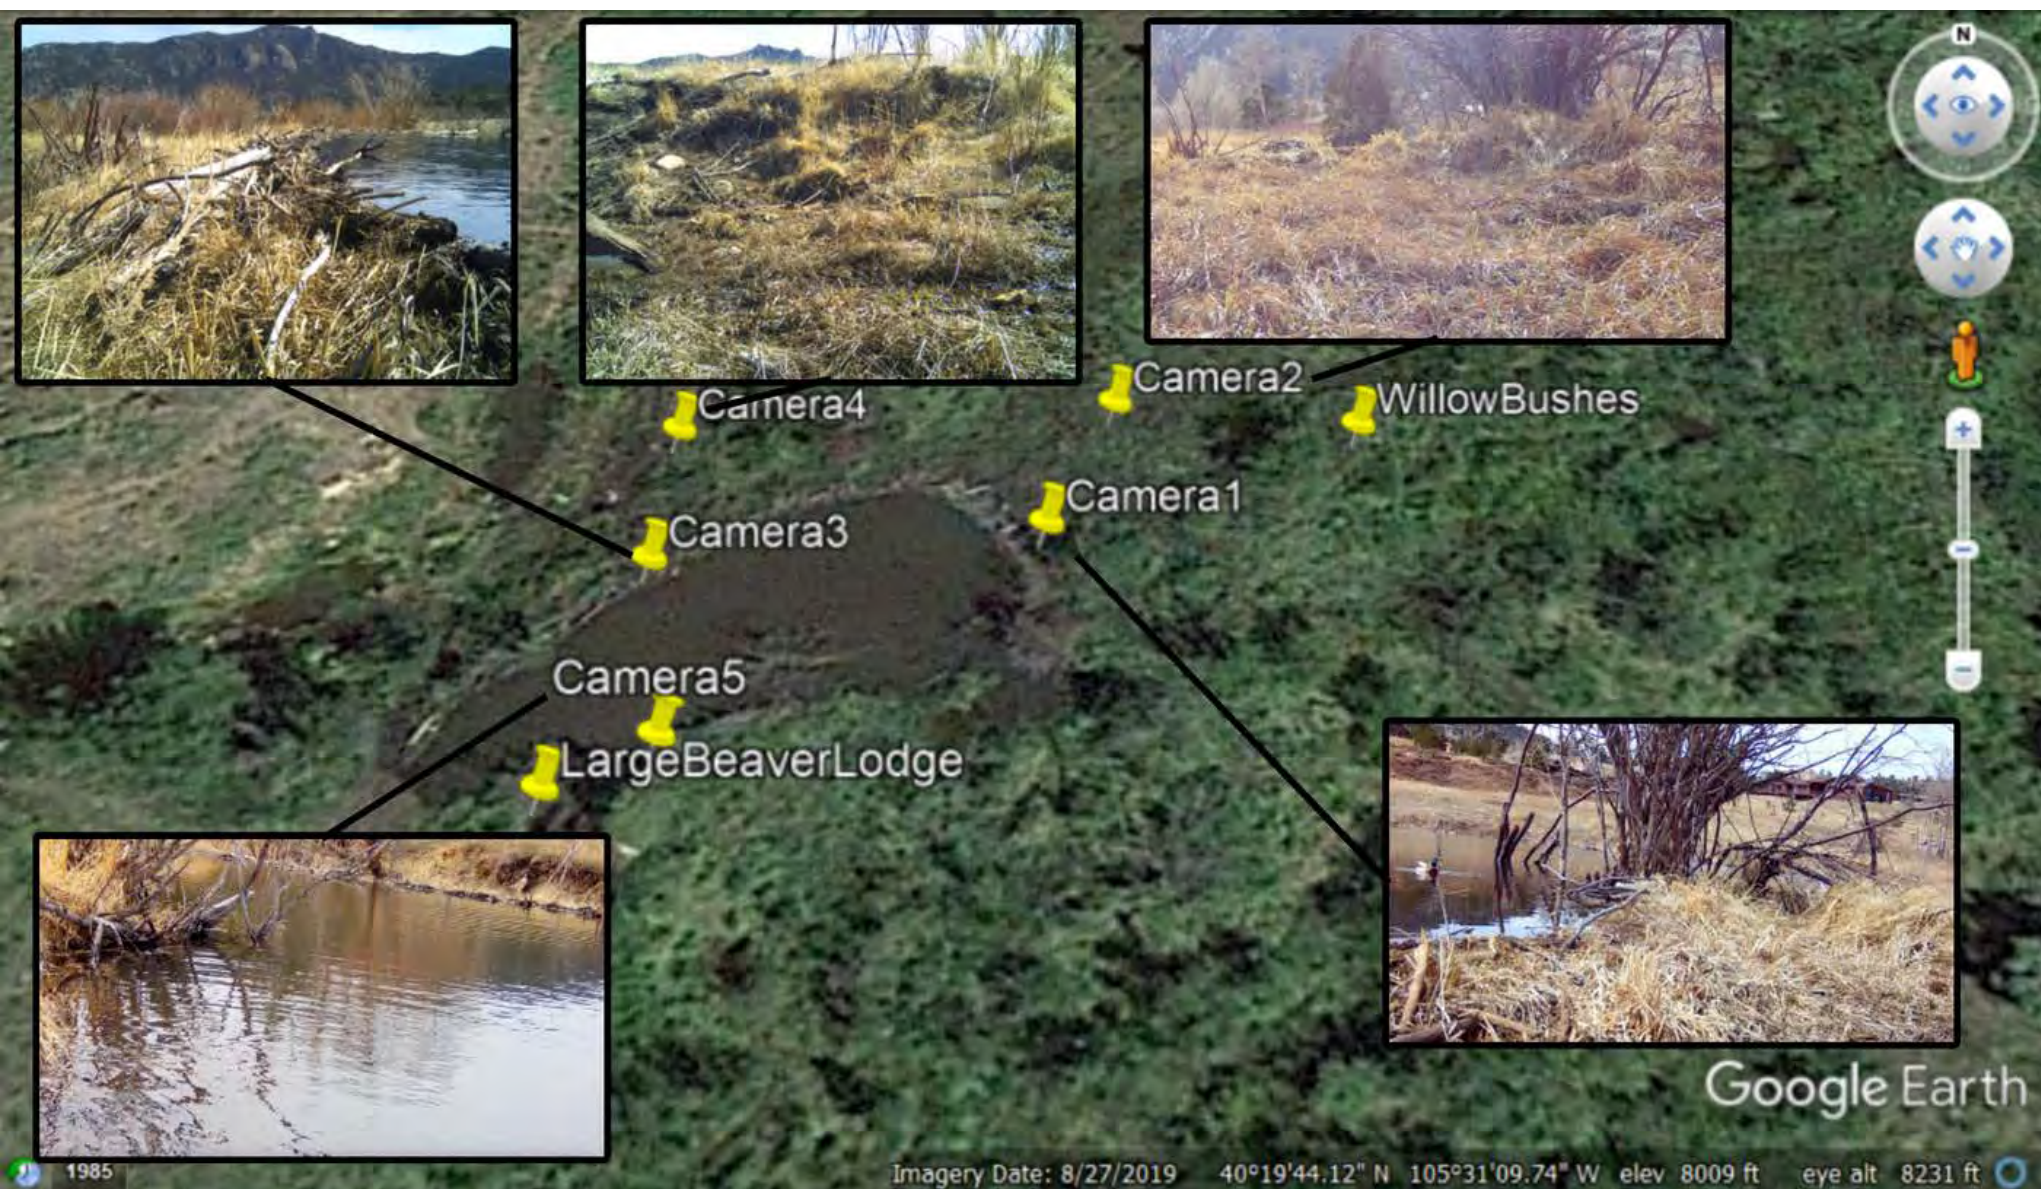
Figure 3.3: Map of Trail Camera Placement Around Beaver Pond in Week 1.

Figure 3.3: Map of Trail Camera Placement Around Beaver Pond in Week 2.

Figure 3.3: Map of Trail Camera Placement Around Beaver Pond in Week 3.

Figure 3.3: Map of Trail Camera Placement Around Beaver Pond in Week 4.

Our team conducted site visits twice each week to retrieve data from the cameras. We uploaded the data to a shared folder hosted by the Estes Valley Watershed Coalition and reassessed our camera placements as determined by capture rates and data quality. The new camera locations can also be seen in Figure 3.3. The cameras were checked to ensure they were operating properly, cleared of stored videos, and armed once again after being serviced. The trail camera data was used to estimate the population of beavers in the lodge, to make observations about their behavior patterns, and to identify their preferred food and building material choices and frequented locations. The results of these observations are displayed in the following chapter.

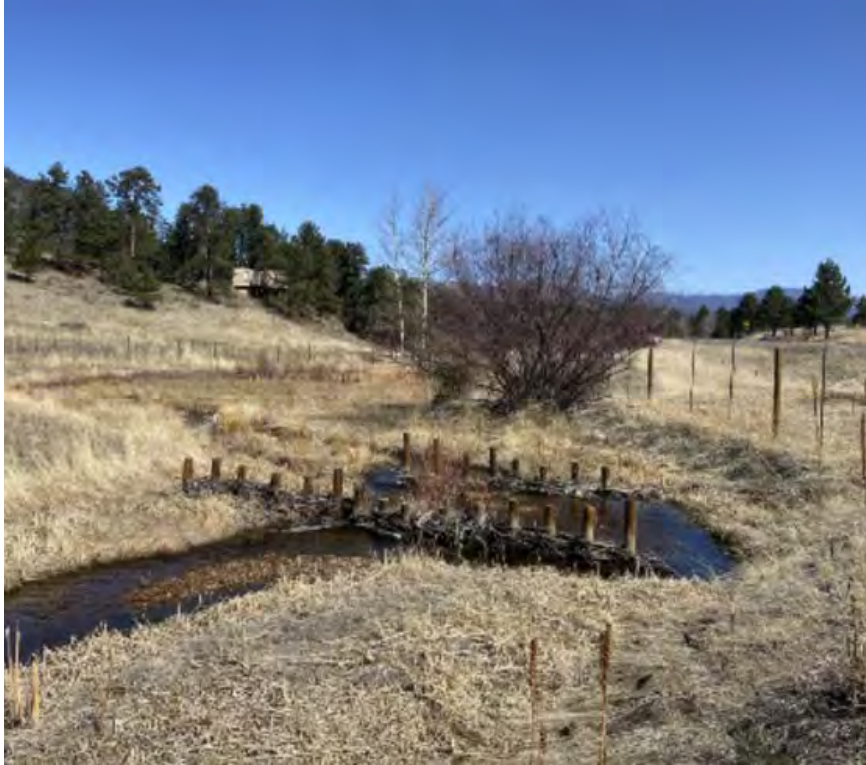
Figure 3.6: The area north of Brook Lane off Fish Creek where we harvested willow. Image taken by Michelle Pan.

Live staking willows at the site consisted of taking sections of willows and replanting them along the creek in areas where the beavers were building dams. The first step in live staking involved harvesting willow cuttings from an area north of Brook Lane off of Fish Creek, an area rich in willows shown in Figure 3.6.

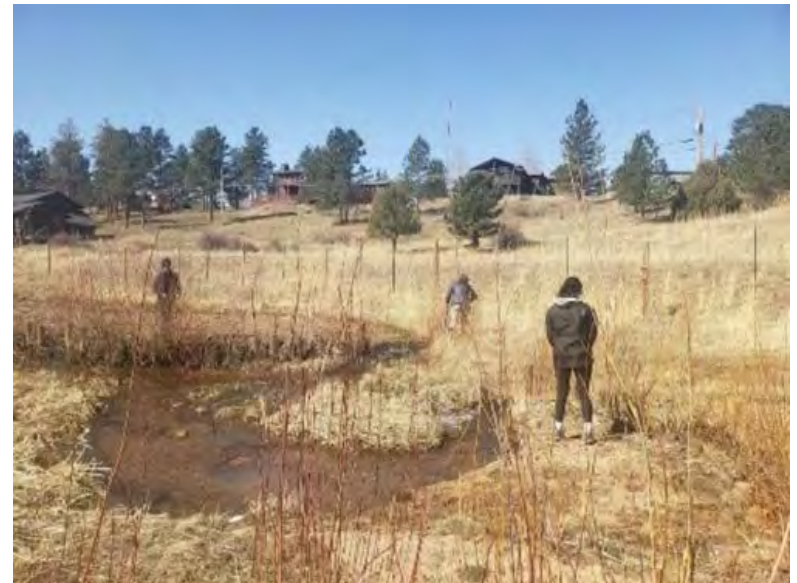
Figure 3.7: Harvesting willow bushes upstream of the Fish Creek riparian corridor near Brook Lane. Photo taken by Michael Beskid.

Working with the EVWC and its consultant firm, Stillwater Science, we selected about 170 healthy willow stems of $\frac{1}{2}$ to $1\frac{1}{4}$ inches in diameter. Our team focused on finding long, straight, stakes from the plants at least as wide as a pinky finger. Care was also taken to remove only a few stakes from each individual plant and to take clippings from a wide area in order to minimize the impact on the vegetation at the harvesting site.

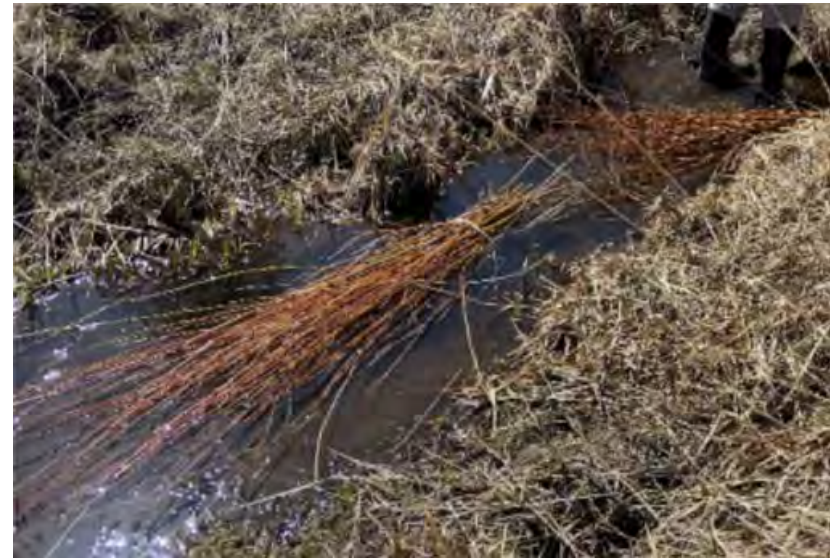
Figure 3.9: The bundles of harvested willow soaking in Fish Creek. Image taken by Michelle Pan.

Each stake was cut at a clean diagonal angle to allow for easier replanting later. The willow stakes were tied into two bundles of 100 stakes each and then taken to the active beaver pond at the Fish Creek site where they were submerged in the water for four days to increase the rate of root formation. The willow bundles can be seen soaking in Fish Creek in Figure 3.9.

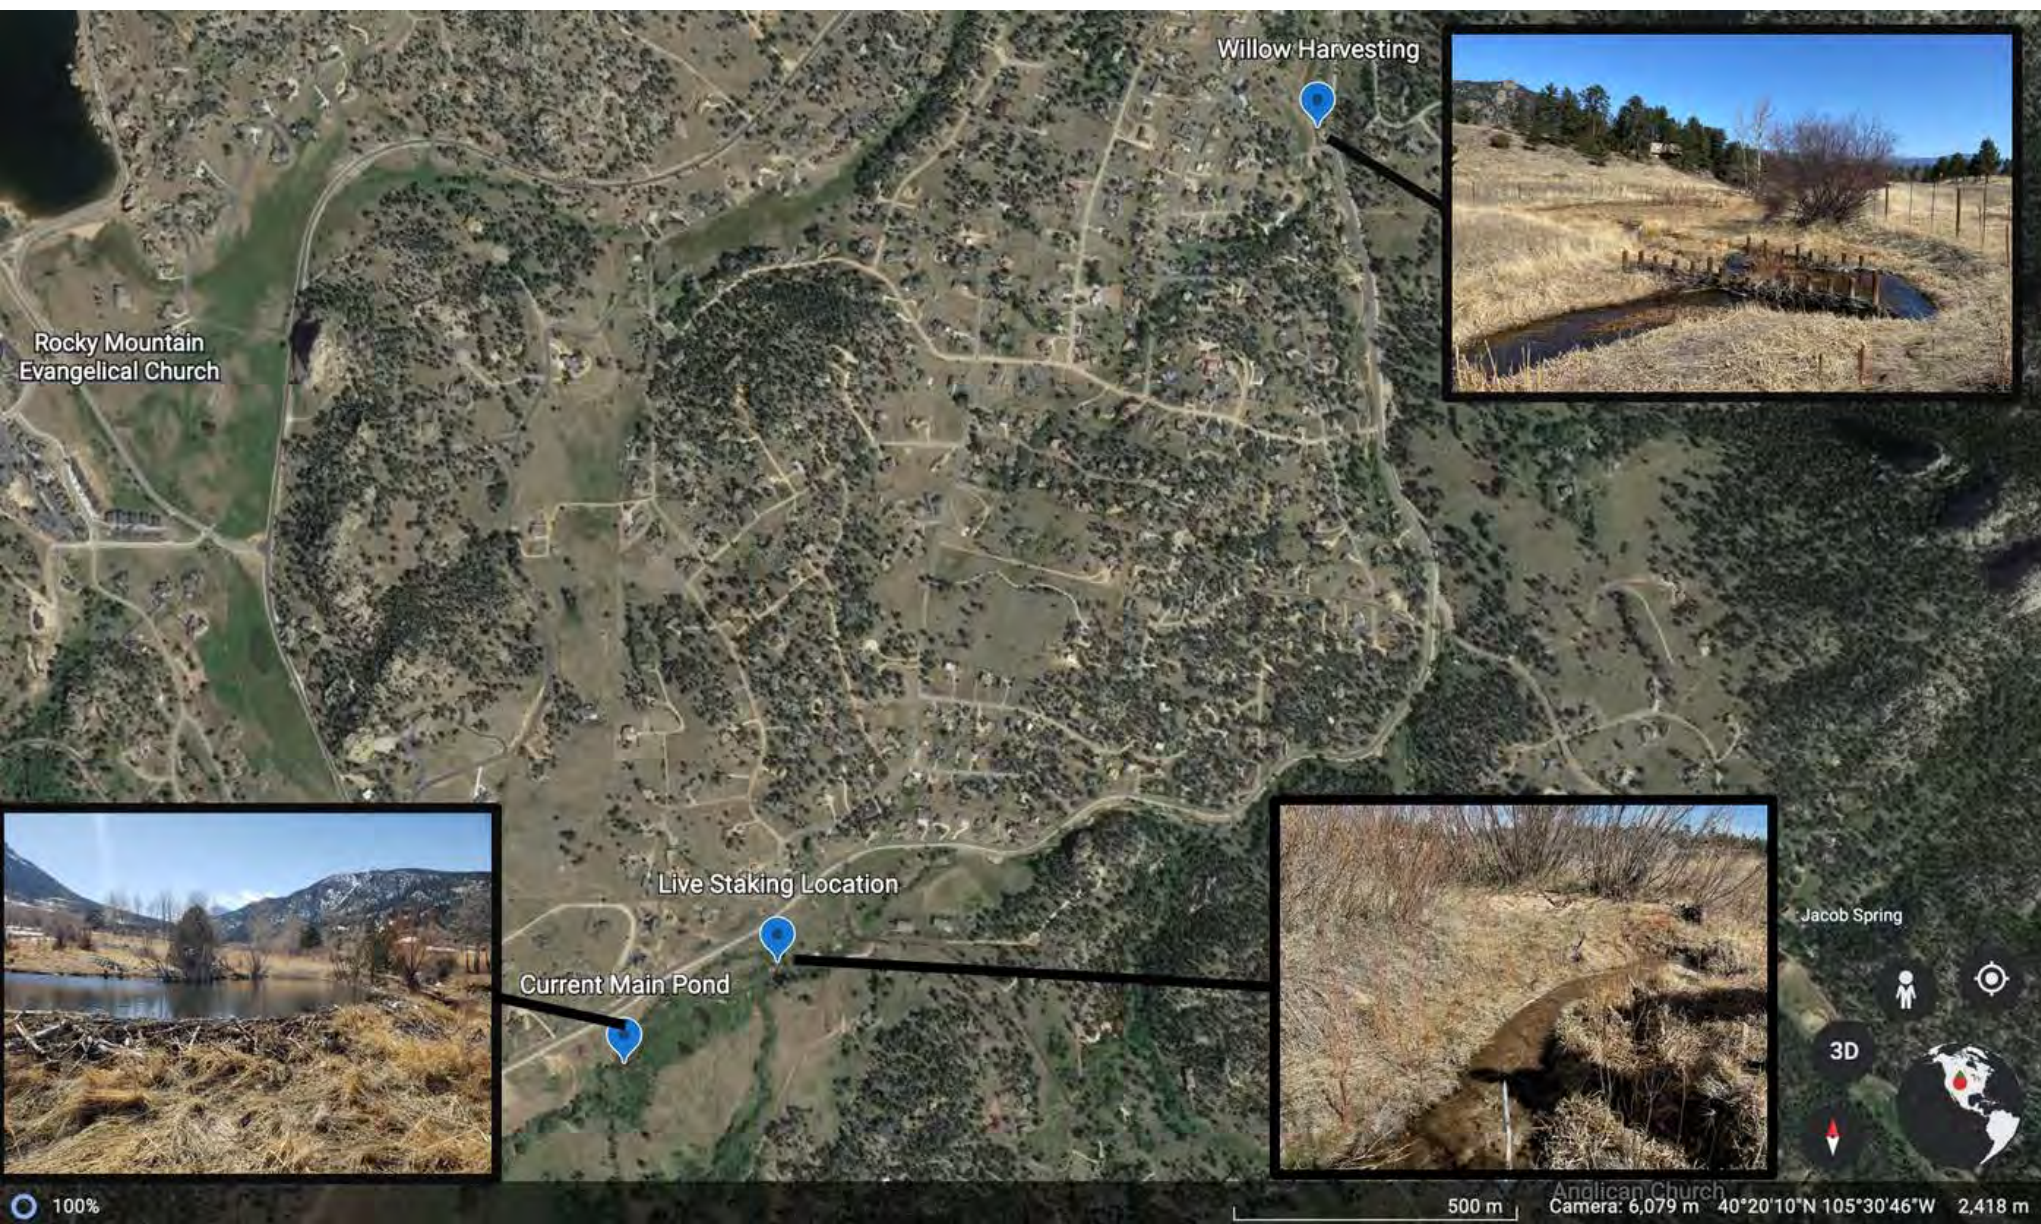
Figure 3.10: Map of where the willow was harvested and staked. Map made by Michelle Pan.

The area we chose for revegetation was a short distance downstream from the active beaver lodge. We chose a spot where the stream was shallower and flowed slower than in other areas, a suitable location for the beavers to dam. The location was also far enough away from the pond to reduce the likelihood that the beavers would forage at it before the transplanted willows had a chance to root. This new vegetation ideally will spread through the area providing resources to encourage the beaver population to seek new sites for lodges and dams downstream.

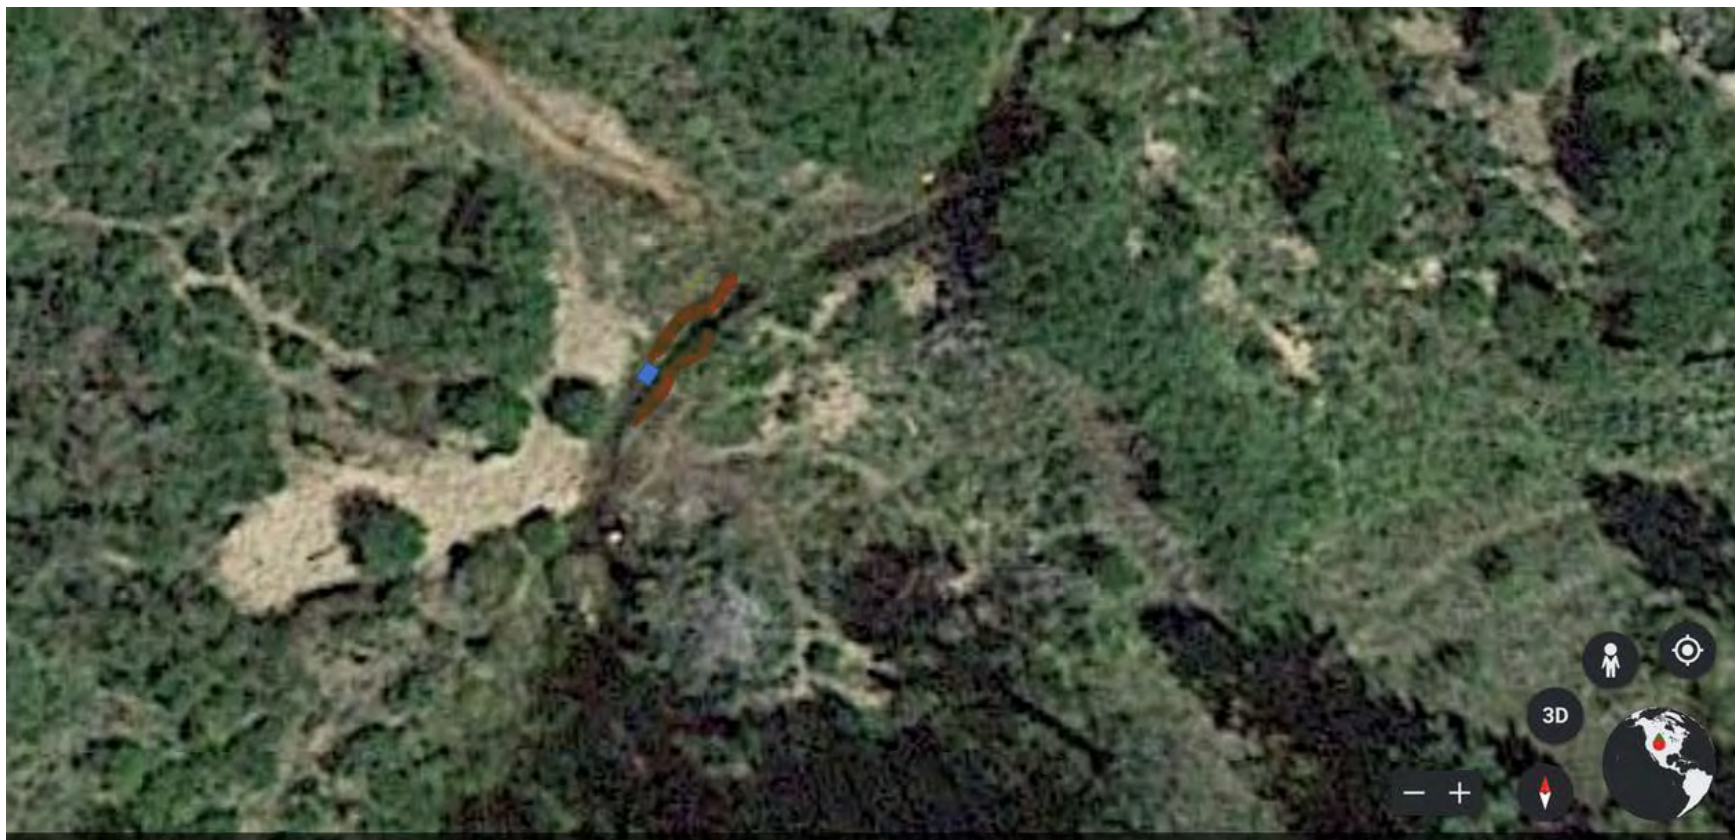
Figure 3.11: Where the willows were staked along the stream and BDA (blue box). Map made by Michelle Pan.

The willows were staked into the banks of the creek a distance downstream from the lodge and next to a BDA, as this is where Stillwater Sciences believed to be the best staking location. Figure 3.11 illustrates the locations of the stakes on a map of the site. The willows were staked on the banks close to the creek so the root systems would be close to the water and to reinforce the soil against erosion. This action will provide a future foraging source for the beaver population and will help to slow the stream and allow more time for the groundwater to recharge.

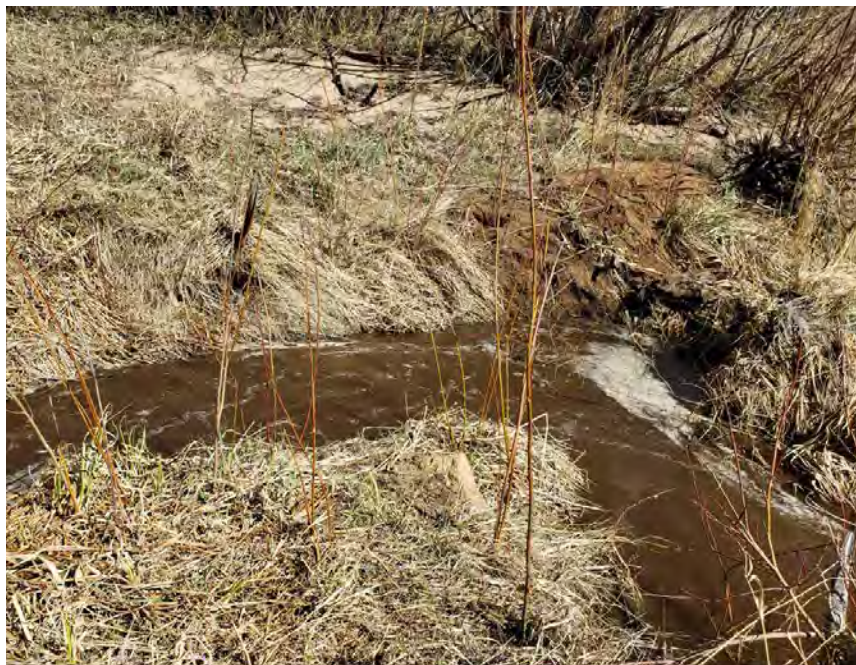
Figure 3.13: Staked willows on the bank of the Fish Creek site. Photo taken by Michael Beskid.

that energy would be focused on root formation instead of stem growth. After trimming, about 200 stems were inserted carefully into the ground along the stream banks about one foot away from the stream.

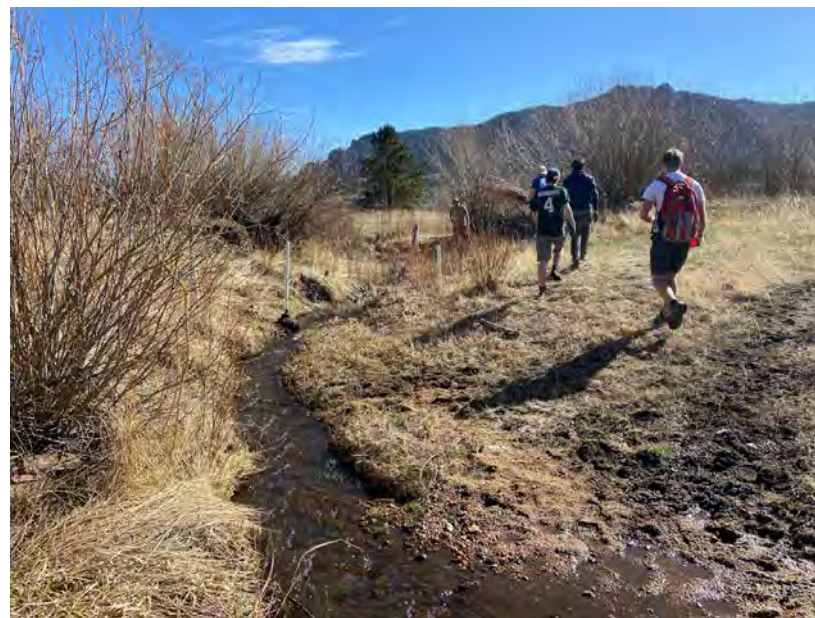
Figure 3.12: The area the willows were staked before staking. Image taken by Michelle Pan.

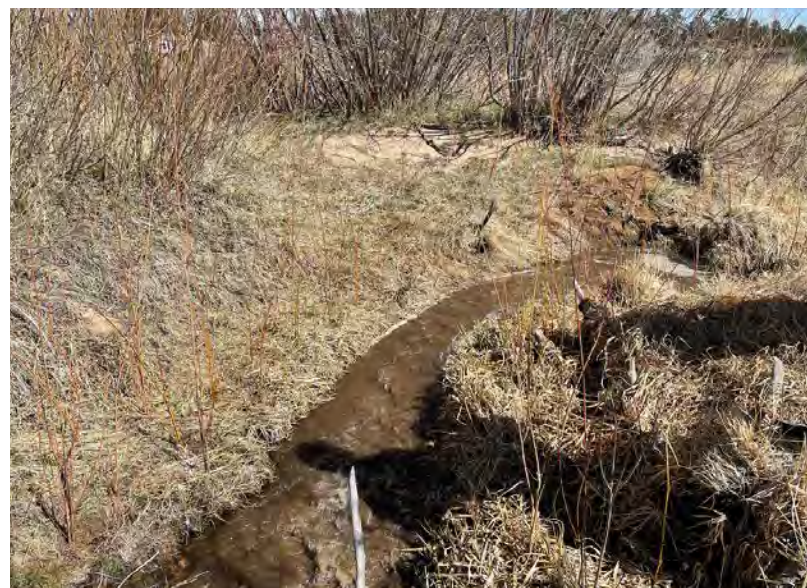
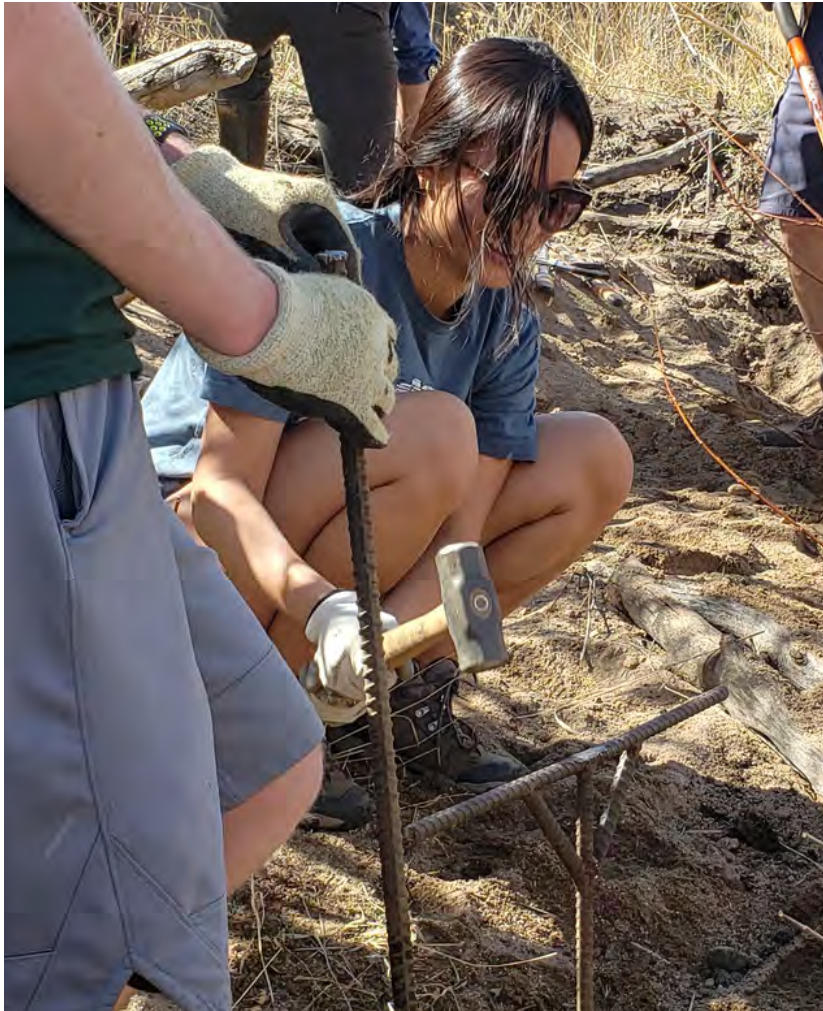
Figure 3.14: Team members staking rebar into the stream banks to prepare for willow planting. Photo taken by Michael Beskid.

Figure 3.15: Team members planting willow stakes along the banks of the creek. Photo taken by Michael Beskid.

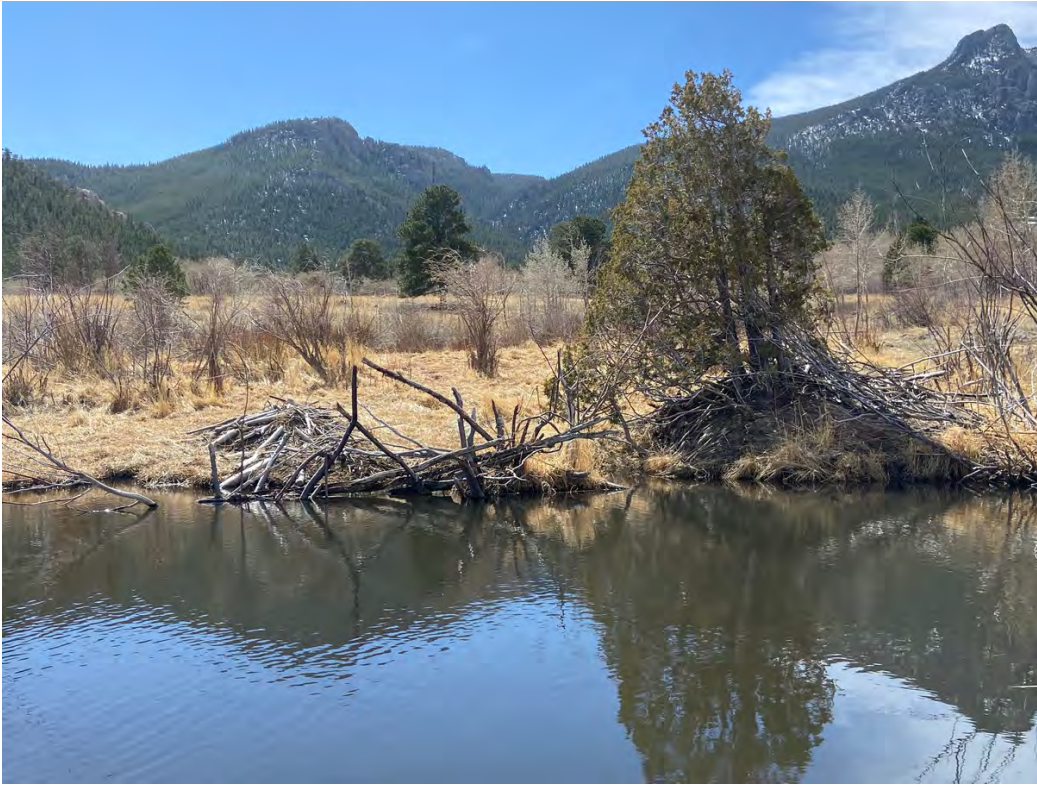
Figure 4.1: Two beaver lodges surrounding the main pond. Abandoned lodge (left) seen by dry mud and old sticks. Active lodge (right) seen by wetter mud and fresher sticks. Image taken by Michelle Pan.

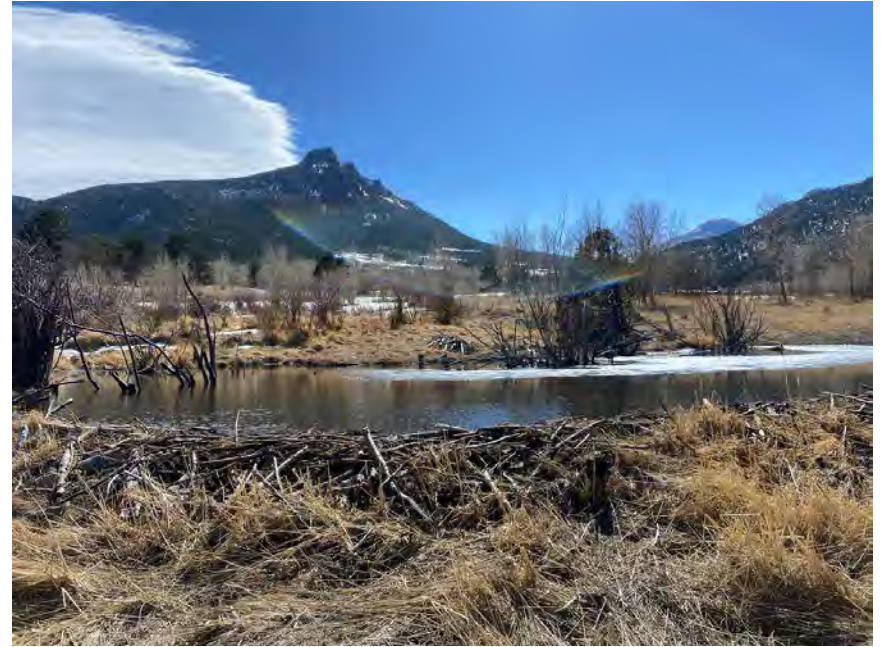
Figure 4.2: The Main Beaver Pond at the Fish Site Creek Facing the Active Lodge. Image taken by Michelle Pan.

Through our visits to Fish Creek, we have determined four locations around the active pond shown in Figure 4.2 that were rich in aspen and willow; these areas are denoted by blue stars in Figure 4.3. These four locations were used in developing maps of the potential routes the beaver was taking to get resources.
