ESTES VALLEY WATERSHED COALITION

**WPG ENVIRO & REC- FISH CREEK AT
CHELEY CAMP RESTORATION**

FINAL REPORT

**PREPARED FOR: COLORADO WATER
CONSERVATION BOARD, WPG PROGRAM
ATTN: ANDREA HARBIN-MONAHAN**

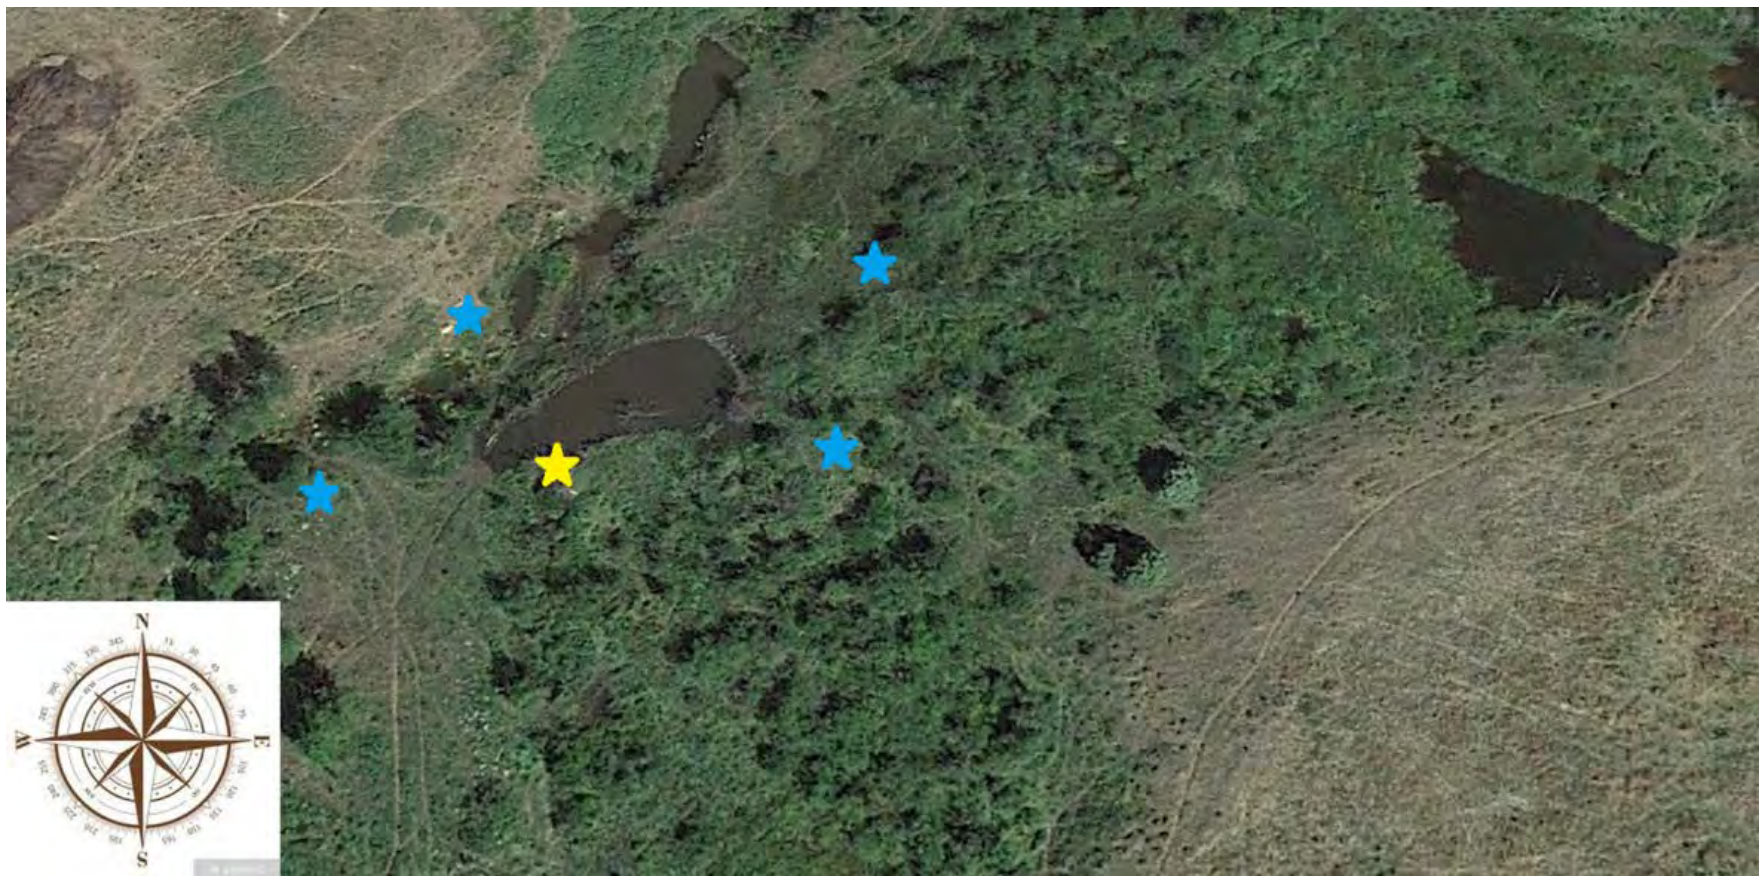
Figure 4.3: Annotated Map of Beaver Foraging Locations. Lodge Identified by Yellow Star. Foraging Locations Indicated by Blue Stars. Map made by Joshua Fernandez.

Through our visits to Fish Creek, we have determined four locations around the active pond shown in Figure 4.2 that were rich in aspen and willow; these areas are denoted by blue stars in Figure 4.3. These four locations were used in developing maps of the potential routes the beaver was taking to get resources.

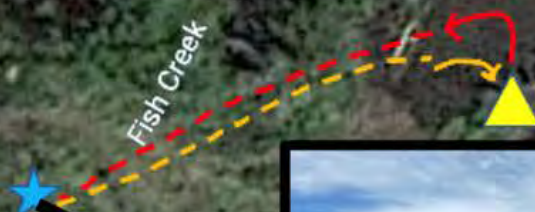
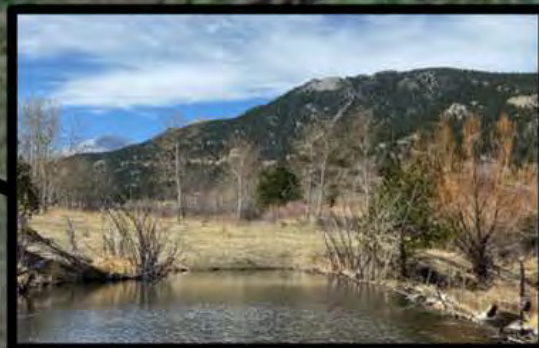
Seen Exiting the Lodge Heading West
April 12: 7:13PM, 7:25PM,
April 18: 5:12AM
April 20: 10:27PM, 11:28PM
April 22: 3:43AM, 4:56AM

Figure 4.7: One route the beaver is likely to have traveled to get to the aspen trees. Map made by Michelle Pan.

However, we saw the beaver heading in a southern direction which is why we predicted it was heading towards the southeastern area of willow. Figure 4.7 was made using the camera facing the entrance of the lodge where the beaver was seen heading west out of the lodge.

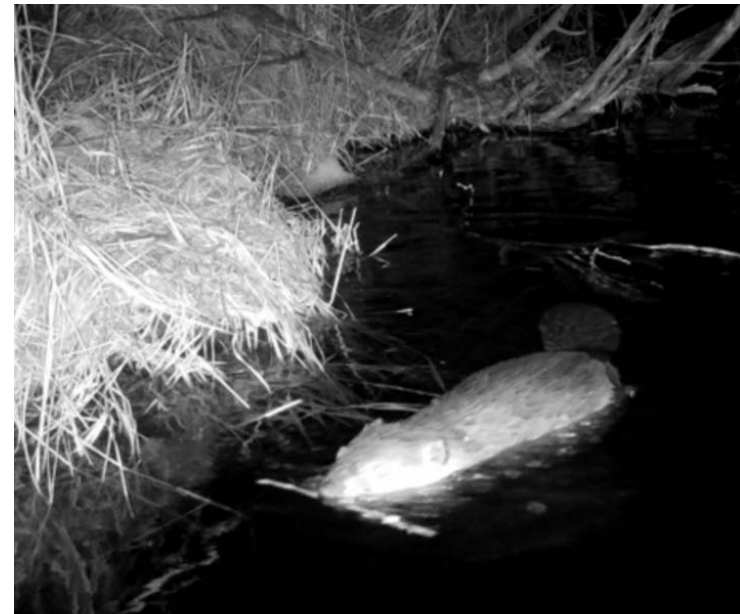
Figure 4.9: An image of a beaver swimming with a willow branch near the active beaver lodge. Image captured through one of our cameras on site.

The beaver primarily used aspen trees and willows for feeding and maintaining its lodge and the dams at the site. Some of the footage we collected shows the beaver swimming into the lodge carrying willow branches, an example of which is shown in Figure 4.9, confirming this behavior.

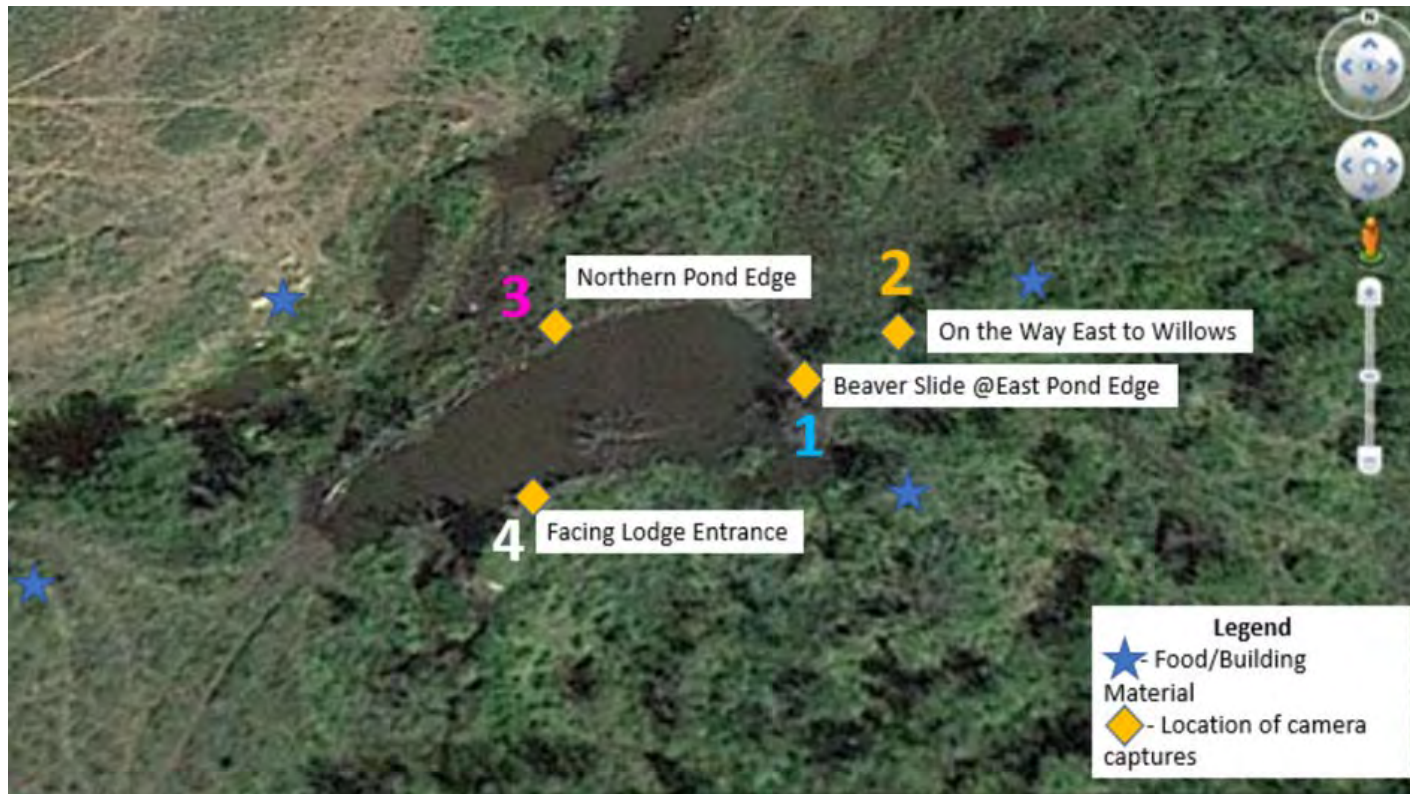
Figure 4.11: Locations described in figure 4.10. Map made by Michelle Pan and Joshua Fernandez.

suggesting that the beaver prefers foraging on the east side. A graph showing the frequency of beaver captures that we obtained per area is shown in Figure 4.10 and a map of these four locations in relation to the foraging sources is shown in Figure 4.11.

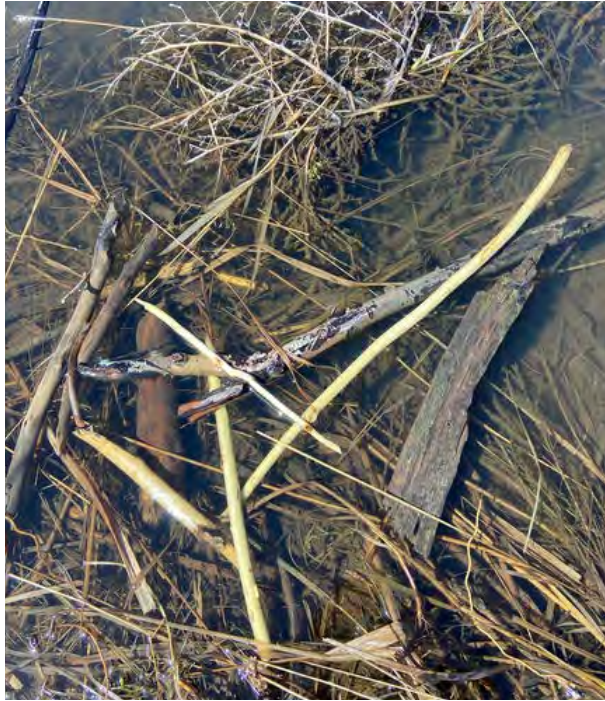
Figure 4.12: De-barked aspen and willow floating in the main pond. Image taken by Michelle Pan.

We visited the Fish Creek site two times a week for four weeks and surveyed the site for beaver activity as well as for signs of other plant and animal species. We identified signs of the beaver's feeding preferences through various bite marks on trees and twigs surrounding the main lodge as seen in Figure 4.12. By the pond where the beaver lodge is located, we saw many floating aspen sticks that had been debarked, a telltale sign of a beaver's presence as beavers typically eat the bark and leave willow branches stripped. We also found green plant leaves

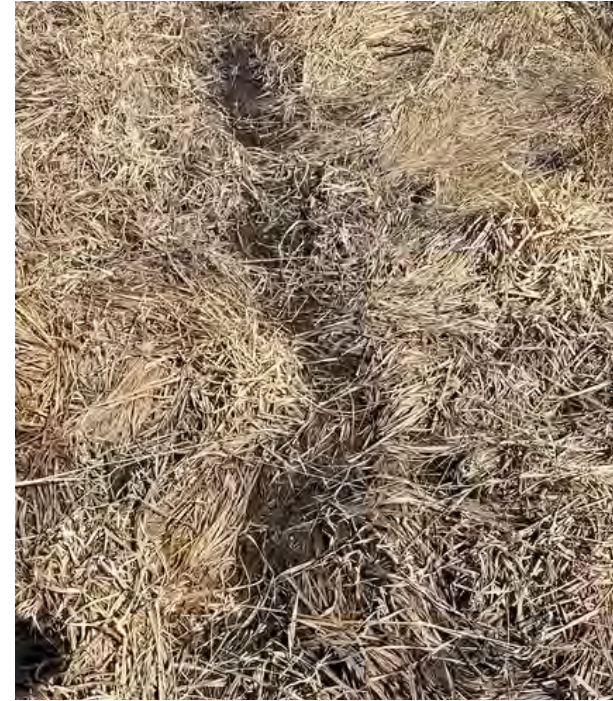
Figure 4.13: Slide coming out of the main pond. Image taken by Michelle Pan.

from this year's growth floating in the water, showing that the beaver's activity in the area is recent. Additionally, we saw slides out of the pond as seen in Figure 4.13 and evidence of beaver feces, indicating its movement around the site. The slides can help identify which ponds the beaver is actively visiting or what paths it is taking to get resources. The feces in the active pond are also another sign of a beaver's presence since they typically defecate close to the lodge.

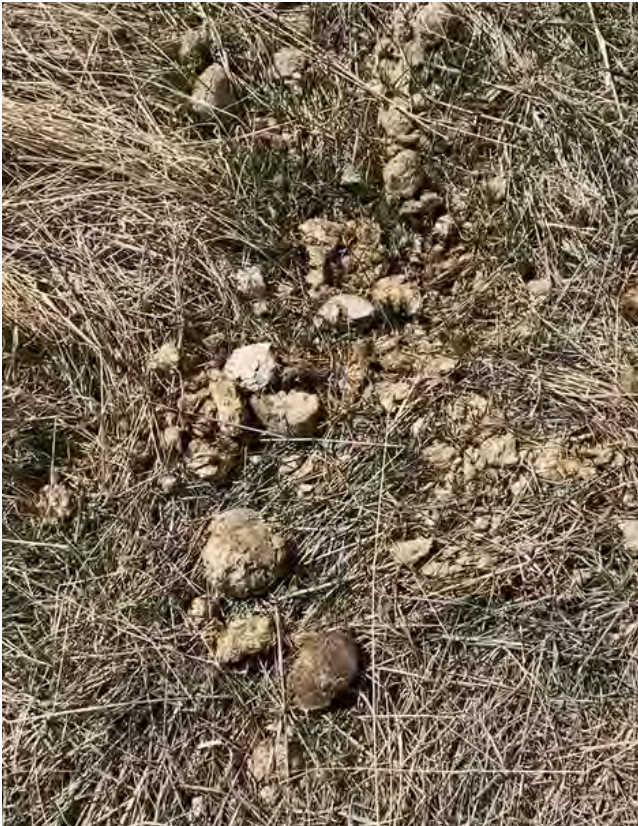
Figure 4.14: Dried horse scat. Image taken by Michelle Pan.

Our team was able to identify signs of other animals passing through the area from the droppings present in the vicinity of the beaver pond. Evidence of horses was found most often at the site as we found dried horse scat as seen in Figure 4.14, since the owners of Cheley Ranch use the area as a grazing zone for up to 150 horses. Evidence of elk was also found through elk scat scattered around the site, pictured in Figure 4.15.

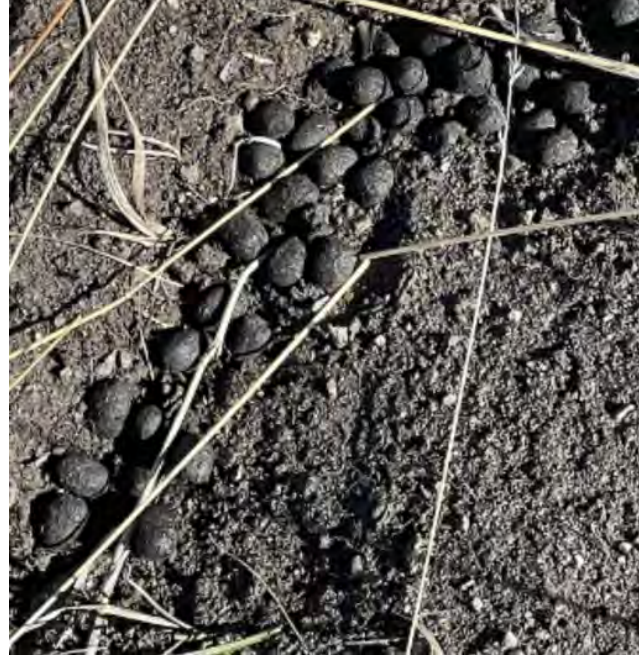
Figure 4.15: Older elk scat seen, indicating the presence of elk roaming through Fish Creek. Image taken by Josh Fernandez.

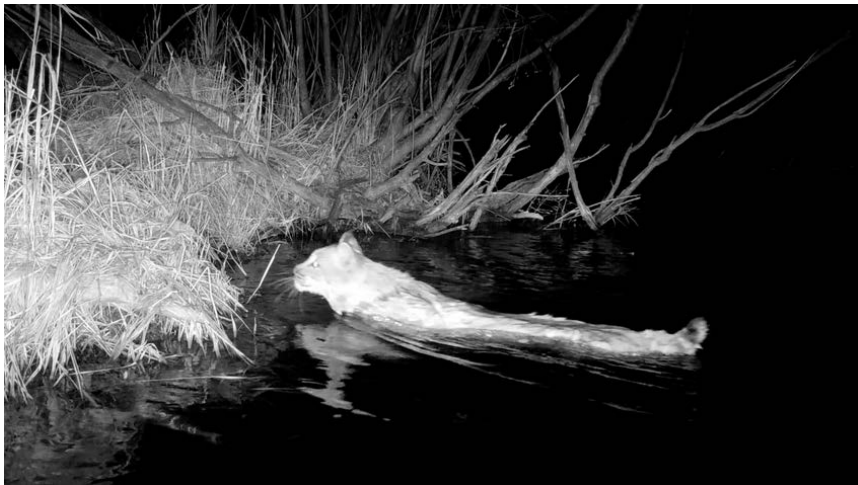
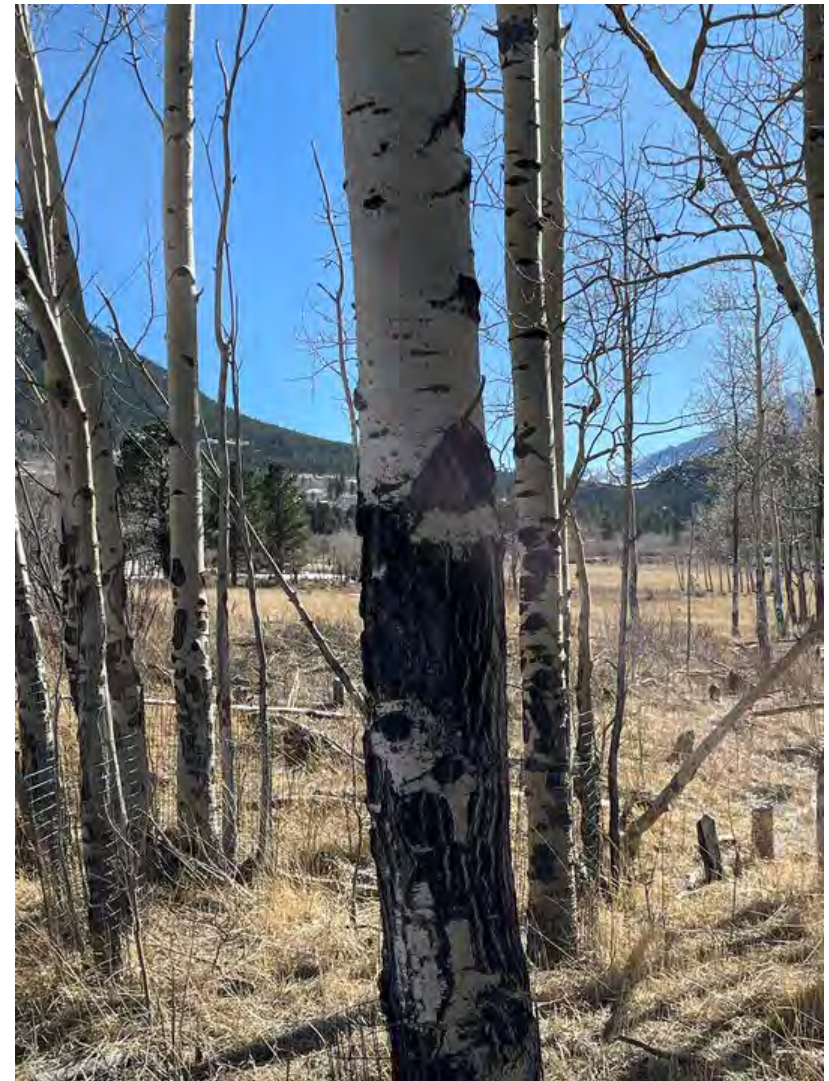
Figure 4.17: Aspen tree with elk and mule deer grazing marks. Image taken by Michelle Pan.

most of the aspen trees had bark eaten off as seen in Figure 4.17. This was most likely grazed by elk and mule deer since the debarked parts of the aspens were above the reach of beavers. Additionally, as Andy Ames, a member of the Estes Valley Watershed Coalition Board of Directors pointed out, we saw many willows whose branches appeared to be nibbled on by elk and/or mule deer. This led us to believe that the beaver's main competition for aspen and willow is mainly with elk and mule deer. Knowing this information also informs us as to where the best locations to stake willow for the beaver along the main creek and its tributaries are.

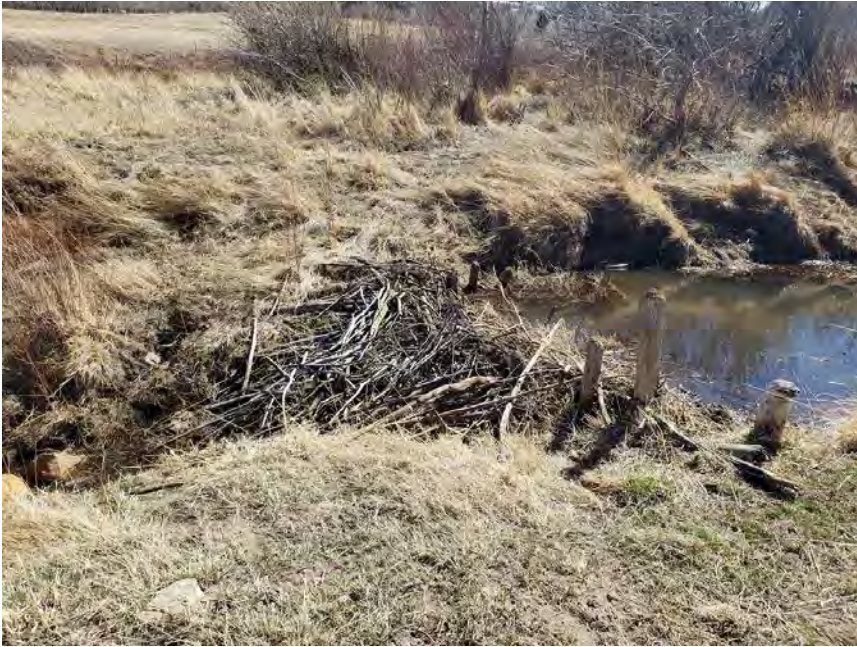
Figure 4.18: A BDA on the Fish Creek site that is being maintained by the beaver. Photo taken by Michael Beskid.

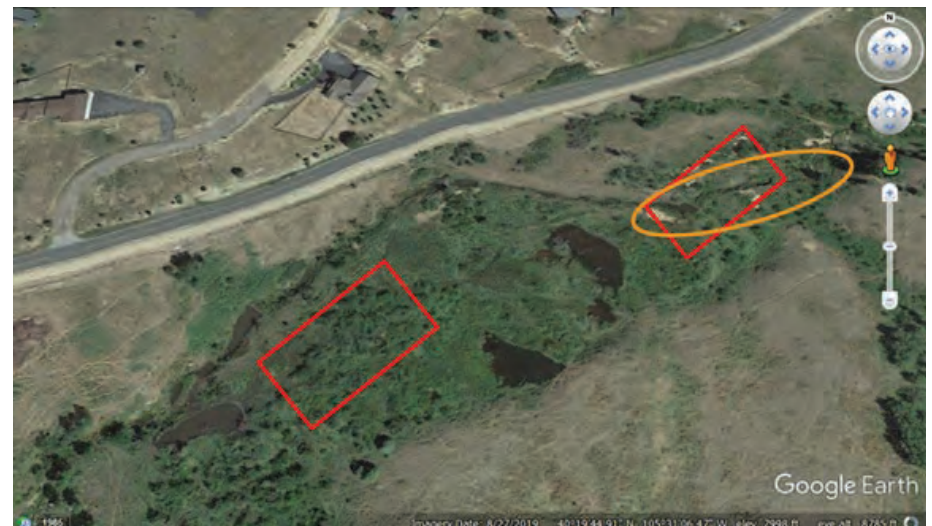
Figure 5.1: (Orange Circle) Where we recommend planting new willows to revegetate the area. (Red Boxes) Areas where we recommend fencing in Fish Creek to prevent overgrazing by mule deer and elk based on current willow populations.

Based off the evidence of other animals roaming through the Fish Creek site that we collected, we believe it is likely that there is competition with the beaver population for resources. To make sure the willow plants are given time to grow, we recommend that the area surrounding the site should be fenced to prevent the local deer and elk from grazing the willow and aspen plants. Recommended fencing locations can also be seen in Figure 5.1. This fence should have enough space to allow the beavers to enter and exit the site freely so that they can continue their work to heal the landscape. This fencing will be useful when mule deer and elk eventually migrate through the area preventing them from interfering with the willows that were previously staked. We recommend limiting the total amount of fencing to mainly focus on the areas around newly staked willow and along the dense willow area directly east of the beaver pond.
