RE: CWCB Watershed Restoration Grant – Adaptive Restoration & Upland Stewardship – Final Report (POGG1, PDAA, 2019-2772)

Studying the Geomorphic and Ecological Responses of Climate Adapted Restoration in the Foothills of Left Hand Creek, in Boulder County, Colorado

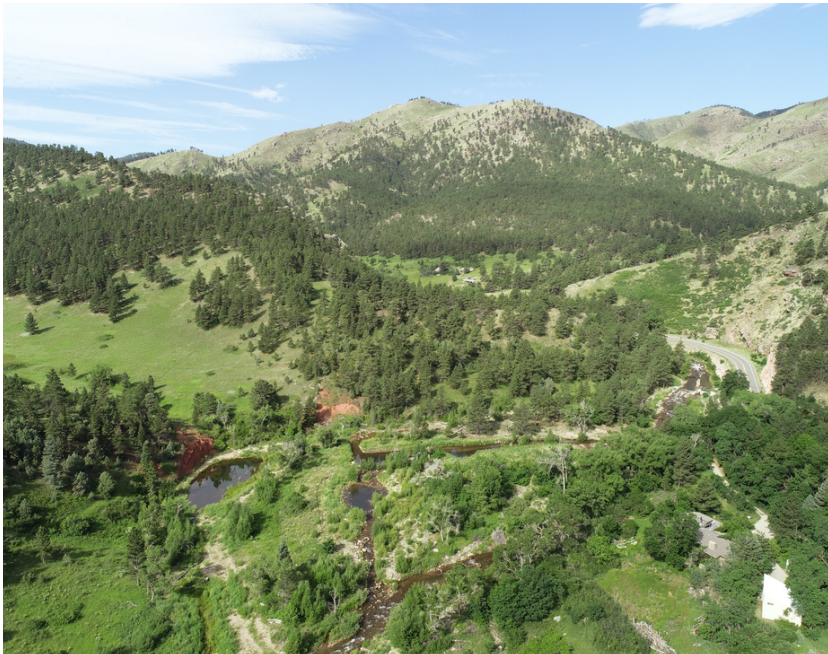
Upstream Reach: geomorphically complex site with a variety of different features, including side channels, beaver mimicry structures, off channel pond, large wood, floodplain roughness.

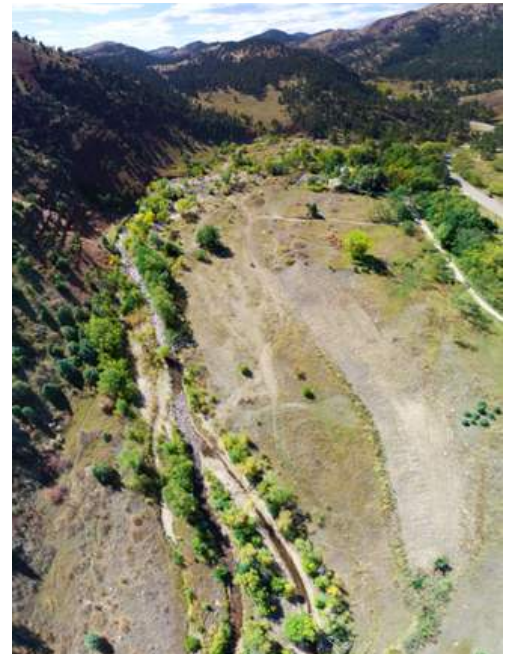
Downstream Reach: traditional restoration site with uniform floodplain grading and limited features.

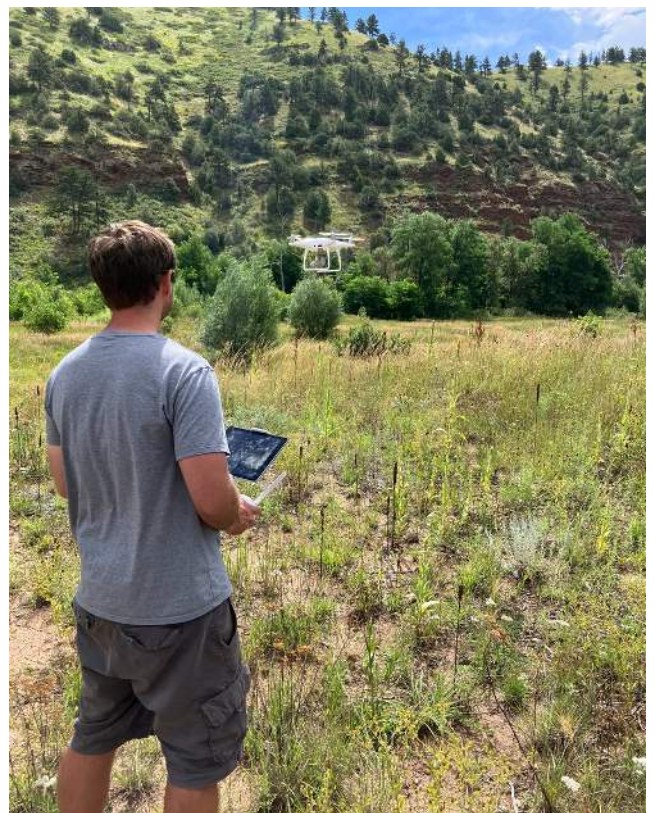
Drone takes off to collect static images

Recommendations for future projects: Drone methods, as opposed to aerial LiDAR flights, offer a relatively cheap and extremely flexible option for developing orthomosaic images, DEMs, DTMs, and REMs that can be used for measuring floodplain connectivity as well as a multitude of other metrics. We recommend these methods for project-level evaluation over a shorter timeframe is preferred.

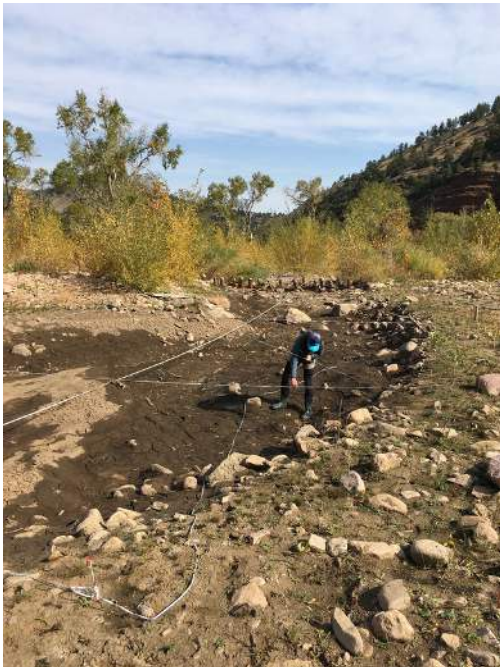
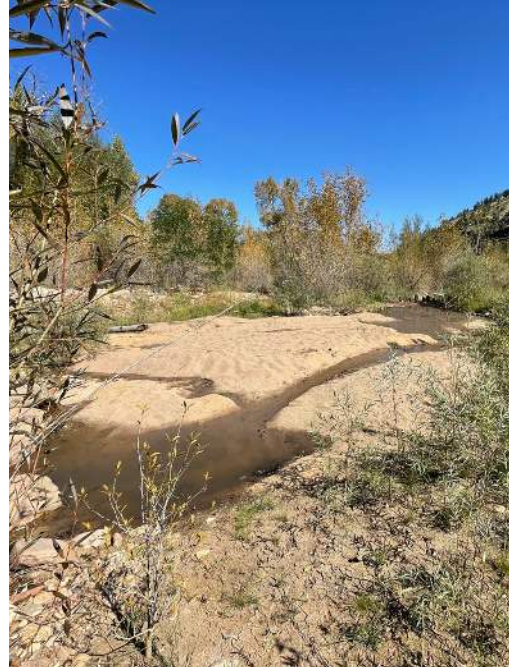
Sediment stored at one Beaver Mimicry Structure in fall 2020 versus fall 2023. A flash flood, carrying high volumes of sediment, occurred in June 2023.

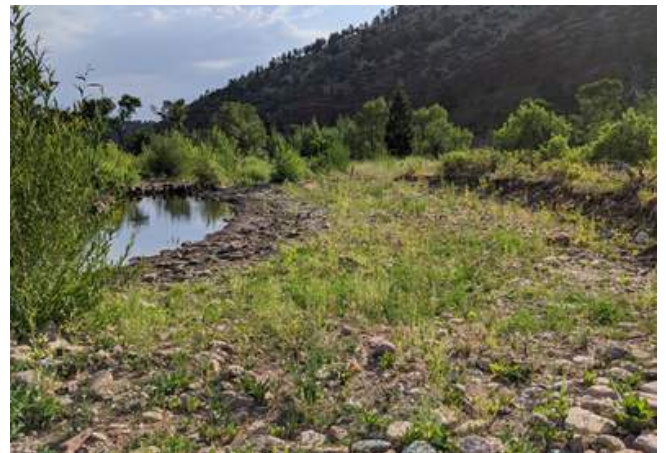
Images showing the three bench heights with different groundwater connection used to study vegetative response.

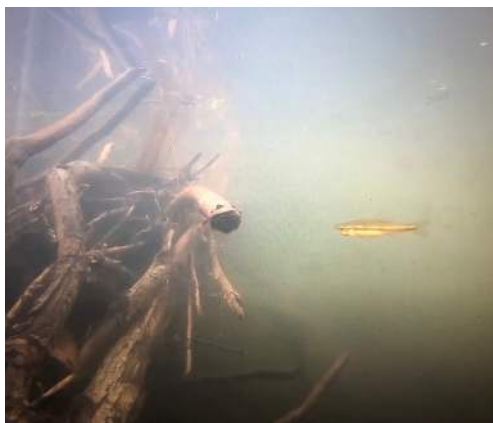
Camera footage of a Northern redbelly dace at a submerged woody brush bundle.

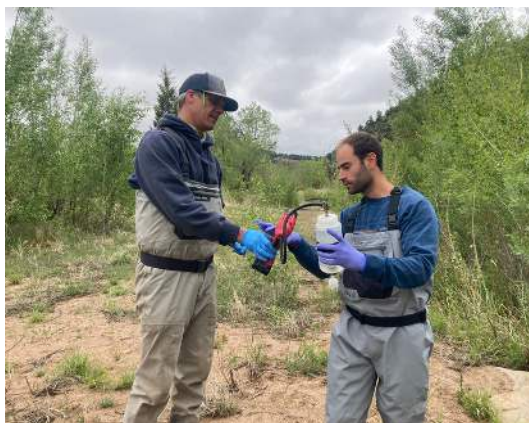
Members of the Northern Redbelly Dace project collect eDNA sample using filtration and bike pumps to pressurize!

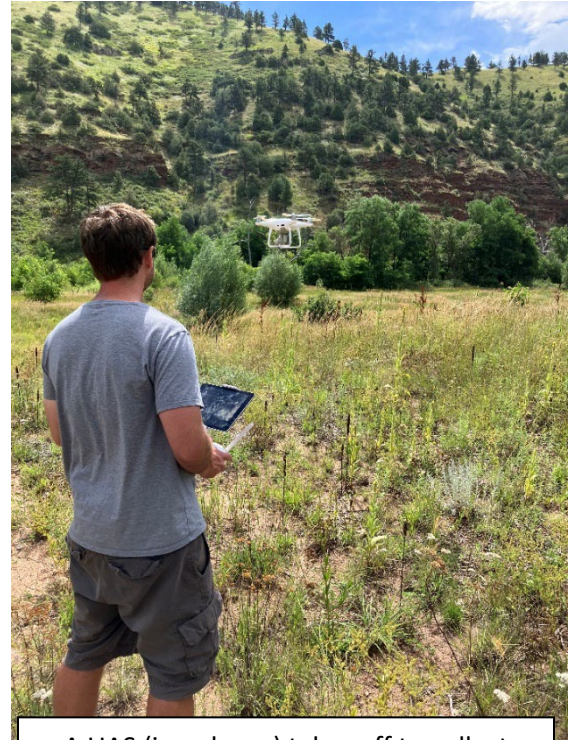
A UAS (i.e., drone) takes off to collect static images that are used to develop high resolution orthomosaic images and digital elevation models.

UAS flights occurred in fall during low flow conditions in 2019 (pre-restoration work), 2020, 2022, and 2023. Flights that took place from 2020-2023 occurred after restoration work was completed. Images from flights were processed in Agisoft Metashape to create digital surface models (DSMs), digital elevation models (DEMs), and orthomosaic images. All metrics were calculated using GIS tools in QGIS (Version 3.28.9), and all graphs were created using R (Version 3.6.3). All raster and vector layers used in the analysis used the NAD83(HARN) / Colorado North (ft US) projected coordinate system (EPSG: 2876). Raster layers from drone image collection were re-projected as needed using bilinear sampling. For a full description of GIS methods, see [here](#).

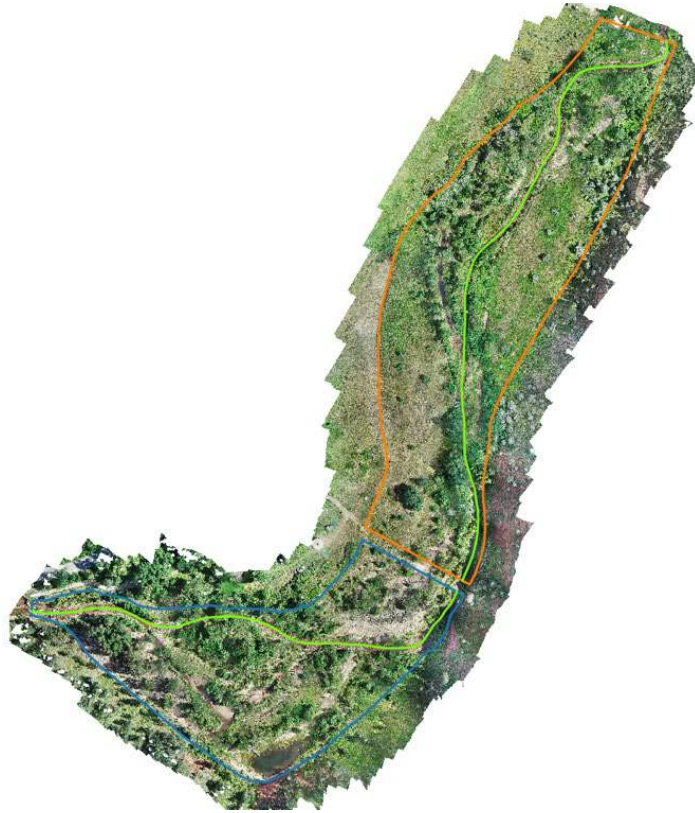
Figure 2. Orthomosaic image showing upstream project area (blue), downstream project area (orange), and valley line (green).

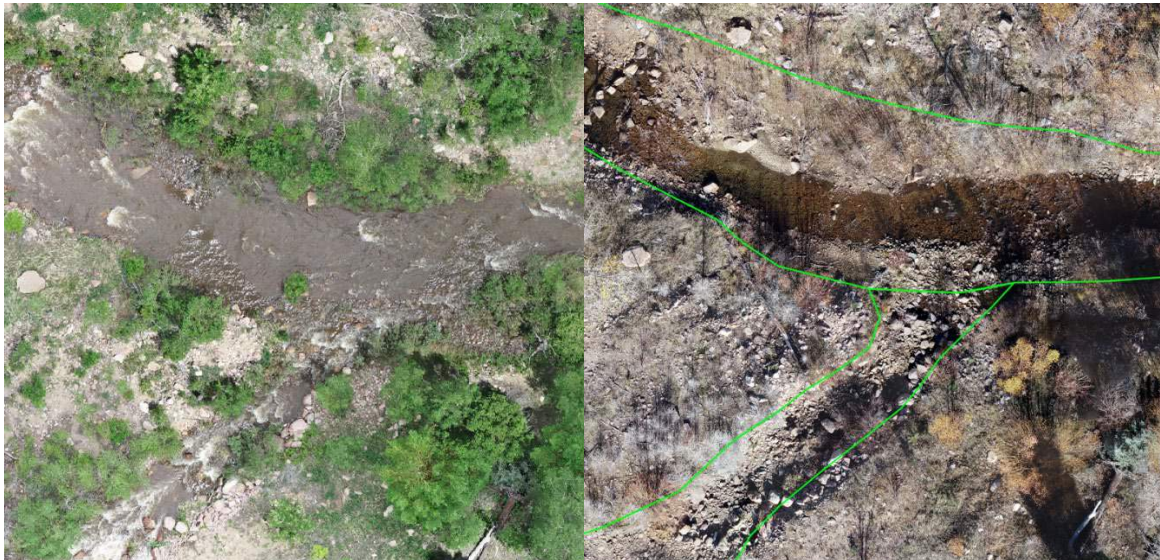
Figure 3. UAS imagery taken during high flows (left) used to delineate active stream channel during low flows (right). Green lines show the final stream channel delineation.

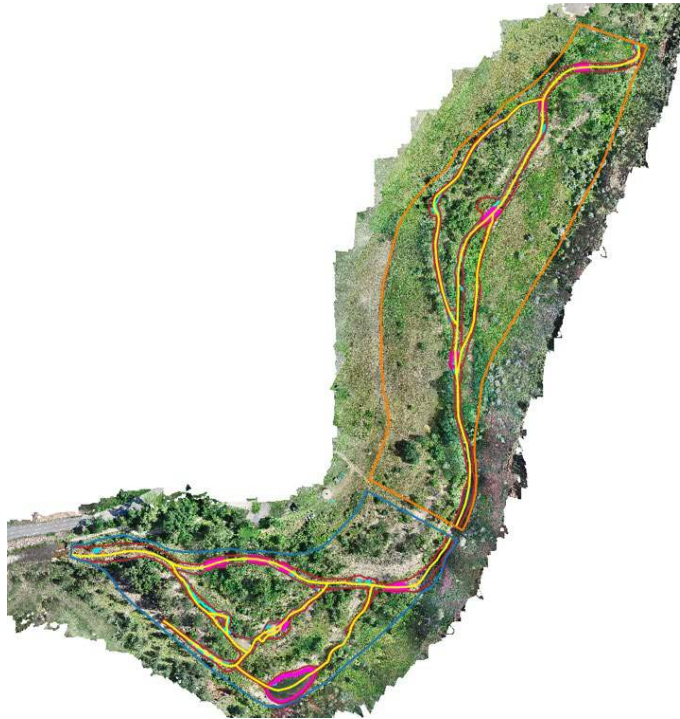
Figure 4. Orthomosaic image showing all delineations. Blue outline represents the upstream project area, orange outline represents the downstream project area, yellow line represents the stream channel bottom, dark red outline represents the active stream channel, pink circles represent pool area, and light blue outlines represent large wood.

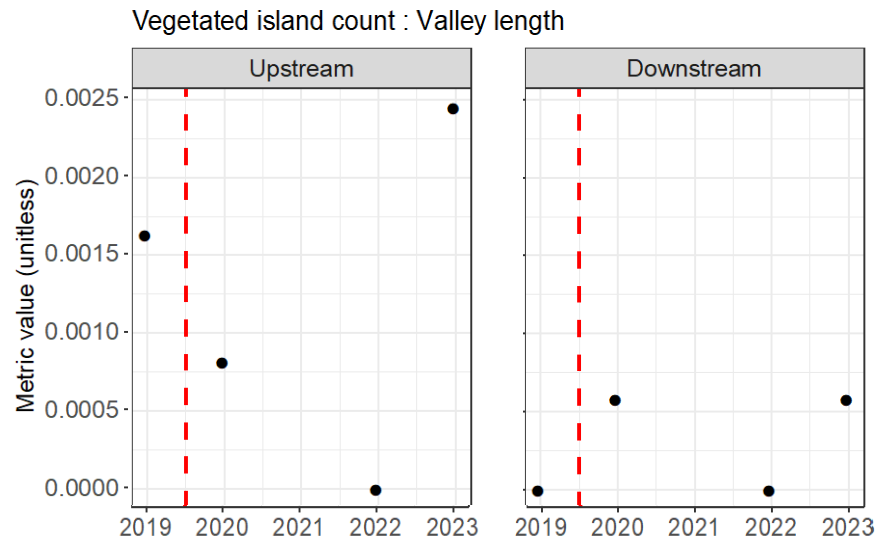
Figure 5. Vegetated island count: valley length ratio for the downstream traditionally restored project area (left) compared to the upstream geomorphically complex restored project area (right). The red vertical dashed line represents the year that restoration was completed. The x-axis represents the year that was measured and the y-axis represents the metric value.

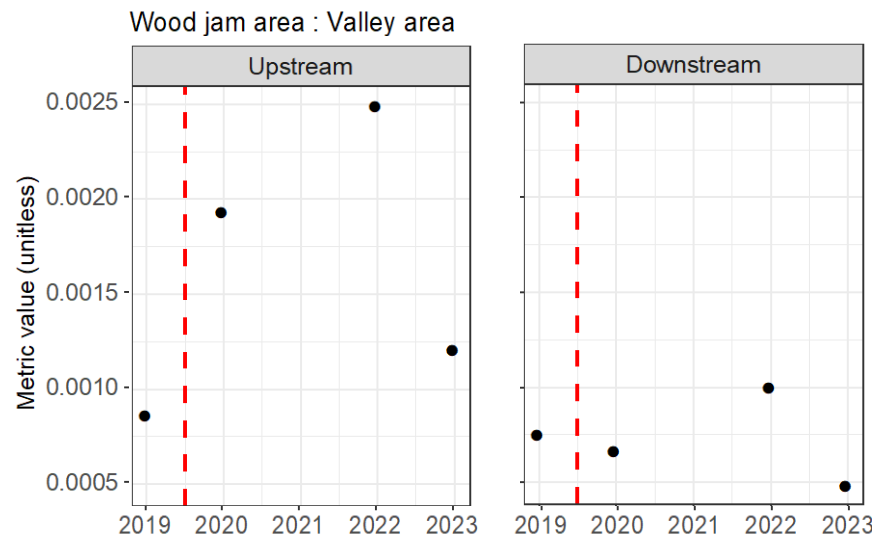
Figure 6. Wood jam area: valley area ratio for the downstream traditionally restored project area (left) compared to the upstream geomorphically complex restored project area (right). The red vertical dashed line represents the year that restoration was completed. The x-axis represents the year that was measured and the y-axis represents the metric value.

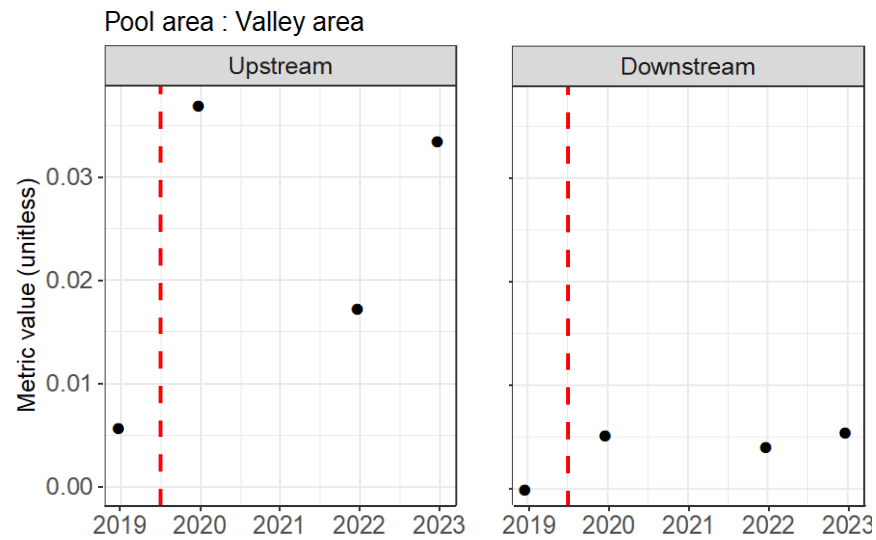
Figure 7. Pool area: valley area ratio for the downstream traditionally restored project area (left) compared to the upstream geomorphically complex restored project area (right). The red vertical dashed line represents the year that restoration was completed. The x-axis represents the year that was measured and the y-axis represents the metric value.

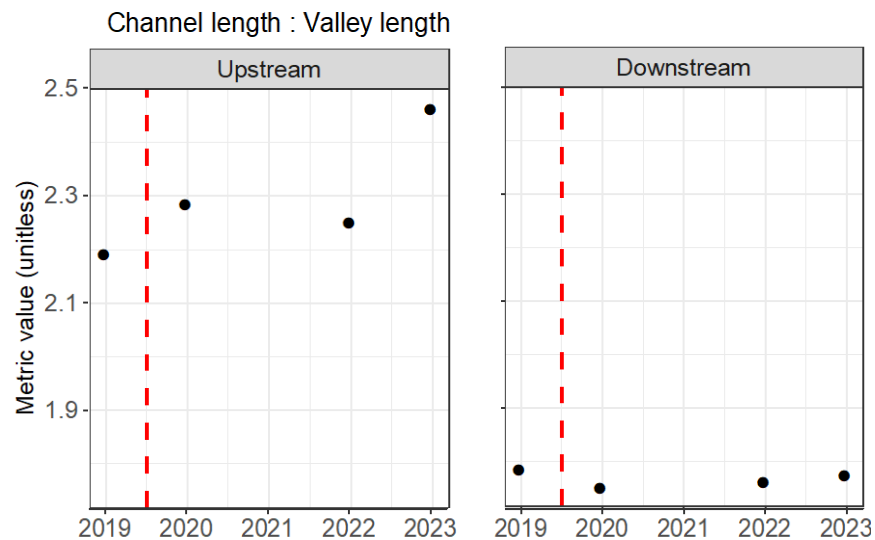
Figure 8. Channel length: valley length ratio for the downstream traditionally restored project area (left) compared to the upstream geomorphically complex restored project area (right). The red vertical dashed line represents the year that restoration was completed. The x-axis represents the year that was measured and the y-axis represents the metric value.

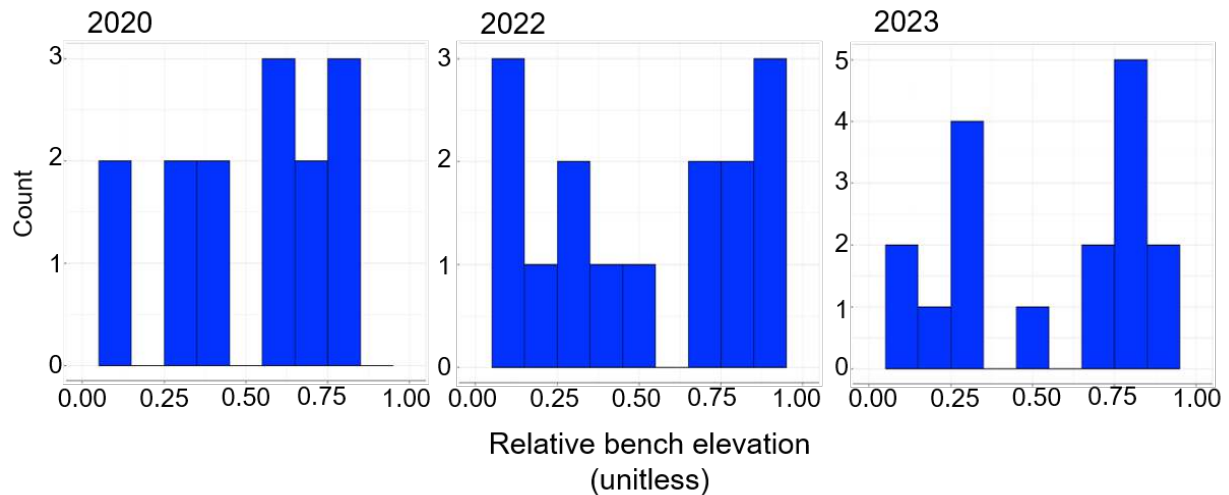
Figure 10. Histograms of post-restoration bench heights in the upstream project area from 2020-2023. The x-axis represents relative elevation to account for UAS-derived differences in absolute elevation in DEMs. The y-axis represents the number of hits for each relative elevation bin. Elevations were re-scaled within each year be relative to the uppermost (relative elevation of 1) and lowermost (relative elevation of 0) points of the valley being measured.

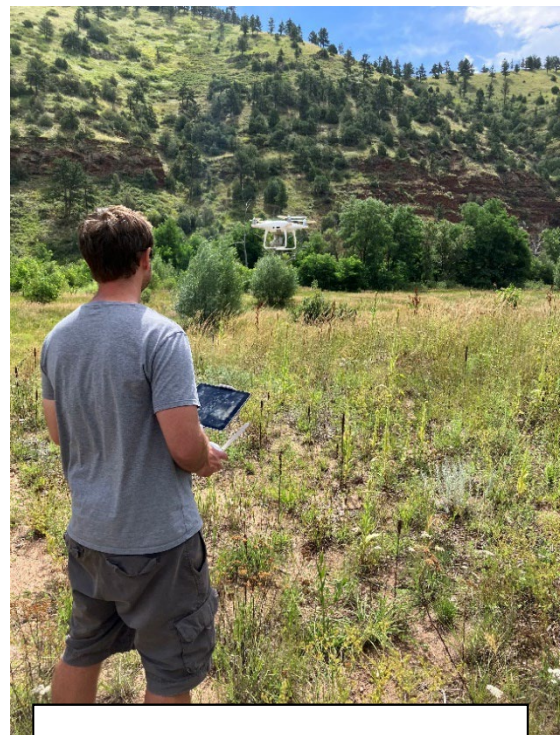
A UAS (i.e., drone) takes off to collect static images that are used to develop digital elevation models

Static images were collected by flying a DJI Phantom 4 UAS over the downstream and upstream project areas in a grid pattern. Orange buckets lids were placed on the ground throughout the site to be used as ground control points (GCPs). Data collection occurred during low flow conditions in the fall of 2019, 2020, 2022, and 2023. The flight pattern was chosen to cover the full extent of the stream channel and its floodplain with sufficient overlap and resolution to create a REM.

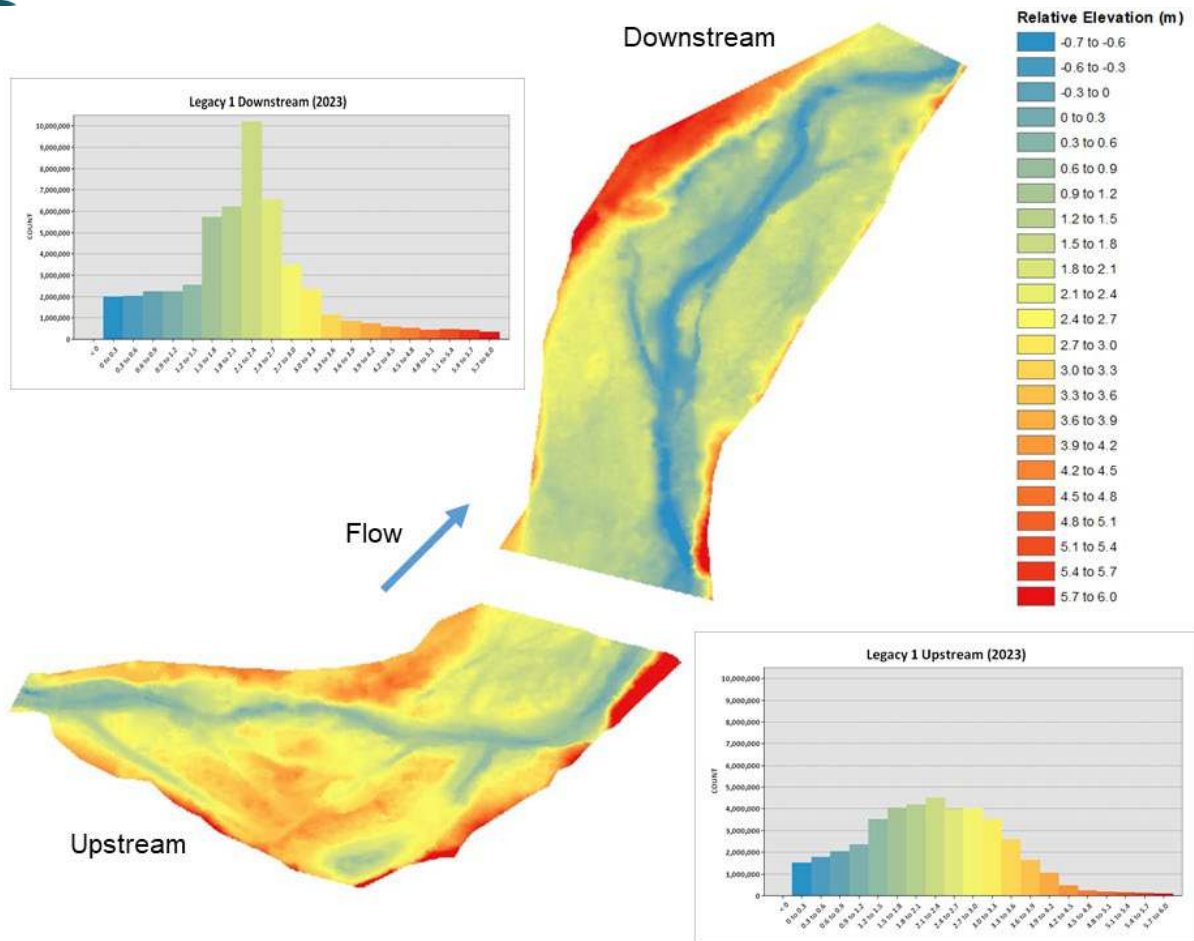
Figure 3. Relative elevation model (REM) and associated histograms for upstream and downstream project areas for 2023. Cooler colors represent areas at lower elevations relative to the stream channel and warmer colors represent areas at higher elevations relative to the stream channel. Histograms represent raw count data for various elevation bins. Note that because they are raw counts, there are more points in the downstream project area because the downstream area is larger than the upstream project area.

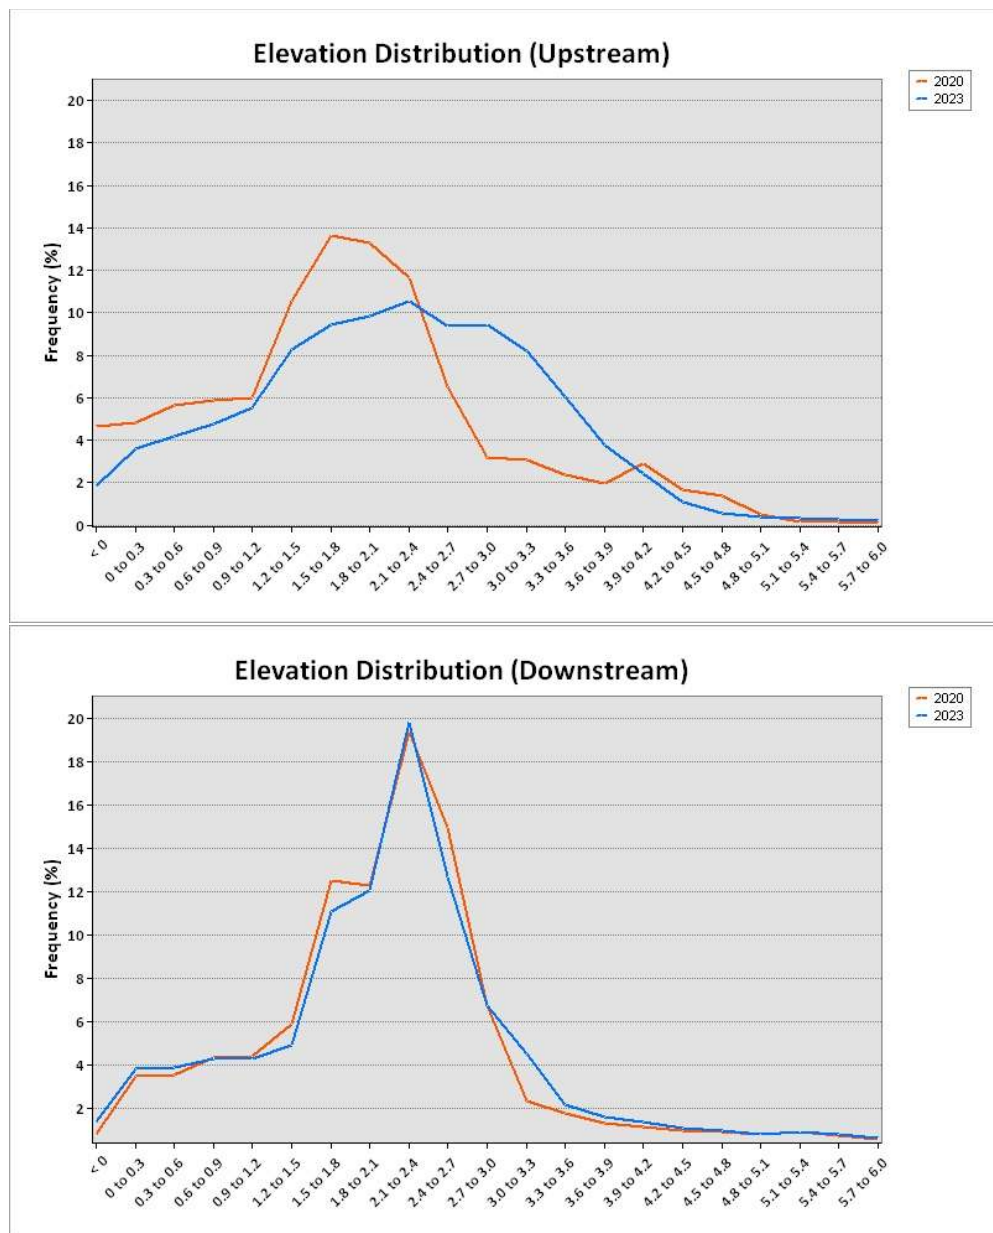
Figure 4. Comparison of frequency of counts for various elevation bins standardized as a percentage of the project area for downstream (top) and upstream (bottom) project areas in 2020 and 2023. The orange line represents the 2020 distribution and the blue line represents the 2023 distribution.

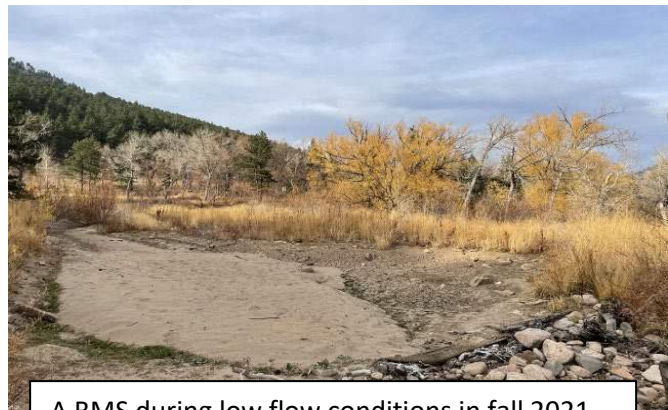
A BMS during low flow conditions in fall 2021.
Note the layer of fine sediment.

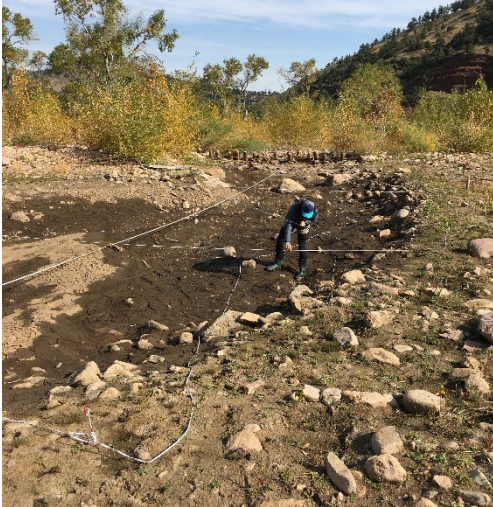
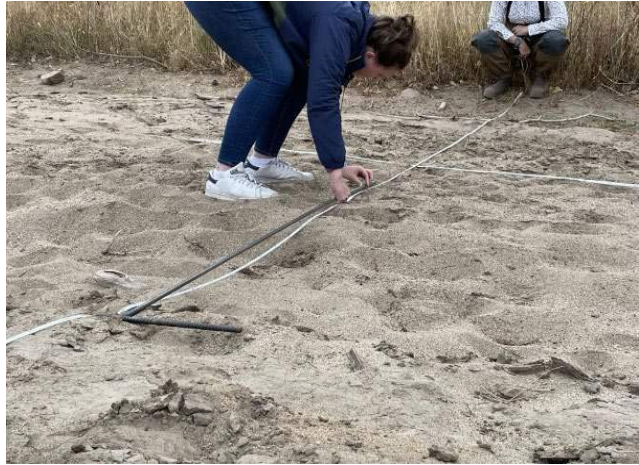
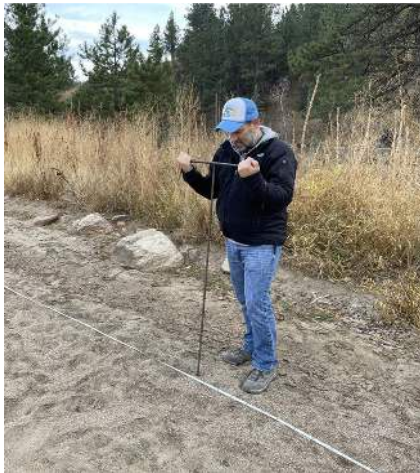
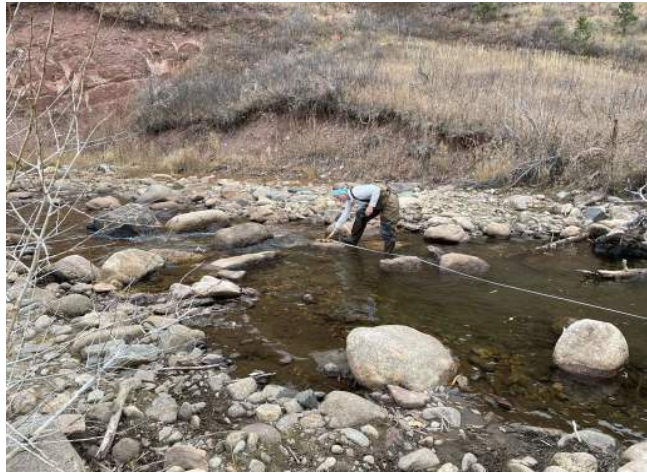
Top left: Example of dry pool set up, where we estimated residual pool water depth and held tapes taut to simulate water depth.

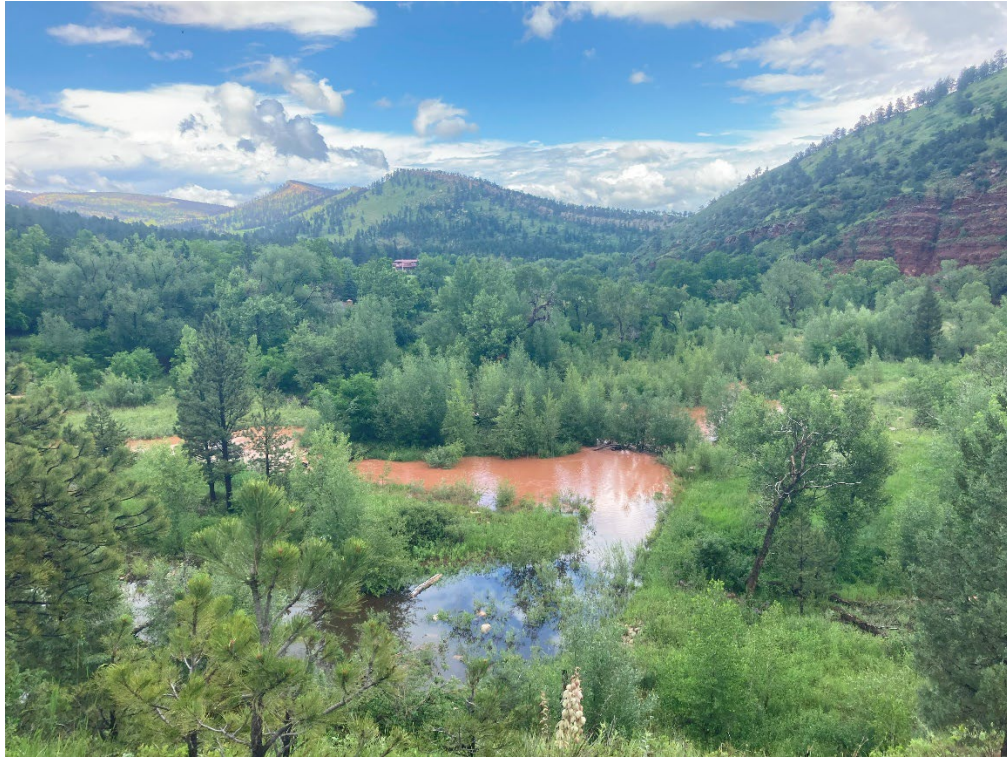
Photo taken of the BMS structures and backwater during a June 2023 flash flood in Left Hand Watershed. This event occurred between 2022 and 2023 sampling years.

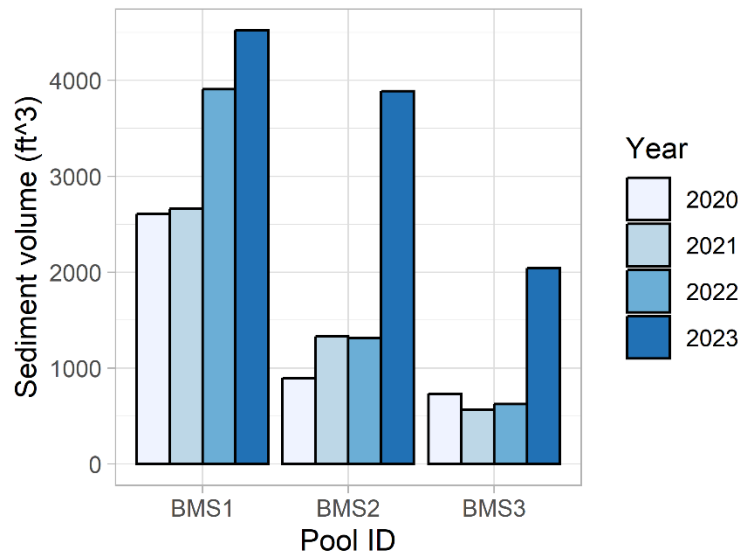
Figure 2. Sediment volume (ft³) across four years in BMSs located in the geomorphically complex restored upstream project area. The x-axis represents the pool ID (oriented upstream to downstream), and the y-axis represents the sediment volume amount. Colors represent year of sampling.

- The BMSs behaved as attenuation features on the floodplain during flash flood conditions. The sediment volumes and V^* at the BMSs both dramatically increased between 2022 and 2023, up to 4,600 ft³ was captured (Figs. 2 and 3). This highlights how impactful BMS features can be at attenuating fluxes in flood events.

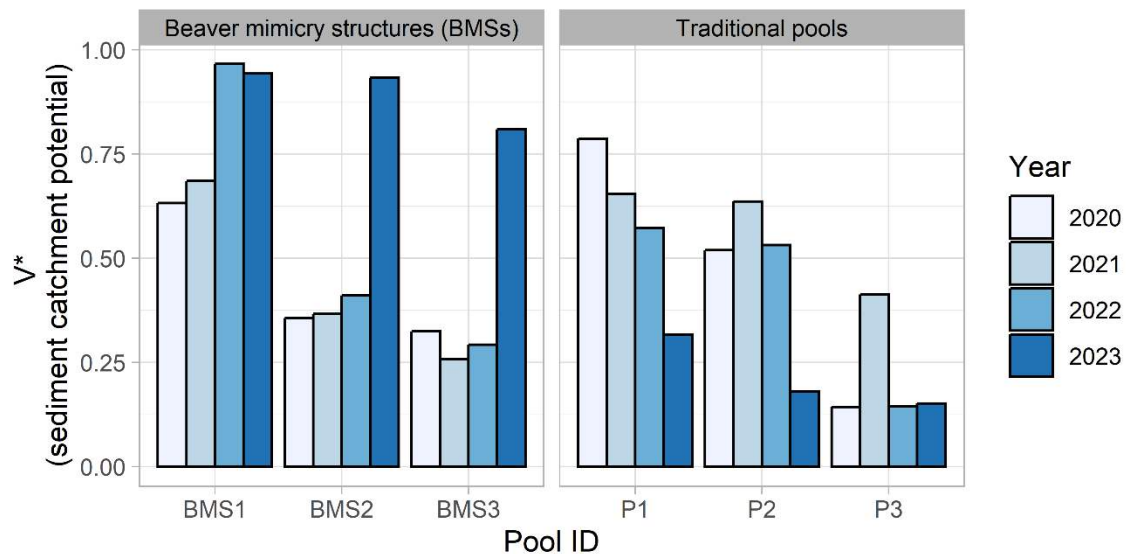
Figure 3. V^* , which represents the catchment potential of a BMS/pool, across four years in the geomorphically complex restored upstream project area and the traditionally restored project area. BMSs were located in the upstream project area and traditional pools were located in the downstream project area. The x-axis represents the pool ID (oriented upstream to downstream), and the y-axis represents the V^* value, which is on a scale of 0 to 1. Colors represent year of sampling. Higher V^* values indicate that the BMS/pool has limited volume remaining to catch and store sediment while lower values indicate that the BMS/pool has more capacity to catch and store future sediment.

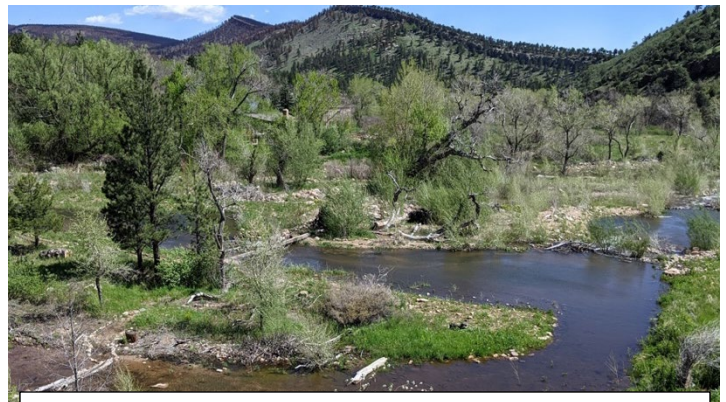
Photo of the geomorphically complex site, with ephemeral channels and beaver mimicry structures.
