Rio Grande Riparian Stabilization Project - Phase 5

Final Report

Prepared for:
Colorado Water Conservation Board Colorado Watershed Restoration Program
Grant Contract Number: CTGG1 PDAA 2021-0020
Attn: Chris Sturm

April 18, 2024

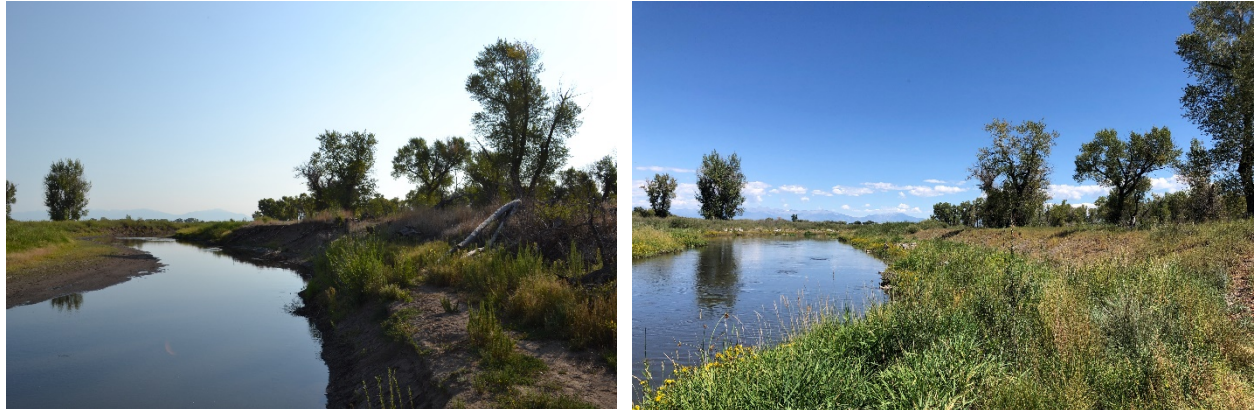
Figure 11: Site 1 before and after photo point.

Table 1. Site 1 Stream Visual Assessment Scores				
Element	Score			
	Preconstruction 8.18.2020	Monitoring 8.31.2021	Monitoring 9.1.2022	Monitoring 8.14.2023
Channel Condition	5	7	8	7
Hydrologic Alteration	3	3	3	3
Bank Condition	2	9	9	8
Riparian Area Quantity	3	6	8	8
Riparian Area Quality	3	6	7	7
Water Appearance	5	6	6	7
Nutrient Enrichment	6	7	7	8
Manure/Waste Presence	10	10	10	10
Pools	3	4	7	8
Barriers to Movement	3	3	3	3
Fish Habitat Complexity	5	3	6	8
Aquatic Invert. Habitat	3	5	5	8
Overall Score:	4.6	6.3	7.2	7.7
1-2.9 Severely Degraded ; 3-4.9 Poor ; 5-6.9 Fair ; 7-8.9 Good ; 9-10 Excellent

Site 1: Robins Construction was awarded the project bid and mobilized in November 2020. They began earthwork, reshaping the streambanks and river channel and constructed the floodplain bench. Cold temperatures caused the river to freeze in December at which time the contractor demobilized until the river thawed in the spring. In March 2021, the contractor remobilized and constructed rock and root wad stabilization and fish habitat structures, planted willow clumps along the floodplain bench, and reseeded the site. Riverbend Engineering provided construction oversight, ensuring that all elements were constructed as designed and in accordance with permit requirements. Construction of Site 1 was complete in April 2021, resulting in bank stabilization and riparian revegetation along 2,112 linear feet of stream. A series of community volunteer revegetation events were held in April 2021 to plant riparian saplings (red osier dogwood, thin leaf alder, and golden current) and reseed a mix of native riparian grasses, sedges and forbs. Through these events, a total of 300 saplings were planted and a half acre was seeded.

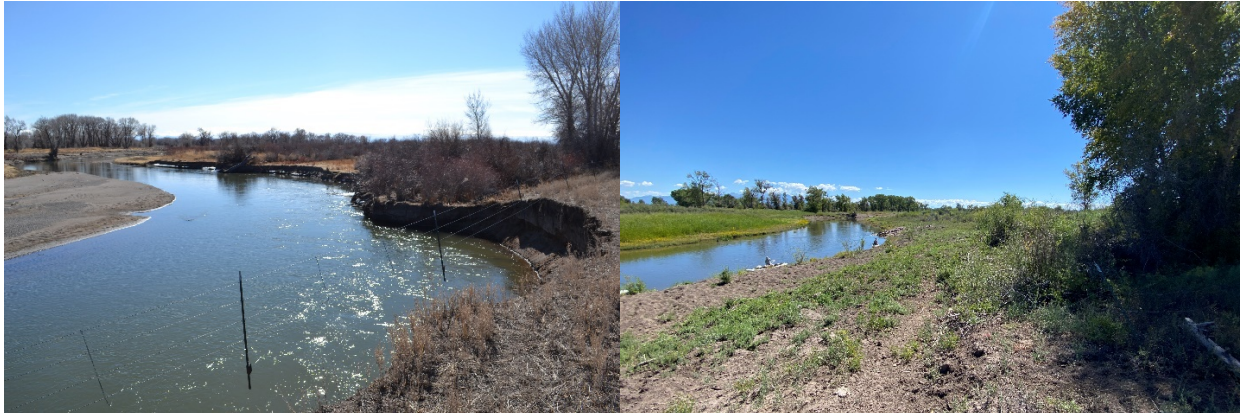
Figure 12: Site 2 before and after photo point.

Table 2. Site 2 Stream Visual Assessment Scores			
Element	Score		
	Preconstruction 8.31.2021	Monitoring 9.1.2022	Monitoring 8.14.2023
Channel Condition	3	8	7
Hydrologic Alteration	2	2	2
Bank Condition	2	9	8
Riparian Area Quantity	4	7.5	8
Riparian Area Quality	4	6.5	7
Water Appearance	4	7	7
Nutrient Enrichment	7	8	8
Manure/Waste Presence	8	8	8
Pools	4	9	9
Barriers to Movement	3	3	3
Fish Habitat Complexity	3	8	8
Aquatic Invert. Habitat	4	9	9
Overall Score:	4.4	7.7	7.6
1-2.9 Severely Degraded ; 3-4.9 Poor ; 5-6.9 Fair ; 7-8.9 Good ; 9-10 Excellent

Site 2: Absmeier Landscaping and Construction, LLC was hired to complete Site 2. In February 2022, they mobilized and begin hauling and staging rock at the site. They completed channel shaping and construction of rock and root wad stabilization structures in April 2022, after the river thawed and conditions were favorable for construction. Following the earthwork and installation of rock and root wad stabilization structures, the contractor planted willow transplants and reseeded site. Riverbend Engineering provided construction oversight, ensuring that all elements were constructed as designed and in accordance with permit requirements. Construction of Site 2 was completed in May 2022, resulting in bank stabilization and riparian revegetation along 2,112 linear feet of stream. In May 2023, riparian fencing was installed to protect the restoration and newly planted riparian vegetation from grazing on the landowner's property.

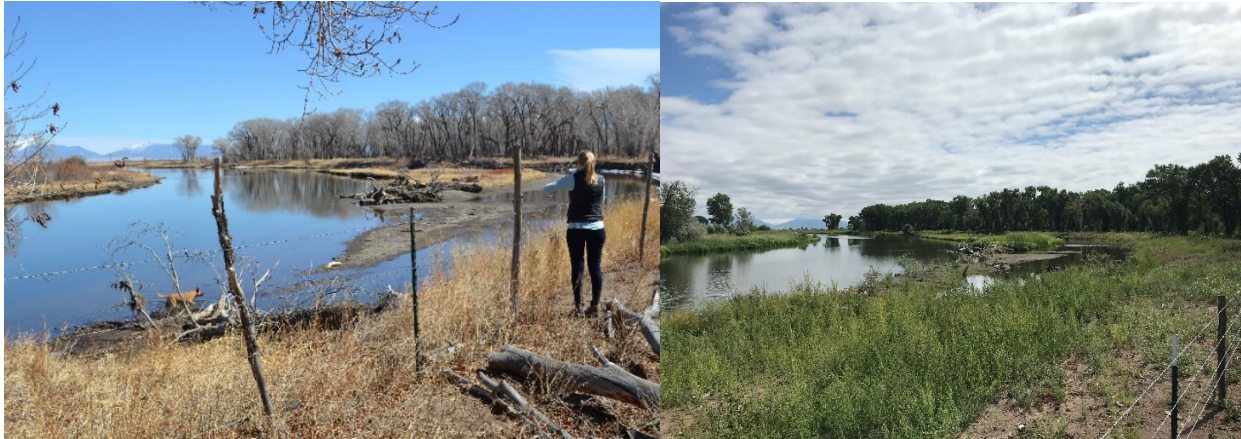
Figure 13: Site 3 before and after photo point.

Table 3. Site 3 Stream Visual Assessment Scores		
Element	Score	
	Preconstruction 8.25.2022	Monitoring 8.14.2023
Channel Condition	4	7
Hydrologic Alteration	3	3.5
Bank Condition	3	8
Riparian Area Quantity	3	9
Riparian Area Quality	4	6.5
Water Appearance	6	7
Nutrient Enrichment	7	8
Manure/Waste Presence	10	10
Pools	2	5
Barriers to Movement	3	3
Fish Habitat Complexity	5	7
Aquatic Invert. Habitat	5	7
Overall Score:	5.0	7.4
1-2.9 Severely Degraded ; 3-4.9 Poor ; 5-6.9 Fair ; 7-8.9 Good ; 9-10 Excellent

Site 3: Absmeier Landscaping and Construction, LLC was hired to complete Site 3. They mobilized in November 2022 and began channel shaping and construction of rock and root wad stabilization structures. At the end of November, freezing conditions caused ice damming that backed up water to a level that required the contractor to stop work. The contractor remobilized March 2023 to complete the remaining work, which included final channel shaping, willow transplants, and reseeded. In addition, an abandoned ditch/berm along the river was removed to reconnect the floodplain and prepare for the installation of new riparian fencing. Construction management was completed by Southwest River Engineering. Riparian fencing

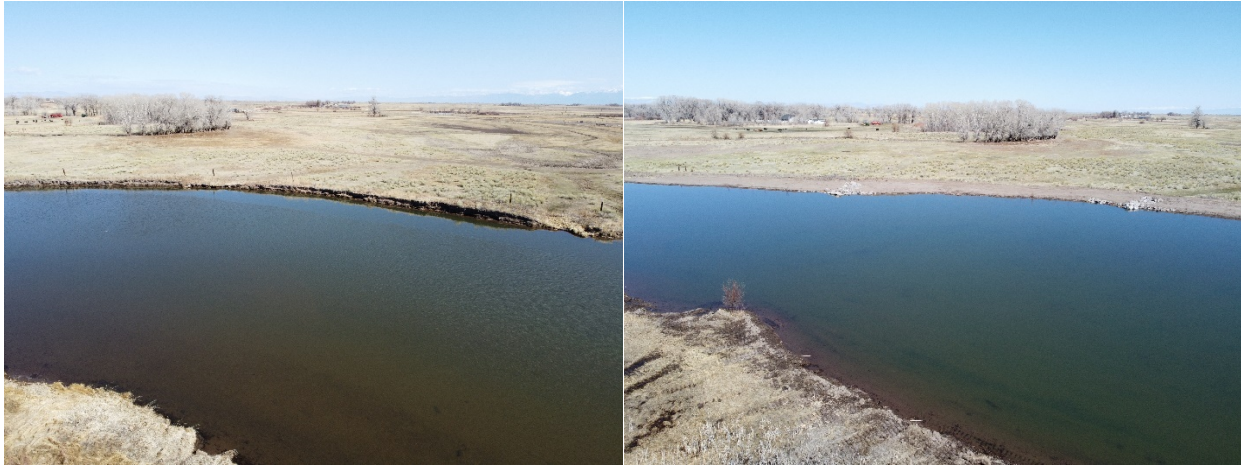
Figure 14: Site 4 before and after photo point.

Table 4. Site 4 Stream Visual Assessment Scores		
Element	Score	
	Preconstruction 8.14.2023	Postconstruction 4.11.2024
Channel Condition	4	7
Hydrologic Alteration	3	3
Bank Condition	3	7
Riparian Area Quantity	5	6.5
Riparian Area Quality	4.5	6
Water Appearance	7	8
Nutrient Enrichment	8	6
Manure/Waste Presence	8	10
Pools	6	8
Barriers to Movement	1	1
Fish Habitat Complexity	4	7
Aquatic Invert. Habitat	4	7
Overall Score:	5.2	7.0
1-2.9 Severely Degraded ; 3-4.9 Poor ; 5-6.9 Fair ; 7-8.9 Good ; 9-10 Excellent

Site 4: Robins Construction was hired to complete Site 4. They began work in March 2024 with channel and bank shaping. Following the initial work in the river channel, rock and root wad stabilization structures were installed and the floodplain bench was revegetated with willow clumps and native seed. Construction management was completed by Southwest River Engineering. Construction of Site 3 was completed in April 2024, resulting in bank stabilization and riparian revegetation along 1,050 linear feet of stream. Riparian fencing will be installed in May 2024 to protect the restoration site and newly planted riparian vegetation from livestock grazing on the landowner's property. This site was completed in conjunction with improvements at the Independent Ditch Diversion, which will also improve river health through more natural flow regimes.

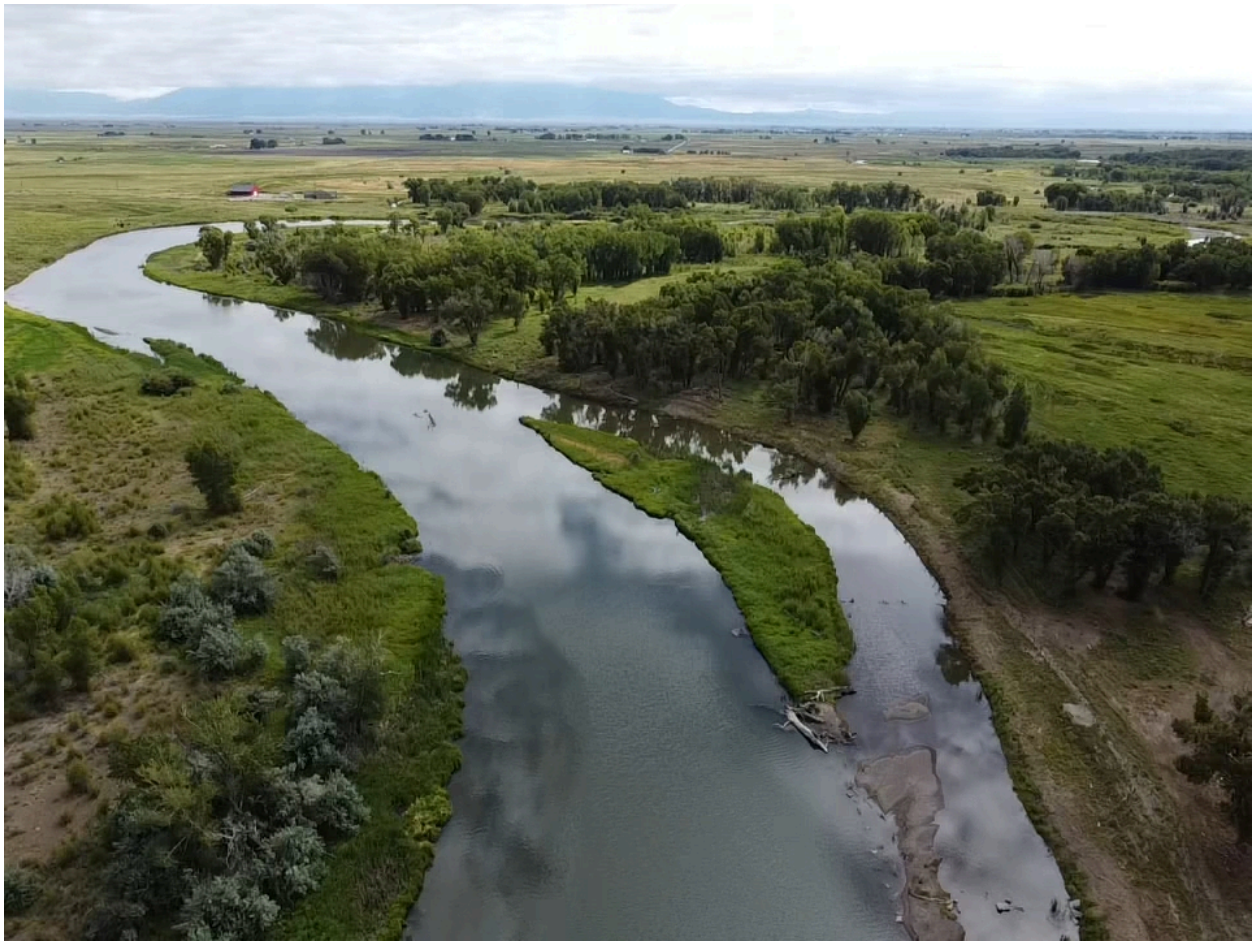
Figure 15: Aerial view of Site 4 following restoration activities.

Phase 5 objectives were met and exceeded through the methods and results described above. Restoration on selected sites stabilized 7,284 linear feet of stream through the installation of rock and root wad stabilization structures. Bank reshaping and stabilization addressed sedimentation and erosion issues while also improving floodplain connectivity. These structures will keep banks stable while riparian plantings and reseeding are established. Riparian revegetation resulted in the planting of 2,375 willows and other native woody shrubs and seeding of native grasses and forbs across 22.5 acres of restored riparian habitat. This work was assisted by 72 volunteers, who learned about the importance of healthy rivers while planting and reseeding within the recently established Alamosa Riparian Park. Work with in the ARP not only resulted in the benefits listed above, but also enhanced the quality of trails within this excellent community open space. Most importantly, completed work linked previously restored sites to create a continuous stretch of over 5 miles of restored river.
