## East Troublesome Fire Watershed Recovery

Final Report

CTGG1 2023\*3149

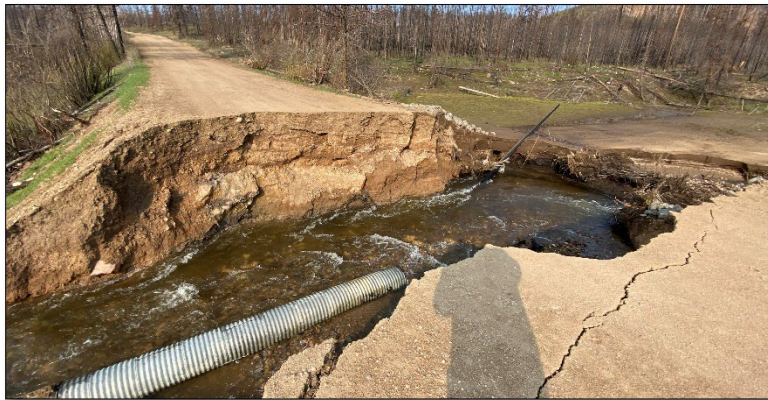
***Stillwater Creek 1 Phase 1, Before***

***Stillwater Creek 1, Phase 1.*** This project is located where Stillwater Pass Road crosses Stillwater Creek. Stillwater Pass Road is a major through route for Grand County residents and national forest users. The road washout in May 2023 at the Stillwater Creek crossing, leaving the route impassable and damaged or destroyed the existing culverts. To restore access and reduce sedimentation in the creek and Lake Granby caused by the recent debris flow and washout events, Northern Water coordinated with USFS and hired Concrete Express Inc (CEI) and in September CEI installed a new Aquatic Organism Passage (AOP) culvert, as well as adjacent stream improvements.

The stream crossing can now handle post-fire flows and improves water quality and reduces sedimentation in Lake Granby because of the rehabilitated riparian habitat, including allowing aquatic organism passage.

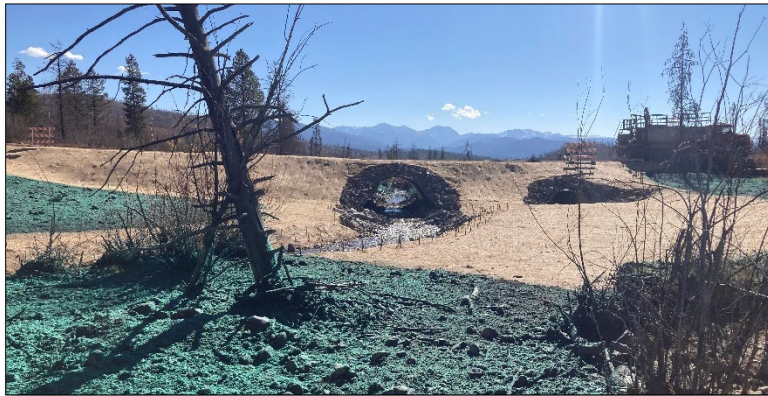
***Stillwater Creek 1 Phase 1, After***

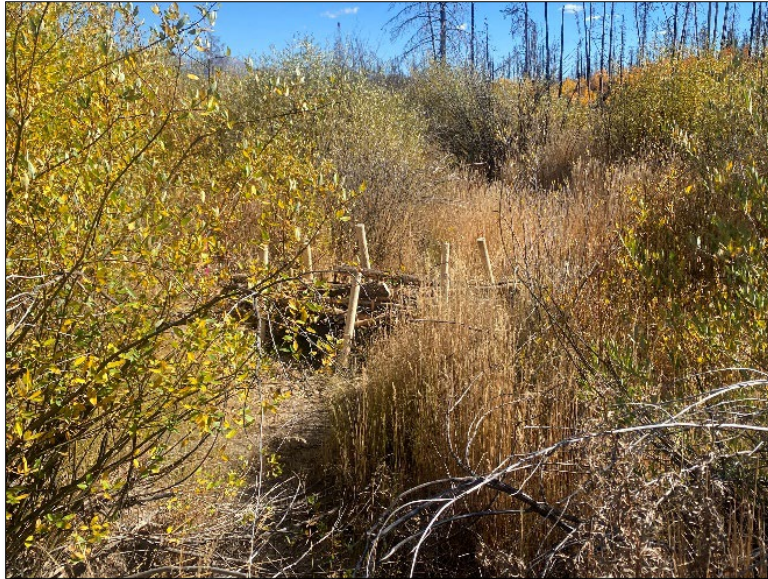
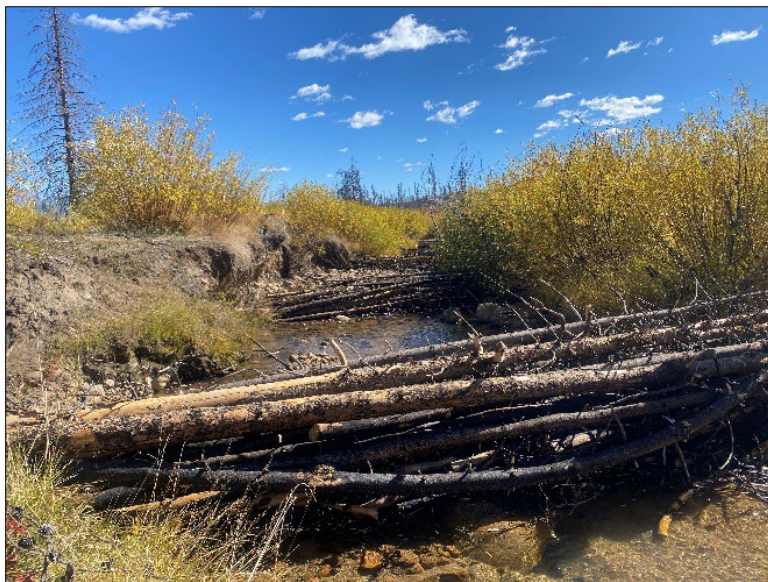
***Constructed PALS on Stillwater Creek***

***Stillwater Creek 1, Phase 2.*** JHL Contractors was selected through a competitive bid to implement this project. Matrix Design Group and its subcontractor, Anabran Solutions, provided construction oversight of the project. Construction occurred in September 2024 and ultimately included a total of thirty-nine (39) PALS that were installed along Stillwater Creek. Thirty-one (31) PALS were installed in-stream within the active channel, eight (8) PALS were installed outside of the active channel along a relic channel. The PALS structures were installed along 2,000-linear feet of Stillwater Creek's stream length. The instream PALS are generally 3-feet tall, 15-feet wide, and 5-feet long. The floodplain PALS are generally 2.5-feet tall, 20-feet wide and 2.5-feet long.

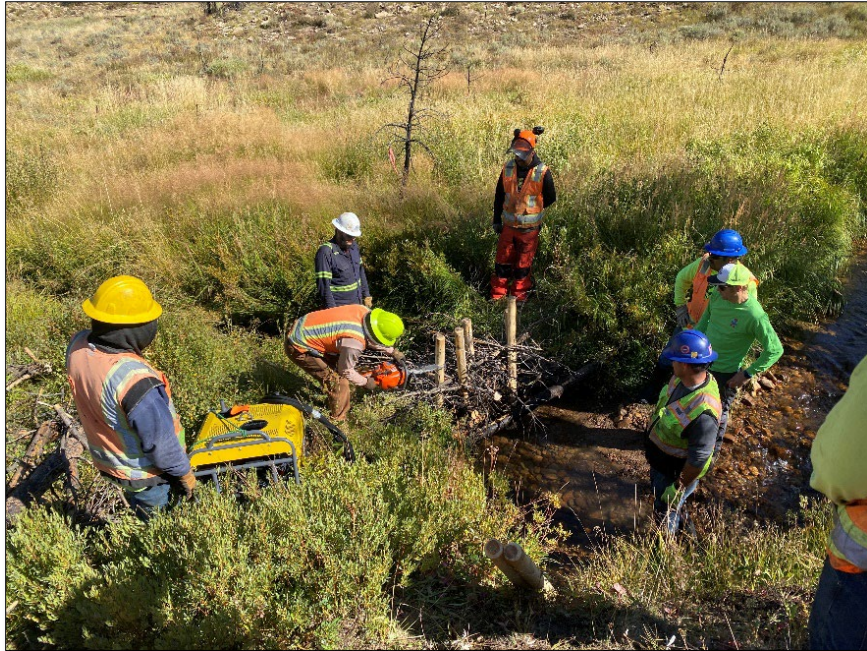
***Installation of PALS on Kauffman Creek***

***Kauffman Creek.*** JHL Contractors were selected through a competitive bid to implement this project. Matrix Design Group and its subcontractor, Anabran Solutions, provided construction oversight of the project. Construction occurred in September and October 2024 and included a total of thirty-four (34) PALS that were installed along Kauffman Creek. Twenty-five (25) PALS were installed in-stream within the active channel, nine (9) PALS were installed on the floodplain outside of the active channel. The PALS structures were installed along 1,700-linear feet of Kauffman Creek's stream length. The instream PALS are generally 3-feet tall, 5-feet wide, and 3-feet long. The floodplain PALS are generally 2.5-feet tall, 40-feet wide and 2-feet long.

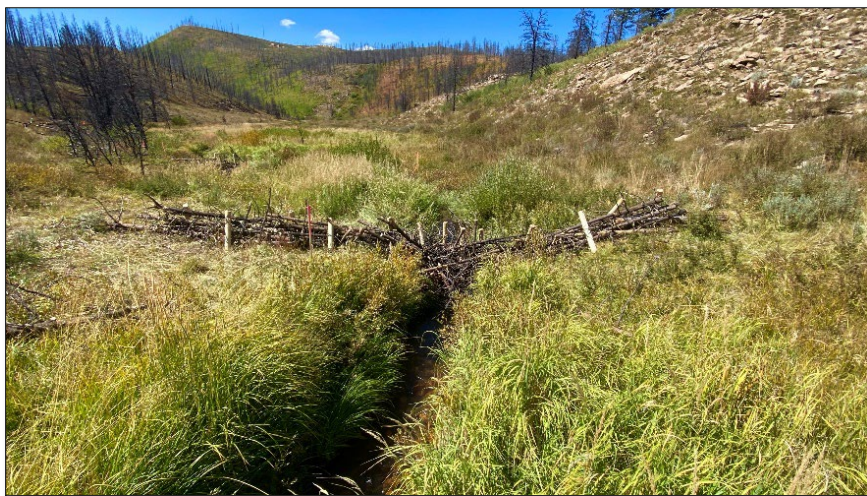
***Constructed PALS on Kauffman Creek***
