Pike National Forest Watershed Resiliency
Final Report

Prepared for:
Colorado Watershed Restoration Program
Attn: Chris Sturm

January 31, 2025

Grantee
Rocky Mountain Field Institute

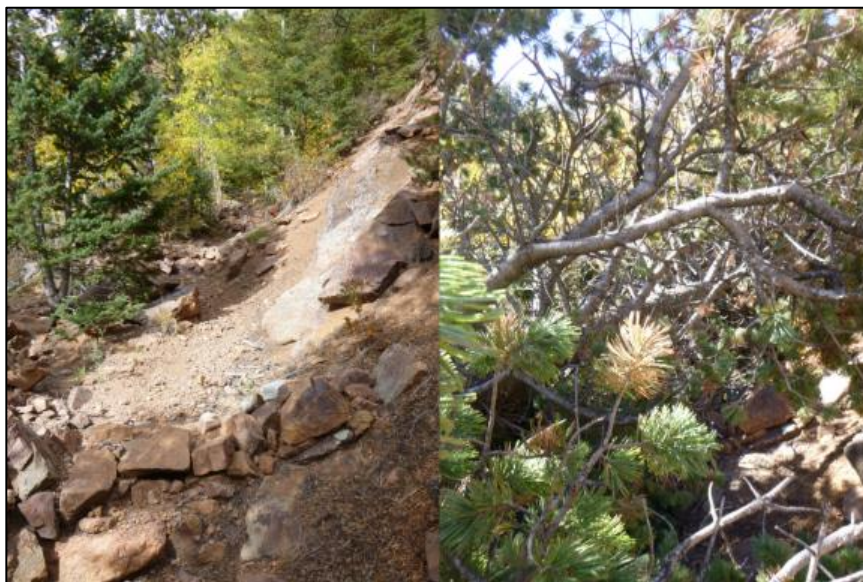
Before and after of Trail #666 closure

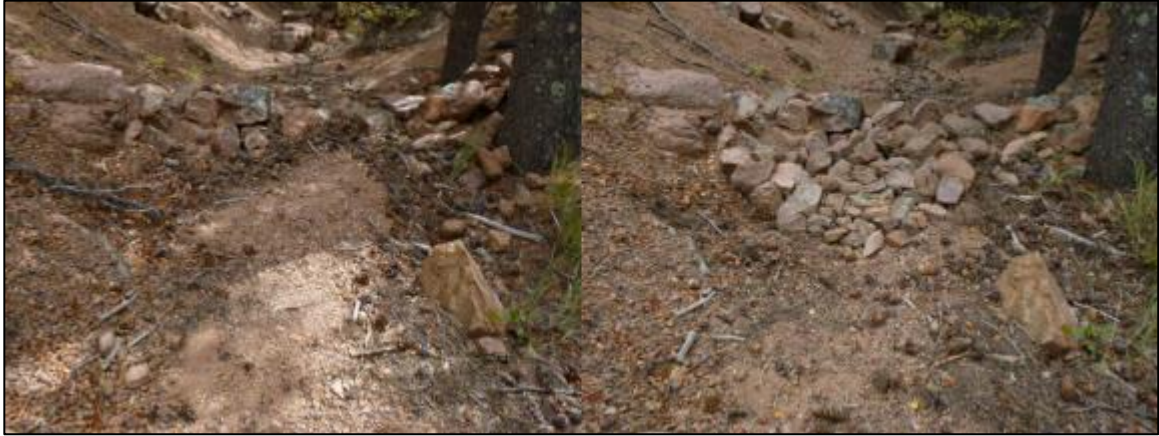
Before and after of fortified check dam

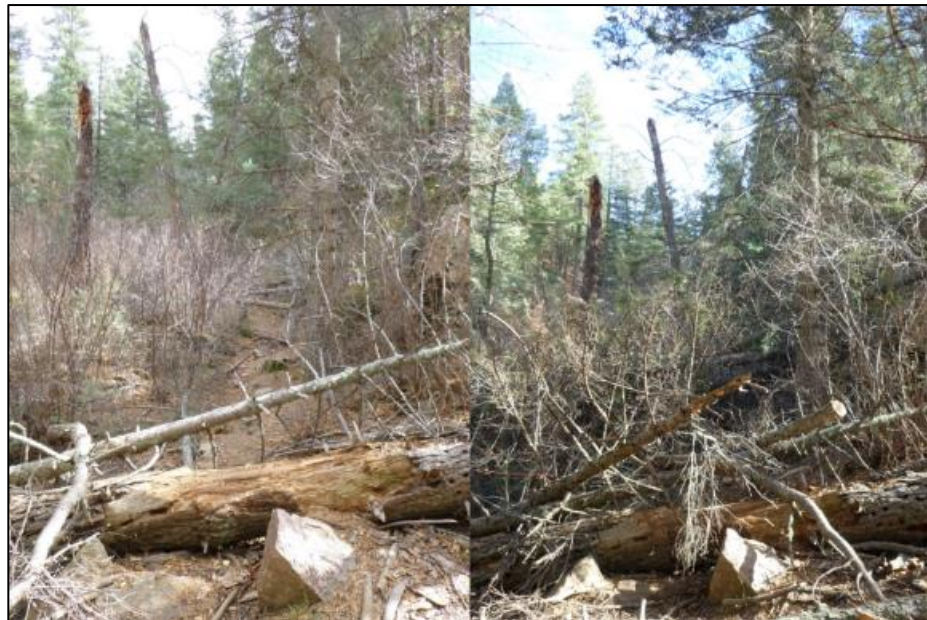
Before and after of Sesame Canyon Trail Closure

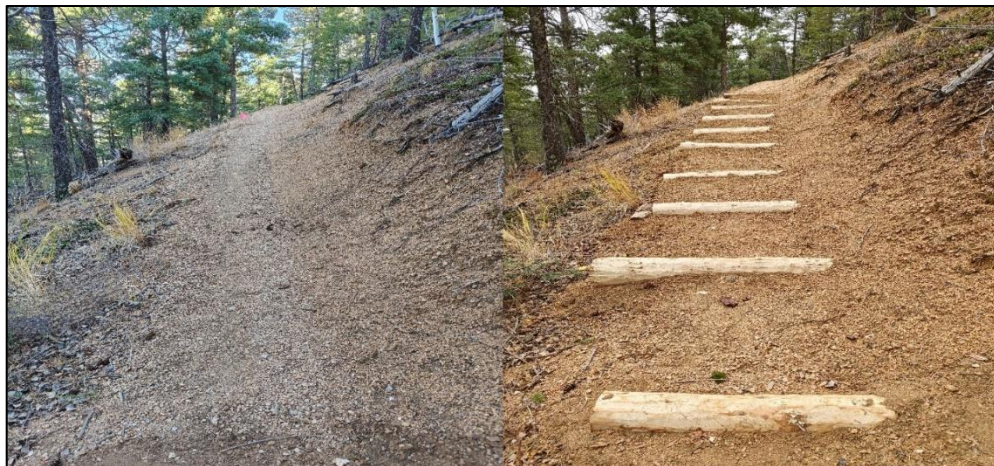
Before and after of check installation

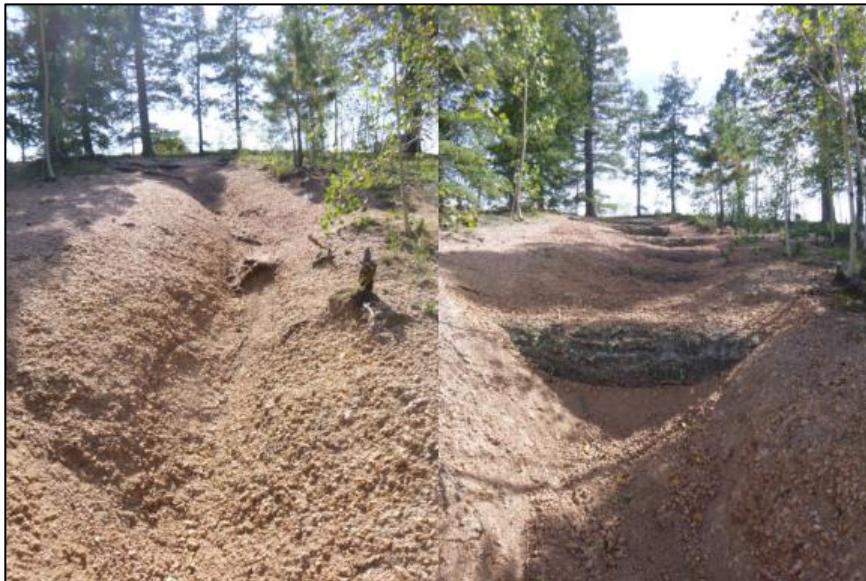
Before and after of check dam installation

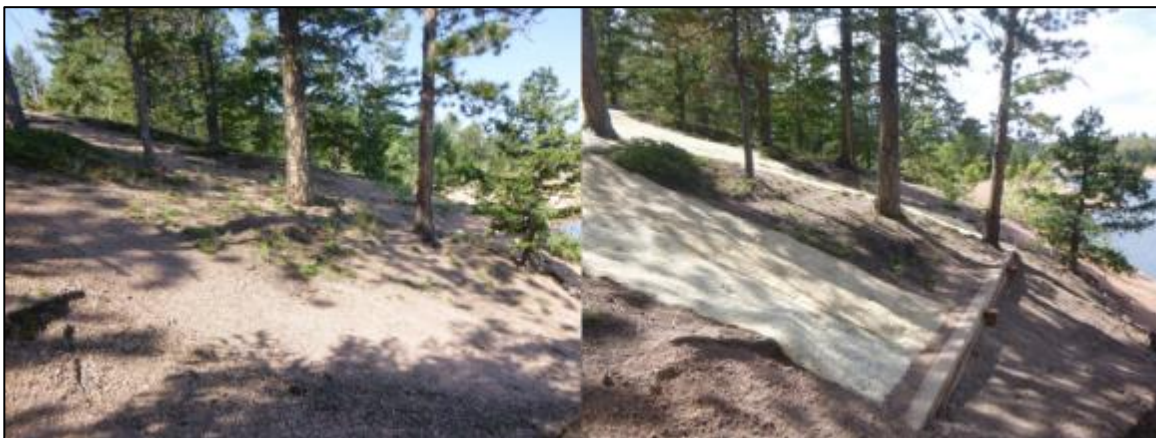
Before and after of retaining wall construction and erosion control matting installation

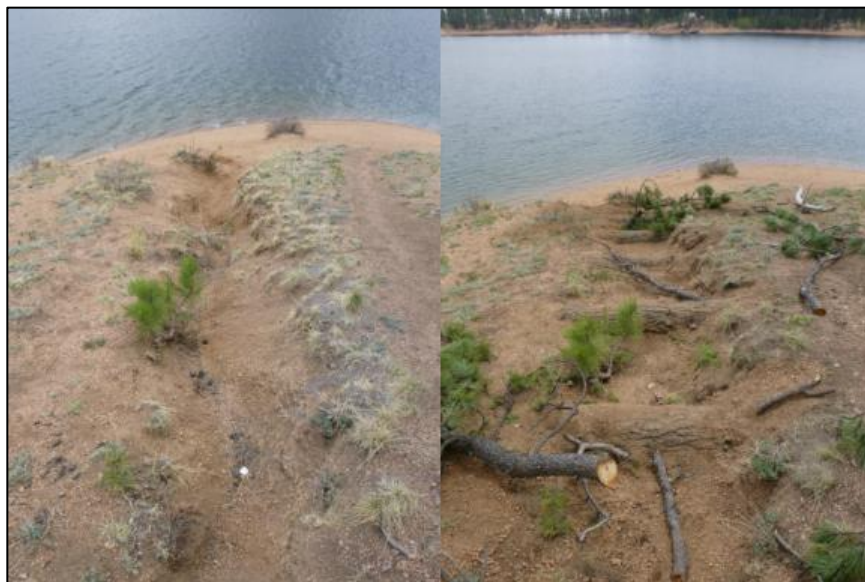
Before and after of check dam installation

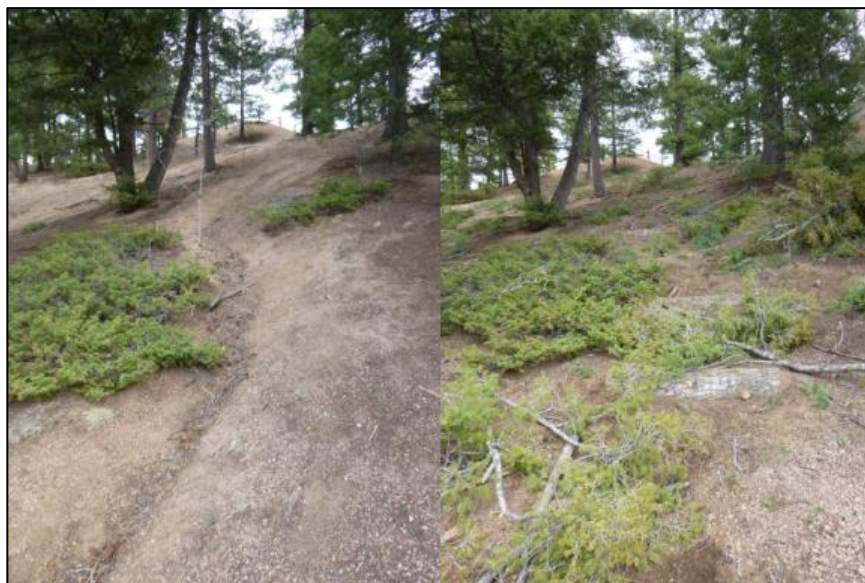
Before and after of check dam installation

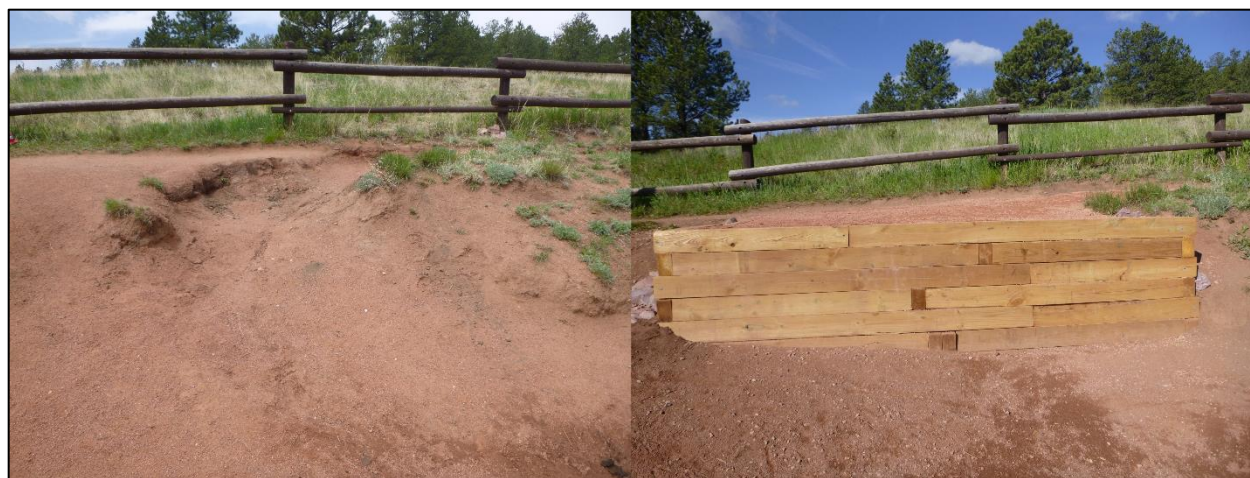
Before and after of retaining wall construction

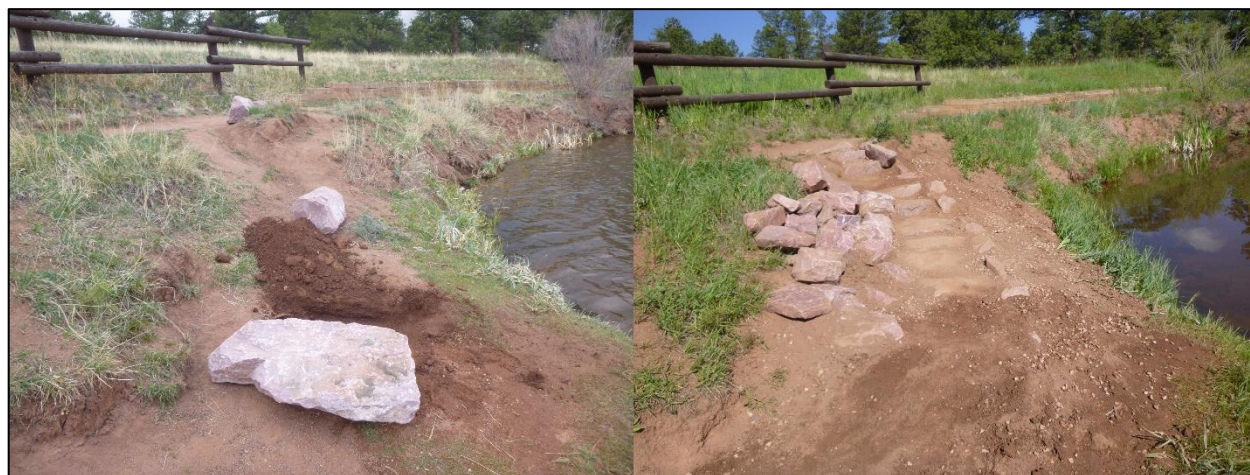
Before and after of rock step construction
