Florida Consolidated Ditch Company

Re: Pastorius Reservoir Headgate Replacement – WSRF Grant – POGG1 2024-2481

Pastorius Headgate Replacement Final Report

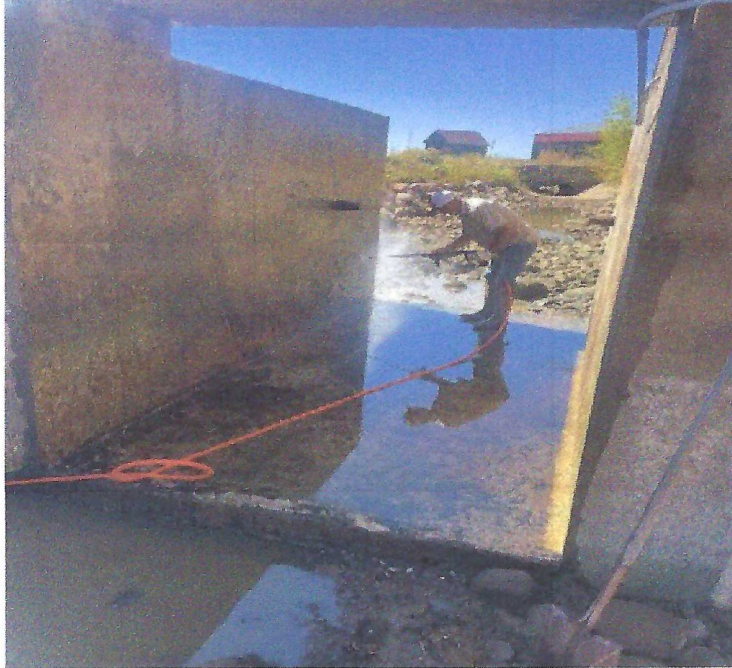
Figure 1 Power washing concrete to remove loose debris/organics a week ahead of time to allow time for concrete to dry thoroughly.

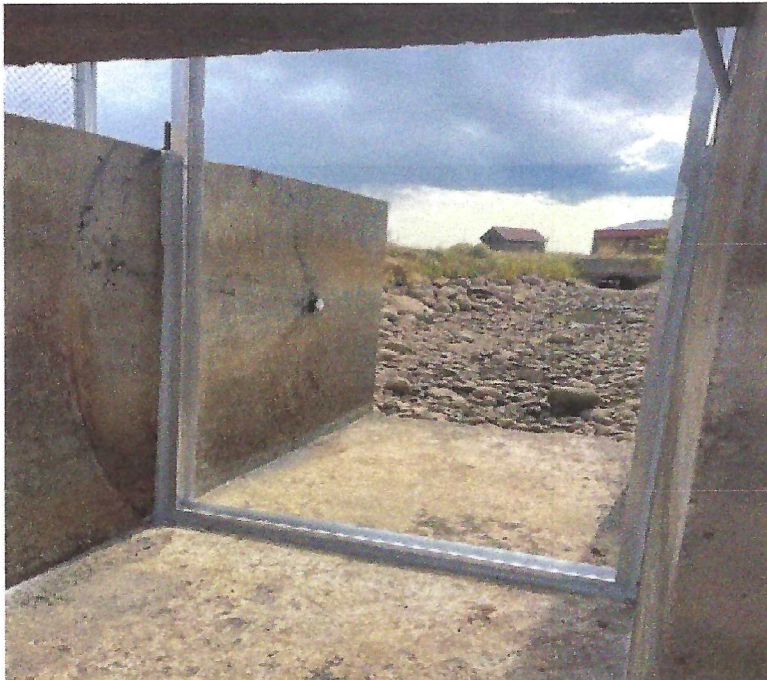
Figure 2 Anchored and sealed bracket into place on Oct.8th.

Prior to installation FCDC crews dropped reservoir level until there was about 10" of water in the canal channel. 4'x4'x3" sandbags were used to dam the water off. FCDC removed the old head gate with the utilization of a neighboring shareholders telehandler. On Oct 8th Rubicon technicians showed up and began installing the frame/bracket that holds the headgate. On Oct 9th FCDC removed the fencing and the headgate itself was installed. The tin on the shed next to the head gate had to be removed as there was about 2" that was in the way as we had to lower the headgate from above to slide into the brackets. The landings were installed, and chain-link fence reinstalled. The headgate was commissioned, and the project was complete by 6 pm Oct 9th. On the morning of Oct 10th FCDC and removed the sandbags.

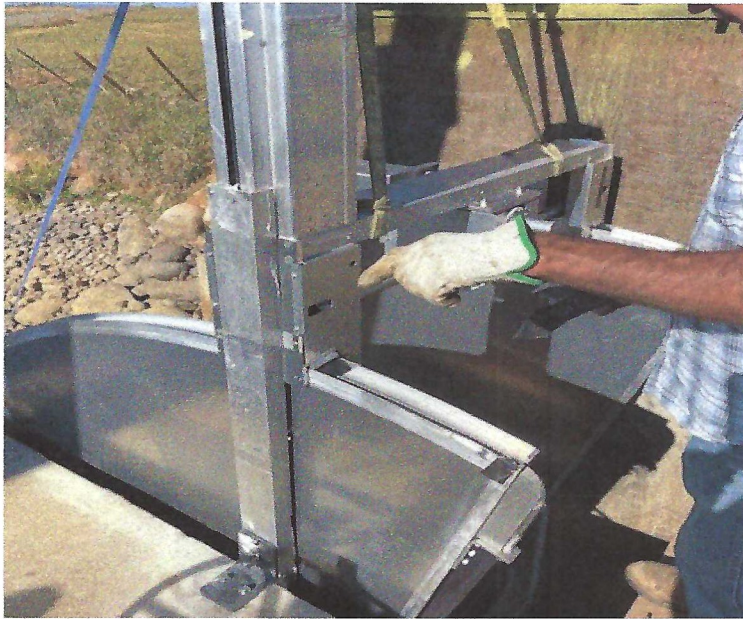
Figure 3 Lowering headgate into bracket on Oct 9th

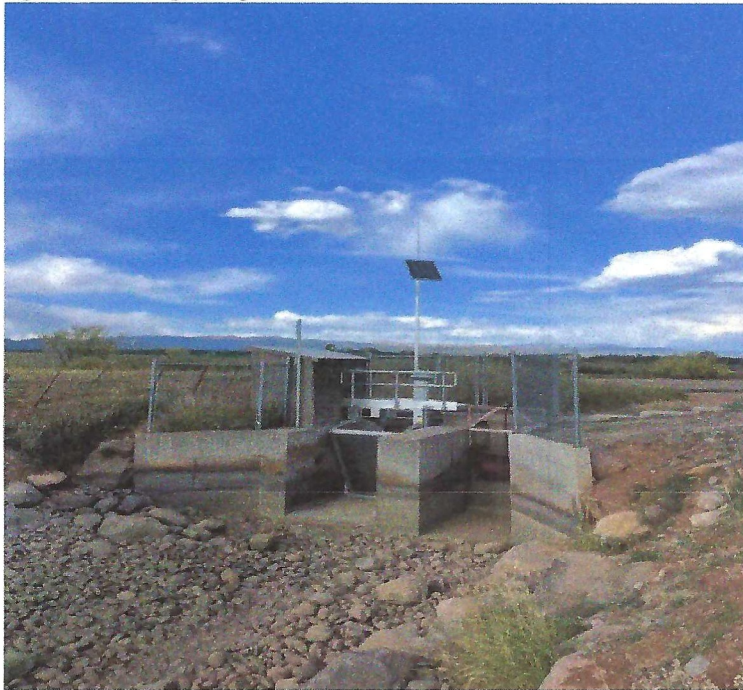
Figure 4 Pastorius headgate installed and commissioning completed Oct 9th.

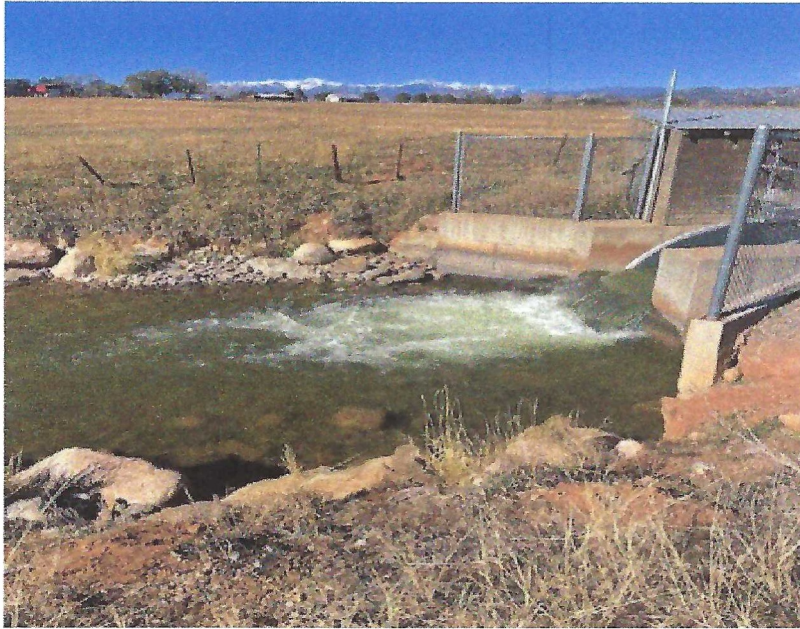
Figure 5 Pastorius headgate in operation Nov 11. during the fall stock water run .

The headgate got its first test when we ran our fall stock water run in November. As we had the reservoir at a low level to install the headgate, we had to replenish the reservoir all the while delivering stock water. The new automation allowed FCDC operations to enter preset positions and raise the gate 2" every hour. This allowed FCDC to fill the reservoir and deliver stock water without going to site and making those adjustments saving time and water. FCDC was able to fill the reservoir without running the canal system for extra days to do so.

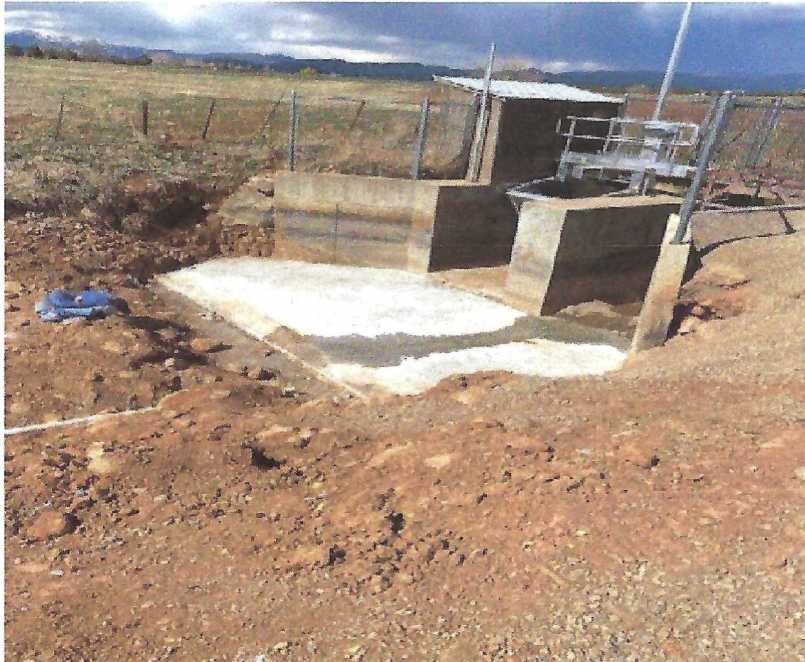
After the fall stock run we noticed that the splash pad would need to be extended. Due to the headgate size, it creates a plunge pool just beyond the edge of the existing concrete. While during normal high flow it's not much of a concern because the channel is full of water. When the canal is at lower flows the plunge pool scoured heavily, this was apparent when we ran the fall stock water run.

Figure 6 Extending concret splash pad March 2025
