COLORADO DIVISION OF RECLAMATION, MINING AND SAFETY COAL PROGRAM INSPECTION REPORT

Permit Number: C-1981-013 Mine Name: Golden Eagle Mine Operator: New Elk Coal Company, LLC Operator Address: Mr Mark Haywood 12250 State Highway 12 Weston, CO 81091	County: Las Animas Operation Type: Underground Permit Status: Permanent Cessation Ownership: Private
Operator Representative Present:	
Operator Representative Signature: (Field Issuance Only)

Inspection Start Date: September 18, 2013 Inspection Start Time: 08:10 Inspection End Date: September 18, 2013 Inspection End Time: 08:40	Inspection Type: Coal Partial Inspection Inspection Reason: Normal I&E Program Weather: Clear
Joint Inspection Agency: None	Joint Inspection Contacts:
Post Inspection Agency: None	Post Inspection Contacts:
Inspector(s): Leigh D. Simmons	Inspector's Signature:

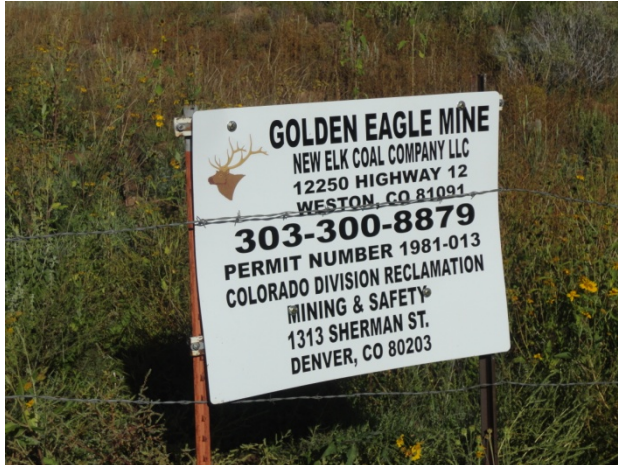
The mine ID sign had been replaced. The new sign shows most of the required information, but per rule 4.30.2(3), a mine in permanent cessation must *“include the name, address, and telephone number of the Division*

office where the mining and reclamation permit is filed” and therefore the number 303 866 3567 should be added to the sign.

Photo 1: New mine ID sign, needs DRMS phone number

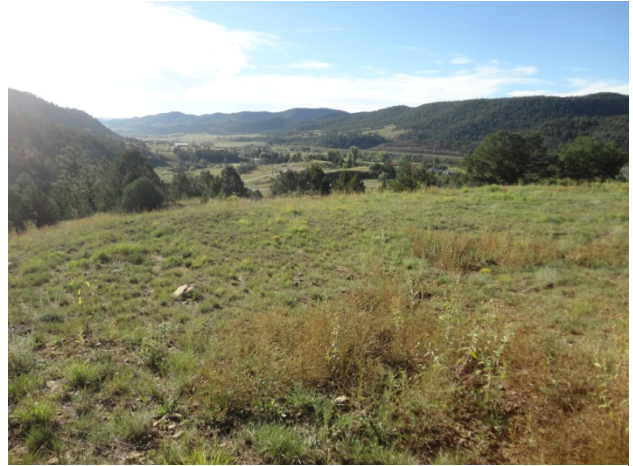
Vegetation still looked green and healthy. NECC expects to contract with Arcadis to conduct vegetation sampling within the next few weeks.

Photo 2: View to the south east, showing vegetation

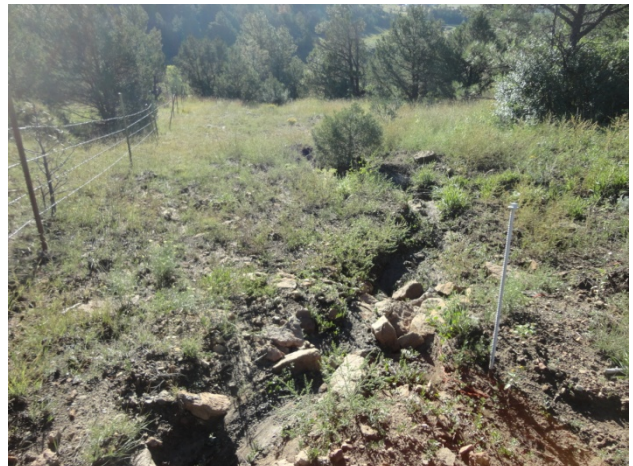
The site was well drained, with no muddy patches. No work had been done to repair the erosion noted previously in the natural drainage at the north-eastern edge of the site. **The rills and a small gully within the Golden Eagle disturbed area boundary markers should be repaired, and flow control structures, such as straw wattles, should be installed to prevent further damage.**

Photo 4: Erosion repairs and controls needed
